# **INSPECTION REPORT SUMMARY**

March 5, 2024

Inspection Report Exclusively For: Aleksey and Tatyana Feldman

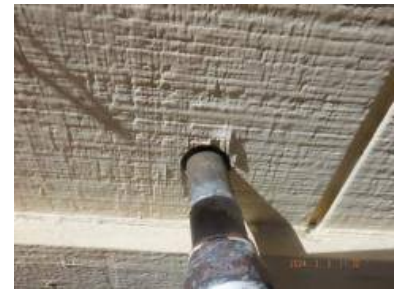
[CR] There were gaps between the wood siding and adjacent materials. These conditions are conducive to moisture intrusion/deterioration. We recommend correcting the condition(s) noted.

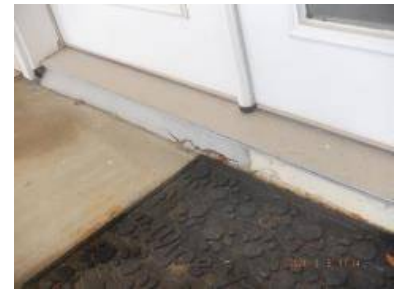
[FE] Past repairs were noted to the door thresholds. Inquire about any previous work done.

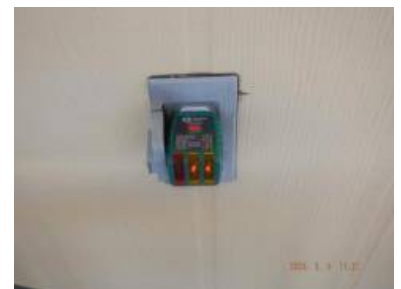
[SC] The accessible receptacles were not GFCI protected as required. This condition is a safety hazard. We recommend correcting the condition(s) noted.

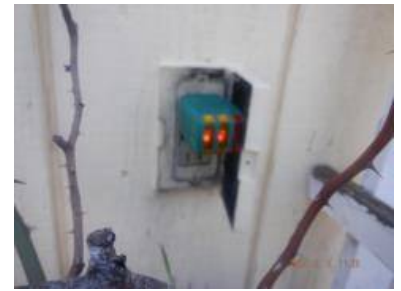
[SC] The GFCI receptacle was providing power, but failed to trip when tested. This condition is safety hazard. We recommend correcting the condition(s) noted.

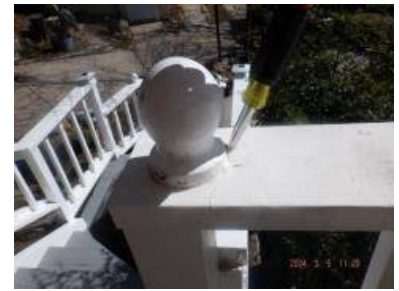
[SC] The guardrails were damaged/deteriorated in areas. We recommend correcting the condition(s) noted.

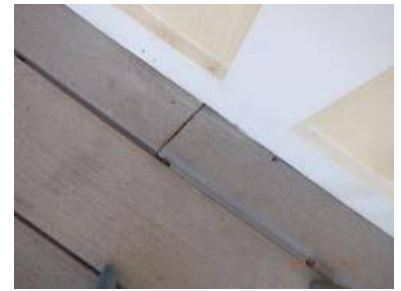
[CR] The deck was located too close too the ground. This condition is conducive to moisture damage and deterioration. We recommend correcting the condition(s) noted.

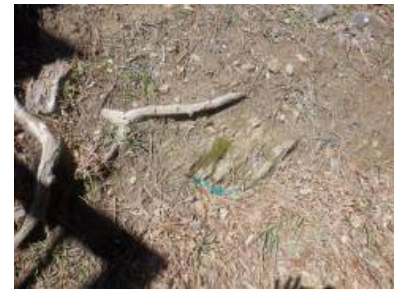
[NOTE] Root activity was noted near the foundation.

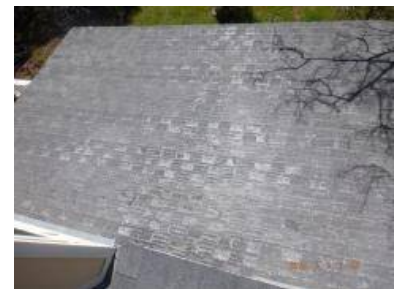
[FE] The shingles had extensive granulation loss, erosion and cracking throughout the shingled surface. These condition(s) are conducive to moisture intrusion, **roof leaks**, and deterioration. We recommend further evaluation and corrections by a specialist in the appropriate trade.

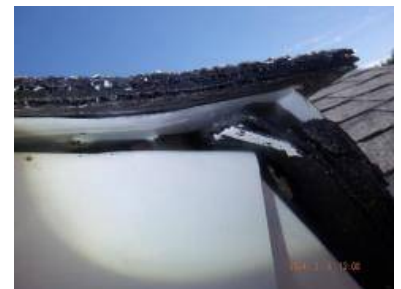
[CR] There were acorns stored underneath the roofing material in some areas. We recommend correcting the condition(s) noted.

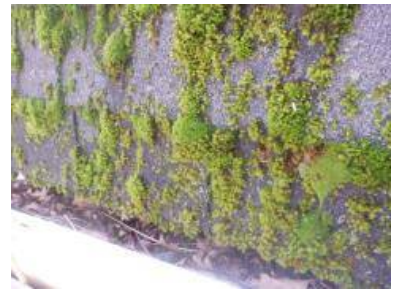
[CR] There was a lichen/algae growing on the roof in areas. We recommend correcting the condition(s) noted.

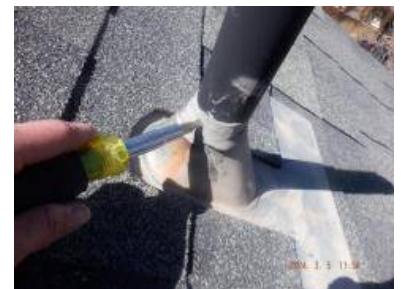
[CR] The mastic used to seal some of the roof connections and penetrations was cracked. We recommend correcting the condition(s) noted using approved methods. [NOTE] Ongoing maintenance

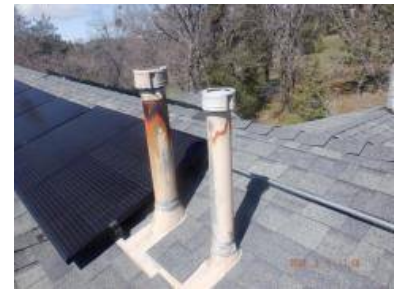
[CR] There were rusted-out/damaged/deteriorated flue pipe cap(s). We recommend correcting the condition(s) noted.

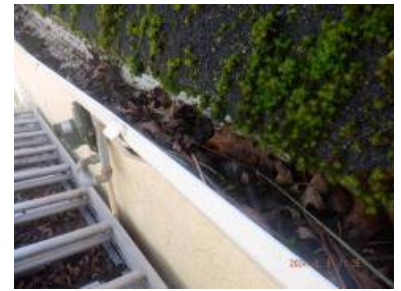
[CR] The gutters were filled with debris which restricts proper drainage. We recommend correcting the condition(s) noted.

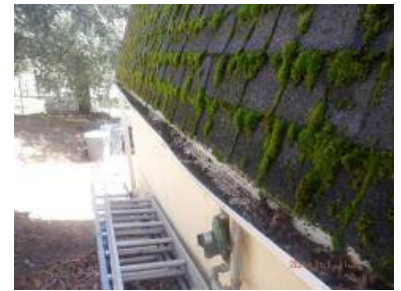
[CR] The rain gutter(s) were improperly sloped and holding water. We recommend correcting the condition(s) noted.

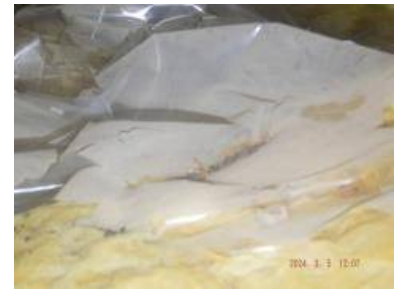
[FE] Evidence of rodent activity was noted in the attic. We recommend a full evaluation by a specialist in the appropriate trade.

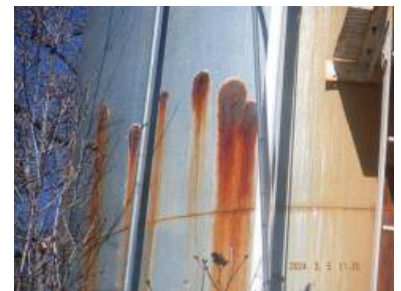
[FE] The well tank was rusted and showed evidence of past leakage. We do not test for function or potable water. We recommend further evaluation and corrections by a specialist in the appropriate trade.

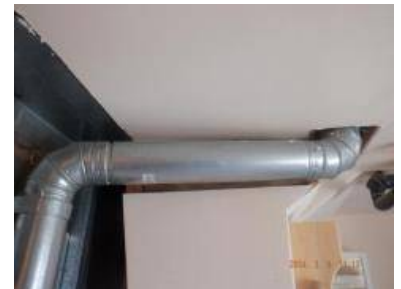
908 *VENTING SYSTEM:* [SC] The flue vent pipe installation was partially horizontal. We recommend correcting the condition(s) noted.

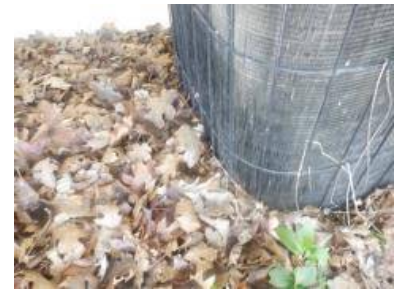
[RU] The condensing unit was not bolted/fastened/strapped in place. We recommend correcting the condition(s) noted.

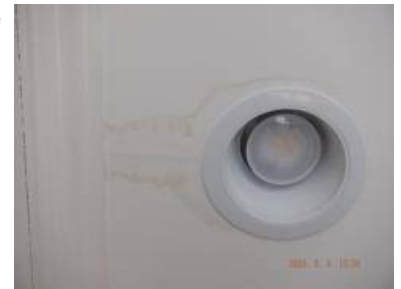
[CR] Moisture/stains were noted on the ceiling. The area tested **actively wet** during the inspection. We recommend locating correcting the source as well as any damaged materials.

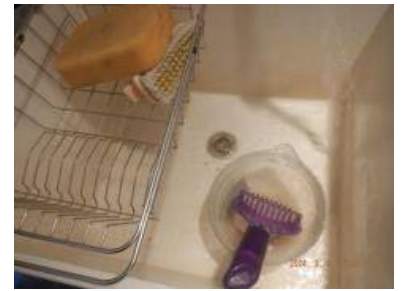
[CR] The sink drain was slow or blocked. We recommend correcting the condition(s) noted.

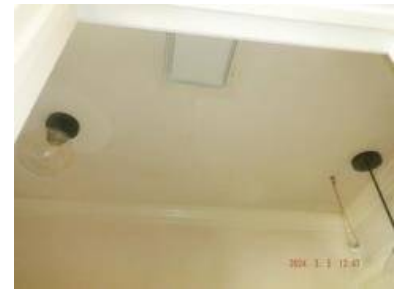
1301 WALLS/CEILING: [FE] Past repairs were noted on the wall(s)/ceiling. We recommend inquiring about any previous work done.

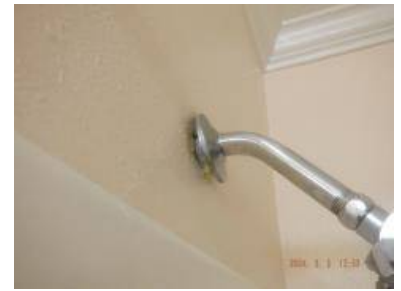
[CR] The faucet(s)/spout were not sealed to the wall/deck. This condition is conducive to moisture intrusion into concealed spaces. We recommend correcting the condition(s) noted.

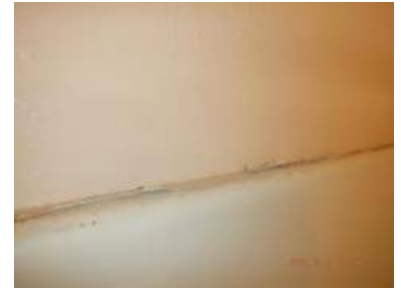
[CR] The grout/caulking was cracked, damaged or missing. This condition is conducive to moisture intrusion into concealed spaces. We recommend correcting the condition(s) noted.

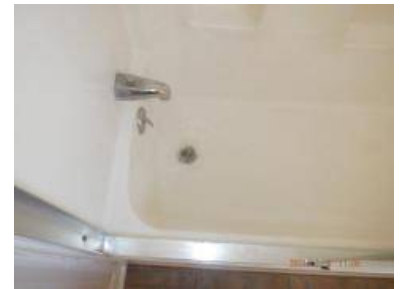
[CR] The tub drain was slow/blocked. We recommend correcting the condition(s) noted.

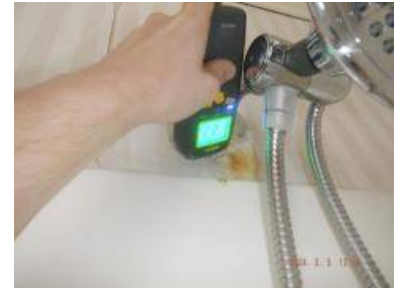
[CR] Moisture/stains were noted on the wall near the shower head. The area tested dry during the inspection. We recommend locating and correcting the source as well as any damaged materials.

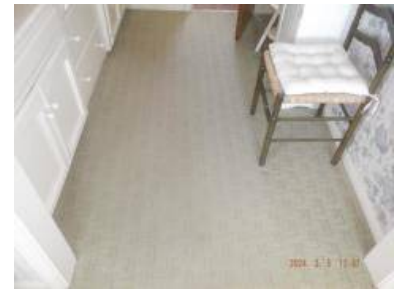
[CR] The carpet was soiled. We recommend correcting the condition(s) noted.  
 [NOTE] Carpeted bathrooms can trap moisture, urine, feces and other substances that can cause damage and health issues. It can also create conditions that may encourage the growth of microbes such as fungi-mold. It also reduces the accuracy for moisture testing around the toilet wax ring. This is not a sanitary or recommended practice and we recommend that all carpet be removed from bathroom areas.

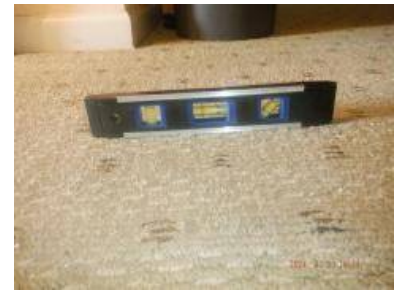
[FE] Areas of the flooring were not level in the finished basement area. We recommend further evaluation and corrections by a specialist in the appropriate trade.
