Building No. / Street C	ity	Zip		Date of Inspection	Number of Pages	
13217 Aurora Drive 11 E	El Cajon	92021		04/11/2024	1 of 6	
HAYD COM			A LICENS	ED PEST CONT	ROL	
		1331 Morena Blvd	OPERATO	OR IS AN EXPER	T IN	
DECT	S	San Diego, CA 92110	HIS/HER	FIELD. QUESTIO	NS	
PEST		1.800.570.2847	RELATIVI	E TO THIS REPO	RT	
CONTROL		Registration #436	SHOULD	BE REFERRED 1	-O	
			HIM/HER	F	Report #: 66030	
Ordered by:	Property Owner and	d/or Party of Interest	Repo	rt sent to:		
Heidi Kresler	Heidi Kresler		Heid	li Kresler		
13217 Aurora Drive 11	13217 Aurora D	rive 11	132	13217 Aurora Drive 11		
El Cajon, CA 92021	El Cajon, CA 92	El Cajon, CA 92021		El Cajon, CA 92021		
Complete Report Limited Report Supplemental Report Reinspection Report				ort \square		
General Description:			Inspection Ta	g Posted:		
Occupied Mobile One Story			Exterior			
No Garage			Other Tags Posted:			
Slab Foundation with Composition Roof			None

Building No. / Street	City	Zip	Date of Inspection	Number of Pages
13217 Aurora Drive 11	El Cajon	92021	04/11/2024	2 of 6

Findings And Recommendations

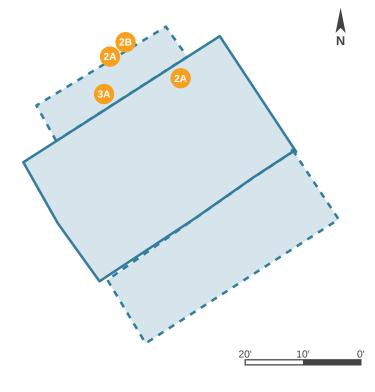
Evidence of drywood termites found in areas marked on Diagram.

Termite damaged wood found at areas marked on diagram.

Fungus damaged wood at areas marked on diagram trim.

Cover entire structure(s) and fumigate with Sulfuryl Fluoride for the elimination of drywood termites. Chloropicrin will be used as a warning agent. Cover or remove accessible termite pellets. Lloyd Termite Control Company assumes no responsibility for damage to any plant life or roofing caused by fumigation operation.

Repair termite damaged wood as needed. Painting is not included in this estimate. If damaged wood extends into concealed or inaccessible areas, cost of repair will be in addition to estimate given.

Remove and replace fungus damaged wood as needed. Painting is included in this estimate. If damaged wood extends into concealed or inaccessible areas, cost of repair will be in addition to estimate given.
