## Home Inspection Report

**1177 Muirlands Vista Way, La Jolla**

**Carlos Arechiga**  
**October 8, 2025**

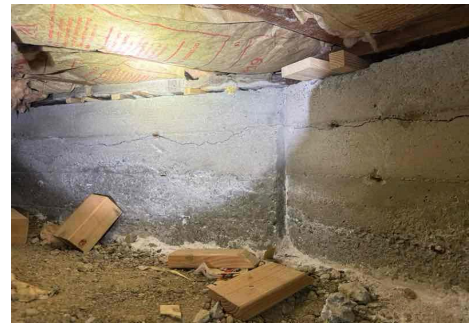
Photo 58

1. A horizontal crack was observed in the foundation wall at the front of the structure. Horizontal cracks may result from various factors, including foundation wall movement or stress. In some cases, they can also be caused by the expansion of reinforcing steel due to moisture intrusion, particularly when near the edge of the formwork used during construction. This condition may indicate a potential defect or developing concern. A thorough evaluation is beyond the scope of this visual inspection. We recommend further assessment by a licensed foundation contractor to determine the cause and whether any repairs are warranted. (See Photo 58) (See Photo 60)

- ! 1. A horizontal crack was observed in the foundation wall at the front of the structure. Horizontal cracks may result from various factors, including foundation wall movement or stress. In some cases, they can also be caused by the expansion of reinforcing steel due to moisture intrusion, particularly when near the edge of the formwork used during construction. This condition may indicate a potential defect or developing concern. A thorough evaluation is beyond the scope of this visual inspection. We recommend further assessment by a licensed foundation contractor to determine the cause and whether any repairs are warranted. (See Photo 58) (See Photo 60)

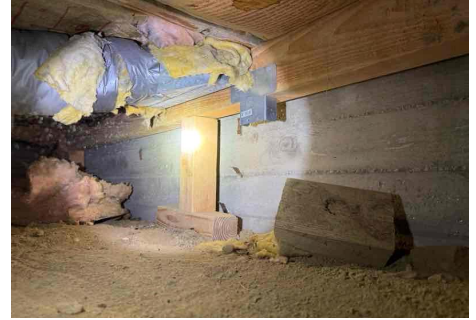
Photo 61

4. One or more girders, piers and/or post at the front of the crawl space have been altered and added improperly. The existing configuration indicated improper design and/or workmanship. We recommend repair or replacement, in accordance with present standards. It is recommended that a qualified licensed contractor be consulted for further advice on structural improvements. (See Photo 61)

- ! 4. One or more girders, piers and/or post at the front of the crawl space have been altered and added improperly. The existing configuration indicated improper design and/or workmanship. We recommend repair or replacement, in accordance with present standards. It is recommended that a qualified licensed contractor be consulted for further advice on structural improvements. (See Photo 61)

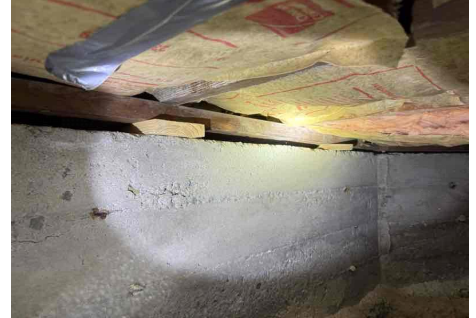
Photo 59

5. As noted from the crawl space portions of the structure have been leveled by shimming the mudsill and piers. This is an indication of past movement in the foundation and we are not qualified to evaluate the repairs. We recommend review of any engineering, plans and/or permits associated with this work by a qualified engineer. (See Photo 59)

- ! 5. As noted from the crawl space portions of the structure have been leveled by shimming the mudsill and piers. This is an indication of past movement in the foundation and we are not qualified to evaluate the repairs. We recommend review of any engineering, plans and/or permits associated with this work by a qualified engineer. (See Photo 59)

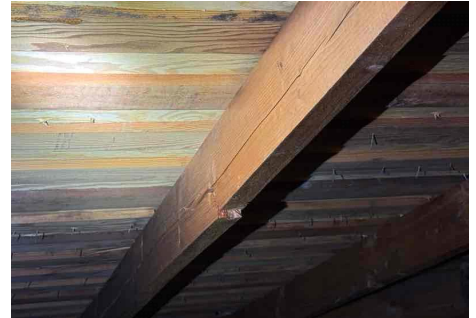
Photo 38

6. One or more roof supports, rafters or joists over the front of the attic are disconnected, cracked and/or damaged. This can may affect the integrity of the roof. This area should be investigated and improved by a qualified licensed professional. (See Photo 38)

- ! 6. One or more roof supports, rafters or joists over the front of the attic are disconnected, cracked and/or damaged. This can may affect the integrity of the roof. This area should be investigated and improved by a qualified licensed professional. (See Photo 38)

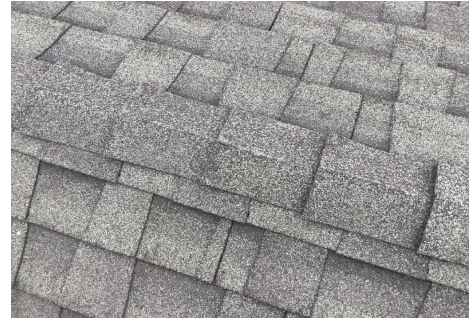
Photo 04

7. Portions of the surface granulation are deteriorated and minor surface cracks are developing. These may be normal signs of aging. For further evaluation of the condition of the roof we recommend you consult a licensed roofing contractor. (See Photo 4)

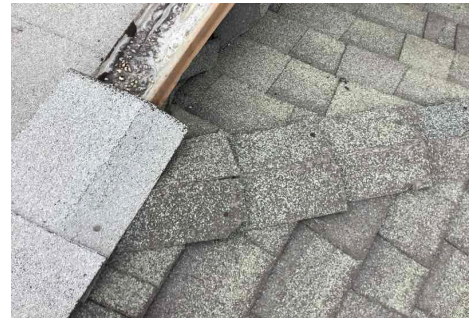
Photo 01

8. Repairs to the roof covering are recommended. Damaged, loose or missing roofing material at the rooftop should be repaired or replaced. All roof penetrations should be examined and sealed as necessary. For further evaluation of the condition of the roof we recommend you consult a licensed roofing contractor. (See Photo 1) (See Photo 2) (See Photo 3)

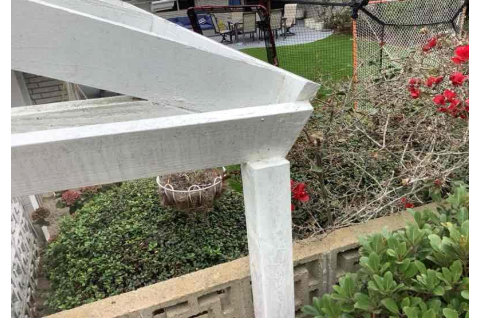
Photo 29

19. The patio cover post's hardware is loose and/or missing. We recommend the patio cover post's hardware be corrected. (See Photo 29)

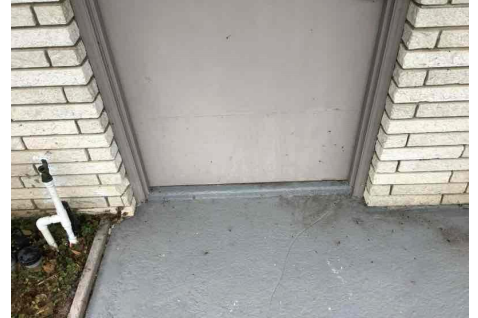
Photo 18

20. A missing or improper threshold was noted at the garage doors. We recommend the installation of a threshold that conforms to present building standards. This will also help to avoid possible trip hazards and limit moisture intrusion. (See Photo 18)

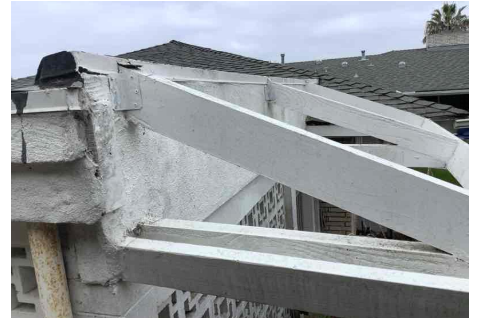
Photo 27

21. The patio cover is improperly attached to the structure with nails/screws. This condition could pose a safety hazard with lateral forces or seismic activity. We recommend the patio cover be secured to the structure with proper flashing and bolts according to local building codes. (See Photo 27)

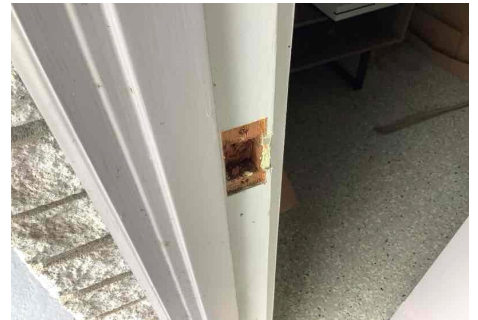
Photo 20

22. Missing hardware was noted at the garage bathroom door. We recommend that hinges, knobs, latches and strike plates be adjusted or replaced to restore full operation. (See Photo 20)

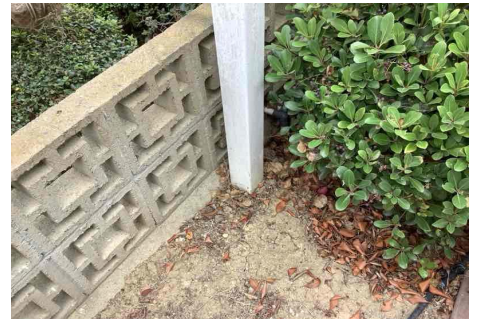
Photo 26

23. Wood/soil contacts at the patio cover posts should be avoided. Wood in contact with soil promotes deterioration to wood members. If any deterioration is noted after the soil has been removed consult a licensed structural pest control operator. (See Photo 26)

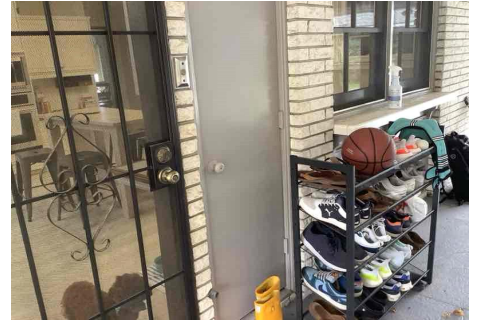
Photo 44

24. The door in the exterior rear was found to be inoperable or to be very difficult to operate. This door should be removed or corrected to allow for proper function. (See Photo 44)

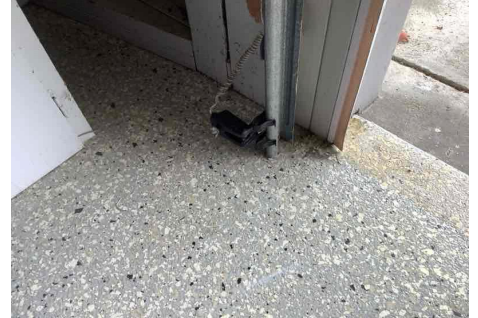
Photo 31

25. The garage door did reverse properly when the infrared detection system for the auto reverse was tested; however, we did note that the detection system for the auto reverse was installed too high or too low from the ground. We recommend proper mounting of the devices on the base of the garage jambs between 4" to 8" inches from the ground as per manufacturers recommendations. Information on the garage door openers is available from the consumer product safety commission at [www.cpsc.gov](http://www.cpsc.gov). (See Illustration 3B) (See Photo 31)

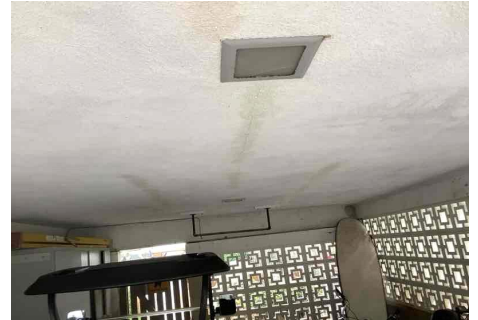
Photo 08

26. Staining was noted at the exterior rear overhang. This could indicate leakage through the roof covering. We recommend further evaluation correction by a licensed contractor. (See Photo 8)

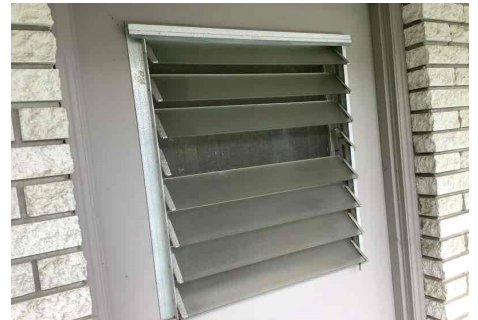
Photo 19

27. Missing windows at the garage bathroom door should be replaced. (See Photo 19)

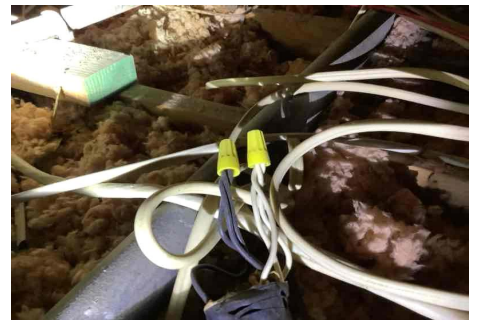
Photo 55

28. Running splices, which are improper connections outside of a junction box, were observed in the attic. We recommend connections be joined with approved connectors inside a junction box to prevent accidental contacts or mechanical damage. (See Photo 55)

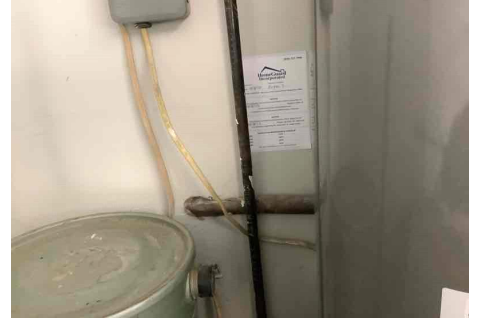
Photo 33

29. We found exposed wiring at the garage walls below 7' feet. Even if insulated, we recommend all wiring be encased in conduit or otherwise protected in accordance with present standards. (See Illustration 4E) (See Photo 33)

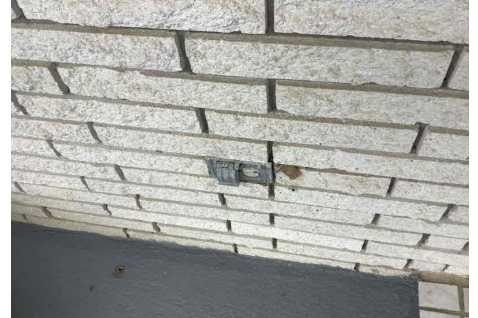
Photo 21

30. Exterior receptacles at the rear are missing a weatherproof cover plate. We recommend an approved exterior cover be installed. (See Photo 21)

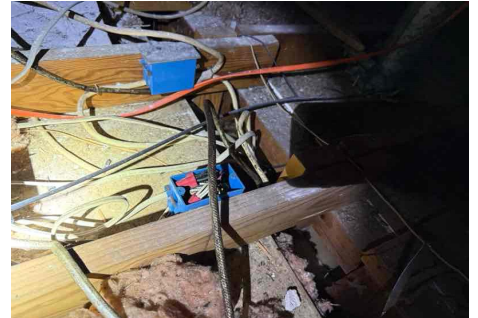
Photo 35

31. Exposed electric connections or open junction boxes at the attic should be corrected. All electric connections should be made inside approved junction boxes fitted with proper cover plates. (See Photo 35) (See Photo 57)

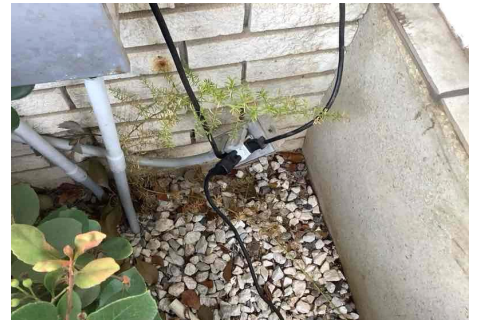
Photo 16

32. One or more outlets and/or receptacle housings at the exterior front are loose. Based upon our inspection of a representative number of outlets we recommend testing of every outlet. All loose outlets and receptacles should be repaired as necessary. (See Photo 16)

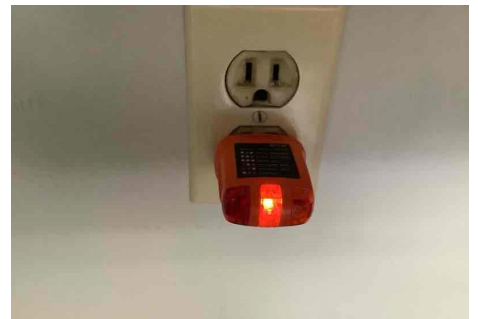
Photo 34

33. Ungrounded "3-prong" outlets at the garage should be improved. A grounded cable or ground wire could be installed at these outlets, the outlet labeled as ungrounded or the original "2-prong" receptacle could be reinstalled. Based upon our inspection of a representative number of outlets, we recommend testing of every outlet. Repairs or rewiring are recommended at all deficient locations. For additional information we recommend a licensed electrician be consulted. (See Illustration 4O) (See Photo 34)

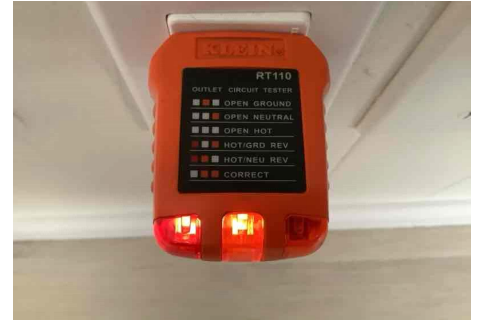
Photo 46

34. One or more outlets at the living room have reversed polarity, i.e. the hot and neutral connection inside the outlet are wired backwards. These outlets and the circuit should be investigated and corrected. Based upon our inspection of a representative number of outlets, we recommend testing of every outlet at a later date. Repairs or rewiring are recommended at all deficient locations. (See Illustration 4M) (See Photo 46)

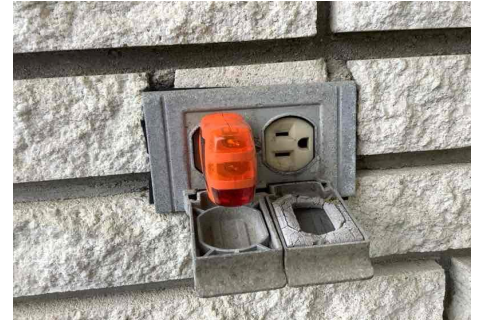
Photo 14

35. One or more outlets at the exterior front were inoperative at the time of our inspection. Possibly due to turned off switches which were not located during our inspection. These outlets and circuits should be investigated and corrected as necessary. Based upon our inspection of a representative number of outlets, we recommend testing of every outlet at a later date. Repairs or rewiring are recommended at all deficient locations. (See Photo 14)

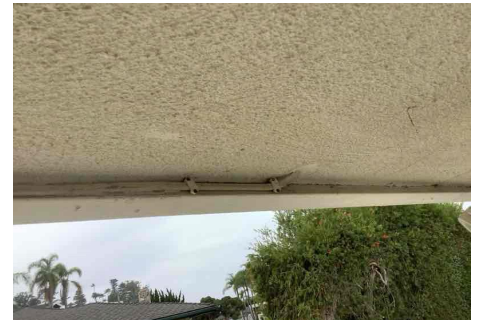
Photo 12

36. We found exposed wiring at the exterior right and left. Even if insulated, we recommend all wiring be encased in conduit or otherwise protected in accordance with present standards. (See Photo 12)

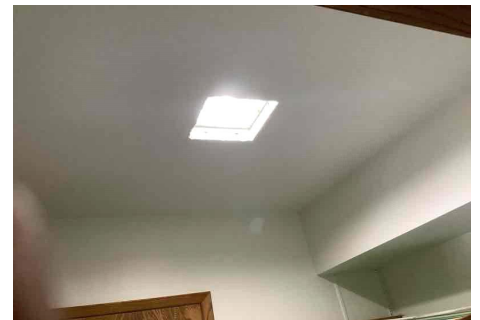
Photo 50

37. The missing cover(s) at the garage and laundry room light fixture should be replaced. (See Photo 50)

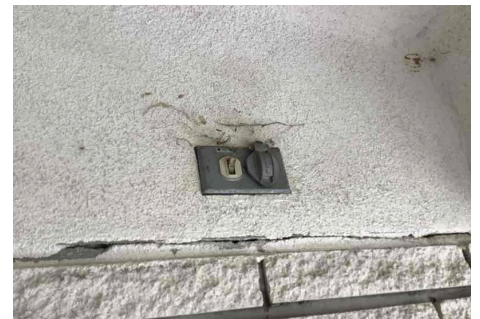
Photo 15

38. An exterior switch at the front is missing a water proof cover plate. We recommend an exterior approved cover be installed. (See Photo 15)

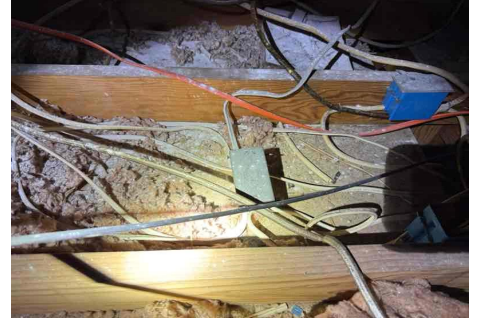
Photo 36

39. One or more electrical outlets or junction boxes at the attic were noted to be loose or unsecured. We recommend all loose or unsecured junction boxes be repaired. (See Photo 36)

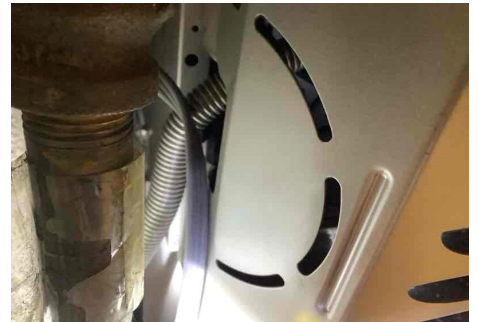
Photo 47

40. We noted a flexible gas line running through the furnace metal housing. We recommend consideration be given to installing rigid piping at the penetration of the housing and the installation of flexible supply piping at the exterior of the furnace. (See Photo 47)

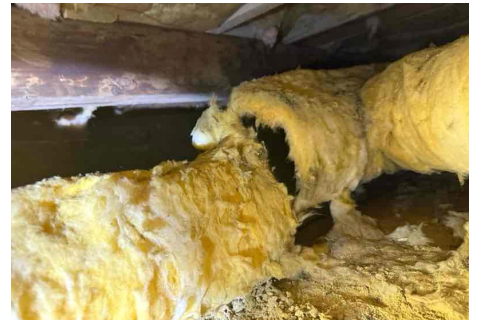
Photo 68

41. One or more sections of HVAC ductwork were observed disconnected at the crawlspace. Disconnections allow conditioned air to escape and can draw unfiltered air into the system, reducing efficiency and comfort. We recommend a qualified HVAC technician fully evaluate all ductwork, reconnect and properly seal joints, replace damaged sections as needed, and restore secure support and continuous, airtight duct runs throughout. (See Photo 68)

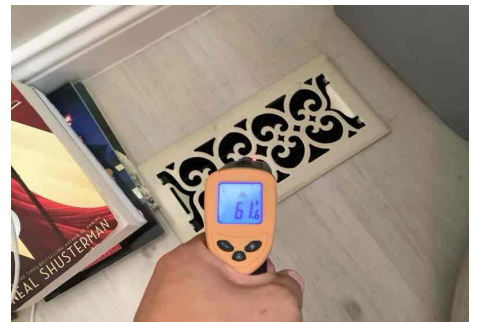
Photo 52

42. During operation of the air conditioning unit or heat pump we noted a minimal temperature change between the output of the cooling system and the ambient room temperature. A low temperature change typically indicates the unit requires servicing or repair. We recommend a licensed HVAC contractor be retained for further evaluation of the system and service if necessary. (See Photo 52)

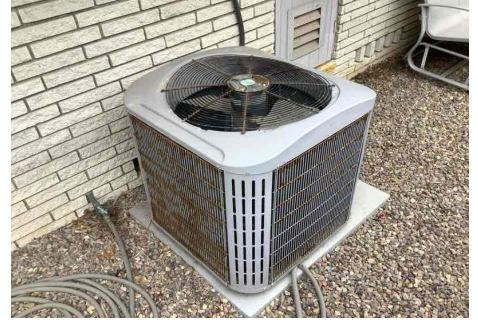
Photo 23

43. The exterior condenser unit shows deterioration. This may be a cosmetic condition, but it could be a sign of other problems beyond the scope of our inspection. We recommend consulting a licensed HVAC contractor for further evaluation. (See Photo 23)

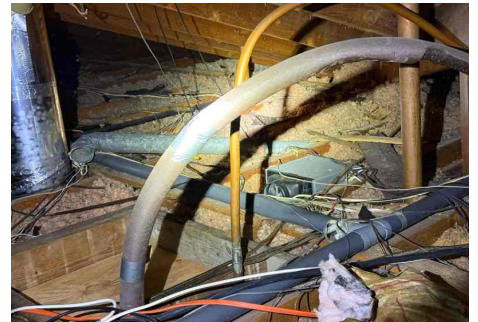
Photo 39

44. Disconnected, missing and/or loose attic exhaust vent pipes for the bathroom should be corrected to fully exhaust air to the exterior. (See Illustration 7D) (See Photo 39)

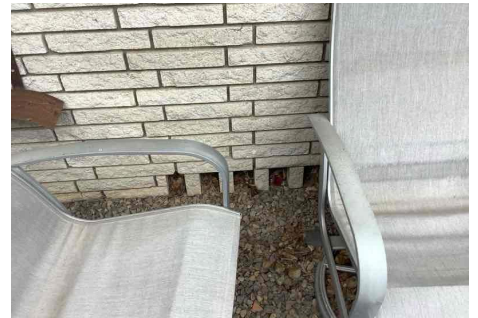
Photo 22

45. One or more of the crawl space vents are even with or below the exterior grade level at the left and rear. This condition can allow moisture to enter the crawl space. We recommend the exterior grading be improved to slope away from the structure. If the opportunity for easy grading does not exist, the installation of dams around the exterior of the vents should be considered. (See Photo 22)

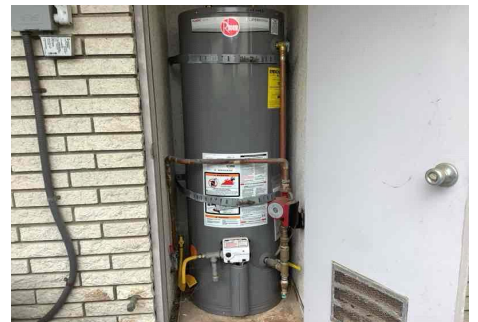
Photo 25

46. The water heater seismic straps are loose, this will allow movement of the tank in an earthquake. We recommend tightening the straps and/or adding bracing between the tank and wall to improve safety. (See Photo 25)

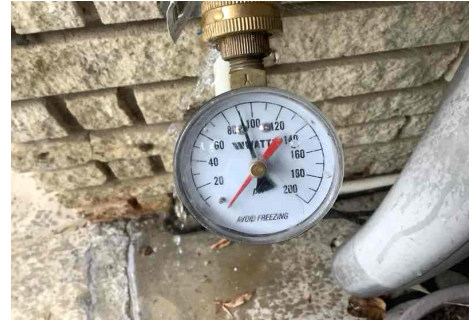
Photo 69

47. The water pressure of the home was tested and found to be 90 psi. The current pressure is higher than the typical range of 45-75 psi. We recommend contacting a licensed plumber for further evaluation of this condition. (See Photo 69)

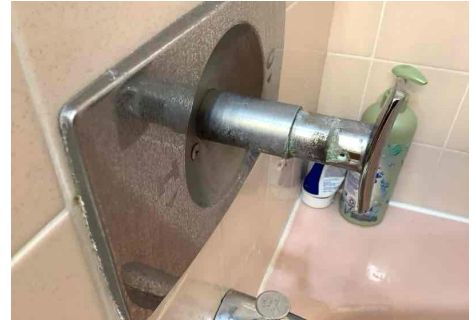
Photo 53

48. The tub faucet and/or handles are leaking at the left side hall bathroom. We recommend all leaks be repaired. (See Photo 53)

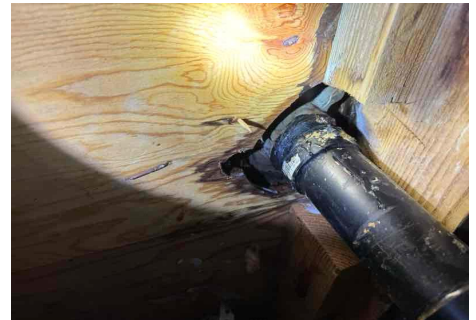
Photo 56

49. The drain is leaking into the crawl space under the master bathroom and left side hall bathroom. We recommend all leaks be repaired. (See Photo 56) (See Photo 67)

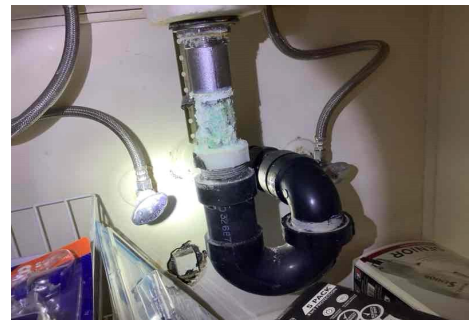
Photo 51

50. There is evidence of a past leaks and corrosion but presently no active leakage on the exterior of the bathroom and kitchen drain/supply lines. This area should be monitored for leakage and repaired as necessary. Upgrading this piping and connections should be considered. (See Photo 51)

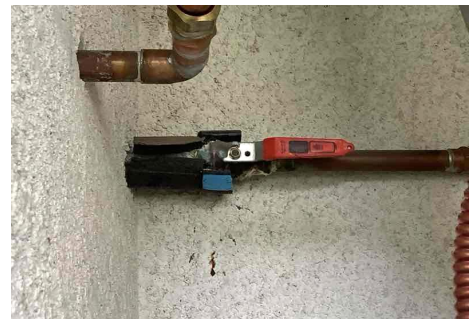
Photo 24

51. There is evidence of heavy corrosion and rust, but no leakage on the exterior of the exposed and accessible metal supply piping at the water heater. This piping should be monitored for leakage and repaired as necessary. Upgrading this piping and connections should also be considered. (See Photo 24)

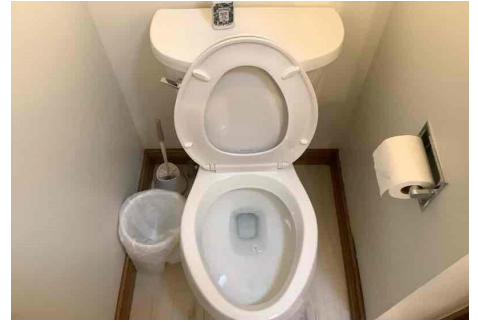
Photo 48

52. The toilet at all bathrooms is loose and should be properly re-secured, tightened and caulked. (See Illustration 8J) (See Photo 48)

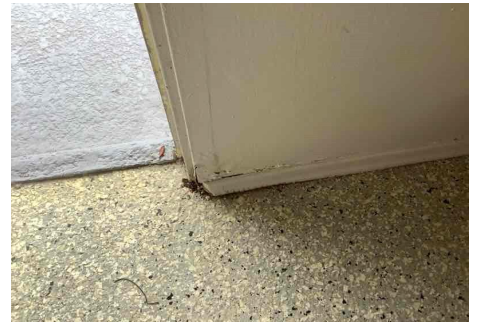
Photo 42

53. The wall at the garage bathroom shows evidence of water damage. We recommend the services of a licensed structural pest control company for investigation. (See Photo 42)

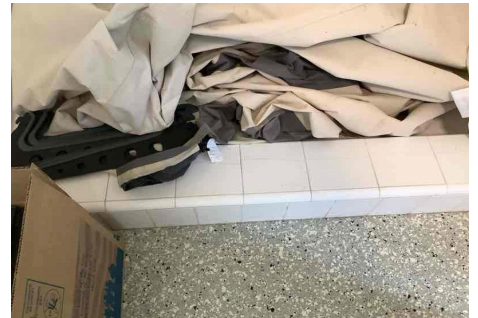
Photo 40

54. Cracked shower tile in the garage bathroom and master bathroom should be replaced. Water leaking through non-sealed areas can cause damage. Damage caused by water seepage cannot be determined by visual observation. (See Photo 40) (See Photo 72)

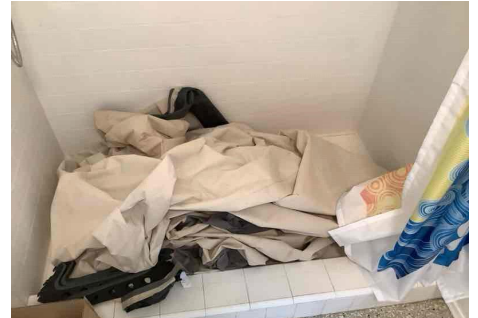
Photo 41

55. Personal storage was blocking access to the interior of the garage bathroom stall shower. Therefore, the area is considered inaccessible and was not fully inspected. With access and a opportunity for complete inspection, conditions in need of attention may be discovered. The personal belongings should be removed so the area may be examined. (See Photo 41)

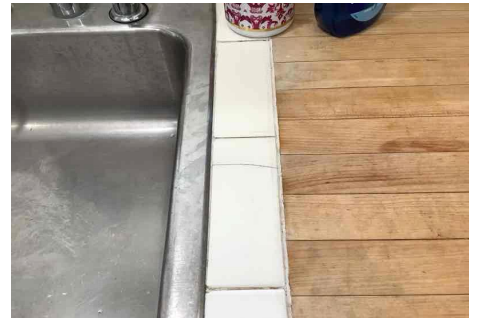
Photo 45

56. Cracked, damaged and loose kitchen countertop tiles should be replaced. Water leaking through non-sealed areas can cause damage. Damage caused by water seepage cannot be determined by this visual inspection. (See Photo 45)

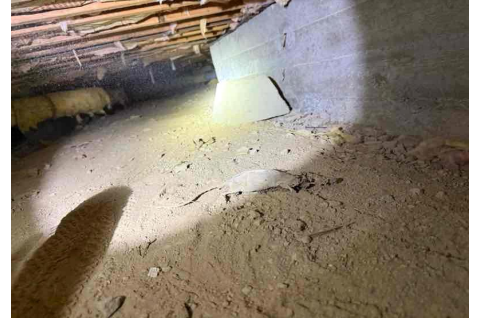
Photo 66

57. Evidence of vermin activity was observed within the structure. It is likely this evidence will extend into inaccessible areas. The owner is advised to contact the appropriate trade for further evaluation and remedial measures if necessary. (See Photo 66)

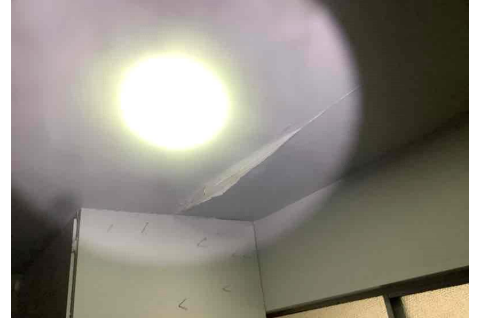
Photo 32

58. The ceiling in the garage is damaged. We recommend it be repaired. (See Photo 32)

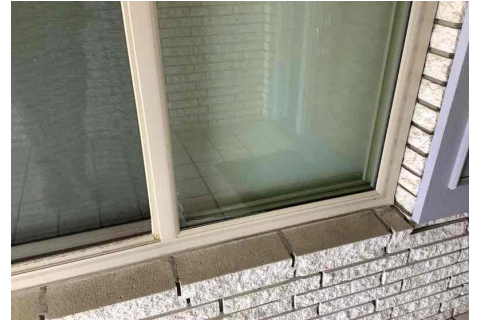
Photo 54

59. The window at the front wall exhibits conditions and/or symptoms that indicate a possible breached seal or failed thermal pane. This has or can result in condensation and/or moisture developing between the panes of glass that will effect the cosmetic appearance of the windows and their insulating performance. We recommend all insulated glass units be further evaluated by a licensed glazier and repaired or replaced as required. (See Photo 54)

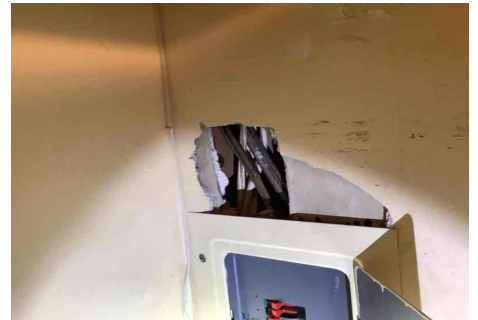
Photo 49

60. Holes in the hall bathroom closet drywall should be repaired as necessary. (See Photo 49)

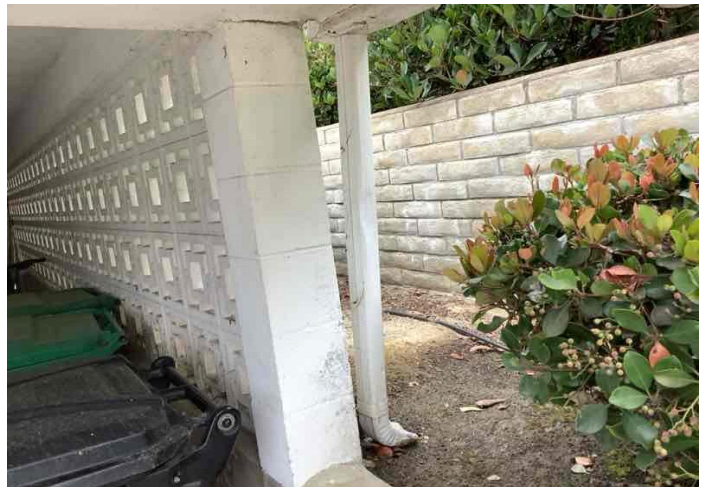
Photo 10

9. Leaks were noted in the downspouts and/or gutters at various areas. During wet weather conditions these areas are more obvious and during dry weather conditions they are noted from the stains at the areas where the leaks have occurred. We recommend all leaks be repaired. (See Illustration 2D) (See Photo 5)
10. Loose/disconnected downspouts at the rear should be repaired or replaced. (See Photo 10) (See Photo 71)
