Home Inspection Report

14029 Barlupi Cir

Sonora, CA 95370

Inspected on Thu, Feb 12 2026 at 9:00AM

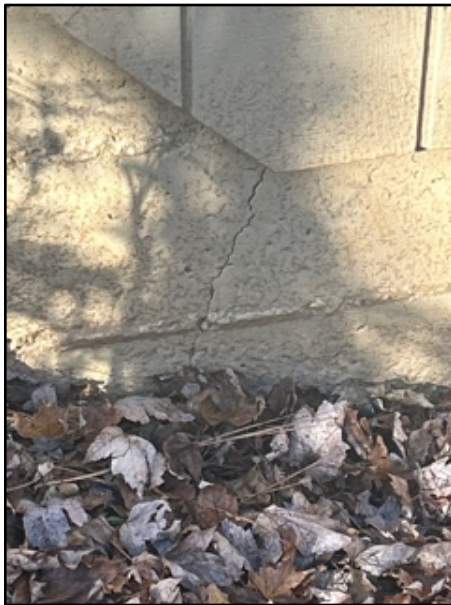
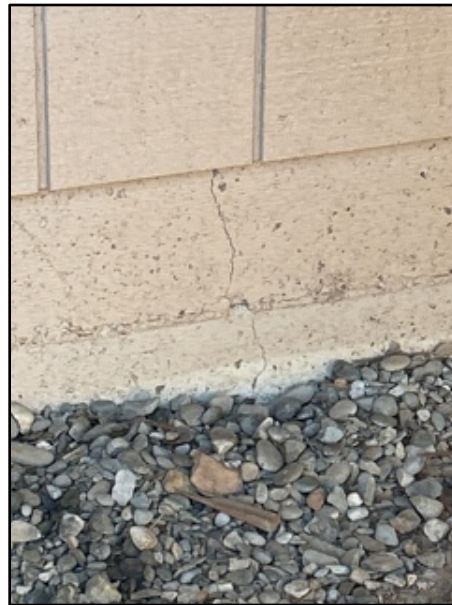
Hairline cracks were noted at areas of the concrete stemwall around the structure. These are considered normal stress cracks and no deflection was noted. This is not considered a structural issue.

- 1) Comment 1: Hairline cracks were noted at areas of the concrete stemwall around the structure. These are considered normal stress cracks and no deflection was noted. This is not considered a structural issue.

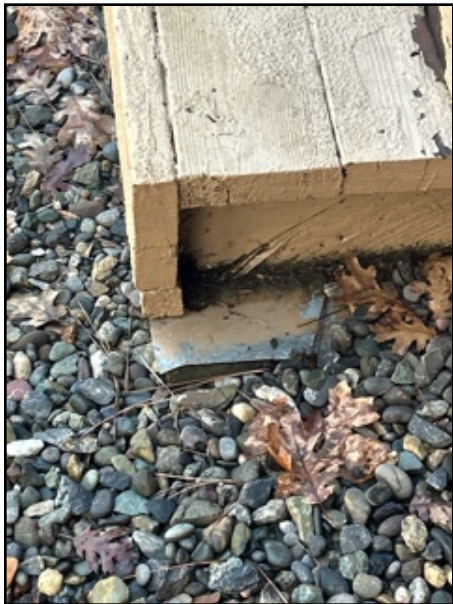
Figure 2-1

Wood deterioration was noted at the stair stringer at the rear steps to the crawlspace. Recommend repairing or replacing all affected materials as needed.

- 2) Comment 2: Wood deterioration was noted at the stair stringer at the rear steps to the crawlspace. Recommend repairing or replacing all affected materials as needed.

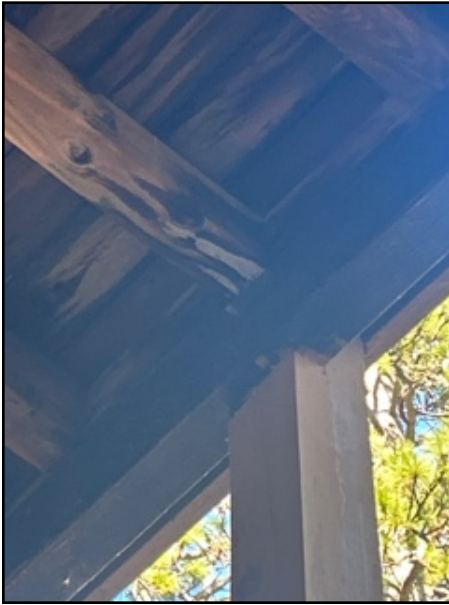
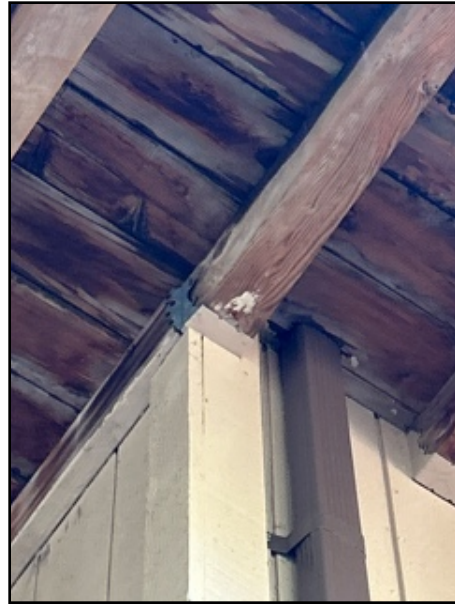
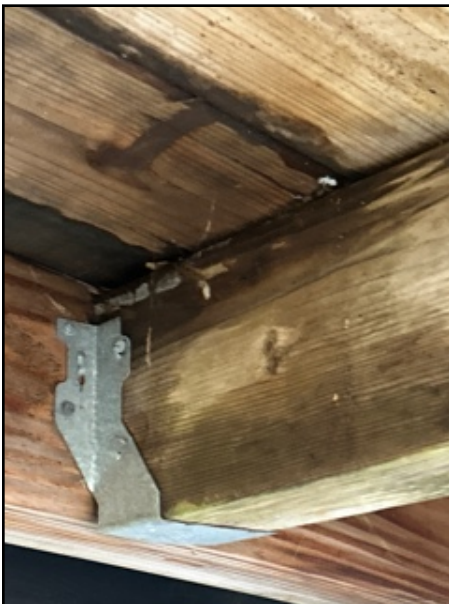
A white substance was noted under the deck at the back of the house. This could be a wood destroying organism. One repair could be scraping and treating the wood with a wood preserver. However, this should be reviewed by a licensed pest inspector and their report should be considered.

- 3) Comment 3: A white substance was noted under the deck at the back of the house. This could be a wood destroying organism. One repair could be scraping and treating the wood with a wood preserver. However, this should be reviewed by a licensed pest inspector and their report should be considered.

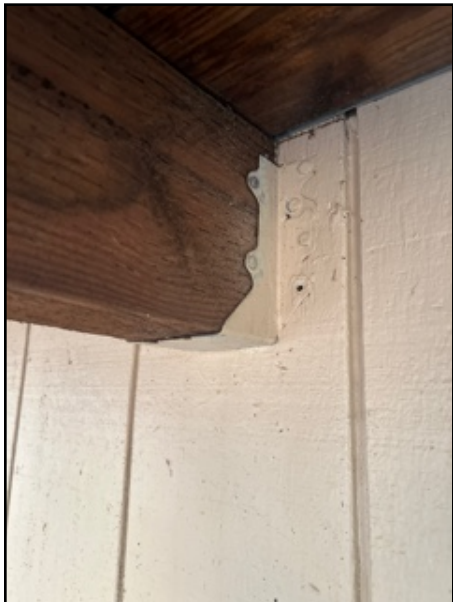
Figure 4-1

Nails were used at the joist hangers at the decks instead of screws. No evidence of separation was present at the time of inspection, however

- 4) Comment 4: Nails were used at the joist hangers at the decks instead of screws. No evidence of separation was present at the time of inspection, however

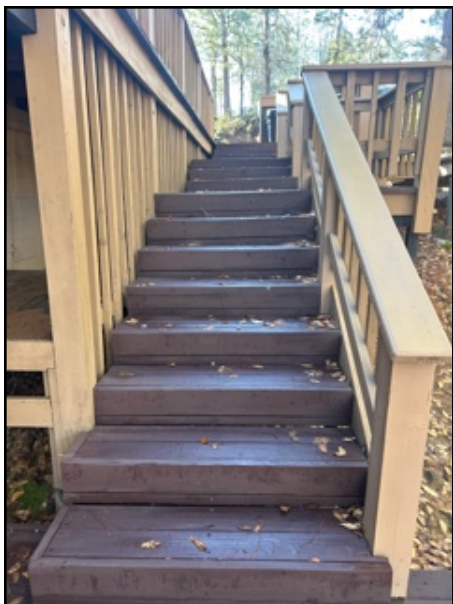
Figure 5-1

All stairs with more than two steps should have a graspable handrail installed.

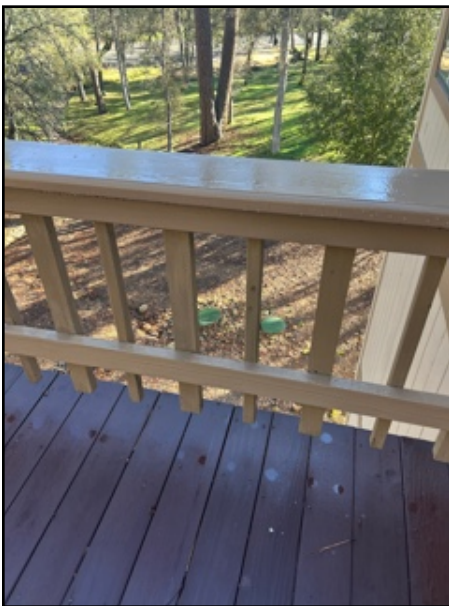
Figure 6-1

Noted that deck railing does not meet current building requirements.

However, this is pre-existing, non-conforming and may or may not need to be updated if there is a permit pulled on the property. This may not be a code in this county, this is information only.

This would include a deck rail height of 42 inches and picket spacing no more than 4 inches apart.

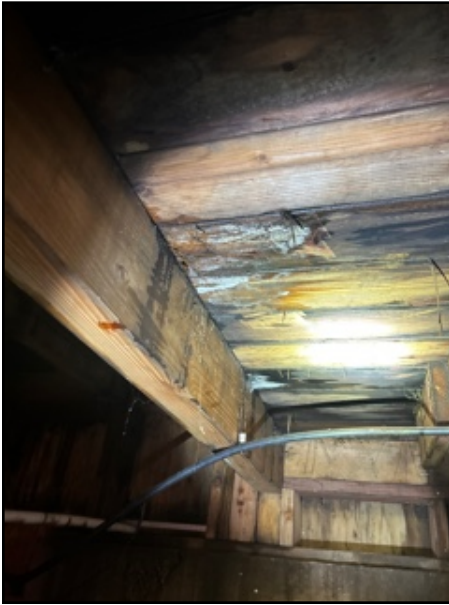
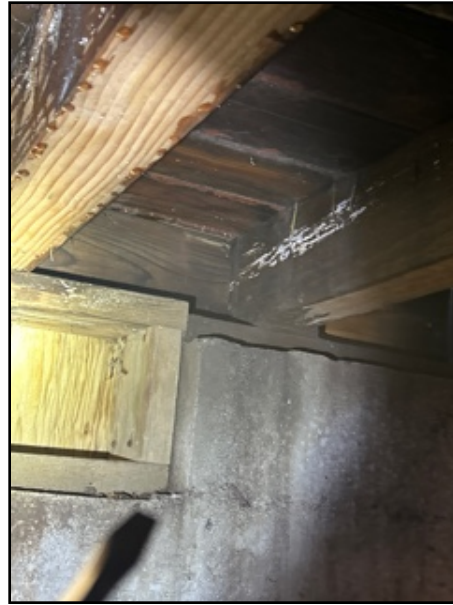
Wood deterioration was noted at areas of the front deck. Recommend repairing or replacing all affected materials as needed.

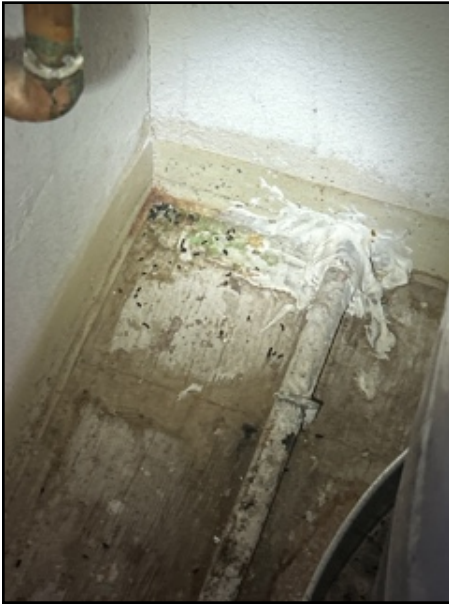
Figure 8-1

There is evidence of mice or other varmints accessing the garage at one point. A proper pest control company should be consulted to determine the extent of any rodents.

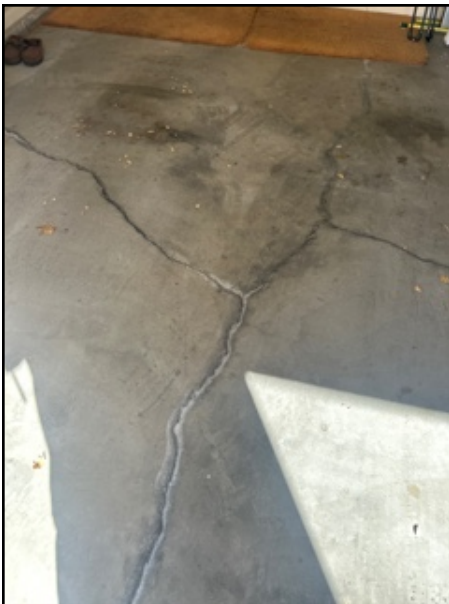
Figure 9-1

Garage floor cracking was noted, this is common for the age of the house as reinforcement was not required in the slab. This is not considered structural to the foundation of the house.

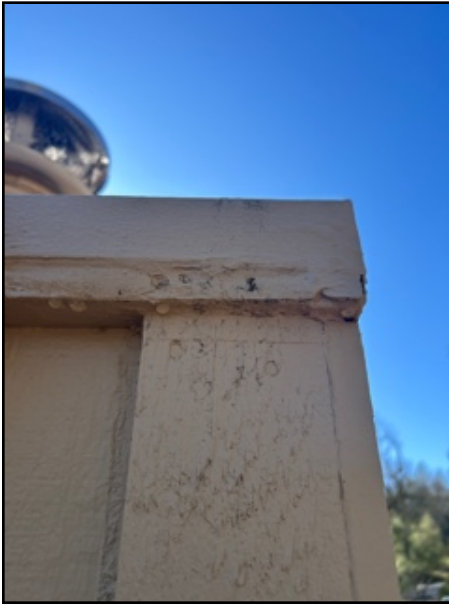
Figure 10-1

Comment 10:
Wood deterioration was noted at the trim at the top of the chimney crown.
Recommend repairing or replacing all affected materials as needed.

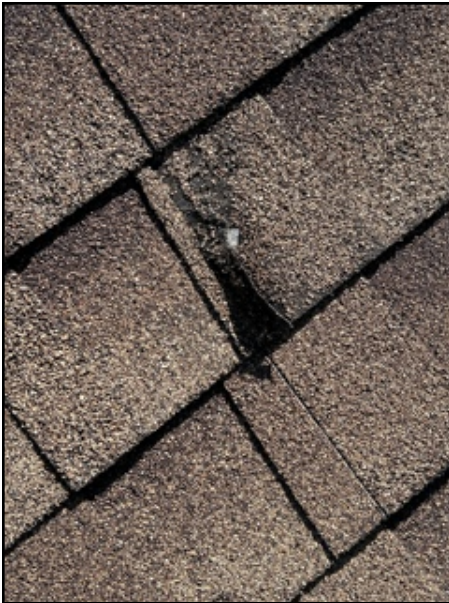
Figure 11-1

One damaged shingle was noted above the garage. Recommend repairs to prevent moisture intrusion at the roof sheathing

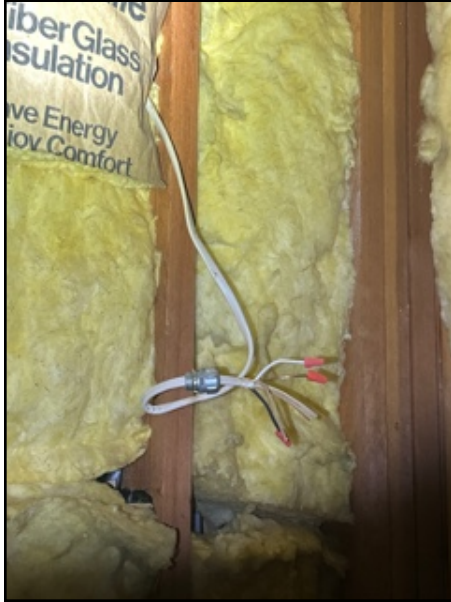
Figure 12-1

An exposed electrical termination was noted behind the downstairs room. This was not live at the time of inspection.

11) Comment 12: An exposed electrical termination was noted behind the downstairs room. This was not live at the time of inspection.

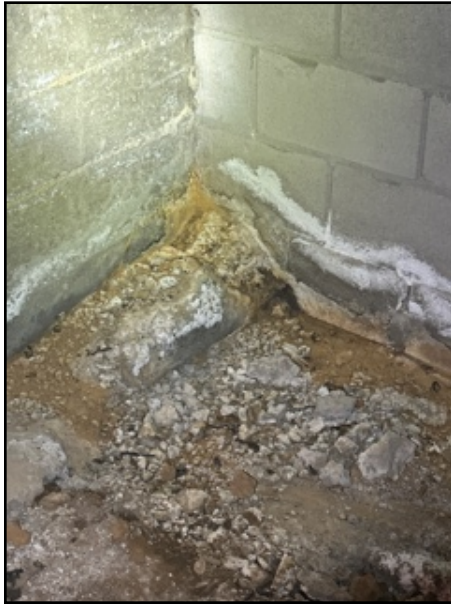
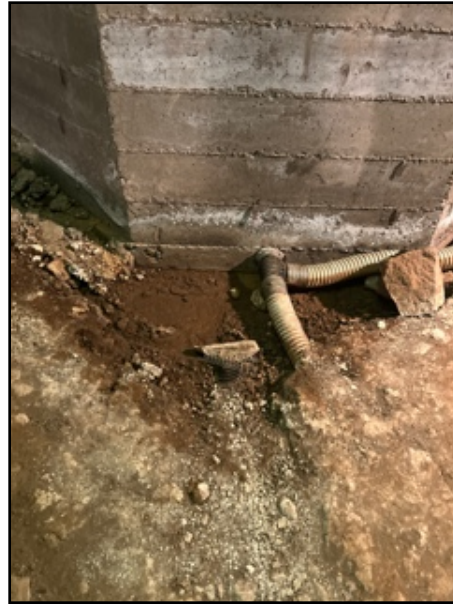
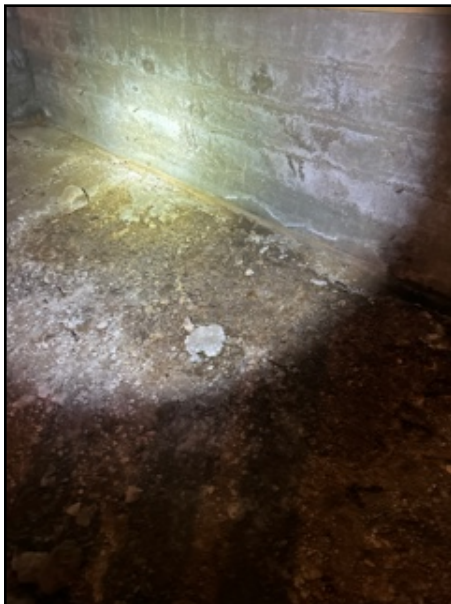
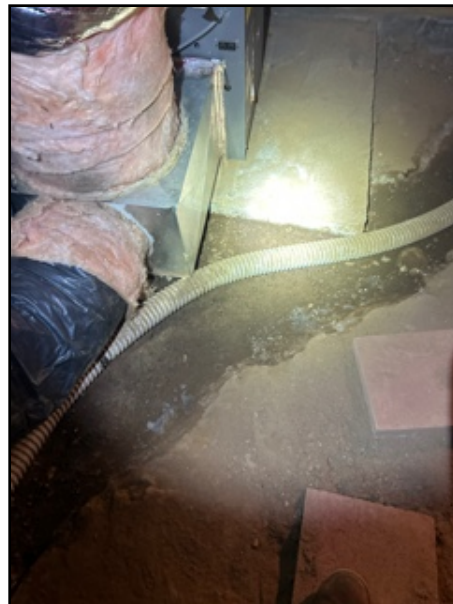
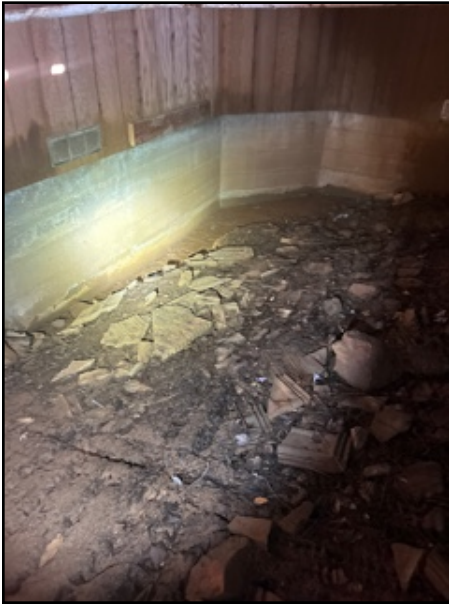
Damp soil was noted at areas of the crawlspace and appears to be accessing from the front of the structure, mainly beneath the front deck. Recommend having the site drainage reviewed by proper trades.

12) Comment 13: Damp soil was noted at areas of the crawlspace and appears to be accessing from the front of the structure, mainly beneath the front deck. Recommend having the site drainage reviewed by proper trades.

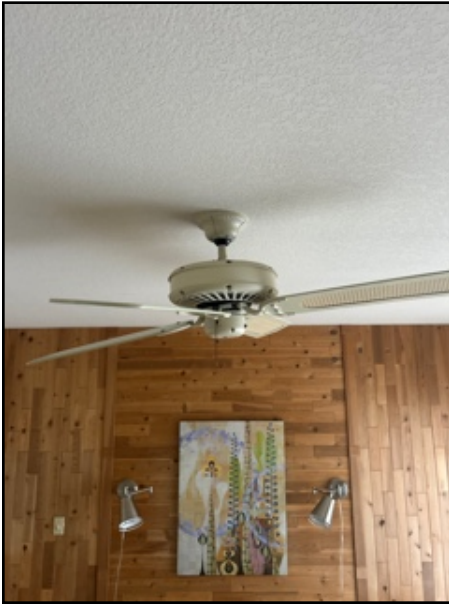
Figure 15-1

The fan at the primary bedroom appeared to be out of balance. Recommend adjustments as needed.

13) Comment 15: The fan at the primary bedroom appeared to be out of balance. Recommend adjustments as needed.

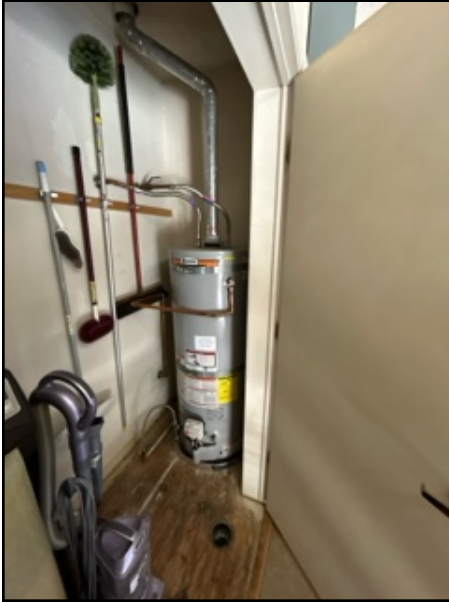
Figure 18-1

Minimal ventilation was noted at the gas water heater closet. Recommend adding this to ensure proper combustion and drafting for the unit.

14) Comment 18: Minimal ventilation was noted at the gas water heater closet. Recommend adding this to ensure proper combustion and drafting for the unit.

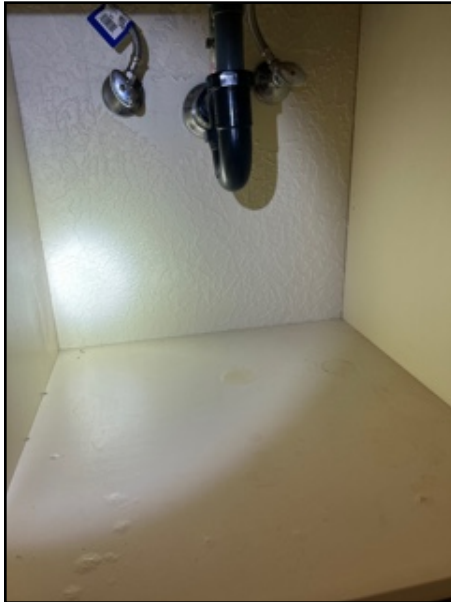
Figure 19-1

An active leak was noted at the right sink drain. Recommend repairs by a licensed plumber.

15) Comment 19: An active leak was noted at the right sink drain. Recommend repairs by a licensed plumber.

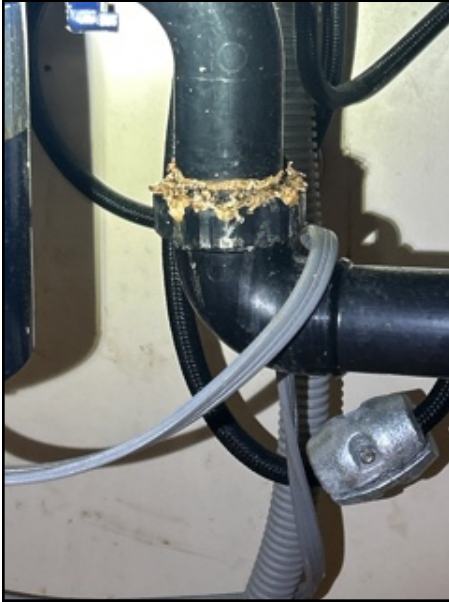
Figure 21-1

**Comment 21:**
An active leak was noted at the kitchen sink drain. Recommend repairs by a licensed plumber.

16) Comment 21: An active leak was noted at the kitchen sink drain. Recommend repairs by a licensed plumber.

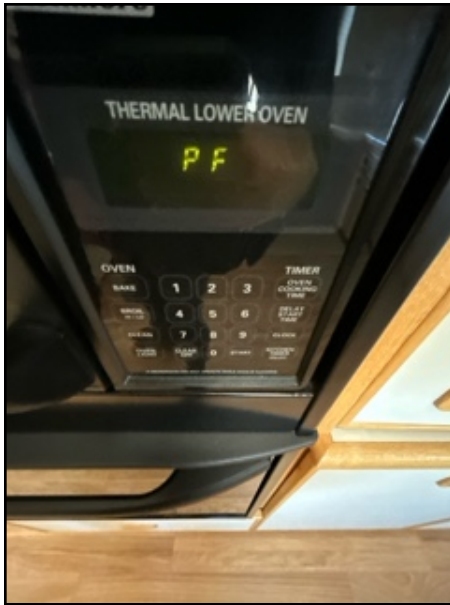
Figure 22-1

The oven was displaying an error code at the time of inspection and could not be reset. Recommend further review by proper trades.

17) Comment 22: The oven was displaying an error code at the time of inspection and could not be reset. Recommend further review by proper trades.

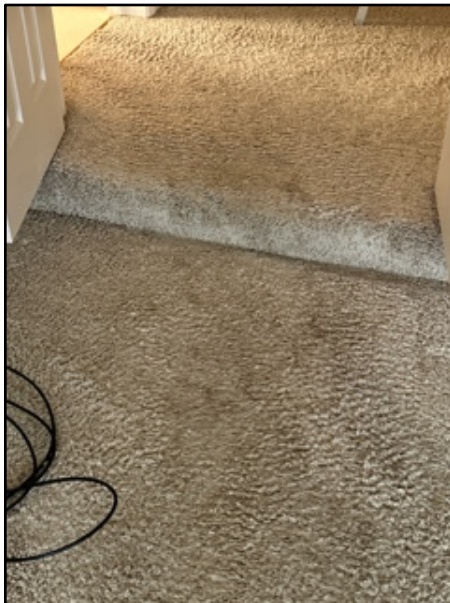
Figure 23-1

The door to the primary bedroom was noted to swing over a step. This may be considered a tripping hazard.

18) Comment 23: The door to the primary bedroom was noted to swing over a step. This may be considered a tripping hazard.

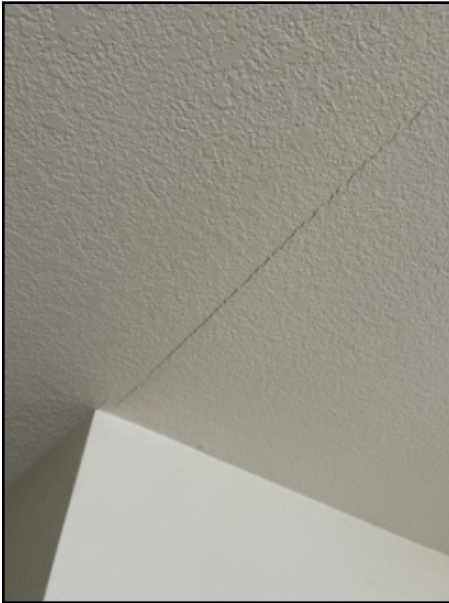
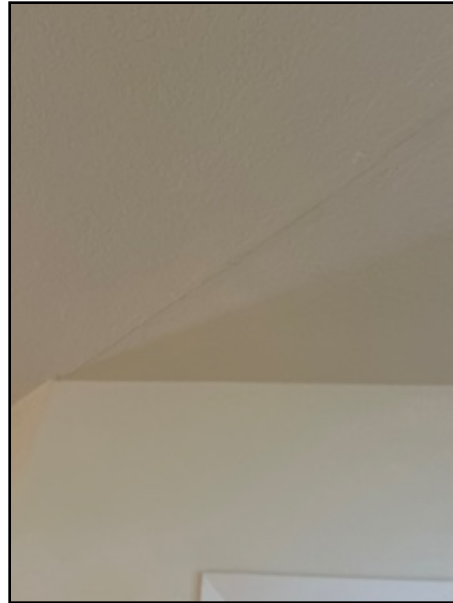
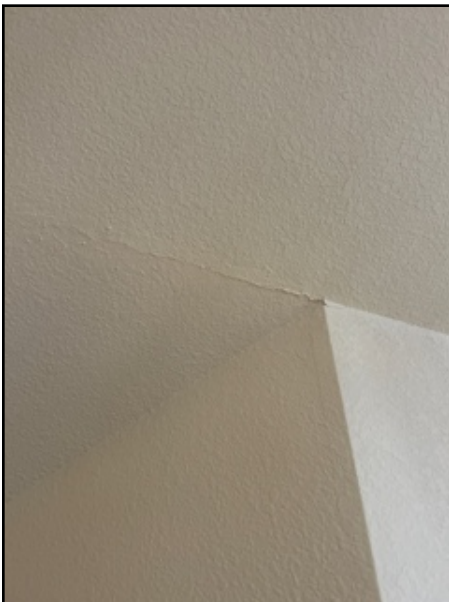
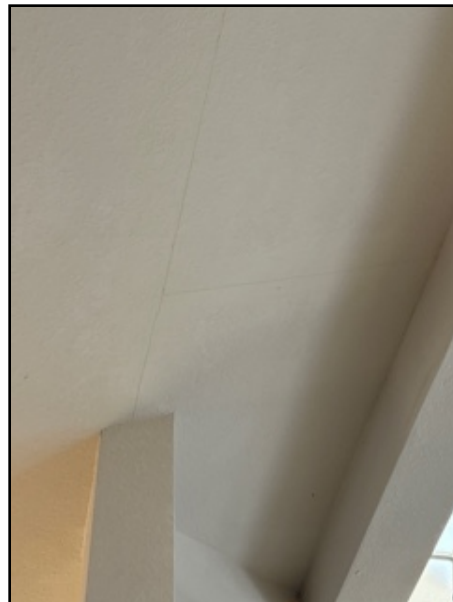
Multiple drywall tape joint cracks were noted throughout the structure. These cracks are not considered settling or structural cracks as they run parallel to the structure.

19) Comment 24: Multiple drywall tape joint cracks were noted throughout the structure. These cracks are not considered settling or structural cracks as they run parallel to the structure.

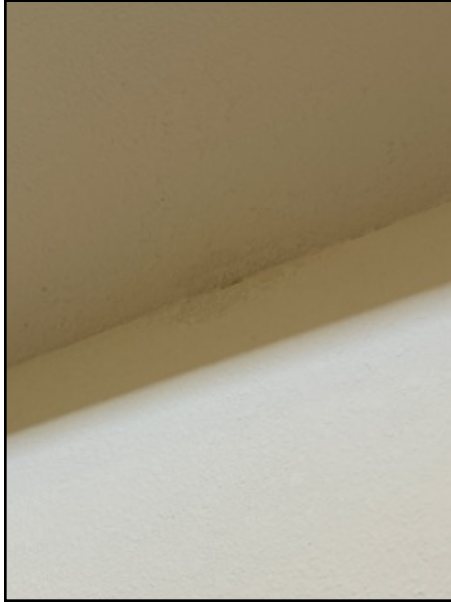
Figure 25-1

Moisture staining was noted at the ceiling above the fireplace. No active moisture was present at the time of inspection.

20) Comment 25: Moisture staining was noted at the ceiling above the fireplace. No active moisture was present at the time of inspection.
