# Your Inspection Report

3771 Texas Street  
San Diego, CA 92104

INSPECTION DATE:  
Tuesday, October 15, 2024

RE: Report No. 2563  
3771 Texas Street  
San Diego, CA  
92104

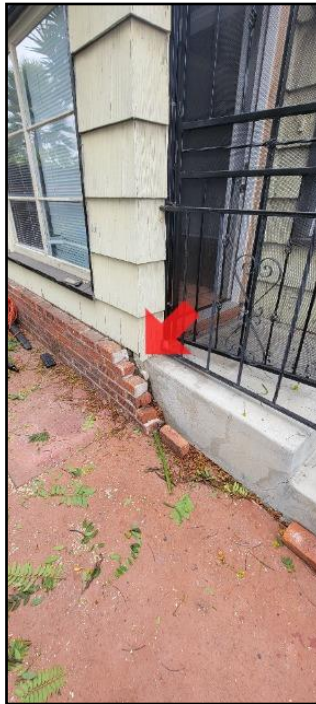
*Seal here*

### **4. Condition:** • Insect damage

Evidence of activity by wood destroying pests noted at many of the exterior window frames, as well as railing systems at the upper rear unit, and at the rear elevated decks. Have a licensed pest control professional evaluate.

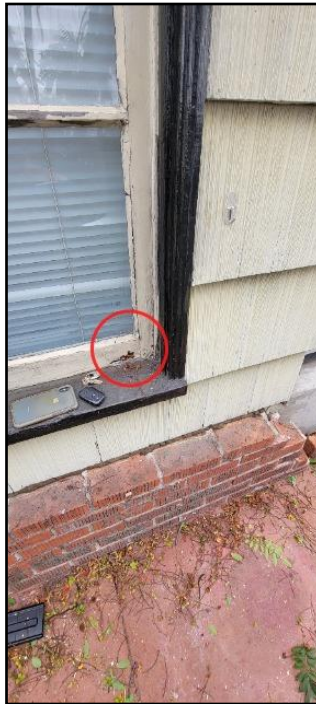
*Wood damage*

**5. Condition:** • Some deck boards have evidence of rot (due to moisture, likely from potted plants above), and some structural timbers have termite activity. Recommend a pest control professional review and offer repair estimates

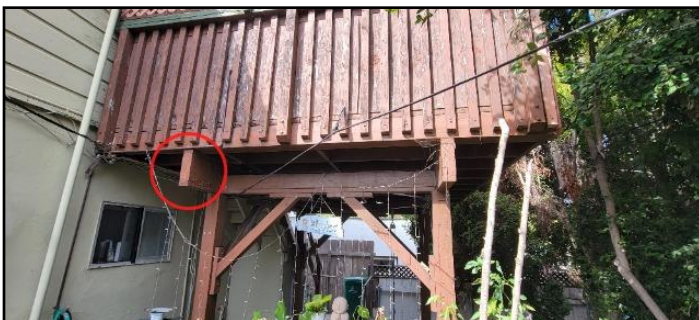
*Insect damage at beam*

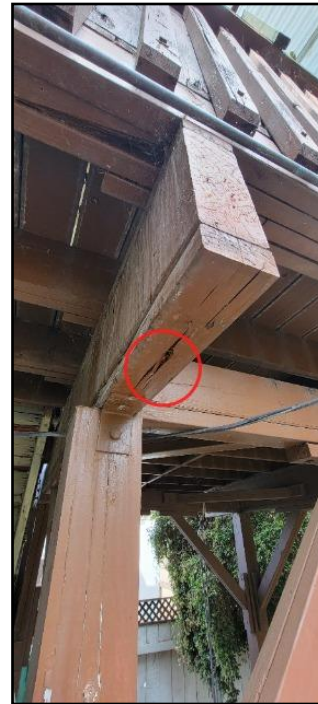
*Termite damage here*

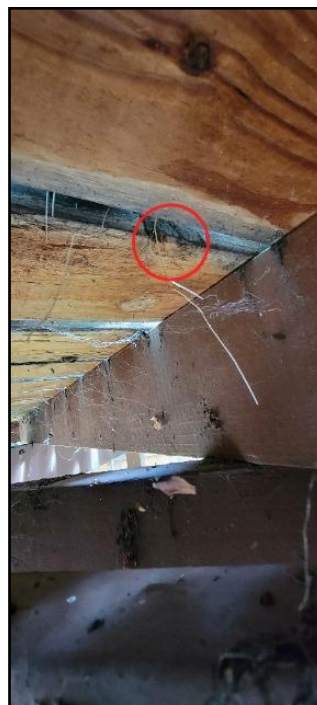
*Fungus damage in deck boards*

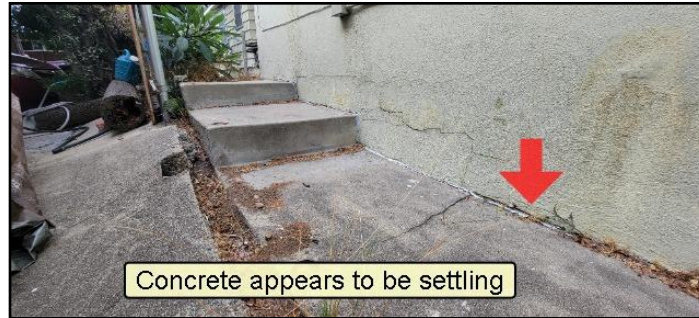
### 6. Condition: • [Unsealed gap at building](#)

The gap between the concrete flat work and the house should be sealed and checked regularly to prevent moisture

*Gaps here and settling*

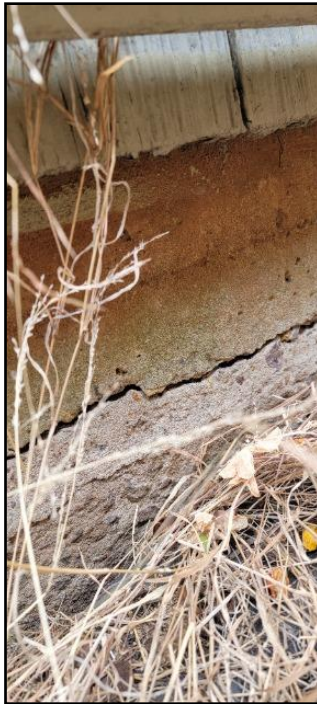
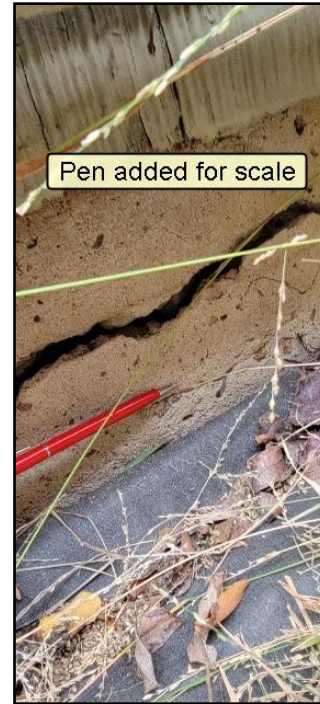
Foundation cracks

Cracking noted at the foundation wall. This is likely caused from rebar which is within the concrete and rusting, which causes the concrete to become loose, crack and spall. Contact a foundation repair person for price estimates prior to the end of clients contingency period. Approximately 15 lf. of repairs will be necessary in this inspectors opinion.

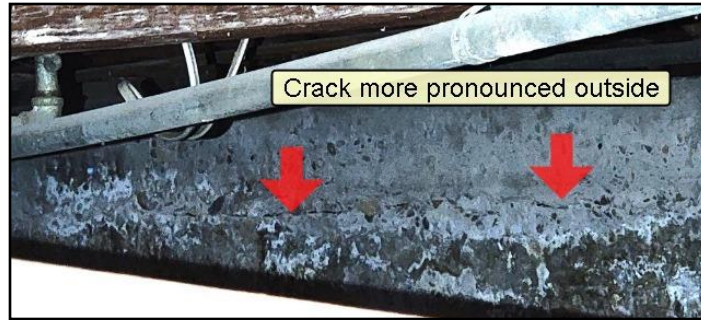
*Same area from inside crawlspace*

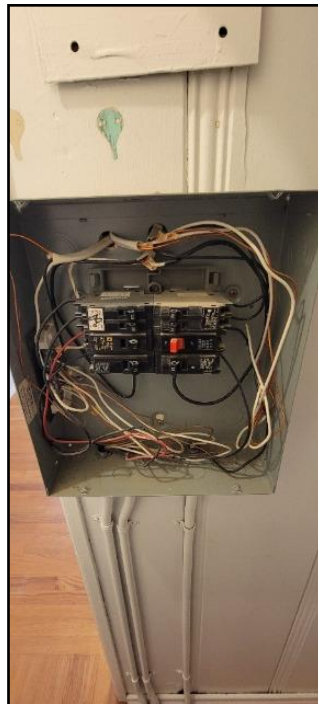
Interchangeable Breakers: Some breaker brands may physically fit in the panel but may not be UL-listed for it. Using non-listed breakers could void warranties or cause safety hazards. Breakers to Avoid: While other brands (e.g., GE, Square D) may physically fit into a Murray panel, they are not certified for use in these panels unless explicitly stated. Always ensure the breakers are listed for your specific panel. For full safety and compliance, Siemens breakers are the recommended and approved option for Murray panels. Always verify compatibility with local electrical codes and consult an electrician if needed.

*Possible unapproved breakers in this panel*

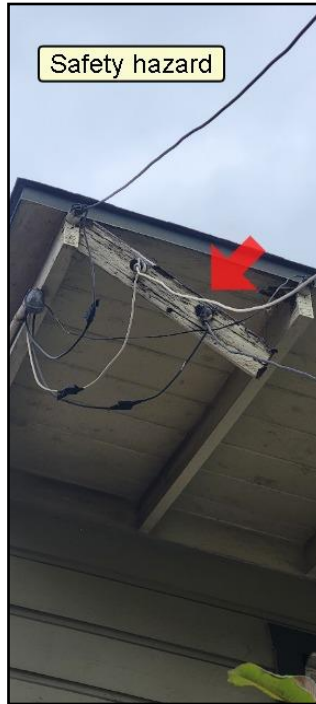
*Wires not anchored correctly*

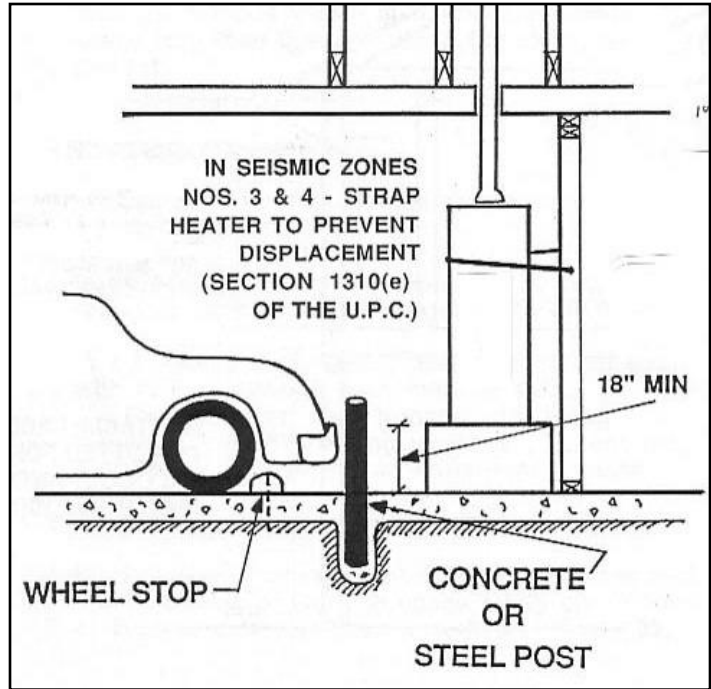
*Bollard could be installed at the gas meters*

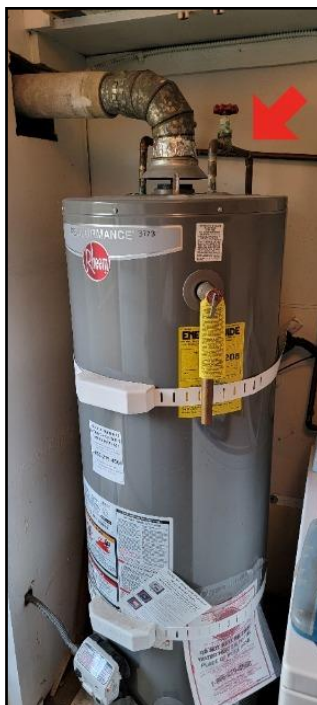
**31. Condition:** • Rigid copper hot/cold lines are not permitted to tie-in the water heater to the water supply system of the home. Recommend contacting a licensed plumber and have the water supply lines changed out to flexible lines for safety.

*Rigid water supply lines*

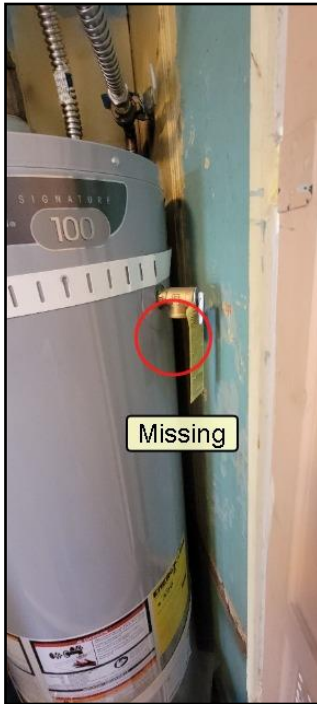
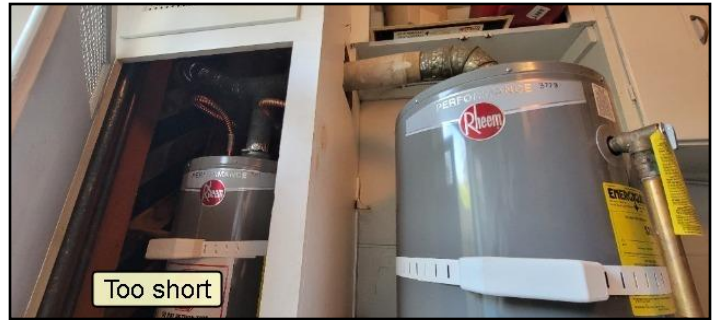
The TPR discharge tube is too short and should be extended for safety according to manufacturer's recommendations.

TPR discharge issue

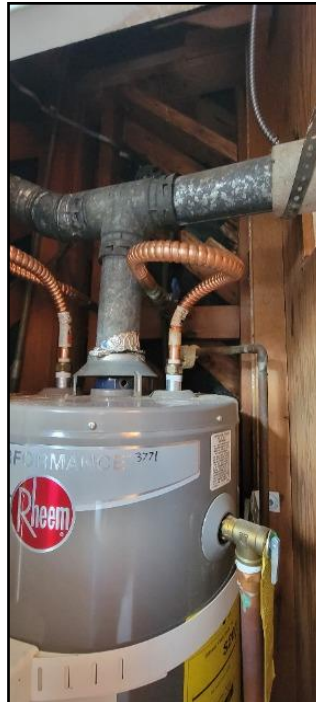
The venting arrangement is improper for the dual water heaters that share a common flue. The single wall sections should be replaced with 'B' type sections to ensure proper drafting. Also, a plumber should investigate if the diameter of the flue pipe is properly sized for the BTU output of both water heaters combined.

*Venting issue*

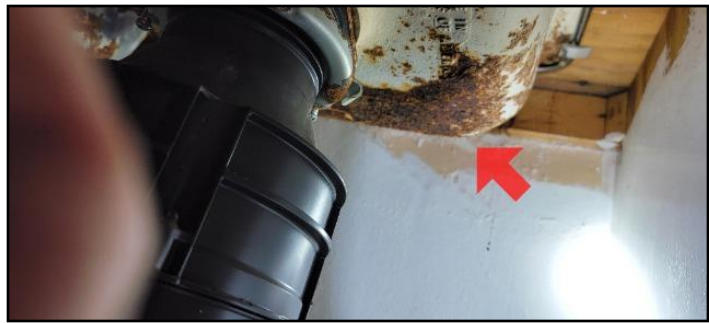
*Rust under sink*

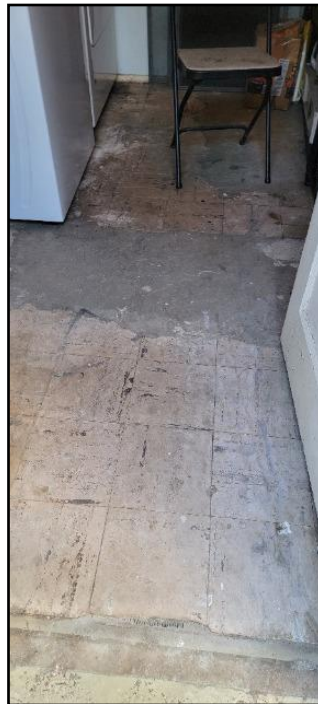
**Condition:** • The tiles and the mastic (glue that adheres tiles to the floor below) may contain asbestos. Asbestos exposure has been linked to certain types of cancer. Asbestos was common in building materials through the early 1970's. Materials that are loose (friable) have the potential to release asbestos fibers into the indoor air, where they can get inhaled. The tiny fibers can become lodged in the lungs and the respiratory system does not have adequate defenses to expel these fibers. Recommend having the materials tested by an accredited lab and removed if asbestos is found.

*Possible asbestos (not tested)*
