**HaslerHomes Inc. DBA**  
**National Property Inspections**

**Lou Bezares, 3522 Brookwood, Oxnard, CA, 93036**

Inspection Date:  
10/21/2026

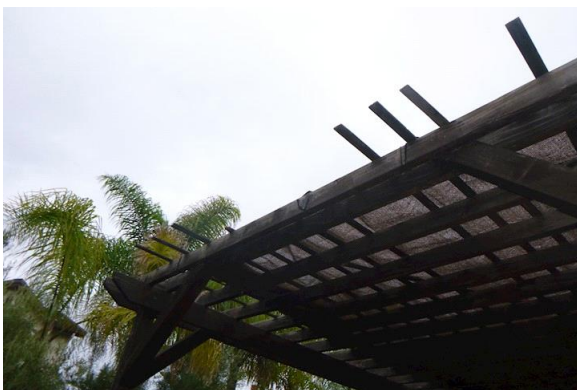
Patio:

Deterioration/damage noted at the patio cover.

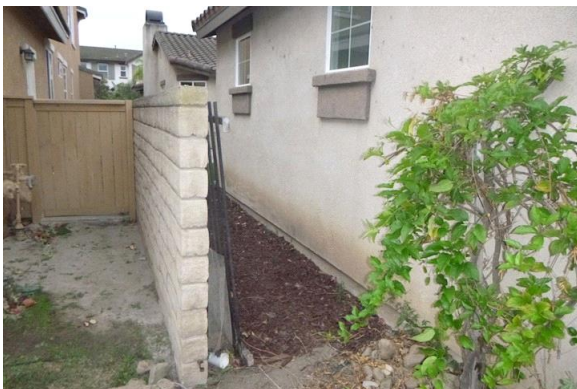
Fences / Gates:

Damaged section of the fence observed on the East side of the dwelling.

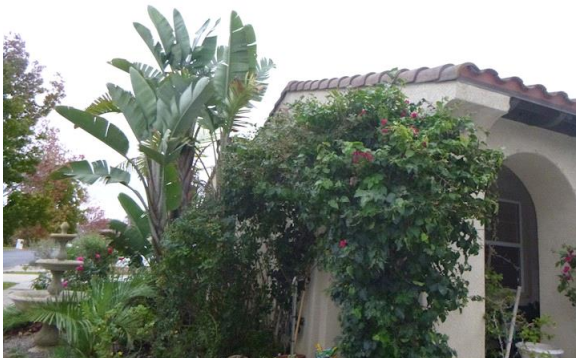
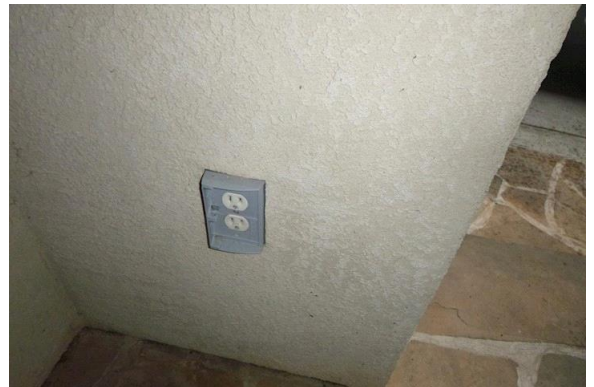
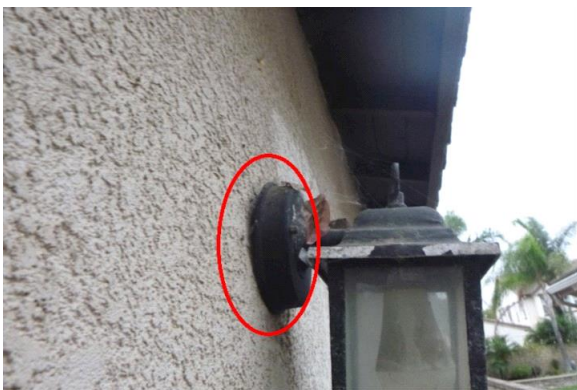
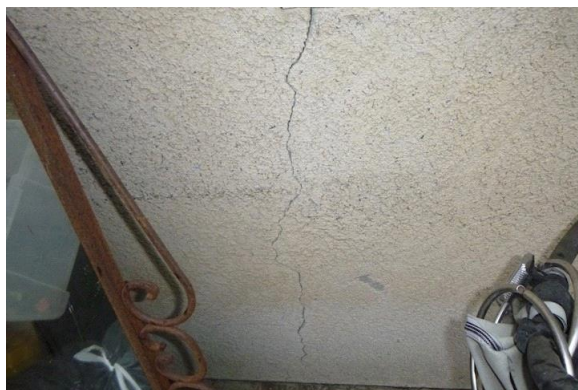
1. Keep vegetation trimmed to help prevent damage to the dwellings' siding and trim.
2. Appropriate weather covers are required to all exterior electrical outlets.
3. Secure and seal all vertically mounted exterior light fixtures to prevent possible water intrusion within the fixtures.
4. Stucco cracks observed a various locations surrounding the dwelling. This condition is not structurally significant.

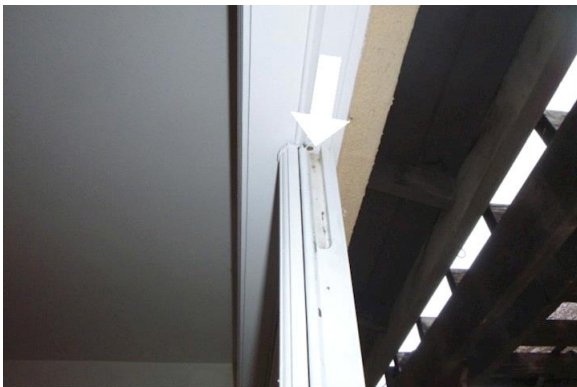
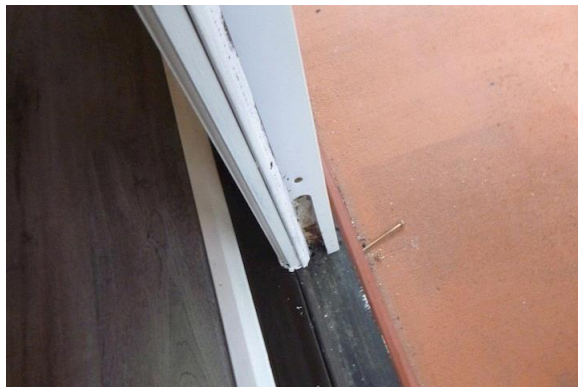
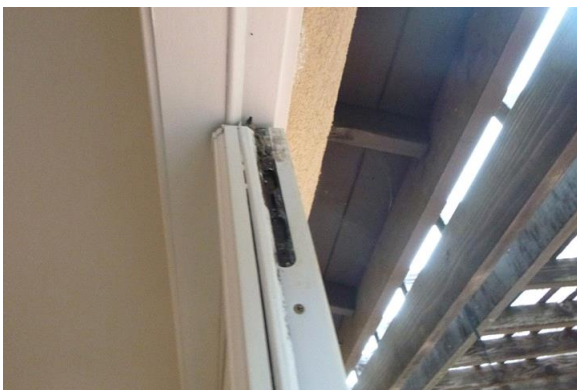
Missing and damaged patio door locks noted.

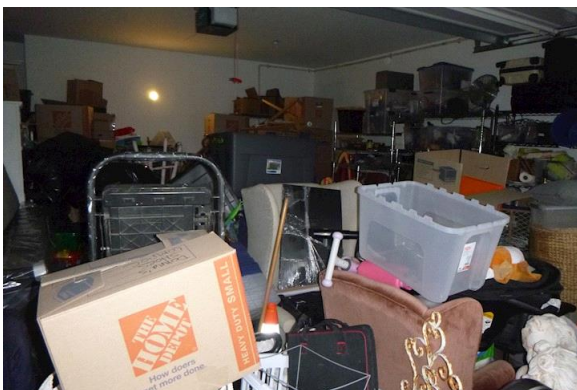
Garage/Carport:

Limited access at the time of the inspection.

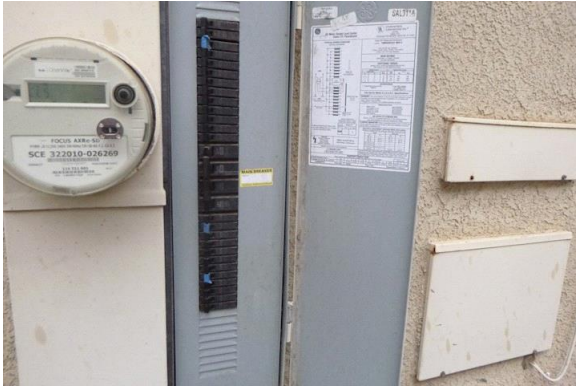
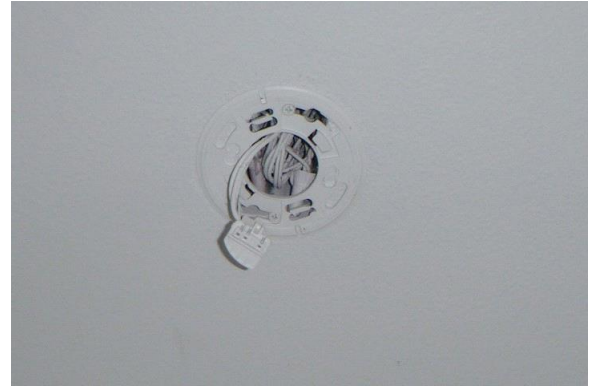
1. All branch circuits (breakers) are required to be labeled. We recommend repair by a qualified electrical contractor.
2. The current smoke alarm safety requirement dictates working smoke alarms are required in hallways adjacent sleeping rooms, within all sleeping rooms as well as on every level of a dwelling. Carbon Monoxide detectors are required on every level of a dwelling with fueled appliances as well as dwellings with attached garages.

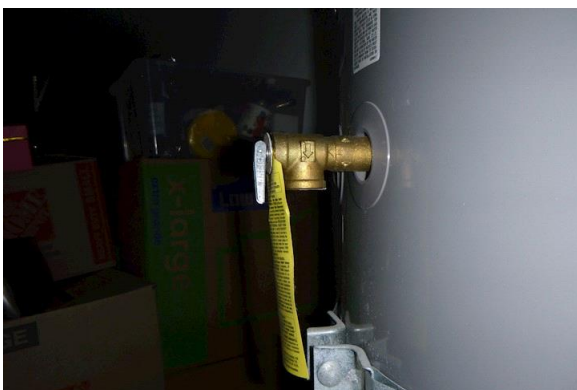
Water Heater:

The water heater pressure relief valve is required to terminate outside the dwelling. The drain pipe was found disconnected.

We recommend repair by a qualified plumbing contractor.

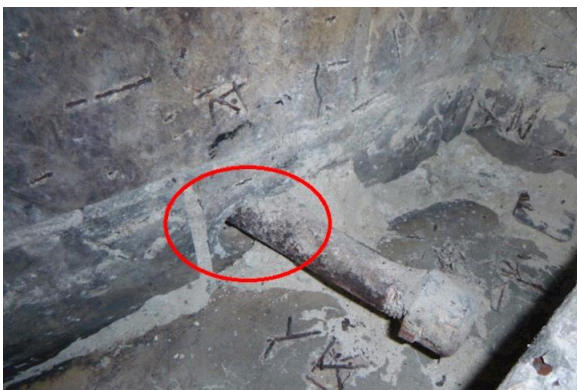
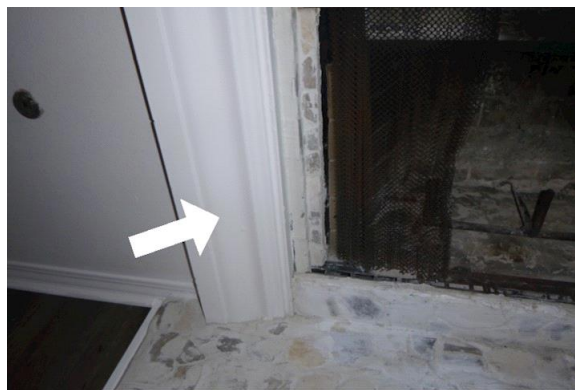
1. The fireplace, flue and chimney are due for professional cleaning.
  2. We recommend sealing the gas supply pipe at the fire box to prevent toxic fumes from migrating into the fireplace cavity and dwelling.
  3. Combustible material is not permittable within 6 inches of the fireplace opening.
- We recommend further evaluation/repair by a qualified contractor.

Recommend annual cleaning - Fireplace design and soot / creosote buildup, in most cases, prevents view of chimney liner / cracks.

1. The fireplace, flue and chimney are due for professional cleaning.
2. We recommend sealing the gas supply pipe at the fire box to prevent toxic fumes from migrating into the fireplace cavity and dwelling.
3. Combustible material is not permittable within 6 inches of the fireplace opening.

We recommend further evaluation/repair by a qualified contractor.

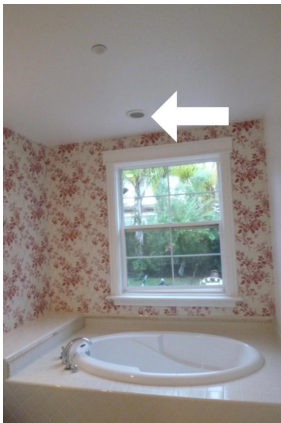
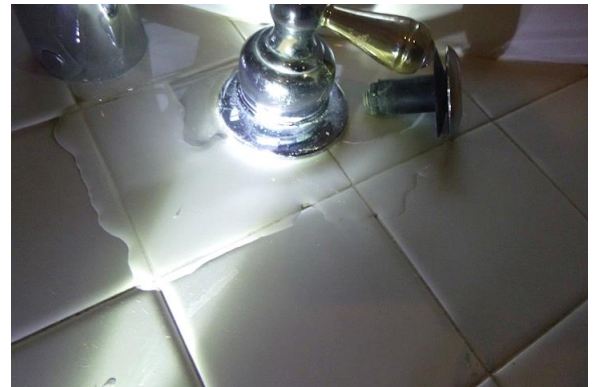
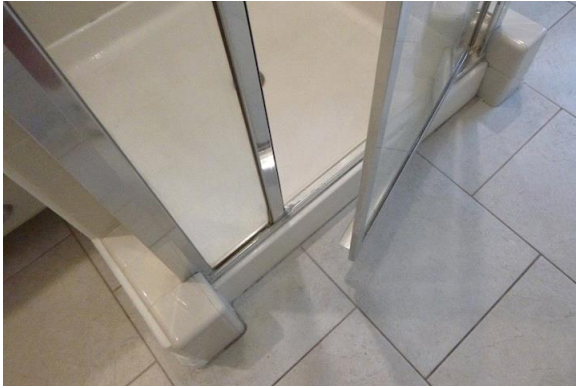
1. The light fixture located above the tub was found inoperable.
  2. The toilet is not properly secured to the floor.
  3. The tub drain stopper was found inoperable.
  4. The tub cold water valve was found leaking during use.
  5. The shower door contacts the threshold limiting its operation.
- We recommend further evaluation/repair by a qualified contractor.

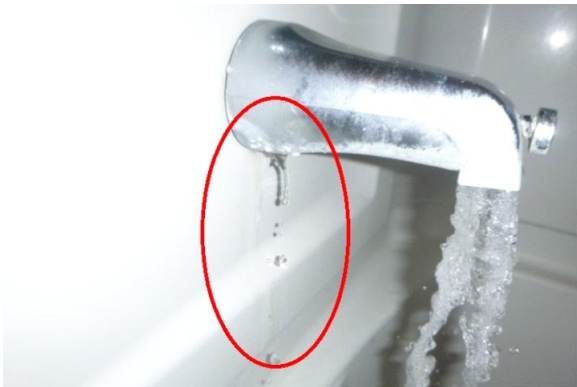
Hall Bathroom:

1. The light fixture located above the tub was found inoperable.
  2. The sink hot water valve was found difficult to operate.
  3. The tub spout was found leaking during use.
  4. Missing tub drain stopper noted.
- We recommend further evaluation/repair by a qualified contractor.

| <ol style="list-style-type: none"><li>1. The light fixture located above the tub was found inoperable.</li><li>2. The sink hot water valve was found difficult to operate.</li><li>3. The tub spout was found leaking during use.</li><li>4. Missing tub drain stopper noted.</li></ol> <p>We recommend further evaluation/repair by a qualified contractor.</p> | |
