Home Inspection Report

**20785 Buttercup Cir
Groveland, CA 95321**

Inspected on Tue, Jul 22 2025 at 9:00AM

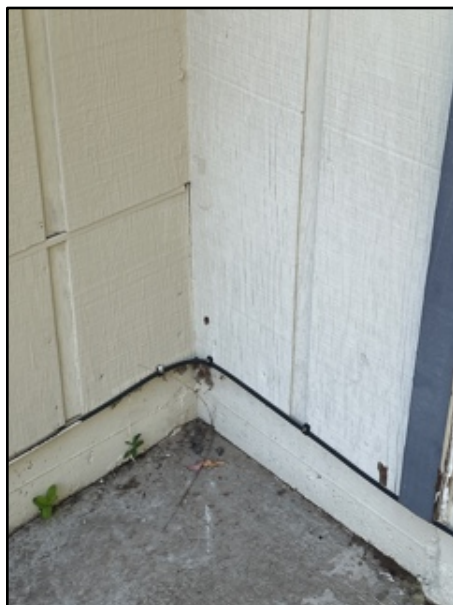
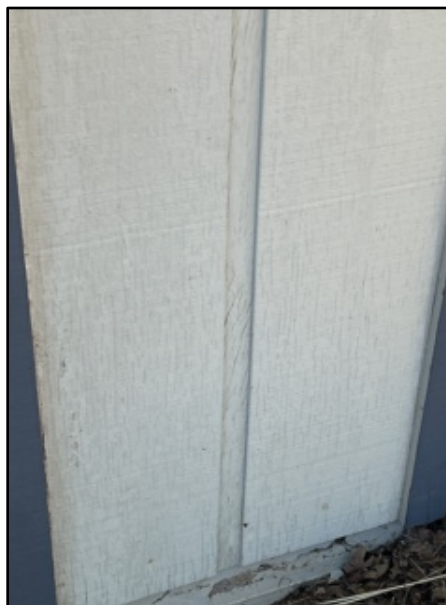
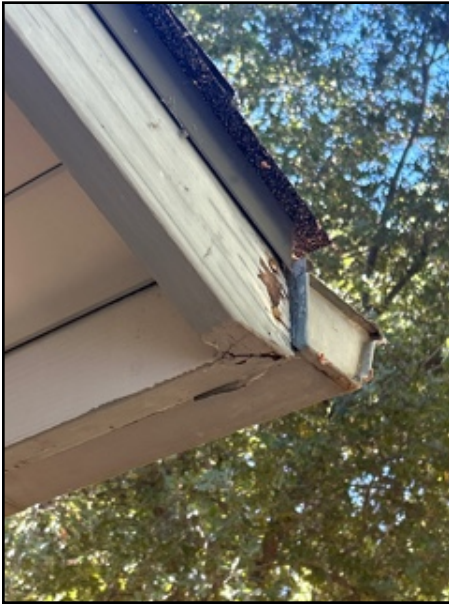
Portions of the home's exterior wood members were paint checked and weathered. Recommend re-painting all affected materials to prevent moisture damage.

- 1) Comment 1: Portions of the home's exterior wood members were paint checked and weathered. Recommend re-painting all affected materials to prevent moisture damage.

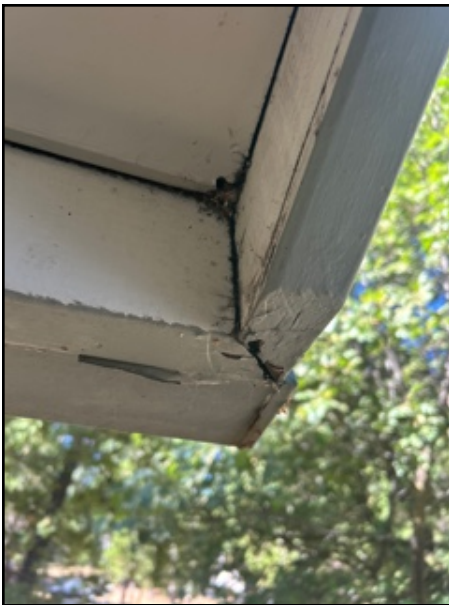
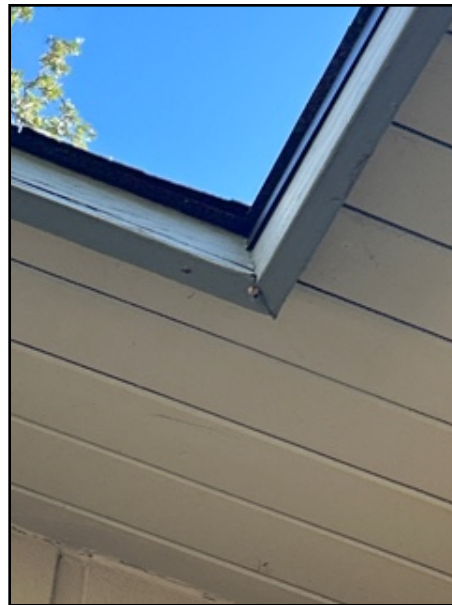
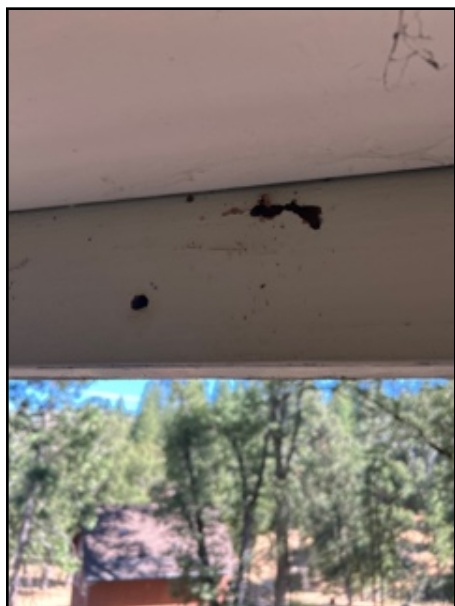
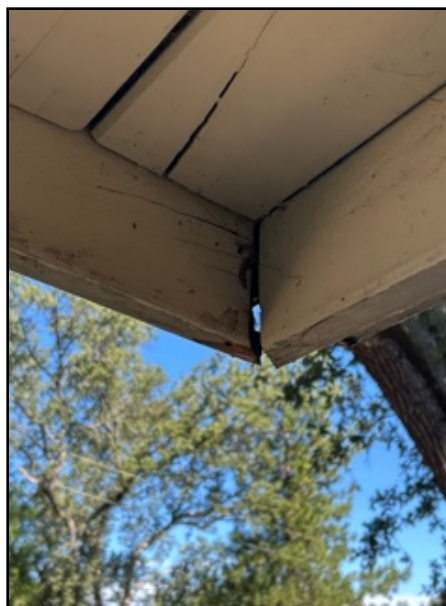
Wood deterioration was noted at several areas of the eaves around the structure. Recommend repairing or replacing all affected materials as needed.

- 2) Comment 2: Wood deterioration was noted at several areas of the eaves around the structure. Recommend repairing or replacing all affected materials as needed.

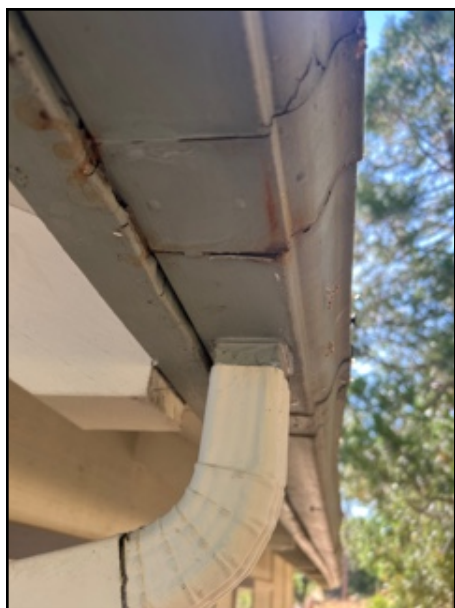
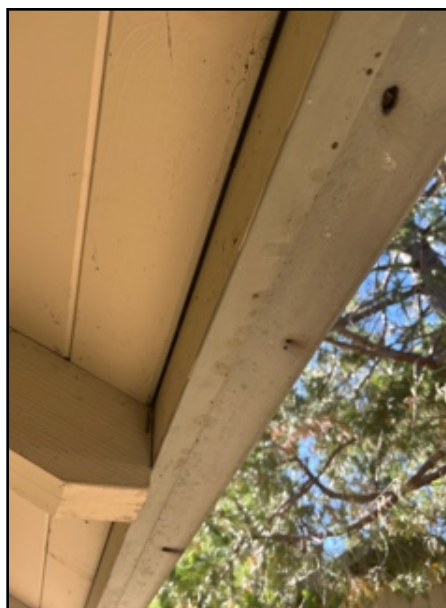
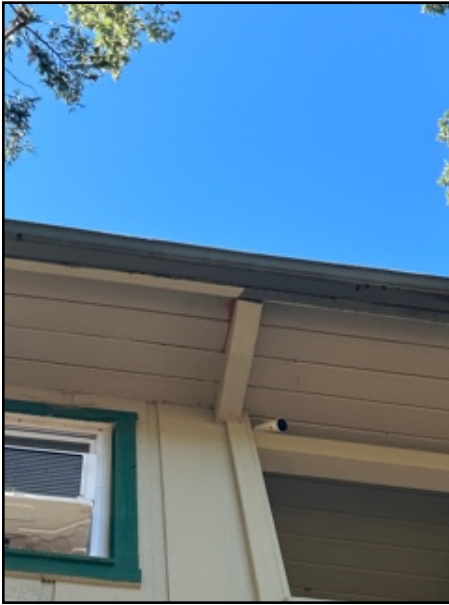
Rusted/damaged gutters were noted at several areas of the eaves around the structure. Recommend repairs or replacement to properly divert roof water away from the building.

- 3) Comment 3: Rusted/damaged gutters were noted at several areas of the eaves around the structure. Recommend repairs or replacement to properly divert roof water away from the building.

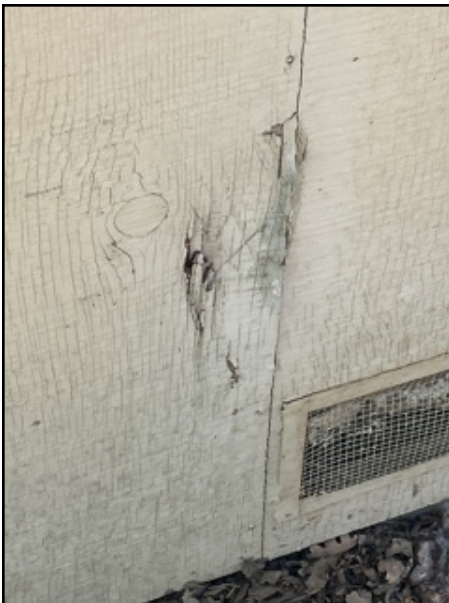
Figure 4-1

Wood deterioration was noted at the siding at the right side of the living room. Recommend repairing or replacing all affected materials as needed.

- 4) Comment 4: Wood deterioration was noted at the siding at the right side of the living room. Recommend repairing or replacing all affected materials as needed.

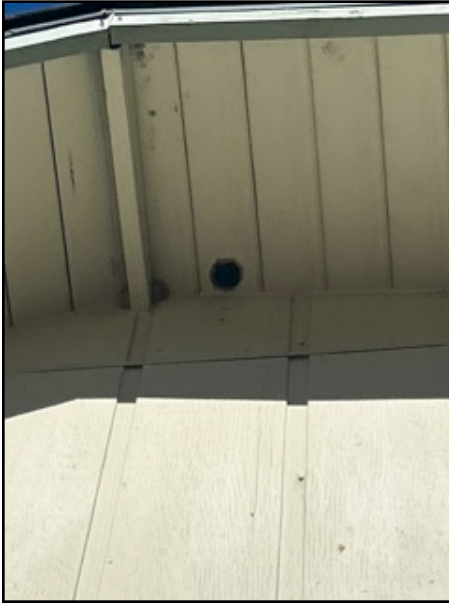
Figure 5-1

Comment 5:
Damaged soffit was noted at the back of the structure.

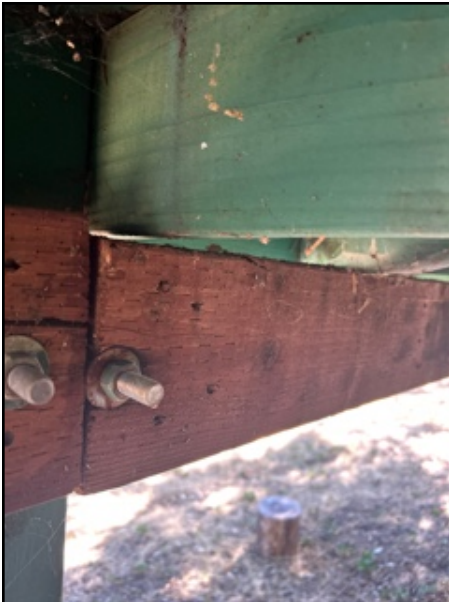
Figure 6-1

Comment 6:
The joists were not sitting on the beam at the front of the front deck. Recommend repairs as needed.

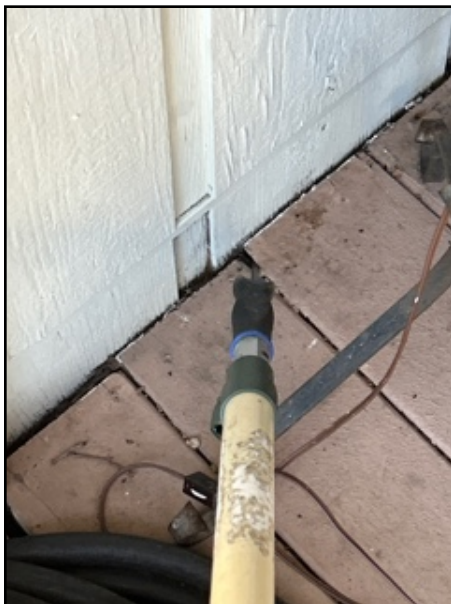
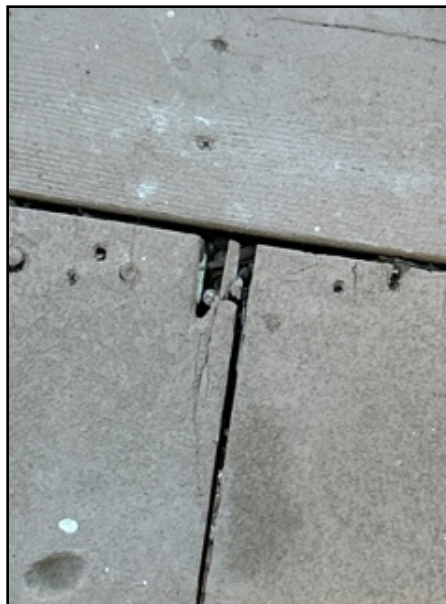
**Comment 7:**
Wood deterioration was noted at multiple deck boards at the front deck. Recommend repairing or replacing all affected materials as needed.

- 7) Comment 7: Wood deterioration was noted at multiple deck boards at the front deck. Recommend repairing or replacing all affected materials as needed.

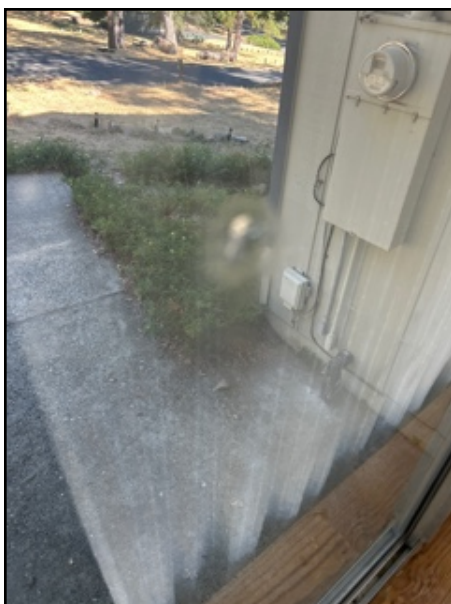
Figure 8-1

**Comment 8:**
A damaged window was noted at the front of the living room. Recommend replacement by proper trades.

- 8) Comment 8: A damaged window was noted at the front of the living room. Recommend replacement by proper trades.

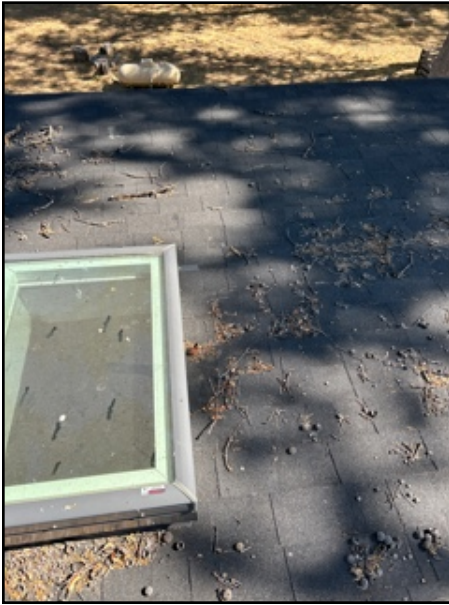
Figure 9-1

Suggest removing all debris from the roof. This will help ensure the lifespan of the roofing material.

It is also suggested to remove any areas of tree branches that are touching or hanging over the structure.

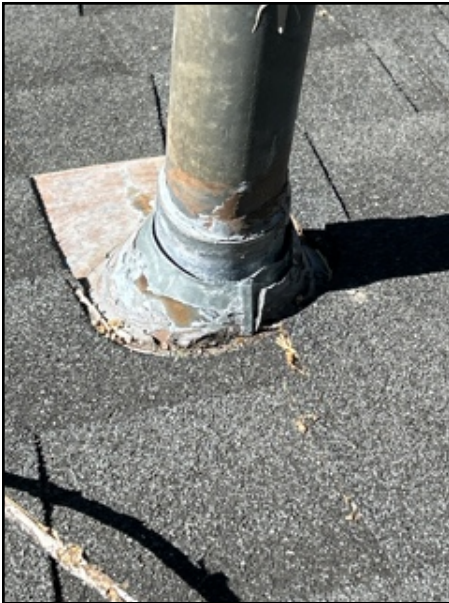
Figure 10-1

Damaged sealant was noted at the service mast collar. Recommend repairs to prevent moisture intrusion at the roof sheathing.

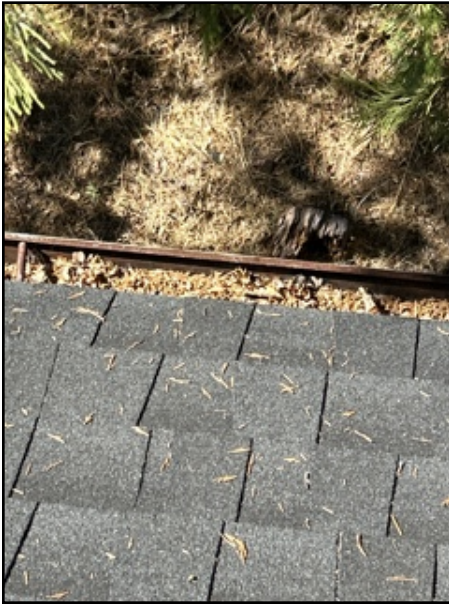
Figure 11-1

Suggest removing all debris and leaves from the gutters. Leaves are the leading cause of rot and rust on gutters. This is due to the acidic value when in contact with water and the galvanized gutters. Suggest cleaning gutters out at least twice a year.

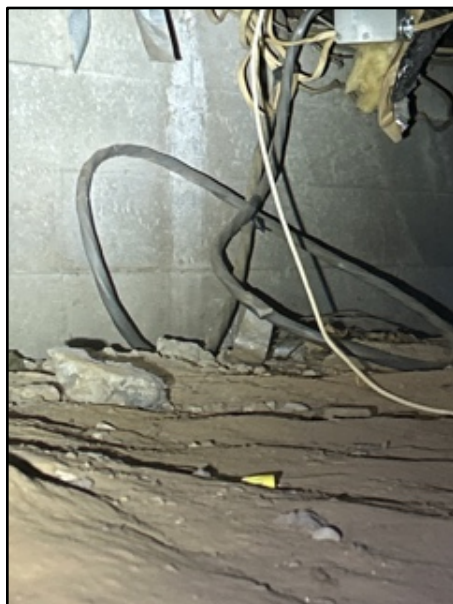
Figure 12-1

Electrical wiring was in contact with the soil beneath the living room. Recommend repairs to prevent damage to wiring.

12) Comment 12: Electrical wiring was in contact with the soil beneath the living room. Recommend repairs to prevent damage to wiring.

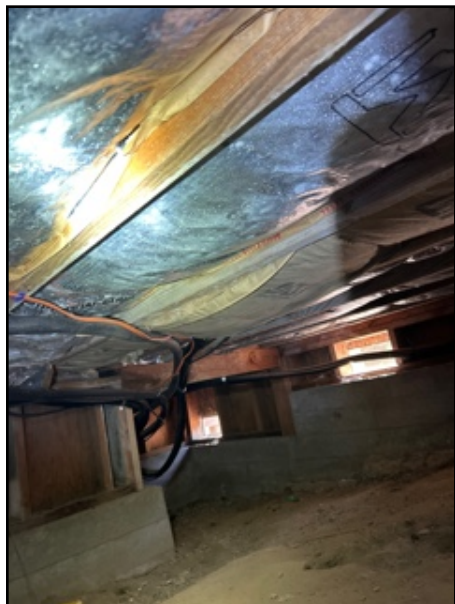
Figure 13-1

The subarea insulation is installed with paper face visible (upside down). The paper side should always face the heated space.

13) Comment 13: The subarea insulation is installed with paper face visible (upside down). The paper side should always face the heated space.

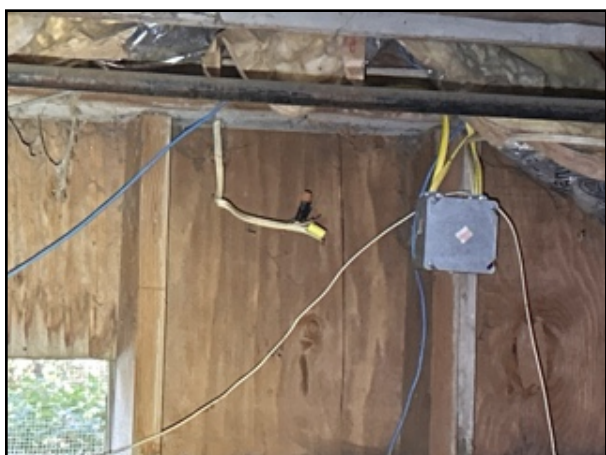
Figure 14-1

A live electrical termination was noted beneath the dining room. Recommend concealing this to prevent contact and damage.

14) Comment 14: A live electrical termination was noted beneath the dining room. Recommend concealing this to prevent contact and damage.

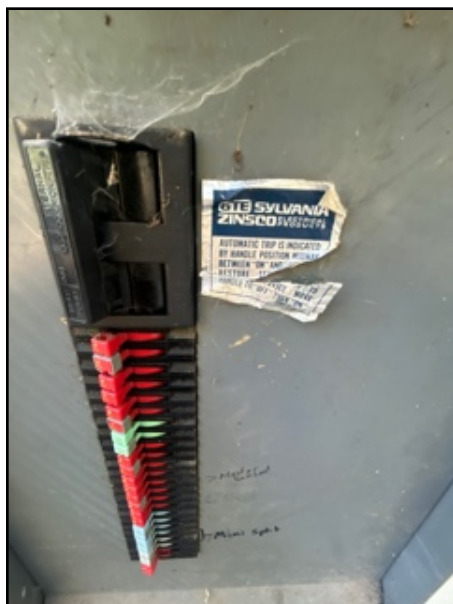
Figure 15-1

This house is equipped with a Zinsco/Sylvania electrical panel. These panels are known to have damage due to the fact that they are manufactured with aluminum buss bars. These bars are known to heat up and can potentially break. There were no signs of overheating at the time of inspection.

15) Comment 15: This house is equipped with a Zinsco/Sylvania electrical panel. These panels are known to have damage due to the fact that they are manufactured with aluminum buss bars. These bars are known to heat up and can potentially break. There were no signs of overheating at the time of inspection.

However, it is suggested to have this panel evaluated by a licensed electrician.

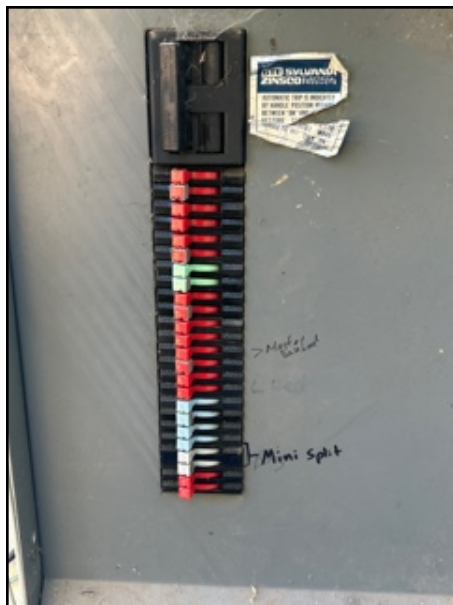
Figure 16-1

Poor labeling noted in the electrical panel. It is suggested to repair this in the event you need to shut off only one breaker instead of the entire system.

16) Comment 16: Poor labeling noted in the electrical panel. It is suggested to repair this in the event you need to shut off only one breaker instead of the entire system.

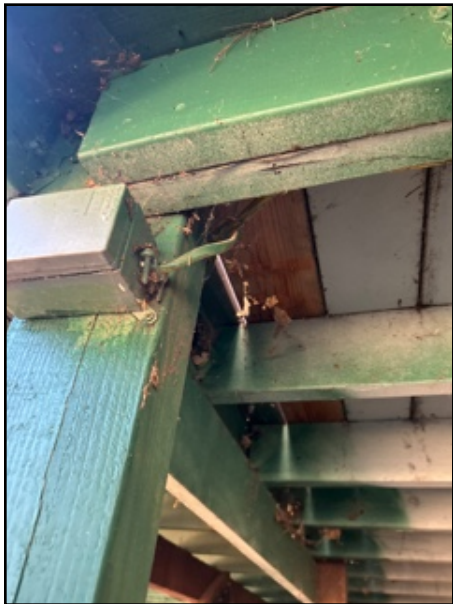
Figure 17-1

**Comment 17:**
Exposed electrical wiring was noted beneath the front deck. Recommend concealing all exterior wiring to prevent contact and damage.

17) Comment 17: Exposed electrical wiring was noted beneath the front deck. Recommend concealing all exterior wiring to prevent contact and damage.

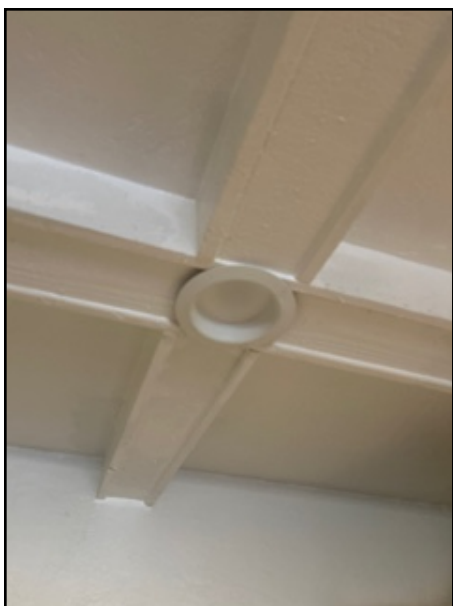
Figure 18-1

**Comment 18:**
One ceiling light fixture in the kitchen was nonfunctional. This may be due to a burnout bulb.

18) Comment 18: One ceiling light fixture in the kitchen was nonfunctional. This may be due to a burnout bulb.

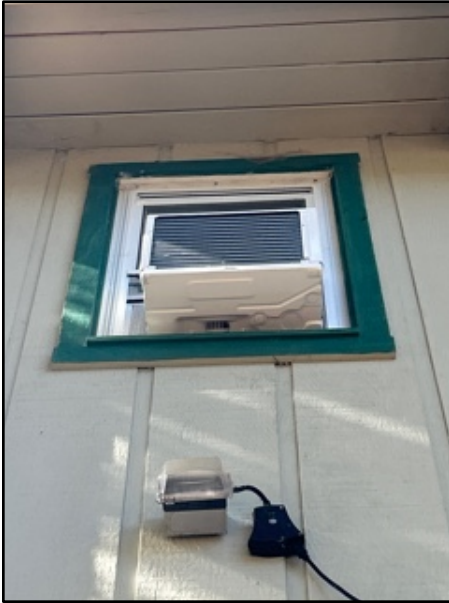
Figure 19-1

**Comment 19:**
Portable air conditioning units are beyond the scope of the general home inspection. No inspection was performed and no warranty is implied.

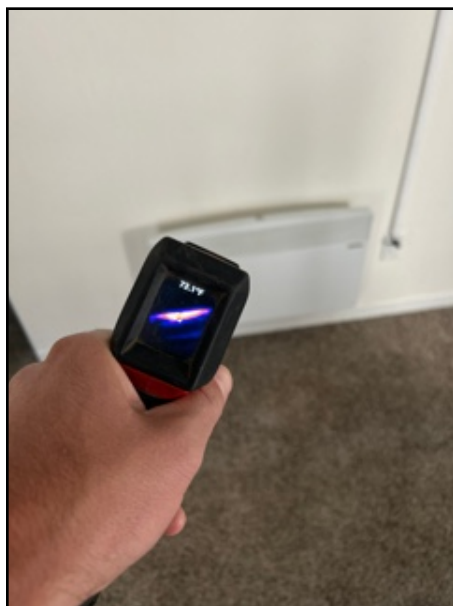
Figure 20-1

The upstairs wall heater was tested and functional.

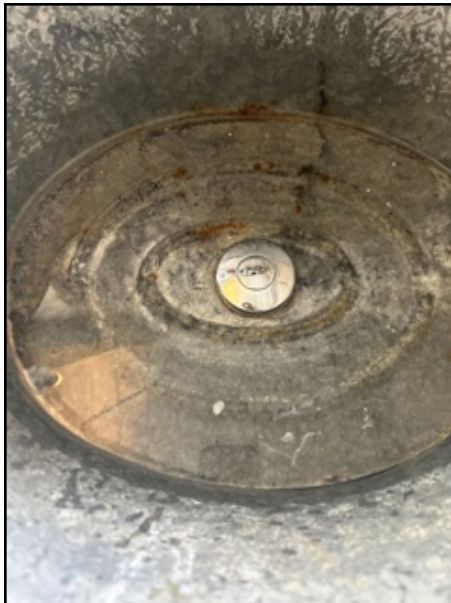
Figure 21-1

The sink was slow to drain. This may be an issue with the P-trap. Recommend having the drain snaked by proper trades.

19) Comment 21: The sink was slow to drain. This may be an issue with the P-trap. Recommend having the drain snaked by proper trades.

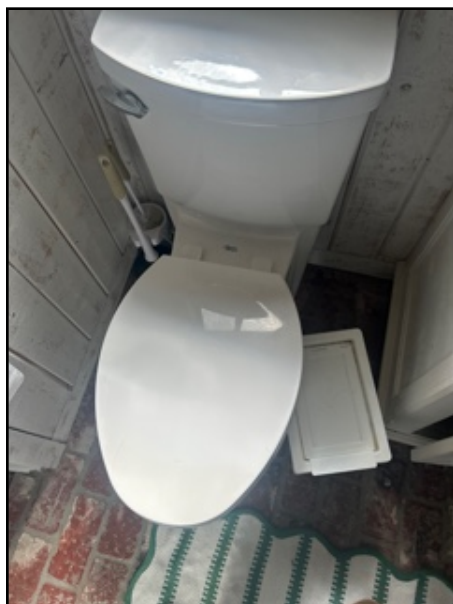
Figure 22-1

The toilet was loose. Suggest removing/replacing wax ring and reinstalling a new wax ring. When the toilet is removed, it is recommended to inspect subfloor for wood deterioration.

20) Comment 22: The toilet was loose. Suggest removing/replacing wax ring and reinstalling a new wax ring. When the toilet is removed, it is recommended to inspect subfloor for wood deterioration.

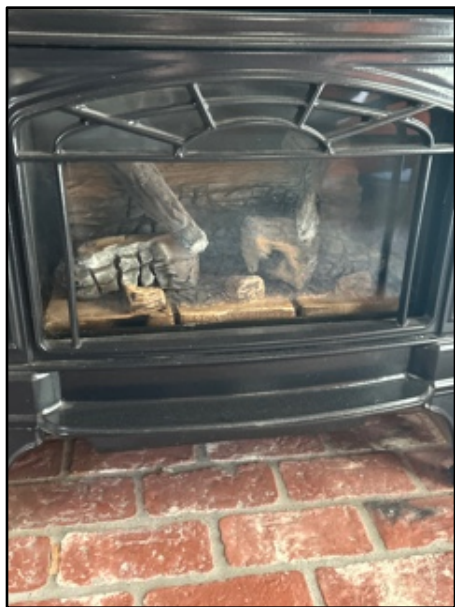
Figure 23-1

The gas fireplace would not ignite at the time of inspection. Recommend further review by proper trades.

21) Comment 23: The gas fireplace would not ignite at the time of inspection. Recommend further review by proper trades.

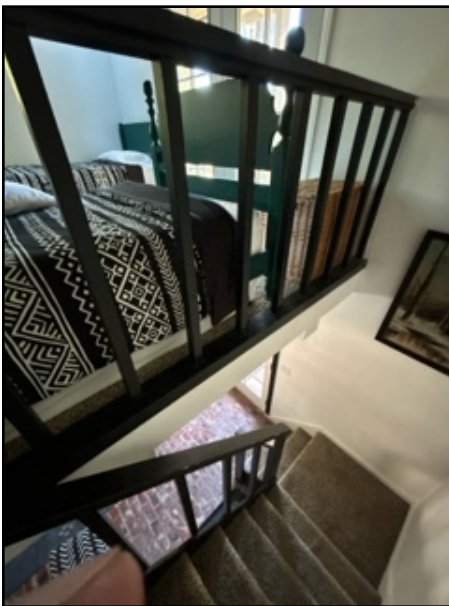
Figure 24-1

**Comment 24:**
Noted that loft and stair railing do not meet current building requirements.

However, this is pre-existing, non-conforming and may or may not need to be updated if there is a permit pulled on the property. This may not be a code in this county, this is information only.

This would include a rail height of 42 inches and picket spacing no more than 4 inches apart.

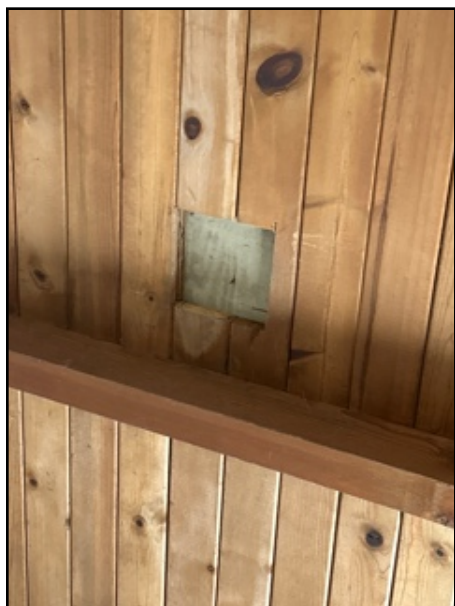
Figure 25-1

**Comment 25:**
A section of the ceiling at the living room appears to have been cut out at some point. Some moisture staining was present which may indicate a previous roof leak. No active moisture was present at the time of inspection.

22) Comment 25: A section of the ceiling at the living room appears to have been cut out at some point. Some moisture staining was present which may indicate a previous roof leak. No active moisture was present at the time of inspection.
