## Cornerstone Home Inspections

## Home Inspection Report

**15984 Tomahawk**

**Sonora, CA 95370**

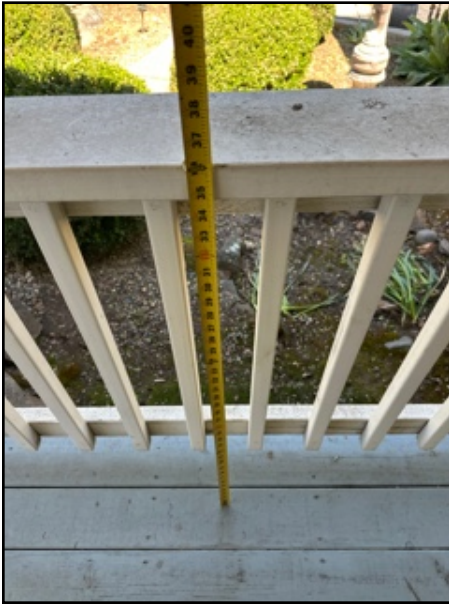
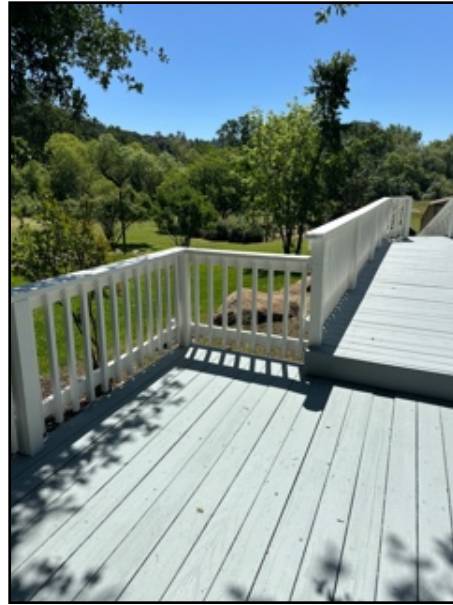
Deck/ porch railing height is not up to code. Current CA building code requires a minimum railing height of 42". However, this height is pre-existing and would only need replaced if a permit were pulled on the property.

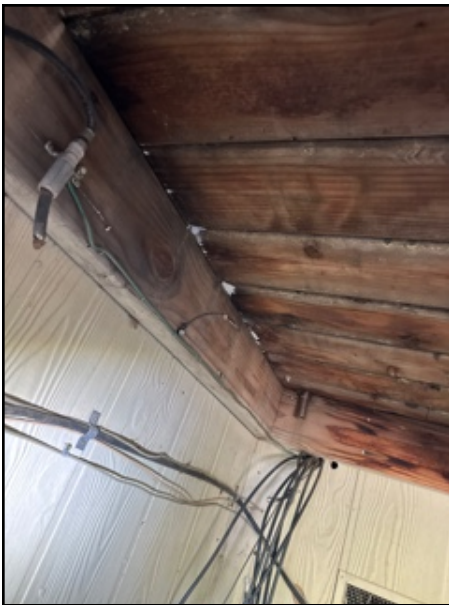
Figure 2-1

White fungus noted beneath deck treads against garage man door. Recommend to scrape & treat.

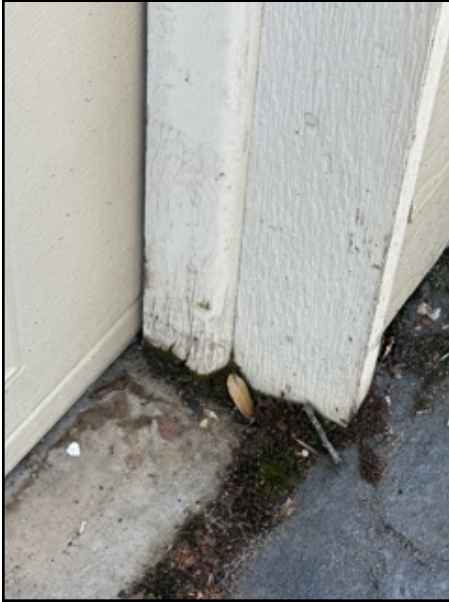
Figure 3-1

Wood decay noted at base of right garage overhead door trim (right side). Refer to a licensed pest inspector.

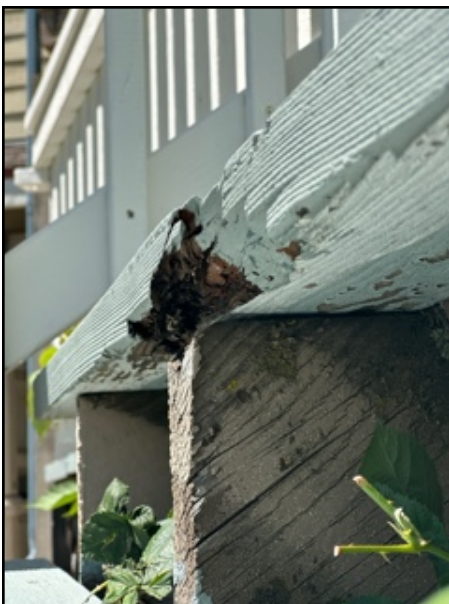
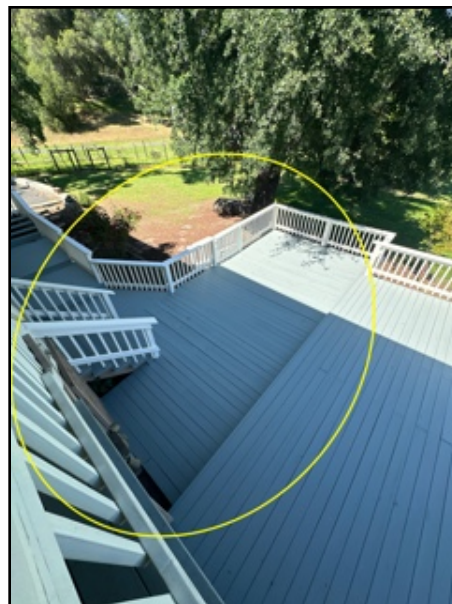
Wood decay noted on various areas of lower back deck structure & stairs. Refer to a licensed pest inspector for further evaluation.

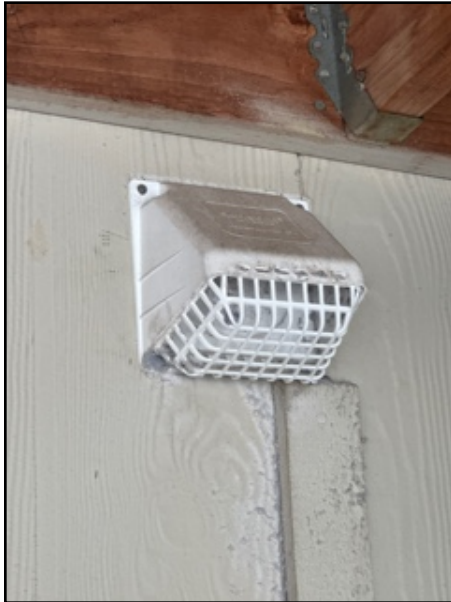
Figure 5-1

Dryer vent has a grate installed over it, which can easily clog with lint. Recommend removing the grate.

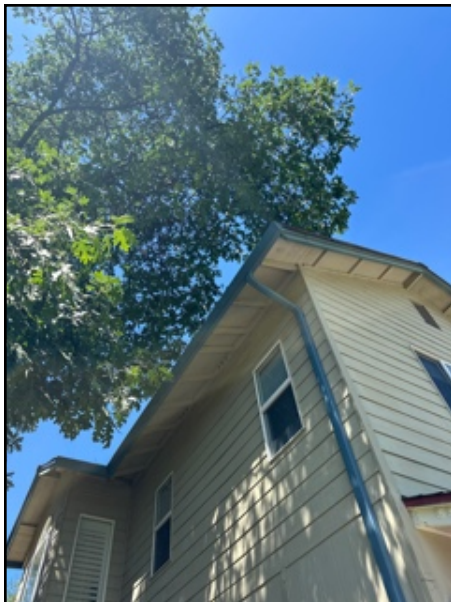
Figure 6-1

Recommend to trim debris away from the structure.

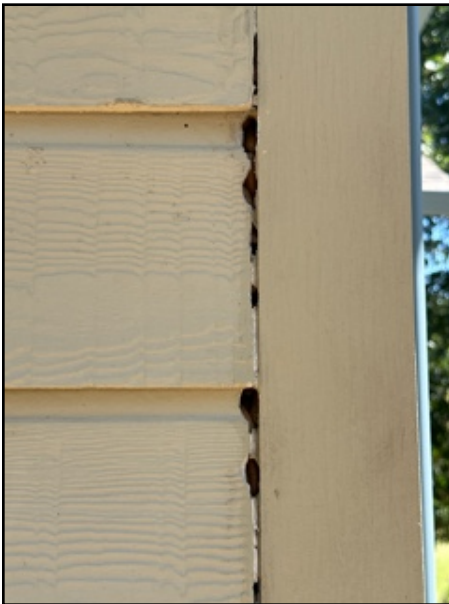
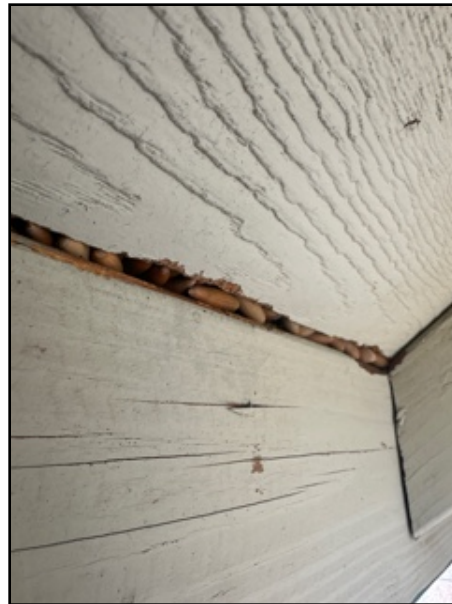
Woodpecker damage noted on various areas surrounding home.

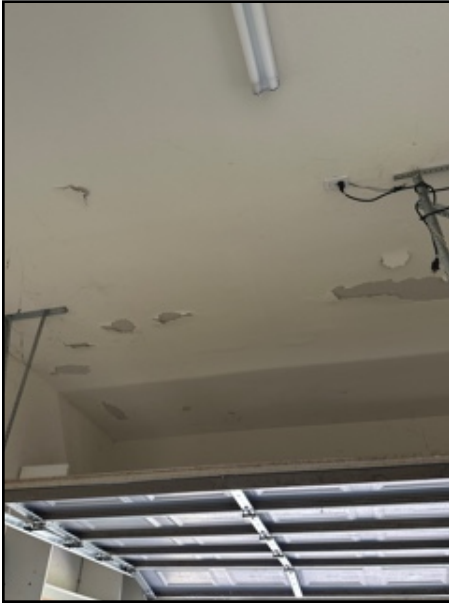
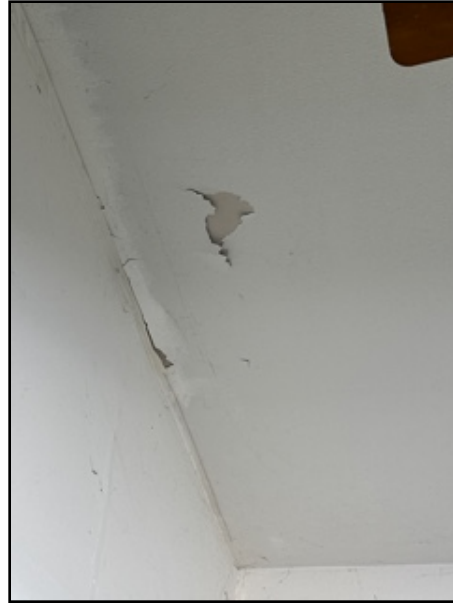
Comment 8:  
Damaged drywall coverings noted in garage.

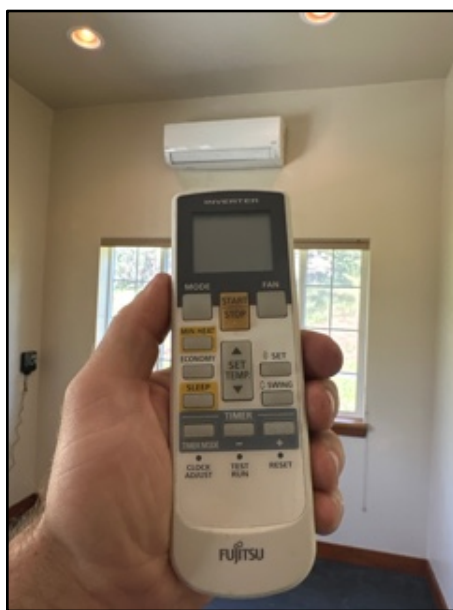
Figure 10-1

Mini-split control remote was dead at time of inspection, therefore mini-split could not be tested for function.

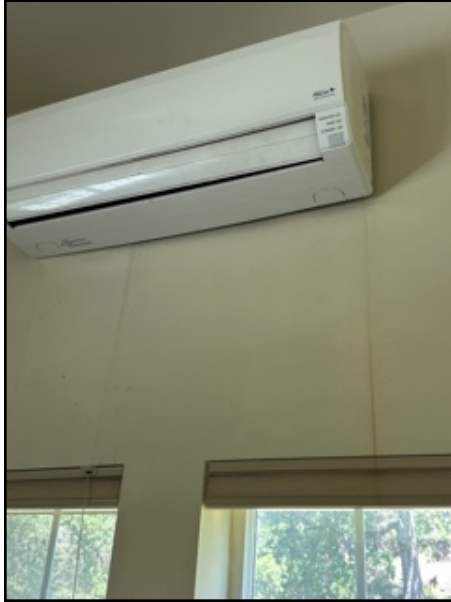
Figure 11-1

Moisture stains noted on wall from behind ADU mini-split. Recommend to have further evaluated by a qualified tradesman.

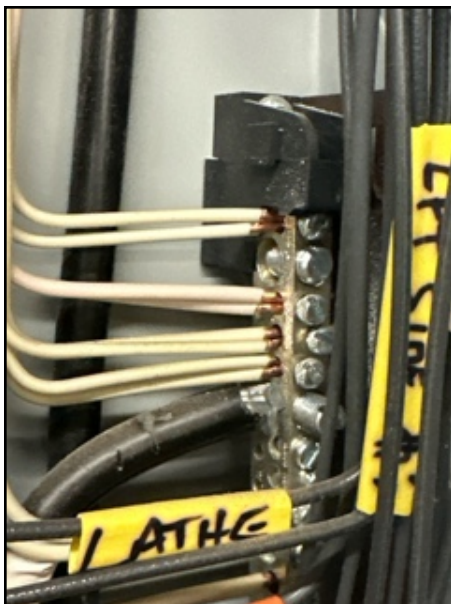
Figure 12-1

Buss bar in detached garage panel has multiple neutrals attached per lug. Each neutral should be attached to its own dedicated lug. Refer to a licensed electrician.

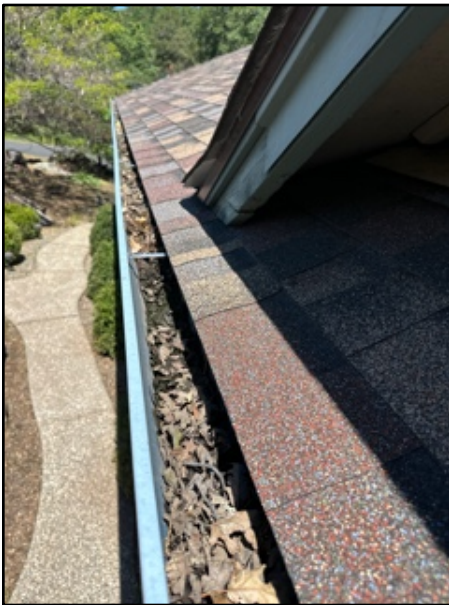
Figure 15-1

**Comment 15:**  
Recommend to clean debris from roofing/ gutters to allow proper drainage.

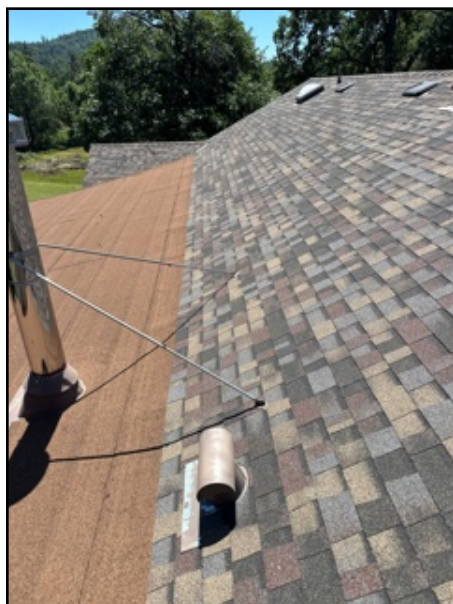
Figure 16-1

**Comment 16:**  
Overall roofing appears to be in excellent condition with multiple years of usable life remaining.

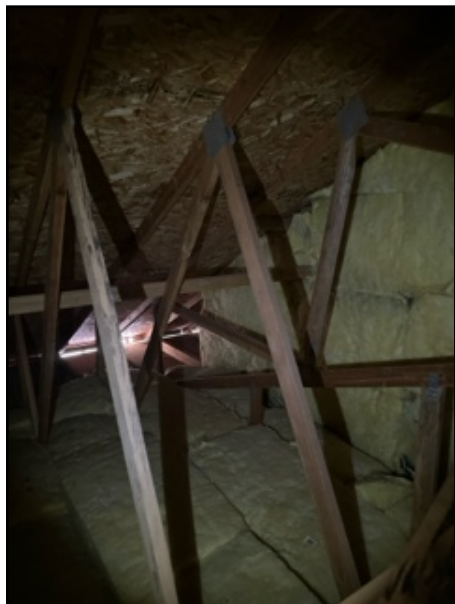
Figure 17-1

Attic was noted to be well insulated with no evidence of leaks or any other issues at time of inspection.

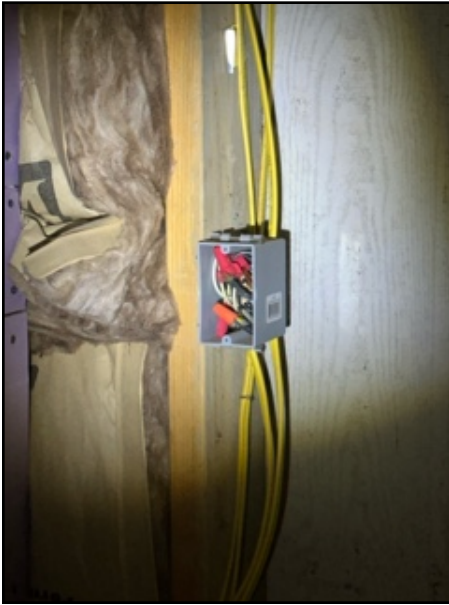
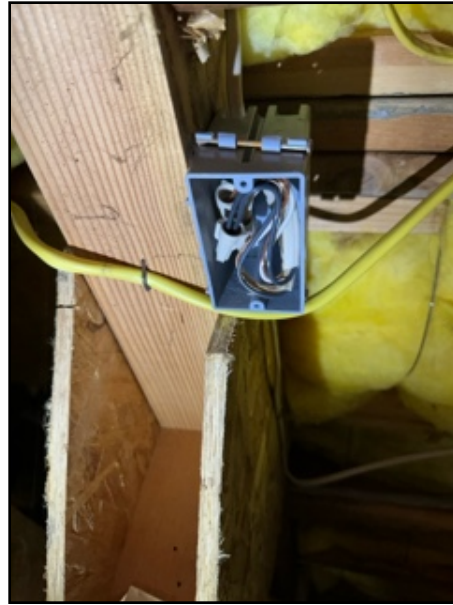
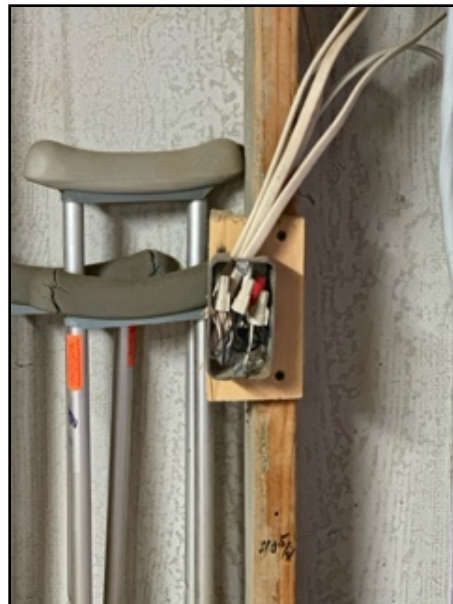
Multiple open junction boxes noted in various areas of crawl space. Recommend securing with faceplates.

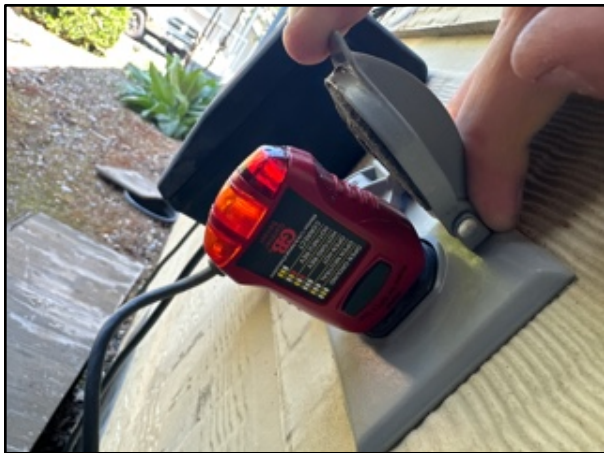
Figure 19-1

Receptacle near garage man door has hot & neutral wires reversed. Refer to a licensed electrician.

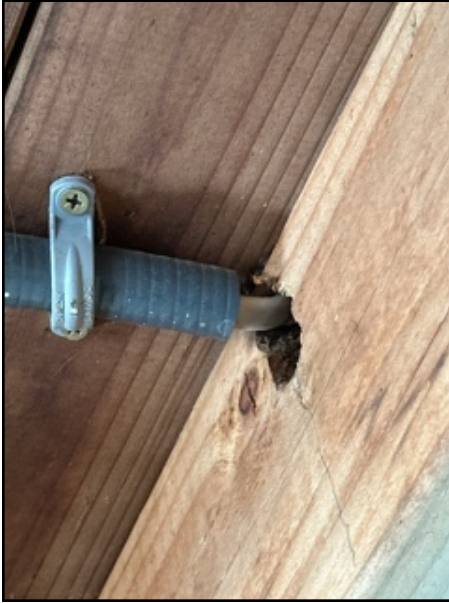
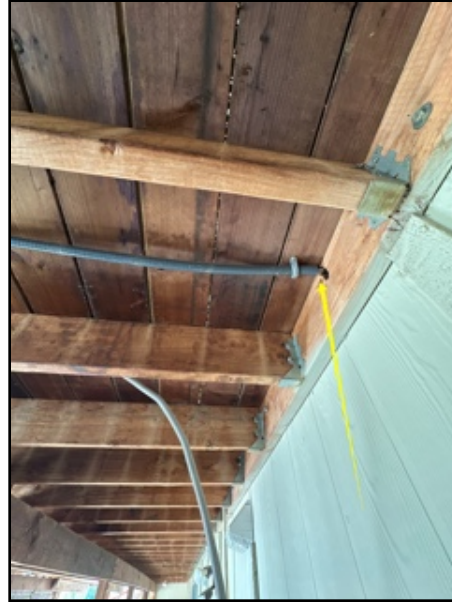
Romex wire has been installed in a conduit on the exterior of home below deck. Romex can not be installed in conduit in any areas outside, below ground, or areas of high moisture. Refer to a licensed electrician.

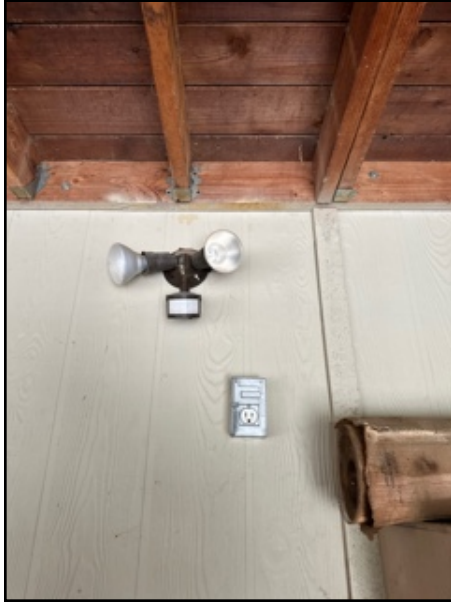
Figure 21-1

Receptacle below deck near light is missing part of the weatherproof cover & has an open hole in the base of the box. Recommend repair.

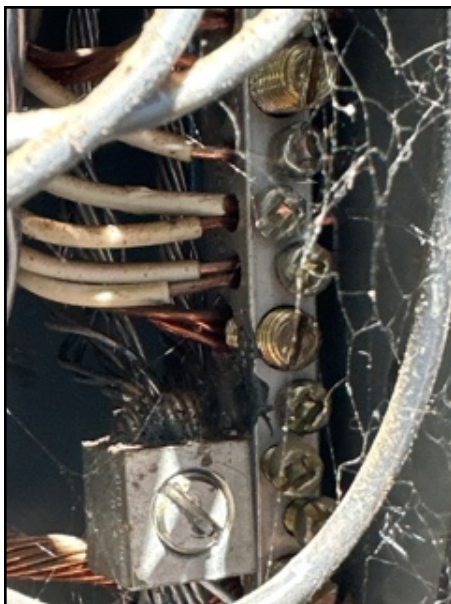
Figure 22-1

Buss bar in main panel has multiple neutrals attached per lug. Each neutral should be attached to its own dedicated lug. Refer to a licensed electrician.

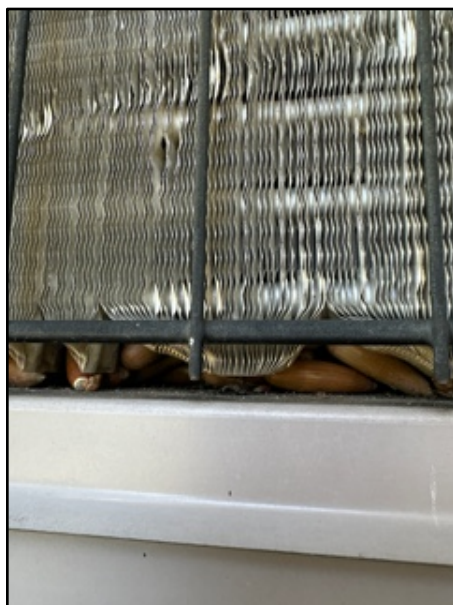
Figure 23-1

Woodpecker damage noted to the HVAC system installed on right side of home. Recommend having further inspected by a licensed HVAC technician.

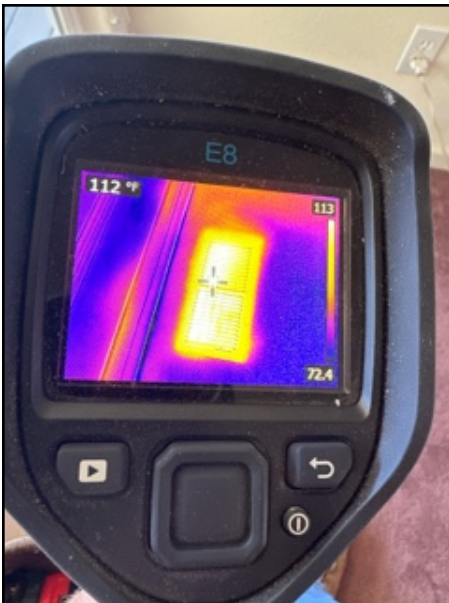
Figure 24-1

Heater tested and recorded an output of over 105 degrees at all registers (unless otherwise noted). Condition is functional.

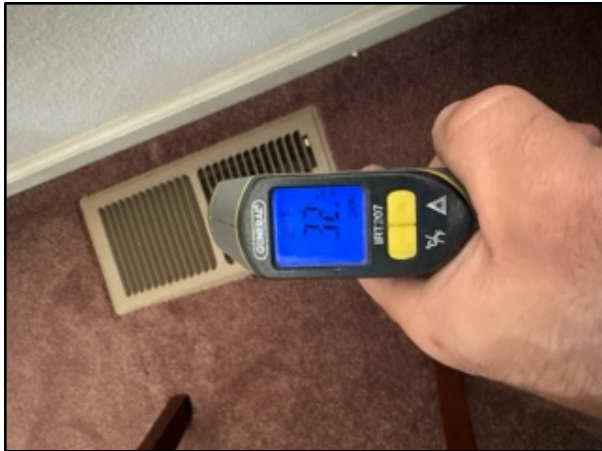
Figure 25-1

Air conditioning recorded an output of 32 degrees with an intake of 66 degrees. Condition is functional.

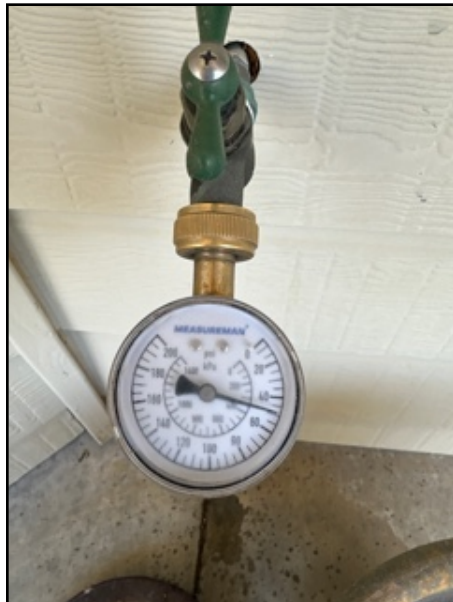
Figure 26-1

**Comment 26:**  
Water pressure noted at 48 psi. Current CA building code allows a maximum pressure of 80 psi. Condition is functional.

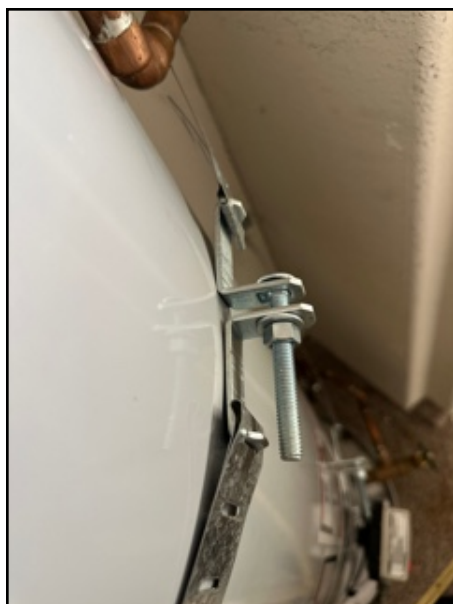
Figure 27-1

**Comment 27:**  
Water heater straps are not installed properly & could easily disconnect. Recommend repair.

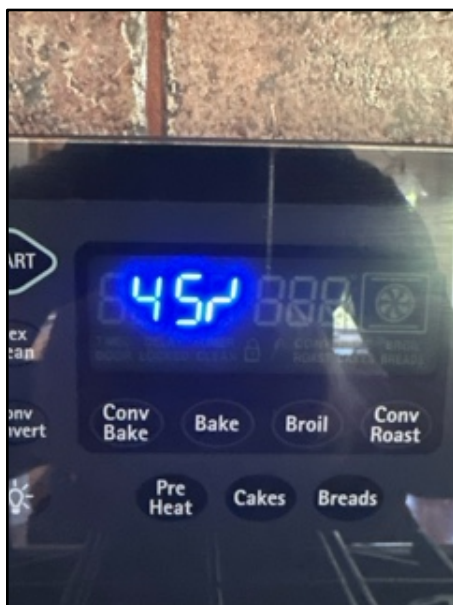
Figure 28-1

Comment 28:  
LCD on range noted to not illuminate properly.

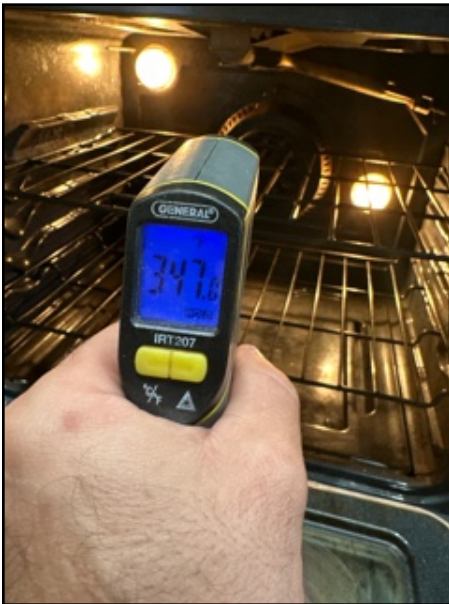
Figure 29-1

Oven set at 350 recorded a temperature of 347 degrees. Condition is functional.

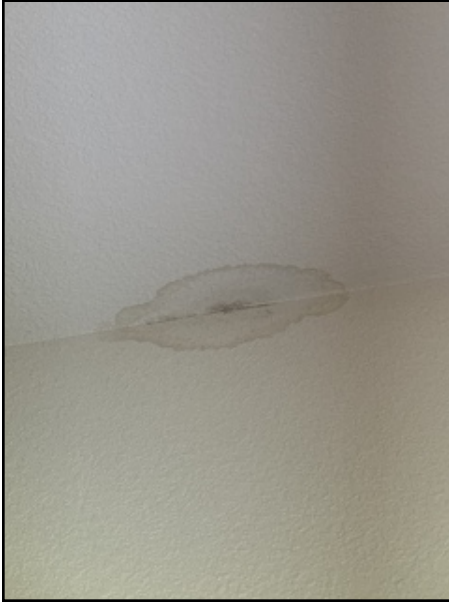
Figure 31-1

Moisture stain noted on hallway ceiling near kitchen. No moisture was present at time of inspection.

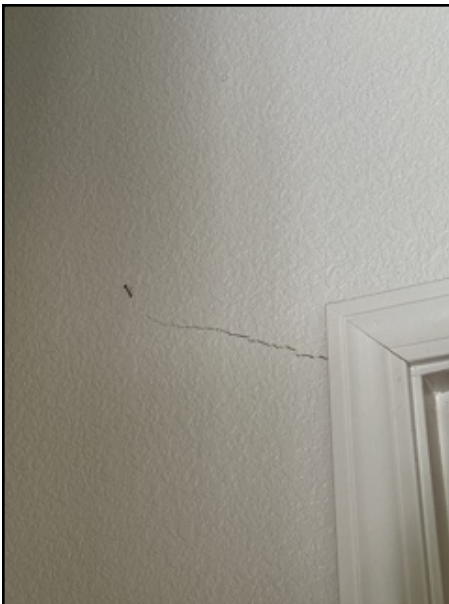
Figure 32-1

Drywall settling cracks noted above laundry room doors.

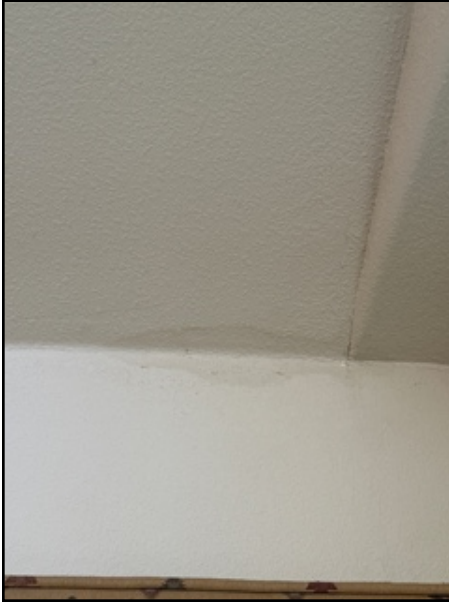
Figure 33-1

**Comment 33:**  
Moisture stain noted above right living area window. No active moisture was present at time of inspection.

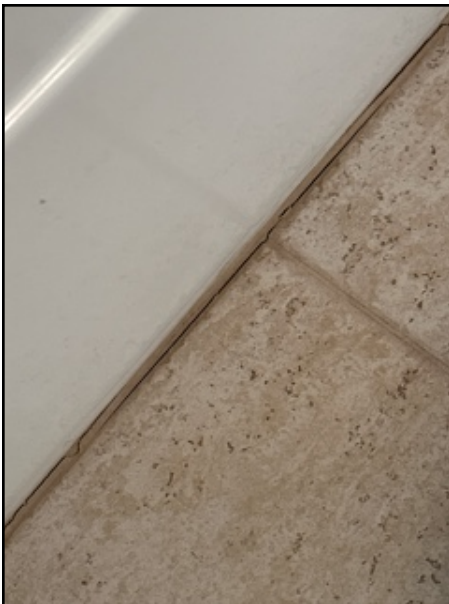
Figure 35-1

Recommend to reseal grout against hallway bathroom tub.

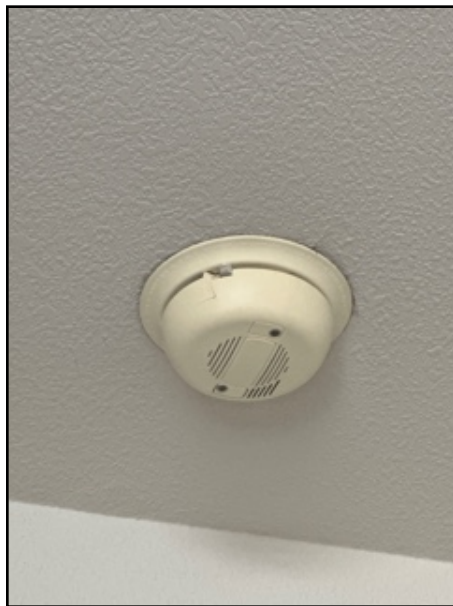
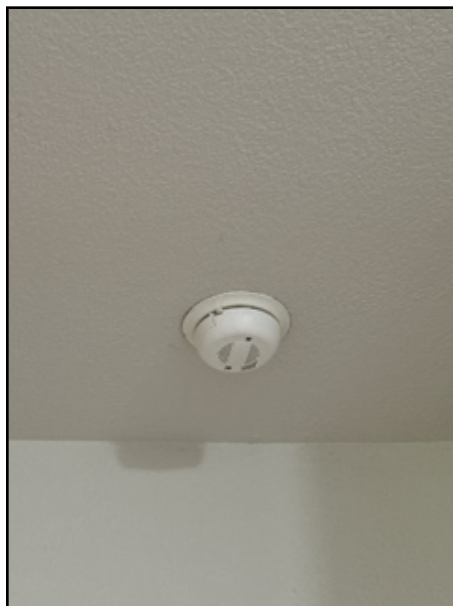
Smoke alarms are not up to current CA Fire Code Requirements.

Ca building code requires all smoke alarms to either contain 10 year non-replaceable batteries / or be hard wired in. Recommend installing as required.

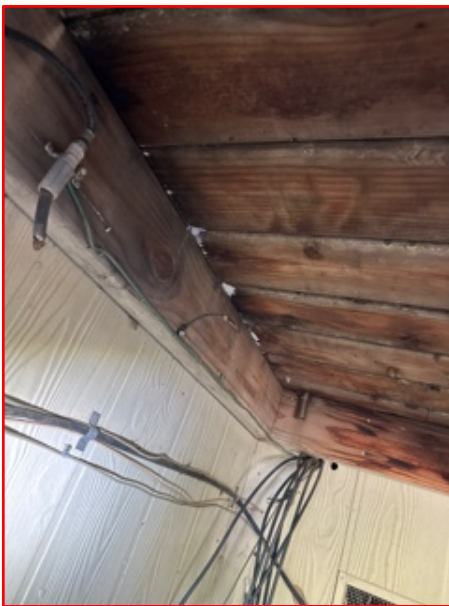
Figure 2-1

1) White fungus noted beneath deck treads against garage man door. Recommend to scrape & treat.

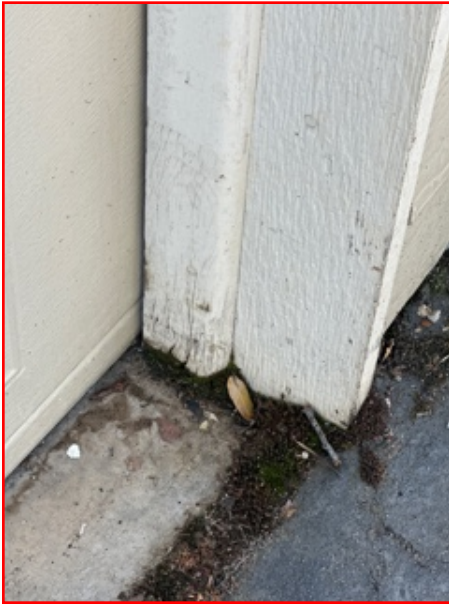
Figure 3-1

2) Wood decay noted at base of right garage overhead door trim (right side). Refer to a licensed pest inspector.

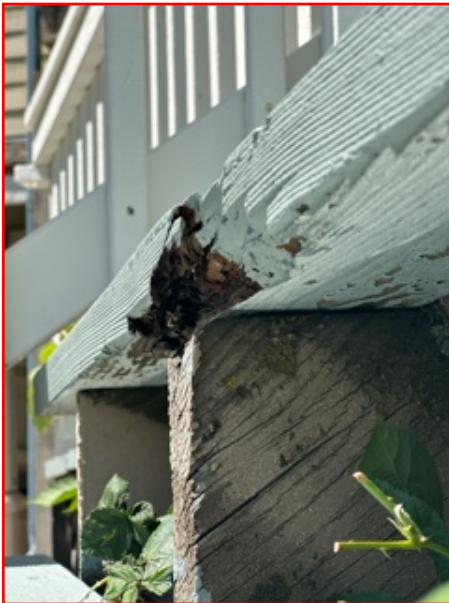
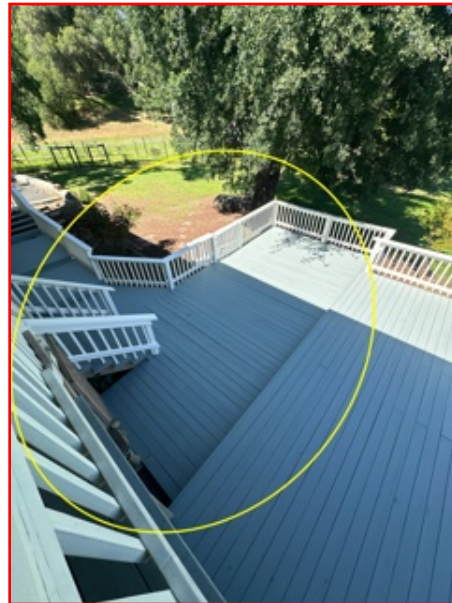
3) Wood decay noted on various areas of lower back deck structure & stairs. Refer to a licensed pest inspector for further evaluation.

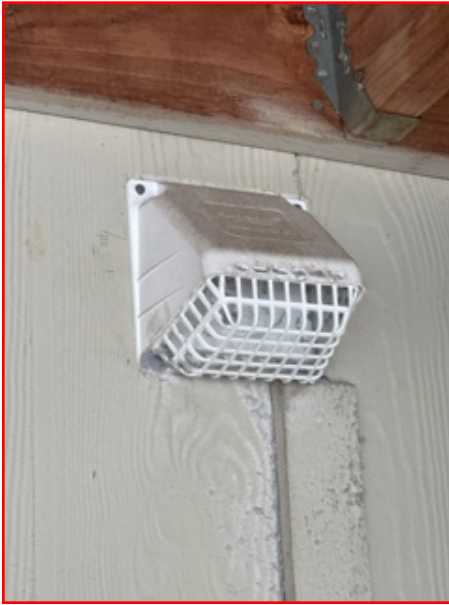
Figure 5-1

4) Dryer vent has a grate installed over it, which can easily clog with lint. Recommend removing the grate.

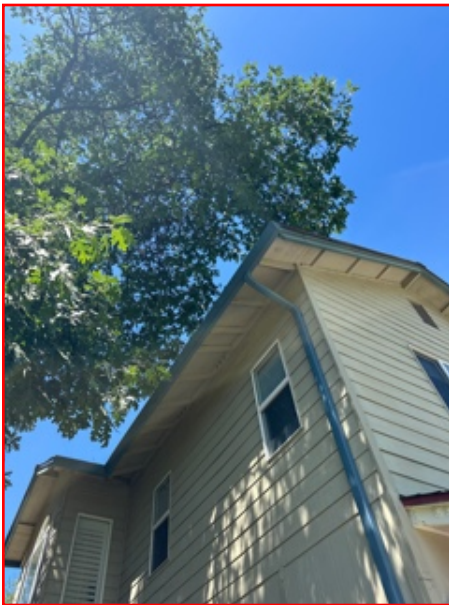
Figure 6-1

5) Recommend to trim debris away from the structure.

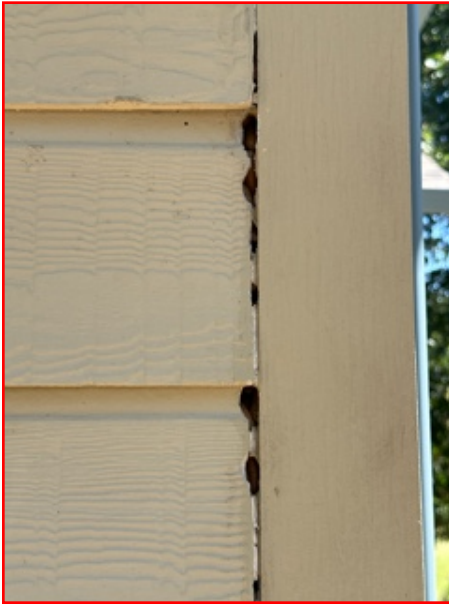
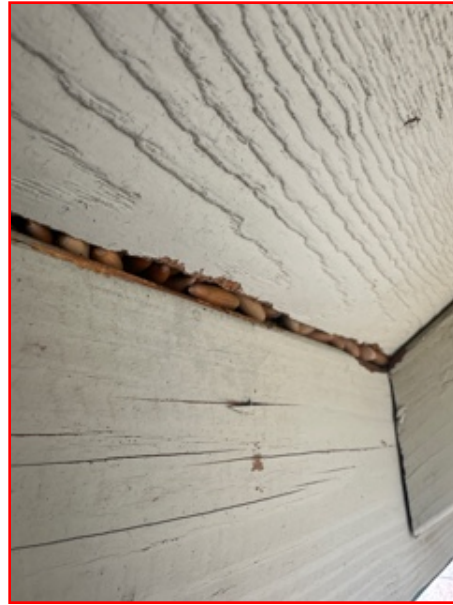
6) Woodpecker damage noted on various areas surrounding home.

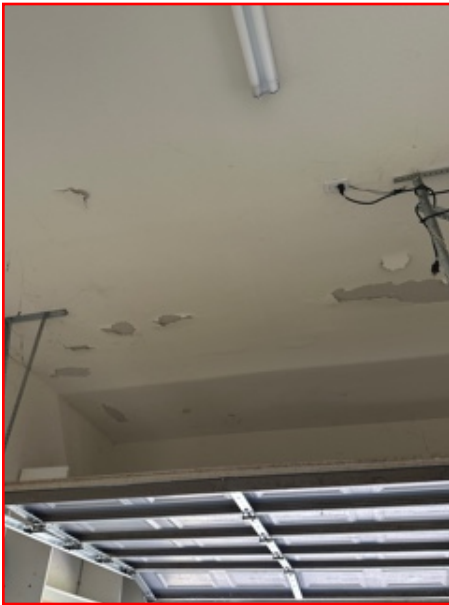
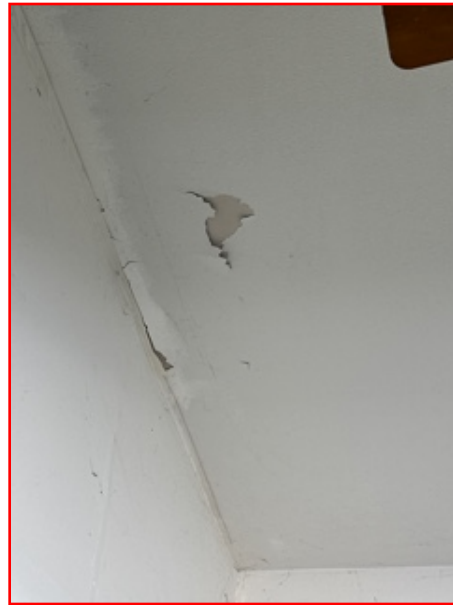
7) Damaged drywall coverings noted in garage.

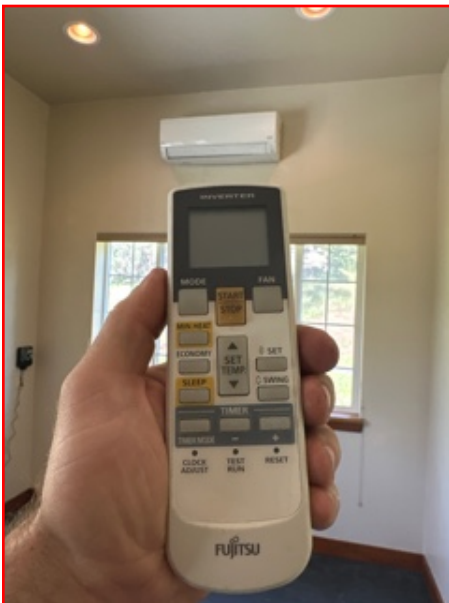
Figure 10-1

9) Mini-split control remote was dead at time of inspection, therefore mini-split could not be tested for function.

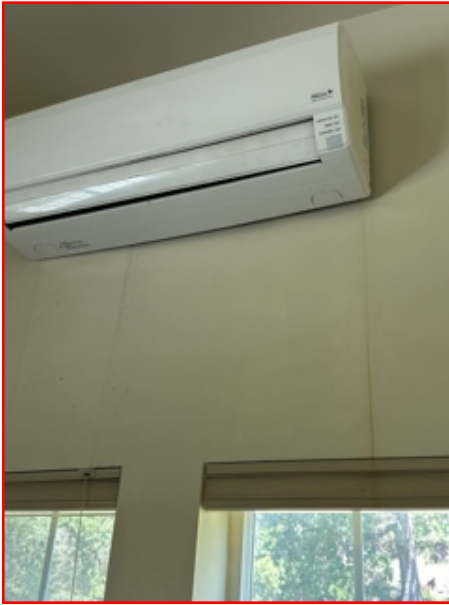
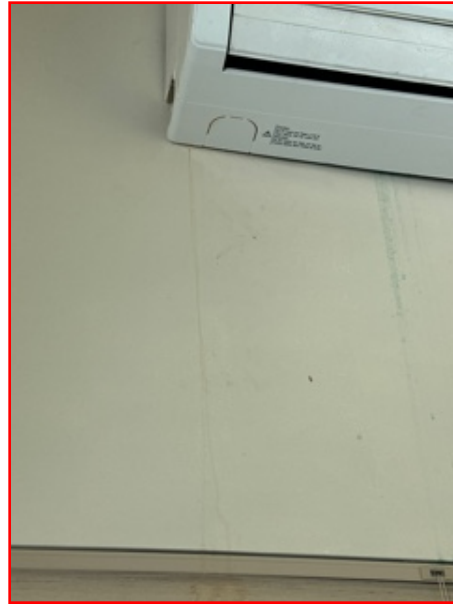
10) Moisture stains noted on wall from behind ADU mini-split. Recommend to have further evaluated by a qualified tradesman.

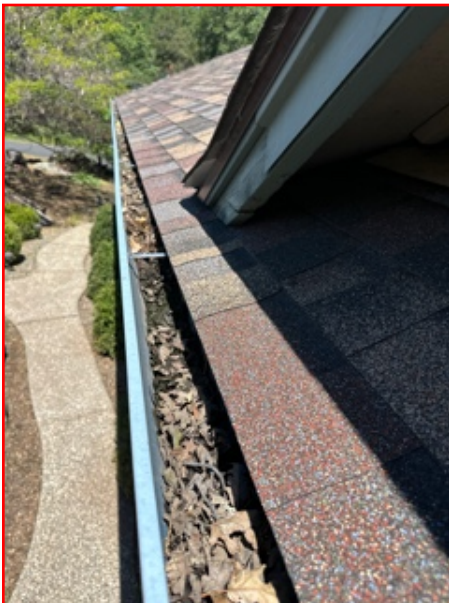
Figure 15-1

13) Recommend to clean debris from roofing/ gutters to allow proper drainage.

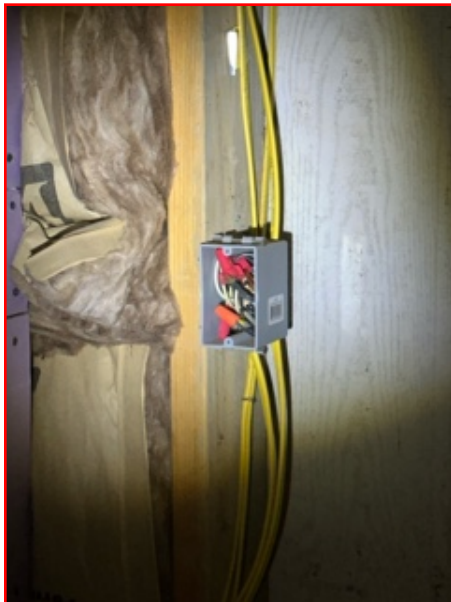
Figure 18-1

14) Multiple open junction boxes noted in various areas of crawl space. Recommend securing with faceplates.

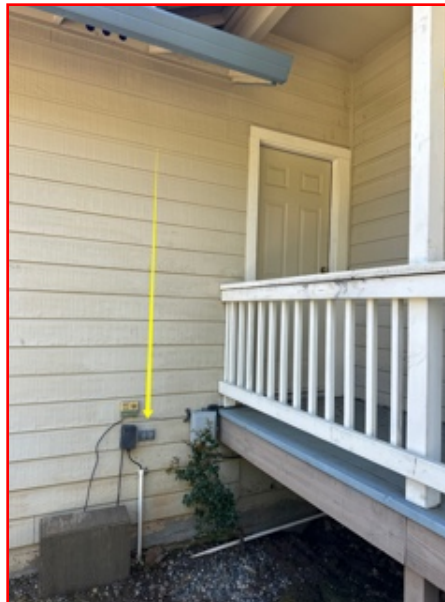
Figure 19-2

15) Receptacle near garage man door has hot & neutral wires reversed. Refer to a licensed electrician.

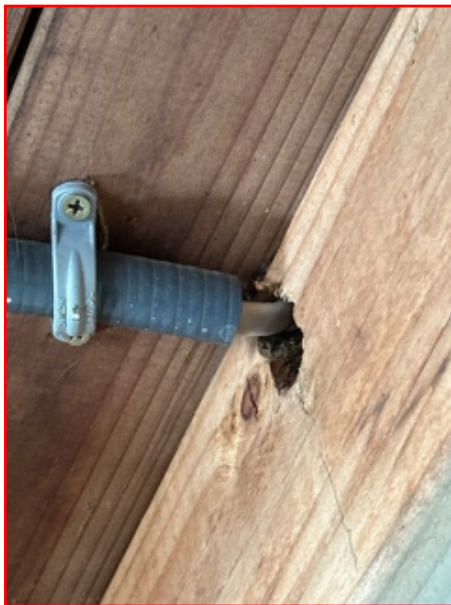
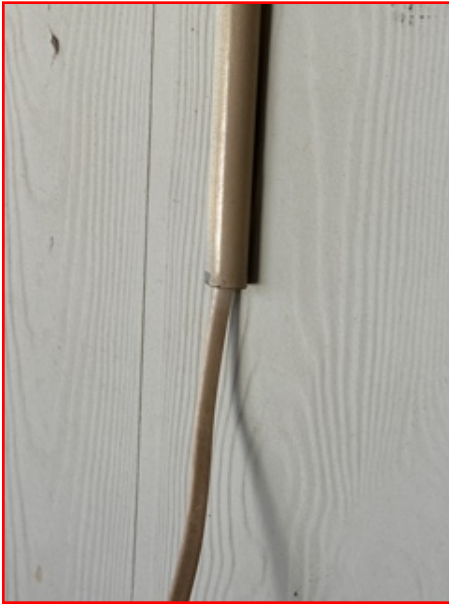
16) Romex wire has been installed in a conduit on the exterior of home below deck. Romex can not be installed in conduit in any areas outside, below ground, or areas of high moisture. Refer to a licensed electrician.

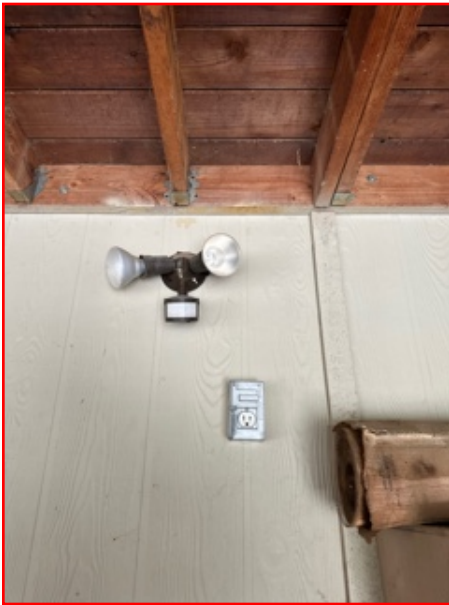
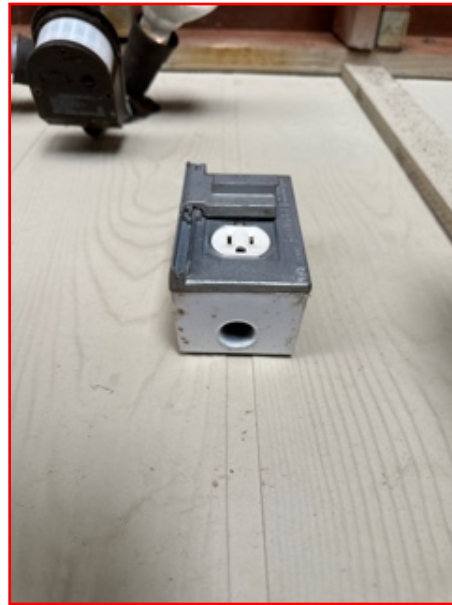
17) Receptacle below deck near light is missing part of the weatherproof cover & has an open hole in the base of the box. Recommend repair.

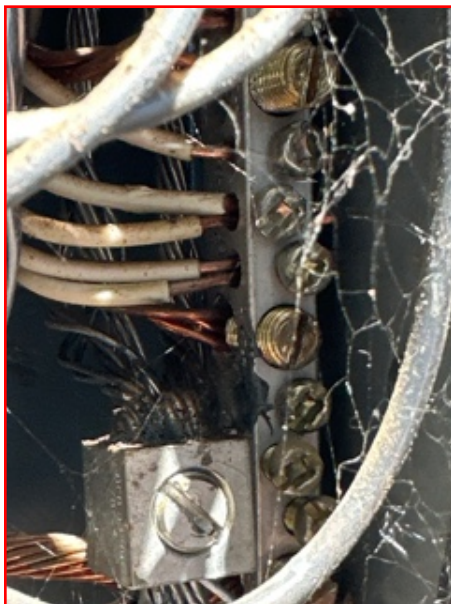
Figure 22-1

18) Buss bar in main panel has multiple neutrals attached per lug. Each neutral should be attached to its own dedicated lug. Refer to a licensed electrician.

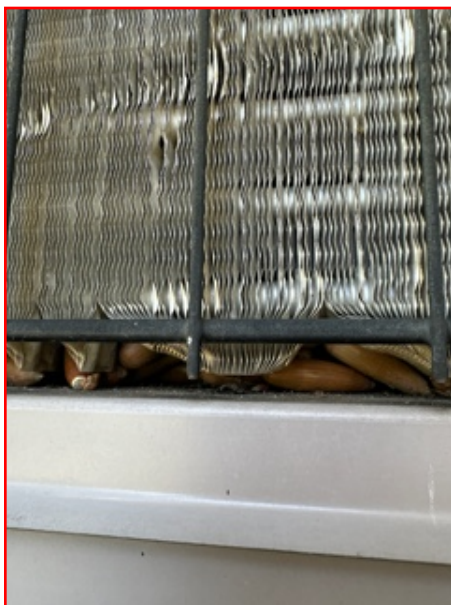
Figure 23-1

19) Woodpecker damage noted to the HVAC system installed on right side of home. Recommend having further inspected by a licensed HVAC technician.

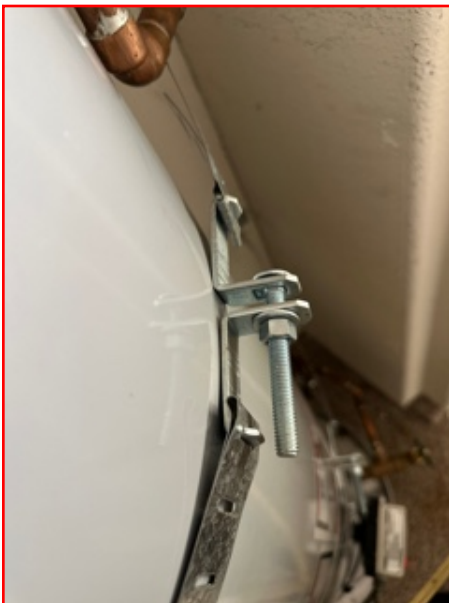
Figure 27-1

20) Water heater straps are not installed properly & could easily disconnect. Recommend repair.

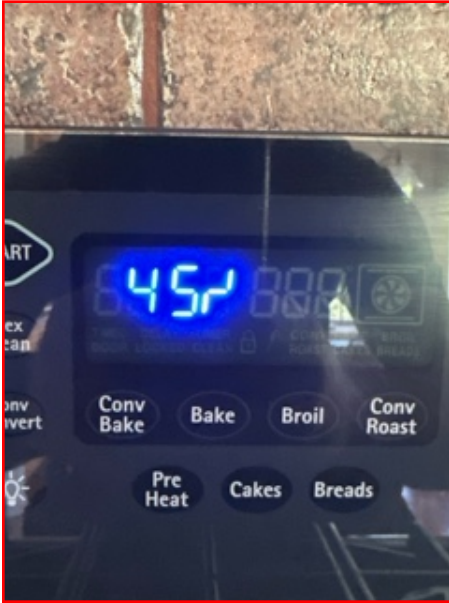
Figure 28-1

21) LCD on range noted to not illuminate properly.

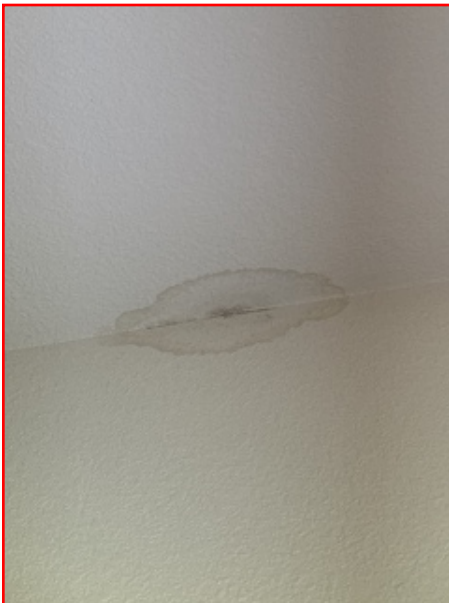
Figure 31-1

22) Moisture stain noted on hallway ceiling near kitchen. No moisture was present at time of inspection.

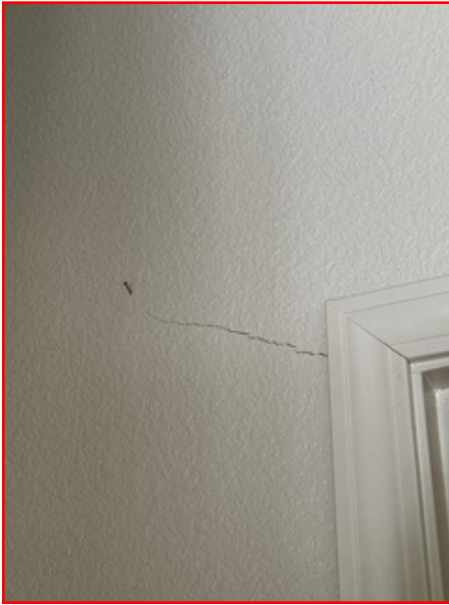
Figure 32-1

23) Drywall settling cracks noted above laundry room doors.

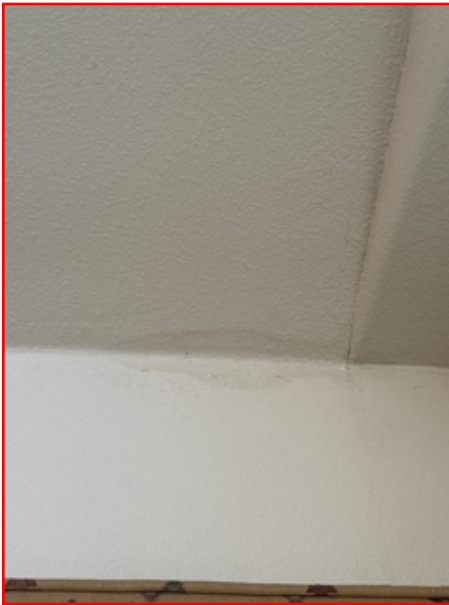
Figure 33-1

24) Moisture stain noted above right living area window. No active moisture was present at time of inspection.

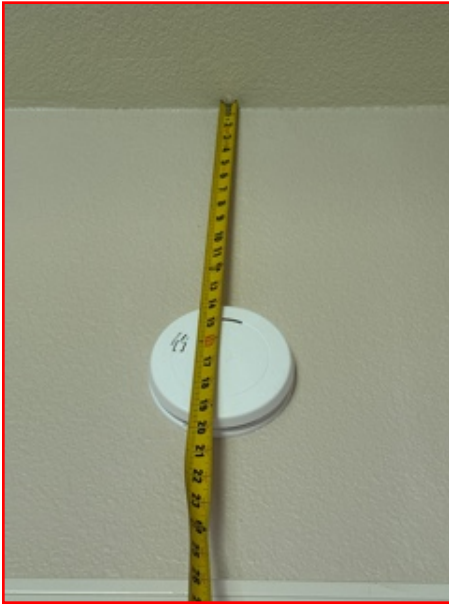
Figure 34-1

25) Recommend to raise smoke alarms to ceiling height as required.

Current CA fire code states: Smoke alarms should be mounted on the ceiling 4" from the wall; wall mounts should be 4-12" from the ceiling. Do not install near draft areas (windows, vents).

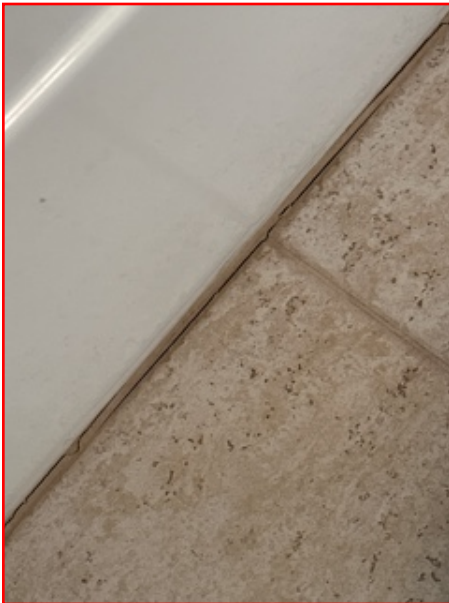
Figure 35-1

26) Recommend to reseal grout against hallway bathroom tub.

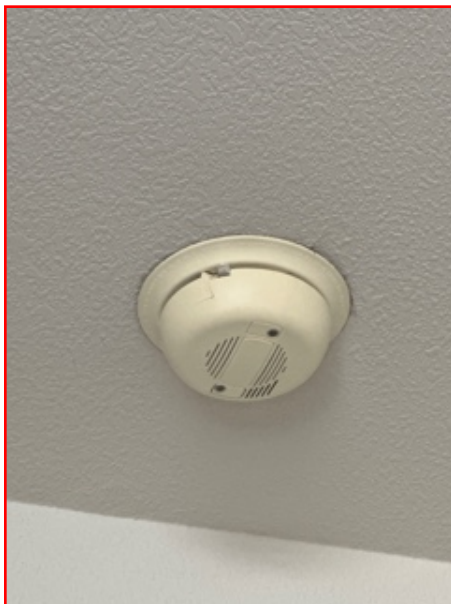
Figure 36-1

27) Smoke alarms are not up to current CA Fire Code Requirements.

Ca building code requires all smoke alarms to either contain 10 year non-replaceable batteries / or be hard wired in. Recommend installing as required.
