PROPERTY LOCATION  
5645 Lake Murray Blvd. #C, La Mesa CA 91942

# WOOD DESTROYING PESTS AND ORGANISMS INSPECTION REPORT

BUILDING NO. <b>5645</b>	STREET, CITY, STATE, ZIP <b>Lake Murray Blvd. #C, La Mesa CA 91942</b>	Date of Inspection <b>3/31/2023</b>	No. of Pages <b>5</b>

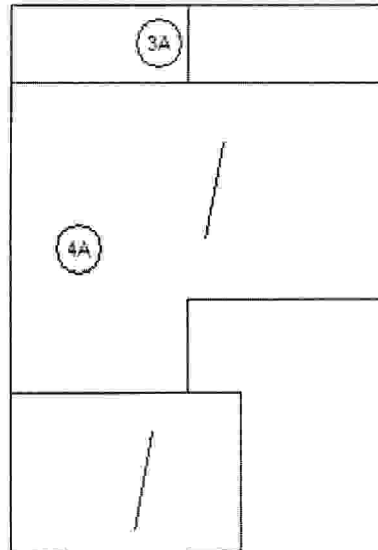
Diagram not to scale, findings in approximate locations.

**FINDING:** Fungus damage noted in patio 6x6 post of residence, see 3A on diagram.

\*\*\*\*\* This is a Section 1 Item \*\*\*\*\*

**FINDING:** Moisture damage noted under kitchen sink of residence, see 4A on diagram.

**RECOMMENDATION:** Remove and replace or repair fungus damaged wood as needed. Work completed by D&S Termite guaranteed for one year. If certification is required D&S Termite must re inspect work completed by others. D&S Termite does not guarantee work completed by others. D&S Termite & Pest Control will apply primer coat, but cannot be responsible for match of color. If during the course of repair work, fungus and/or termite damage extends into inaccessible areas, there may be an additional charge for repairs. D&S Termite & Pest Control will contact you about additional charges if any.

**RECOMMENDATION:** Remove and replace or repair moisture damaged wood as needed. Work completed by D&S Termite guaranteed for one year. If certification is required D&S Termite must re inspect work completed by others. D&S Termite does not guarantee work completed by others. D&S Termite & Pest Control will apply primer coat, but cannot be responsible for match of color. If during the course of repair work, fungus and/or termite damage extends into inaccessible areas, there may be an additional charge for repairs. D&S Termite & Pest Control will contact you about additional charges if any.
