HOME INSPECTION REPORT

13431-69 Hwy 8 Business
El Cajon, CA 92021

Kroon Family Trust c/o Ann and Ray Petta
07/25/2023

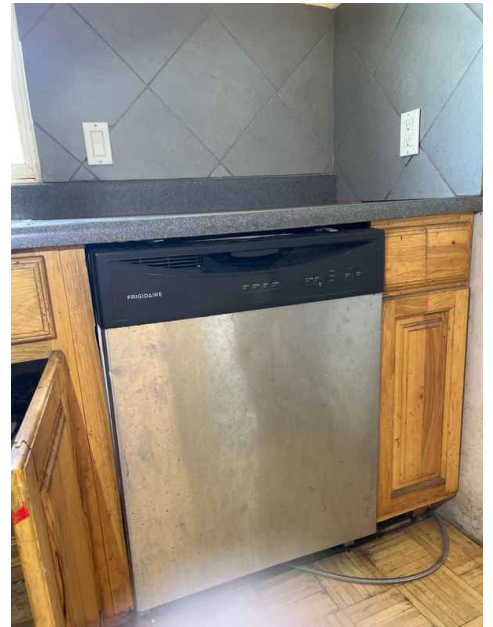
DOOR SPRINGS INOP

Contact a qualified appliance repair professional.

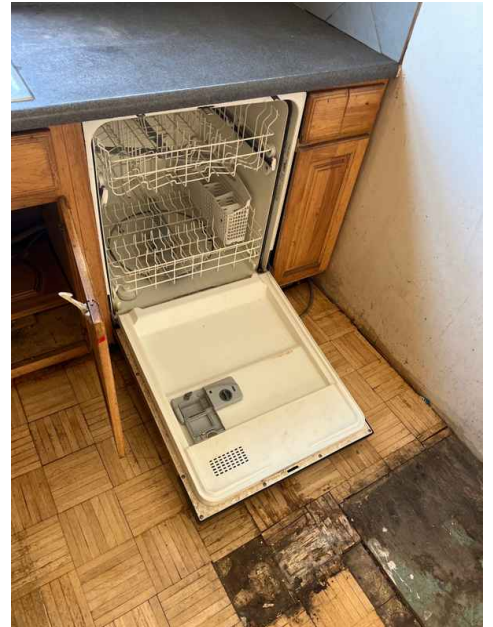
ANTI-TIP MISSING

Contact a qualified appliance repair professional.

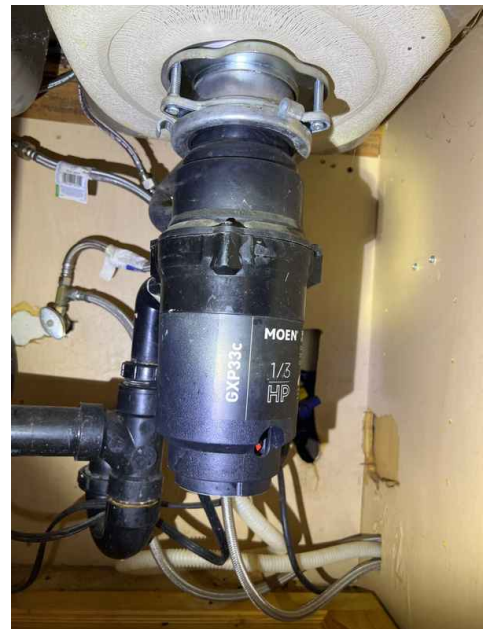
DISPOSER INOP- NO POWER

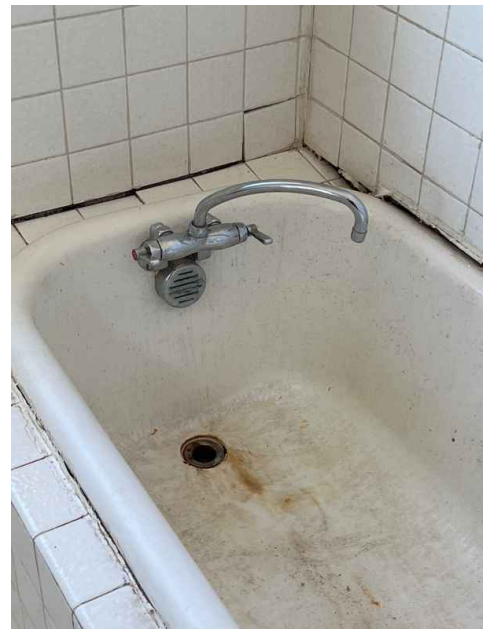
FAUCET - WATER OFF

Contact a qualified professional.

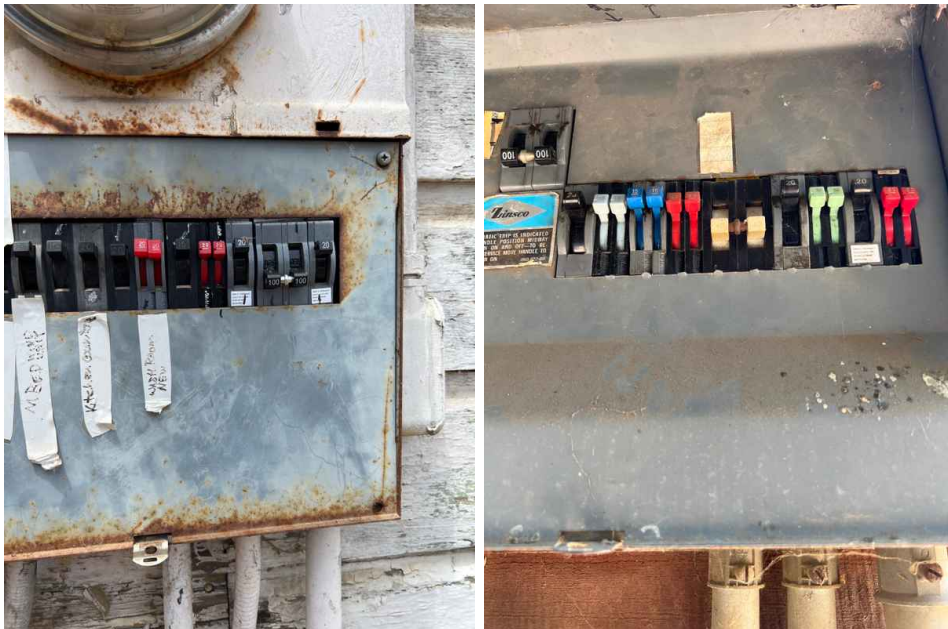
RUST IN PANEL

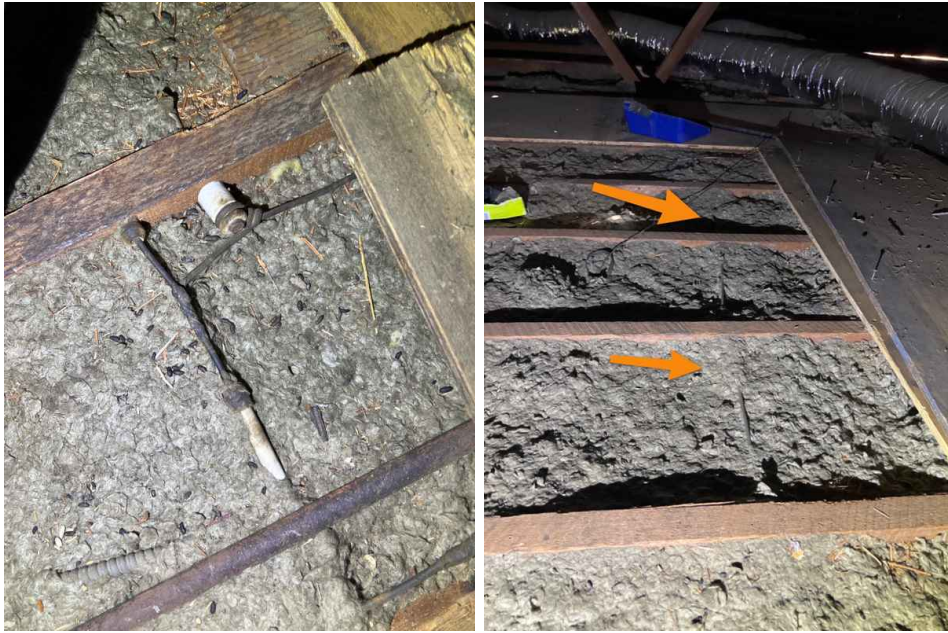
EXPOSED ROMEX

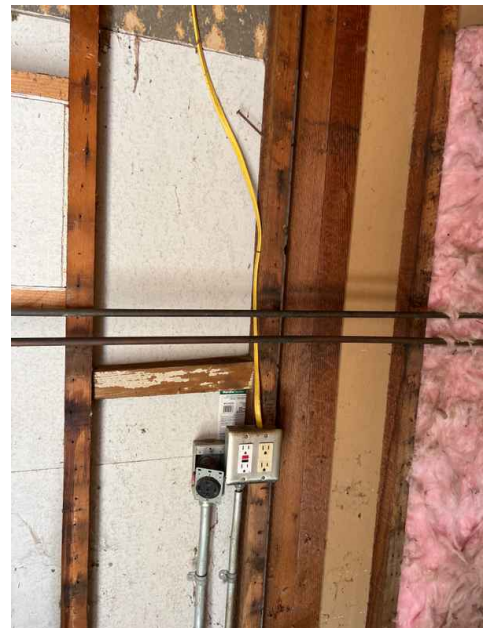
IMPROPER TERMINATION

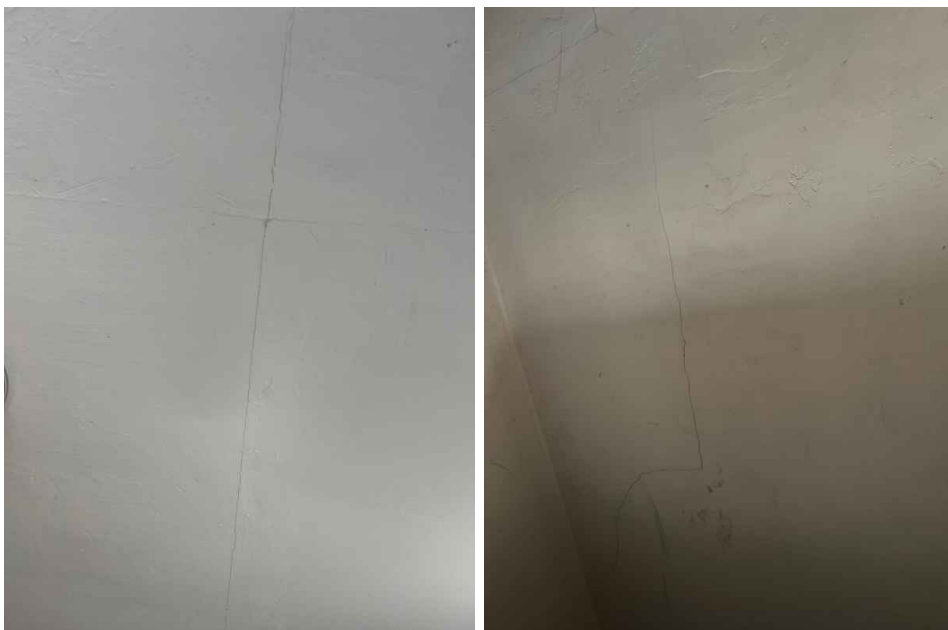
MODERATE CRACKS

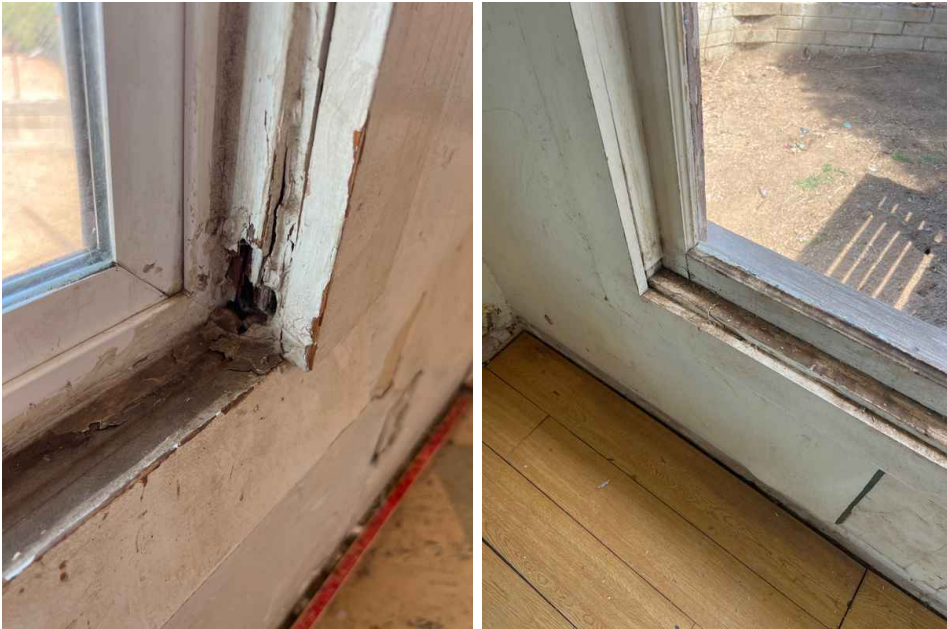
PLASTER/DRYWALL DAMAGED

Wall board was damaged in several locations throughout the house. Recommend repair as needed

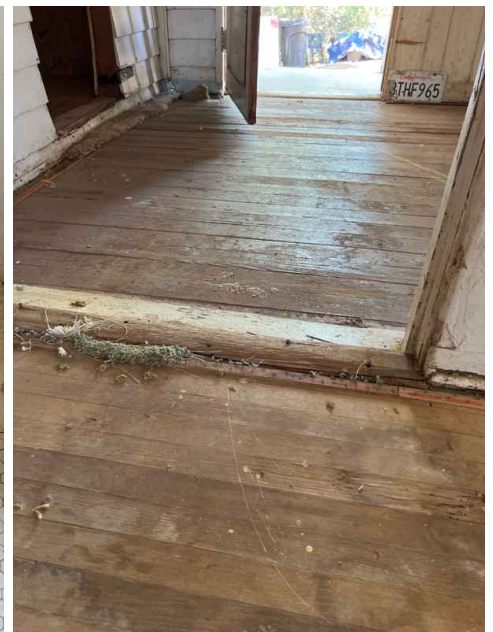
FLOOR TRIM - LOOSE

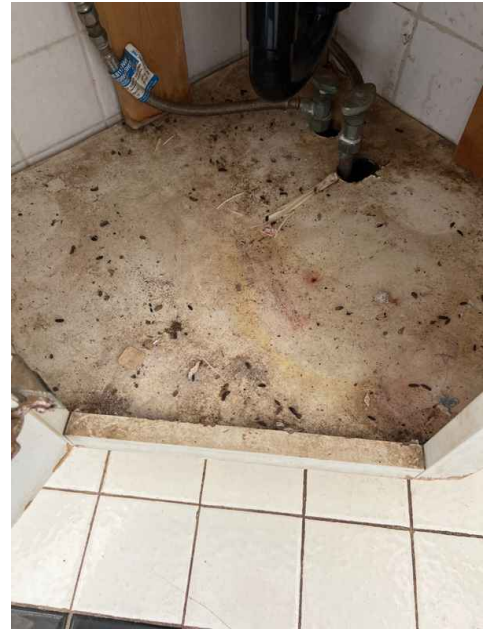
STAINS DRY - CABINET - PAST LEAK

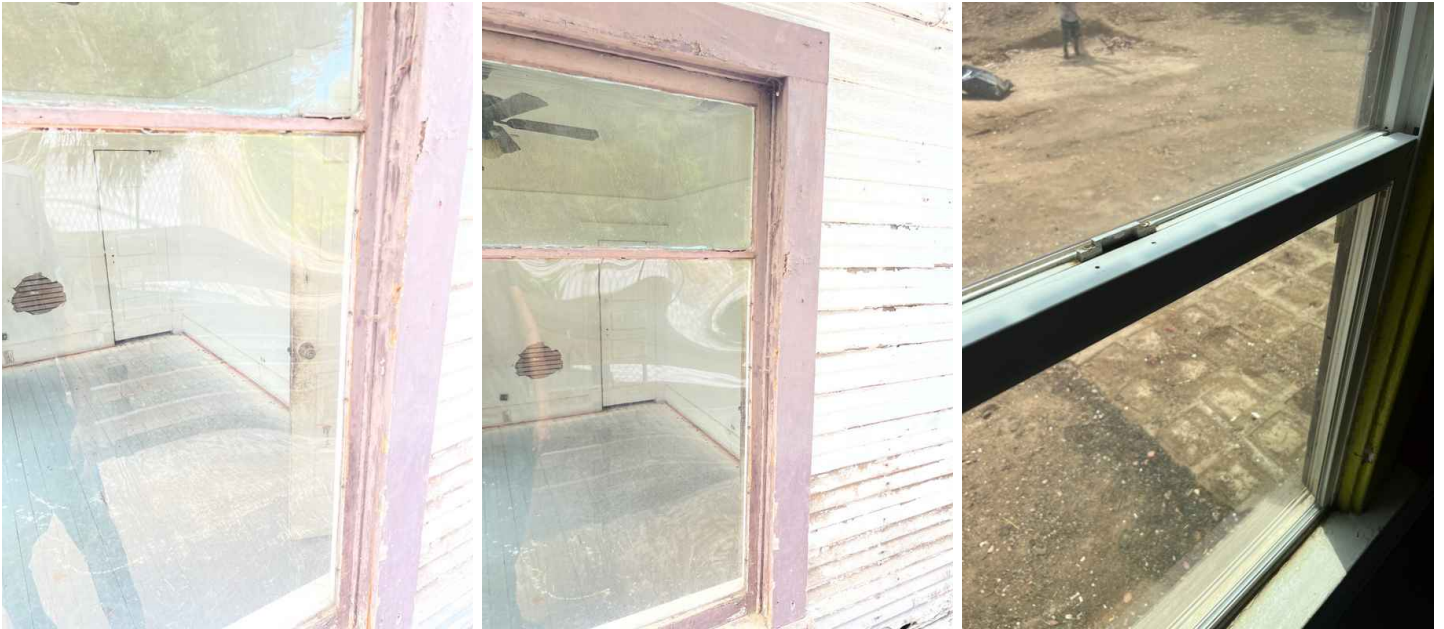
GLASS CRACKED/BROKEN

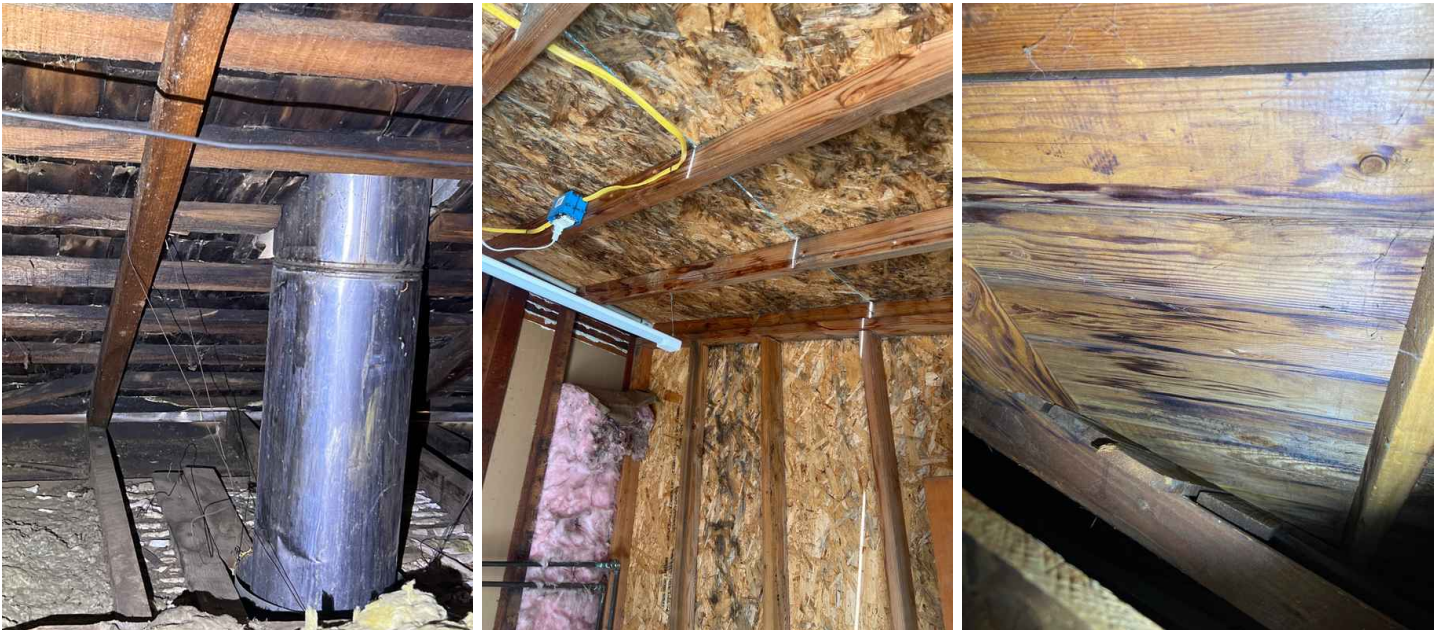
SHEATHING - DRY ROT

Repairs were observed to the roof sheathing. We recommend further review with a Qualified roofer.
