REAL ESTATE INSPECTION REPORT

Property Address:
72325 Roxbury Dr
Rancho Mirage, CA 92270

Prepared and Written by Bruce Carmichael , Inspector - Exclusively for
Mark Stine

Inspection Date
Thursday, August 4, 2022 at 8:30 AM

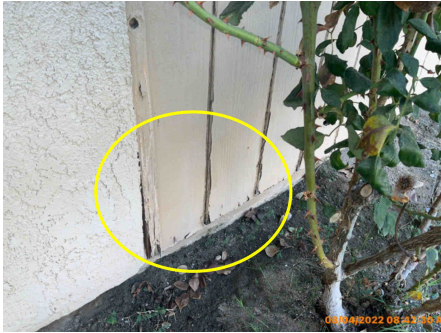
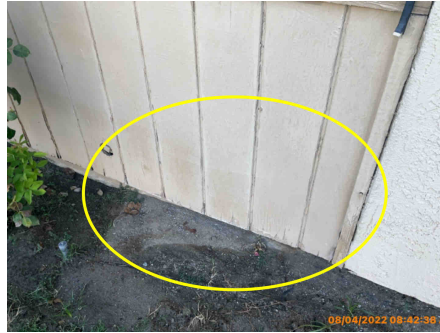
NR Damage noted to wood siding, recommend further review for the presence of any wood destroying pest or organisms by a qualified termite Inspector

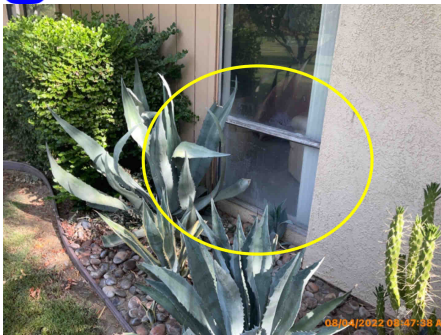
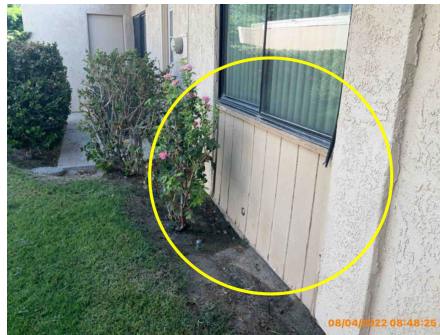
NR It appears that sprinklers are spraying against house, adjustment needed to sprinklers at rear and right side

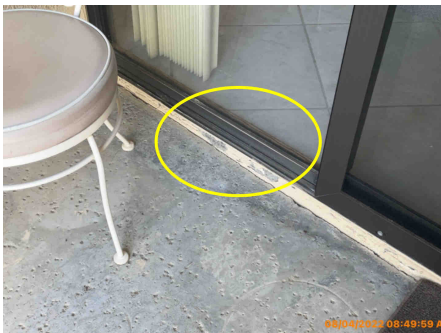
RM Damaged stucco noted under patio door(s). Builders stucco's the slab for looks, but the stucco has no wiring to help it bond. All slabs will wick moisture and the moisture will caused the stucco to peel. Recommend area be covered with metal.

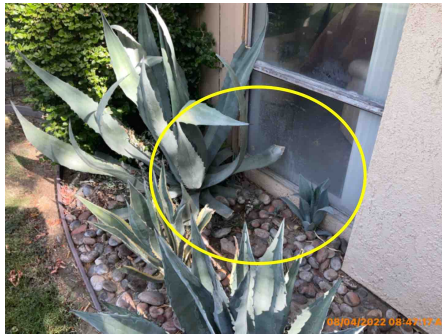
NR Soil grade is blocking the stucco weep screed at bottom of stucco wall at rear exterior . There should be a minimum 3 " maximum 6 " inches between the soil and the bottom of the weep screed. This will allow the wall to ventilate and drain properly.

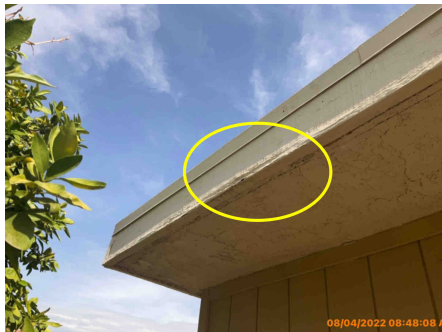
NR Damage noted at rear fascia(s). We recommend further review and repairs by a qualified specialist in the appropriate trade.

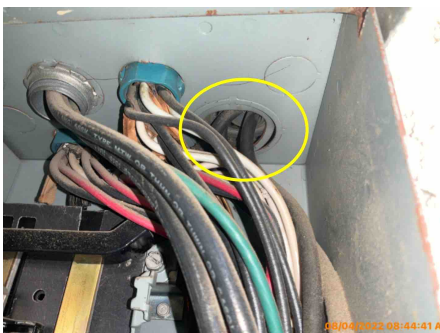
SC Missing protective bushing for wires that enter inside the main electrical panel, wire should be protected from metal enclosure. Recommend further review and repair by qualified Electrical Contractor.

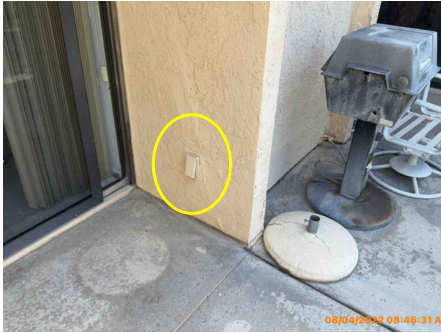
SC GFCI receptacle(s) did not test properly when tested with a circuit tester at rear exterior of house. Recommend further review and repair by qualified Electrical Contractor.

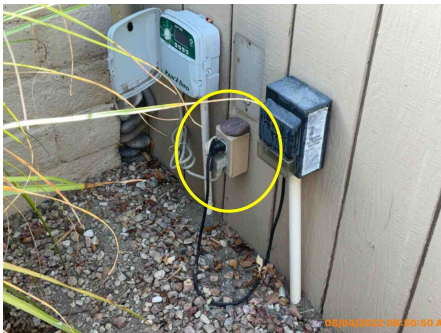
RM Recommend installation of listed outdoor cover for unattended cords to protected receptacles from moisture damage at exterior of house.

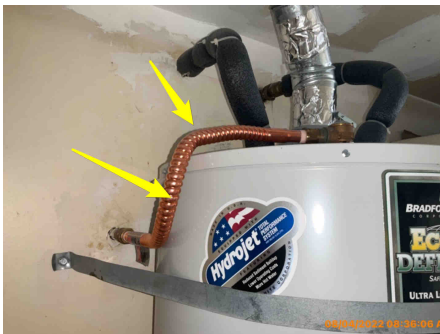
SC Flexible drain line is not approved for this installation. This type of pipe is reduced inside. Piping for TPR valve can not be reduced. We recommend the advice and services of a qualified Plumbing Contractor

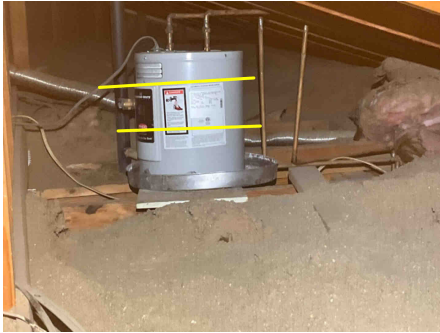
SC Seismic straps missing, Seismic straps need to be installed per manufactures instructions, We recommend further review and repairs by a qualified specialist in the appropriate trade.

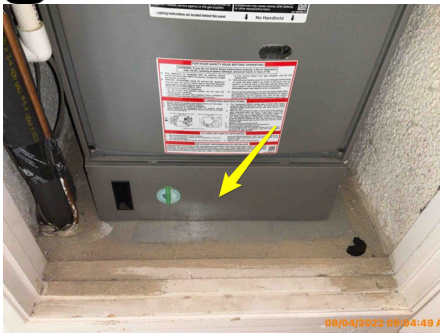
Note Filter located under heating units fan compartment.

RM Heater filter is dirty, new filter is needed, suggest cleaning/changing filter regularly

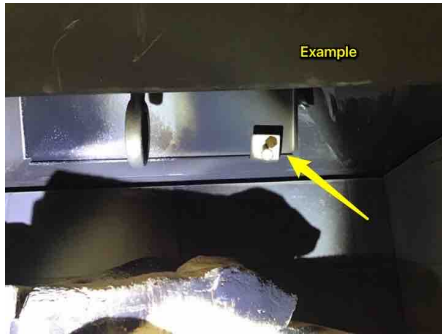
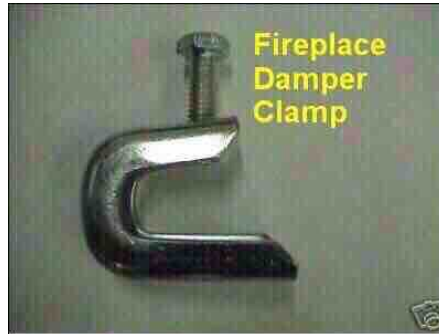
SC Damper was in good working condition. All gas fireplaces are required to have damper clamp installed on the damper so damper does not close. This is a new requirement as of 2011 that any gas fireplaces have a damper clamp installed in case there is a gas leak the gas will go up the flue and not into the house

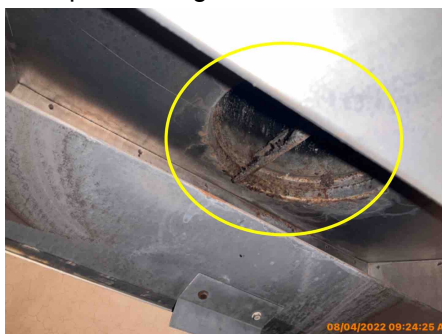
RM Residue in the fireplace has built to at least 1/8" and fireplace is due for servicing/cleaning by a chimney sweep. Cleaning should be done before use.

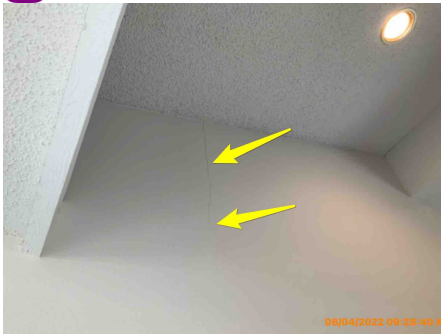
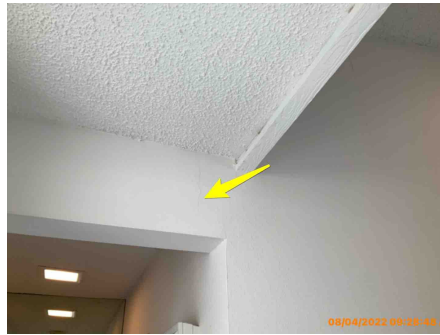
RM Cracks noted at living room wall

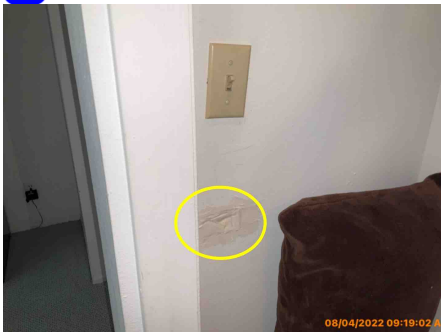
NR Damage noted to primary wall at closet

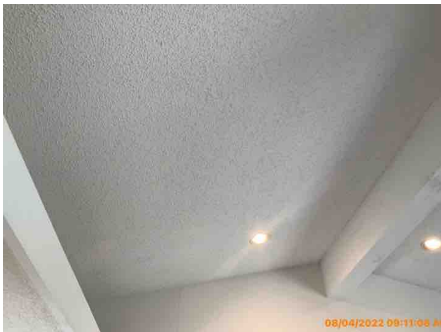
RM Possible asbestos containing material in closet ceilings, We recommend further review and repairs by a qualified specialist in the appropriate trade.

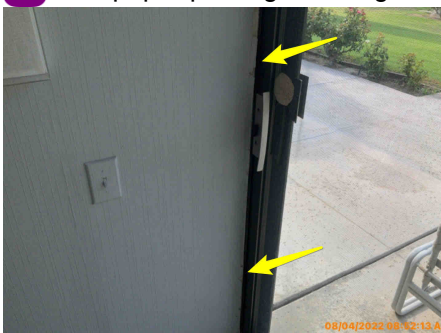
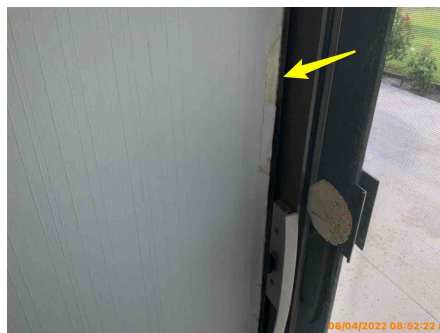
RM Wallpaper peeling at dining area

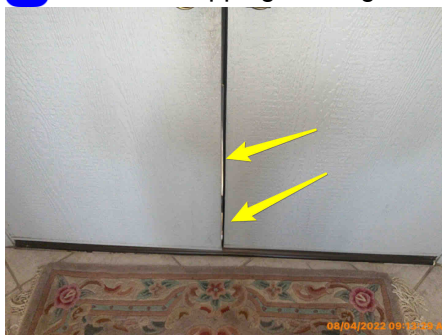
NR Weather stripping missing at front door.

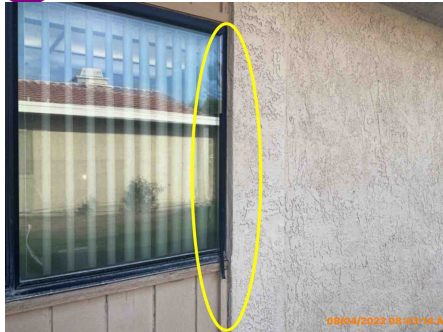
RM Exterior window trim is loose/damaged at right side

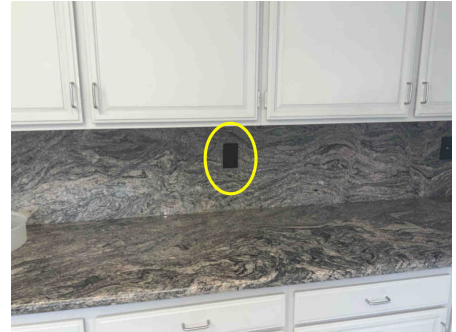
SC All Kitchen receptacles are required to be GFCI protected when a kitchen is remodeled, electrical is required to be updated. GFCI receptacles need to be installed at all receptacles serving all counters, Recommend further review and repairs as needed by a Qualified Electrical Contractor.

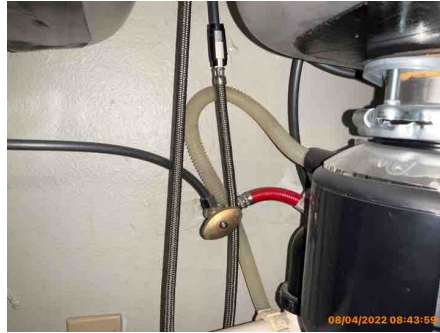
RM High loop dishwasher drain line not high enough to prevent siphoning. We recommend further review and repairs by a qualified specialist in the appropriate trade.

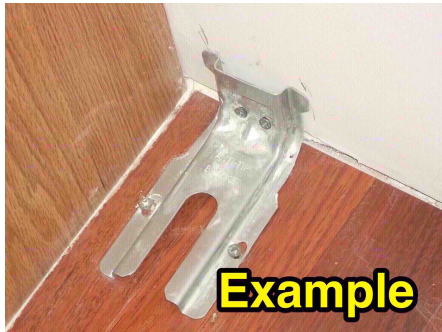
SC There is no anti-tip leg assembly on the range, creating a tip hazard, recommend installation to prevent accidental tipping of unit if a child were to open oven door and climb up on it causing unit to tip. We recommend further review and repairs by a qualified handyman

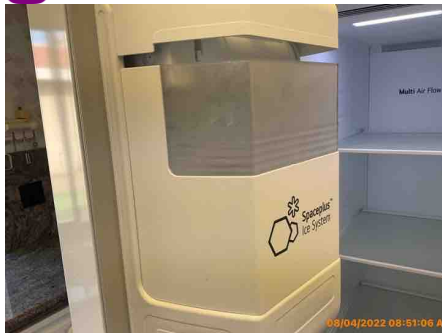
RM Kitchens refrigerators ice maker was turned off could not test. Inquire with seller.

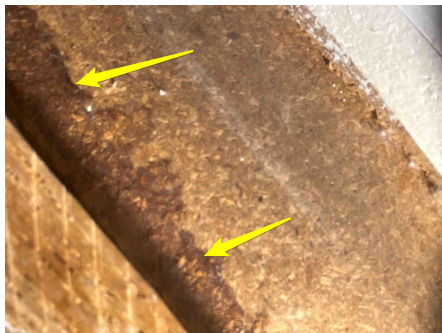
SC Mold like substance and moisture damage noted at decking under sink. We recommend further review and repairs by a qualified specialist in the appropriate trade.

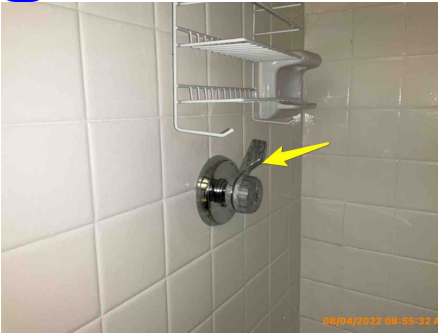
NR Shower valve did not work. We recommend the advice and services of a qualified Plumbing Contractor

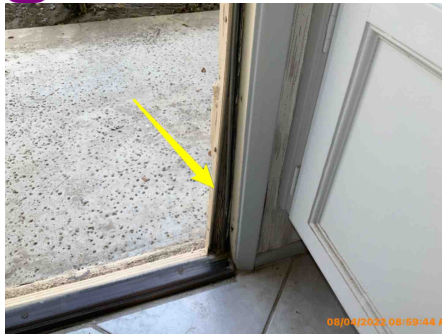
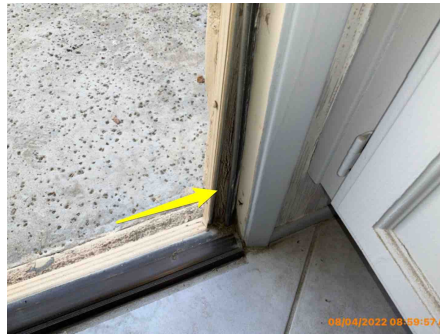
RM Moisture damage noted at door frame

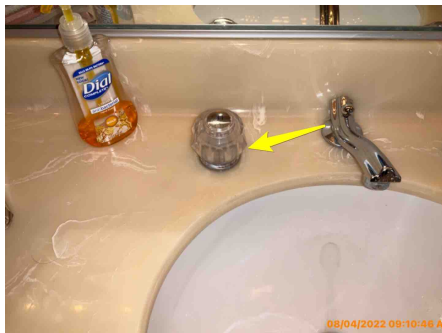
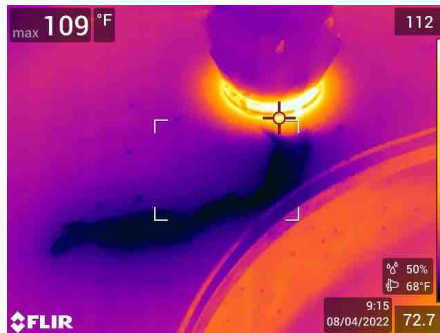
NR Thermal Image shows faucet handles leaking. We recommend further review and repairs by a qualified specialist in the appropriate trade.

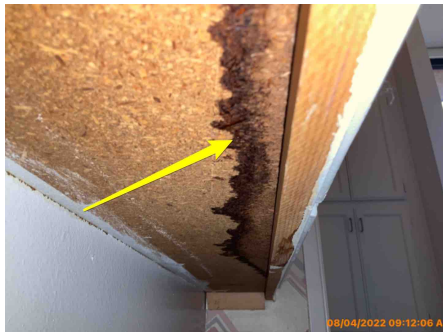
SC Moisture damage and mold like substance noted at cabinet under sink. We recommend further review and repairs by a qualified specialist in the appropriate trade.

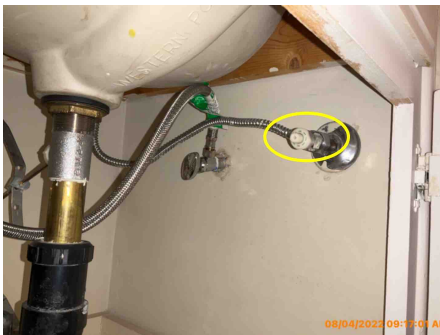
NR Water shut off valve handle missing under sink, We recommend further review and repairs by a qualified specialist in the appropriate trade.

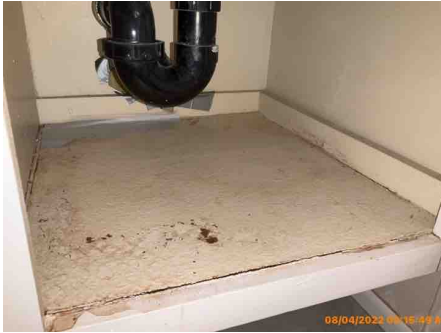
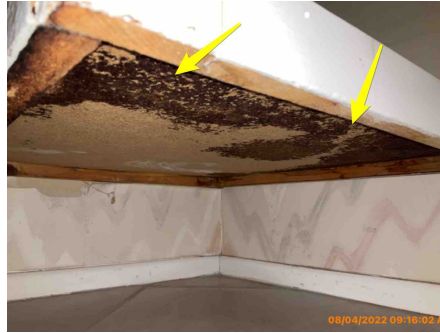
SC Moisture damage and mold like substance noted at cabinet under sink. We recommend further review and repairs by a qualified specialist in the appropriate trade.
