# WOOD DESTROYING PESTS AND ORGANISMS INSPECTION REPORT

| Building No.<br><b>7787</b> | Street<br><b>ORIEN AVE.</b> | City<br><b>LA MESA</b> | Zip<br><b>91941</b> | Date of Inspection<br><b>09/30/24</b> | Page<br><b>1 of 5</b> |

**Report # 2035395 LI**

| General Description:<br><b>TWO STORY SINGLE FAMILY</b><br><b>RESIDENCE OCCUPIED AND FURNISHED</b> | Inspection Tag Posted:<br><b>METER BOX</b><br>Other Tags Posted:<br><b>NONE</b> |

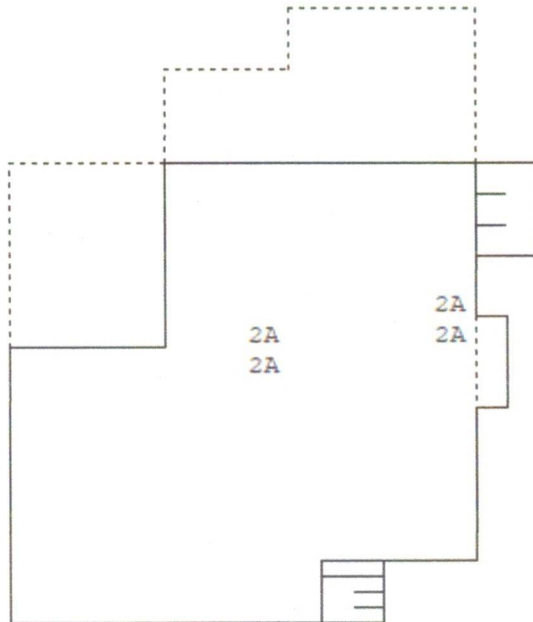
2A. FINDING: Infestation of Drywood Termites was noted at the INTERIOR TRIM AT WALL AND TRIM AT WINDOW DINING ROOM.

RECOMMENDATION: Due to the nature of these infestations, it will be necessary to seal the entire structure and fumigate it with Vikane (Sulfuryl Fluoride).
