**BPG Inspection, LLC**

**1015 Rachelle Way  
El Cajon CA 92019**

Client(s): Camberos  
Inspection Date: 4/22/2026  
Inspector: Mark Kirkland ,

| <b>Property:</b> 1015 Rachelle Way, El Cajon, CA 92019 | | <b>Prepared By:</b> Mark Kirkland |

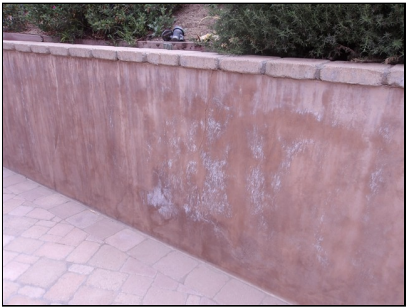
- ◆ No weep holes are present at the base of the retaining wall at the right side of the property. Weep holes are often installed in retaining structures to facilitate drainage and relieve water pressure behind the wall.
  - If the need for additional drainage becomes apparent, weep holes should be installed to reduce the pressure on the retaining structure, and extend its effective life.

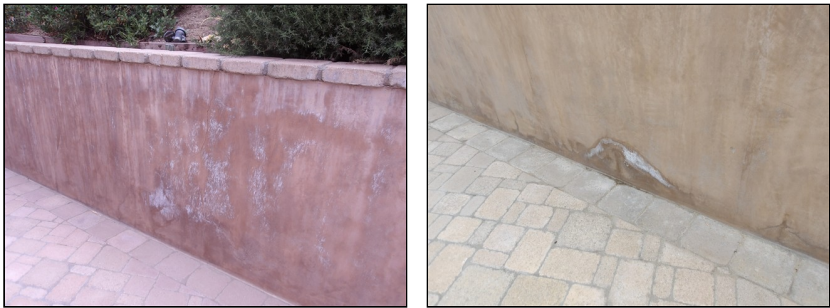
- ◆ A condition known as efflorescence is evident on portions of the retaining walls. This whitish, fuzzy material is a mineral deposit left when moisture in the concrete evaporates. The presence of efflorescence and water marks often indicates an occasional surplus of moisture on the outside of the wall. The efflorescence was minor in the

opinion of the inspector. The areas should be monitored for signs of excess moisture and repaired by a licensed technician if needed.

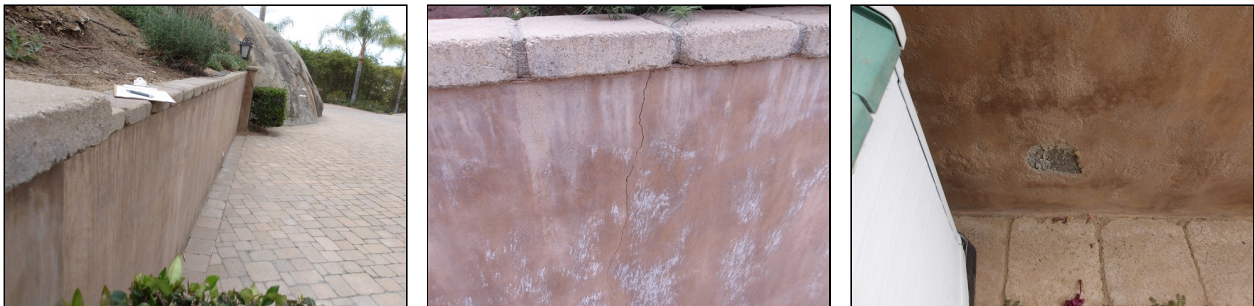
- ◆ The retaining wall at the right side of the carport is cracked/damaged in several areas with signs of possible leaning. We are unsure of when the cracks/damage occurred or when it started leaning. A qualified licensed contractor should perform any needed repairs or modifications.

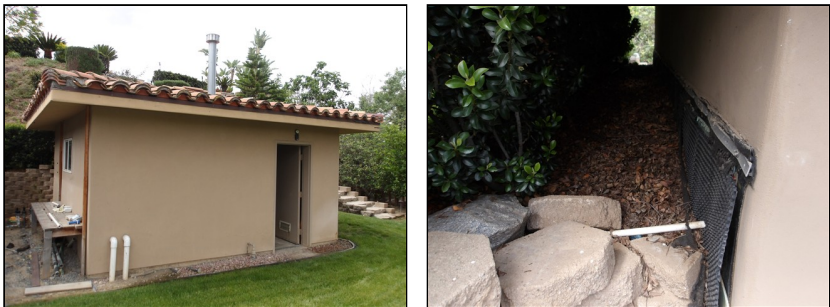
- ◆ The yard grading on the pool equipment structure has a very low slope grade or drains toward the home. Water may tend to pool along this side of the house. A below grade drainage system, regrading the area, or installing swales may help to drain this area quickly. Monitor the area during heavy rains.
- Have a qualified contractor or landscaper evaluate the area and perform repairs as needed.

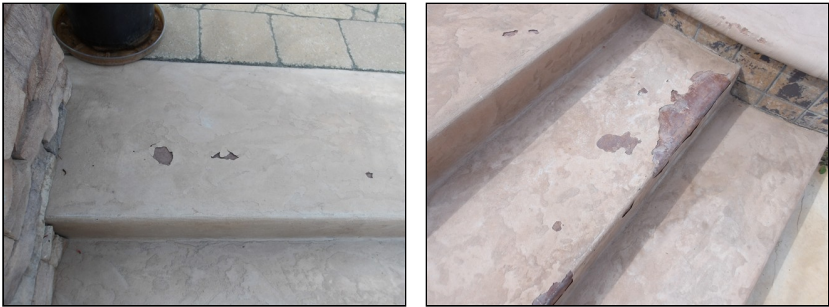
- ◆ The concrete at the rear patio is deteriorated, peeling and/or damaged in several areas. The qualified technician should repair the damaged areas.

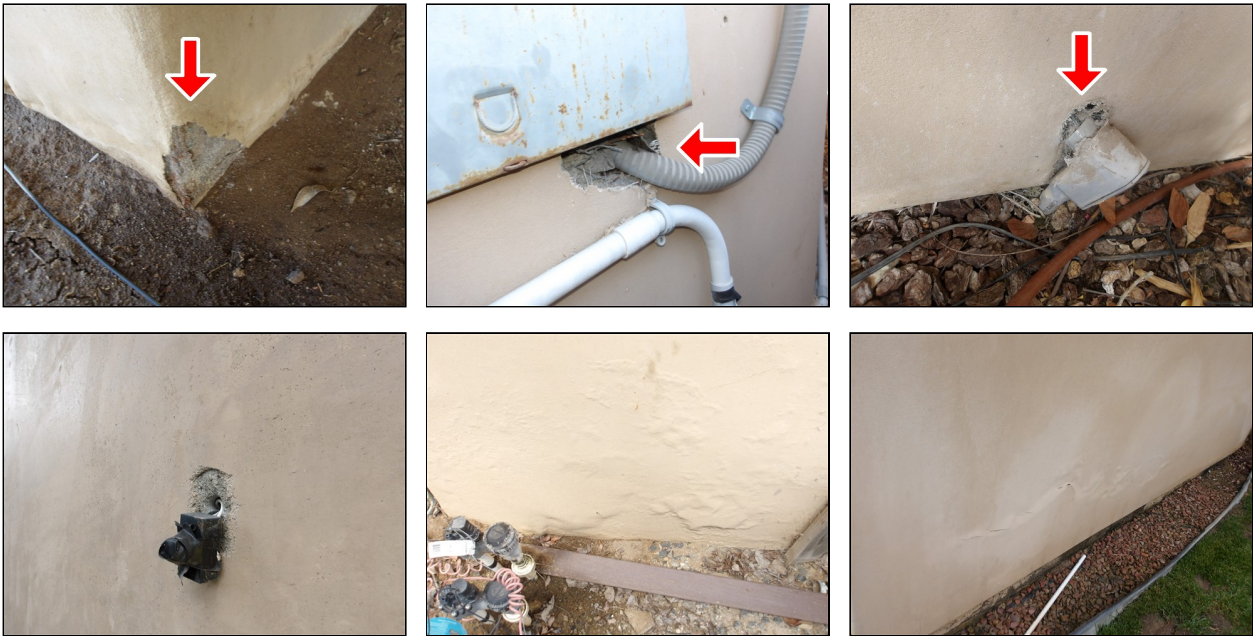
- ◆ Sections of the stucco at the exterior of the building, retaining walls, and fences is cracked, deteriorated or damaged. We did not list or identify every location in this report.
  - A qualified plastering technician should evaluate the stucco and make repairs or modifications as necessary.

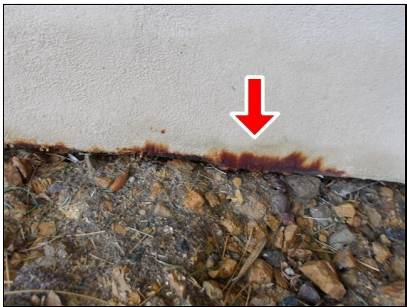
- ◆ The weep screed at the base of the stucco-finished exterior walls is corroded in spots and/or damaged.
  - A qualified technician should replace any damaged weep screed, as needed.

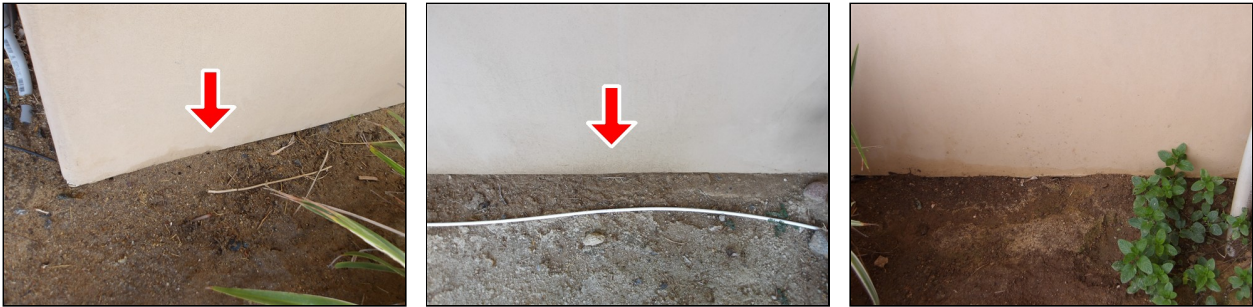
- ◆ Soil is at or above the weep screed at several areas.
  - We recommend adequate clearances be provided in accordance with current standards.

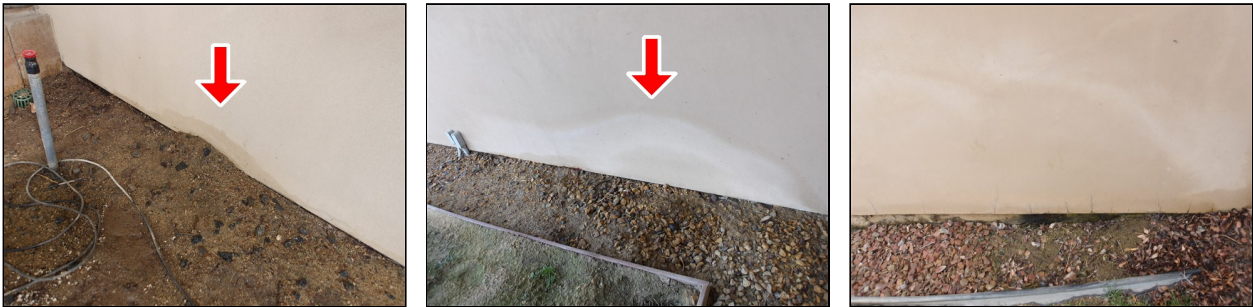
♦ One or more of the sprinkler heads on several areas sprays the building. This can promote damage to the siding, trim or structure. The sprinkler heads should be adjusted to ensure that they do not spray the building.

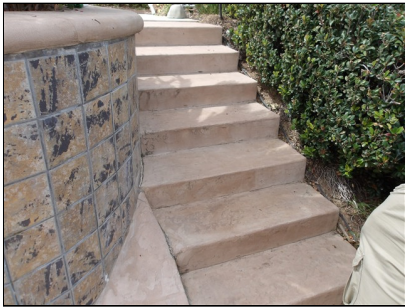
- ❌ ♦ A proper handrail is needed on the exterior steps at the pool area. No rail is installed.  
- Handrailings should be installed, to reduce the potential for personal injury at this location.

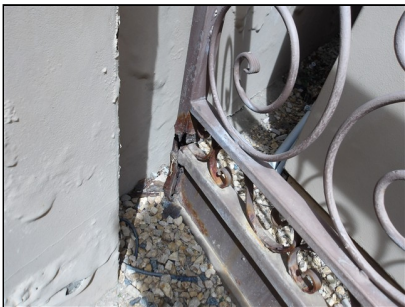
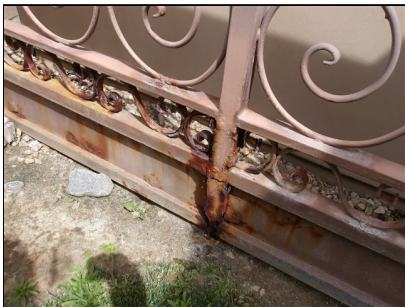
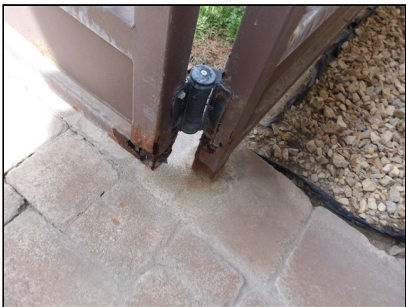
- ◆ The metal fencing has heavy corrosion, damaged and deteriorated. - Damaged fence elements should be repaired if possible, or replaced as necessary.

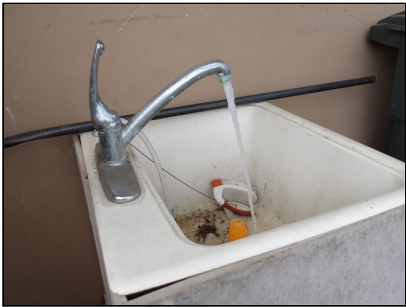
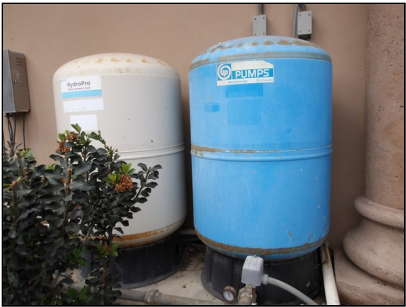
- ◆ The sink at the exterior of the exterior storage building has cold water only. We are unable to verify the drain discharge location. There is no trap on the sink and it looks like it drains toward the yard drain. A licensed contractor and/or specialist should perform repairs.

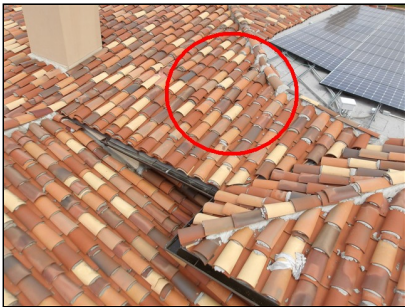
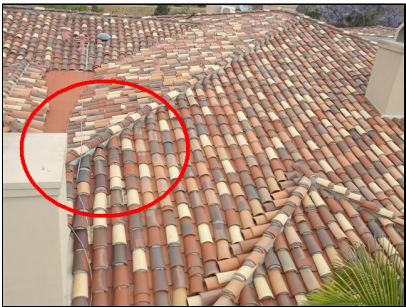
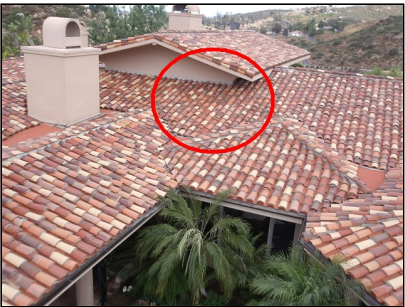
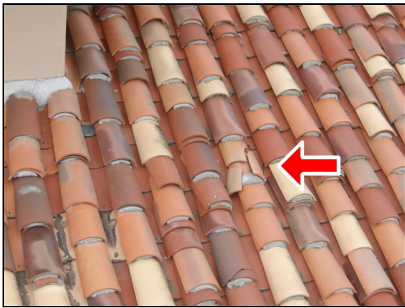
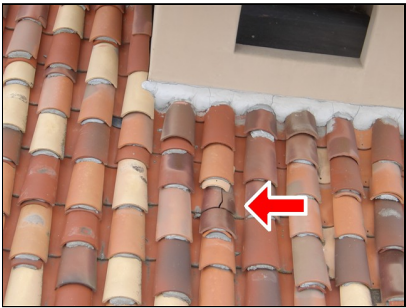
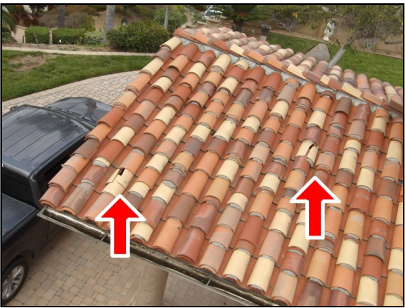
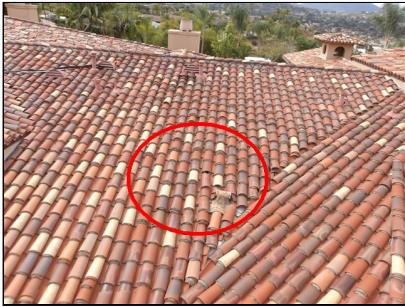
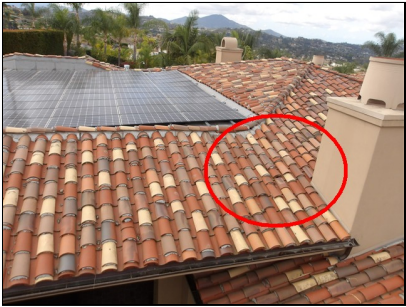
♦ Roof tiles were noted to be cracked, damaged, or displaced. Further evaluation and repairs/replacement is needed. Since inspectors do not walk on concrete/clay/composite roof tiles, there could be additional tile defects. Have the roofing technician who corrects this/these reported conditions, check the rest of the roof.

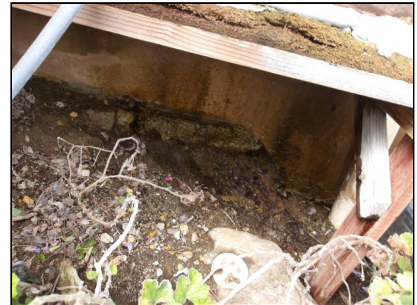
- ◆ There is a water softener or filtration system on the property. Testing the function of this device is not within the scope of this inspection.
- ✗ ◆ Inspection of the well water system is outside the scope of this inspection. However, we observed active leaking noted at the well pipes. We recommend a licensed plumber perform repairs.

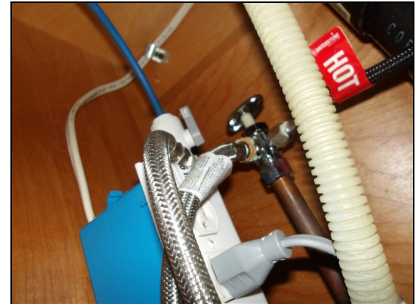
- ◆ Backflow prevention devices are now required on exterior hose bibbs to prevent contamination of the domestic water supply. These devices are inexpensive and available at most hardware stores. Consider upgrading the hose bibbs by installing backflow devices.
- ◆ There is surface corrosion in the visible supply and/or waste piping at several valves, fixture and drains in the home. We observed no signs of active leaks at the time of the inspection but leaks can develop anytime without warning. All valves and fixtures should be evaluated during your final walk through and before close of escrow to verify that no new leaks have developed.
  - This piping should be evaluated for leaks on a regular basis and repaired by a qualified technician when necessary.

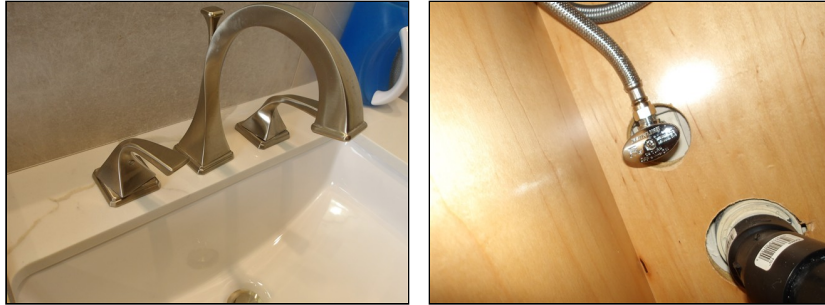
- ✗ ◆ The water is off to the sink in the right side middle bedroom bathroom. We are unsure of why the water is off. Inspectors do not turn on valves that are shut off. Have a plumber evaluate the reason the water is off and perform necessary repairs.

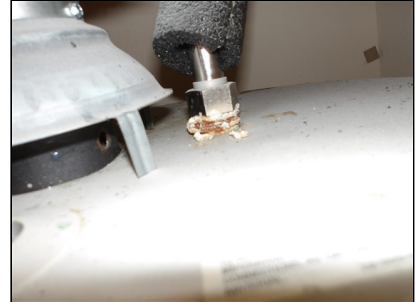
- ◆ The water line connections are corroded at both of the house water heaters.
  - These connections are dry at the time of the inspection and repairs should be made as necessary.

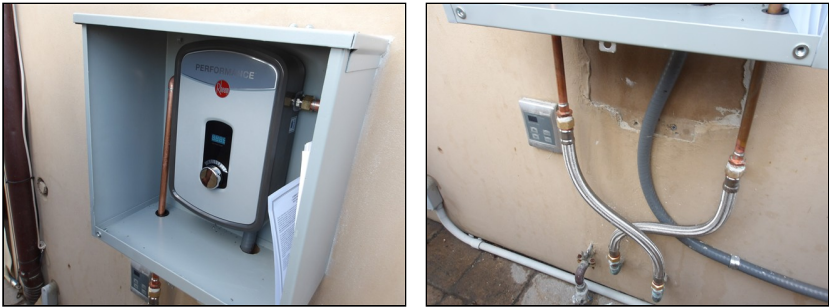
- ◆ There is a tankless water heater installed at the exterior of the cabana. Limited access prevented us from being able to fully inspect the water heater. These are smaller water heaters and are typically designed for small single bathrooms and do not always have the same features as full size water heaters. The water heater does not have any visible service valves or TPR valve. We recommend having a licensed plumber verify proper installation and perform repairs as needed.

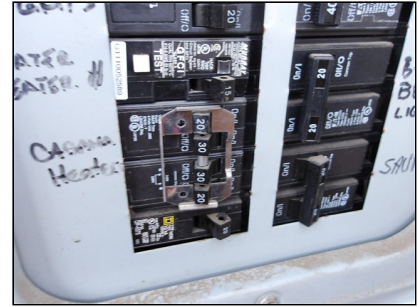
- ◆ One or more breakers in the exterior cabana sub panel are in the off position at the time of this inspection. We did not activate the breakers, or energize the circuits because doing so could create a hazard.
- The owner may have information as to why the breakers are in the OFF position. If it is not functional, a licensed electrician should make appropriate repairs before closing escrow.

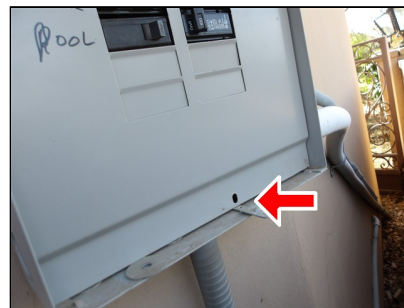
- ◆ The exterior cabana electric panel is missing a cover screw and labels. A qualified technician should install a cover screw and label the circuits.

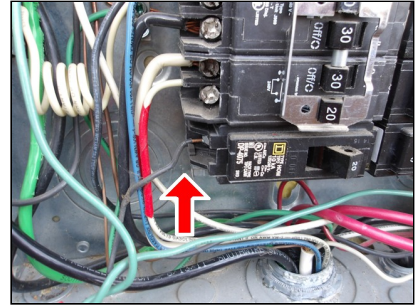
- ◆ The problem(s) discovered in the exterior cabana sub panel such as uncapped abandoned wires, 20 amp breaker on size 14 wire, and any other problems that an electrician may discover while performing repairs need correcting. We recommend a licensed electrician inspect further and correct as needed.

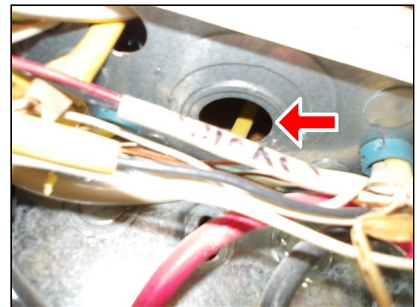
- ❌ ♦ The problem(s) discovered in the master bedroom sub panel such as double lugged neutral wires at buss, frayed wires, knock out missing, and any other problems that an electrician may discover while performing repairs need correcting. We recommend a licensed electrician inspect further and correct as needed.

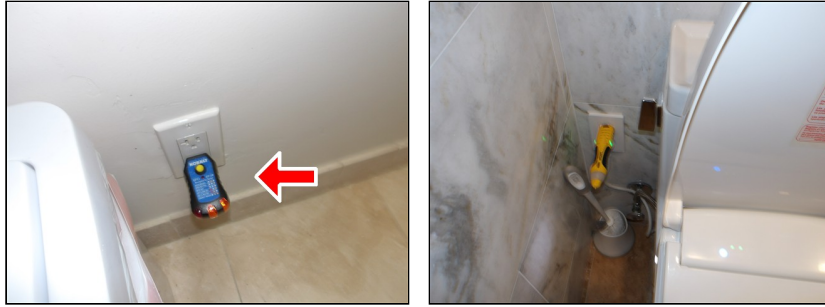
- ❌ ♦ No GFCI (ground fault circuit interrupter) protection is present at all locations per current industry standards. Several in garage, cabana lower wall near bath sink, half bath near toilet. This may not have been required at the time of construction but current industry standards requires GFCI protection in all bathrooms, garages, exteriors, laundry rooms, basements and kitchens. **As a safety upgrade, consider installing GFCI protection at all recommended locations.**

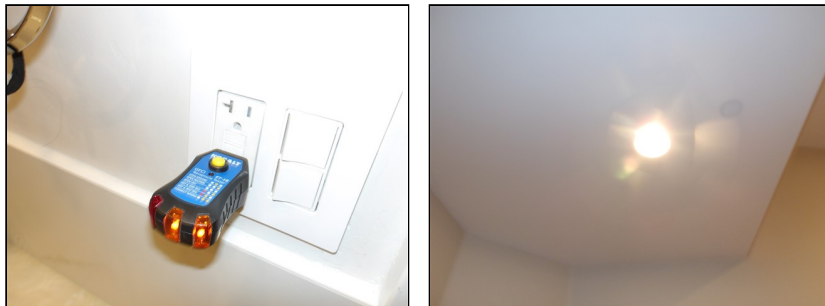
- ☒ ◆ The middle bedroom bathroom GFCI outlet is wired to the bedroom entryway lights. If the GFCI trips then the lights will also go out, this could create a trip hazard if this happens in the dark. We recommend installing additional lights to assist you if the lights go out from tripping the GFCI. A licensed contractor and/or specialist can perform the work.

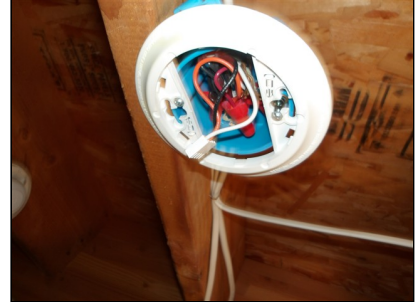
- ❌ ♦ There are several open junction boxes at various locations in the attics. Lack of covers can create a shock or fire hazard.
- A qualified technician should check the system and install proper covers on all junction boxes.

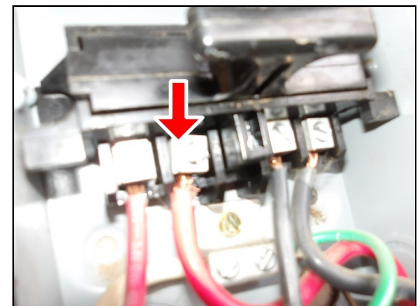
- ❌ ♦ Two of the AC electric disconnects has frayed wire connections at the rear exterior of the home. A licensed electrician should perform repairs.

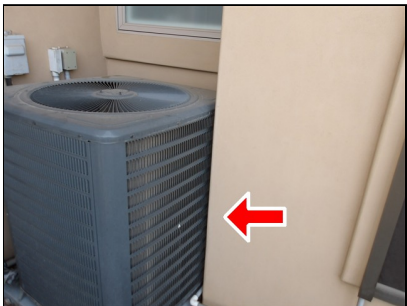
- ◆ The compressor is too close to the structure to allow proper ventilation around the cooling coils. A qualified HVAC contractor should make any needed repairs or modifications.

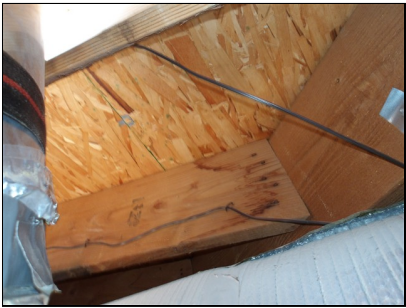
master bedroom attic

♦ Water stains are evident on the roof sheathing. However, we could not confirm an active leak.
- The source should be identified and necessary repairs performed.

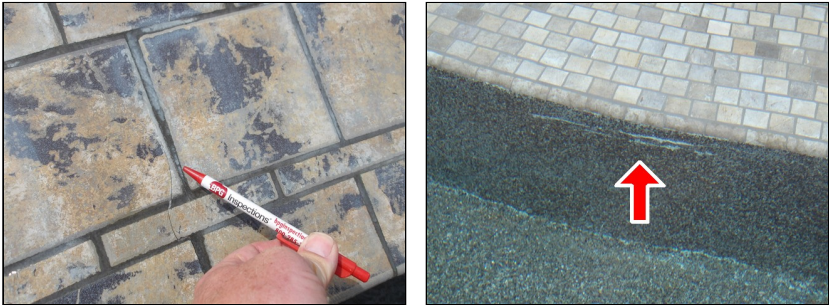
- ◆ One or more cracked tiles were noted in the spa. We observed deterioration and possible cracks in the spa. A licensed pool contractor and/or specialist should repair all damaged areas.
