WOOD DESTROYING PESTS AND ORGANISMS INSPECTION REPORT

Building No. 29621	Street Lassen Dr.	City Cold Springs	Zip 95335	Date of Inspection 04/09/26	Number of Pages 1 of 10
------------------------------	-----------------------------	-----------------------------	---------------------	---------------------------------------	-----------------------------------

Report # 7346

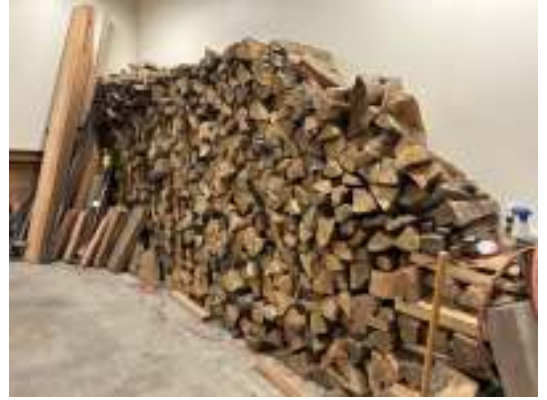
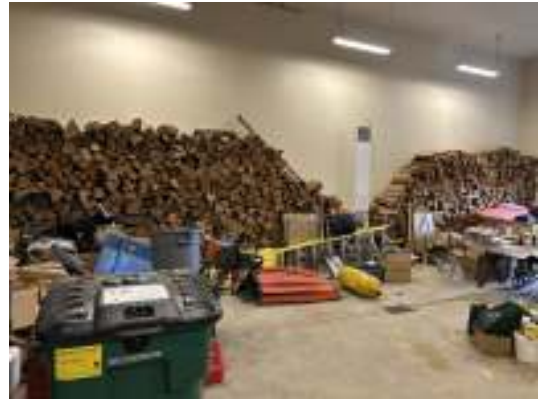
8A:

Firewood has been stacked inside the structure. This can attract subterranean termites to the structure.

RECOMMENDATION: Others to remove firewood as necessary.

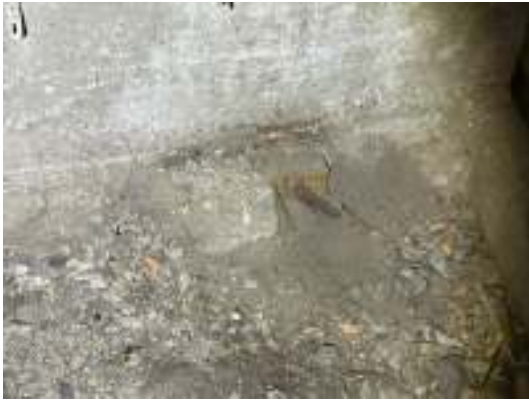
1A:

Form stakes are present in the subarea; this can attract subterranean termites.

RECOMMENDATION: Remove form stakes as practical. If it is found impractical to remove all form stakes, treat remaining with disodium octaborate tetrahydrate in accordance with manufacturer labels. All chemicals to be applied by a state licensed applicator.

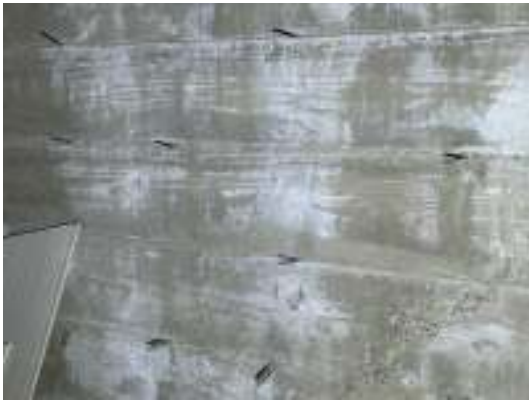
1B:

NOTE: Efflorescence is present at the foundation wall indicating previous moisture at the exterior of

foundation in this area.

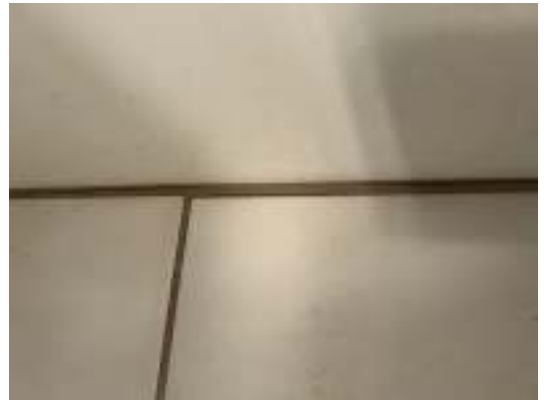
10A:

A void was noted between base of the bathtub and the tile flooring in the main level hall bathroom. This can allow excessive moisture to accumulate at the adjacent wood members.

RECOMMENDATION: Seal void.

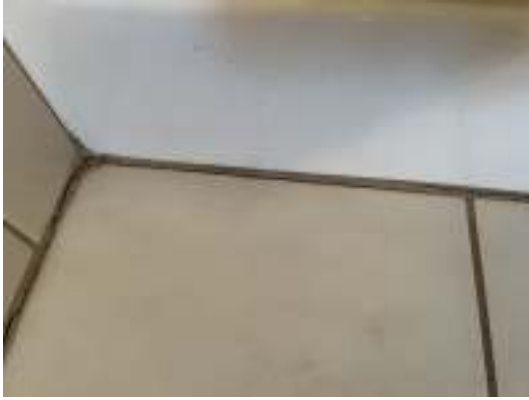
10B:

A void was noted between the base of the shower pan and the tile flooring in the master bathroom. This can allow excessive moisture to accumulate at the adjacent wood members.

RECOMMENDATION: Seal void.

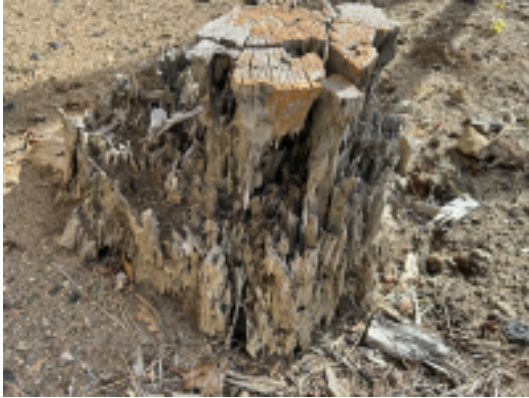
11A:

Tree stump is noted at exterior next to deck. Subterranean termites are present.

RECOMMENDATION: Remove stumps as practical. Treat any remaining portions of stumps and/or root systems with CENTERFIRE 75 / Termidor for the control of subterranean termites. All chemicals are to be applied by a state licensed applicator in accordance with manufacturer labels.

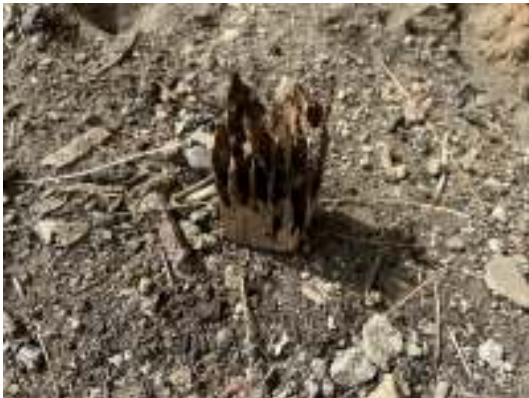
11B:

Subterranean termites are infesting the debris / roots under the back deck, next to the structure.

RECOMMENDATION: Remove debris of a rakable size. Trench / rod exterior soil and treat for the control of subterranean termites with PREMISE 75. All chemicals to be applied by a state licensed applicator in accordance with manufacturer labels.
