ELITE GROUP

INSPECTION PROFESSIONALS

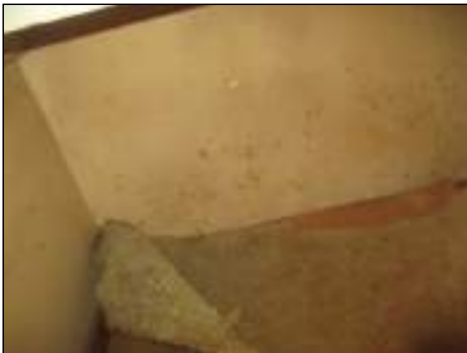
Stains/blistered areas - tested dry with moisture meter/thermal Imaging device at time of inspection - monitor area for moisture

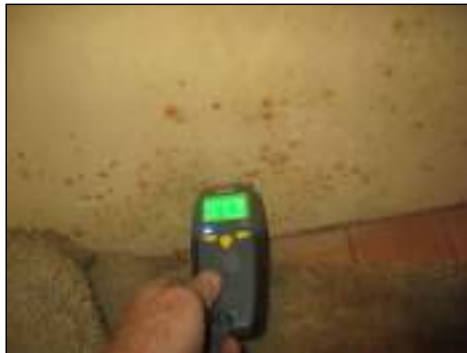
Stains/blistered areas - tested dry with moisture meter/thermal Imaging device at time of inspection - monitor area for moisture

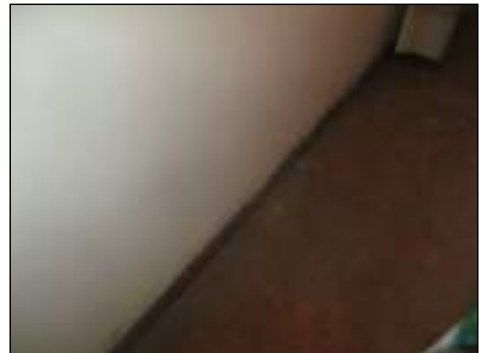
Small cracks/holes/chipped/dirty areas/protruding nails/cosmetic blemishes observed - typical for age of structure

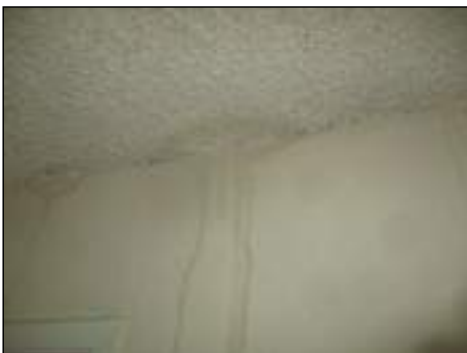
Stains/blistered areas - tested dry with moisture meter/thermal Imaging device at time of inspection - monitor area for moisture

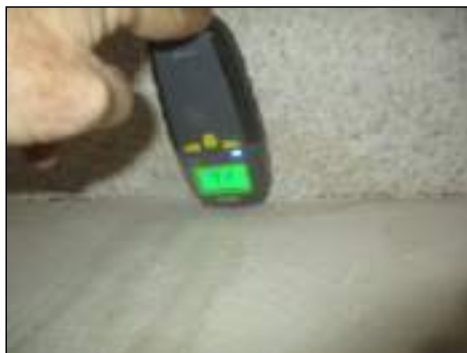
Stains/blistered areas - tested dry with moisture meter/thermal Imaging device at time of inspection - monitor area for moisture

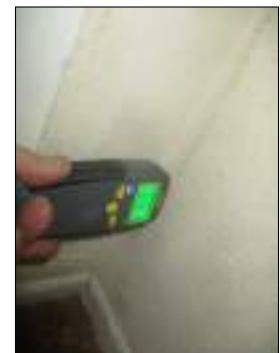
Stains/blistered areas - tested dry with moisture meter/thermal Imaging device at time of inspection - monitor area for moisture

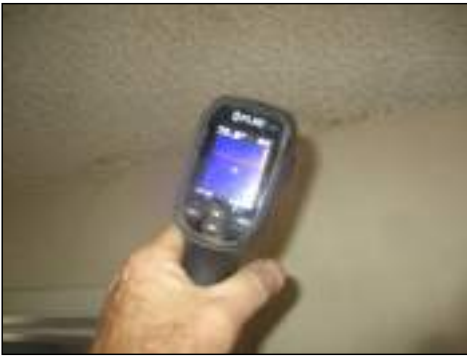
Stains/blistered areas - tested dry with moisture meter/thermal imaging device at time of inspection - monitor area for moisture

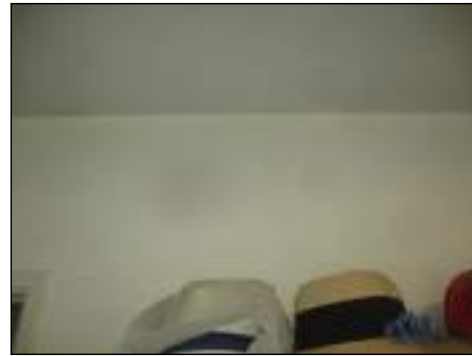
Small cracks/holes/chipped/dirty areas/protruding nails/cosmetic blemishes observed - typical for age of structure

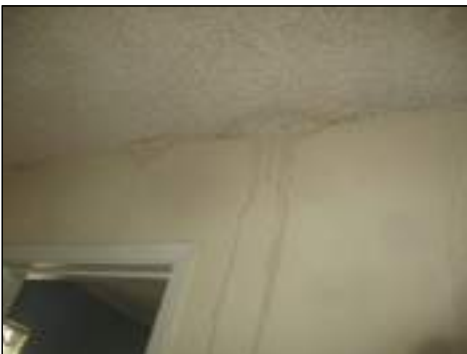
Evidence of possible roof leak at bedroom north - needs to be serviced/further evaluated

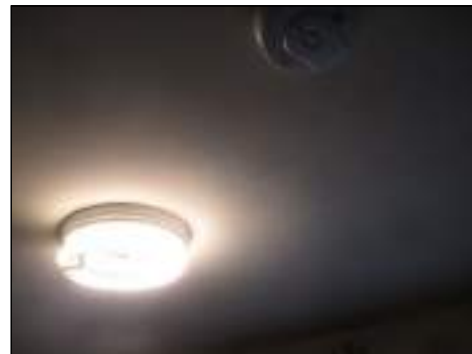
Small cracks/holes/chipped/dirty areas/protruding nails/cosmetic blemishes observed - typical for age of structure

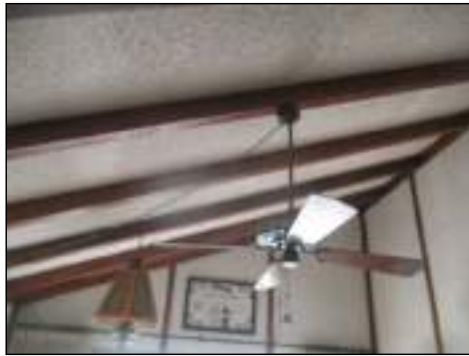
Improper electrical installation - needs to be serviced/further evaluated

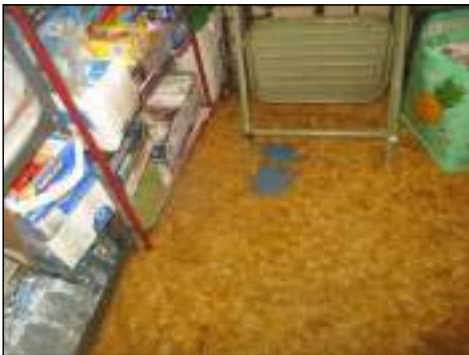
Worn/stained heavily in areas - recommend servicing

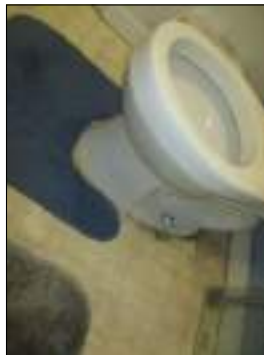
Moisture damaged at jack and Jill bathroom area - needs to be serviced

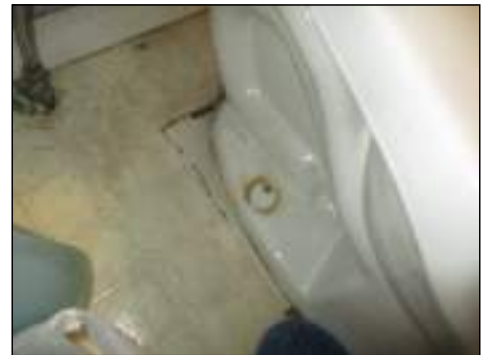
Moisture damaged at jack and Jill bathroom area - needs to be serviced

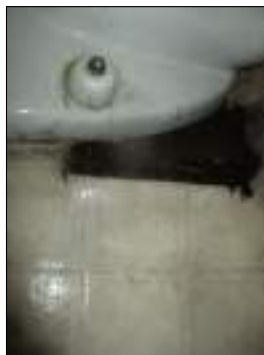
Moisture damaged at jack and Jill bathroom area - needs to be serviced

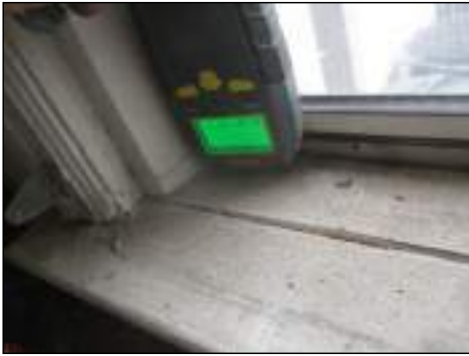
Stains/blisters at sill - tested dry for moisture at the time of the inspection - monitor the areas for moisture intrusion

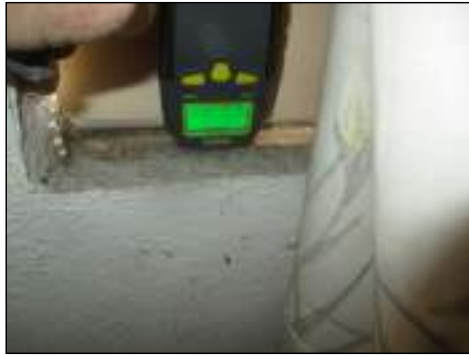
Stains/blisters at sill - tested dry for moisture at the time of the inspection - monitor the areas for moisture intrusion

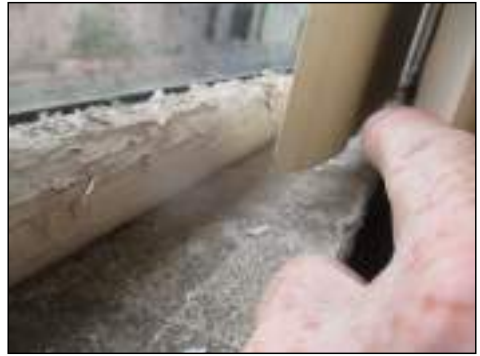
Microbial growth/irregular staining present - further evaluation is recommended

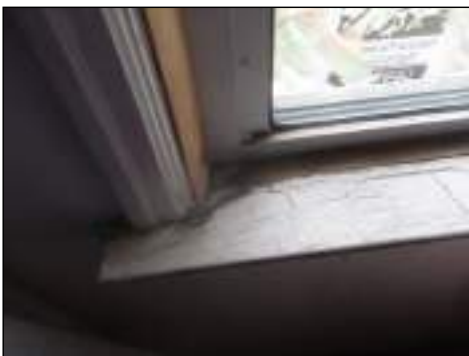
Evidence of possible moisture entry point - needs to be serviced/further evaluated

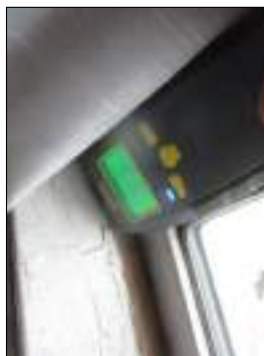
Stains/blisters at sill - tested dry for moisture at the time of the inspection - monitor the areas for moisture intrusion

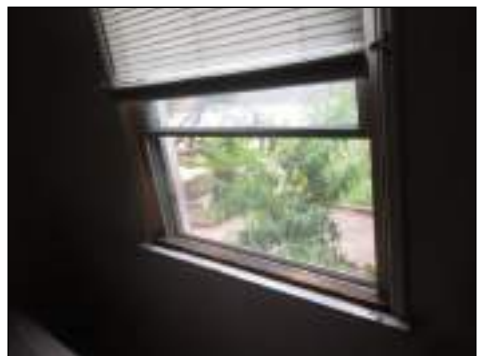
Evidence of possible moisture entry point - needs to be serviced/further evaluated

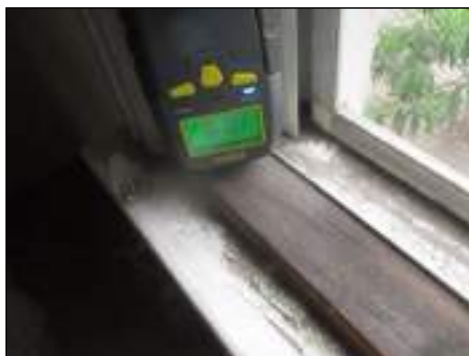
Stains/blisters at sill - tested dry for moisture at the time of the inspection - monitor the areas for moisture intrusion

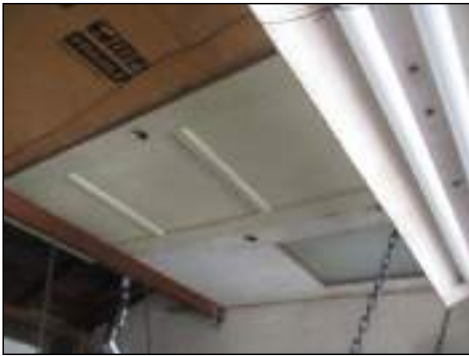
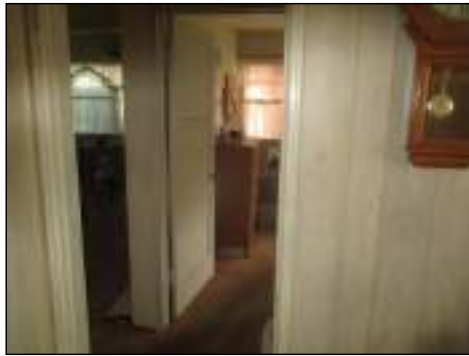
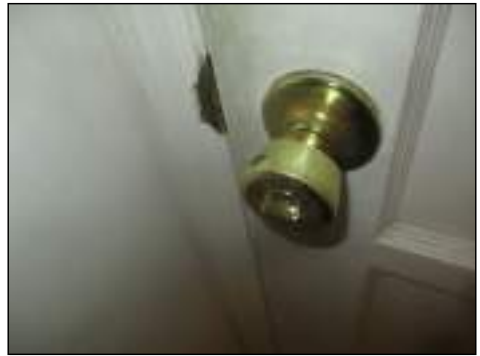
Did not latch properly/sticks at jamb hall bathroom area - recommend servicing

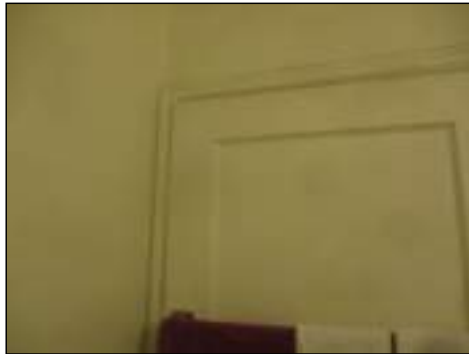
Did not latch properly/sticks at jamb hall bathroom area - recommend servicing

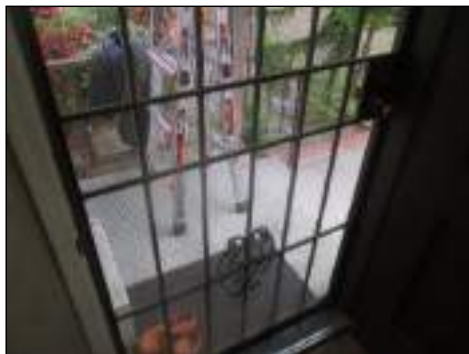
9. Sliding Glass Doors

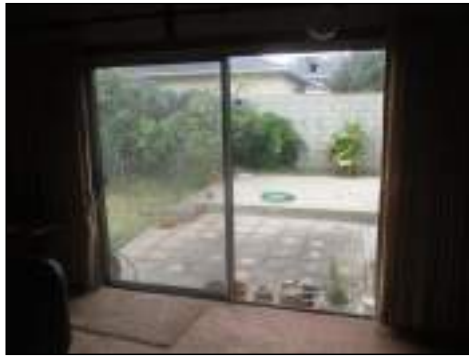
10. Sliding Door Screens

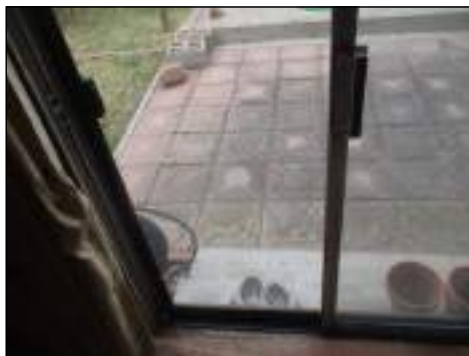
- Operated at time of inspection
- Normal wear at the time of the inspection with no major visible defects

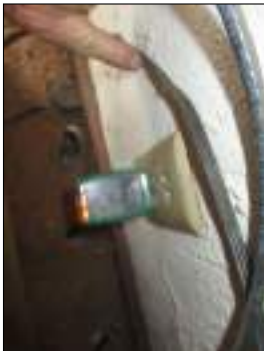
A representative number of receptacles and switches were tested and found to be operational at time of inspection

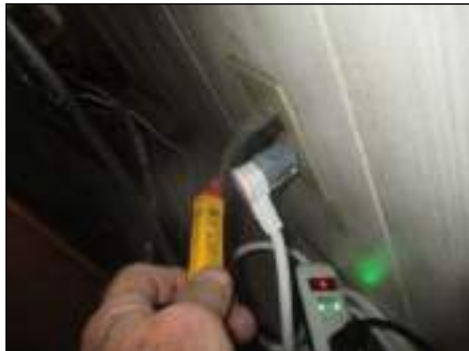
Worn/loose outlets/switches - typical for age consider upgrading

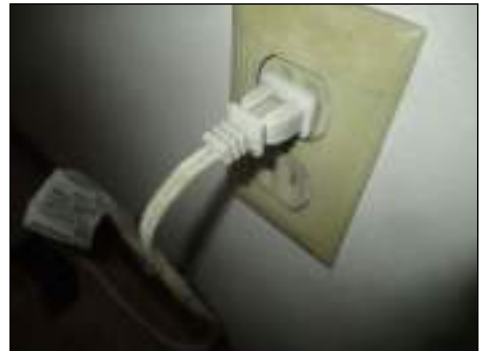
Ungrounded outlets present - typical for the age of the structure - consider upgrading electrical services

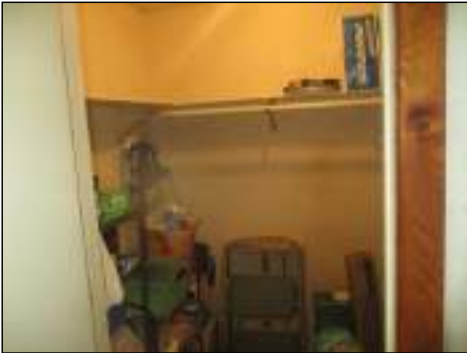
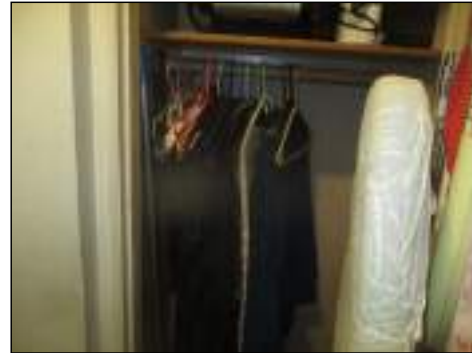
- Normal wear for age with no major visible defects

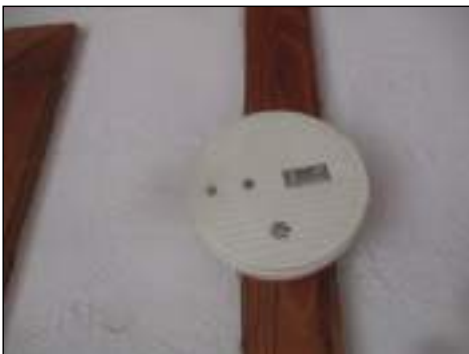
Operational at time of inspection via factory installed test button at rear and bedrooms

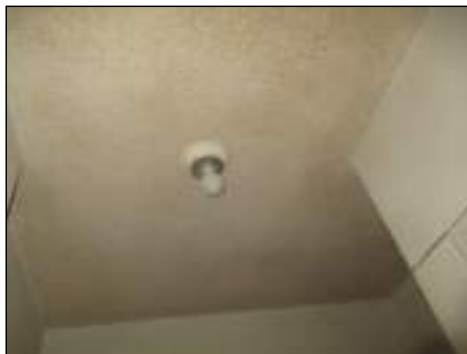
Missing at hall - needs to be installed

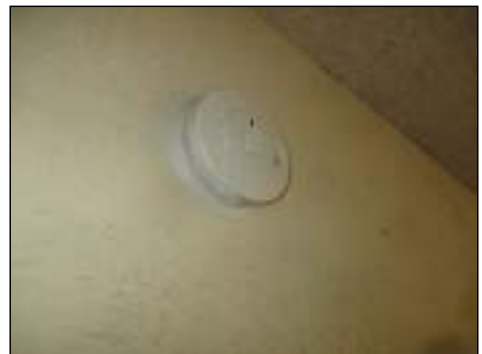
Operational at time of inspection via factory installed test button at rear and bedrooms

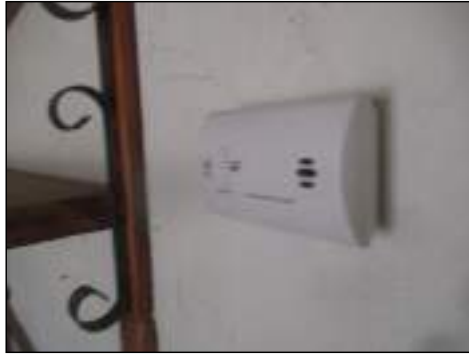
Operational at time of inspection via factory installed test button at rear

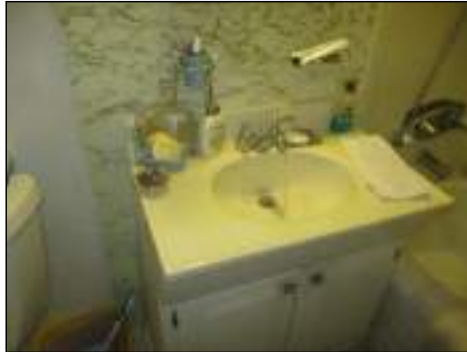
- Counter has normal wear for age at time of inspection with no major visible defects

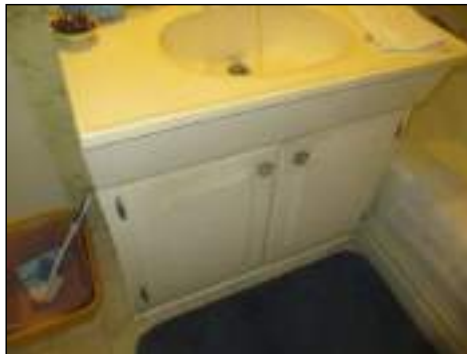
- Normal wear for age of material - no major visible defects
- Worn cabinets with loose/worn hardware - typical for age
- Stained/blistered area(s) - tested dry at time of inspection - monitor area for moisture

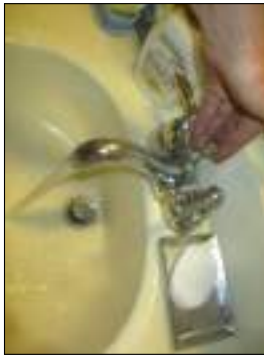
Drain stopper did not operate properly or missing - recommend installation/maintenance to prevent clogging or slow drain

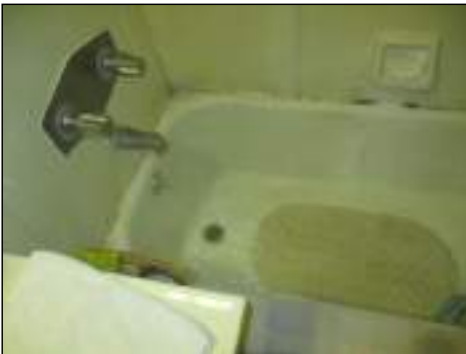
Tub fixture drips when valve is off - needs to be serviced

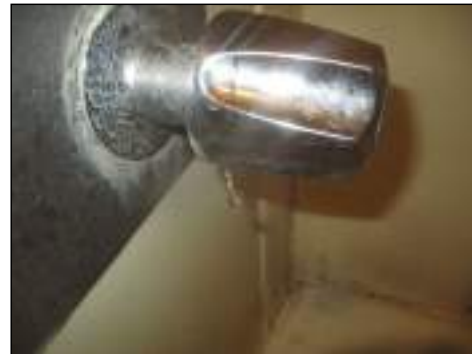
Tub fixture leaks when operated - recommend maintenance or replacement

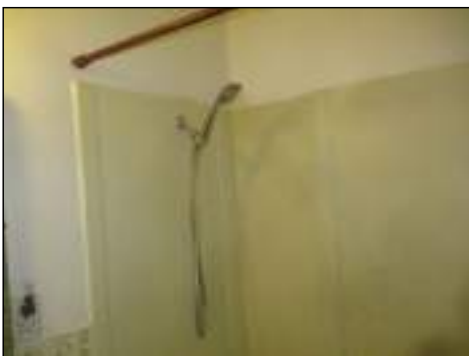
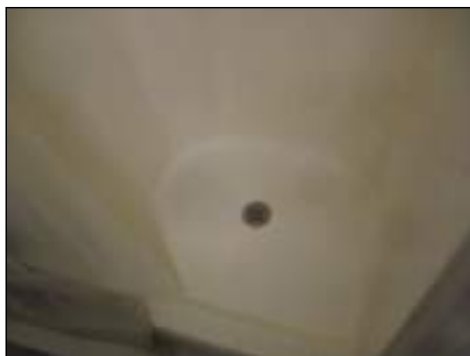
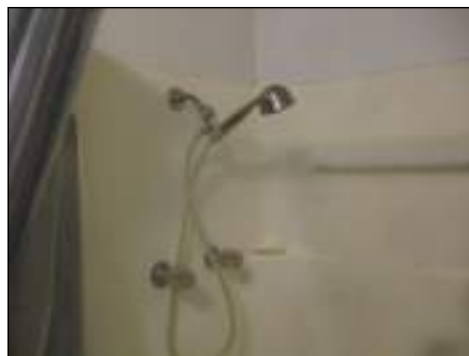
- Fixture was tested and operating at time of inspection via normal fixture controls
- Fixture had normal wear for age of material - no major visible defects

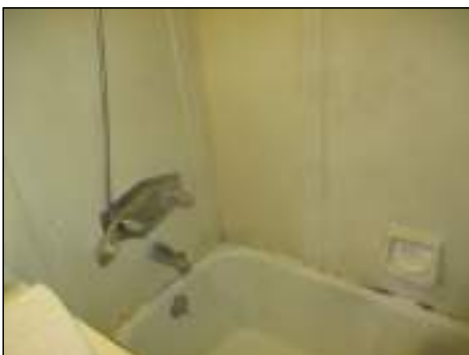
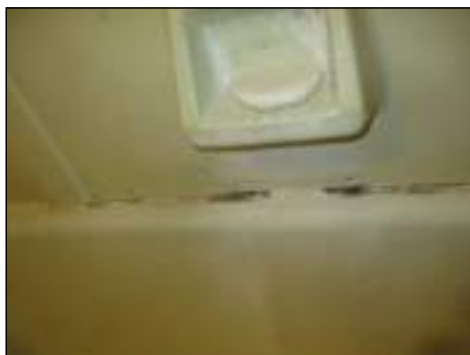
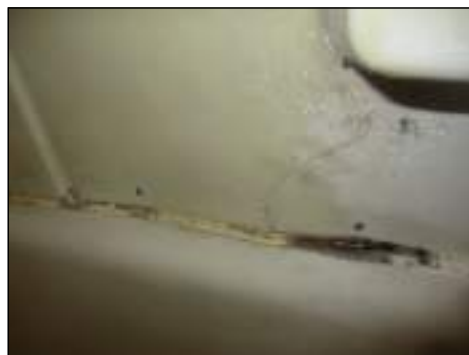
Irregular installation/workmanship at hall - needs to be serviced

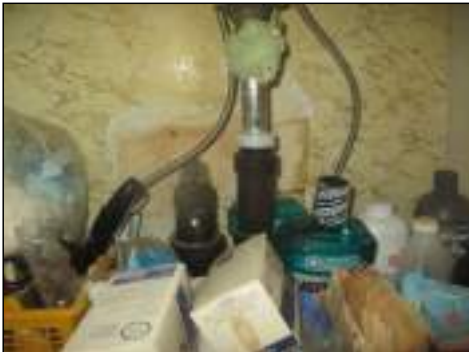
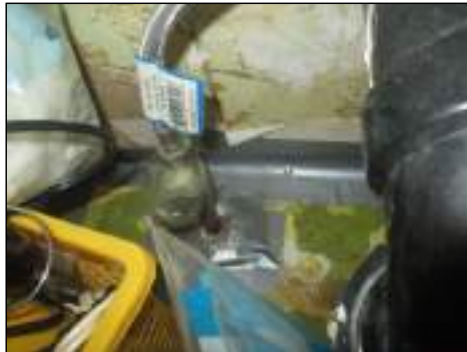
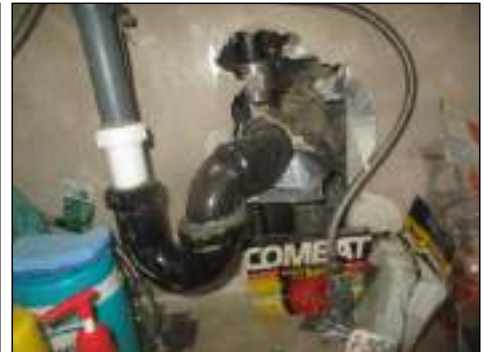
Irregular materials/installation/workmanship used at drain under sink hall - needs to be serviced

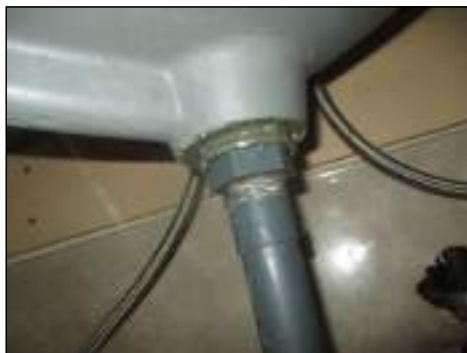
Visible leaking under sink jack and jill - recommend licensed plumbing contractor for further evaluation and repair

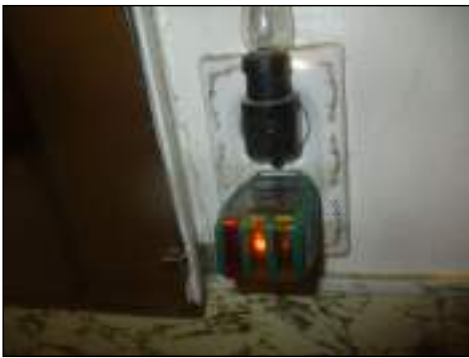
A representative number of receptacles and switches were tested and found to be operational at time of inspection

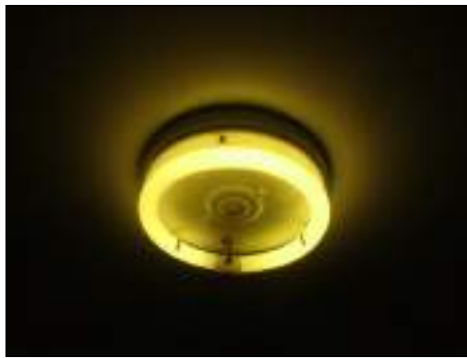
Missing fixture globes or covers

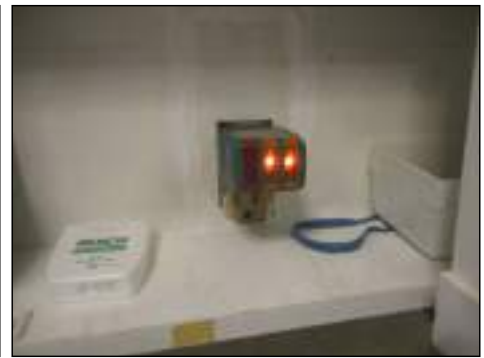
Loose/worn outlets/switches - typical for age consider upgrading

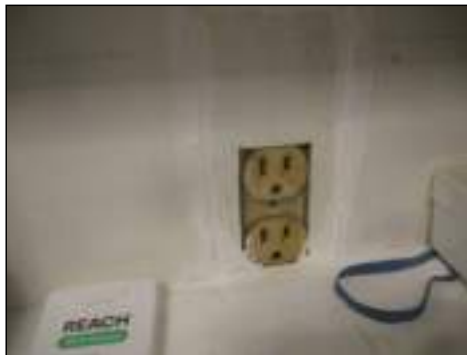
Missing/damaged outlet/switch covers - recommend installation/replacement of all covers for safety

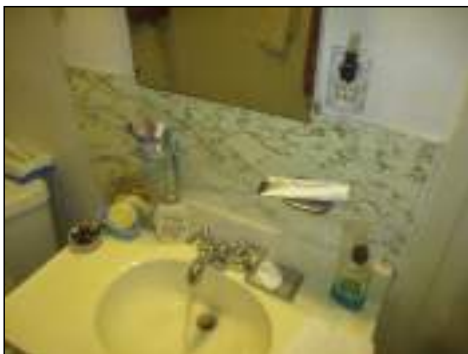
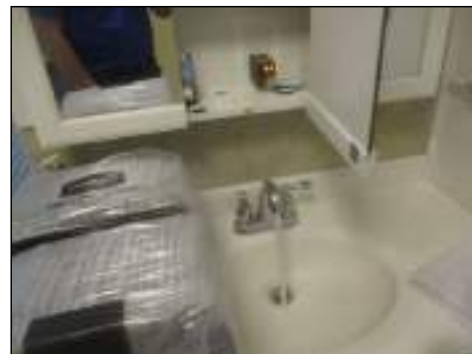
- Recommend upgrading all receptacle to **GFCI** protection within 6 feet of all potential wet locations

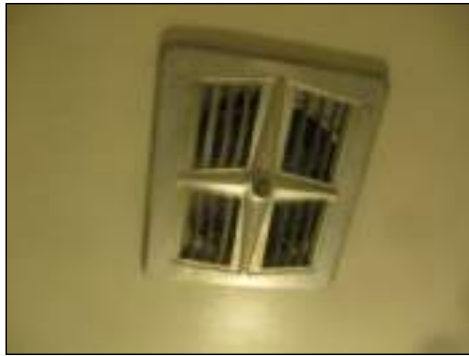
Exhaust fan did not operate at hall - needs to be serviced

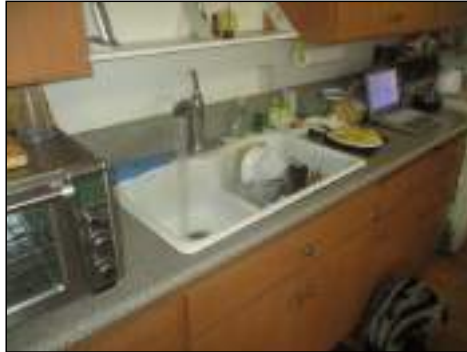
- Some counter areas not visible for inspection due to personal storage
- Counter has normal wear for age at time of inspection with no major visible defects
- Recommend grout/sealer/stone maintenance

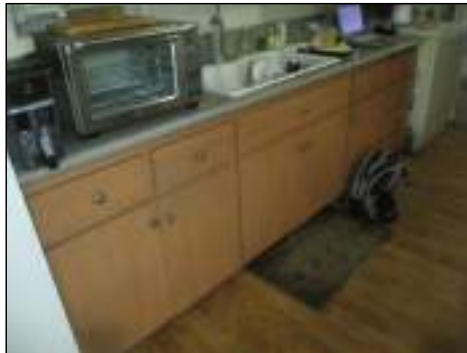
- Normal wear for age of material - no major visible defects
- Worn cabinets with loose/worn hardware - typical for age

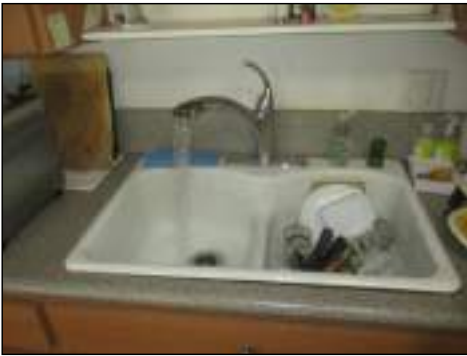
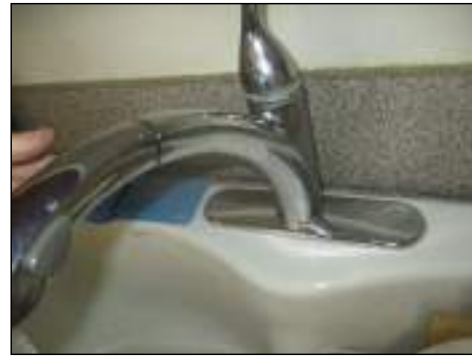
Fixture seized/stuck in position - not functional - recommend service

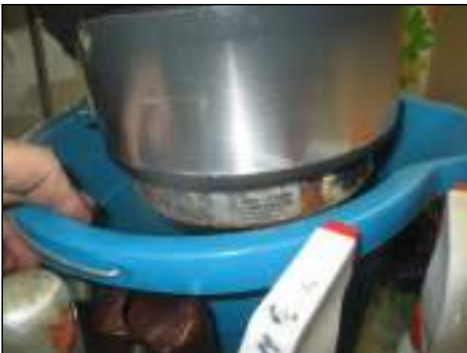
Evidence of leakage observed under sink - needs to be serviced - hidden defects may exist

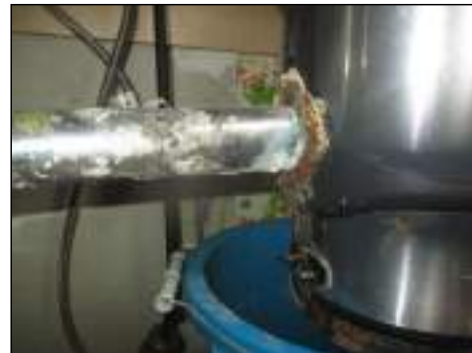
Heavily damaged - needs to be serviced

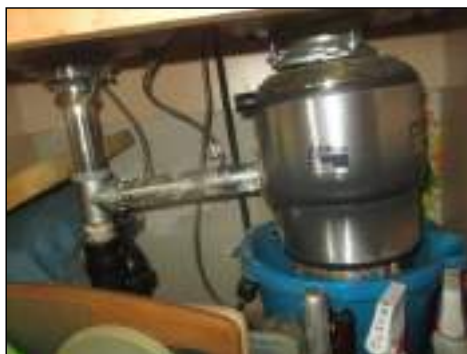
- Operational at time of inspection via normal fixture controls with no major visible defects
- Angle stops/hoses/drain pipes are in a normal condition for their age - no major visible defects

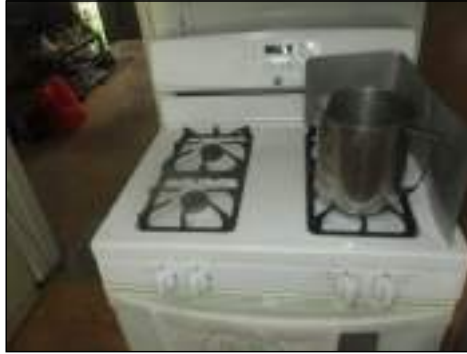
- The range or cooktop has a limited inspection, the Inspector cannot predict the remaining life of the unit nor determine the BTUs output by each burner or if/how well the burners will cook food. For gas units - gas leaks cannot be detected with this inspection - a full evaluation by the Gas Company of all gas supplied appliances is recommended beyond this inspection.
- Gas supplied unit
- Normal wear for age - no major visible defects

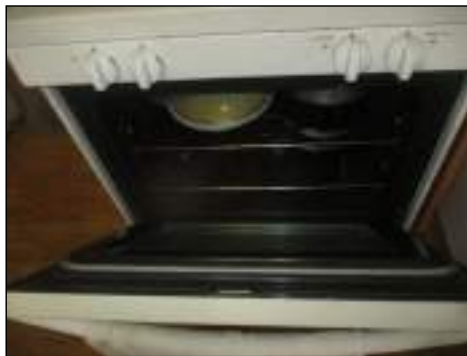
- Personal storage/pots/pans inside - unit was not tested
- Gas supplied unit
- Normal wear for age - no major visible defects
- Anti-tip device is not visible/not tested - we recommend that an anti-tip device be installed to prevent a possible tip hazard

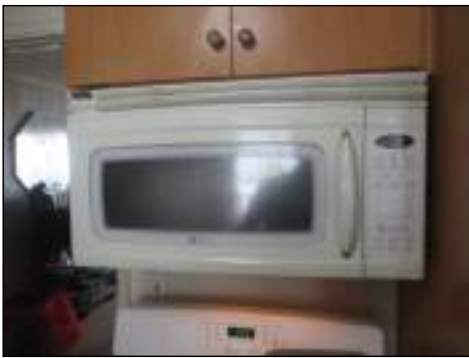
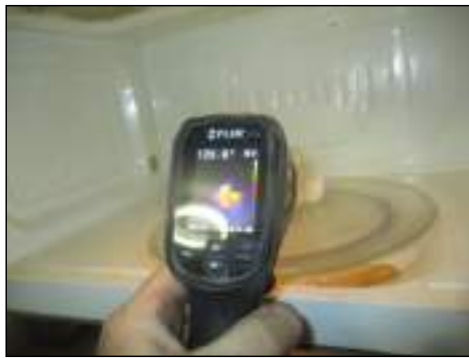
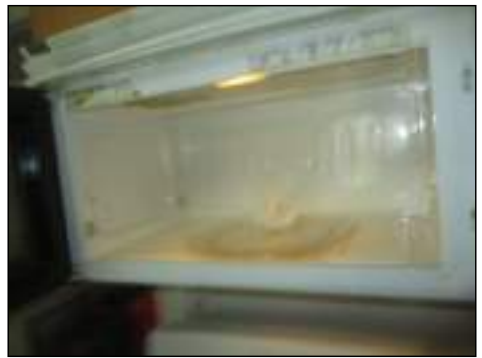
- The microwave is tested with a microwave tester or damp sponge/cloth only. No other features of the microwave are tested or evaluated for cooking. The home inspector cannot predict the remaining life left in the unit.
- Tested and operational at time of inspection via normal controls
- Worn/older unit - typical wear for age and use
- Stained/dirty inside - needs to be serviced and cleaned

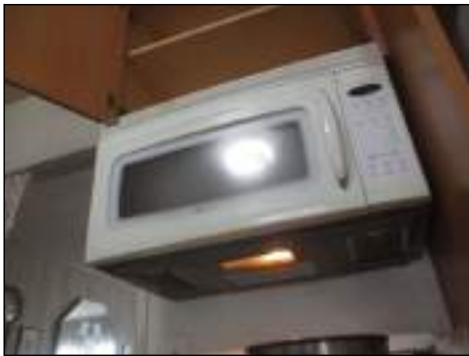
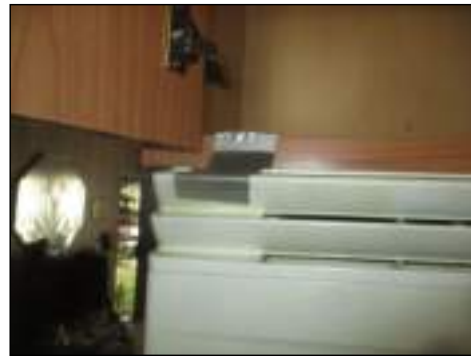
- The exhaust fan/vent is tested using the normal controls only. No smoke testing or other testing is done to determine the CFMs or how well the unit evacuates air. The home inspector cannot predict the remaining life left in the unit.
- Tested and operational at time of inspection via normal controls
- Normal wear for age - no major visible defects

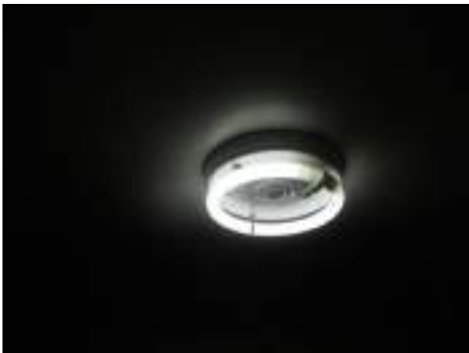
Missing/damaged outlet/switch/globe covers - recommend installation/replacement of all covers for safety

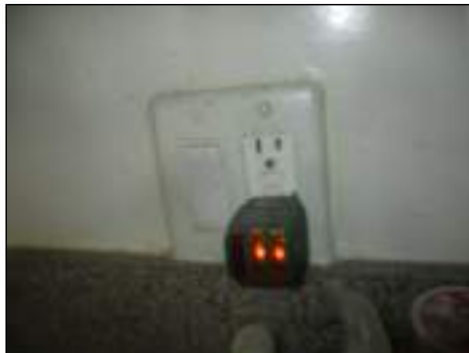
A representative number of receptacles and switches were tested and found to be operational at time of inspection

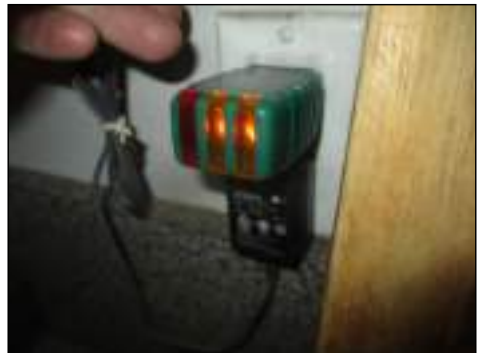
Outlets/switches had normal wear for age - no major visible defects

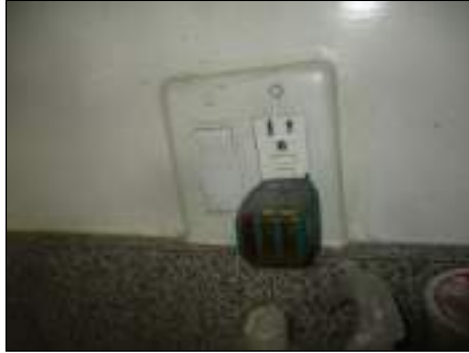
- Tested and operational at time of inspection via normal control

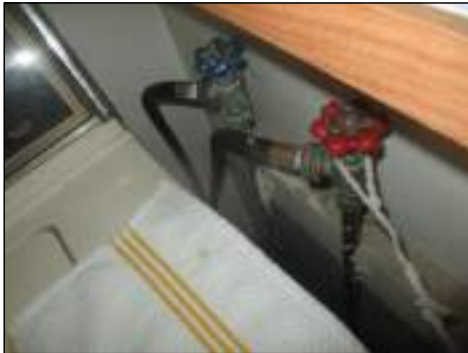
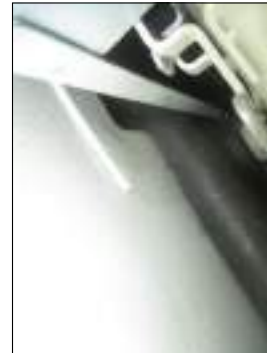
- Washer/dryer unit(s) present during inspection and obstruct the view of the wall/plumbing areas
- Visible fixtures had normal wear for age at the time of the inspection - no major visible defects
- Drain trap is not visible at the time of the inspection - n/a - note: laundry drains are not water or pressure tested during this inspection

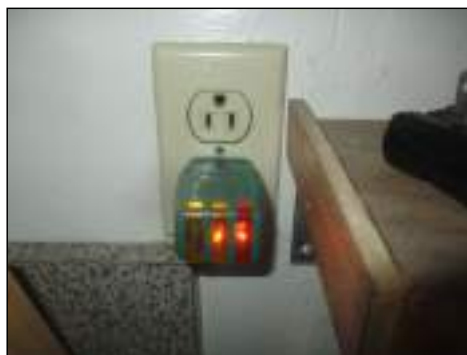
Outlet hot wired in reverse with neutral - recommend further evaluation by a licensed electrician

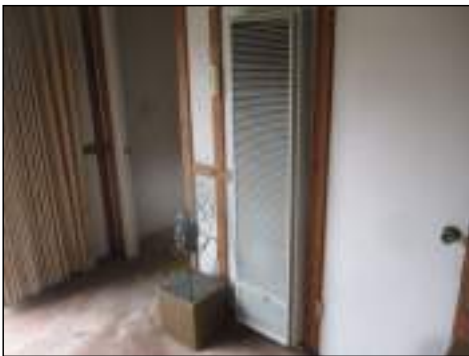
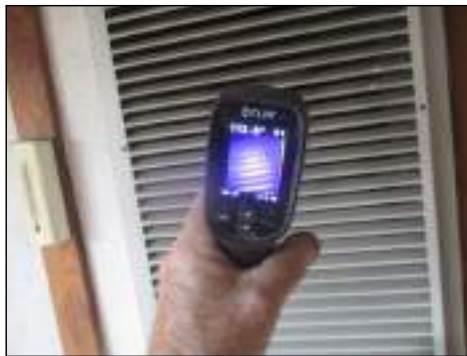
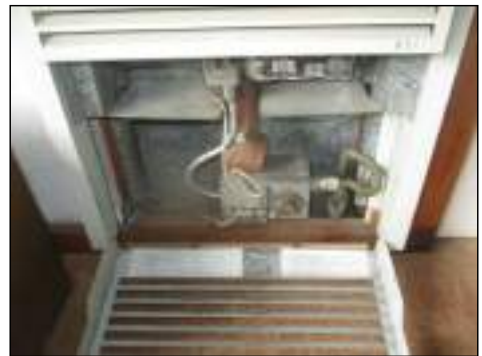
Operated at time of inspection

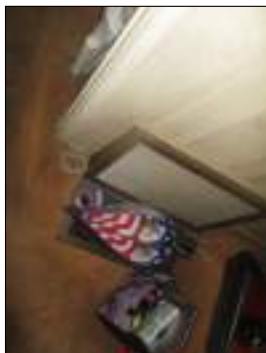
Pilot not lit could not test - needs to be serviced

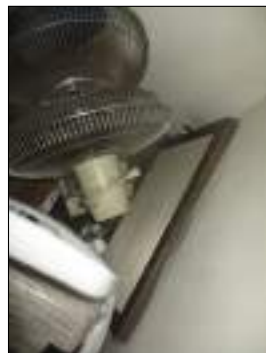
Floor heater is very old/worn - these types of heating systems are considered out dated - consider upgrading the heating system for this structure

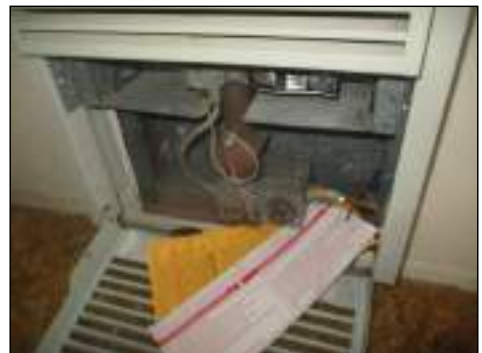
Gas heater located in a bedroom - recommend removal for safety - consult a HVAC contractor to further evaluate

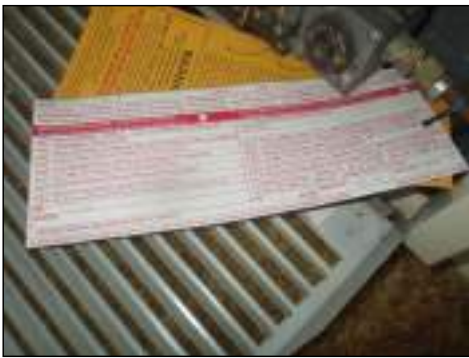
Red-tagged by gas company - needs to be serviced/evaluated by HVAC contractor

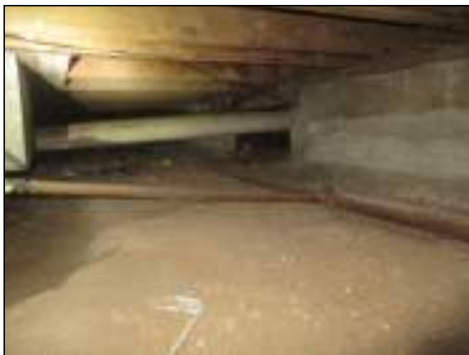
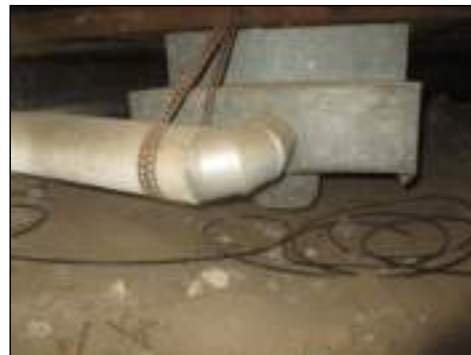
3. Gas Supply Valves and Pipes

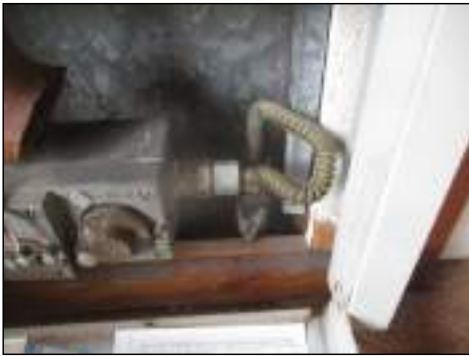
Old brass type gas line present - recommend immediate upgrade

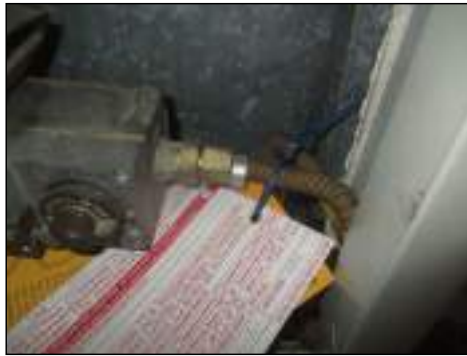
Old brass type gas line present - recommend immediate upgrade

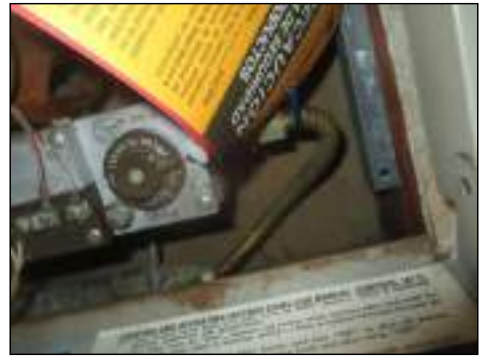
Old brass type gas line present - recommend immediate upgrade

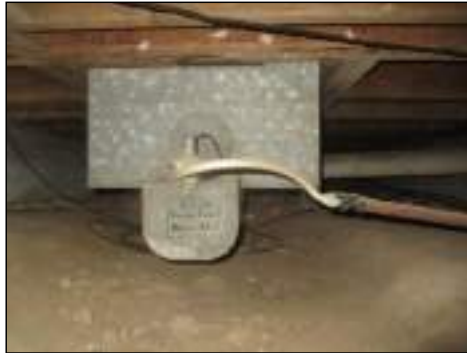
Aluminum gas line is present - immediate upgrade to appropriate flexible gas line is recommended

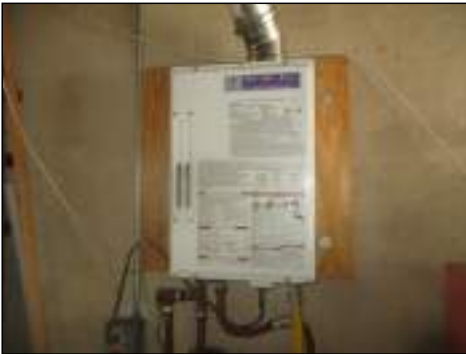
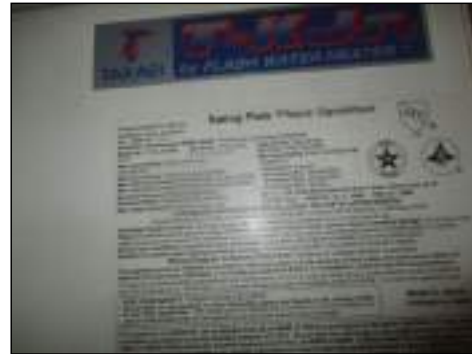
Operated at the time of the inspection - Gas unit

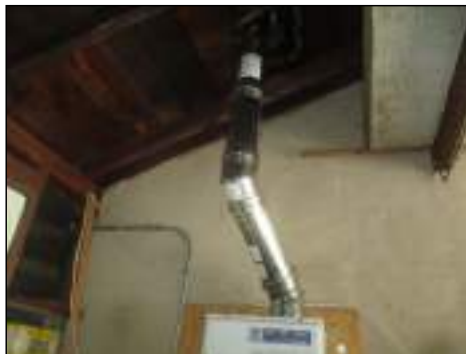
- Normal wear day of the inspection - no major visible defects

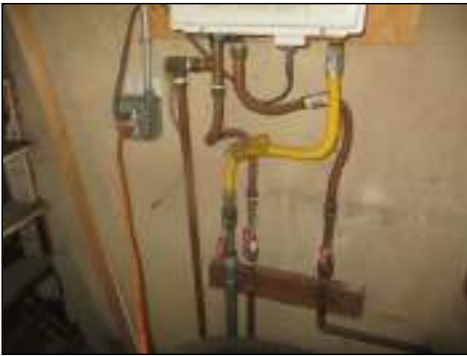
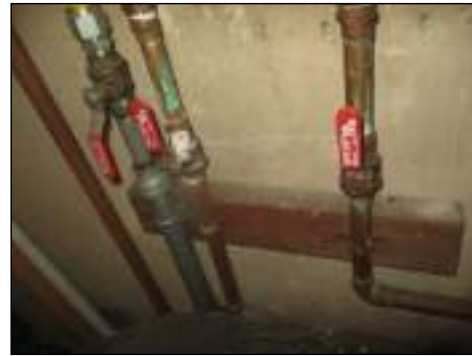
- Normal wear at time of inspection - no major visible defects or leaks found at the time of the inspection
- Water distribution pipes not insulated - recommend upgrade
- Corrosion present - signs of wear and a slow leak - monitor for moisture

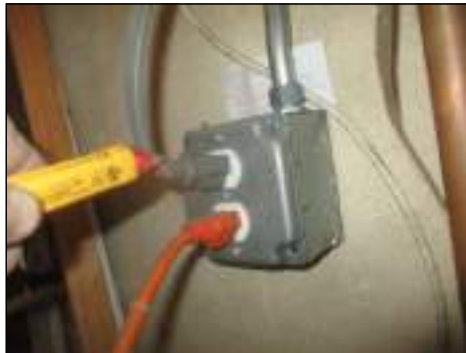
5. Temperature Pressure Release Valves

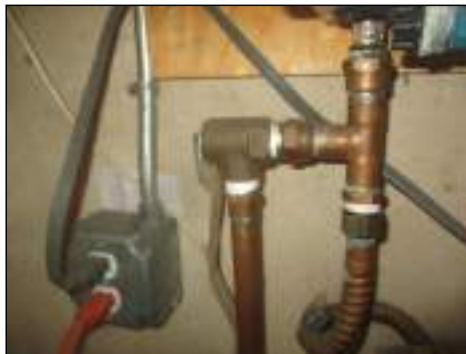
- The inspector visually inspects the TPRV only - this valve is not opened or tested during the inspection
- Normal wear on the day of the inspection - no major visible defects

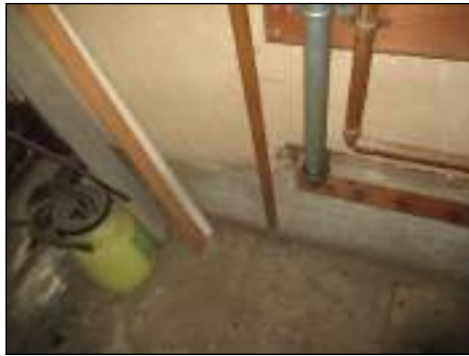
7. Water Heater Temperature

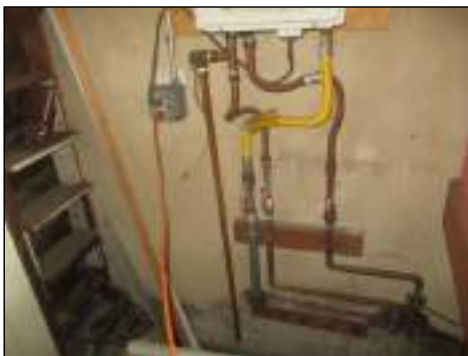
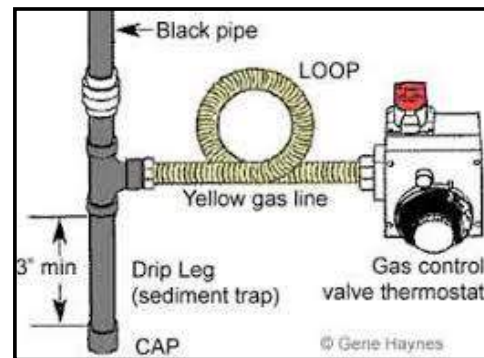
- Normal wear at time of inspection - no major visible defects
- No sediment trap at gas supply - may have not been required at time of original installation, but is recommended

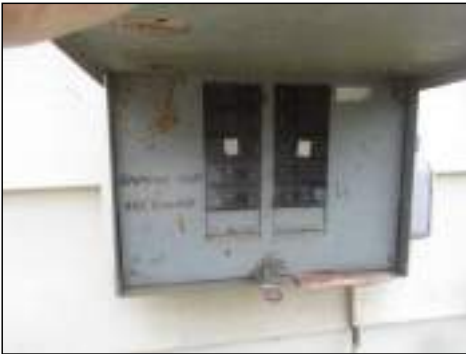
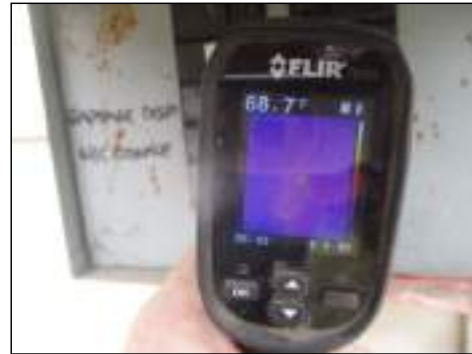
Thermal Image View - Normal temperature readings with no visible signs of overheating at time of inspection

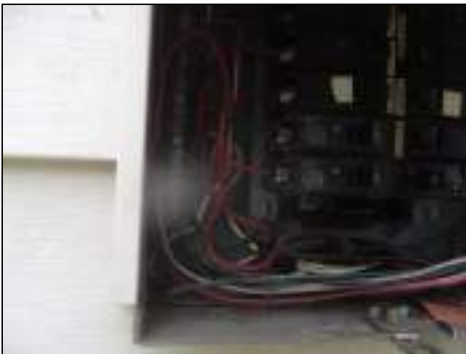
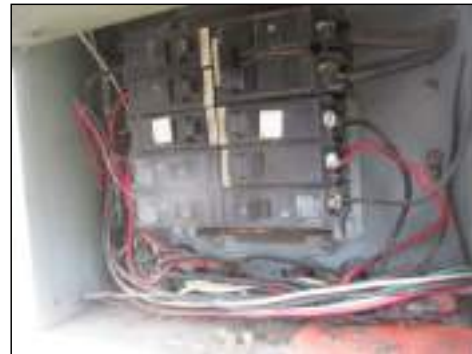
- Wiring type: copper and multi-strand aluminum at 240-Volt circuits
- Grounded panel - main ground/bonding wire observed and appears to be normal for the age of the panel
- Visible wiring has normal wear for age with no major visible defects at the time of the inspection

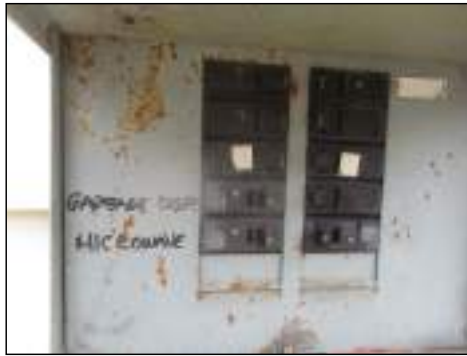
4. Breaker Amp Capacity

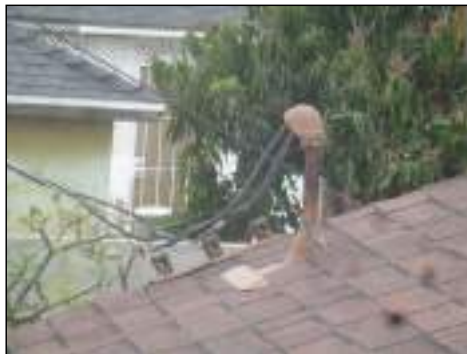
- Overhead - normal wear for the age on day of the inspection - no major visible defects

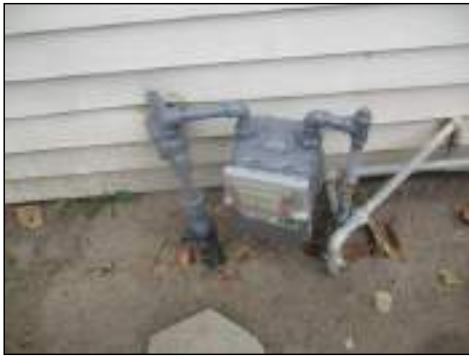
- Natural gas present
- Valve has normal wear for age at the time of inspection - no major visible defects
- No seismic safety valve present - some counties require seismic valves, check residential building codes - recommend installation for increased safety

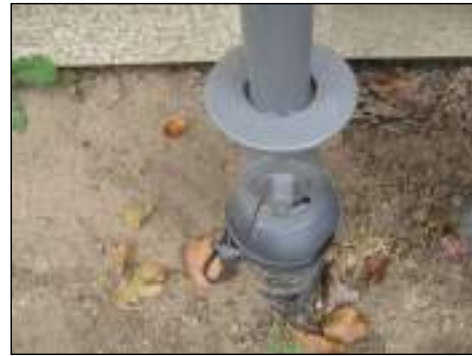
Valve has normal wear for age at the time of inspection - no major visible defects

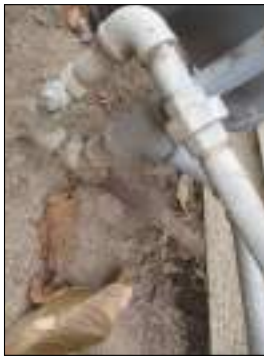
Minor rusting - typical for age - recommend rust treatment

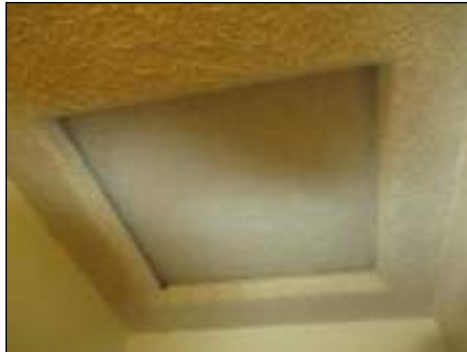
- Location of access: Hall ceiling
- Normal wear at access door - no major visible defects

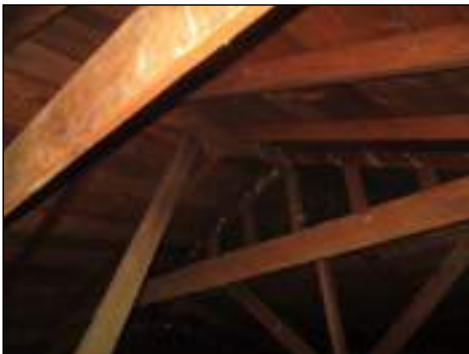
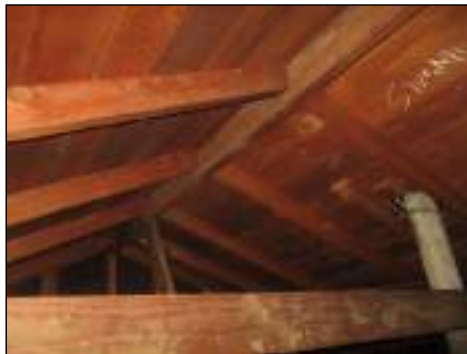
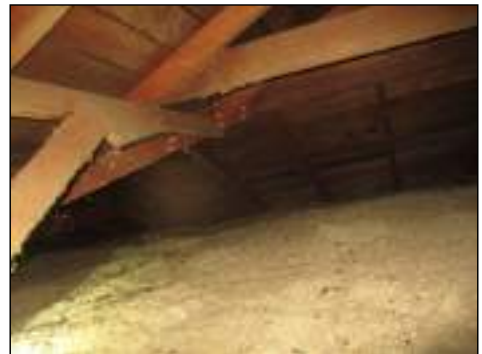
- Framing has been altered or modified and is not original to the structure - check all building permits to ensure that all framing was installed to code
- Consult termite report for all wood areas in the attic
- Conventional framing present, normal wear at time of inspection - no major visible defects
- Large stains present on wood members of structure - needs to be serviced and further evaluated for possible leak
- Visible daylight can be seen in areas - recommend contractor to evaluate and seal any holes/gaps

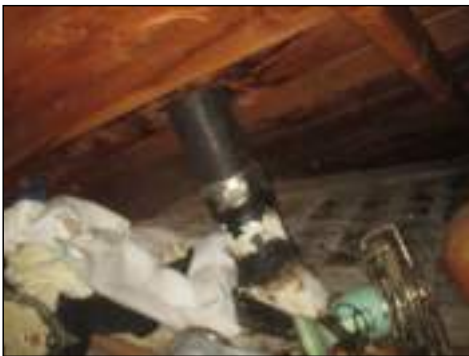
Large stains present on wood members of structure - needs to be serviced and further evaluated for possible leak

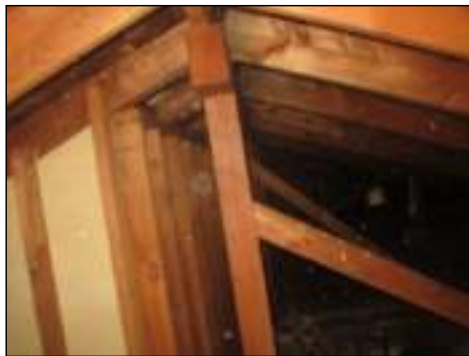
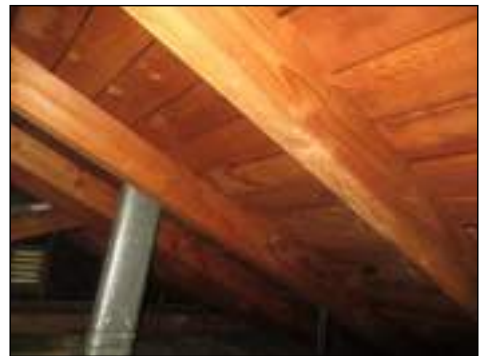
Large stains present on wood members of structure - needs to be serviced and further evaluated for possible leak

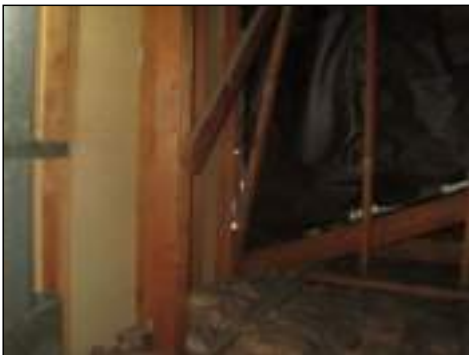
Visible daylight can be seen in areas - recommend contractor to evaluate and seal any holes/gaps

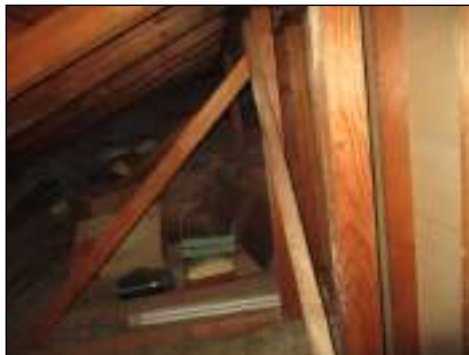
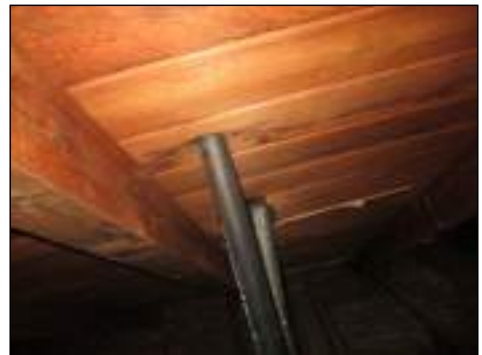
Large stains present on wood members of structure - needs to be serviced and further evaluated for possible leak
