ELITE GROUP

INSPECTION PROFESSIONALS

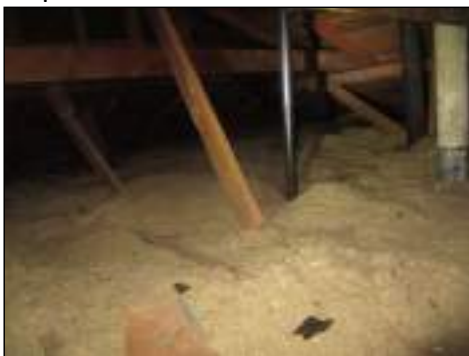
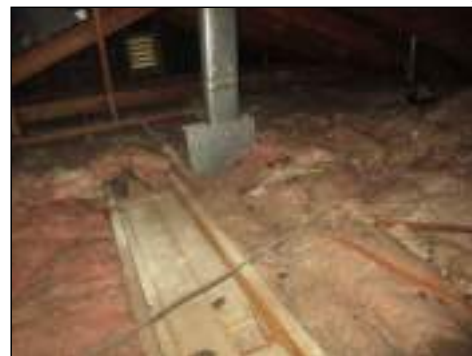
- All visible insulation appears to have normal wear for age with no major visible defects at the time of the inspection
- Loose/displaced insulation in areas - recommend repair/replacement as needed for best efficiency

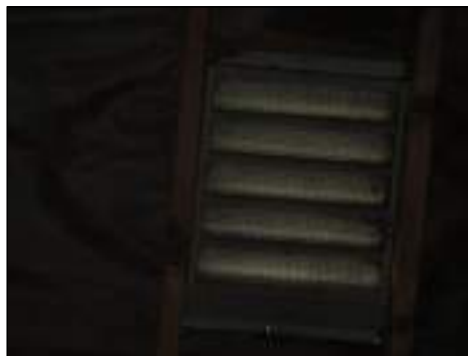
- Visible ventilation screens appeared to be functional at time of inspection
- Recommend maintaining vent screen to prevent pest intrusion

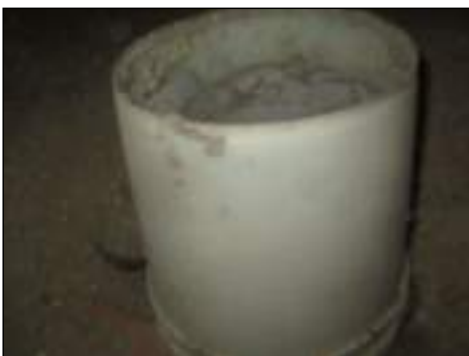
Bathroom or other exhaust fan duct appears to terminate in attic, have duct routed to exterior to minimize moisture

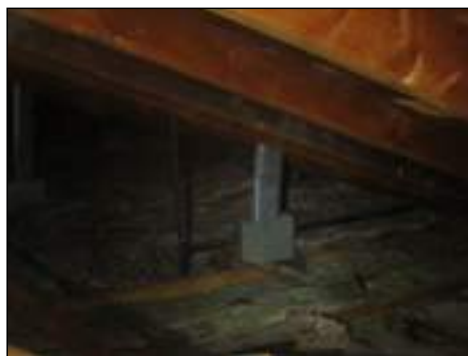
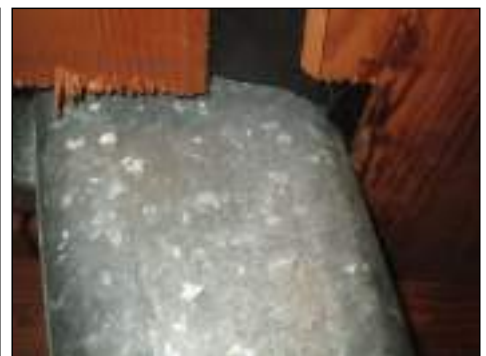
Heat exhaust vent does not have proper clearance from combustibles - needs to be serviced

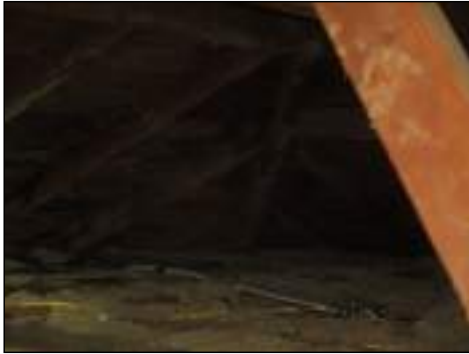
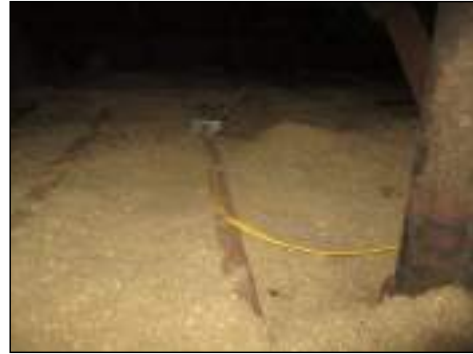
- Evidence of electrical alterations in the attic - check all permits for electrical alterations to ensure that all electrical was installed to city/county electrical code
- Visible electrical areas appear to have normal wear for age with no major visible defects at the time of the inspection

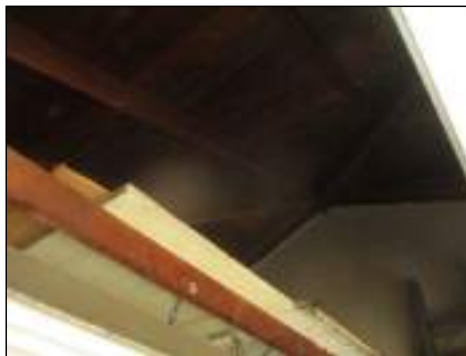
3. Main Automotive Doors

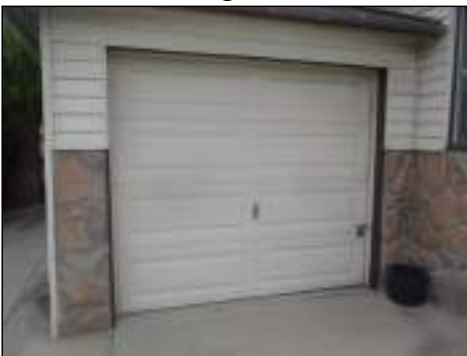
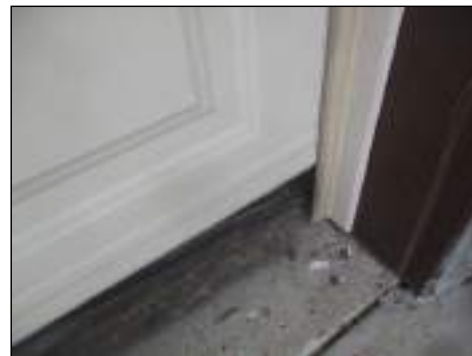
Door weatherstripping is missing or damaged - recommend servicing

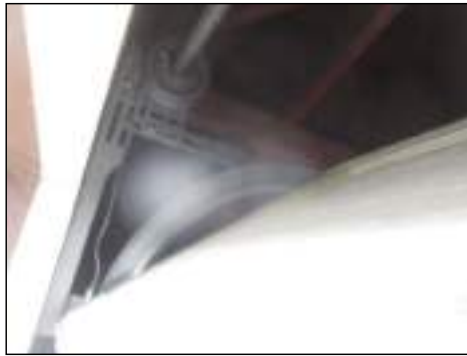
Did not operate properly - needs to be serviced/further evaluated

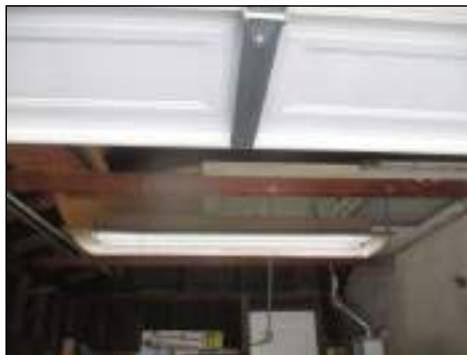
- None installed - recommend further evaluation

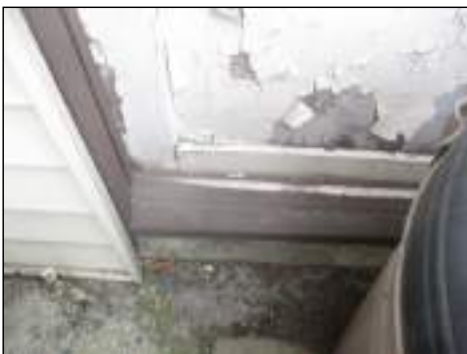
Irregular installation/materials/workmanship - needs to be serviced

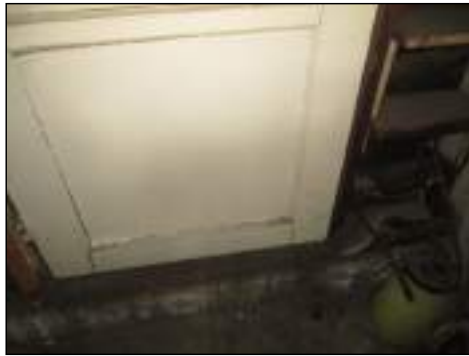
Evidence of moisture entering - needs to be serviced

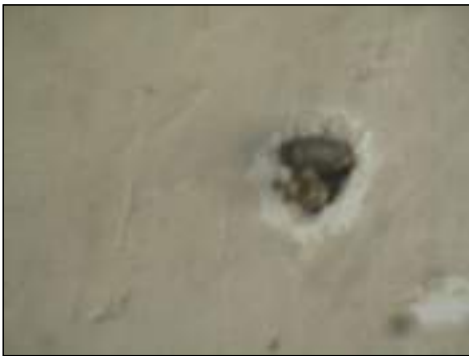
Holes present - needs to be serviced to retain integrity of fire separation

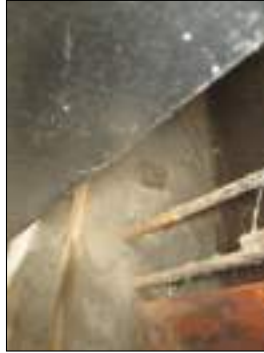
- Present - normal wear for age

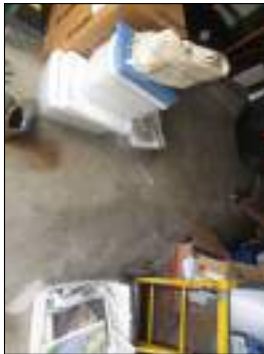
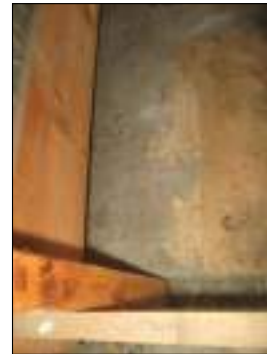
Evidence of rodents/pests - recommend pest services inspection for further evaluation

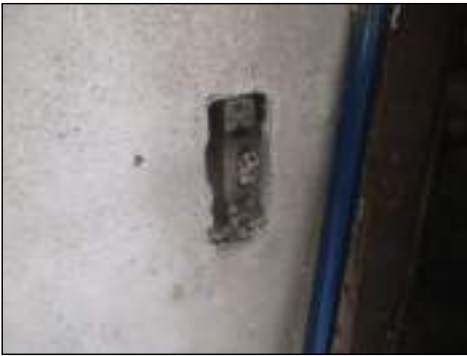
Missing/damaged outlet/switch cover - recommend installation of all covers for safety

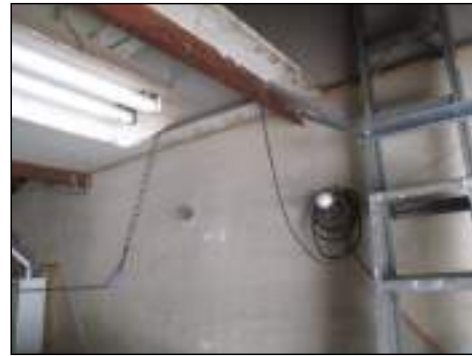
Using extension cord for power - this is not a recommended installation a more permanent installation should be done by a licensed electrician

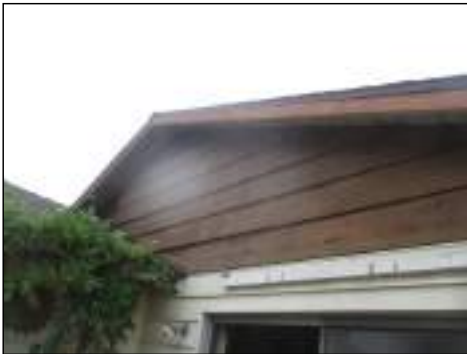
Worn/weathered/cracked materials where visible – recommend siding maintenance

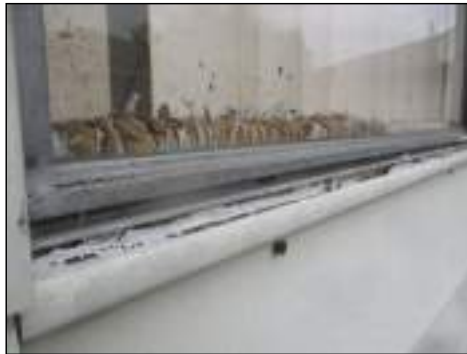
Gaps in siding at joints and around windows/doors - recommend servicing to prevent moisture entry

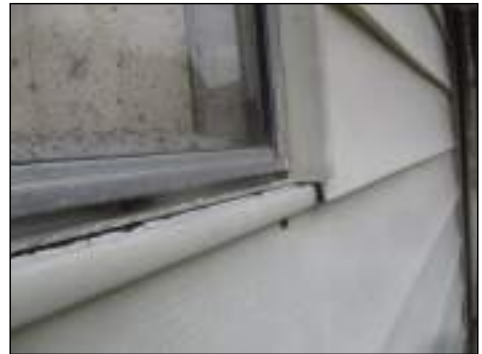
Gaps in siding at joints and around windows/doors - recommend servicing to prevent moisture entry

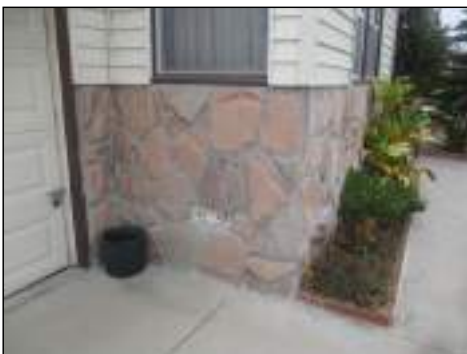
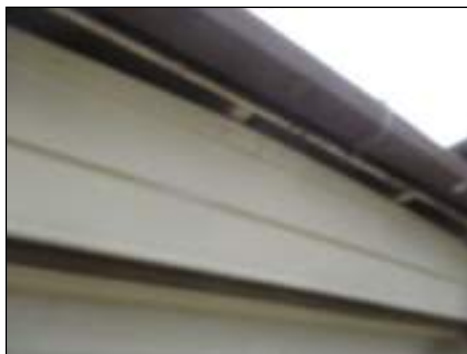
Loose in area - needs to be serviced

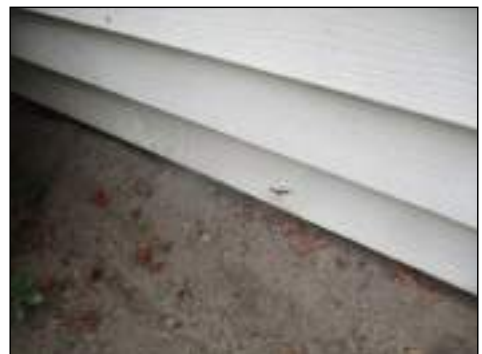
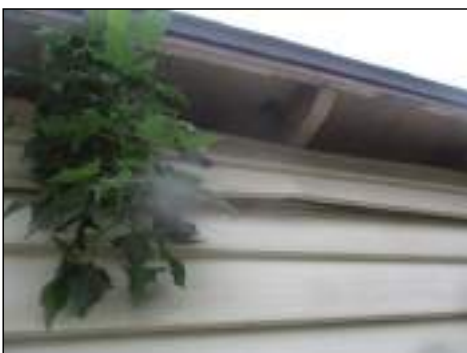
Loose in areas - needs to be serviced

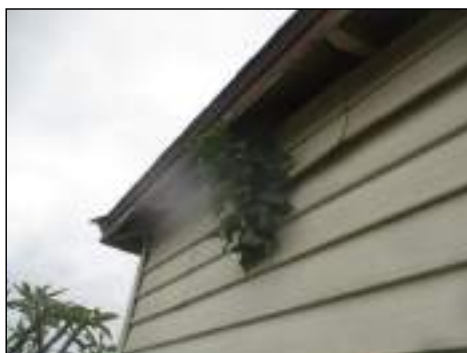
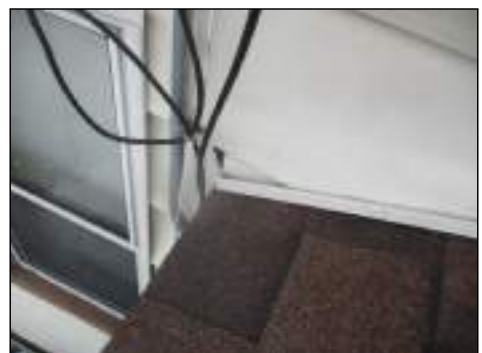
Gaps in siding at joints and around windows/doors - recommend servicing to prevent moisture entry

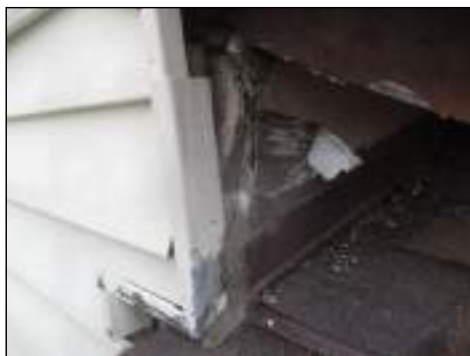
Gaps in siding at joints and around windows/doors - recommend servicing to prevent moisture entry

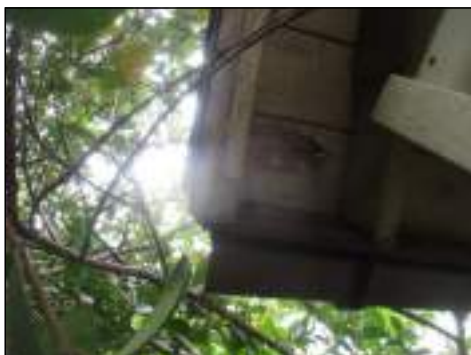
Water stains at fascia/eaves may indicate roof leakage - recommend further evaluation

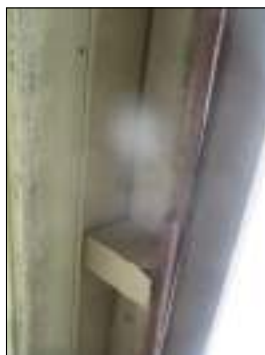
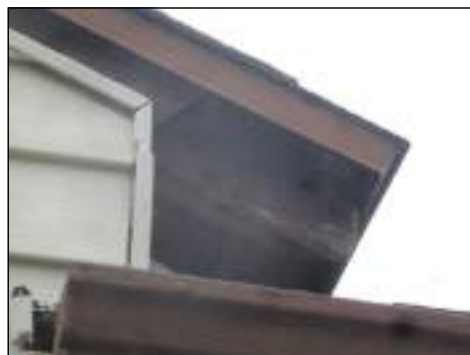
Water stains at fascia/eaves may indicate roof leakage - recommend further evaluation

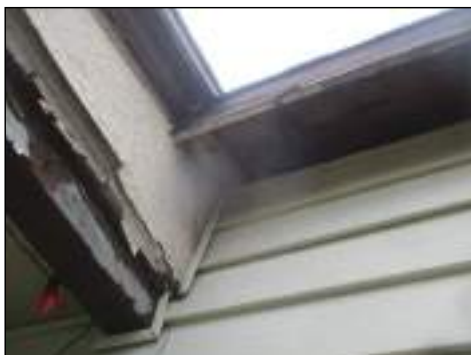
Water stains at fascia/eaves may indicate roof leakage - recommend further evaluation

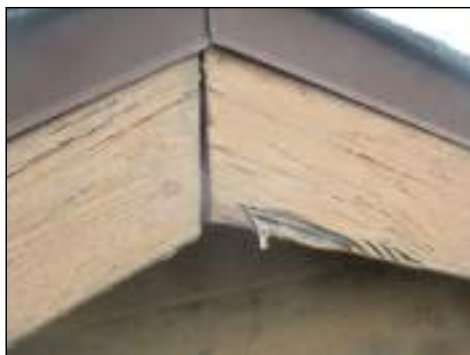
Inspector does not determine wood destroying organism presence or damage - always obtain a structural pest control inspection

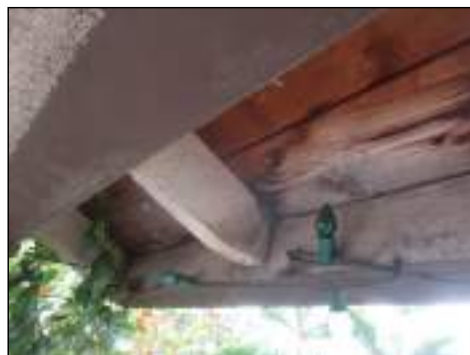
Water stains at fascia/eaves may indicate roof leakage - recommend further evaluation

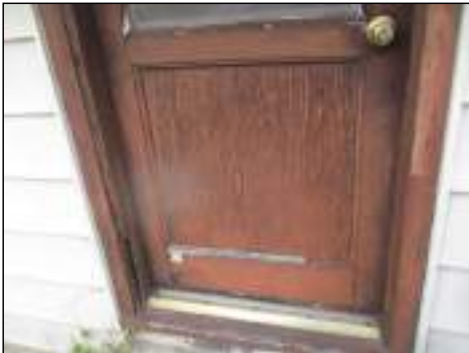
Heavily damaged/deteriorated/peeling - needs to be serviced

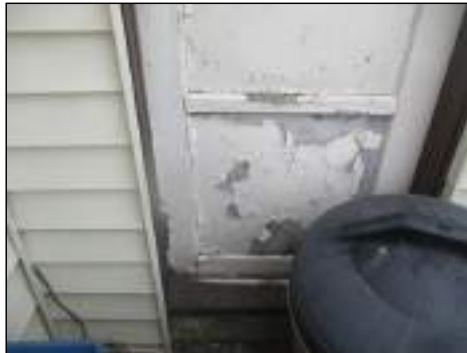
Heavily damaged/deteriorated/peeling - needs to be serviced

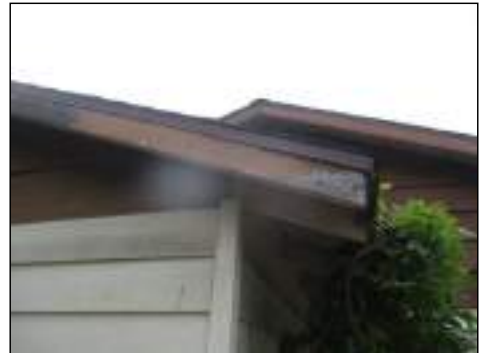
Exposed wood surfaces, wood rot & deterioration can occur - recommend servicing

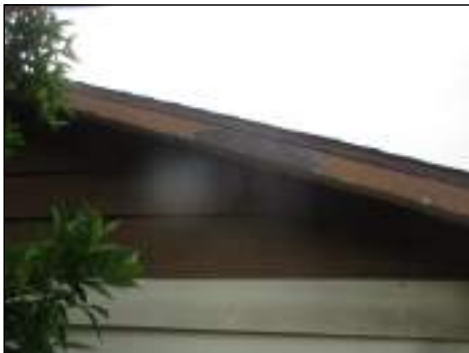
Heavily damaged/deteriorated/peeling - needs to be serviced

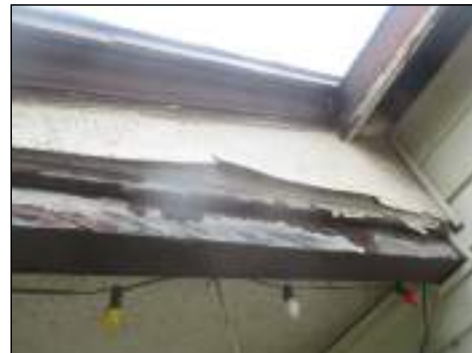
Heavily damaged/deteriorated/peeling - needs to be serviced

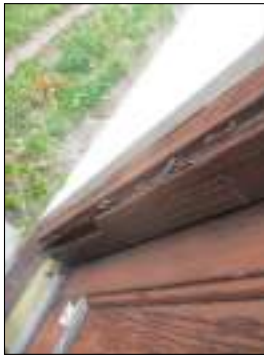
Visible gaps around the door frame - missing weather stripping or damaged - recommend exterior water tight service to prevent possible moisture intrusion

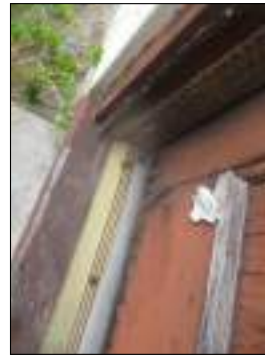
Visible gaps around the door frame - missing weather stripping or damaged - recommend exterior water tight service to prevent possible moisture intrusion

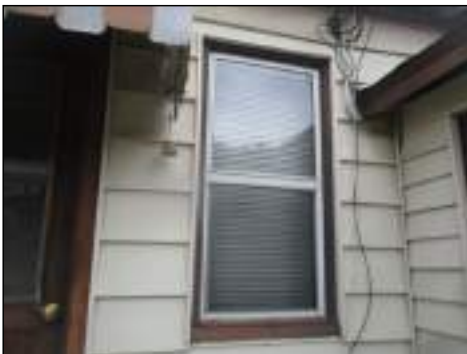
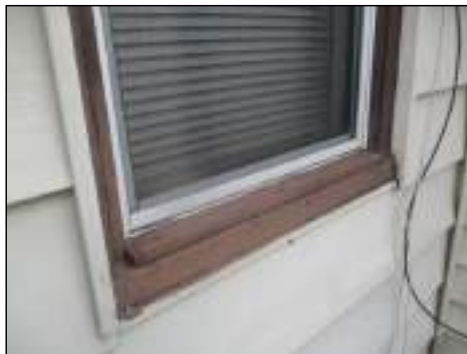
Visible gaps around window frame - recommend exterior water tight sealant to prevent moisture entering the structure

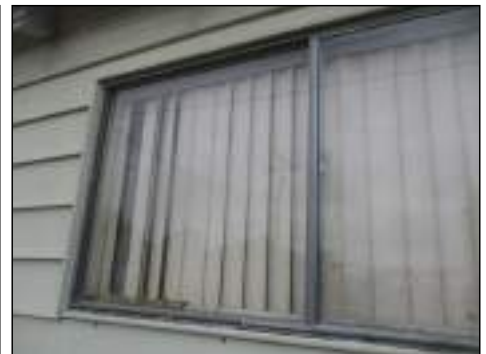
Missing screens - screens are recommended at all openable windows

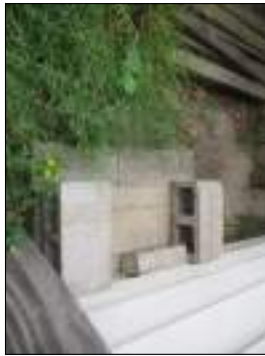
Irregular installation/workmanship - needs to be serviced

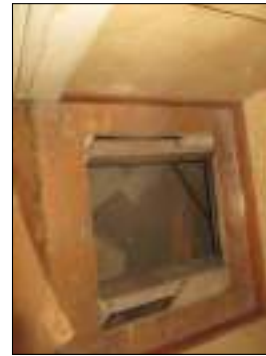
Irregular installation/workmanship - needs to be serviced

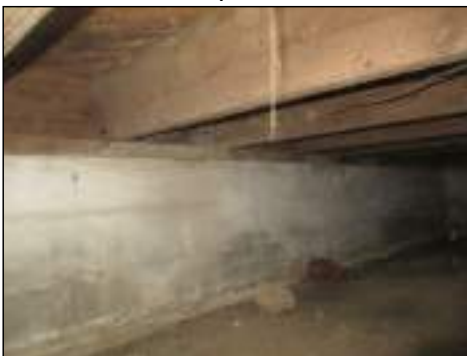
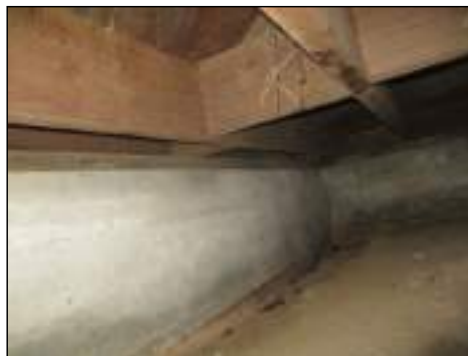
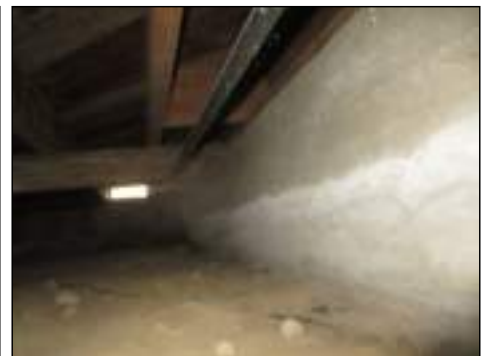
Efflorescence present - indicates past moisture accumulation - monitor for further moisture intrusion

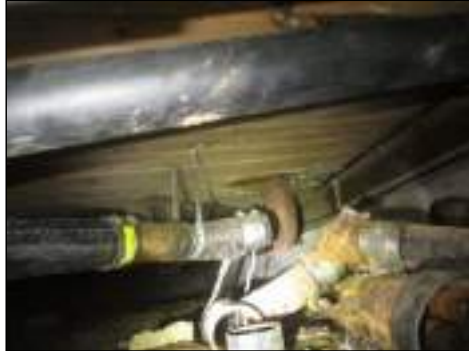
5. Posts and Girders

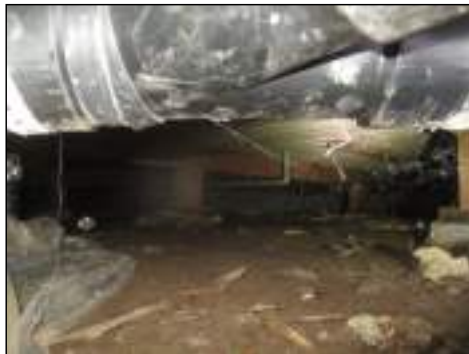
- Normal wear for the age of the structure at the time of the inspection with no major visible defects

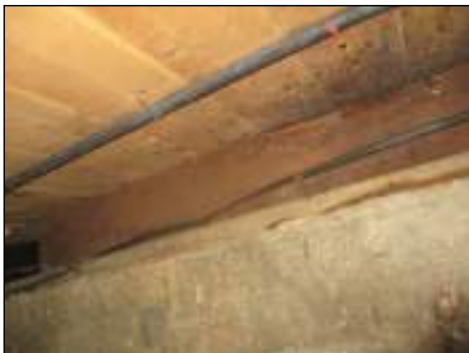
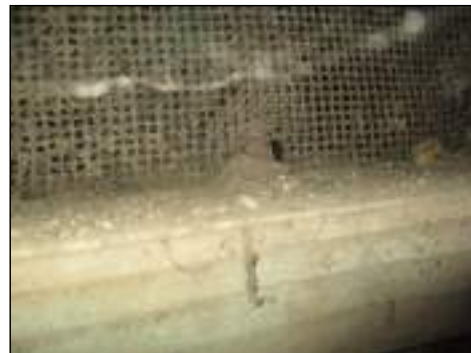
- Anchor bolts present and have normal wear for age with no major visible defects

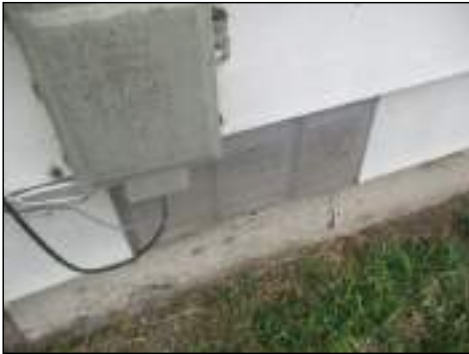
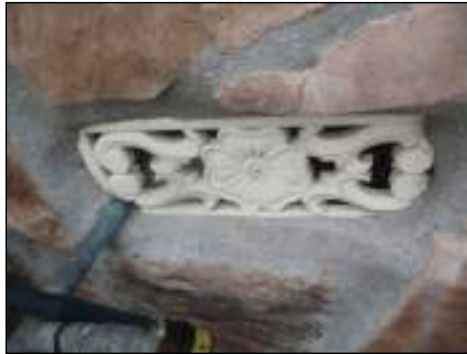
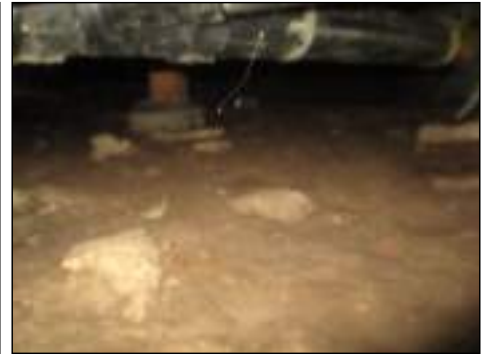
Moisture present under structure at rear addition area - needs to be serviced

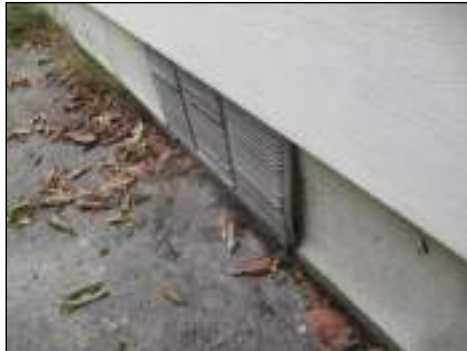
Loose screens - recommend maintenance and repairs to prevent pest intrusion

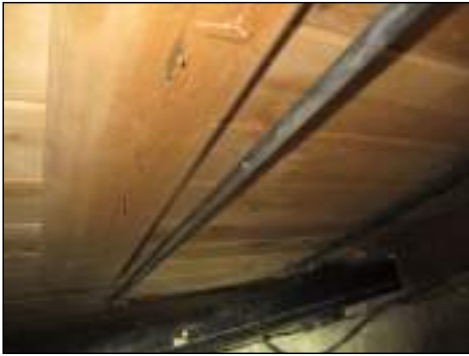
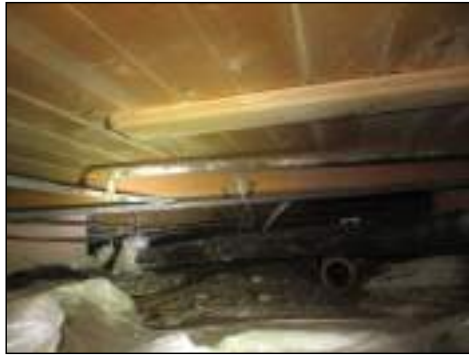
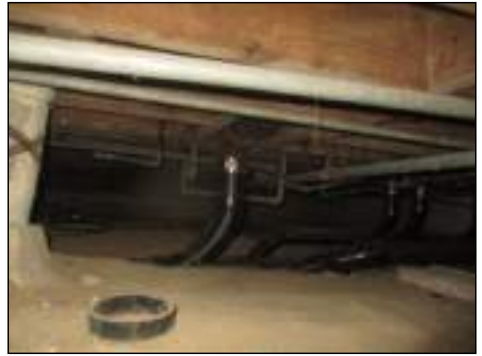
Copper tubing discolored - recommend complete water distribution system evaluation by a licensed plumber

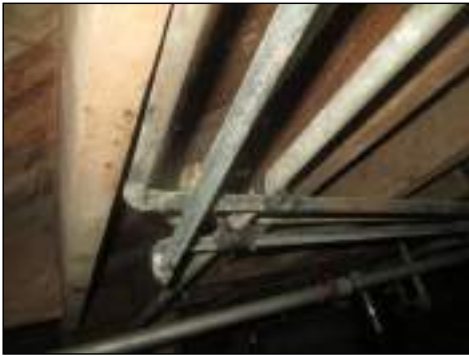
Copper to galvanized plumbing missing proper insulation – needs to be serviced by licensed plumber

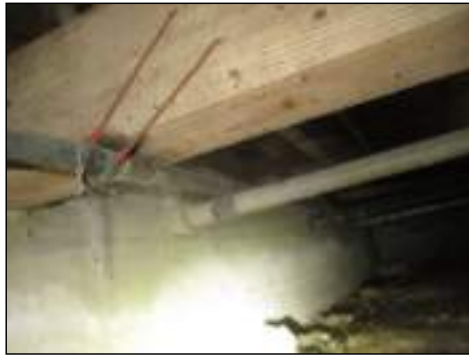
Copper to galvanized plumbing missing proper insulation – needs to be serviced by licensed plumber

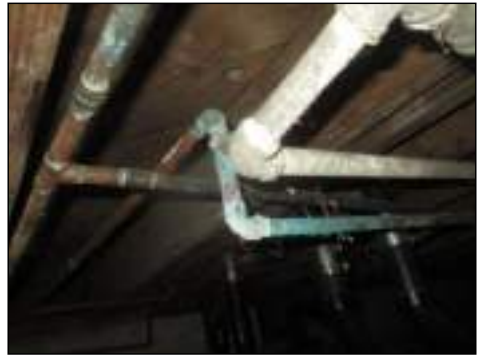
Corrosion at supply piping - recommended further evaluation by a licensed plumber

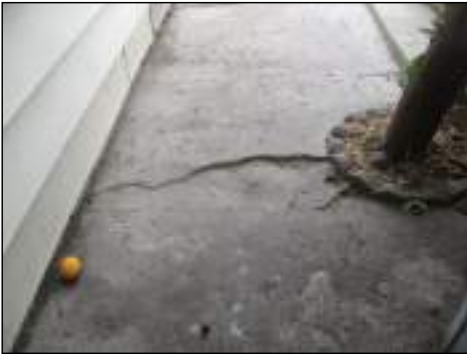
Walkway displacement/uplifted/uneven areas - potential trip hazard - needs to be serviced

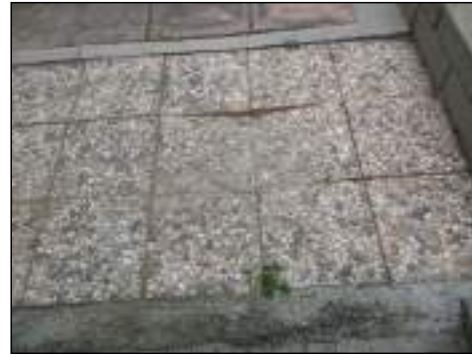
Walkway displacement/uplifted/uneven areas - potential trip hazard - needs to be serviced

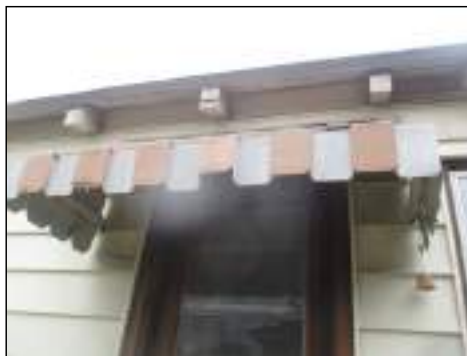
Worn/weathered/stained materials - typical for age - material in need of maintenance

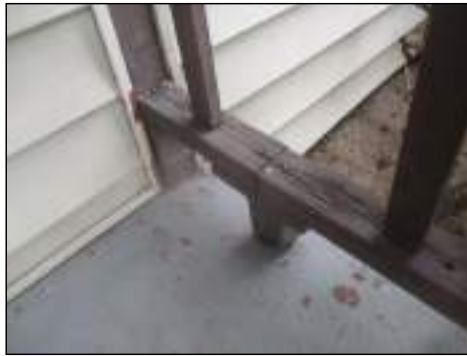
Deteriorated wood - needs to be serviced - consult termite report

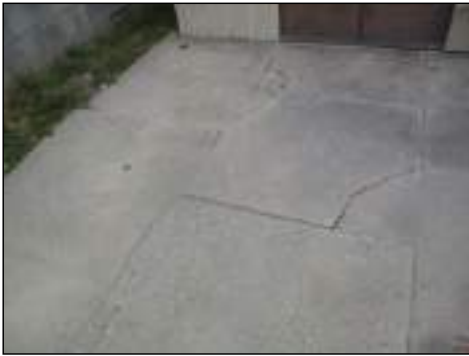
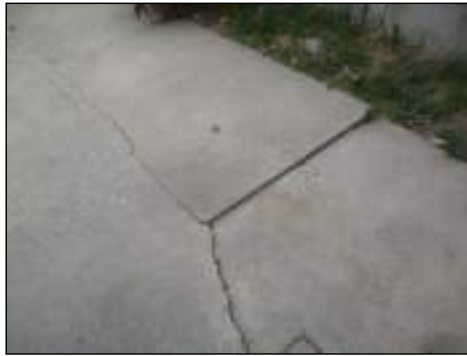
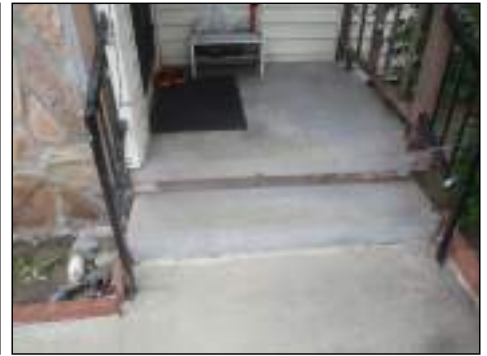
Displaced/lifted/uneven areas trip hazard - needs to be serviced

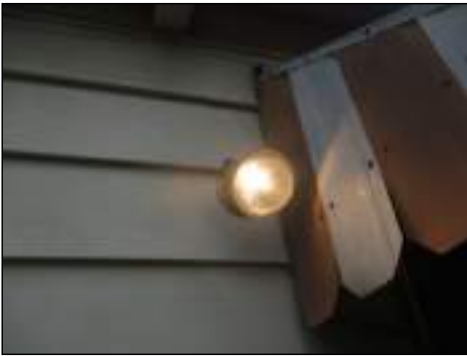
Accessible lights/switches/outlets were tested on the day of the inspection

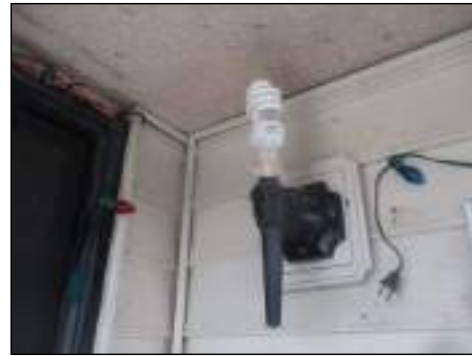
Missing fixture globe(s)

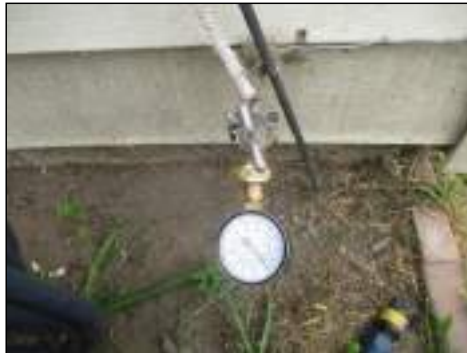
We recommend adding anti-siphon/backflow preventers (if not already present) on all exterior hose bibs for optimum potable water protection

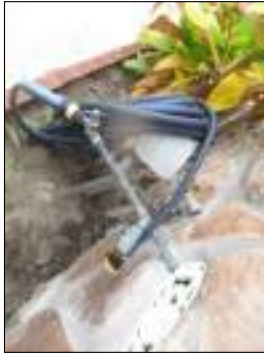
Location: south side

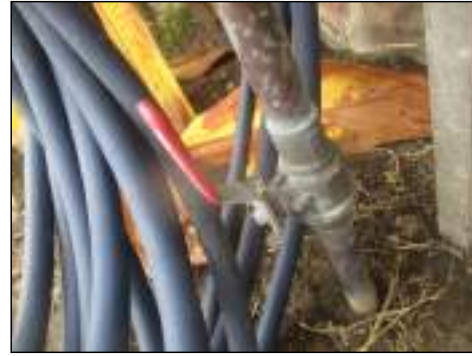
Main valve appears to have normal wear at the time of inspection - no major visible defects

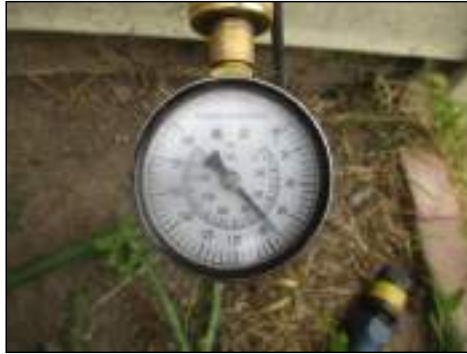
Approximate pounds per square inch: 70

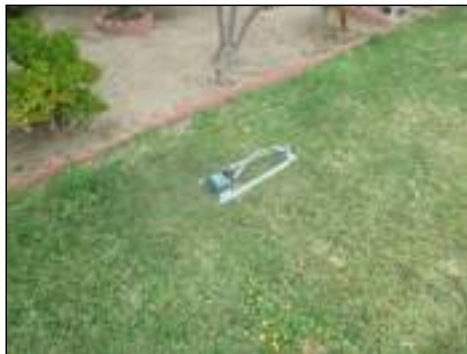
13. Fencing and Walls

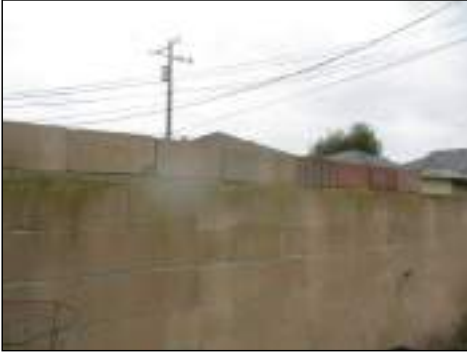
Loose/missing top caps/materials - recommend servicing

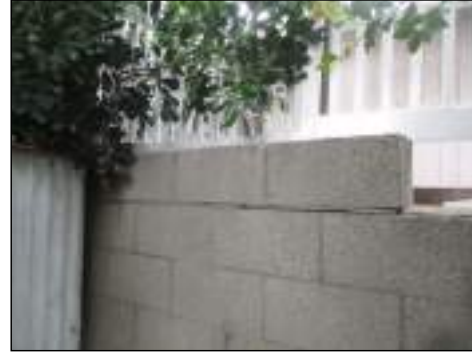
Small cracking/chipping - did not affect the performance of the fence - monitor for further cracking and repair as needed

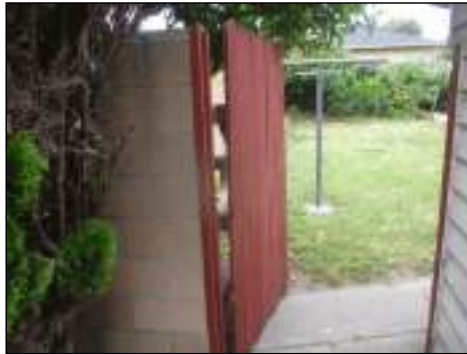
- Operated on the day of the inspection
- Weathered and worn materials - typical for age

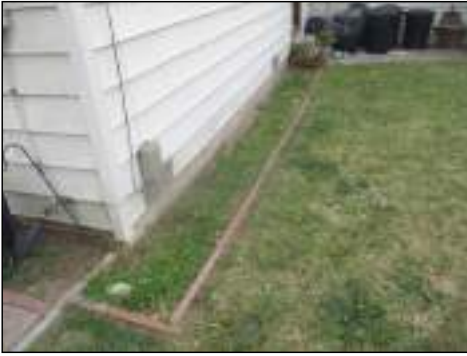
Low spots along the foundation - recommend adding additional backfill to create the proper slope away from the house to allow for effective drainage

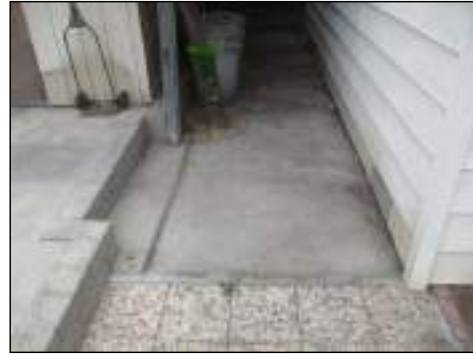
Small localized water ponding may occur in areas - monitor these areas as drains may be needed

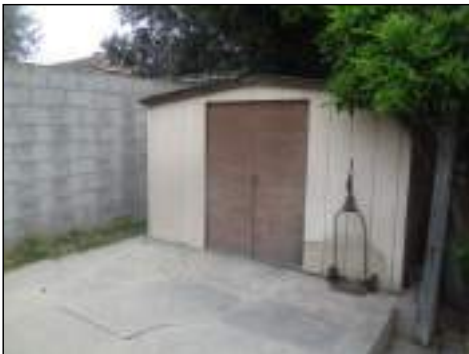
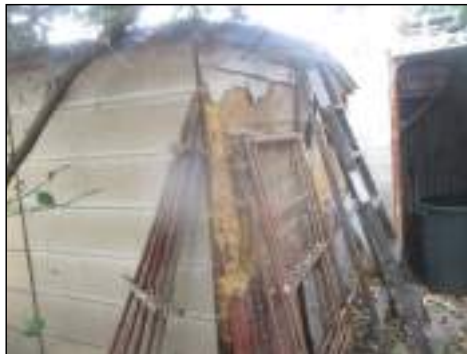
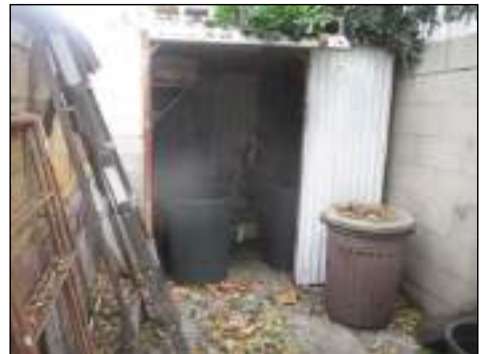
- Out buildings, detached structures, play equipment, exterior BBQ areas, fire pits, bird baths, fountains/water features and above ground pools are not completely inspected for functionality. You are advised to check permits for any out structure(s) present - the home inspector is not a building code violation inspector

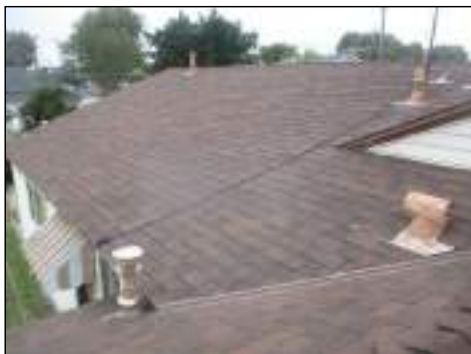
Worn and weathered materials present - typical for age and weather exposure - roof needs maintenance

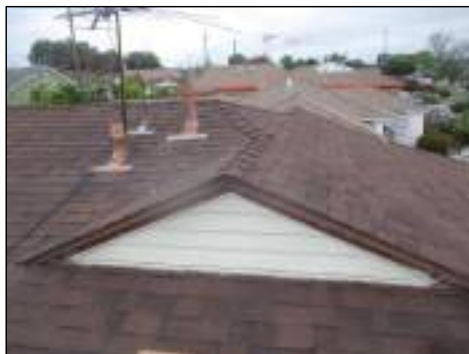
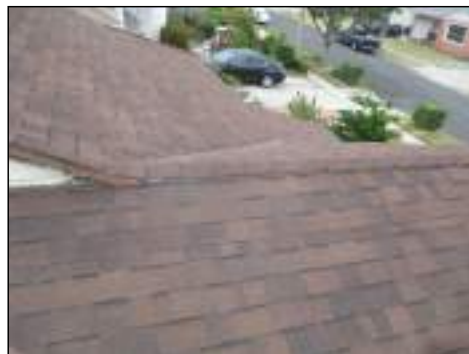
Shingles exhibited visible granule loss - normal for age of material

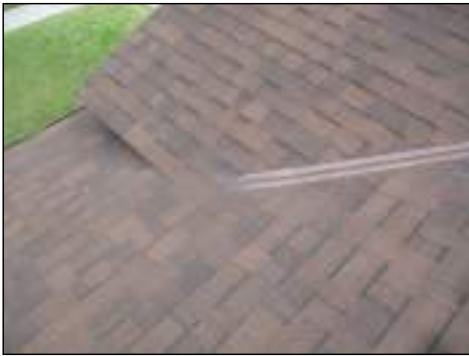
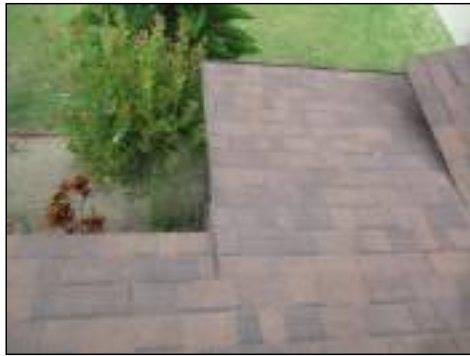
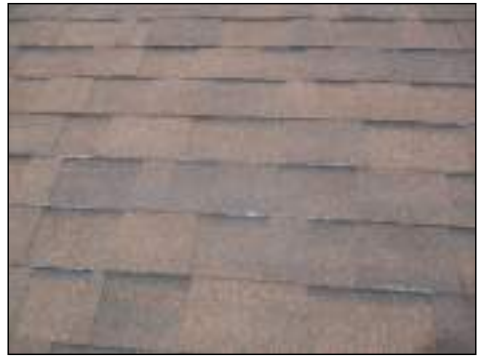
Worn and weathered materials present - typical for age and weather exposure - roof needs maintenance

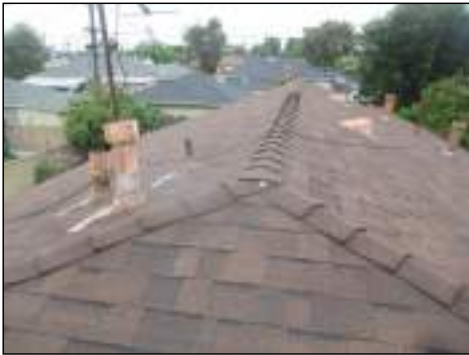
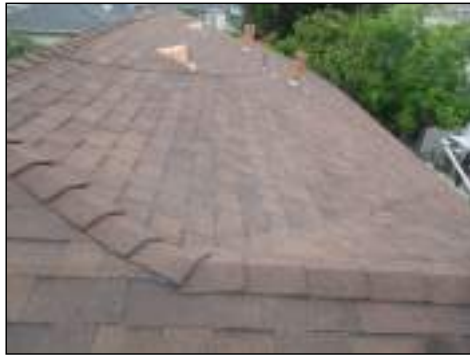
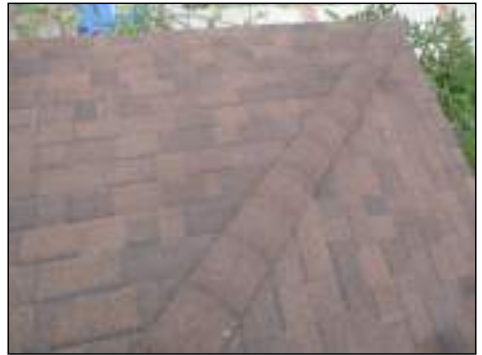
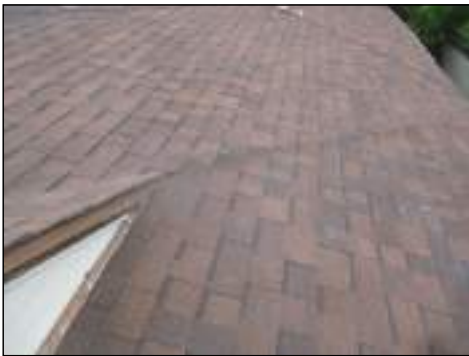
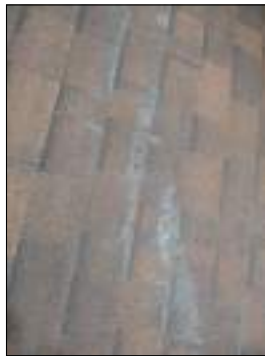
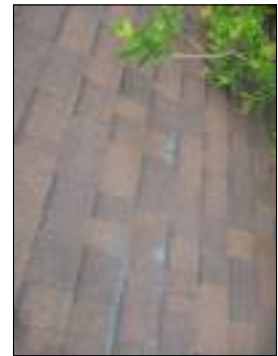
Missing/damaged shingles/tiles in areas - needs to be serviced

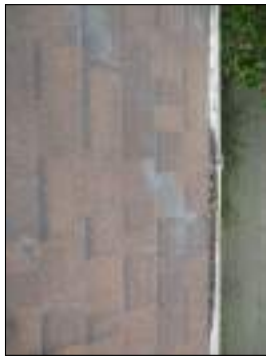
Missing/damaged shingles/tiles in areas - needs to be serviced

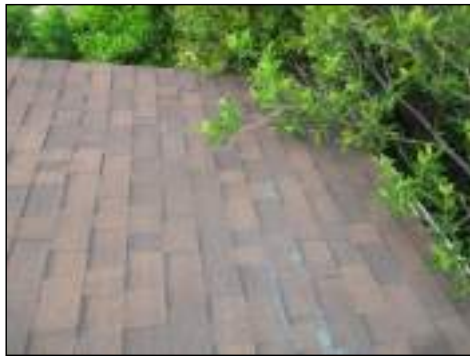
Tree branches rub roof - needs to be cut back

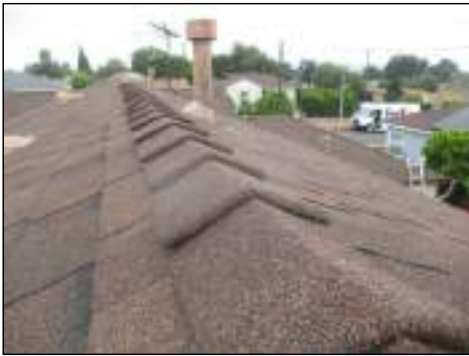
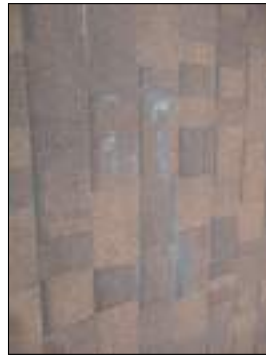
Missing/damaged shingles/tiles in areas - needs to be serviced

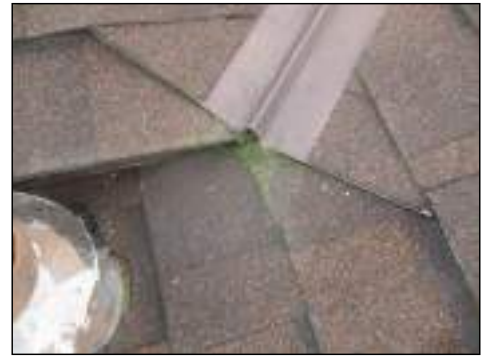
Moss growth present in areas - sign of moisture accumulation and lack of sunlight for drying - recommend servicing as part of seasonal maintenance

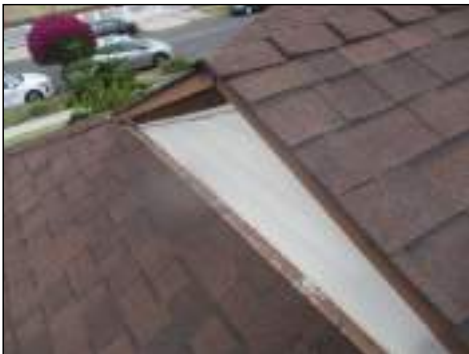
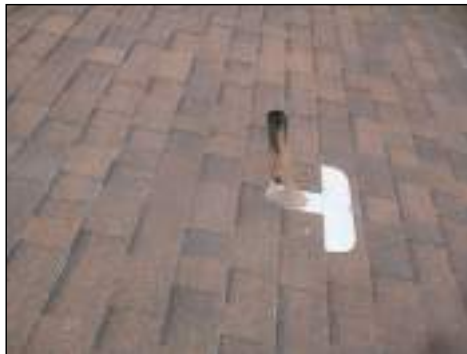
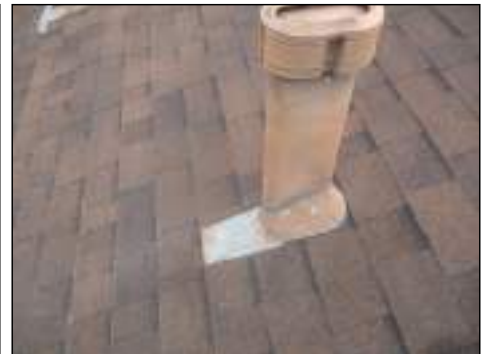
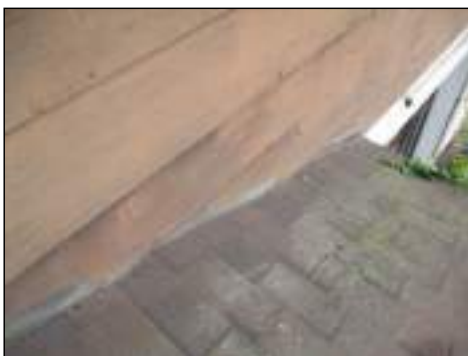
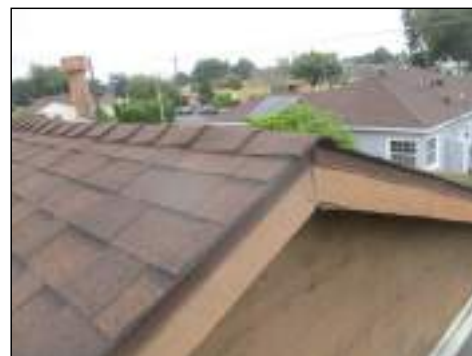
3. Gutters and Down Spouts

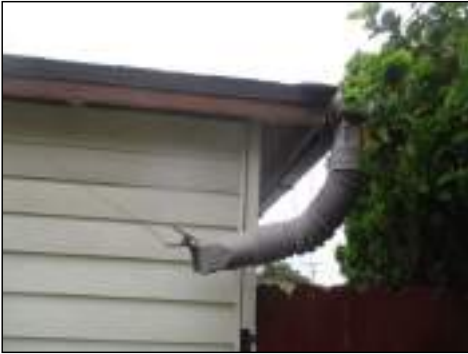
Missing gutter/downspout section(s) - needs to be serviced

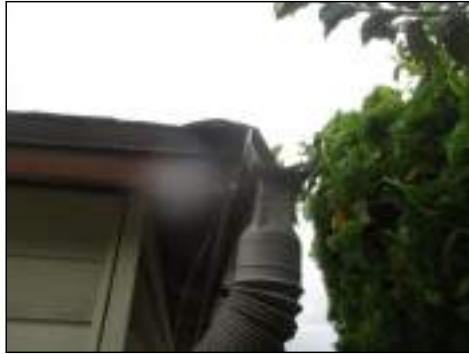
Missing gutter/downspout section(s) - needs to be serviced

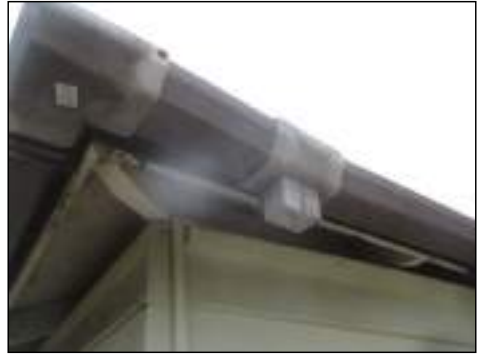
Missing gutter/downspout section(s) - needs to be serviced

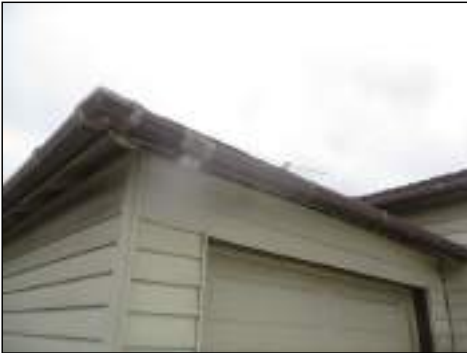
Plastic gutters present - subject to sun damage - recommend cleaning and routine maintenance on gutter system to maintain life expectancy

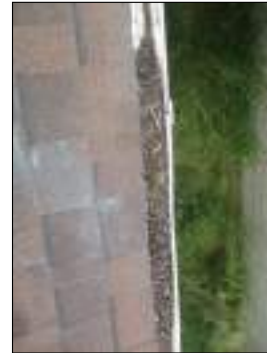
Clogged/restricted by debris in areas - recommend servicing

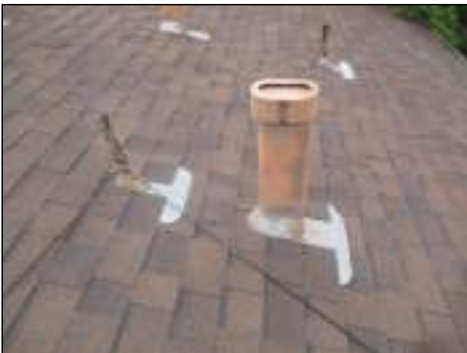
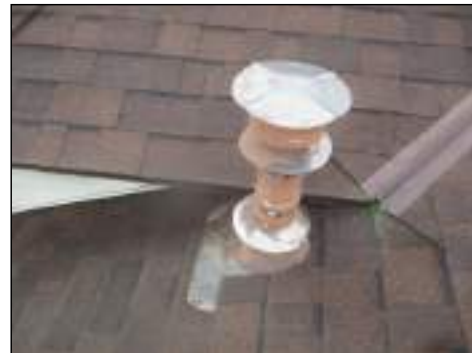
- Normal at time of inspection - no major visible defects - recommend seasonal maintenance to ensure that caps do not become loose or develop other defects
