# Building Inspection Report

**1212 Granvia Altamira, Palos Verdes Estates, CA**

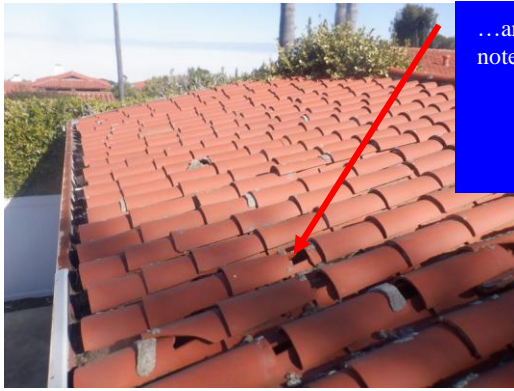
...and tile damage was noted...

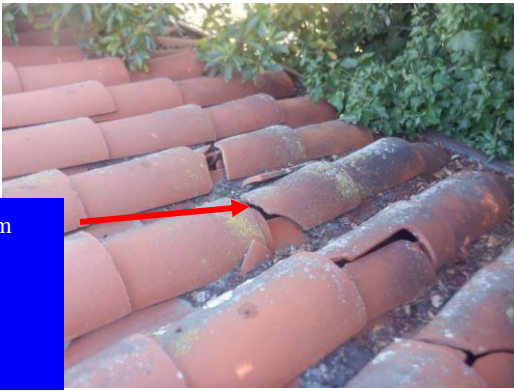
...throughout the system

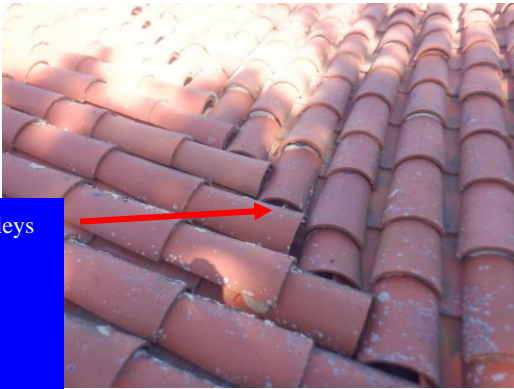
...features 'woven' valleys that obstruct damage...

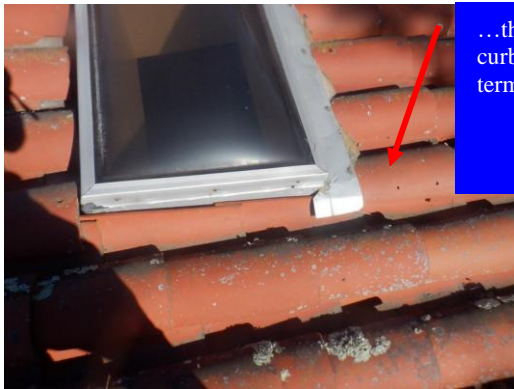
...the skylight's sloped side curb flashing pans terminate below tiles...

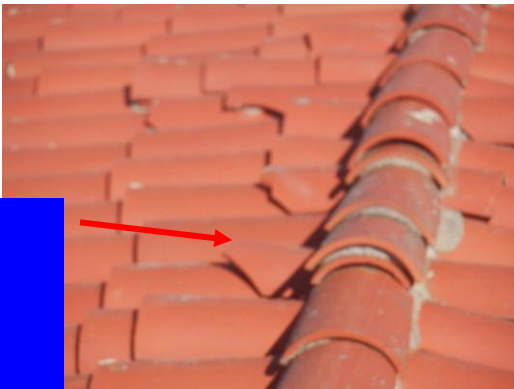
...and many tiles are damaged, displaced...

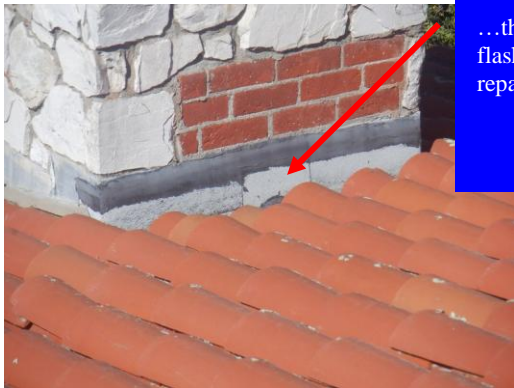
...the living room chimney flashing shows crude repairs...

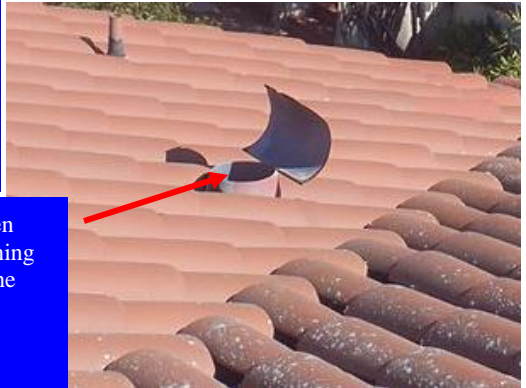
...damage to the kitchen exhaust hood roof flashing allows water entry to the building...

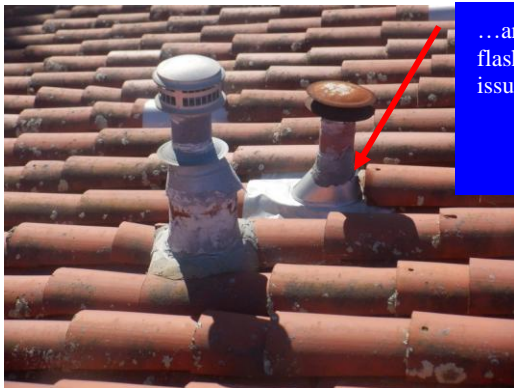
...and some replaced flashings indicate past issues

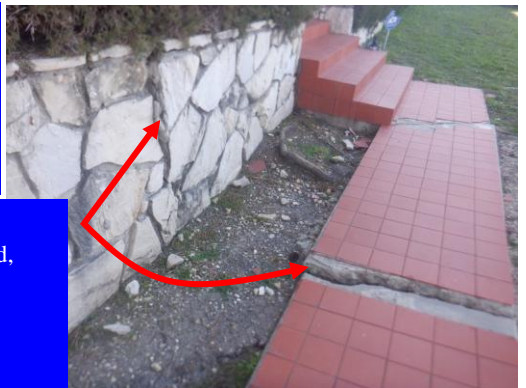
The front planter and walkways have buckled, off-set...

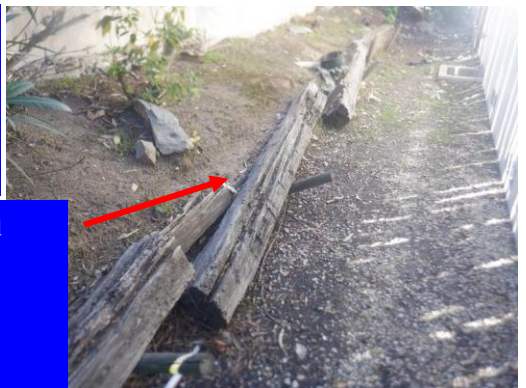
...below which a wood planter has failed

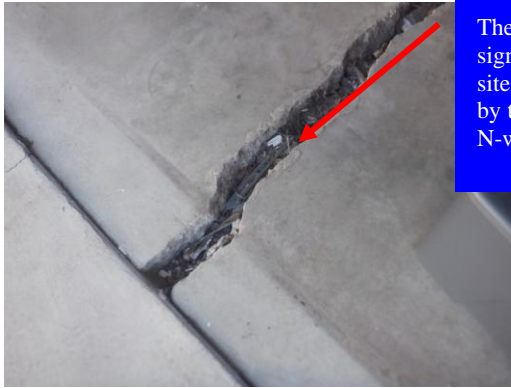
The garage shows significant offsets due to site conditions as illustrated by the floor cracks, tipped N-wall, etc.

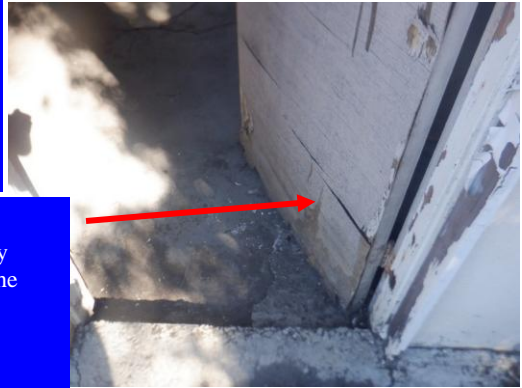
The wood elements throughout the property show neglect such as the garage service door...

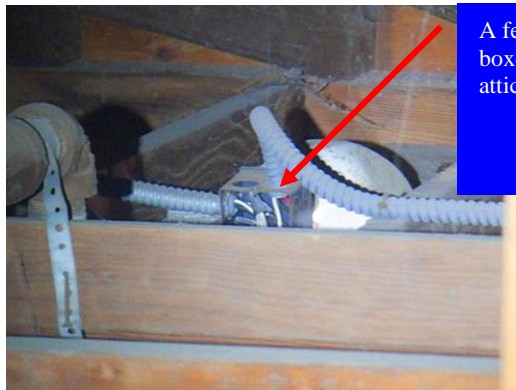
A few open electrical boxes were noted at the attic...

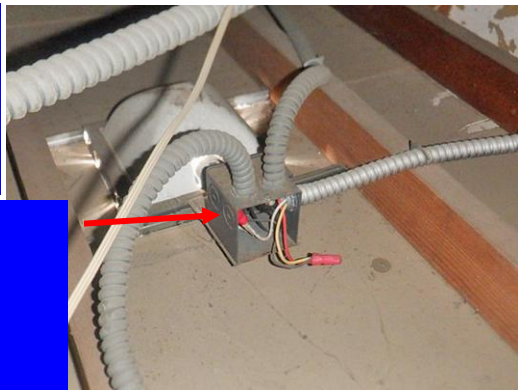
...that present fire hazards...

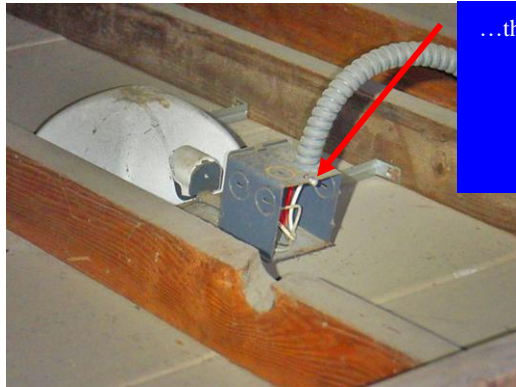
...that must be capped

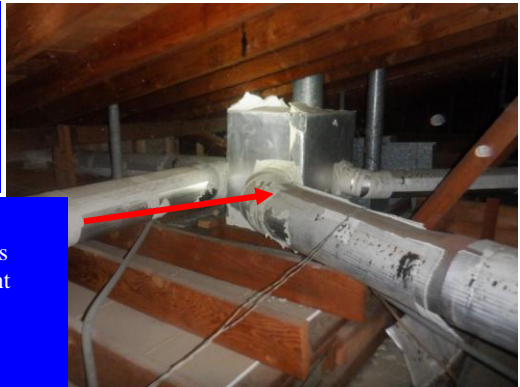
The forced air heating system attic ducting has damaged and inefficient insulation containing asbestos

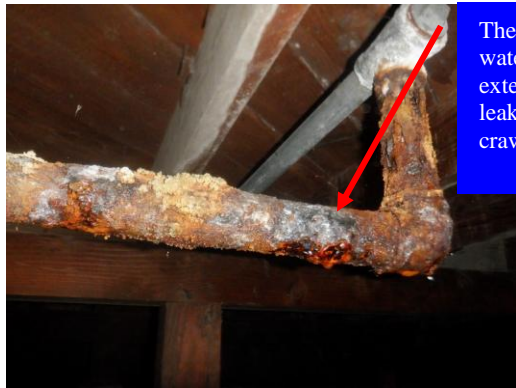
The original galvanized water supply piping shows extensive corrosion and leaks at the living room crawl space...

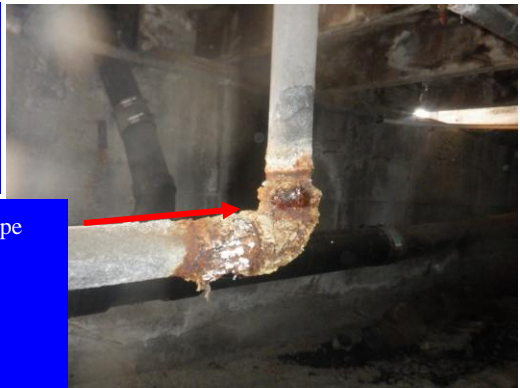
...and at many other pipe sections...

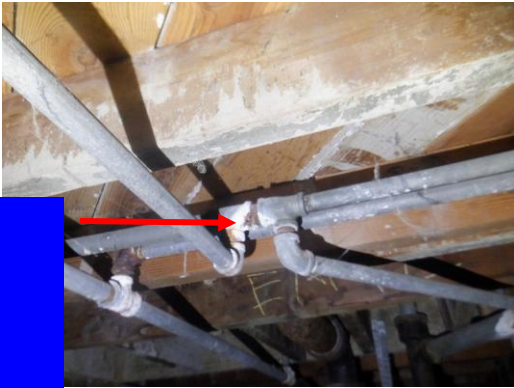
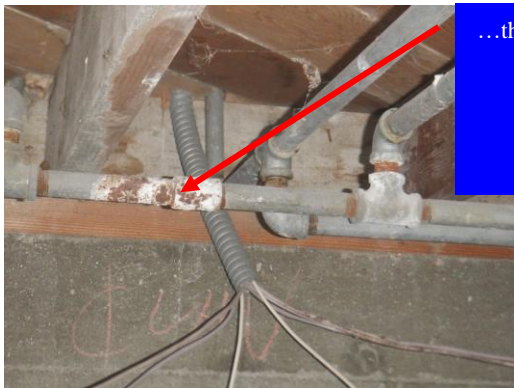
...that requires replacement

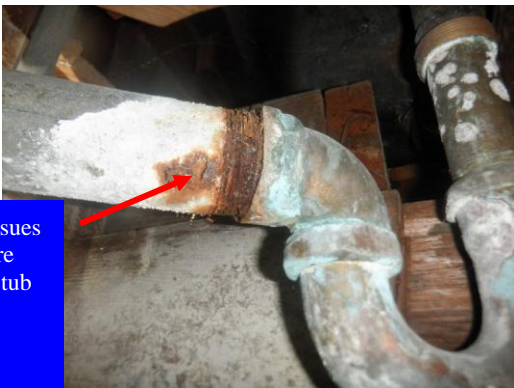
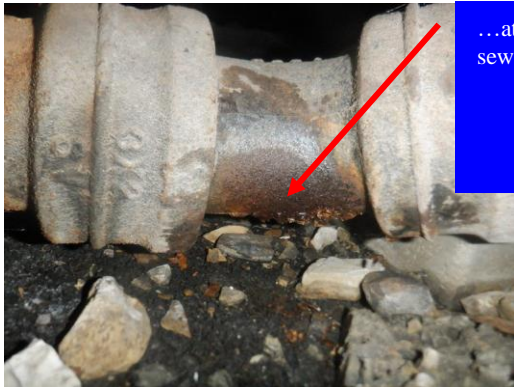
...at that bathroom's main sewer drain...

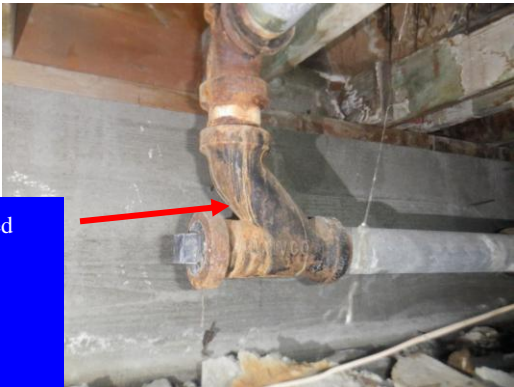
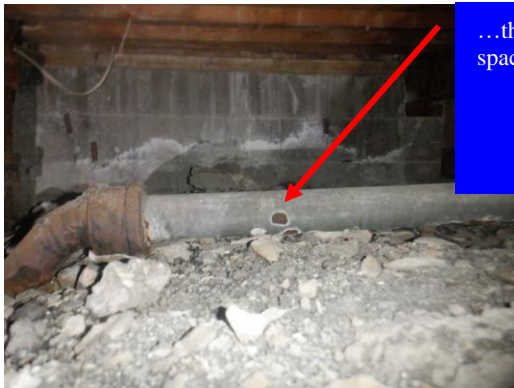
...throughout the crawl space...

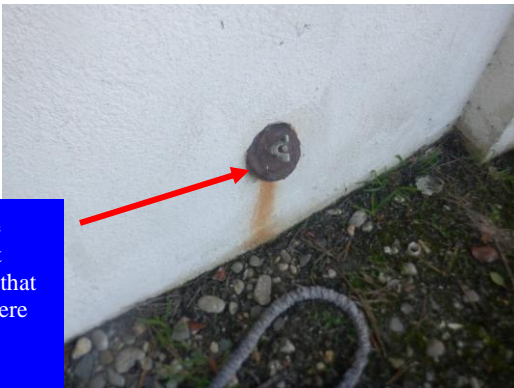
... where back-ups have occurred given stains at exterior clean-outs and that additional clean-outs were added

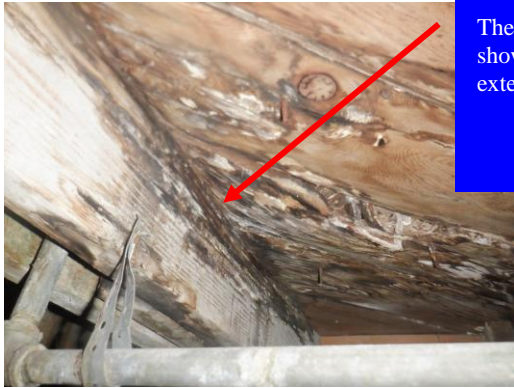
The Jack & Jill bath shower pan framing shows extensive damage...

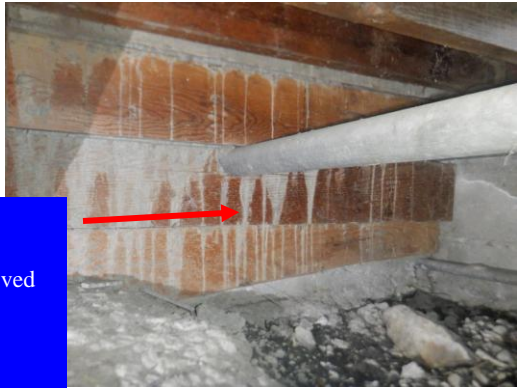
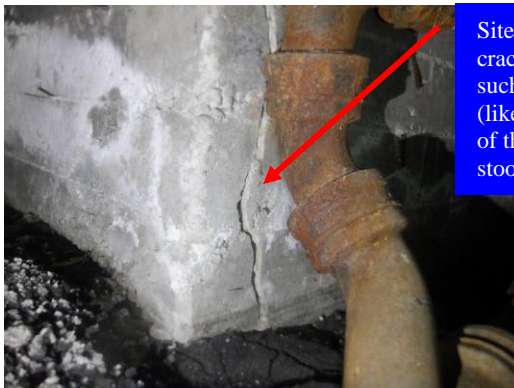
Site conditions have cracked the foundation such as at the hall bath (likely related to movement of the abutting large entry stoop)...

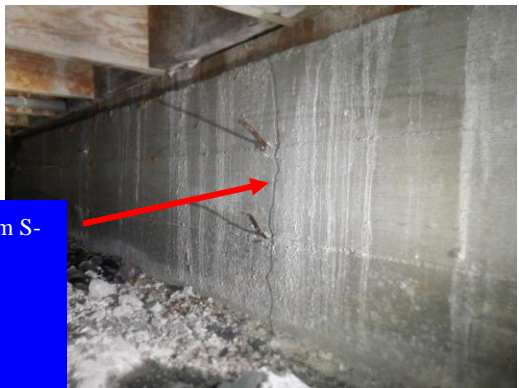
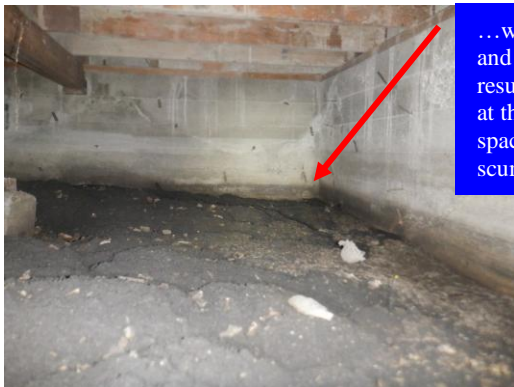
...where the expansive soil and site drainage has resulted in captured water at the living room crawl space as indicated by the scum line...

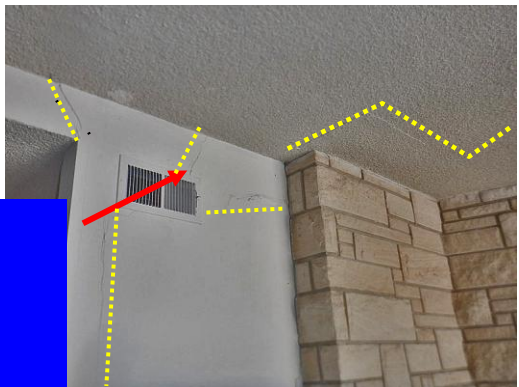
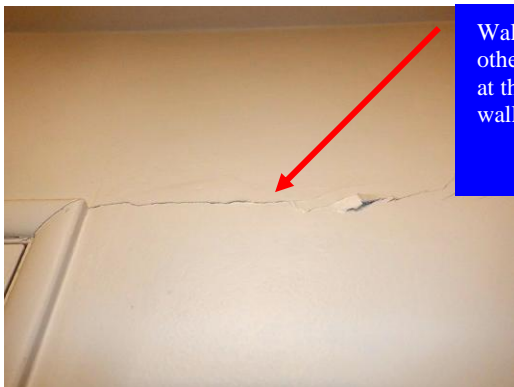
Wall cracks were noted at other areas as well such as at the Jack & Jill bath S-wall

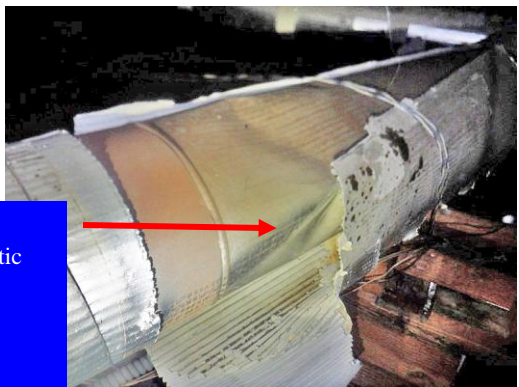
The forced air heating system has damaged attic ducting insulation...

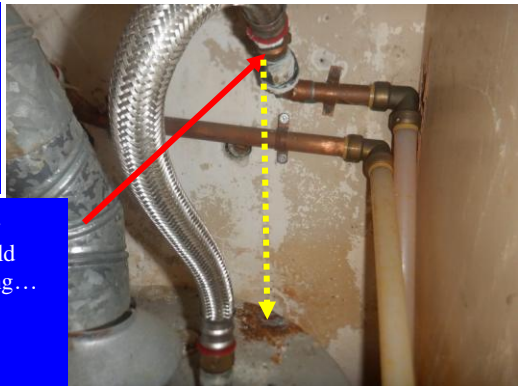
The laundry area water heater has a leaking cold water supply pipe fitting...

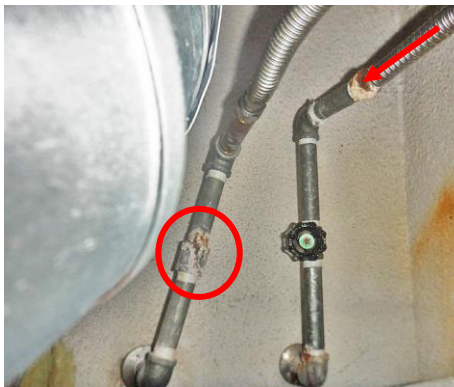
...as does the hallway water heater

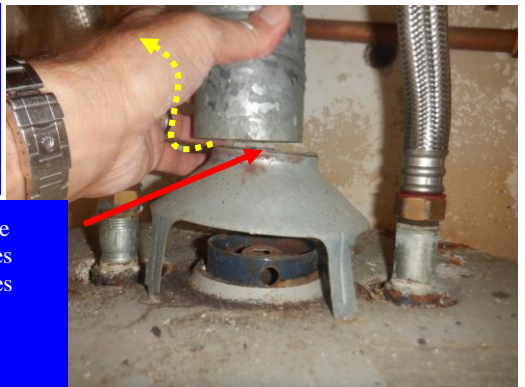
Both water heaters have loose exhaust vent pipes where combustion gases can escape

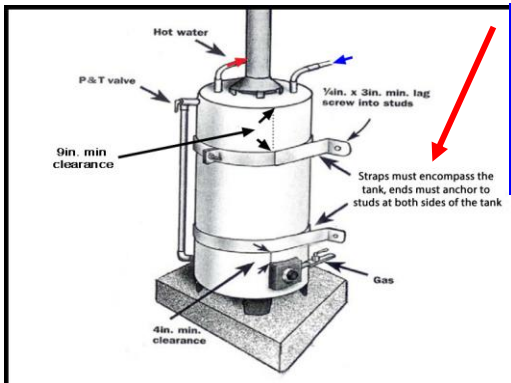
As well, both water heaters lack proper seismic strapping

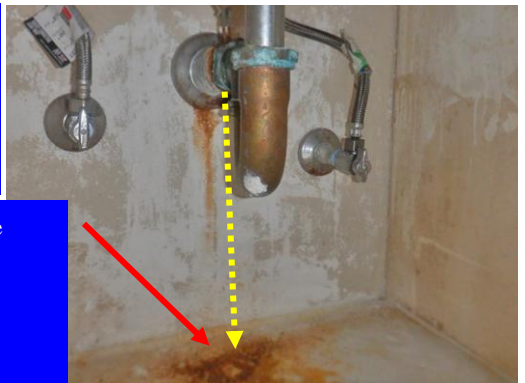
Many of the sinks have active drain leaks...

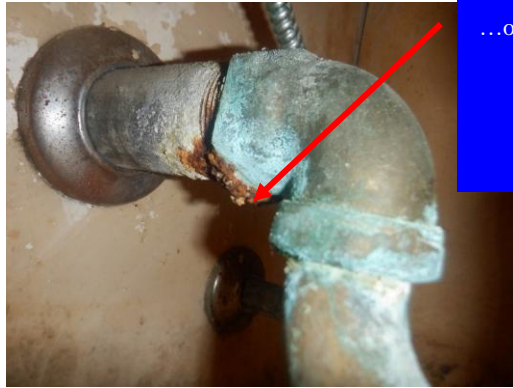
...or intermittent leaks...

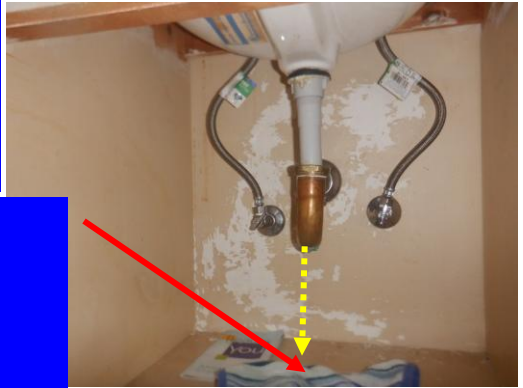
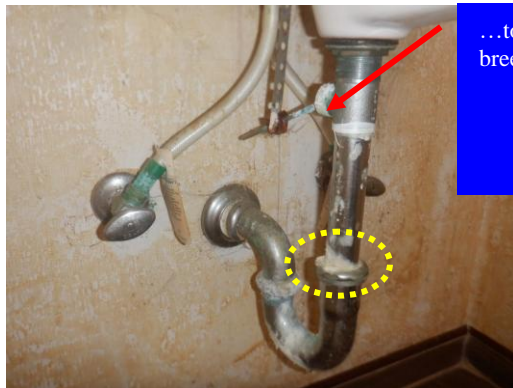
...to prevent damage and breeding of organics

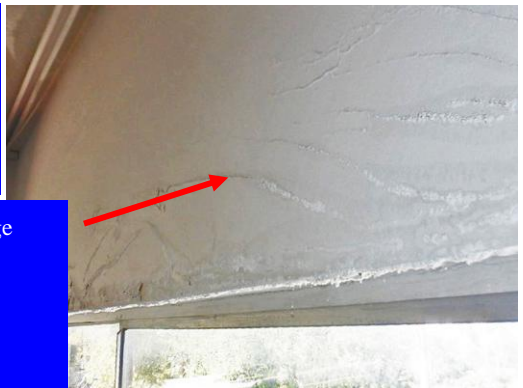
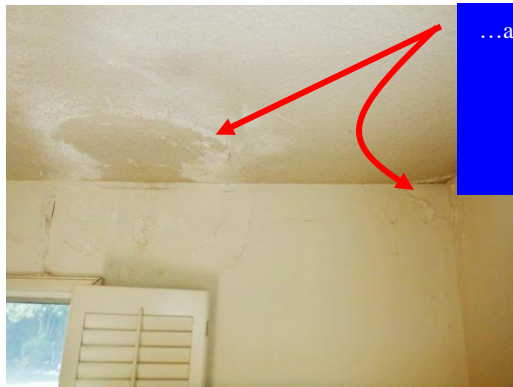
...and S-bedroom ceiling

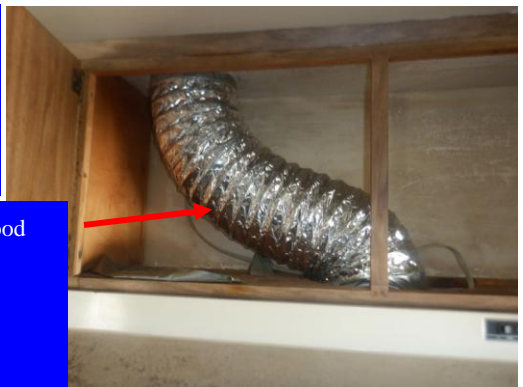
## Party Limitations & Duties
