Report # W8010

# WOOD DESTROYING PESTS AND ORGANISMS INSPECTION REPORT

| Building Address:<br><b>9316 Telkaif Street, Lakeside, CA 92040</b> | | Date of Inspection<br><b>09/04/2026</b> | Number of Pages<br><b>5</b> |

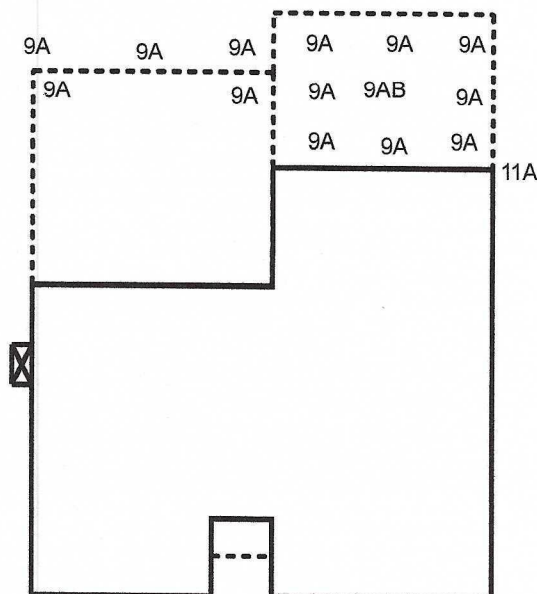
FINDINGS: Dry-rot wood members found at time of inspection at attached patio cover framing joists/shade strips/blocking/post/post trim/cap as indicated on the diagram.

FINDINGS: Dry-rot wood members found at time of inspection at attached patio cover framing as indicated on the diagram.

FINDINGS: Dry-rot wood members found at time of inspection at fascia as indicated on the diagram.

RECOMMENDATION: Replace dry-rot damaged wood members as necessary. Painting is included in this estimate.

RECOMMENDATION: Remove and haul away attached patio cover with shade screen only. Cost includes dump fees and patching and painting stucco holes left by ledger. This option is in lieu of repairing (item 3A).
