Kevin Kelpin 7177 Sunny Place Yucca Valley, CA 92284

**Client Information:** Andrew Alder-Larue (2/7/2024) 76 Calle Manzanita Rancho Mirage, CA 92270

## Pool Area

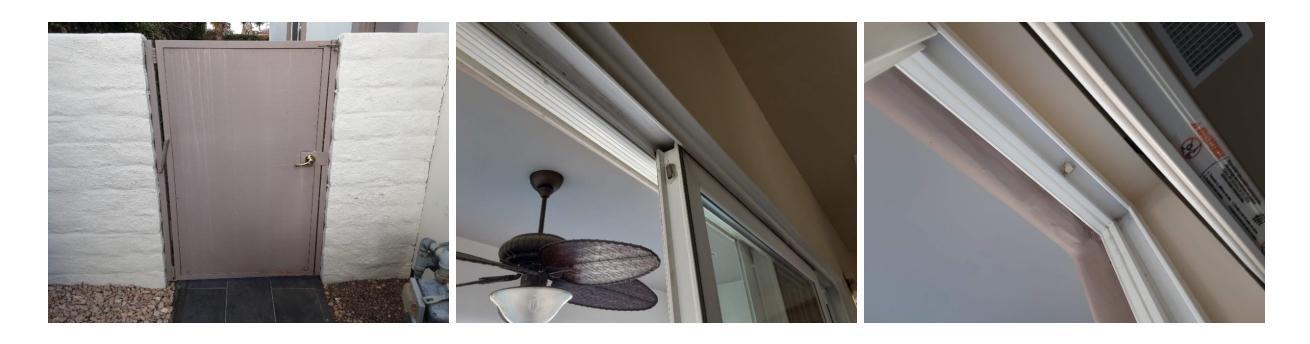
The side gate providing direct access to the pool area from the street was properly self-closing and selflatching. It was noted that alarms were present on all doors and windows leading to the pool area from the home. Because there is no fence or pool cover, recommend activating alarm system on every door and window of the home that leads to the pool area when children are present. It is recommended that the alarms last for 30 seconds or more and must trigger within 7 seconds of the door/window opening for child safety.

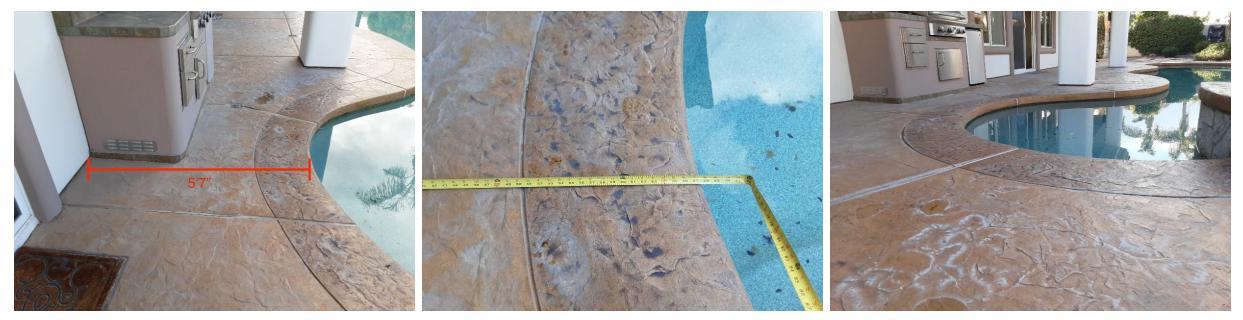
The pool was installed less than 10 feet from the house (5'7") and the grill area allows less than 4 feet to the pools edge (safety hazard). National building codes, as outlined by the National Fire Protection Association (NFPA), require an outdoor inground pool to be at least 10 feet away from the walls of a house. There was excessive hard water buildup throughout the pool deck.Recommend contacting a licensed pool contractor for further evaluation.

Less Than 10 feet

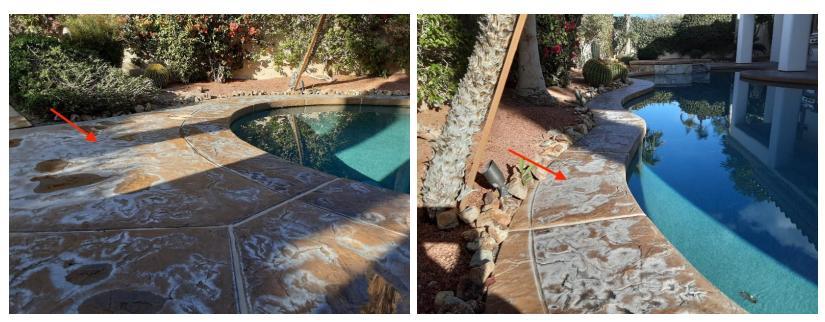
Hard Water Buildup

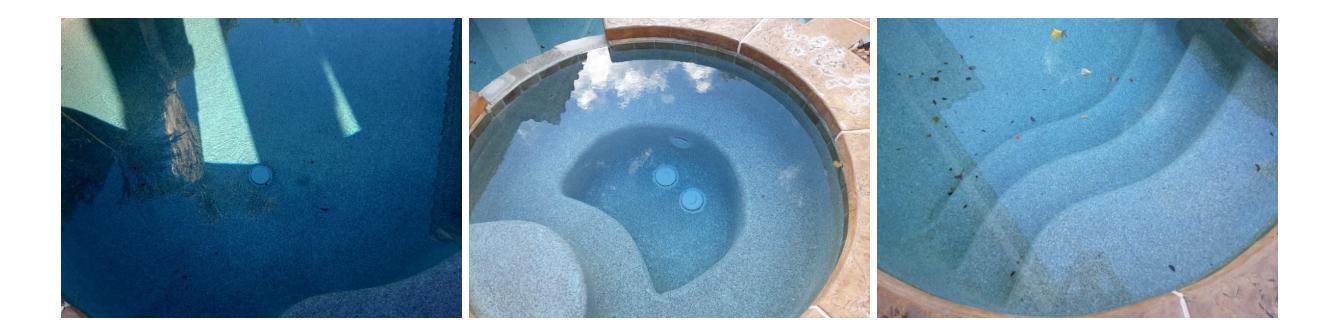
The main basin drains of the pool and spa had anti-vortex covers installed (satisfactory). No visible defects noted for pool shell.

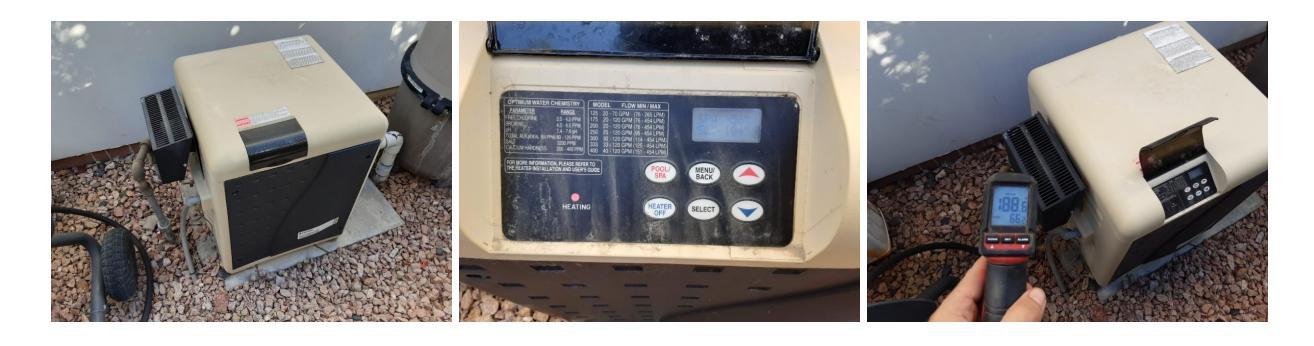
The gas furnace pool heater was manufactured in 2022. The unit was operational at time of inspection. Bonding wire was not installed on the unit. Note: All electrical pool equipment must be attached to the bonding grid for safety. Recommend licensed pool contractor repair.

No Bonding Wire

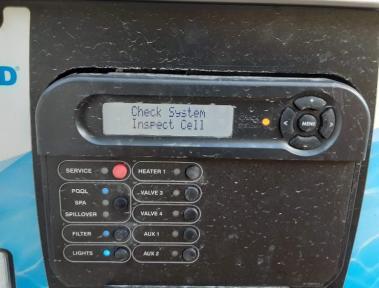
Check System - Inspect Cell

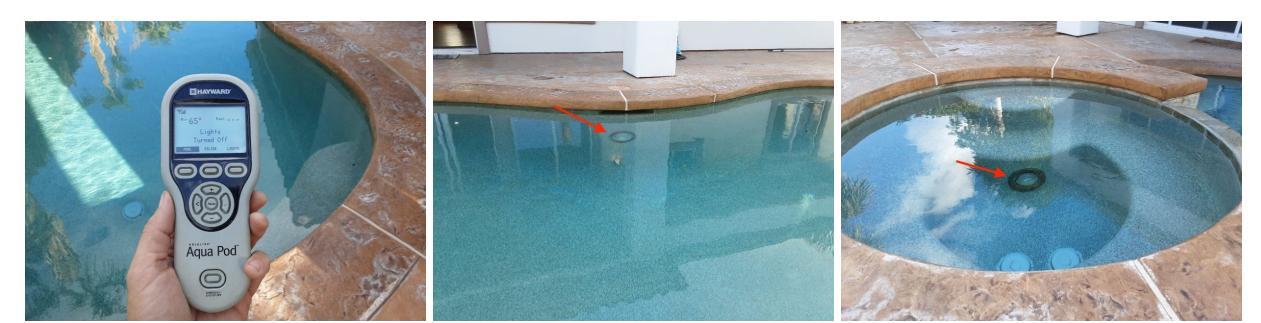
All systems were tested from the control panel and returned back to there original settings (Auto Mode) after testing. The exact age of the filter pump could not be determined from the data tag. The unit was tested and operational. Bonding wire was installed on the unit. No defects noted at cartridge filter. There was a "Check System - Inspect Cell" error code at the control panel. The Pool/Spa lights were non-operational at time of inspection. The spa jets were operational.

Non-Operational - Pool Light

Non-Operational - Spa Light

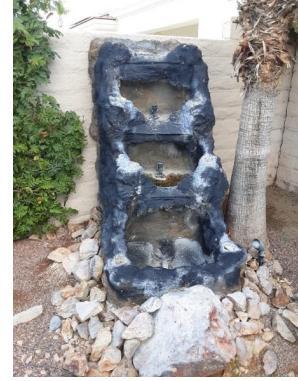
The water feature (fountain) at the Northwest corner could not be fully inspected due to no water in the basin at time of inspection.

Additional Water Feature - Not Tested

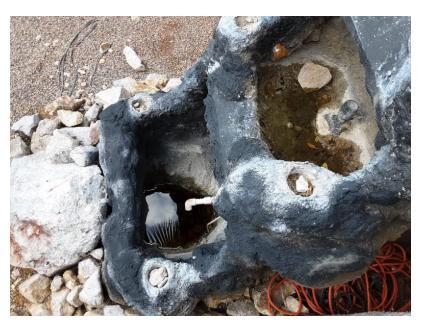
Additional Water Feature - Not Tested -No Water
