INSPECTION PROFESSIONALS

4842 Rockbluff Dr, Rolling Hills Estates, CA 90274
Inspection prepared for: Mike Eardley
Real Estate Agent: Cameron Stearns -

Date of Inspection: 8/17/2020 Time: 10:00 AM
Age of Home: 1957 (63 Years Old) Size: 1,865 Sq. Ft.
Weather: Cloudy, Warm, Dry
Order ID: 215396

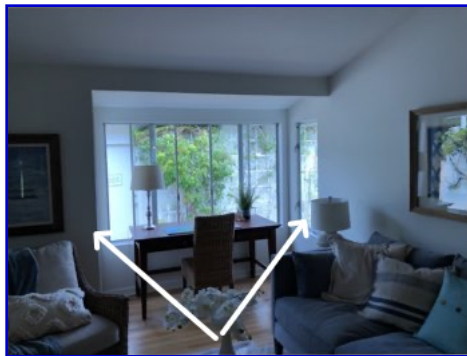
- Accessible windows were tested and operated at time of inspection
- Recommend general window maintenance/lubrication and weather tight service
- Windows/glass below 18" and window glass in any doors should be tempered
- Tempered glass label observed
- **Missing crank handle or stripped crank - window not tested - needs to be serviced**

Missing crank

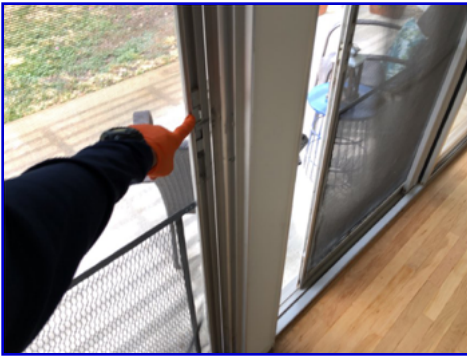
- Operated at time of inspection
- Worn screens with loose/worn hardware/frame/rollers/tracks - typical for age
- Did not latch/lock properly - needs to be serviced
- Torn heavily - needs to be serviced

Not latching

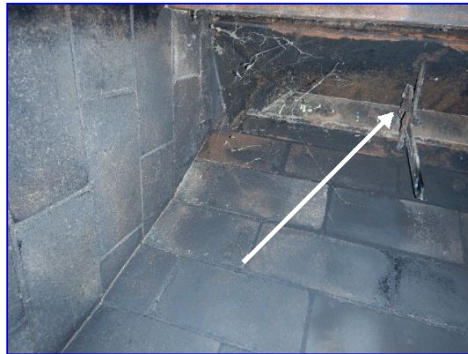
No damper clamp

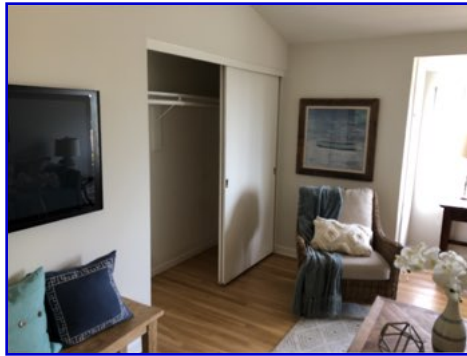
- Worn closets with loose/worn hardware - typical for age
- Bypass door guides missing at base - needs to be serviced

Missing base guides

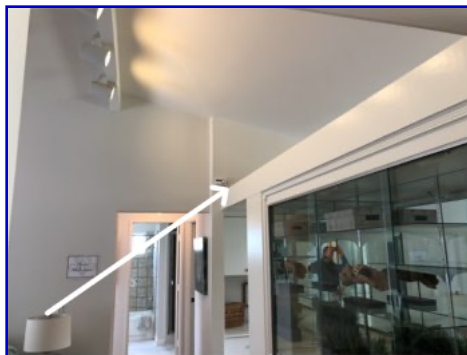
- Carbon monoxide detectors are tested via the accessible test button only, they are not tested/measured/evaluated per manufacturer specifications for installation height or suggested locations.
- For safety purposes, we recommend that carbon monoxide detectors be placed in all hallways outside of sleeping areas (bedrooms) and on all levels of multi-level dwellings. For longer hallways and/or oddly located bedrooms, multiple carbon monoxide detectors are suggested and should be placed at each end of the hallway to ensure optimum safety alert.
- Operational at time of inspection via factory installed test button
- Not in proper position/location - recommend placing closer to floor - needs to be serviced

Too high

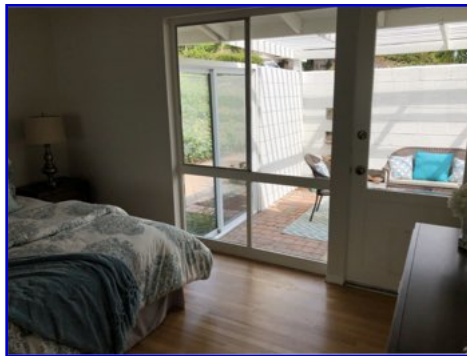
- Accessible windows were tested and operated at time of inspection
- Recommend general window maintenance/lubrication and weather tight service
- Windows/glass below 18" and window glass in any doors should be tempered
- **Did not operate - needs to be serviced - MASTER BEDROOM**
- **Not tempered glass - unsafe - needs to be serviced**

Not tempered glass; Not operating

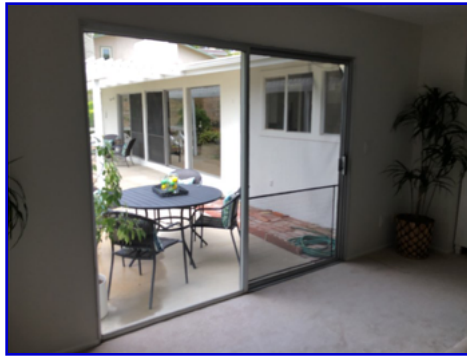
- Recommend service/lubrication and general maintenance to extend the life of the slider
- Single pane
- Slider operated at the time of the inspection
- Worn door with loose/worn hardware/frames/rollers/tracks - typical for age
- **Not tempered glass- unsafe - needs to be serviced**

Not tempered glass

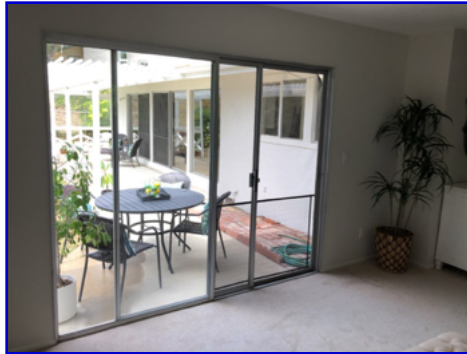
- Worn screens with loose/worn hardware/frame/rollers/tracks - typical for age
- Did not latch/lock properly - needs to be serviced
- Difficult to slide/operate - needs to be serviced

Not latching; Difficult to operate

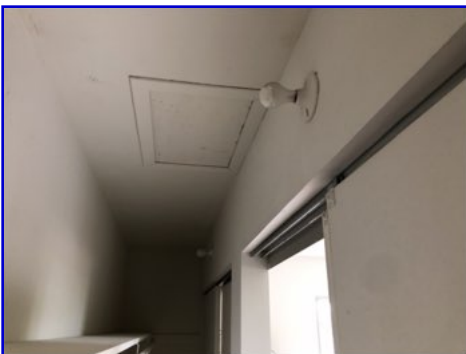
Bulbs

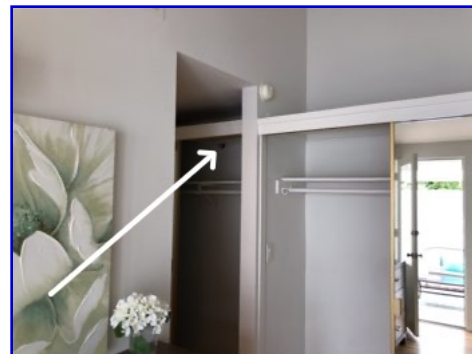
J-box missing cover

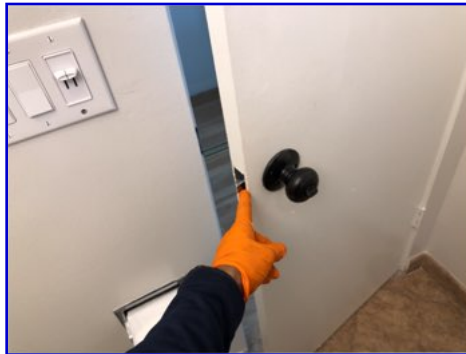
- Operated at time of inspection
- Did not latch properly - needs to be serviced - MASTER BATHROOM

Not latching

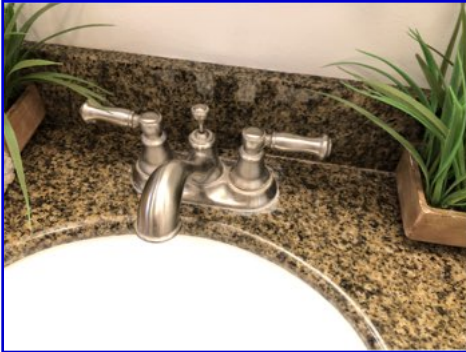
Corrosion

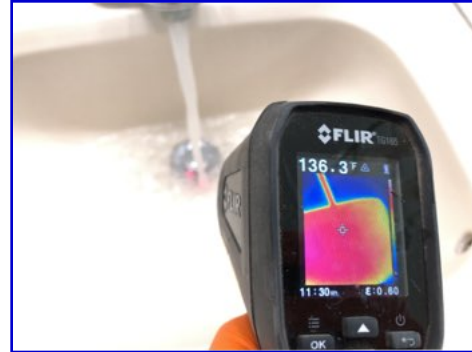
Too hot

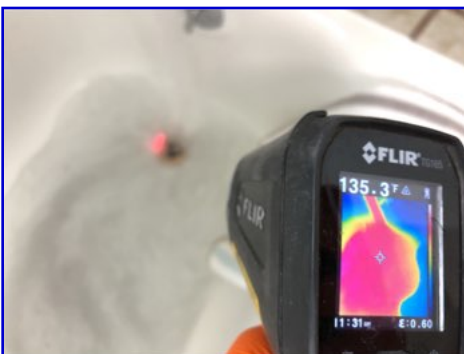
- Drain stopper operated at the time of the inspection
- Hot water above 120 degrees - recommend adjusting the temperature at the water heater or upgrading fixture to anti-scald device

Too hot

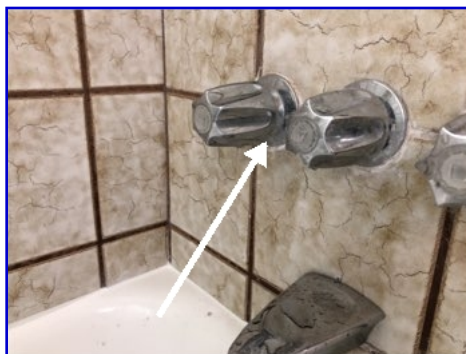
Leaks

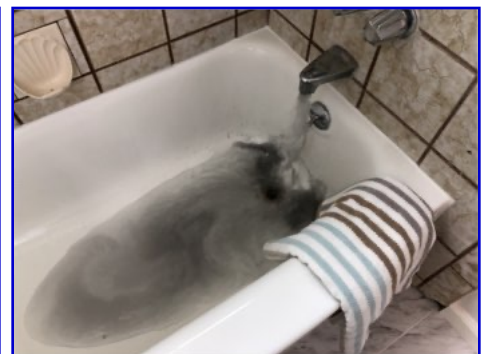
Discolored water

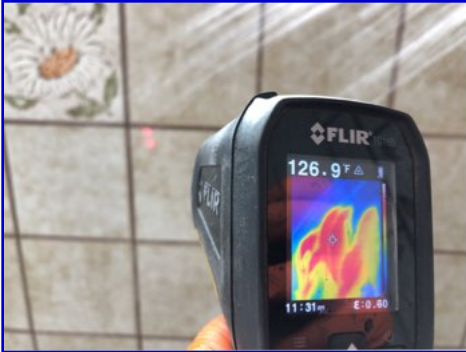
Too hot

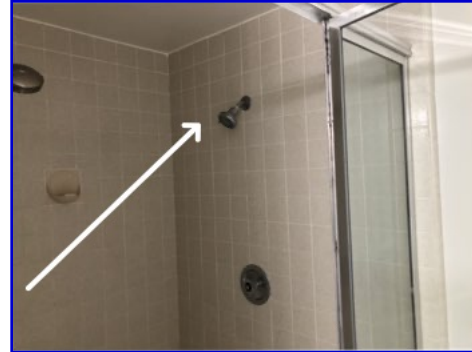
- Based on the inspection industry's definition of a recommended water test for "functional drainage" in a plumbing system, the plumbing drainpipes appear operational at this time. However, only a video scan of the interior of drainpipes and drain lines can fully confirm their actual condition. When the house is vacant, the plumbing system is older, there are prior known problems, or there are large trees on the grounds, it would be prudent to have the drain lines "video scanned" prior to closing.
- Fixture was tested and operating at time of inspection via normal fixture controls
- Hot water above 120 degrees - recommend adjusting the temperature at the water heater or upgrading fixture to anti-scald device
- **Did not operate - needs to be serviced - HALL BATHROOM**

Not operating

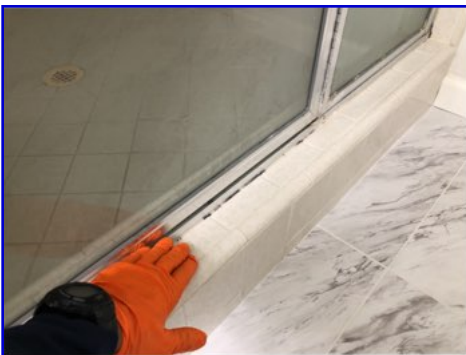
Non porous microbial growth

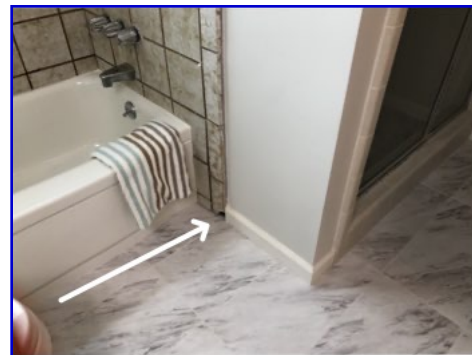
- **Large cracks - needs to be serviced - HALL BATHROOM**

Large crack

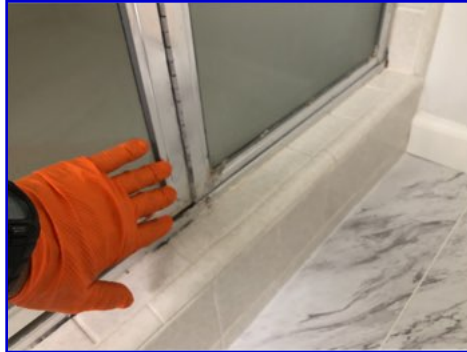
- Operational at time of inspection
- Tempered glass label observed
- Corrosion present in areas - signs of wear and moisture accumulation

Corrosion

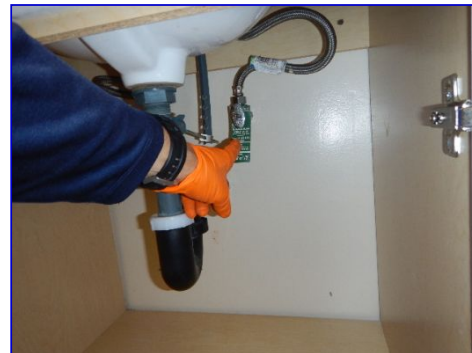
Shutoff corroded

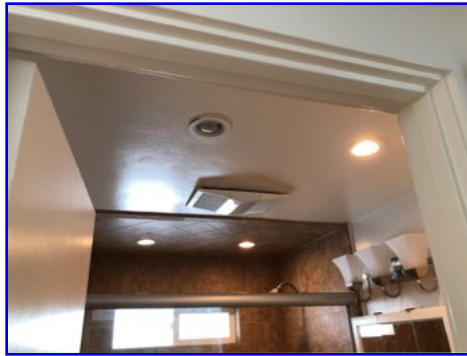
- A representative number of receptacles and switches were tested and found to be operational at time of inspection
 - Some bulbs defective/missing/light(s) did not function - check bulbs/consult electrician to further evaluate
- MASTER BATHROOM

Bulbs

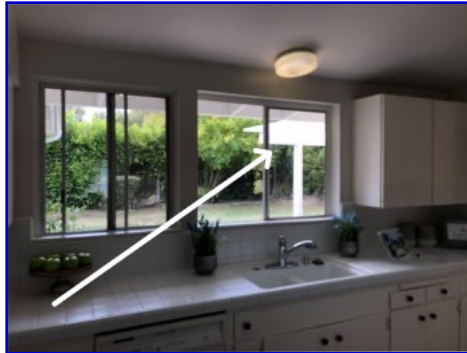
- Accessible windows were tested and operated at time of inspection
- Recommend general window maintenance/lubrication and weather tight service
- **Did not operate - needs to be serviced**

Not operating

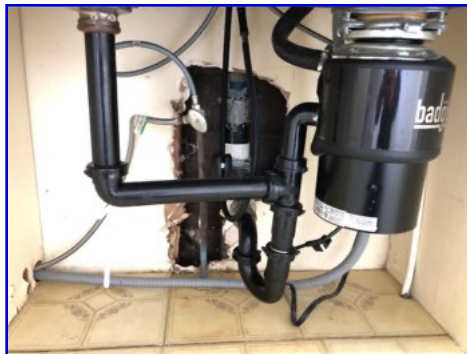
- Worn cabinets with loose/worn hardware - typical for age
- **Large cracks or holes - needs to be serviced**

Large holes

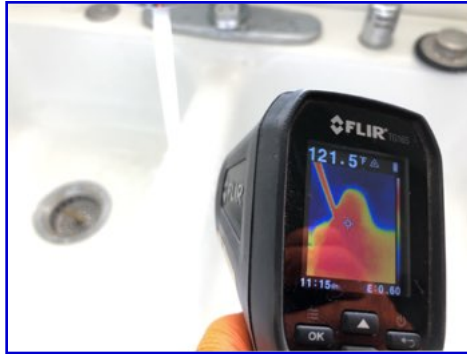
- Based on the inspection industry's definition of a recommended water test for "functional drainage" in a plumbing system, the plumbing drainpipes appear operational at this time. However, only a video scan of the interior of drainpipes and drain lines can fully confirm their actual condition. When the house is vacant, the plumbing system is older, there are prior known problems, or there are large trees on the grounds, it would be prudent to have the drain lines "video scanned" prior to closing.
- Fixture operated at the time of the inspection
- Hot water above 120 degrees - recommend adjusting the temperature at the water heater

Too hot

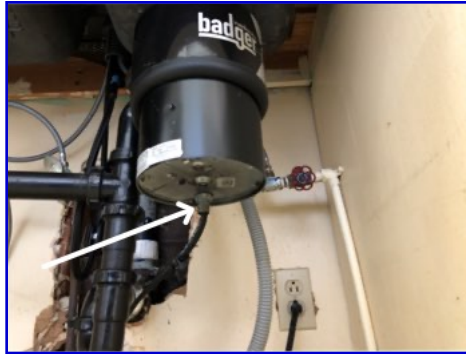
- The garbage disposal has a limited inspection, the Inspector cannot predict the remaining life of the garbage disposal nor determine how well the garbage disposal disposes of food or other items. The sharpness or adequacies of the internal blades is not determined during the home inspection.
- Tested and operational at time of inspection via normal controls
- No visible leaks at the time of the inspection
- Unit unusually noisy - may require replacement at any time
- **Missing proper wire grommet at wire connection to unit - needs to be serviced**

Noisy; Missing wire grommet

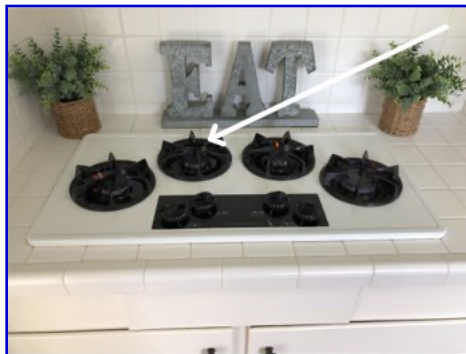
- The range or cooktop has a limited inspection. The inspector cannot predict the remaining life of the unit nor determine the BTUs output by each burner or if/how well the burners will cook food. For gas units - gas leaks cannot be detected with this inspection - a full evaluation by the Gas Company of all gas supplied appliances is recommended beyond this inspection.
- Gas supplied unit
- Not operating properly - needs to be serviced
- **Left rear element/burner not operating - needs to be serviced**

Not operating

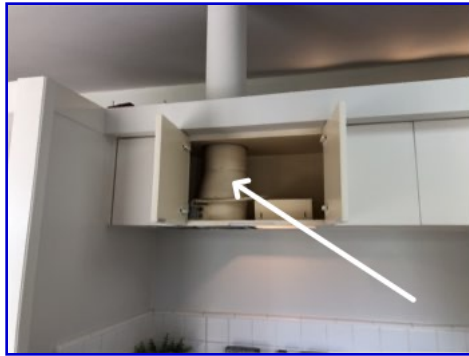
- The exhaust fan/vent is tested using the normal controls only. No smoke testing or other testing is done to determine the CFMs or how well the unit evacuates air. The home inspector cannot predict the remaining life left in the unit.
- **Does not operate - needs to be serviced**

Not operating

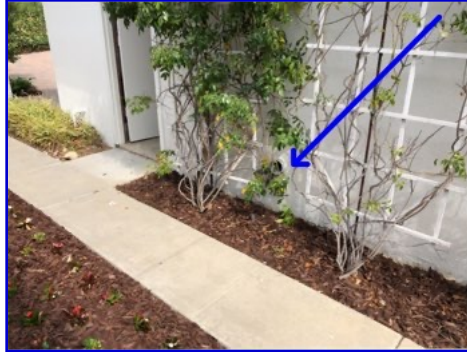
- Dryer vent should be cleaned periodically to prevent lint fire hazards
- **Missing the exterior cover - needs to be installed**

Missing exterior cover

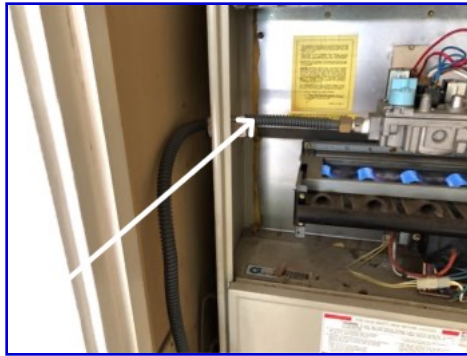
- Normal wear at time of inspection
- No sediment trap at gas supply - may have not been required at time of original installation, but is recommended
- Flexible connector through sheet metal cabinet - needs to be serviced

Flex through sheet metal

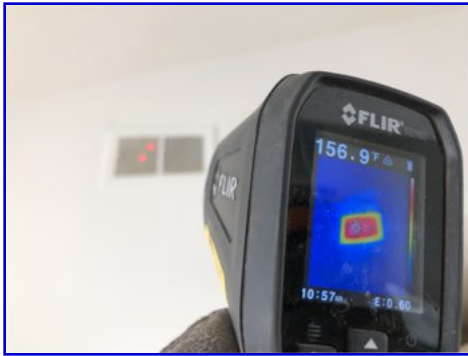
- Representative number tested and functional day of the inspection
- Air flow weak at some registers or significant temperature differences were observed when operating the HVAC system - recommend further evaluation by a licensed HVAC technician

Thermal Image View

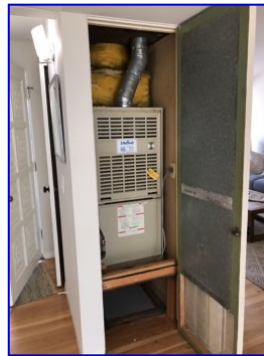
- Note: Good **combustion air** is an unconfined space that is one whose volume is not less than 50 cubic feet per 1,000 Btu/hr of the total input rating of all appliances installed in the space.
- Combustion air appears to be adequate at the time of the inspection
- Dust at door jamb/stop/frame indicates inadequate combustion air - needs to be serviced
- **Door to enclosure does not seal, allowing for an improper mixture of air used for burning fuel (combustion air) and air used for breathing (conditioned air) - recommend adding weatherstripping to perimeter of opening - needs to be serviced**

Dust; Not sealing

Page 28 Item: 9	Combustion Air	• Door to enclosure does not seal, allowing for an improper mixture of air used for burning fuel (combustion air) and air used for breathing (conditioned air) - recommend adding weatherstripping to perimeter of opening - needs to be serviced

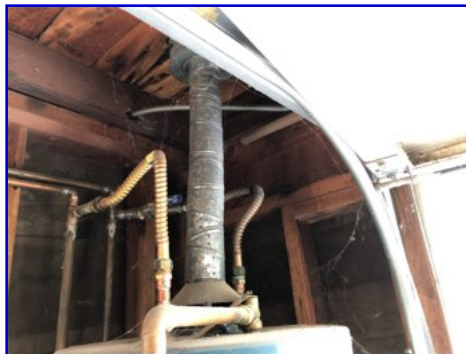
- Recommend sealing all connections at venting with foil/heat resistant tape and screws at all joints - needs to be serviced
- Vent is worn and older - consider upgrading vent
- Missing screws at vent connections - three screws are recommended at all vent connections - needs to be serviced

Missing screws

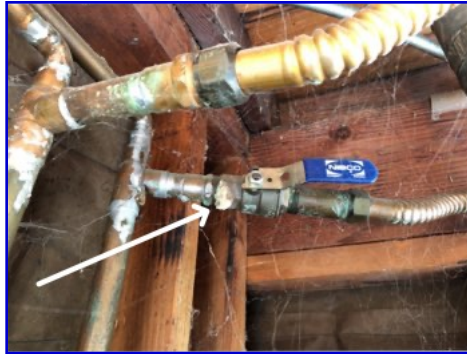
- Worn valve/piping/connections - typical for age - no visible leaks found at the time of the inspection
- Water distribution pipes not insulated - recommend upgrade
- **Shutoff valve is corroded - needs to be serviced**

Shutoff corroded

Page 30 Item: 3	Plumbing	• Shutoff valve is corroded - needs to be serviced
-----------------	----------	--

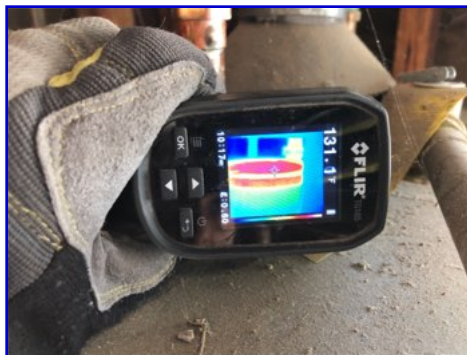
- Temperature was above 120 F at the unit - this a potential scald hazard - needs to be serviced/adjusted
- Temperature was above 120 F at one or more fixtures within the structure - this a potential scald hazard - needs to be serviced/adjusted

Too hot

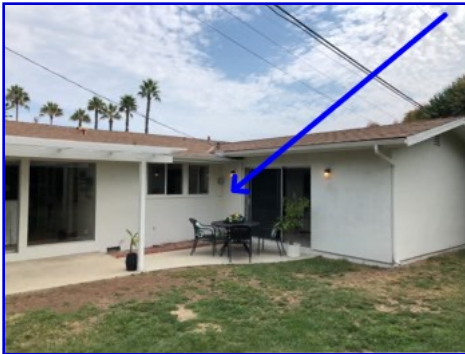
MAIN ELECTRICAL PANEL

- Worn/weathered panel - typical for age and weather exposure
- Worn/older panel - consider upgrading services
- Recommend upgrading services due to age of electrical system
- **Manufacture of panel a brand (Zinsco) known for frequent issues - recommend further evaluation by a licensed electrician**

Page 32 Item: 1	Main Panel	• Manufacture of panel a brand (Zinsco) known for frequent issues - recommend further evaluation by a licensed electrician
-----------------	------------	--

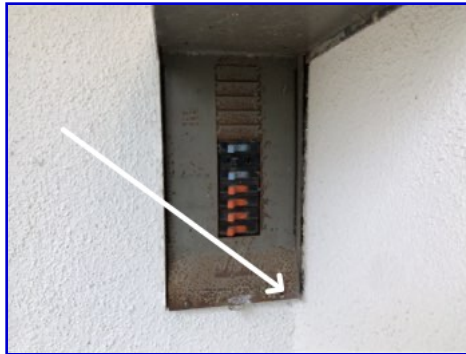
Not labeled; Missing screw;
Zinsco

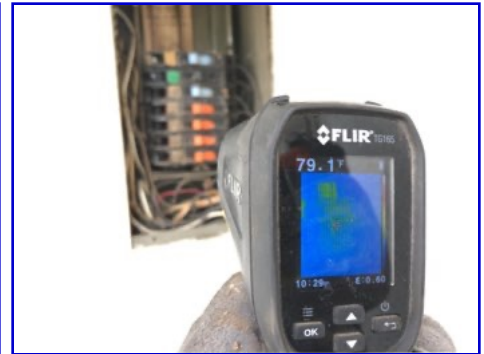
Thermal Image View - Normal
temperature readings with no
visible signs of overheating at time
of inspection

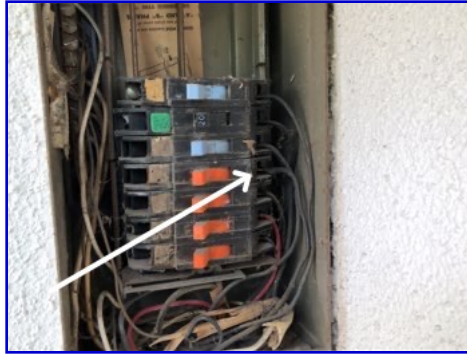
- No visible labeling for breakers on panel cover - needs to be serviced
- Loose/worn breakers - typical for age
- Loose breakers present - needs to be serviced
- Worn/old breakers - may require replacement at any time
- Breakers or panel may require upgrade soon due to age
- **Burned, scorched, or melted wiring/breakers observed - recommend further evaluation by a licensed electrician**
- **Manufacture of breakers/panel is a brand (Zinsco) known for frequent issues - recommend further evaluation by a licensed electrician**

Zinsco breakers; Melted wire

Page 32 Item: 3	Breakers	• Burned, scorched, or melted wiring/breakers observed - recommend further evaluation by a licensed electrician • Manufacture of breakers/panel is a brand (Zinsco) known for frequent issues - recommend further evaluation by a licensed electrician
-----------------	----------	---

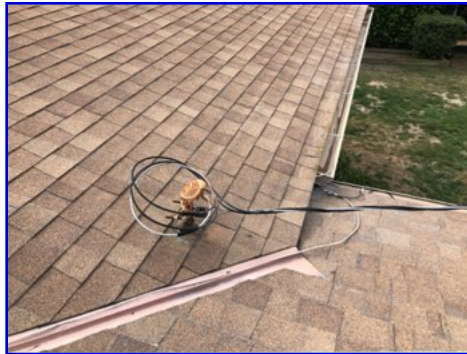
- Overhead - worn/weathered - needs service/maintenance
- Older style wiring connections to the structure - it is recommended that you upgrade these areas
- Cable clearance over roof is not to proper height (must be three feet from roof, eight feet from flat roof, 10 feet from balcony) - needs to be serviced
- Service entrance cable too close to roof - needs to be serviced

Too close to roof

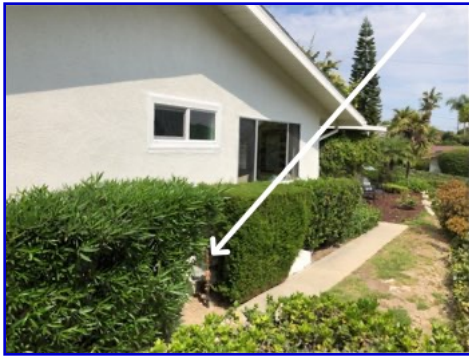
MAIN GAS VALVE LOCATION

- We recommend the gas supplier be contacted to safety check all fuel gas systems/appliances during the contingency period or at least prior to purchase and occupancy. The Inspector cannot determine if a gas leak is present in any area of the home or underground at any time during the inspection.
- Natural gas present
- Worn valve - typical for age
- Recommend gas valve wrench be placed near valve for optimal preparedness
- No seismic safety valve present - recommend installation for increased safety
- We recommend the gas supplier be contacted to safety check all fuel gas systems/appliances during the contingency period or at least prior to purchase and occupancy. The Inspector cannot determine if a gas leak is present in any area of the home at any time during the inspection.
- **Significant rusting - needs to be evaluated by Gas Company**

Page 33 Item: 6	Main Gas Valve	• Significant rusting - needs to be evaluated by Gas Company
-----------------	----------------	--

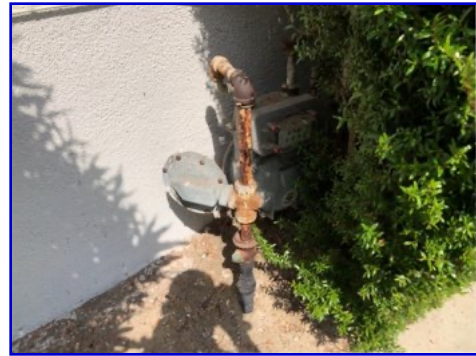
MAIN GAS VALVE; Significant rust

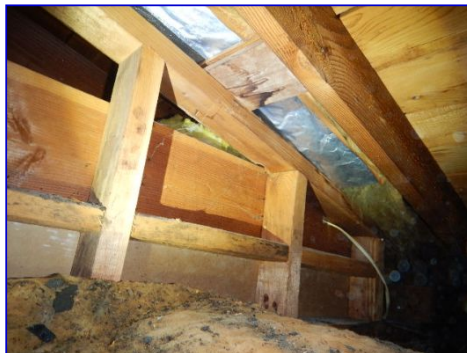
- Consult termite report for all wood areas in the attic
- Conventional framing present
- Cracking small at wood members - typical for age
- Cracked wood - typical for age
- Microbial growth/irregular staining on wood in attic often referred to as "lumber yard microbial growth" and is common on exposed wood in many attics. Consult with an appropriate contractor beyond this home inspection at your discretion to calculate the appropriate ventilation requirements for the attic and add exhaust fans or additional ventilation openings as needed. The attic should be checked as part of the regular home maintenance to ensure that there are no active moisture problems.
- **Deteriorated wood observed - consult termite report - needs to be serviced**
- **Stains present on wood members of structure - evidence of past moisture entering structure - monitor for future moisture intrusion**

Microbial growth; Stained; Deteriorated wood

Page 35 Item: 2	Structure	• Deteriorated wood observed - consult termite report - needs to be serviced • Stains present on wood members of structure - evidence of past moisture entering structure - monitor for future moisture intrusion
-----------------	-----------	--

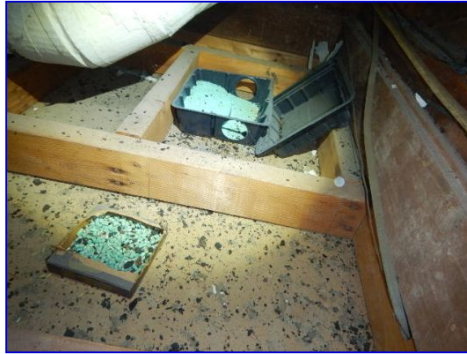
- All visible insulation is worn/older/dirty - typical for the age of the structure
- **Evidence of rodents/birds/pests in the attic - recommend further evaluation by pest services company**

Evidence of rodents

Page 35 Item: 3	Insulation	• Evidence of rodents/birds/pests in the attic - recommend further evaluation by pest services company
-----------------	------------	--

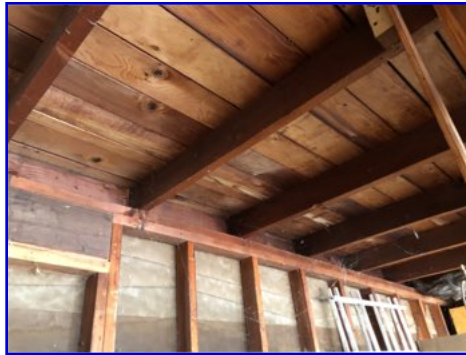
- Exposed wood rafters/joists - consult termite report for all wood
- Cosmetic blemishes observed
- Cracking small - typical for age - recommend patching
- Stains present - tested dry at time of inspection - monitor for possible moisture intrusion
- **Moisture damage/stains - needs further evaluation**

Moisture stains/damage

Page 37 Item: 2	Rafters & Ceilings	• Moisture damage/stains - needs further evaluation
-----------------	--------------------	---

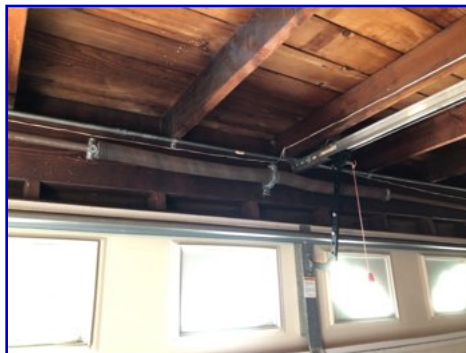
- Garage doors require periodic maintenance and is recommended to ensure that all hardware is properly lubricated and secured
- Door hardware is in a worn or loose condition - recommend standard service/lubrication
- Main spring is worn and rusted - may require replacement soon

Rusted siding

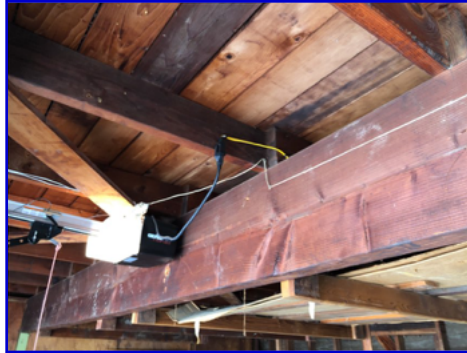
- Opener(s) were tested using the normal wall button on the day of the inspection (remote controls are not tested)
- One unit present
- Opener operated at time of inspection
- Operates with an extension cord as permanent wiring - needs to operate from a proper outlet near the opener - needs to be serviced

Uses extension cord

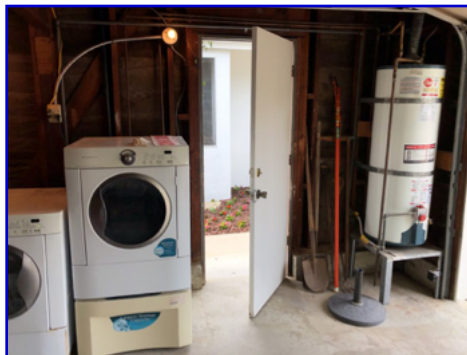
- Operated at the time of inspection
- Worn/weathered door - typical for age
- Missing proper weatherstripping/seals - needs to be serviced
- Missing threshold - needs to be serviced
- Did not latch - needs to be serviced
- Evidence of attempted forced entry — needs to be serviced

Weatherstripping, threshold missing; Attempted forced entry; Not latching

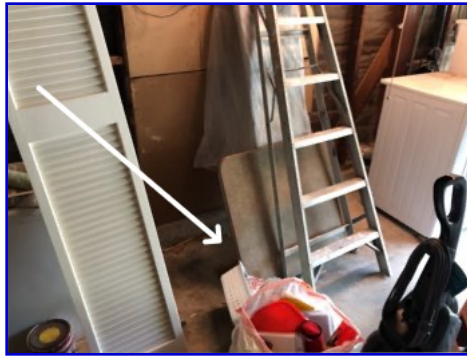
- Small cracks/chipped areas - typical for the age of the materials
- Worn and stained areas - typical for age of the material
- Evidence of rodents/pests - recommend pest services inspection for further evaluation

Evidence of rodents

Page 38 Item: 9	Slab	• Evidence of rodents/pests - recommend pest services inspection for further evaluation
-----------------	------	---

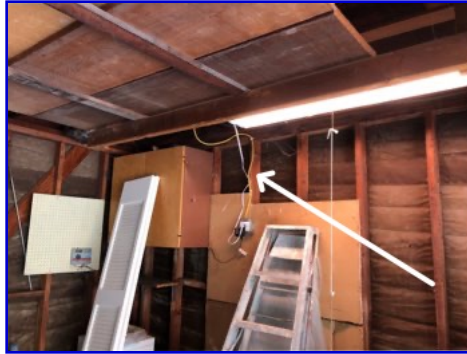
- A representative number of receptacles and switches were tested and found to be operational at time of inspection
- Loose/worn outlets/switches - typical for age consider upgrading
- Ungrounded outlets present - typical for the age of the structure - consider upgrading electrical services
- **Exposed nonmetallic wire (romex/cloth) below eight feet - needs to be serviced**

Exposed Romex

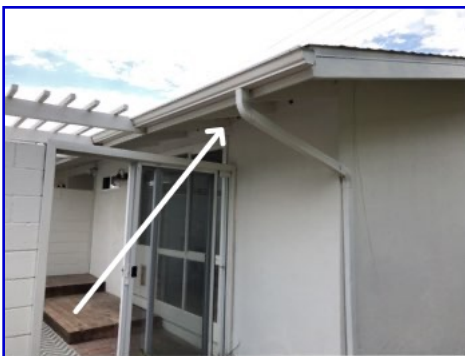
- Consult termite report for all wood areas at the structure
- Cracking/weathering/worn where visible - typical for age and weather exposure
- Weathering and staining present in areas
- **Moisture damage - consult termite report - needs to be serviced**
- **Deteriorated in areas - consult the termite report - needs to be serviced**

Deteriorated wood

Page 40 Item: 5	Eaves & Fascia	• Moisture damage - consult termite report - needs to be serviced • Deteriorated in areas - consult the termite report - needs to be serviced
-----------------	----------------	--

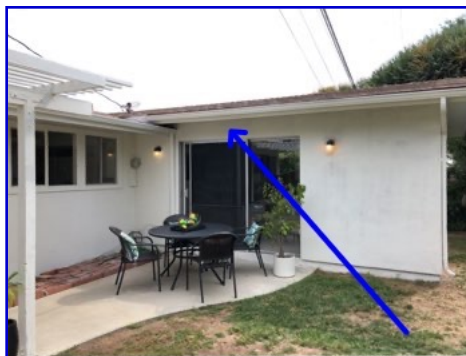
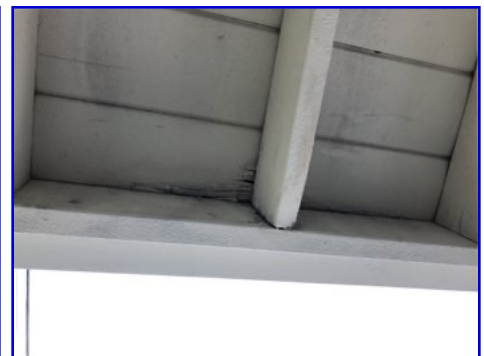
Moisture damage

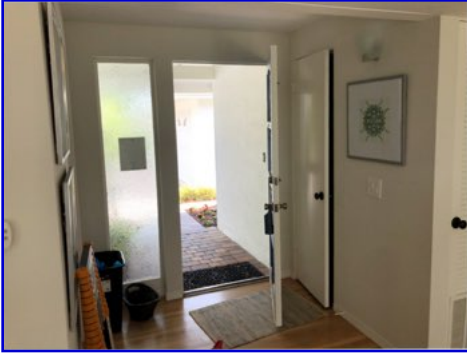
- Exterior doors require seasonal maintenance to extend lifespan and maintain weather tight seals
- See interior section for more information
- All visible and accessible doors were tested during this inspection
- Loose/worn hardware and hinges - typical for age
- Pet door present - SIDE
- Missing weather seals - needs to be serviced - FRONT
- Not tempered glass - unsafe - needs to be serviced - SIDE

No weatherstripping

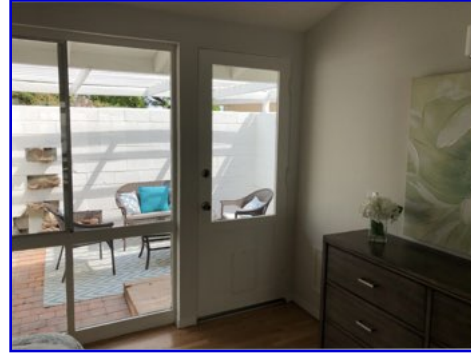
Pet door; Not tempered

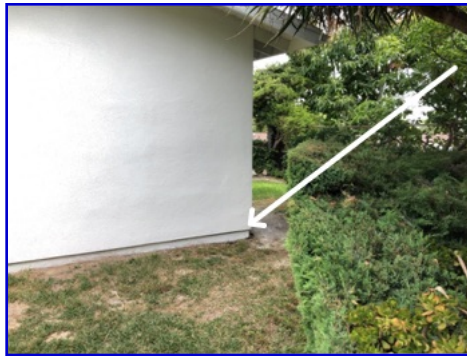
- Most perimeter areas are not visible - N/A
- Vegetation growing against structure prevents visibility or access to some areas of foundation perimeter for inspection
- Hillside present on property - we recommend a geological inspection on all hillside areas
- Worn and cracked - typical for the age of the structure
- Worn and stained areas - typical for age of the structure
- Paint or stucco is chipping and flaking
- Cracked/chipped areas

Cracked

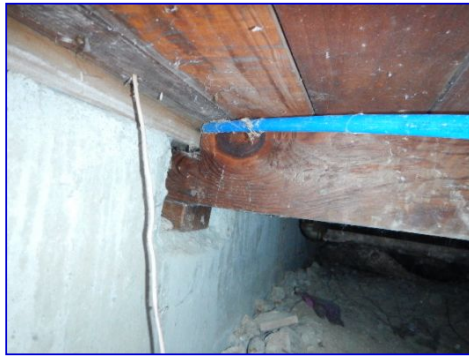
- Stained and worn areas - typical for age of structure
- Small cracking at wood members - typical for age of structure
- Brackets for all attachment points would benefit the structure
- **Beam/joist over notched/bored - needs to be serviced**

Overnotched

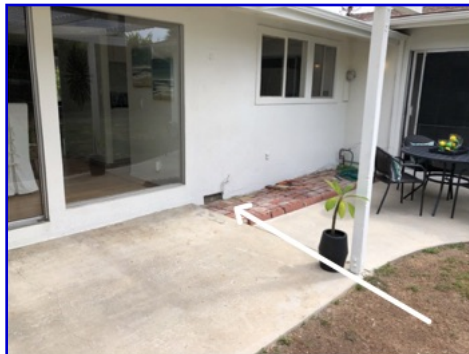
- Existing ventilation appeared to be adequate on the day of the inspection
- Grade above vents will direct water into structure - needs to be serviced

Grade above vents

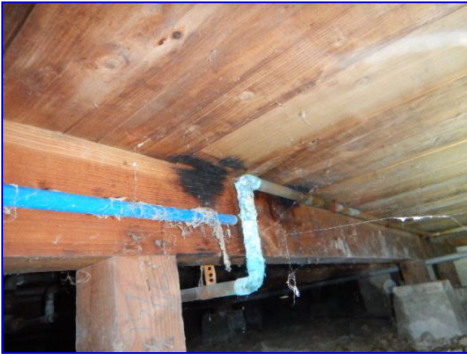
Corrosion

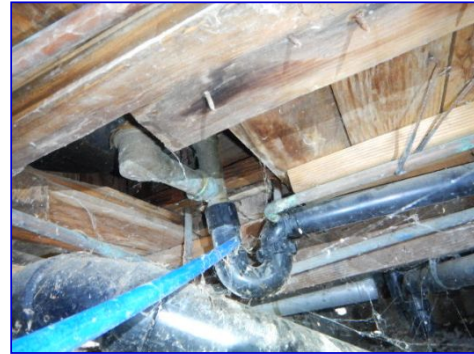
- Visible/accessible plumbing areas have worn and older piping in typical condition for the age of the structure
- **Leak found under tub - needs to be serviced**

Leaking under tub

Page 44 Item: 12	Plumbing	• Leak found under tub - needs to be serviced
------------------	----------	---

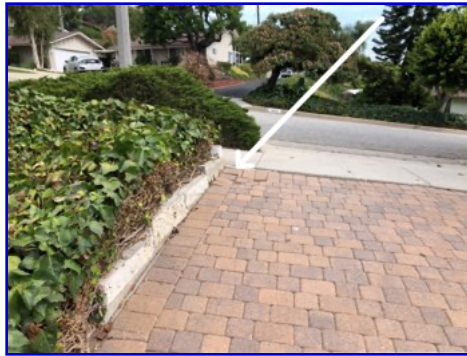
- Worn with common cracks/chips - typical for age of material
- Small cracking/chipping - typical for age
- Small localized water ponding may occur in areas - area drains may be needed
- Walkway displaced/uplifted/uneven areas - potential trip hazard - needs to be serviced

Uneven

Page 45 Item: 1	Driveways and Walkways	• Walkway displaced/uplifted/uneven areas - potential trip hazard - needs to be serviced
-----------------	------------------------	--

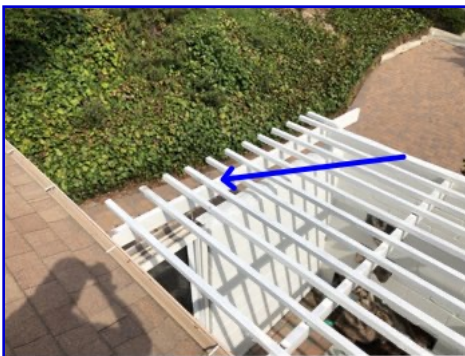
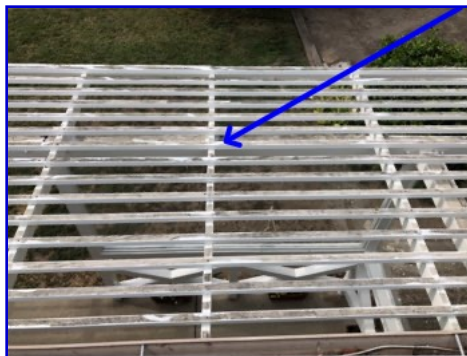
- Worn/weathered materials - typical for age
- Consult termite report for all exterior wood conditions
- Structure attached to fascia board – irregular installation – recommend licensed contractor to evaluate
- **Wood deterioration observed - consult termite report - needs to be serviced**

Deteriorated wood

Page 45 Item: 2	Patio and Porch Roofs	• Wood deterioration observed - consult termite report - needs to be serviced
-----------------	-----------------------	---

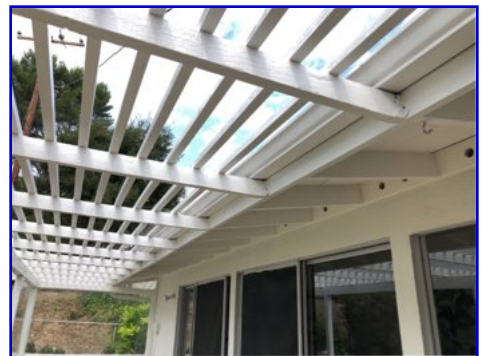
Attached to fascia

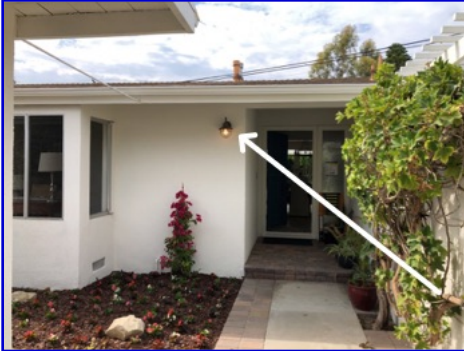
- Accessible lights/switches/outlets were tested on the day of the inspection
- Electrical fixtures need to be caulked/sealed to wall attachments to help prevent moisture entry - ALL
- **No power present at outlet - needs to be serviced**
- **Exterior switch did not operate - needs to be serviced**

Needs caulking

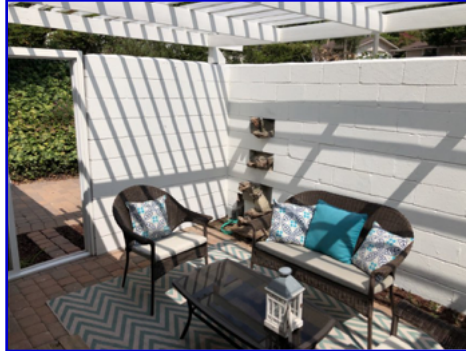
No power

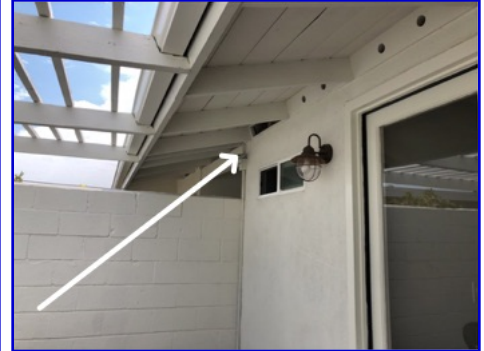
Switch inoperable

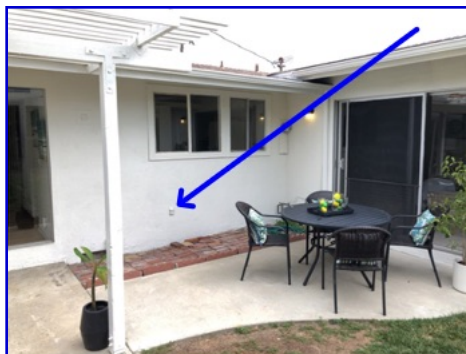
- None visible/installed - recommend upgrade for increased safety
- **GFCI** upgrades are recommended on exterior outlets for increased safety
- Outlets not GFCI protected - needs to be serviced

Not GFCI protected

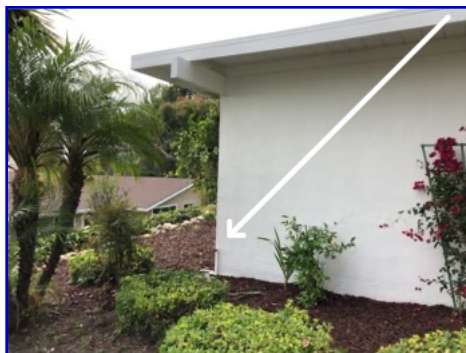
- We recommend adding anti-siphon/backflow preventers (if not already present) on all exterior hose bibs for optimum potable water protection
- Exterior plumbing is present and not original to the structure - check all installation permits to ensure installation to building code
- Accessible exterior faucets operated/worn at time of inspection via normal fixture controls
- **Exterior hose faucet leaks/drips when off - needs to be serviced**

Drippy faucet

Page 46 Item: 6	Exterior Plumbing and Faucets	• Exterior hose faucet leaks/drips when off - needs to be serviced
-----------------	-------------------------------	--

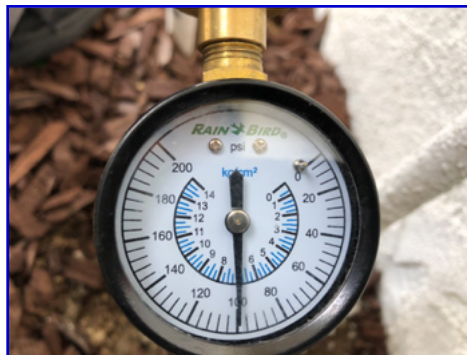
- Recommended water pressure is between 55 to 80 pounds per square inch (psi)
- Water Pressure can fluctuate depending upon time of day and municipal service adjustments
- **Approximate pounds per square inch: 100--HIGH PRESSURE**

HIGH PRESSURE

Page 47 Item: 9	Pressure Regulator	• None visible and pressure is above 80 PSI - recommend adding pressure regulator to allow adjustments - needs to be serviced
-----------------	--------------------	---

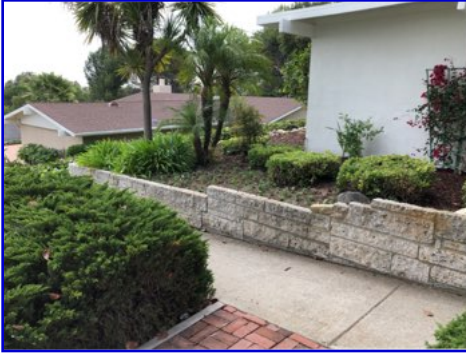
Larger cracks

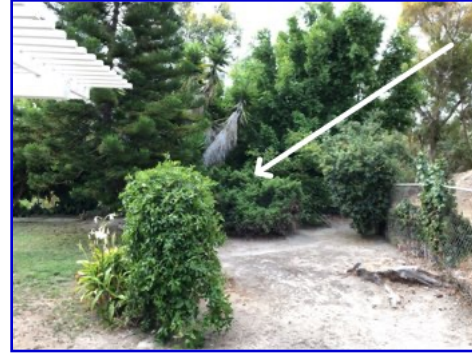
- Visible fencing/wall areas are worn and weathered - typical for the age of the materials
- Large cracks/separation cracks present - needs to be serviced
- Loose/leaning areas of fencing/walls – needs to be serviced

Leaning fence

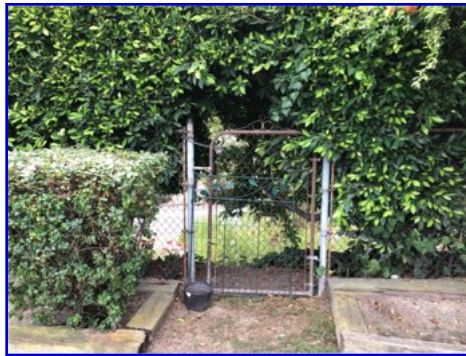
- Gate locked - not tested
- Operated on the day of the inspection

Locked

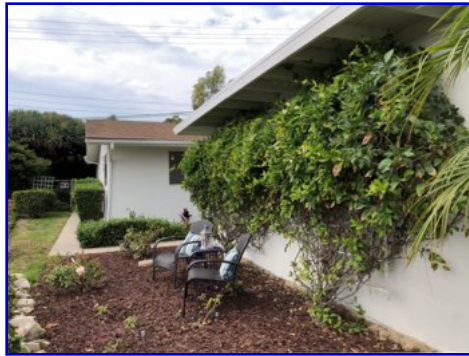
- Recommend pruning or removing any plants or trees that are in contact or proximity to structure to eliminate pathways of wood destroying insects and moisture
- Tree limbs within 10 feet of roof should be trimmed away to provide air and sunlight to roof, while minimizing debris & dampness
- Recommend trimming trees or bushes that are in contact or proximity to home, as branches can abrade roofing or siding
- Trees or vegetation too close to structure areas - needs to be serviced

Vegetation too close

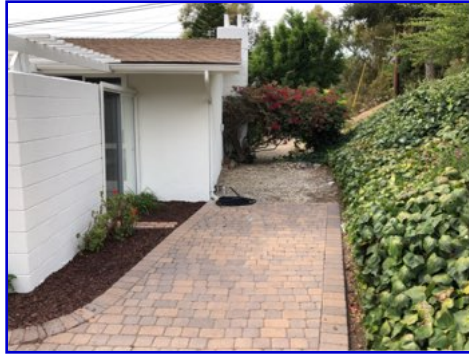
- Steep hillsides, fire safety, and inaccessible areas on the grounds are excluded from this inspection
- No drains visible at the property at the time of the inspection - drains are recommended to divert water away from structure
- Small localized water ponding may occur in areas - monitor these areas as drains may be needed
- **Grade slopes towards structure - needs to be serviced**

Slopes toward structure

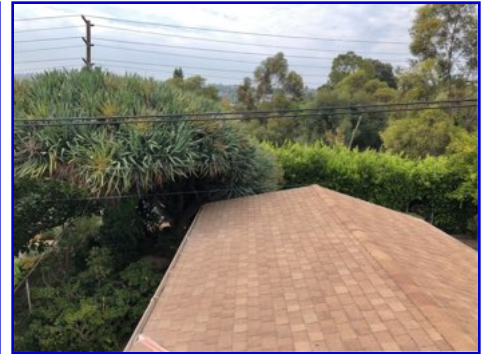
Trees

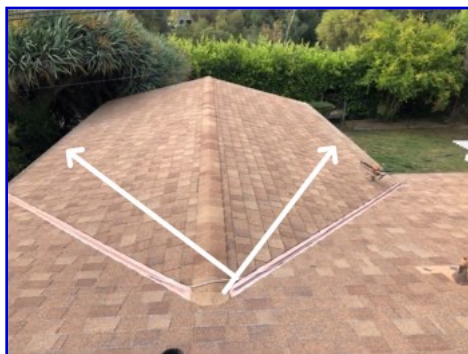
Poor drainage

Page 50 Item: 1	Condition	<ul style="list-style-type: none">• Signs of poor slope or lack of proper drainage on roof - needs to be serviced• Improper materials present on a low pitch roof - recommend further evaluation by a licensed roofer
Page 51 Item: 2	Flashings	<ul style="list-style-type: none">• Reroof covers flashings - improper installation - needs further evaluation by a licensed roofer• Not properly integrated into masonry chimney - needs to be serviced• Missing at roof to wall juncture - needs to be serviced
Page 52 Item: 6	Spark Arrestors	<ul style="list-style-type: none">• No spark arrestor/rain cap present - recommend installation

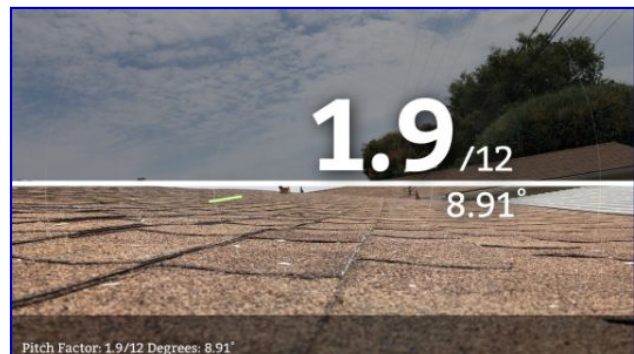
- Worn and weathered materials present - typical for age and weather exposure - roof needs maintenance
- Trees/vegetation too close to structure - needs to be serviced
- Tree branches rub roof - needs to be serviced
- Materials appear to be nearing end of useful life - needs to be further evaluated by a licensed roofer
- Satellite dish fastened direct to roof - screws will need periodic caulk maintenance
- Signs of poor slope or lack of proper drainage on roof - needs to be serviced
- Improper materials present on a low pitch roof - recommend further evaluation by a licensed roofer

Shingles on flat

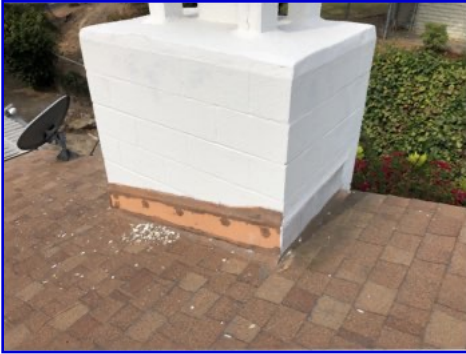
Not integrated

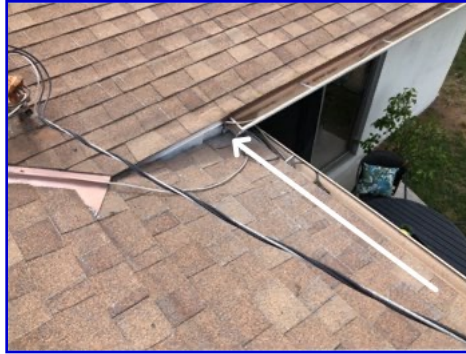
Missing flashing

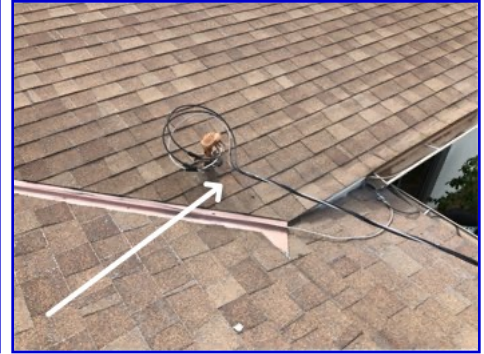
- Worn/weathered/rusted/bent - typical for age - recommend seasonal mastic maintenance to prevent moisture intrusion
- Reroof covers flashings - improper installation - needs further evaluation by a licensed roofer
- Not properly integrated into masonry chimney - needs to be serviced
- Missing at roof to wall juncture - needs to be serviced

Reroof covers flashing

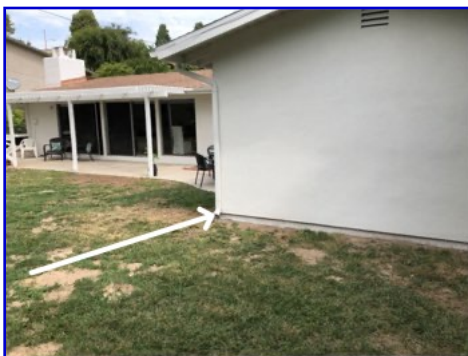
Needs extension

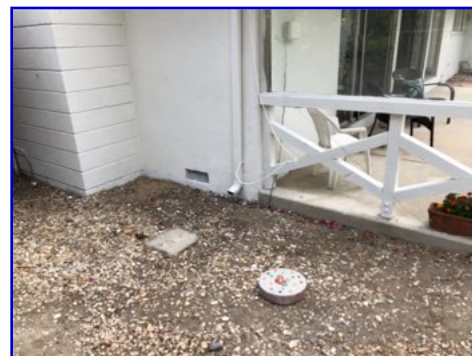
Needs extension

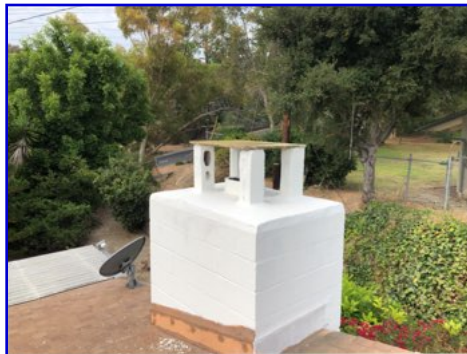
- No spark arrestor/rain cap present - recommend installation

No spark arrestor

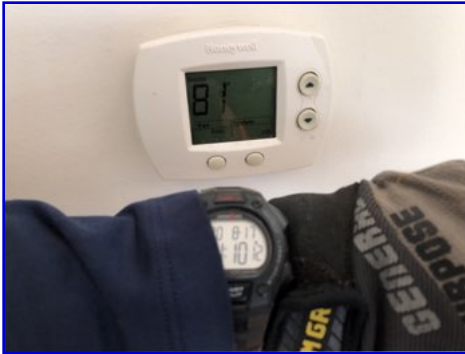
Thermostat turned off upon completion

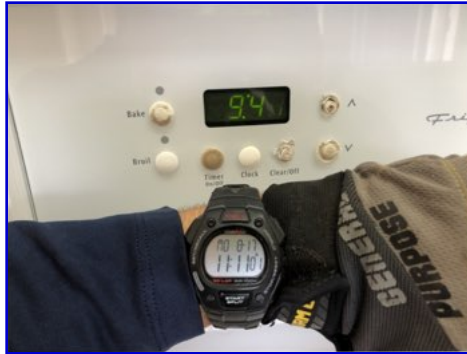
Ovens turned off upon completion
