# WOOD DESTROYING PESTS AND ORGANISMS INSPECTION REPORT

Building No. 4266	Street Keefer Road	City Chico	Zip 95973	Date of Inspection 06/20/2017	Number of Pages 4
----------------------	-----------------------	---------------	--------------	----------------------------------	----------------------

COMPLETE REPORT <input checked="" type="checkbox"/> LIMITED REPORT <input type="checkbox"/> SUPPLEMENTAL REPORT <input type="checkbox"/> REINSPECTION REPORT <input type="checkbox"/>	
GENERAL DESCRIPTION: One story wood frame single family dwelling.	Inspection Tag Posted: At the water heater <hr/> Other Tags Posted:
An inspection has been made of the structure(s) shown on the diagram in accordance with the Structural Pest Control Act. Detached porches, detached steps, detached decks and any other structures not on the diagram were not inspected.	
Subterranean Termites <input type="checkbox"/> Drywood Termites <input type="checkbox"/> Fungus / Dryrot <input checked="" type="checkbox"/> Other Findings <input checked="" type="checkbox"/> Further Inspection <input checked="" type="checkbox"/>	
If any of the above boxes are checked, it indicates that there were visible problems in accessible a

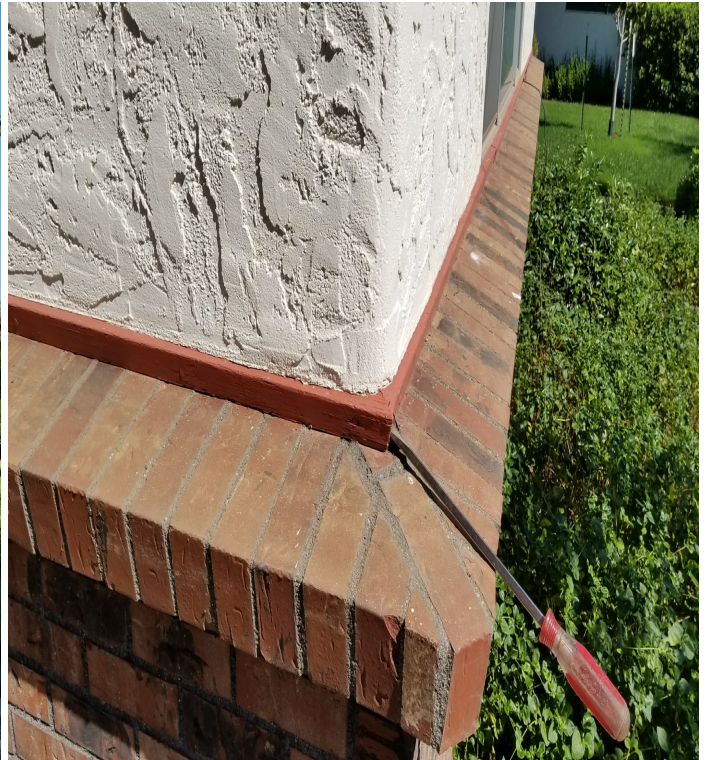
**FINDING:** Fungus damage was found to the wood trim.

3 A - Damaged trim.

**RECOMMENDATION:** Remove the damaged wood members and replace with new material. Prime paint only.

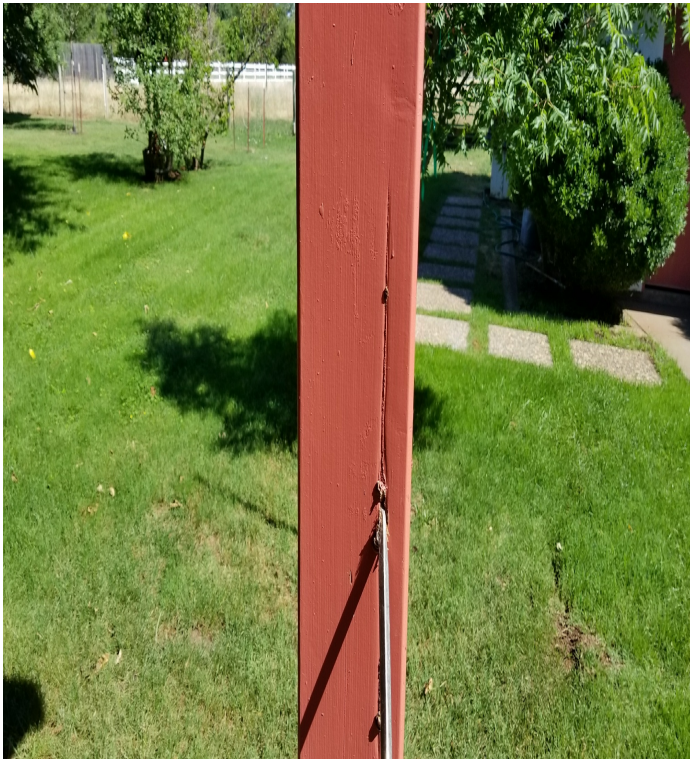
**FINDING:** Fungus damage was found to the 4x6 support post.

3 B - Damaged post.

**RECOMMENDATION:** Remove the damaged wood members and replace with new material. Prime paint only.

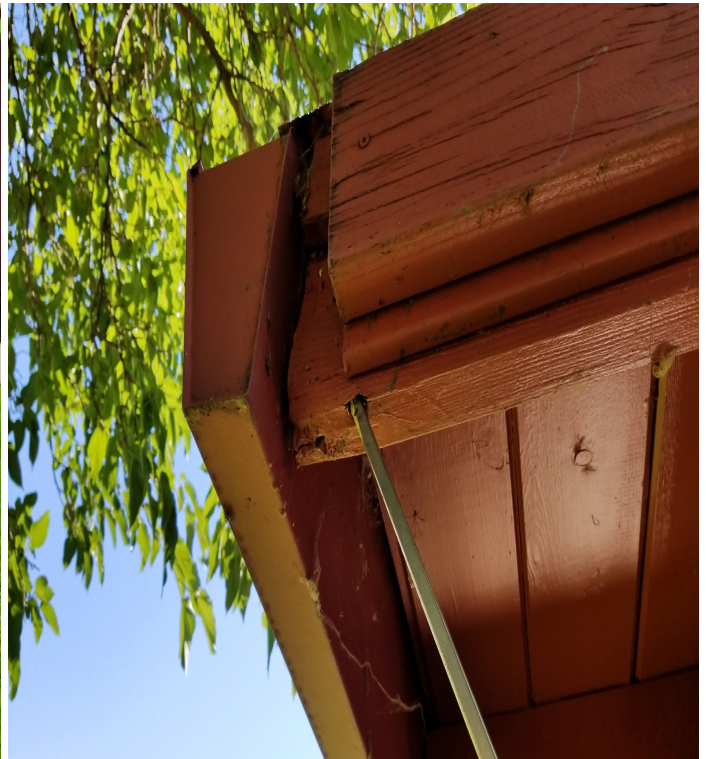
**FINDING:** Fungus damage was found to the support joist, beams and decking on the rear patio.

3 C - Damaged joist.

**RECOMMENDATION:** Lift up roofing to allow for repairs. Remove the damaged wood members and replace with new material. Prime paint only. Re-install roofing.

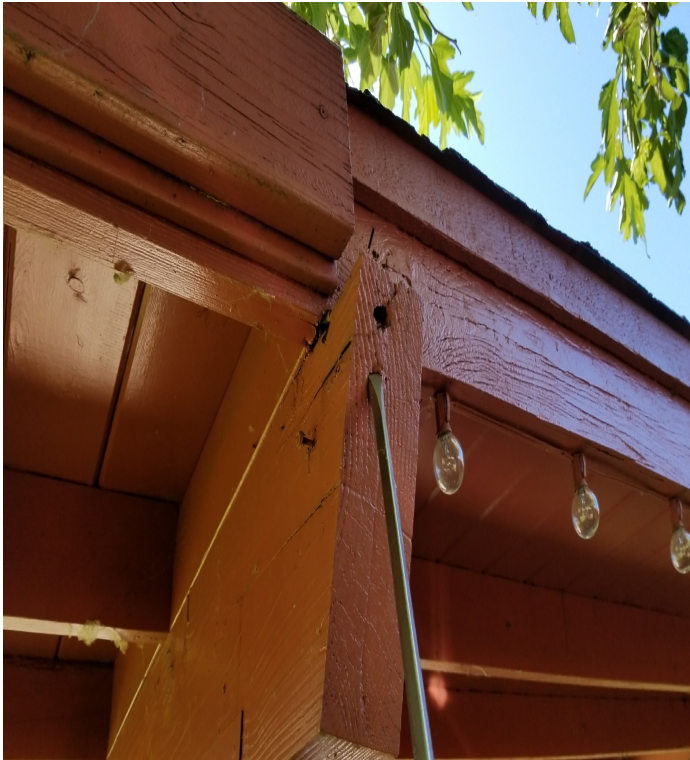
3 C - Damaged beam.

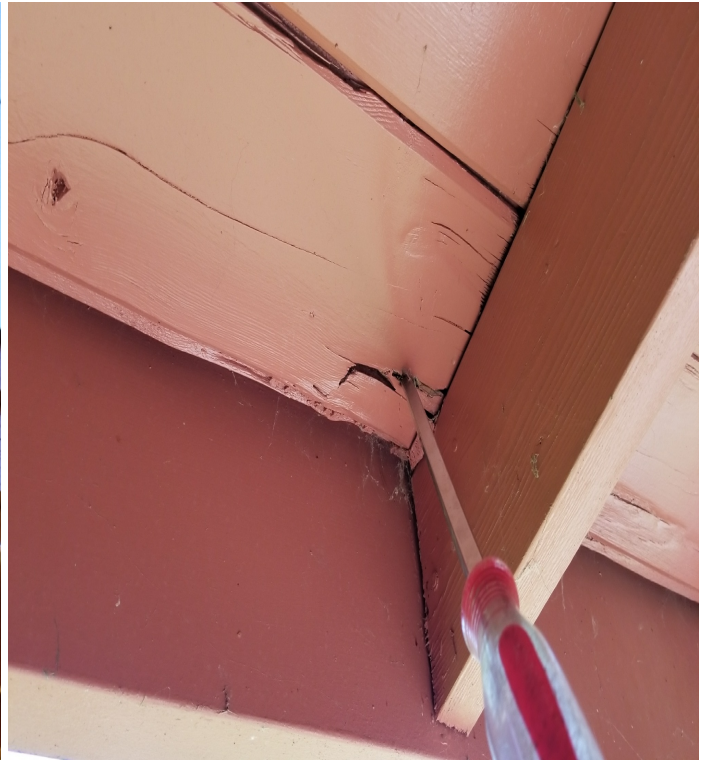
3 C - Damaged decking.

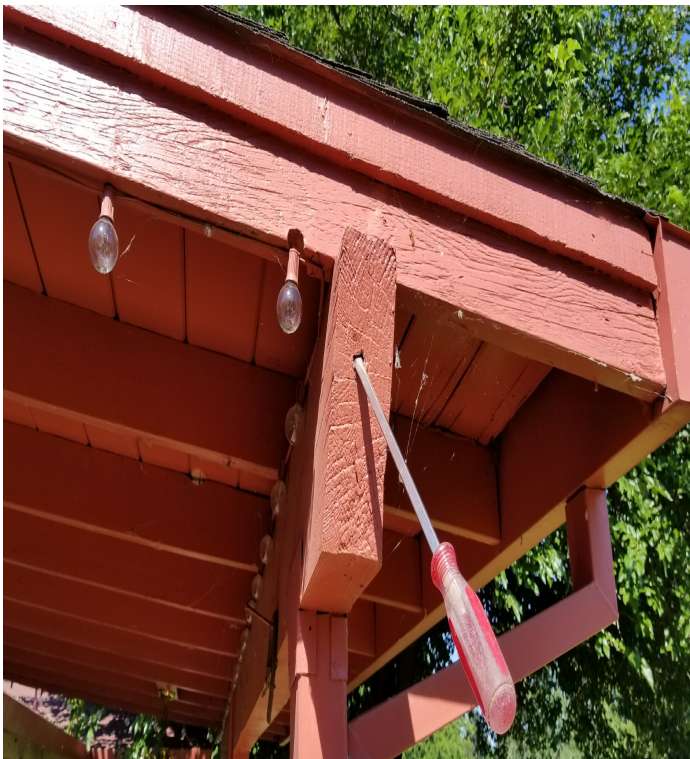
3 C - Damaged beam.

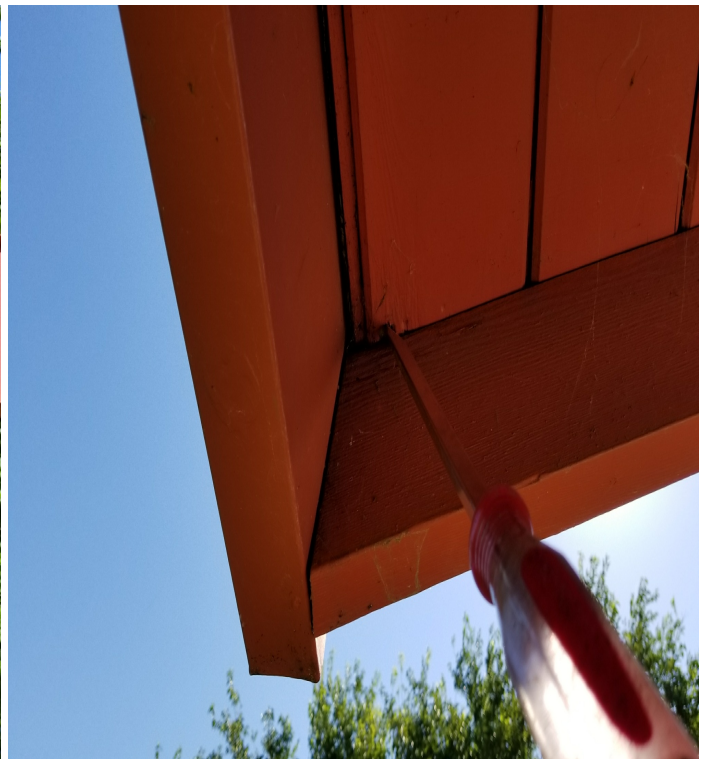
**FINDING:** Fungus damage was found to a section of roof eaves.

3 D - Damaged eaves.

**RECOMMENDATION:** Lift up the roofing to allow for repairs. Remove the damaged wood members and replace with new material. Prime paint only. Re-install roofing.
