# ELITE GROUP

INSPECTION PROFESSIONALS

32021 Via La Plata , San Juan Capistrano, CA 92675  
Inspection prepared for: Suzette Cummings  
Real Estate Agent: Stuart Wann - First Team Real Estate

Date of Inspection: 4/23/2019 Time: 2:00 PM  
Age of Home: 1977 Size: 1350  
Weather: Sunny, warm, dry  
Order ID: 171751

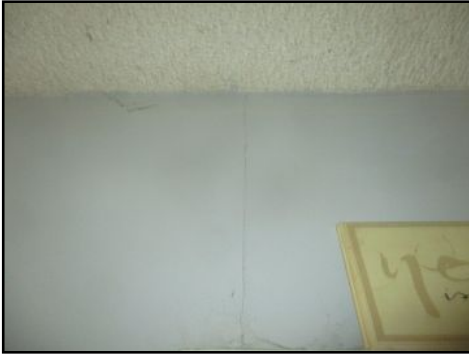
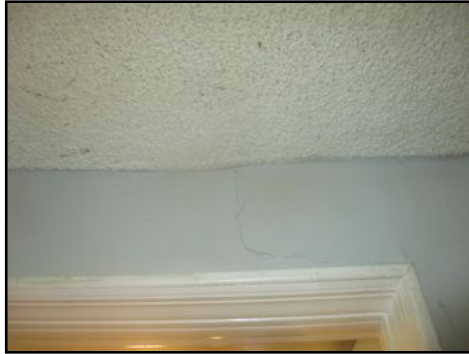
#### 1. Wall Conditions

Large cracking/separation present – larger than typical - needs to be further evaluated/serviced

Large cracking present – larger than typical - needs to be further evaluated/serviced

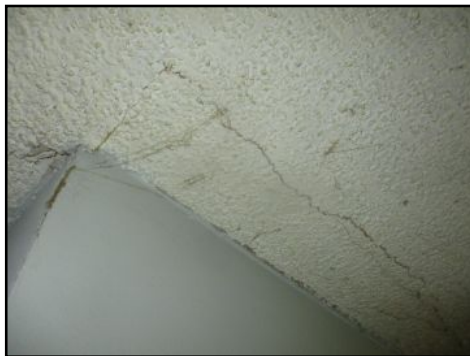
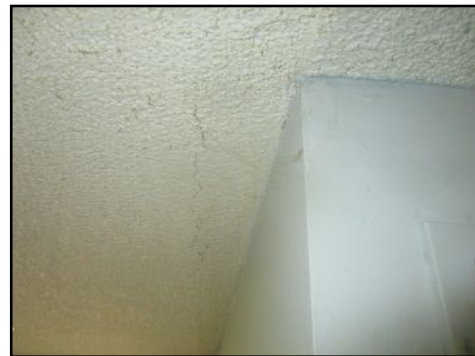
Uneven/damaged areas • Large cracking/separation present – larger than typical - needs to be further evaluated/serviced

Large cracking present – larger than typical - needs to be further evaluated/serviced

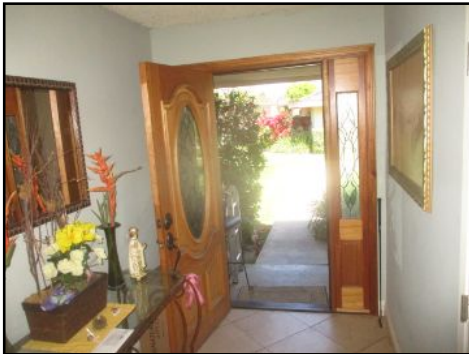
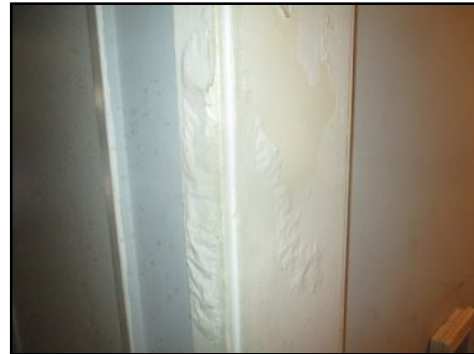
### 5. Doors

Operated at time of inspection • Loose/worn hardware needs minor service - typical for age • Blistered paint at door jamb - cannot determine cause • **Door(s) not square in the jamb** • **Difficult to lock - needs to be serviced**

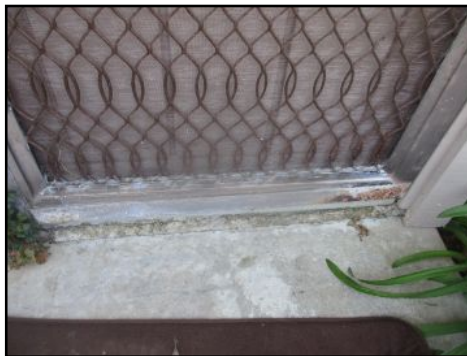
### 6. Screen Doors

Worn/weathered • Rusted door/hardware • Loose/worn hardware - typical for age

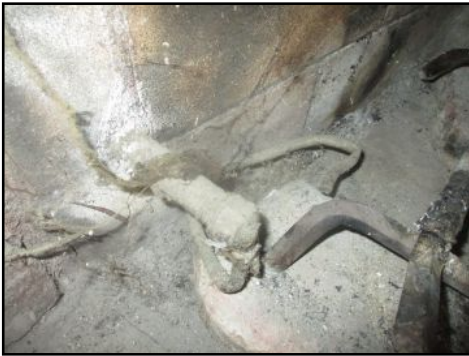
Small cracks/worn areas present - typical for age • Minor deterioration • Damper was worn/rusted/dirty - recommend cleaning • Gas log lighter present • **No damper stop clamp - required for cosmetic gas logs, fire-glass or other cosmetic fire system that uses gas at the primary fuel** • **Gas log lighter/connector damaged/cut - needs to be serviced** • **Heavy soot present/dirty** • **Recommend further evaluation by CSIA certified chimney sweep**

Gas log lighter/connector damaged/cut - needs to be serviced

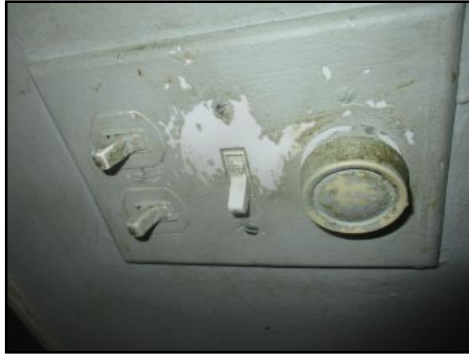
### 10. Electrical

Some outlets not accessible - not inspected • Only the visible and accessible switches/outlets are testing during this inspection, personal items/furnishings are not moved to access any outlets/switches behind them. • **Loose/worn outlets/switches - typical for age consider upgrading**

Loose/worn outlets/switches - typical for age consider upgrading

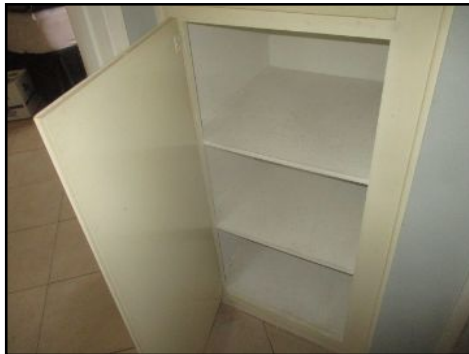
### 12. Cabinets

Worn cabinets with loose/worn hardware - typical for age

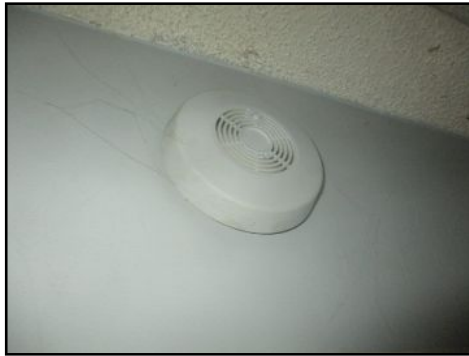
**Did not operate - needs to be serviced or replaced**

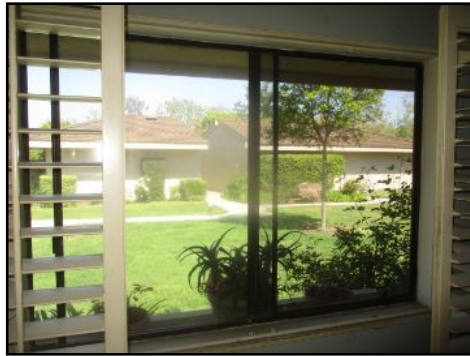
Visible/accessible windows have worn frames/hardware/sills/tracks - typical for age • Difficult to operate or slide - needs to be serviced

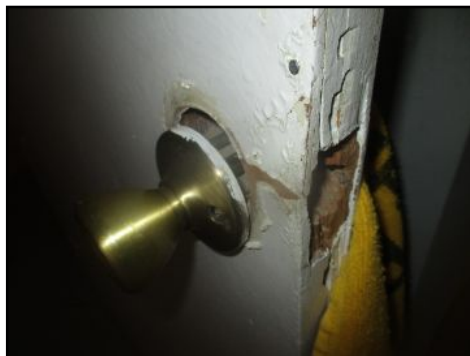
Operated at time of inspection • Weathered/worn door(s) - typical for age • Loose/worn hardware needs minor service - typical for age • **Damaged door/hardware - did not operate properly - needs to be replaced - at master bedroom**

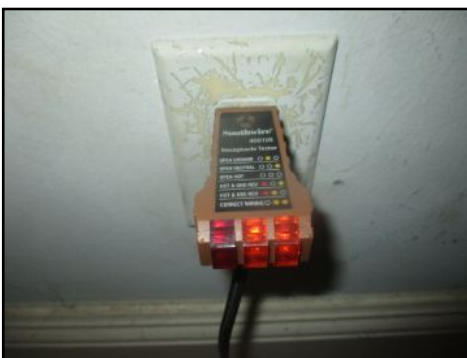
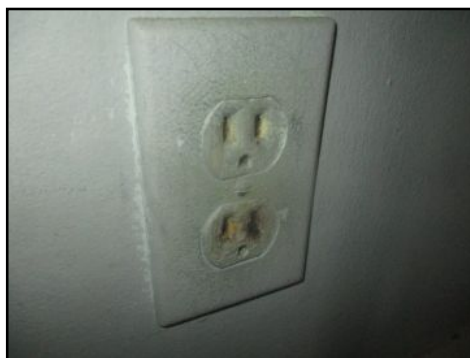
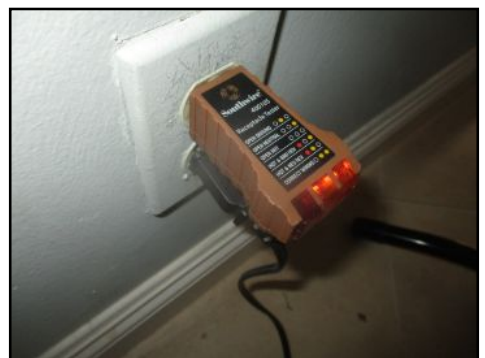
Loose/worn outlets/switches - typical for age consider upgrading • **Burnt outlet - needs to be serviced/evaluated - at master bedroom**

**Burnt outlet - needs to be serviced/evaluated - at master bedroom**

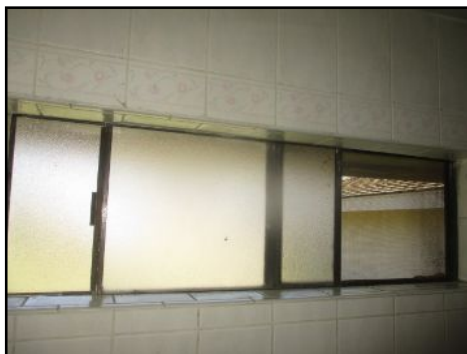
### 5. Window Conditions

Visible/accessible windows have worn frames/hardware/sills/tracks - typical for age • Recommend general window maintenance/lubrication and weather tight service

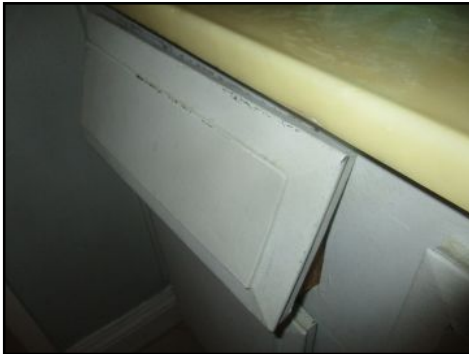
### 8. Cabinets

Some interior cabinet areas not visible for inspection due to personal storage • **Worn cabinets with loose/worn hardware** • **Broken drawer(s)/hardware** • **Stained areas below sink** • **Moisture damaged under sink - needs to be serviced - at hall bathroom**

Broken drawer(s)/hardware

Page 17 Item: 8	Cabinets	<ul style="list-style-type: none"> <li>• Worn cabinets with loose/worn hardware</li> <li>• Broken drawer(s)/hardware</li> <li>• Stained areas below sink</li> <li>• Moisture damaged under sink - needs to be serviced - at hall bathroom</li> </ul>
Page 17 Item: 9	Sinks	<ul style="list-style-type: none"> <li>• Worn fixture/sink - typical for the age</li> </ul>
Page 17 Item: 10	Bath Tubs	<ul style="list-style-type: none"> <li>• Fixture was in a worn/older condition at the time of the inspection - typical for age</li> <li>• Drain operated slowly - needs to be serviced</li> </ul>
Page 18 Item: 12	Shower Walls	<ul style="list-style-type: none"> <li>• Cracked/loose/missing grout in areas - recommend grout and sealer</li> <li>• Gaps present - needs to be serviced and sealed to prevent moisture leaks</li> <li>• Recommend maintenance and sealing holes &amp; gaps at all wall/plumbing junctures to prevent water infiltration into walls</li> </ul>

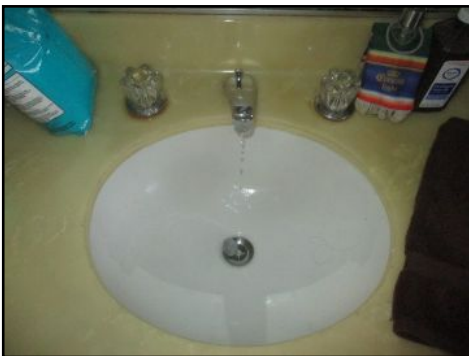
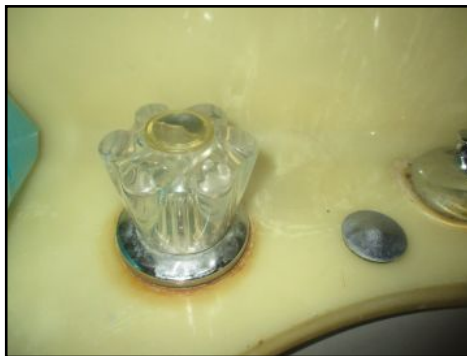
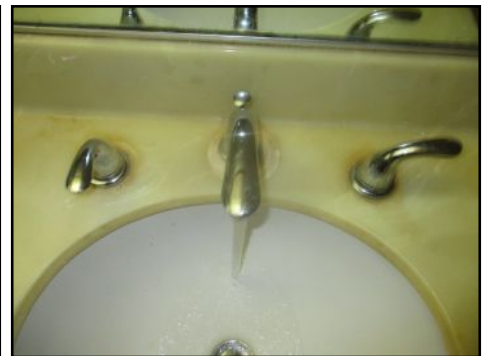
### 9. Sinks

**Worn fixture/sink - typical for the age**

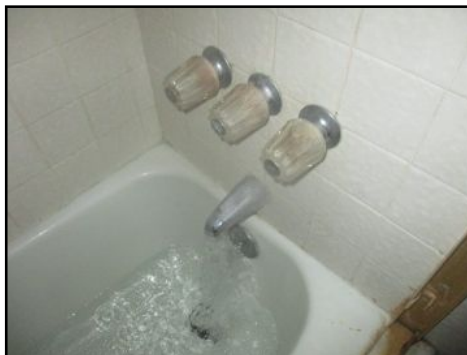
### 10. Bath Tubs

Tub is worn/older/stained/scratched/chipped - typical for the age • **Fixture was in a worn/older condition at the time of the inspection - typical for age** • **Drain operated slowly - needs to be serviced**

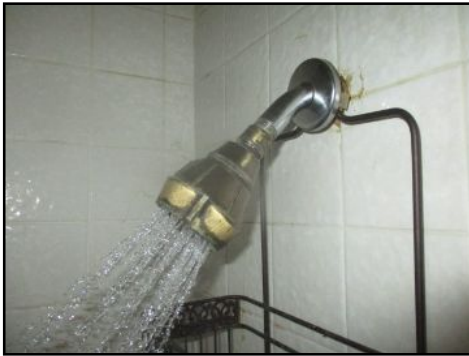
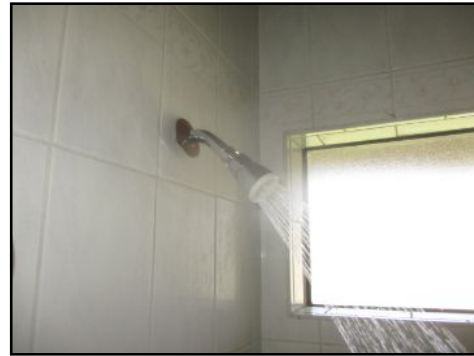
### 11. Showers

Tub/Shower combo present - see tub notes for additional information • **Fixture was in a worn and older condition - typical for the age**

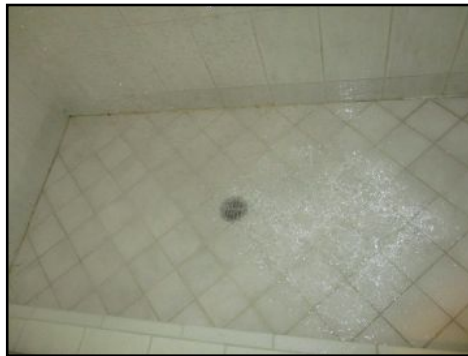
**12. Shower Walls**

Tile and grout present • Wall materials in a worn/stained-faded/old condition - typical for age - recommend routine grout and sealer maintenance • Shower pan is in a worn/stained/older condition - typical for the age - recommend routine grout and sealer maintenance • **Cracked/loose/missing grout in areas - recommend grout and sealer** • **Gaps present - needs to be serviced and sealed to prevent moisture leaks** • **Recommend maintenance and sealing holes & gaps at all wall/plumbing junctures to prevent water infiltration into walls**

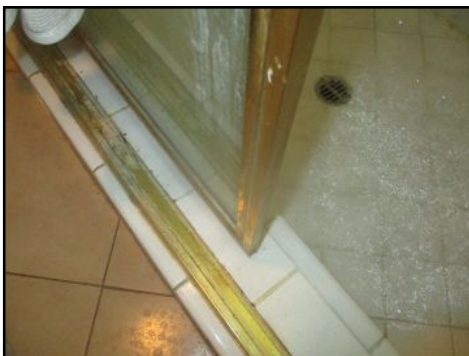
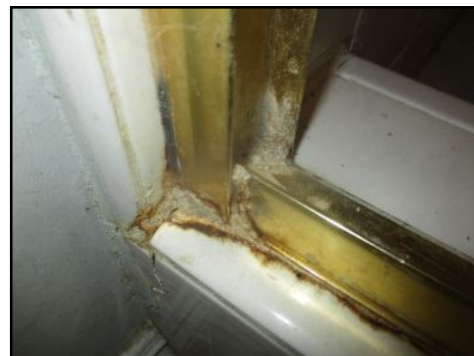
**Bypass doors missing bottom track guide - doors swing - at master bathroom** • **Enclosure door(s) in a worn/older condition with loose/worn hardware - typical for the age** • **Corrosion present in areas - signs of wear and moisture accumulation** • **Evidence of past leaking - recommend resealing the enclosure to prevent further leaking**

**Corrosion present in areas - signs of wear and moisture accumulation**

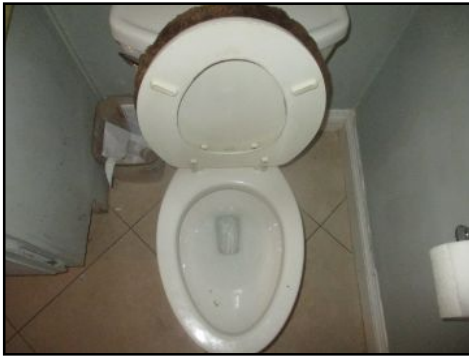
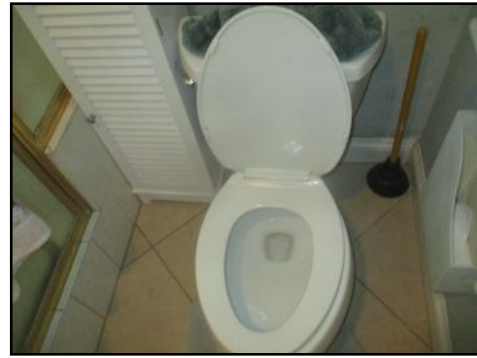
**14. Toilets**

Toilet is in a worn and older condition at the time of the inspection - typical for age • No visible leaking at the time of inspection and flush testing • Recommend upgrade to low flow 1.6 gal/flush toilets for water conservation

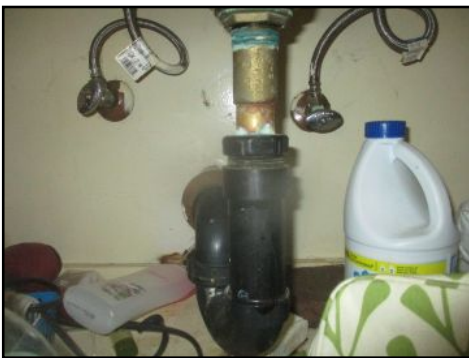
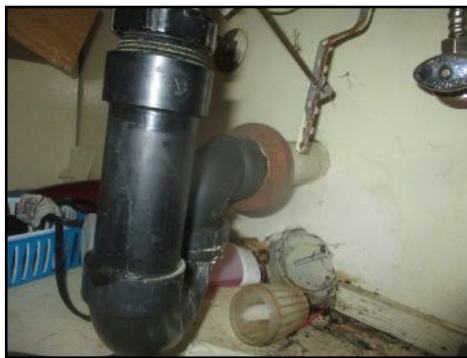
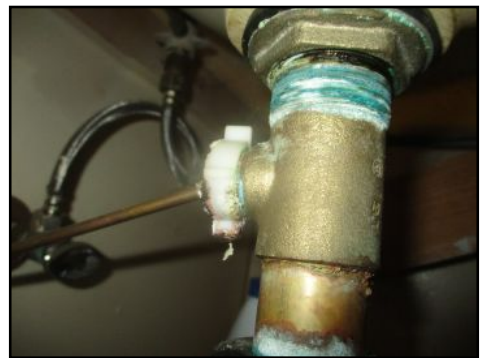
Some areas not visible due to personal items • Corrosion is present at plumbing areas • Angle stops/hoses/drain pipes are worn/older - recommend upgrading these areas with new fixtures • Visible leaking under sink - recommend licensed plumbing contractor for further evaluation and repair

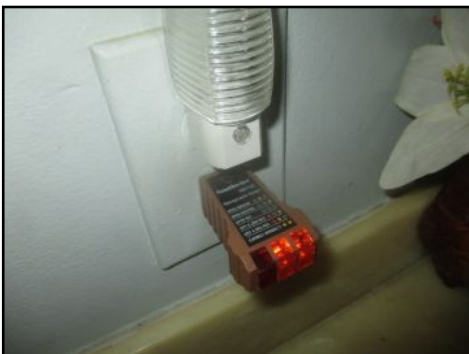
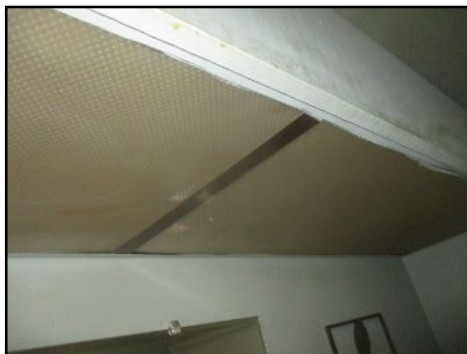
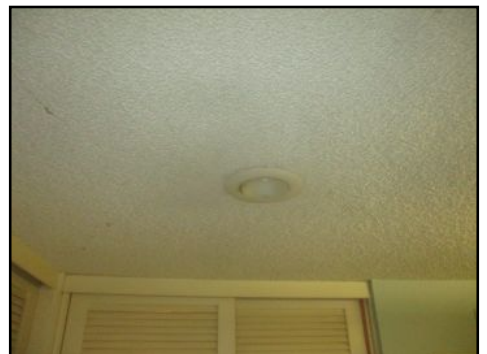
### 16. Electrical

Loose/worn outlets/switches - typical for age consider upgrading • Some bulbs defective/missing/light(s) did not function - check bulbs/consult electrician to further evaluate

Page 24 Item: 14	Electrical	<ul style="list-style-type: none"> <li>• Some bulbs defective/missing/light(s) did not function - check bulbs/consult electrician to further evaluate</li> </ul>

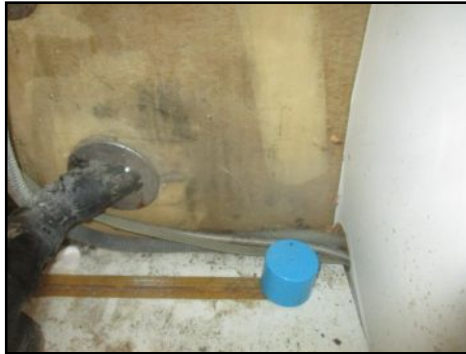
Small cracks/holes/chipped/dirty areas/cosmetic blemishes observed - typical for age of structure • Patched/partial painted areas present - consult seller regarding patched areas • **Moisture damage in areas - evidence of moisture intrusion/leaking under sink • Microbial growth/irregular staining present - further evaluation is recommended**

Microbial growth/irregular staining present - further evaluation is recommended

Page 21 Item: 1	Wall Conditions	<ul style="list-style-type: none"> <li>• Moisture damage in areas - evidence of moisture intrusion/leaking under sink</li> <li>• Microbial growth/irregular staining present - further evaluation is recommended</li> </ul>
Page 21 Item: 5	Counters	<ul style="list-style-type: none"> <li>• Tile and grout is worn - recommend grout and sealer maintenance</li> </ul>
Page 22 Item: 6	Cabinets	<ul style="list-style-type: none"> <li>• Cabinets gapped at ceiling</li> <li>• Stained/worn under sink - needs to be serviced - hidden defects may exist</li> </ul>
Page 22 Item: 7	Sinks	<ul style="list-style-type: none"> <li>• Loose/worn fixtures</li> <li>• Gaps present between sink and countertop - potential for leakage - needs to be serviced</li> </ul>
Page 22 Item: 8	Dishwashers	<ul style="list-style-type: none"> <li>• Not operating properly - needs to be serviced</li> </ul>
Page 22 Item: 10	Plumbing	<ul style="list-style-type: none"> <li>• Angle stops/hoses/drain pipes are worn/older - recommend upgrading these areas with new fixtures</li> </ul>

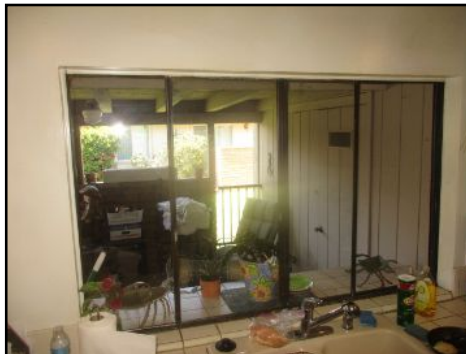
### 4. Window Conditions

Visible/accessible windows have worn frames/hardware/sills/tracks - typical for age • Difficult to operate or slide - needs to be serviced

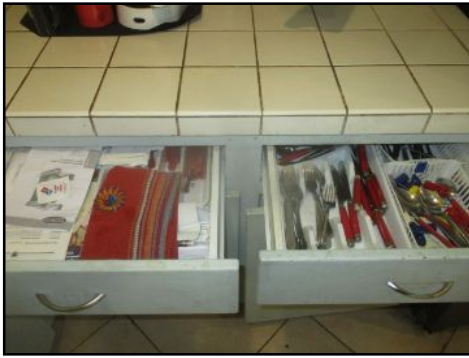
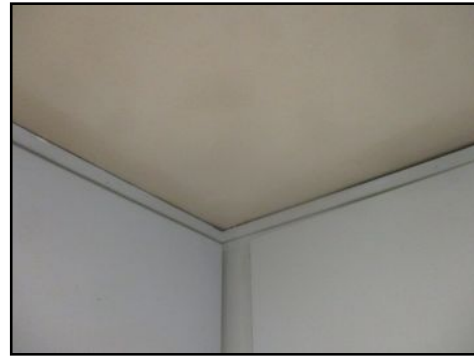
Worn cabinets with loose/worn hardware - typical for age • Stained areas below sink - dry at time of inspection • **Cabinets gapped at ceiling • Stained/worn under sink - needs to be serviced - hidden defects may exist**

Cabinets gapped at ceiling

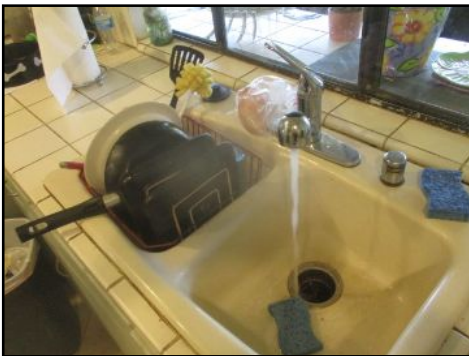
Loose/worn fixtures

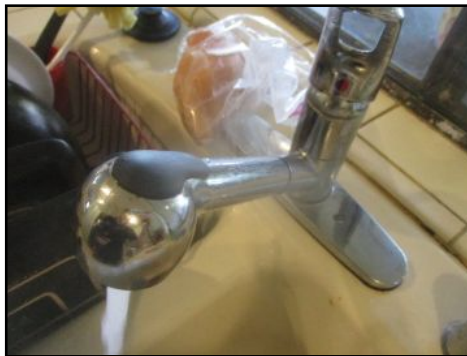
Fixture operated at the time of the inspection • Loose/worn fixtures • Gaps present between sink and countertop - potential for leakage - needs to be serviced

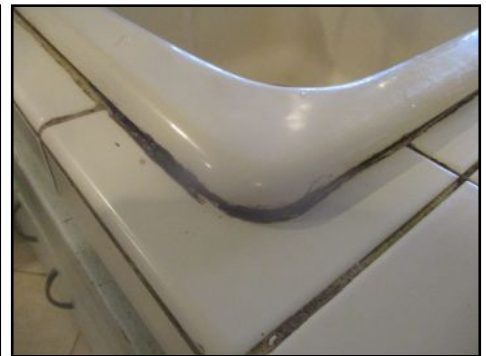
Gaps present between sink and countertop - potential for leakage - needs to be serviced

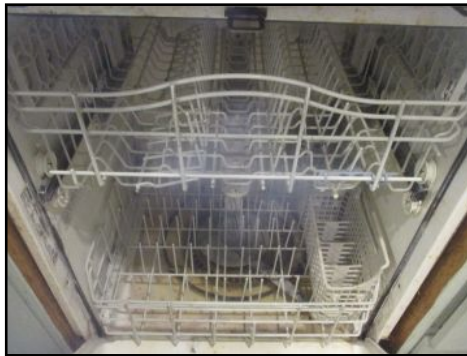
### 8. Dishwashers

Not operating properly - needs to be serviced

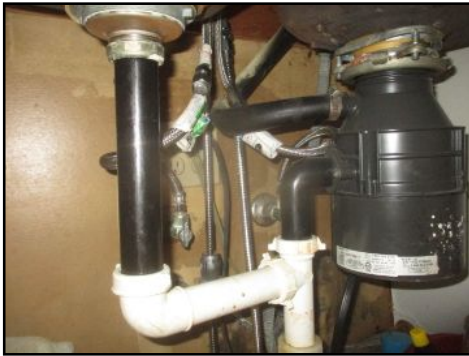
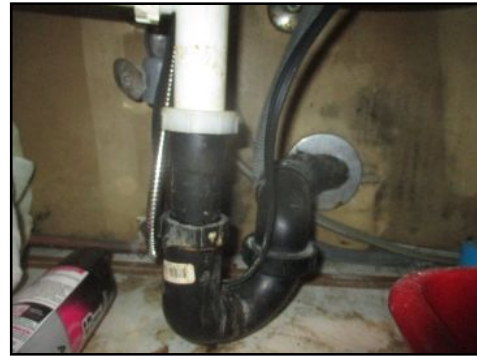
Angle stops/hoses/drain pipes are worn/older - recommend upgrading these areas with new fixtures

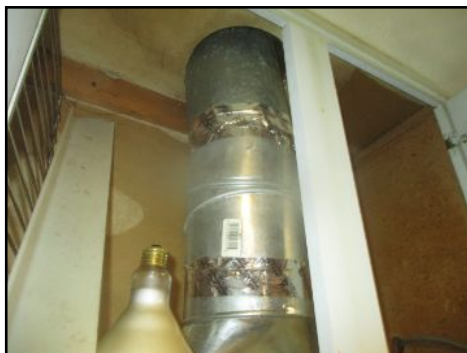
### 13. Exhaust Vents

Tested and operational at time of inspection via normal controls • Worn/older unit - typical wear for age and use • Greasy/dirty unit - recommend cleaning • Worn/dirty filters, recommend cleaning or replacing

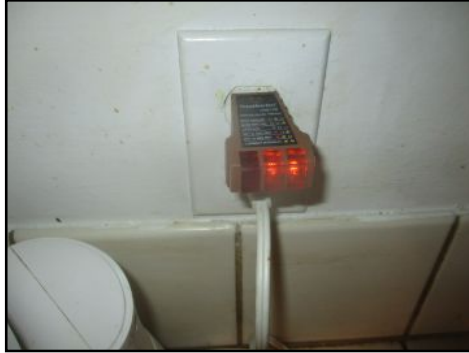
#### 14. Electrical

Loose/worn outlets/switches - typical for age consider upgrading • **Some bulbs defective/missing/light(s) did not function - check bulbs/consult electrician to further evaluate**

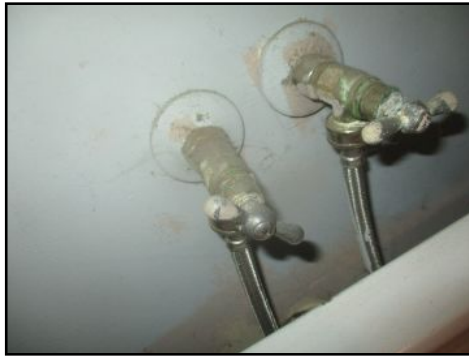
### 5. Plumbing

Washer/dryer unit(s) present during inspection and obstruct the view of the wall/plumbing areas • Visible fixtures were worn/old - typical wear for age • No visible leaks at time of inspection • Drain trap is not visible at the time of the inspection - **n/a** - note: laundry drains are not water or pressure tested during this inspection

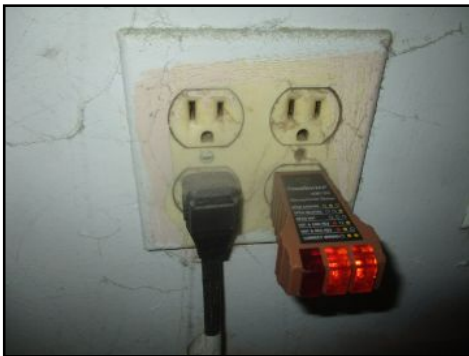
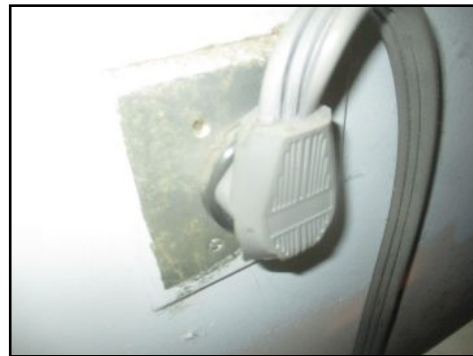
### 7. Electrical

Loose/worn outlets/switches - typical for age consider upgrading • Could not access 240v service - not inspected

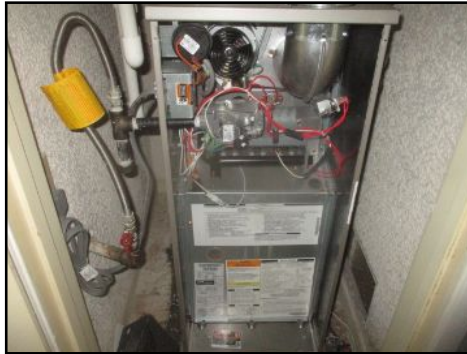
**Type:** Gas fired forced hot air

Operated at time of inspection • Newer unit/not original to the structure - check all installation permits to ensure that this unit was installed to code

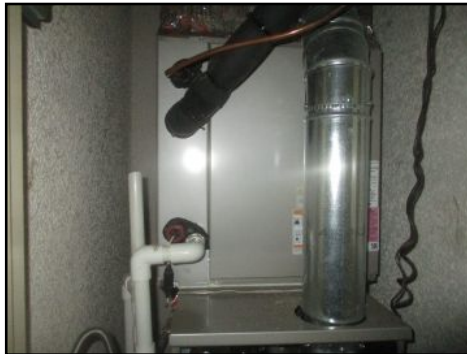
### 2. A/C Evaporator Coil Box

The visible areas of the coil box have normal wear at the time of inspection - no major visible defects

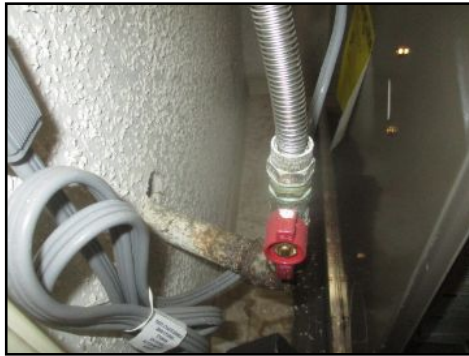
### 5. Gas Supply Valves and Pipes

Worn valve, consider upgrading to newer style valve

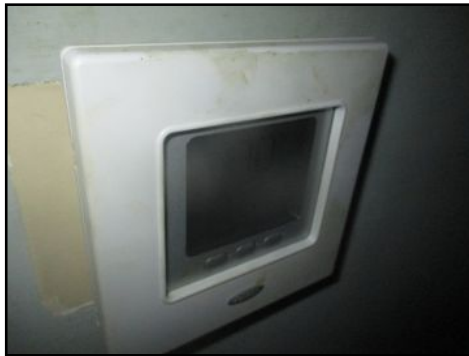
### 7. Thermostats

Digital type present - functional day of the inspection

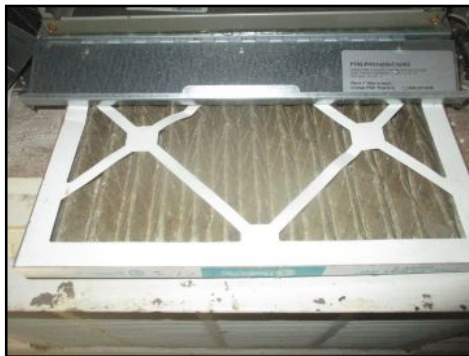
### 8. Filters

Filter size: 14"x25"x1" • Located below heater in a slot cut into the frame  
We recommend that the filters be changed or cleaned every 3 to 6 months depending on the usage of the heating and air conditioning systems • **Filter is worn/dirty - needs replacement**

**Filter is worn/dirty - needs replacement**

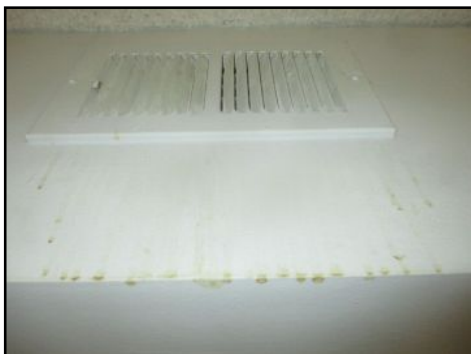
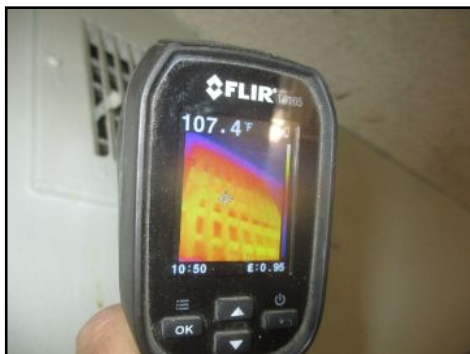
Heater Temperature at Registers: • **A/C** Temperature at Registers: • Temperature at Air Return: • **Visible register covers are worn and older - consider upgrading to newer style registers • Dirty/dusty registers - possible sign that ducts need cleaning - needs to be serviced • Rust present at register(s) - needs to be serviced • Air flow weak / moderate temperature differences measured at some registers when operating the HVAC system - recommend system and ducting evaluation by a licensed HVAC contractor.**

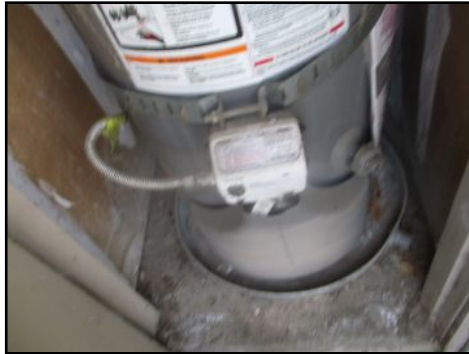
### 1. Water Heaters Condition

**Location/s:** Exterior closet

Operated at the time of the inspection - Gas unit • This is a newer unit (not original to this structure) - check all installation permits to ensure that this unit was installed to city code and manufacturer specifications

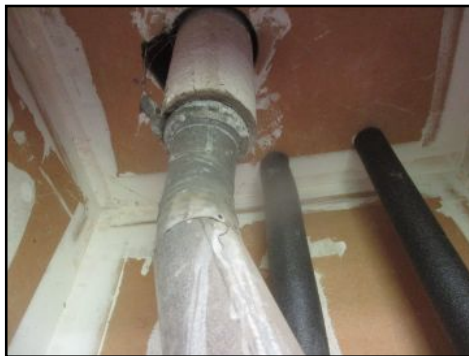
### 2. Venting

Vent is worn and older - consider upgrading vent • Masonry/cement/transite type chimney being used for newer water heater - needs to be serviced and possibly upgraded • Loose connections – needs to be serviced

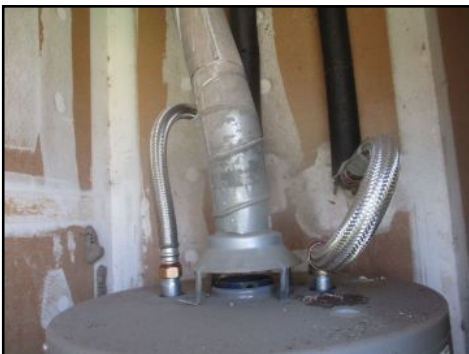
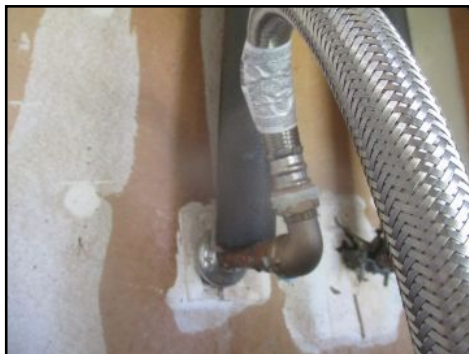
### 3. Plumbing

**Material type:** Copper • Insulated lines - plumbing is not fully visible

Worn valve/piping/connections - typical for age - no visible leaks found at the time of the inspection

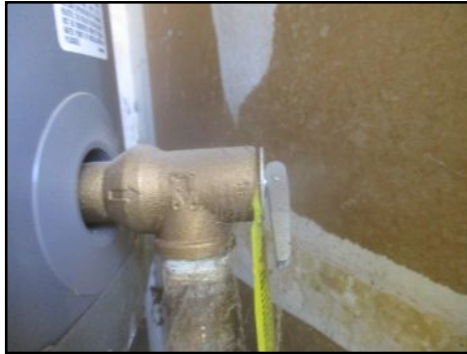
#### 4. Temperature Pressure Release Valves

Normal wear on the day of the inspection - no major visible defects

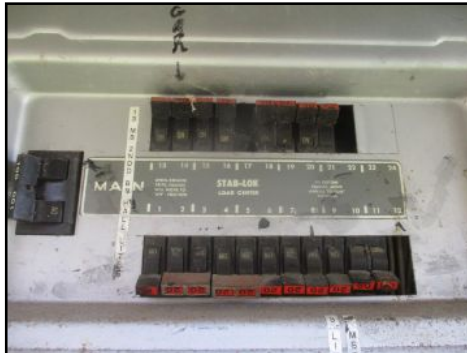
**Location/s:** South side of the structure

Worn/older panel - consider upgrading services • **Manufacture of panel a brand (Federal Pacific) known for issues - recommend further evaluation by a licensed electrician**

**Manufacture of panel a brand (Federal Pacific) known for issues - recommend further evaluation by a licensed electrician**

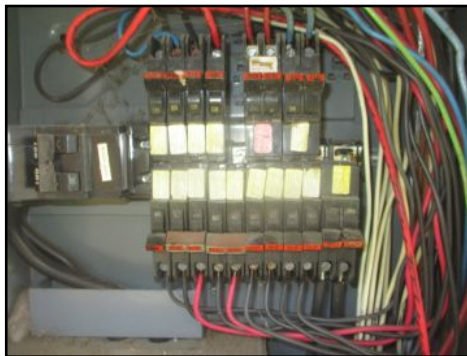
### 4. Breakers

No visible labeling for breakers on panel cover - needs to be serviced

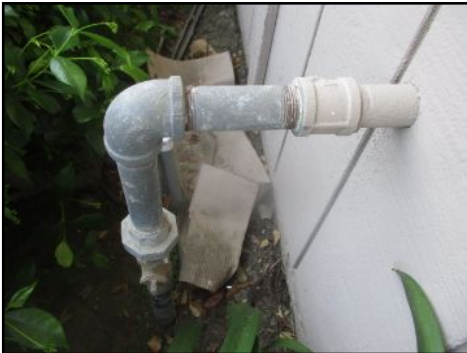
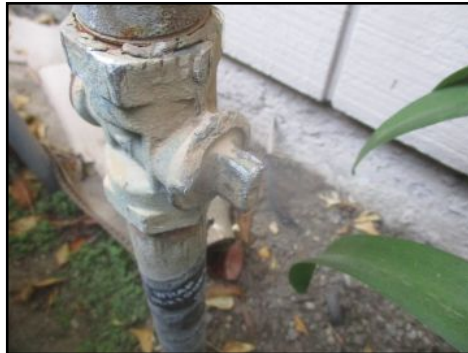
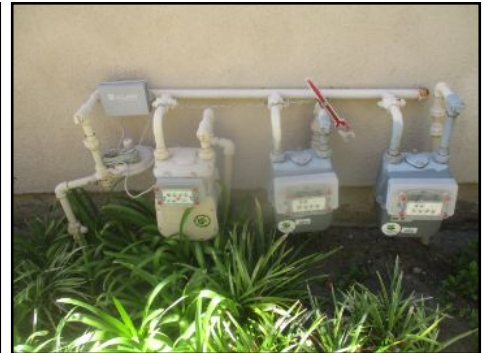
**Location:** We recommend the gas supplier be contacted to safety check all fuel gas systems/appliances during the contingency period or at least prior to purchase and occupancy. The Inspector cannot determine if a gas leak is present in any area of the home or underground at any time during the inspection. • East side of the structure

Natural gas present

- Worn valve - typical for age
- Recommend gas valve wrench be placed near valve for optimal preparedness
- Minor rusting - typical for exterior weathering - recommend rust treatment

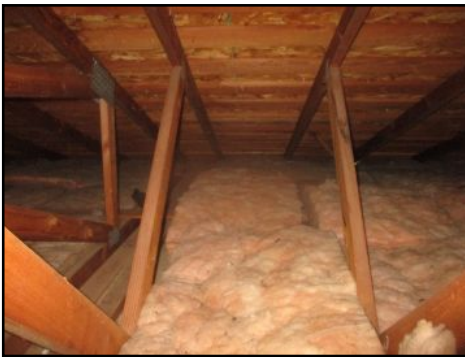
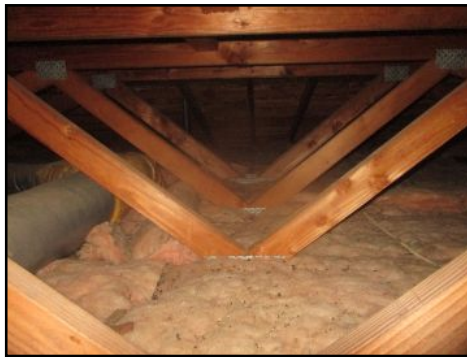
### 2. Structure

Conventional framing present, normal wear at time of inspection - no major visible defects • Cracking small at wood members - typical for age • Stains present on wood members of structure - evidence of past moisture entering structure- monitor for future moisture intrusion • Consult termite report for all wood areas in the attic • **Cracked wood/rafters- needs to be serviced**

**Cracked wood/rafters- needs to be serviced**

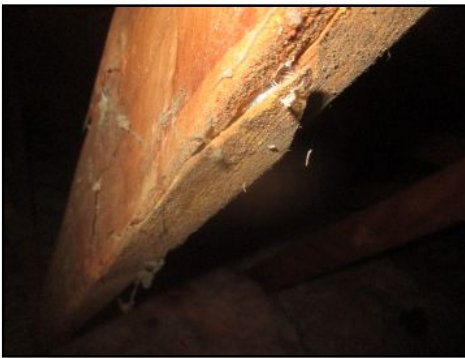
**Cracked wood/rafters- needs to be serviced**

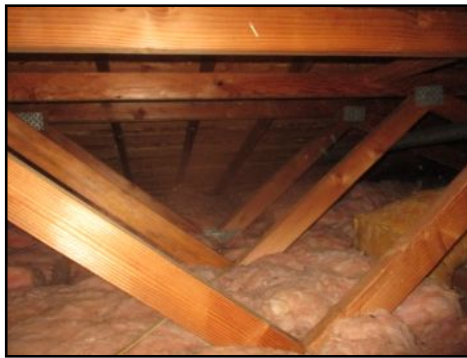
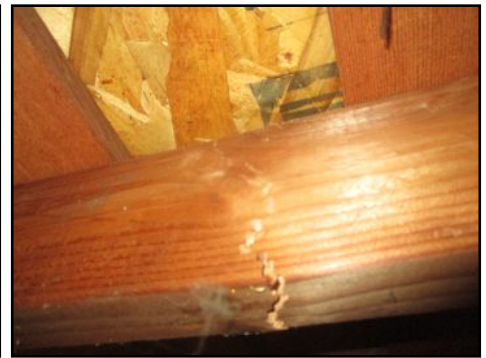
**Cracked wood/rafters- needs to be serviced**

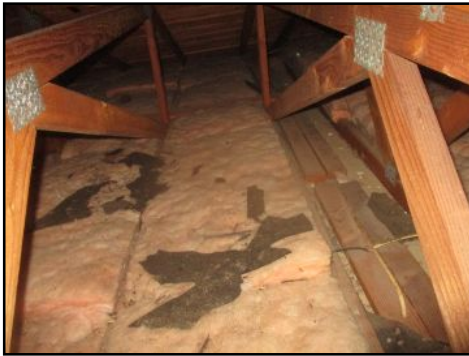
### 3. Insulation

**Evidence of rodent/bird/pest activity in the attic - recommend further evaluation by pest services company**

Evidence of rodent/bird/pest activity in the attic - recommend further evaluation by pest services company

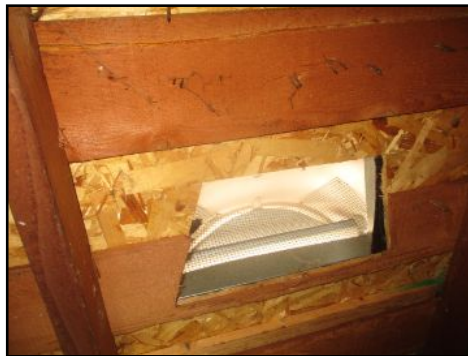
#### 4. Ventilation

Existing ventilation appeared to be adequate on the day of the inspection • Ridge and soffit vents appeared to be adequate on the day of the inspection

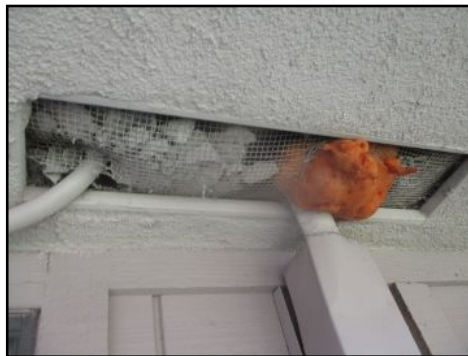
#### 5. Vent Screens

Visible ventilation screens appeared to be functional at time of inspection • Torn mesh/screens - needs to be serviced to prevent pest entry

Torn mesh/screens - needs to be serviced to prevent pest entry

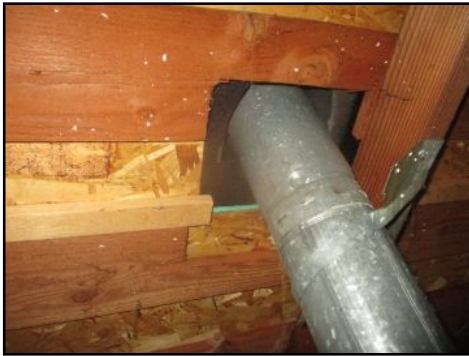
#### 6. Exhaust Vents

Some vents are not visible or accessible and cannot be inspected - N/A • Visible vents are older and worn - typical for the age of the structure - consider upgrading • Dryer vent appears to need cleaning/serviced - dryer lint escaping vent in attic - needs to be serviced

Dryer vent appears to need cleaning/serviced - dryer lint escaping vent in attic - needs to be serviced

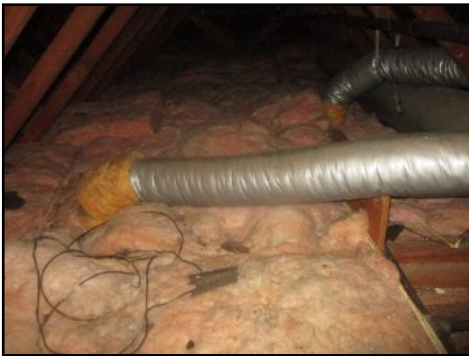
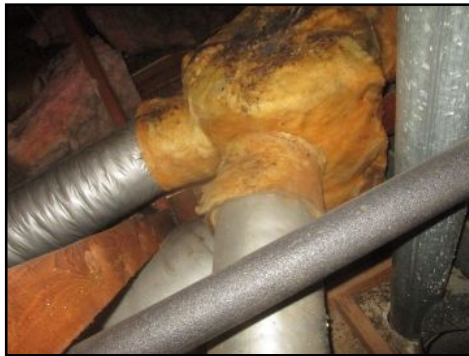
### 7. Duct Work

Older/worn ducts present - recommend routine maintenance and cleaning to extend the life of the existing ducts • Disconnected • Loose connections - needs to be serviced

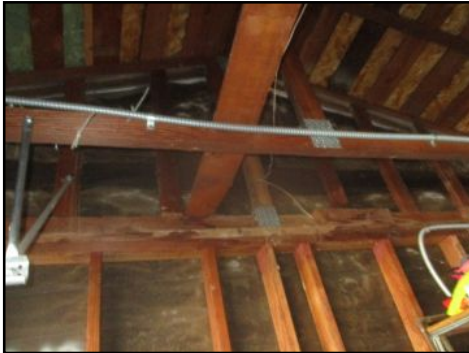
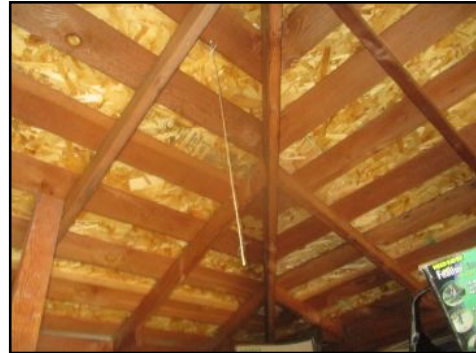
### 2. Rafters & Ceilings

Exposed wood rafters/joists - consult termite report for all wood • Some ceiling/rafter areas are not visible or accessible/inspected due to personal storage/wood boards

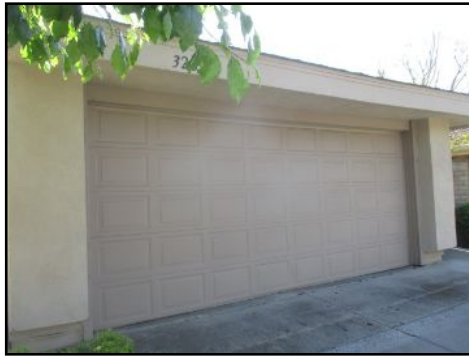
**General view**

**Type:** Metal sectional  
 Normal wear for age at the time of the inspection - no major visible defects

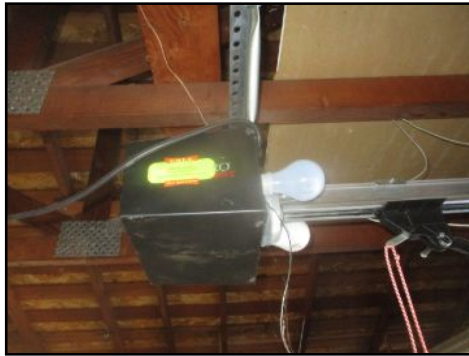
### 5. Garage Door Openers

Opener(s) operated at the time of the inspection

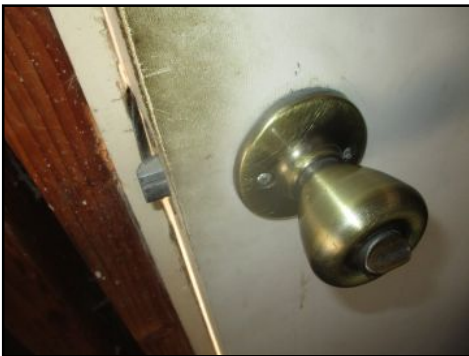
**Damaged jamb/trim - needs to be serviced - consult termite report**

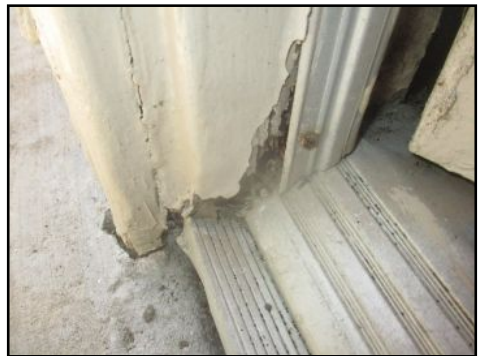
Worn/weathered door - typical for age • Recommend weather tight service/maintenance to prevent moisture intrusion • **Loose/worn hardware** • **Worn/weathered door** • **Did not latch - needs to be serviced** • **Damaged jamb/trim - needs to be serviced - consult termite report**

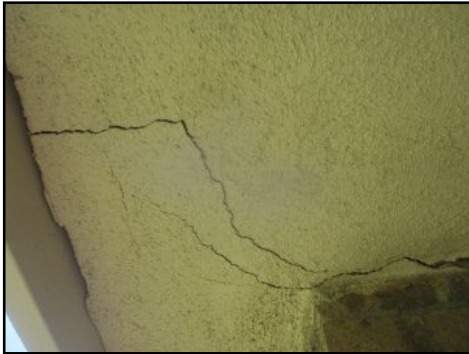
**Large cracking at soffit area(s) by chimney - needs to be serviced**

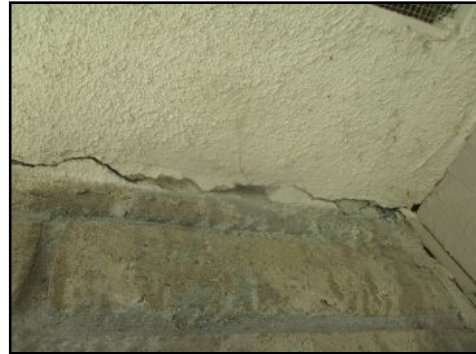
- Small cracking/chipping/holes present in areas - recommend stucco service/maintenance
- Patching present - consult seller for past repaired areas
- **Large cracking at soffit area(s) by chimney - needs to be serviced**

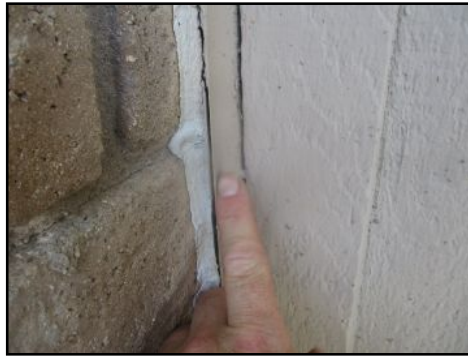
**Recommend general trim maintenance and sealing any holes/gaps**

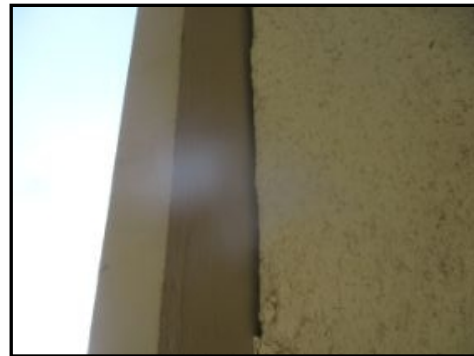
**Small gaps at wood trim/stucco junctures - needs to be sealed to prevent pest intrusion**

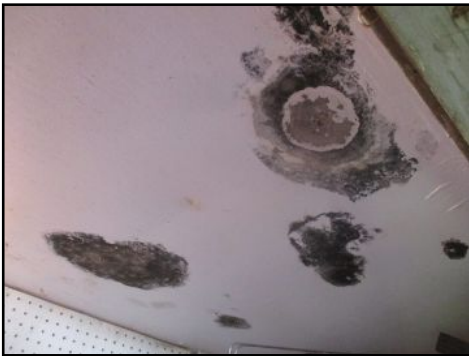
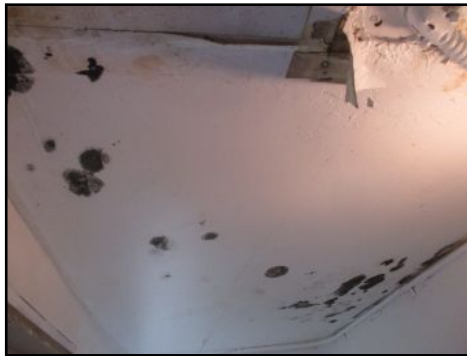
**Microbial growth/irregular staining present - further evaluation is recommended**

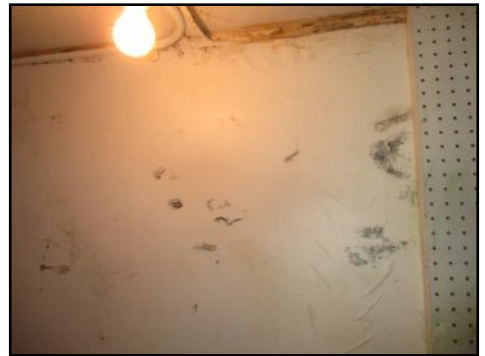
**Moisture damaged/blistered area(s) - moisture present at time of inspection - evidence of past moisture intrusion and/or roof leaking - needs to be serviced • Microbial growth/irregular staining present - further evaluation is recommended**

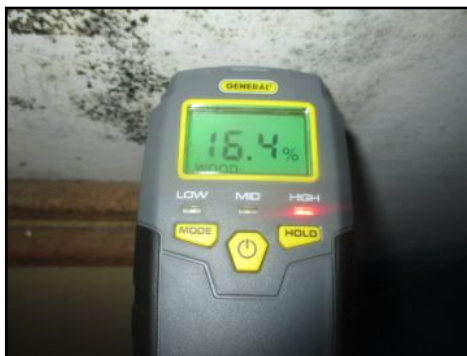
**Moisture damaged/blistered area(s) - moisture present at time of inspection - evidence of past moisture intrusion and/or roof leaking - needs to be serviced**

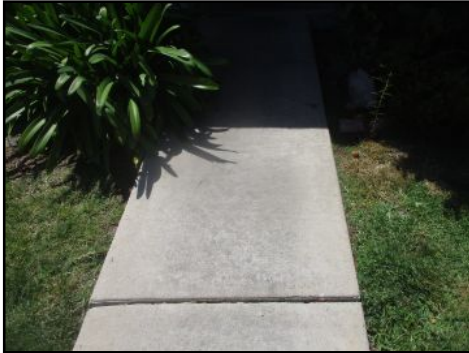
**Walkway/concrete displacement/uneven areas - needs to be serviced**

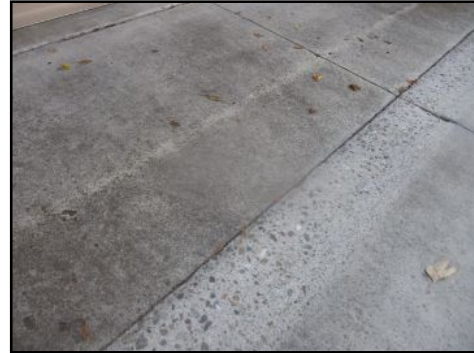
Common area – likely maintained by Home Owner’s Association - not inspected - consult HOA • Cracking/chipping small and typical for age • Tile and grout present in areas, tile surfaces may be slippery when wet • Worn tile and grout, recommend grout and sealer maintenance • **Walkway/concrete displacement/uneven areas - needs to be serviced**

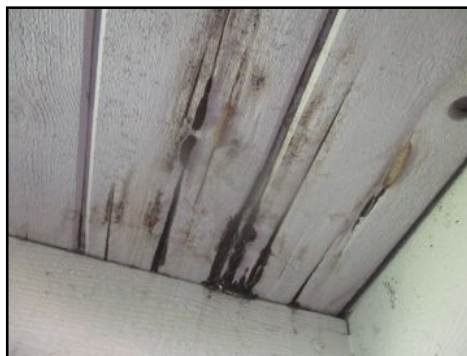
**Evidence of patio roof leaking - stained/moisture damaged/fungus present at under side - needs to be serviced**

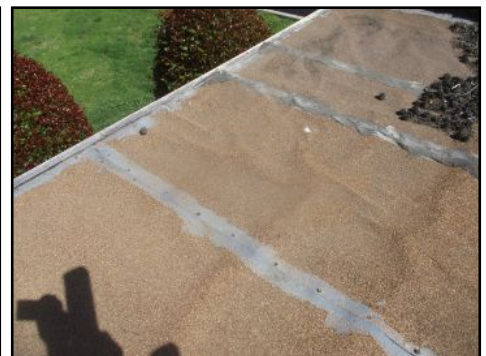
**Wrinkled/worn/weathered rolled materials**

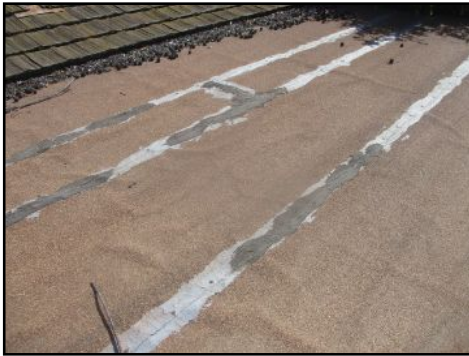
**Improper installation of rolled materials/fasteners/flashing(s)**

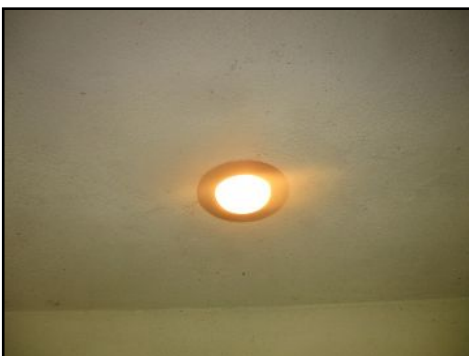
**Some light(s) did not function (some may be on sensors or timers) - check bulbs first, then consult an electrician to further evaluate as needed**

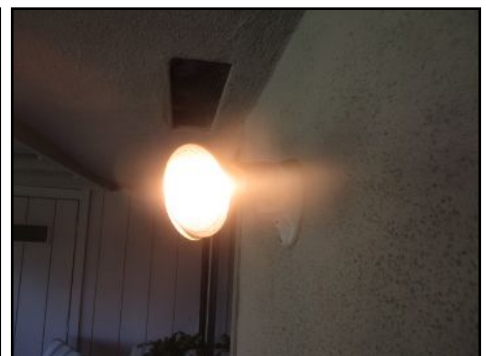
- Loose fixture(s) - needs to be serviced
- **Some light(s) did not function (some may be on sensors or timers) - check bulbs first, then consult an electrician to further evaluate as needed**

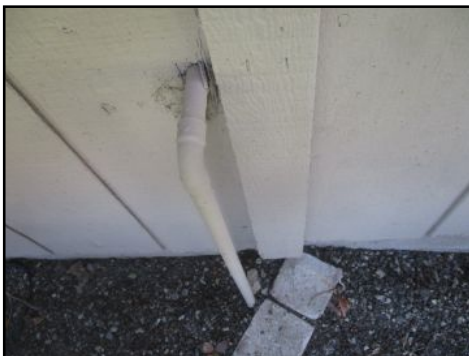
**Exterior plumbing is present and not original to the structure - check all installation permits to ensure installation to building code**

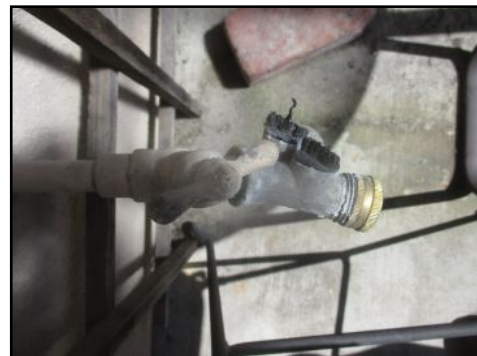
**Capped at exterior hose bibb - could not test - N/A**

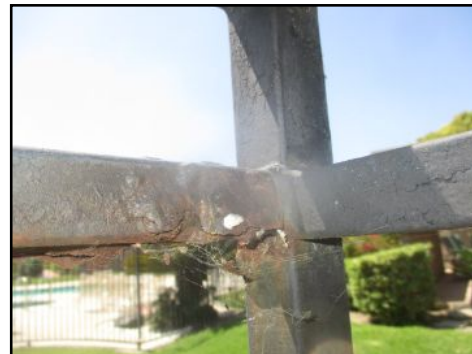
Visible fencing/wall areas are worn and weathered - typical for the age of the materials • Cracking small and typical for age - monitor for further cracking and repair as needed • Rust/rust damage at metal fence materials - needs to be serviced

Rust/rust damage at metal fence materials - needs to be serviced

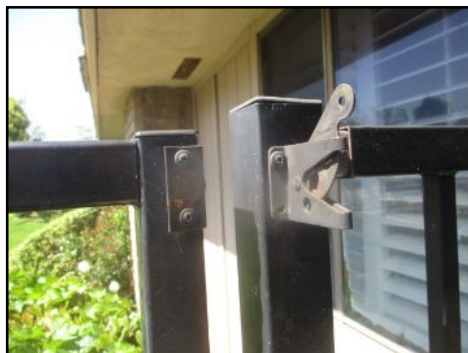
Loose/worn hardware - typical for age • Weathered and worn materials - typical for age • Gate not latching properly - missing hardware - at west side patio - needs to be serviced

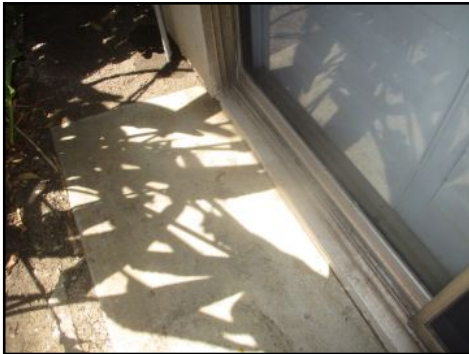
Exterior door landing/pad slopes toward structure

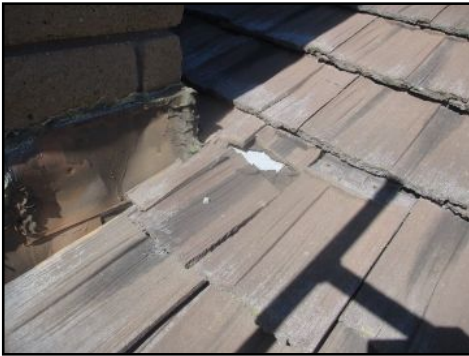
Cracked/broken/loose tiles in areas - needs to be serviced
