# ELITE GROUP

INSPECTION PROFESSIONALS

32021 Via La Plata , San Juan Capistrano, CA 92675  
Inspection prepared for: Suzette Cummings  
Real Estate Agent: Stuart Wann - First Team Real Estate

Date of Inspection: 4/23/2019 Time: 2:00 PM  
Age of Home: 1977 Size: 1350  
Weather: Sunny, warm, dry  
Order ID: 171751

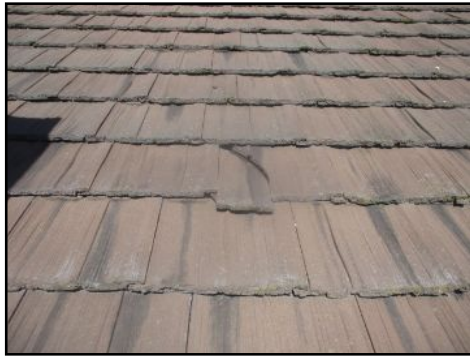
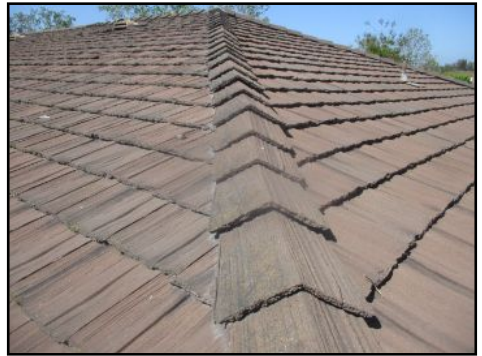
Common area/roof - Maintained by Homeowner's Association - Not Inspected • Cracked/chipped tiles/mortar - typical for age/materials - recommend seasonal roof maintenance • Moss growth present in areas - sign of moisture accumulation and lack of sunlight for drying - recommend servicing as part of seasonal maintenance • **Cracked/broken/loose tiles in areas - needs to be serviced**

Cracked/broken/loose tiles in areas - needs to be serviced

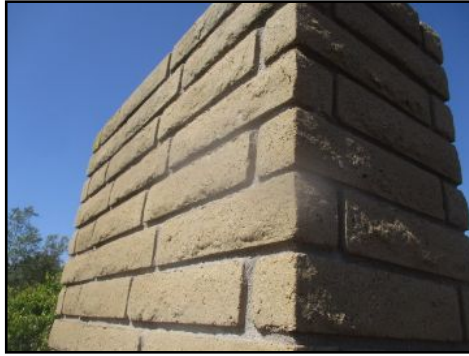
Worn/weathered chimney – recommend seasonal maintenance and care  
• Cracks in bricks - aesthetic but monitor • Roof not accessed - not visible for inspection
