WOOD DESTROYING PESTS AND ORGANISMS INSPECTION REPORT

Building No. 823	Street Plata Road	City Arroyo Grande	Zip 93420	Date of Inspection 05/24/2017	Number of Pages 1 of 5
---------------------	----------------------	-----------------------	--------------	----------------------------------	---------------------------

General Description: Two story; Single family residence; Stucco exterior; Composition shingle roof; Furnished and occupied.	Inspection Tag Posted: ATTIC
Other Tags Posted:

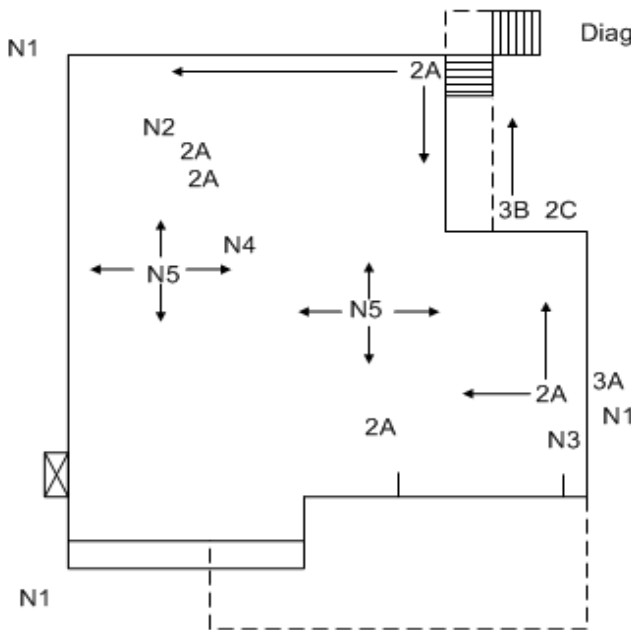
Diagram not to scale-Finding locations approximate

Finding: 2A Evidence of Drywood Termite infestation was found at the attic and appears to extend into inaccessible areas of the structure.

Finding: 2B Evidence of Drywood Termite infestation was found at the interior.

Finding: 2C Evidence of Drywood Termite infestation was found at the exterior.

Finding: 3A Fungus damage was found at the fascia of the eave area.

Finding: 3B Fungus and drywood termite damage was found at the second story fascia of the eave area.

Recommendation: Seal the structure and fumigate with a gas lethal to Drywood Termites (Sulfuryl Fluoride) . All occupants and pets must vacate the structure until the fumigation is complete. This company will exercise reasonable caution, but cannot be held responsible for damage to plants, TV antennas or roofing due to the fumigation. Further terms and instructions will be supplied upon request or upon scheduling of the fumigation. Information may also be obtained from the fumigation page on our website at www.keytermite.com
*****Fumigations are guaranteed for 5 years from the date completed*****

Recommendation: Replace the fungus damaged portions of fascia as needed.
