# WOOD DESTROYING PESTS AND ORGANISMS INSPECTION REPORT

Building No. 998	Street Park Avenue	City Cayucos	Zip 93430	Date of Inspection 10/09/2017	Number of Pages 1 of 8
---------------------	-----------------------	-----------------	--------------	----------------------------------	---------------------------

**Report #: 86437**

General Description: Two story; Single family residence; Brick and wood exterior; Hot mop and Compston roof; Furnished and occupied.	Inspection Tag Posted: GARAGE  Other Tags Posted:
---	--

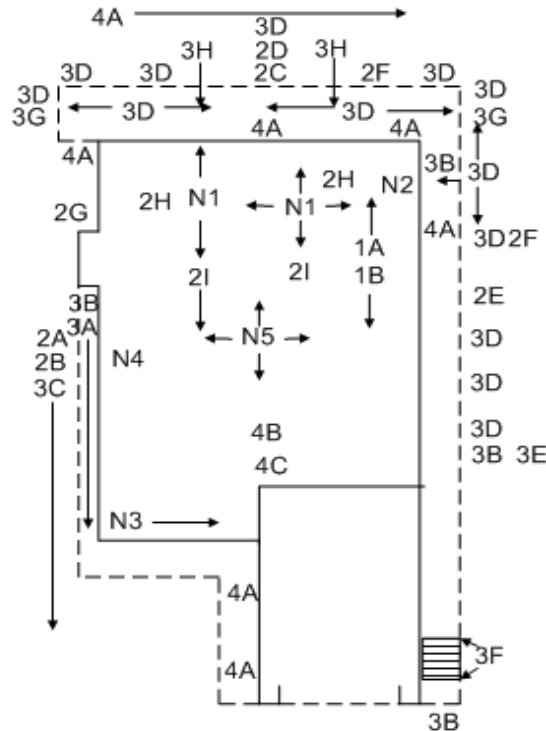
\*\*\*Complete Inspection Report\*\*\*  
 Diagram not to scale-Finding locations approximate

Finding: 1A Evidence of Subterranean Termite infestation was found at the substructure and indicates an infestation in the soil below the structure.

Finding: 1B Subterranean Termite damage was noted at the substructure post.

Finding: 2A Evidence of Drywood Termite infestation was found at the exterior and appears to extend into inaccessible areas of the structure.

Finding: 2B Drywood Termite damage was found at the handrail.

Finding: 2C Drywood Termite damage was found at the deck support.

Finding: 2D Drywood Termite damage was found at the deck fascia.  
Recommendation: Remove and replace the damaged portion of the deck fascia as needed.  
Note: Included in 3D  
Price: Included as noted in recommendation.

Finding: 2E Drywood Termite damage was found at the deck planking.  
Recommendation: Remove and replace the damaged portion of the deck planking as needed.  
Note: Included in 3D  
Price: Included as noted in recommendation.

Finding: 2F Minor Drywood Termite damage was found at the deck joist.  
Recommendation: Repair the minor damage of the wood member with a wood filler.  
Note: Included in 3D  
Price: Included as noted in recommendation.

Finding: 2G Drywood Termite damage was found at the boxed eave trim.  
Recommendation: Remove and replace the damaged portion of the boxed eave trim as needed.  
Price: \$178.00

Finding: 2H Evidence of Drywood Termite infestation was found at the interior.  
Recommendation: Refer to item 2A for recommendation. Cost included in item 2A.  
Price: Included as noted in recommendation.

Finding: 2I Minor Drywood Termite damage was found at the 6x10 interior beam.  
Recommendation: Repair the minor damage of the wood member with a wood filler.  
Price: \$890.00

Finding: 3A Fungus damage was found at the roof sheathing of the eave area.  
Recommendation: Replace the fungus damaged portions of roof sheathing as needed.  
Note: If damage is found to be extending into inaccessible areas, a supplemental report may be issued with further findings, recommendations, and costs.  
Price: \$267.00

Finding: 3B Fungus damage was found at the wood siding.  
Recommendation: Replace the damaged portions of the wood siding. Note: In cases of plywood siding, repair may involve installing wood trim in place of siding removed and/or metal flashing at cut sections of siding replacement. Additional costs will apply if replacement of full sheet(s) of plywood siding is desired by the parties in interest.  
Price: \$3,560.00

Finding: 3C Fungus damage was found in the deck handrail.  
Recommendation: Replace the fungus damaged portions of the handrail as needed.  
Note: Included in 3D  
Price: Included as noted in recommendation.

Finding: 3D Fungus infection and damage were found in the wood deck throughout the decking and framing.

Finding: 3E Fungus damage was found at the exterior wood trim.  
Recommendation: Replace the damaged portions of the trim as necessary.  
Price: \$178.00

Finding: 3F Fungus damage was found in the wood stairway.  
Recommendation: Replace the fungus damaged portions of the wood stairway as needed. This may involve complete replacement.  
Price: \$801.00

Finding: 3G Fungus damage was found at the decorative wind break.  
Recommendation: Remove and replace the damaged portions of the decorative wind break as needed to eliminate the fungus infection and damage.  
Price: \$1,246.00

Finding: 3H Fungus damage was found at the 6x12 beam.  
Recommendation: Remove and replace the damaged portions of the beam as needed to eliminate the fungus infection and damage.  
Note: If damage is found to be extending into inaccessible areas, a supplemental report may be issued with further findings, recommendations, and costs.  
Price: \$6,923.00

Finding: 4A Moisture damage was noted at the siding and appears to have been caused by a previous moisture condition.  
Recommendation: Remove and replace the damaged portions of the siding as needed.  
Price: \$2,225.00

Finding: 4B An excessive moisture condition exists due to plumbing leakage at the lower level bathroom wall.  
Recommendation: Contact a licensed plumber to correct the excessive moisture condition.  
Price: No Bid offered at this time. Owner should contact appropriate tradesman to complete recommended corrections.

Finding: 4C The toilet was found to be loosely bolted to the floor. This creates a potential source of leakage.  
Recommendation: Reset the toilet using a new wax seal and bolts. Additional costs may apply if the toilet flange is found to be damaged or if existing supply line/valve cannot be reused.  
Price: No Bid offered at this time. Owner should contact appropriate tradesman to complete recommended corrections.

Recommendation: Chemically treat the soil in areas of Subterranean Termite activity using Termidor (fipronil). In addition, an application will be made to the soil adjacent to the exterior wall around the complete perimeter of the structure. Holes may be drilled through concrete, paving or masonry adjacent to the foundation in areas such as, but not limited to; patios, sidewalks, porches and driveways, to allow for chemical treatment of the soil below. We will exercise reasonable caution when drilling but assume no liability for damage to hidden plumbing, electrical, or other utility below these areas. The location of such utilities should be identified prior to our arrival. Regardless of locations of Subterranean Termite infestation found, control of the entire structure is guaranteed. Control is guaranteed by Key Termite and Pest Control for a period of 5 years from the date of treatment.

Recommendation: Remove and replace the damaged wood members noted.

Recommendation: Seal the structure and fumigate with a gas lethal to Drywood Termites (Sulfuryl Fluoride). All occupants and pets must vacate the structure until the fumigation is complete. This company will exercise reasonable caution, but cannot be held responsible for damage to plants, TV antennas or roofing due to the fumigation. Further terms and instructions will be supplied upon request or upon scheduling of the fumigation. Information may also be obtained from the fumigation page on our website at [www.keytermite.com](http://www.keytermite.com)

Recommendation: Remove and replace the damaged portion of the handrail as needed.

Recommendation: Remove and replace the damaged portion of the deck support as needed.

Recommendation: Remove and replace the damaged woodmembers of the deck. This will most likely involve complete replacement of the wood deck. In areas where a sound wood member is not replaced and VERY MINOR surface fungus growth is present but no detectable deterioration has occurred, scrape away the surface growth with a wire brush and chemically treat the woodmember with disodium octaborate tetrahydrate or copper naphthenate. Repair includes replacement with nailed con-common redwood decking and doug-fir framing. Additional costs for upgrades to deck screws, con-heart, deck-heart, synthetic decking or pressure treated framing will be quoted upon request.
