# Inspection Report

**Property Address:**  
30924 Rue De La Pierre  
Rancho Palos Verdes CA 90275

<b>Property Address</b> 30924 Rue De La Pierre Rancho Palos Verdes CA 90275	<b>Date of Inspection</b> 6/28/2021	<b>Report ID</b> 210628-01
<b>Customer(s)</b> Nicholas Mack	<b>Time of Inspection</b> 09:00 AM	<b>Real Estate Agent</b> Thomas Royds Redfin

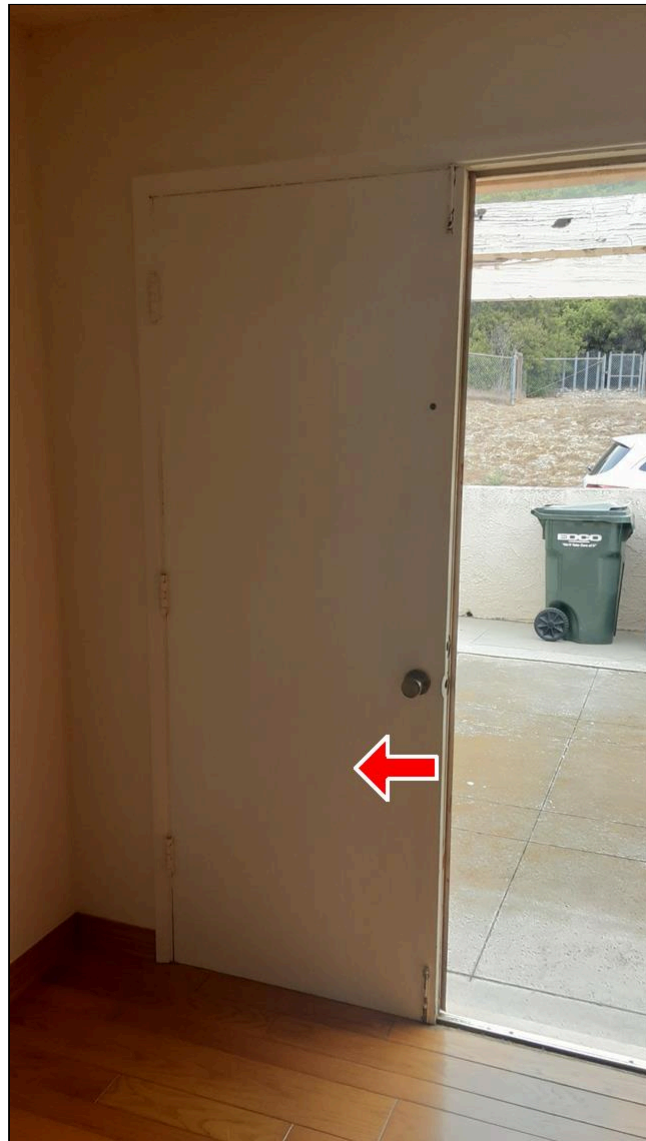
**1.2 (1)** Front entry stationary door would not open properly at time of inspection. Recommend a qualified person further inspect for repair or replacement recommendations.

1.2 Item 1(Picture) Front entry door

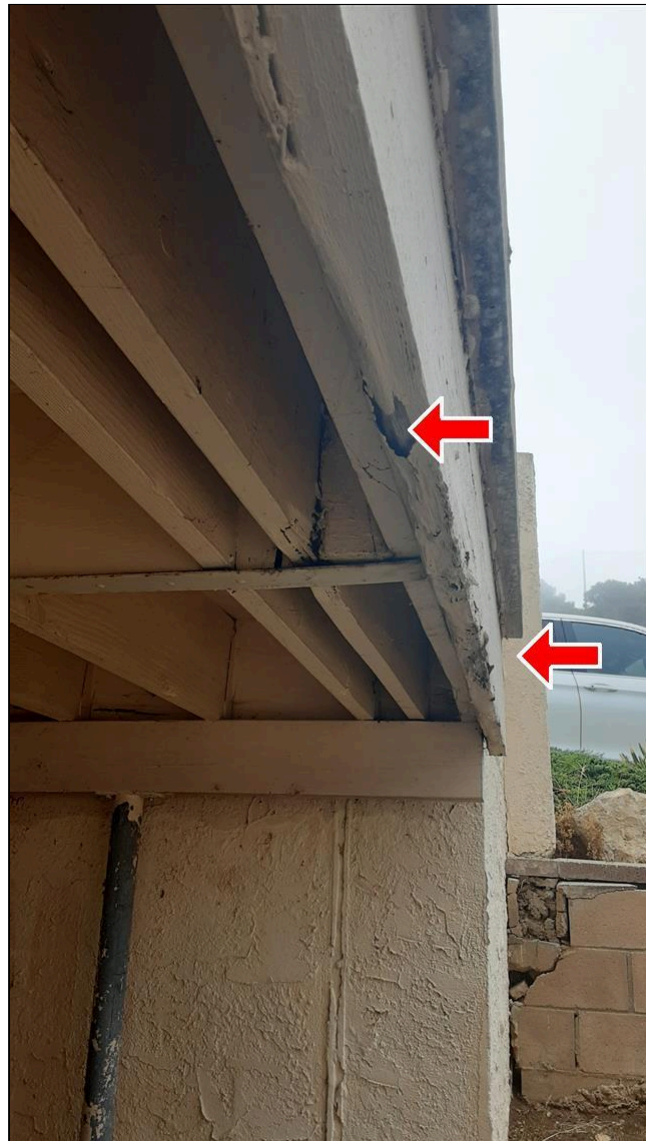
1.5 Wood damage found to bridge structure on main entry walkway. Recommend a qualified person further inspect for repair or replacement recommendations.

1.5 Item 1(Picture) Wood damage, main entry bridge

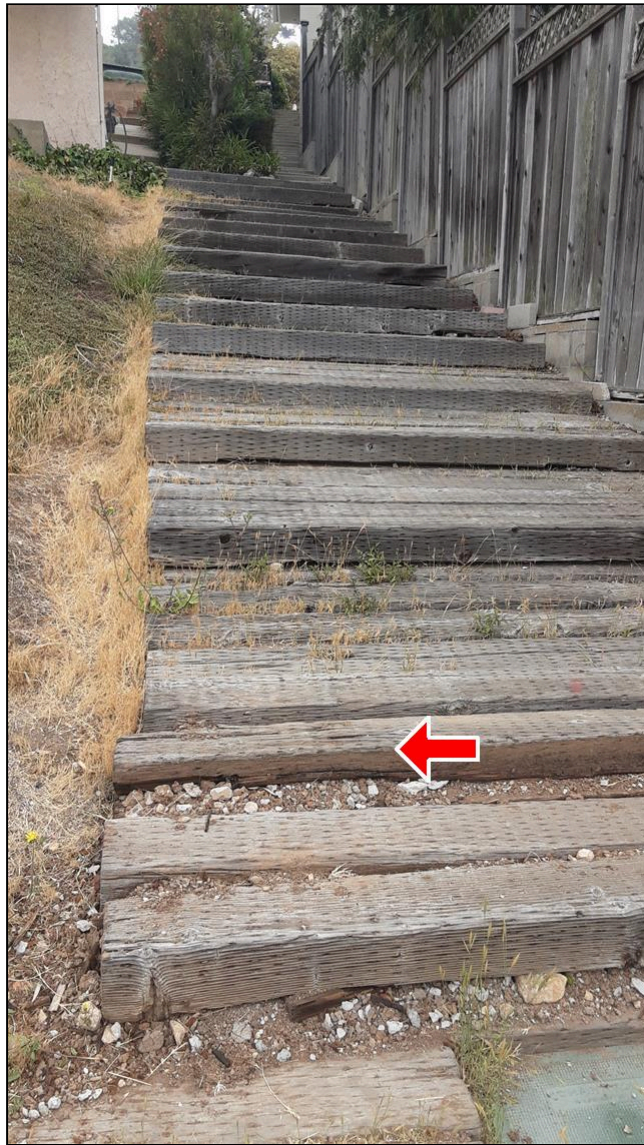
**1.6 (1)** Wood planks used as steps leading to west side of property are loose and unstable. Steps have potential tripping hazards. Recommend a qualified person further inspect for repair or replacement recommendations.

1.6 Item 1(Picture) Steps leading to west side

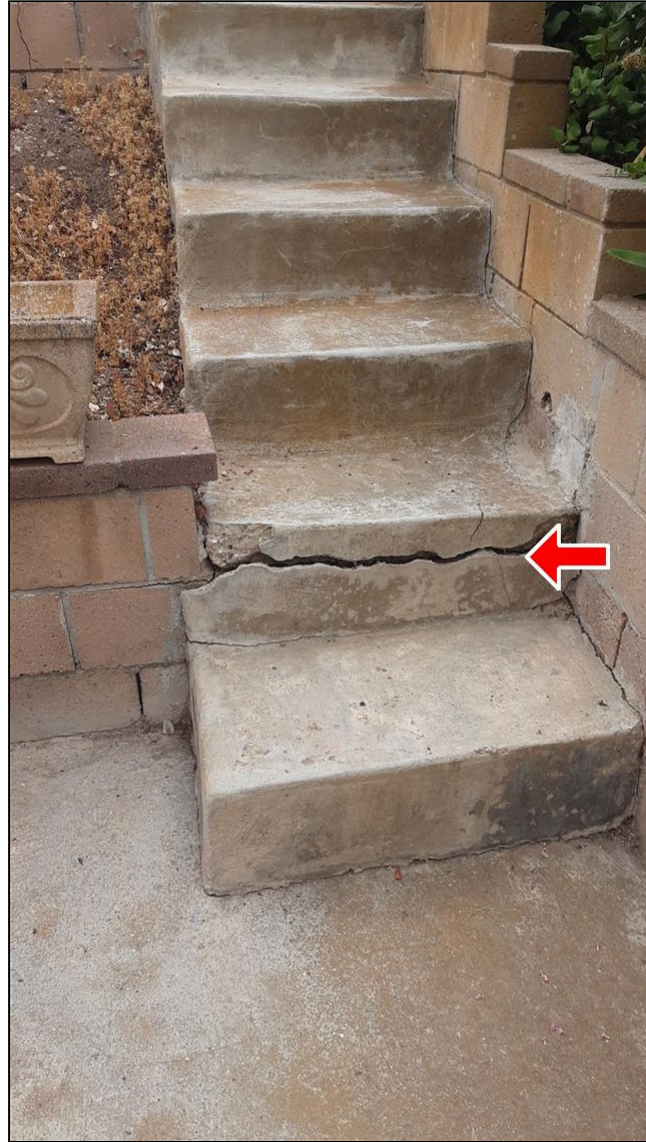
1.6 (2) Concrete steps leading to front patio are cracked and settling. Recommend a qualified person further inspect for repair recommendations.

1.6 Item 2(Picture) Cracking steps leading to front patio

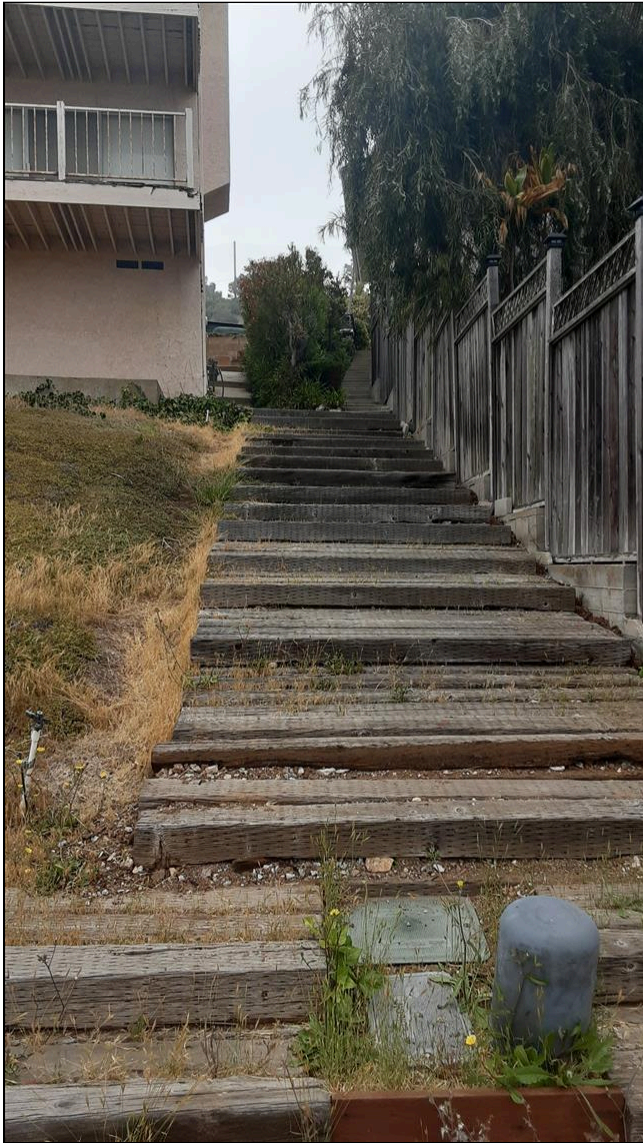
1.7 (1) Shared steps leading to the west side of property and steps leading to front patio do not have a railing. All steps with three or more risers should have a railing. Recommend a qualified person further inspect for installation recommendations.

1.7 Item 1(Picture) Missing railing, steps leading to west side

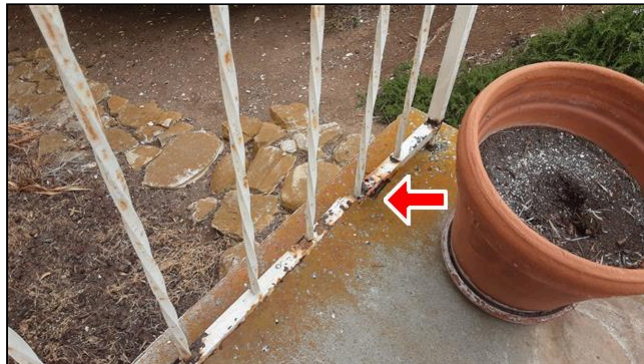
1.7 Item 3(Picture) Damaged railing

1.7 (2) Railings throughout property (front entry and balcony) are rusted and deteriorated in multiple areas. Recommend a qualified person further inspect all railings for repair or replacement recommendations.

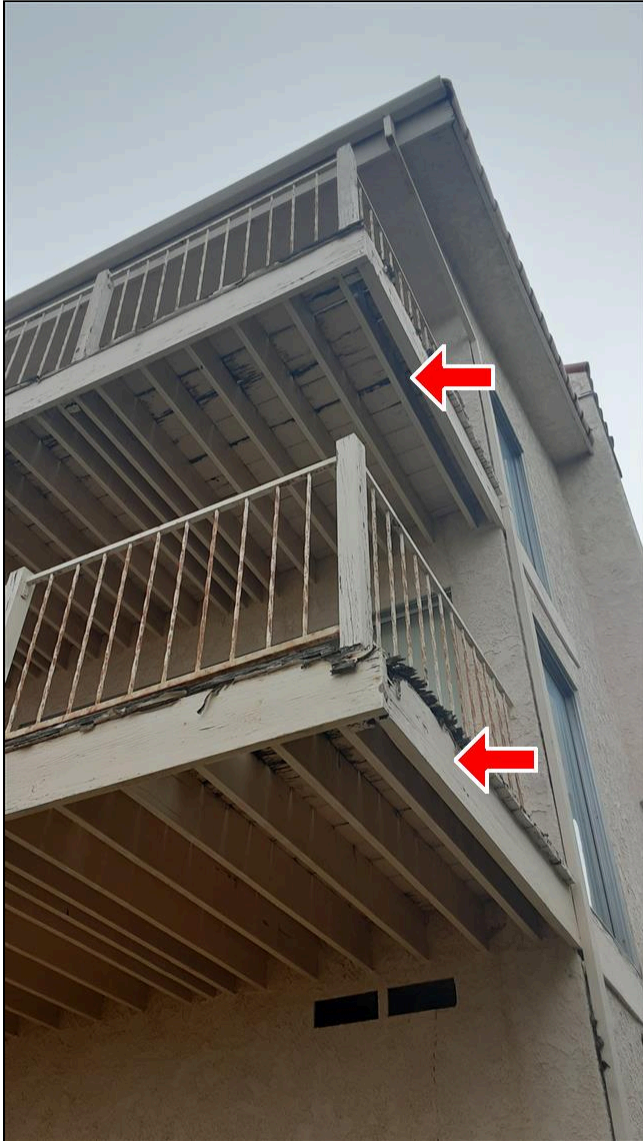
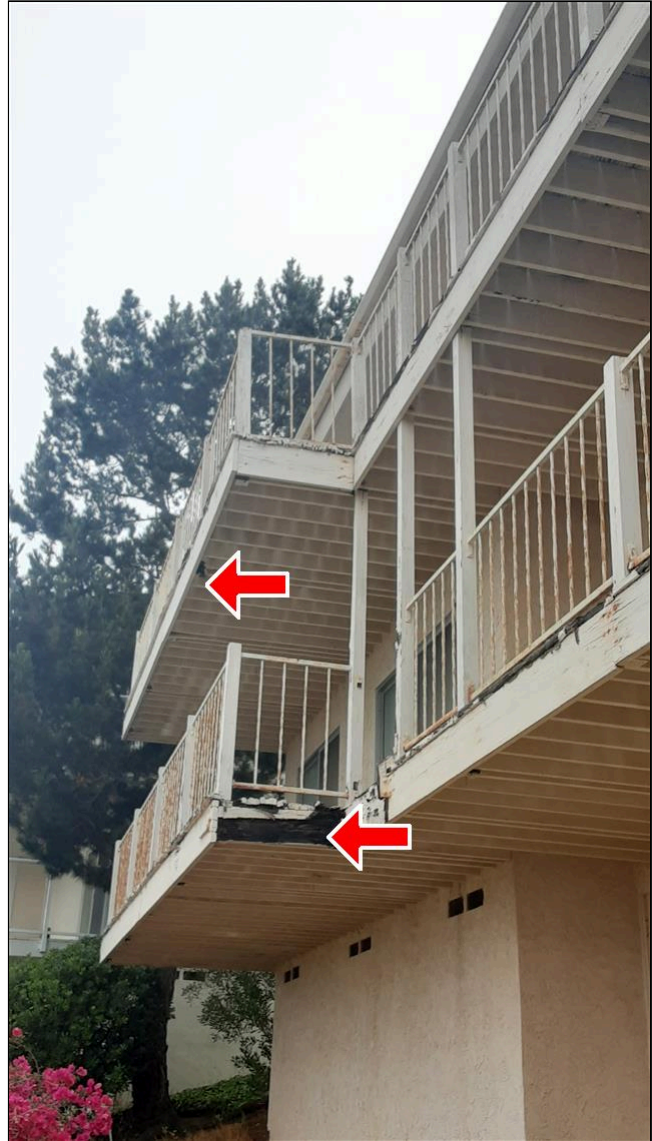
1.8 (1) Balcony structure on west side of home has significant wood damage. Wood structure and deck boards are in damaged condition and were not safe to walk on. Recommend a qualified person further inspect balcony structure for repair or replacement recommendations.

1.8 Item 1(Picture) Wood damage, balcony

1.8 Item 2(Picture) Wood damage, balcony

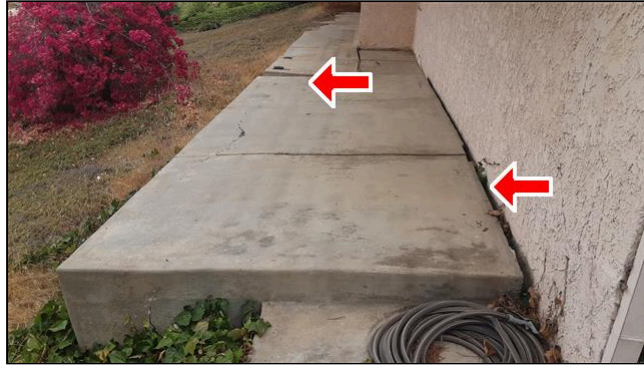
1.8 Item 3(Picture) Concrete damage, west side

**1.8 (2)** Concrete patio/landing at west side of home has significant settlement and separation from exterior siding. Possible tripping hazards are present. Recommend a qualified person further inspect concrete slab for repair or replacement recommendations.

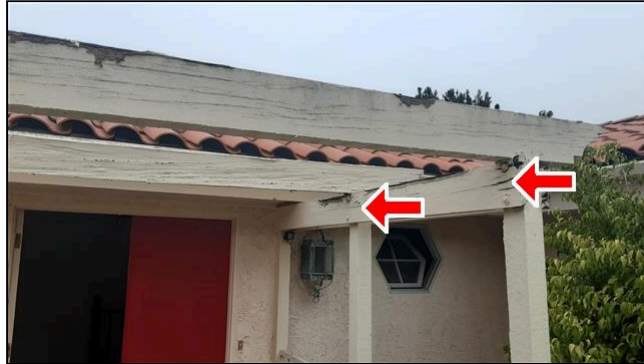
1.8 Item 4(Picture) Wood damage, front entry

**1.8 (3)** Front entry structure has visible wood damage. Recommend a qualified person further inspect wood structure for repair or replacement recommendations.

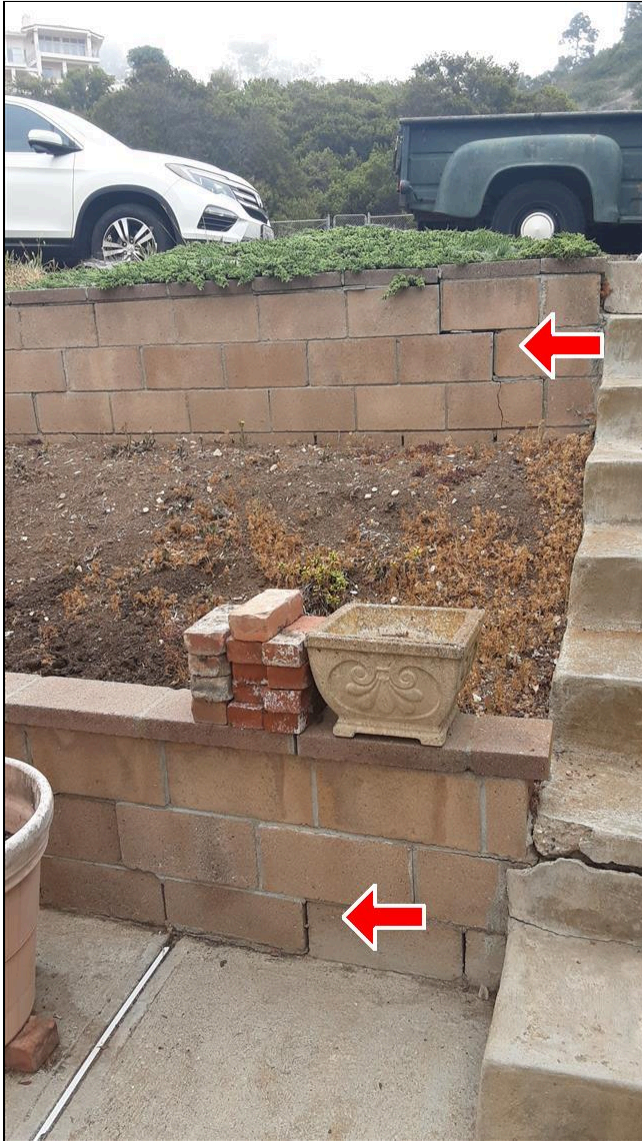
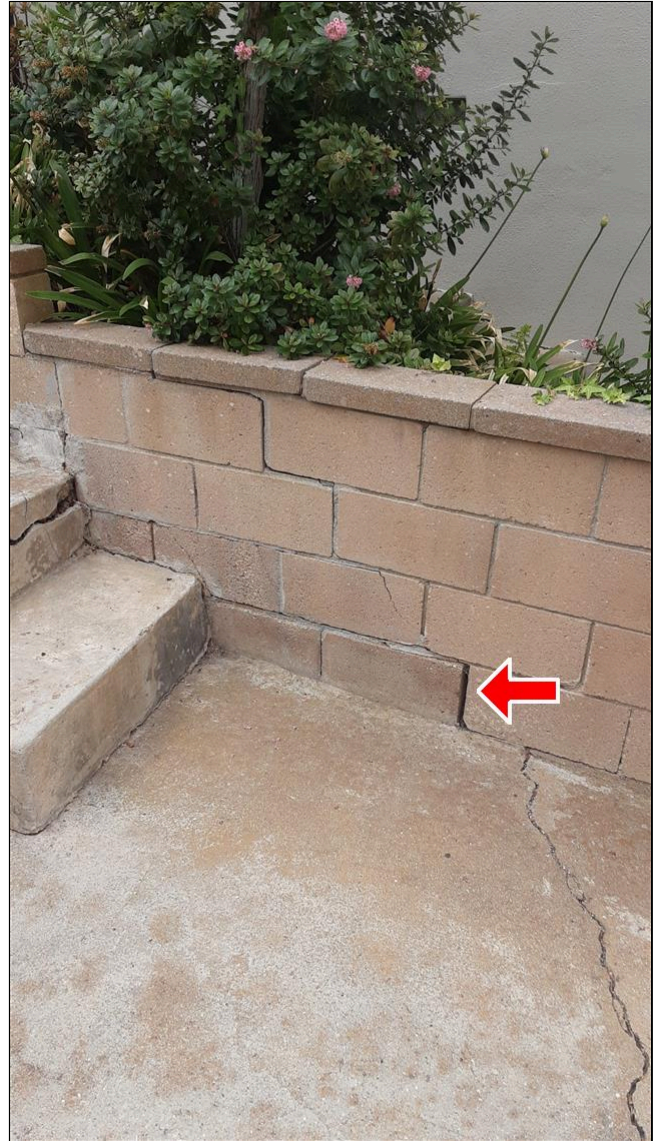
**1.9 Multiple retaining walls throughout property are settling and have visible damage. Recommend a qualified person further inspect for repair or replacement recommendations.**

1.9 Item 1(Picture) Retaining walls

1.9 Item 2(Picture) Retaining wall

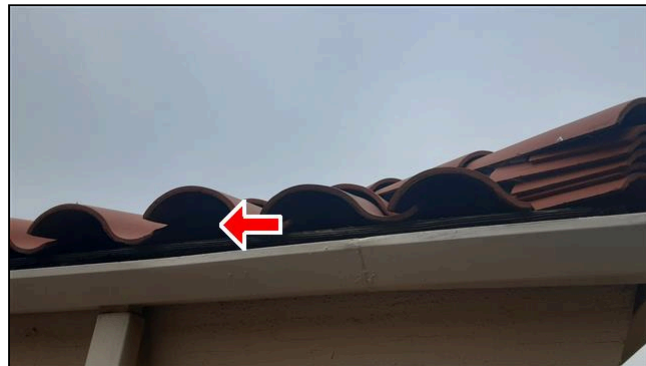
2.0 Item 1(Picture) Missing bird stops

**2.0 (1)** Roof tiles are missing bird stops at roof edge. Bird stops prevent birds and insects from entering below roof covering and nesting. Recommend a qualified person further inspect for repair recommendations.

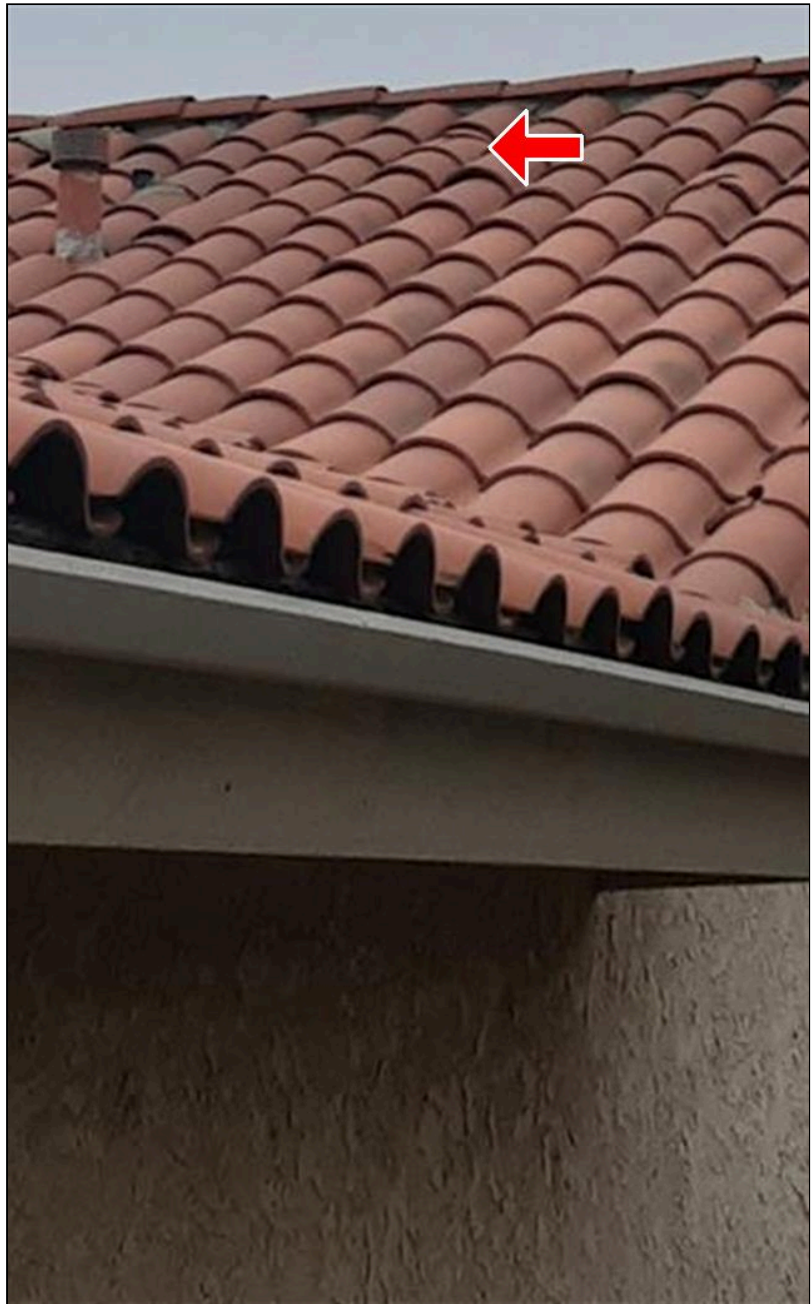
**2.0 (2)** Multiple roof tiles are cracked or damaged. Recommend a qualified roof specialist further inspect for repair recommendations.

2.0 Item 2(Picture) Cracked roof tile

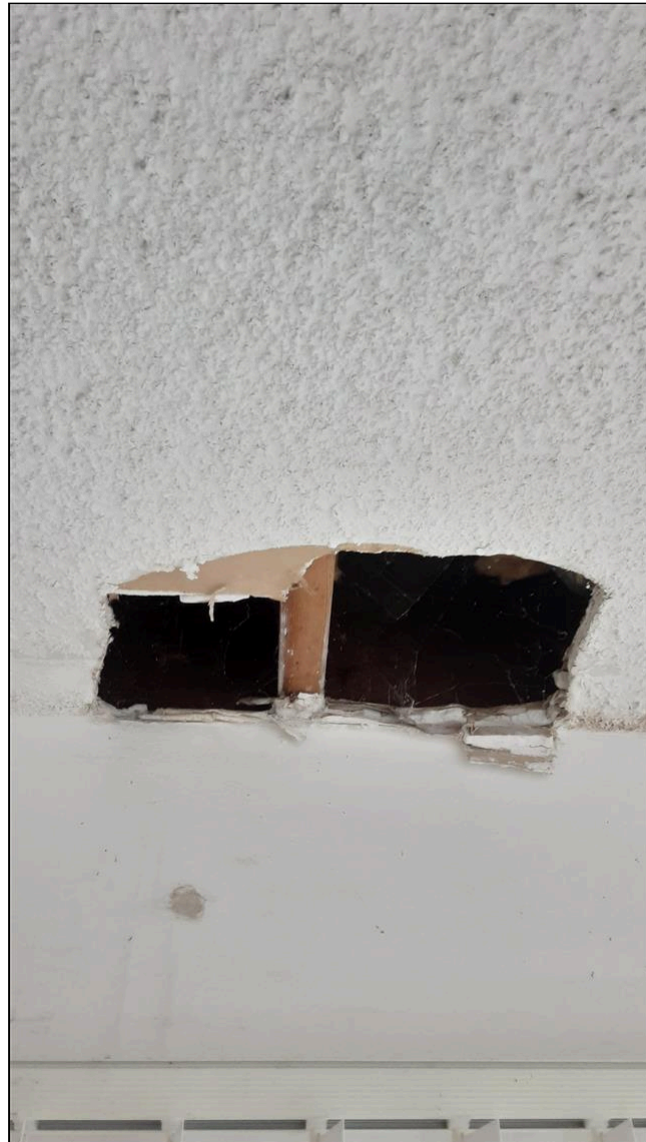
**4.0 (2)** Damaged ceiling inside lower level northwest bedroom. Recommend a qualified person further inspect for repair or replacement recommendation.

4.0 Item 1(Picture) Ceiling damage, lower level northwest bedroom

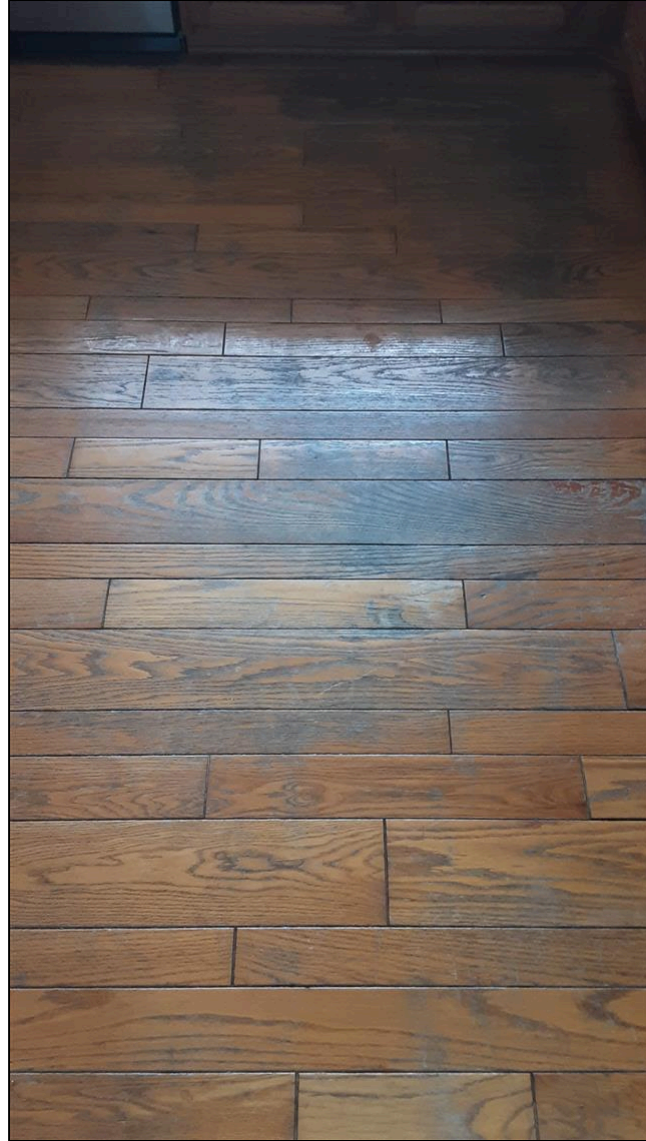
**4.2 (1)** Hardwood floors have multiple marks and significant wear and tear. Recommend a qualified flooring specialist further inspect for repair recommendations.

4.2 Item 1(Picture) Wear and tear

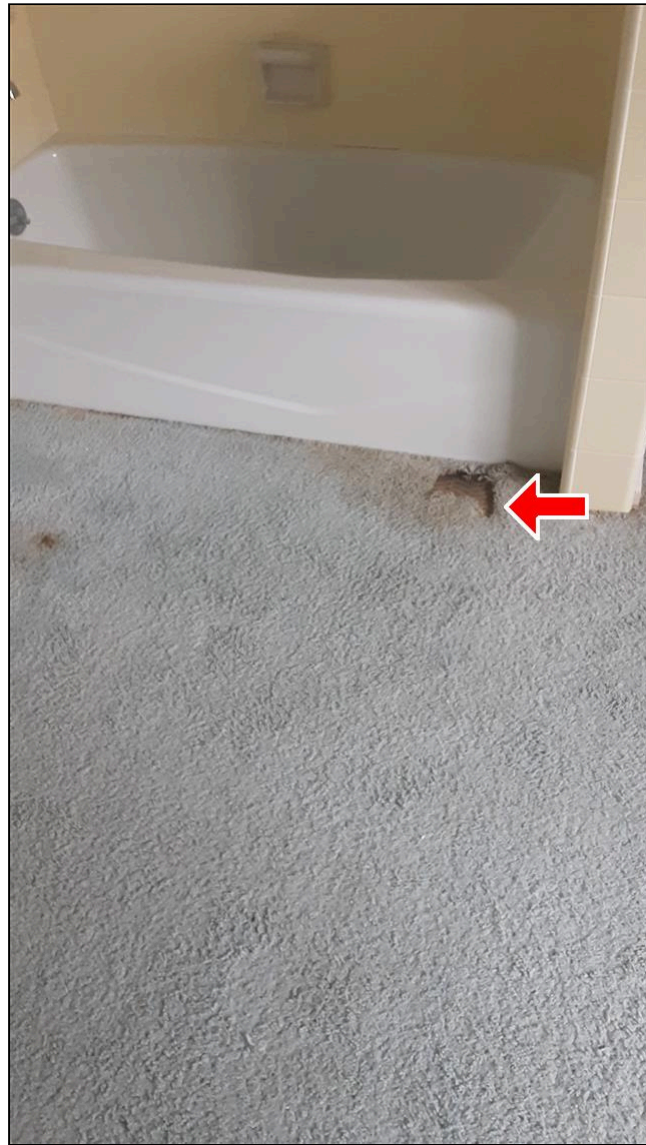
4.2 (2) Carpet throughout home is dated, damaged, or stained in areas throughout. Recommend a qualified floor specialist repair or replace carpeting as needed.

4.2 Item 2(Picture) Damaged carpet

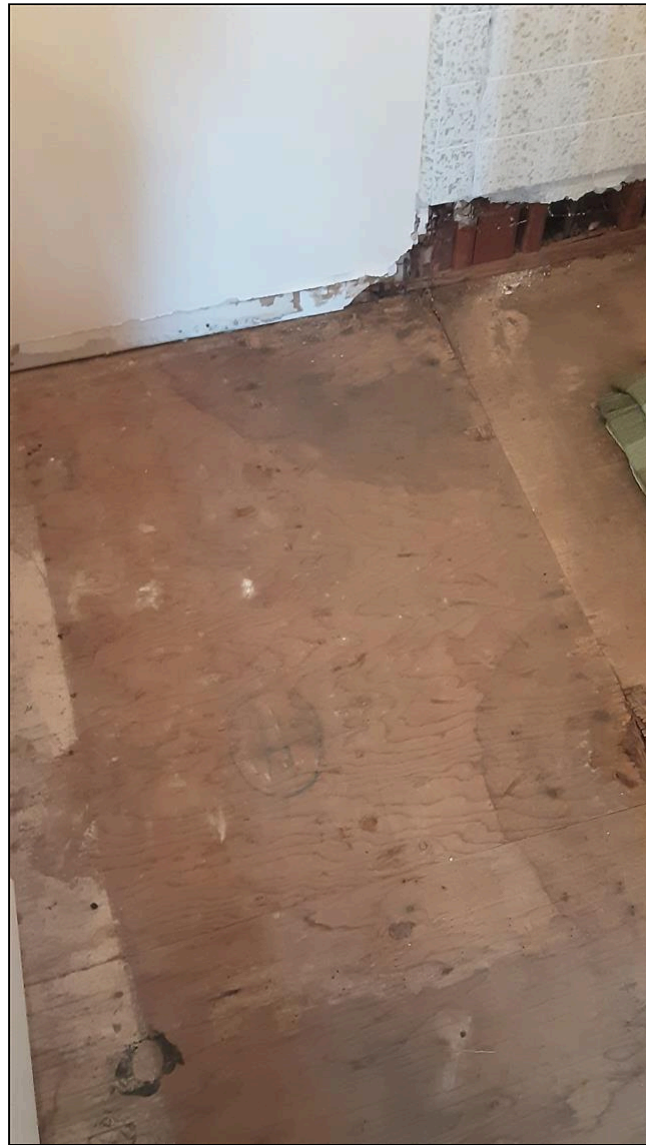
**4.2 (3)** Lower level hall bathroom is missing flooring. Recommend a qualified person further inspect for repair recommendations.

4.2 Item 3(Picture) Missing flooring, lower level hall bathroom

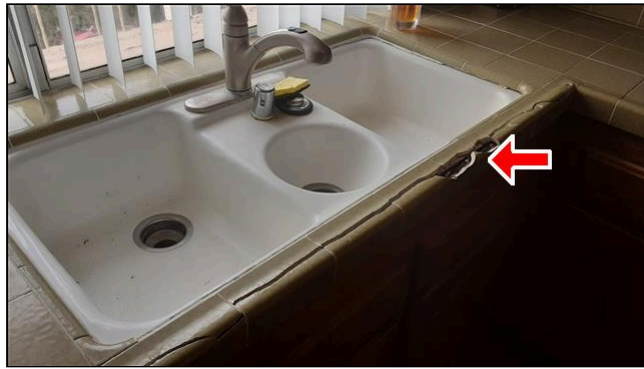
4.5 Item 1(Picture) Kitchen countertop, tile damage

**4.5 (1)** Significant damage to tile countertop inside the kitchen. Tile is a possible lead material. Recommend a qualified licensed environmental specialist further inspect prior to repairs or disturbing.

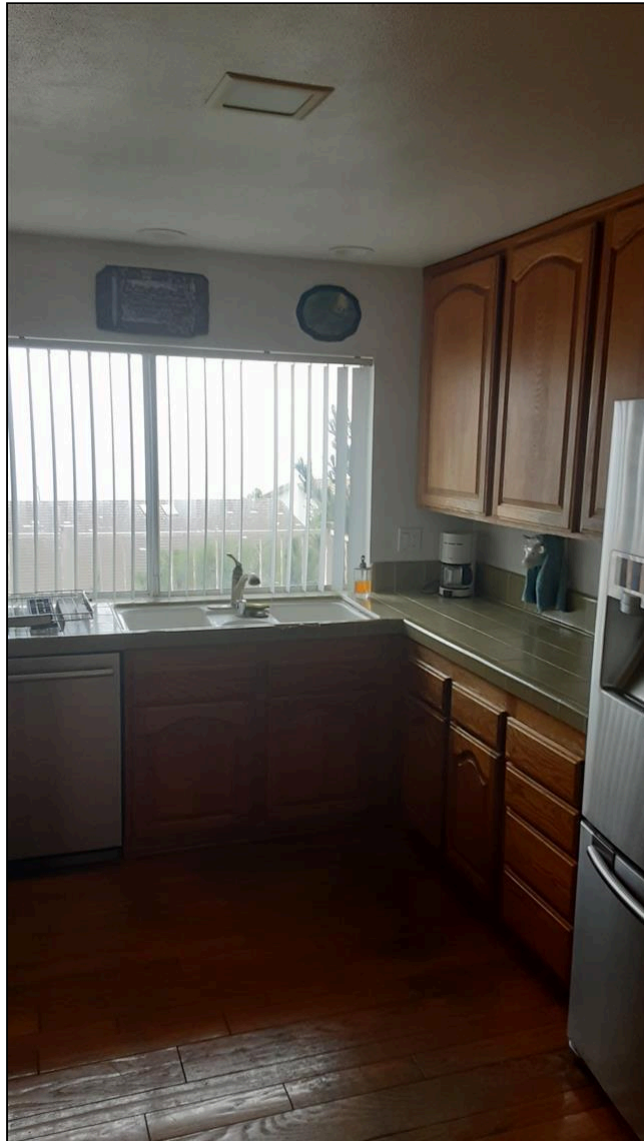
**4.5 (2)** Significant wear and tear on kitchen base and upper wall wood cabinets and on base cabinets in bathrooms. Recommend a qualified person further inspect for repair or replacement recommendations.

4.5 Item 2(Picture) Kitchen cabinets

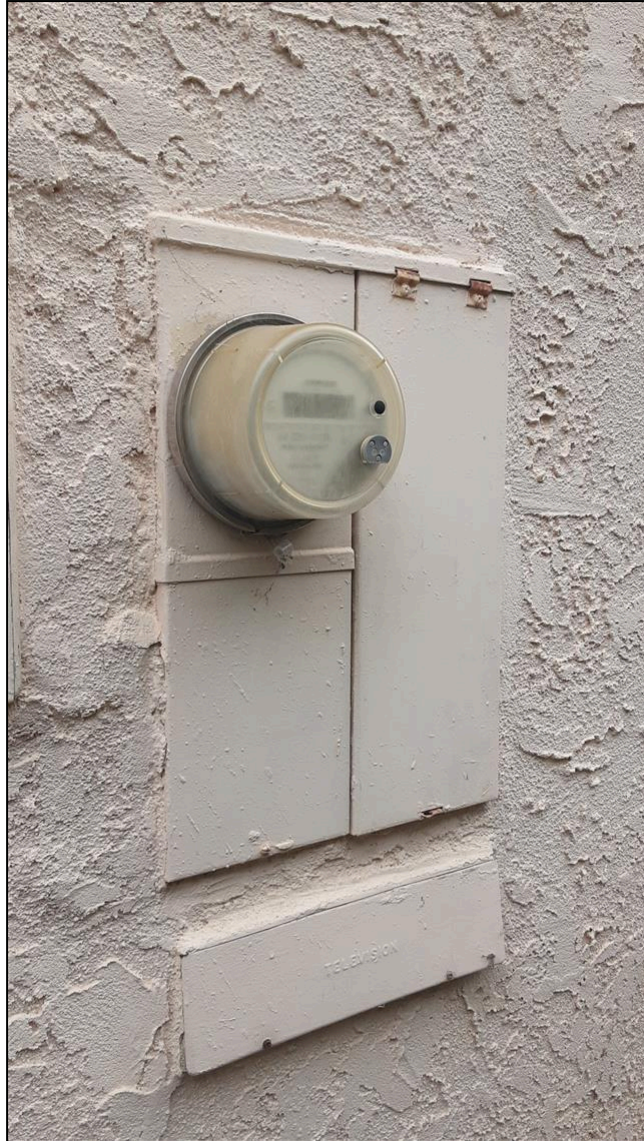
**5.1** Meter and main distribution panel are located on the south exterior wall.

5.1 Item 1(Picture) Electric meter and main distribution panel

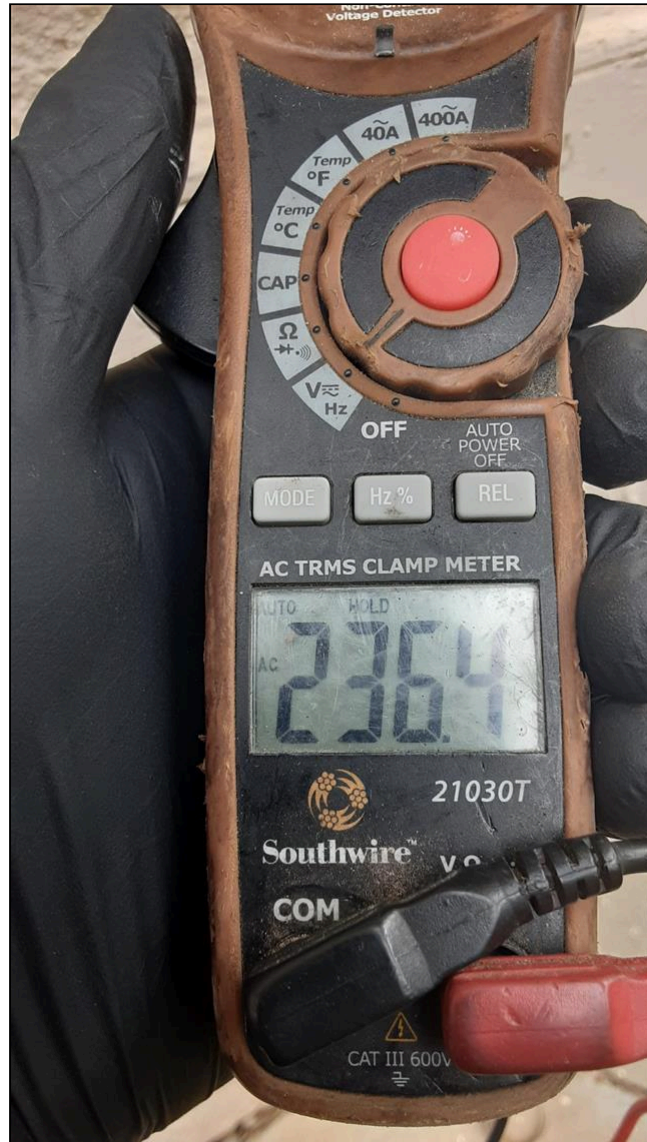
5.3 (1) Voltage at main distribution panel was 236.4 volts at time of inspection.

5.3 Item 1(Picture) Voltage

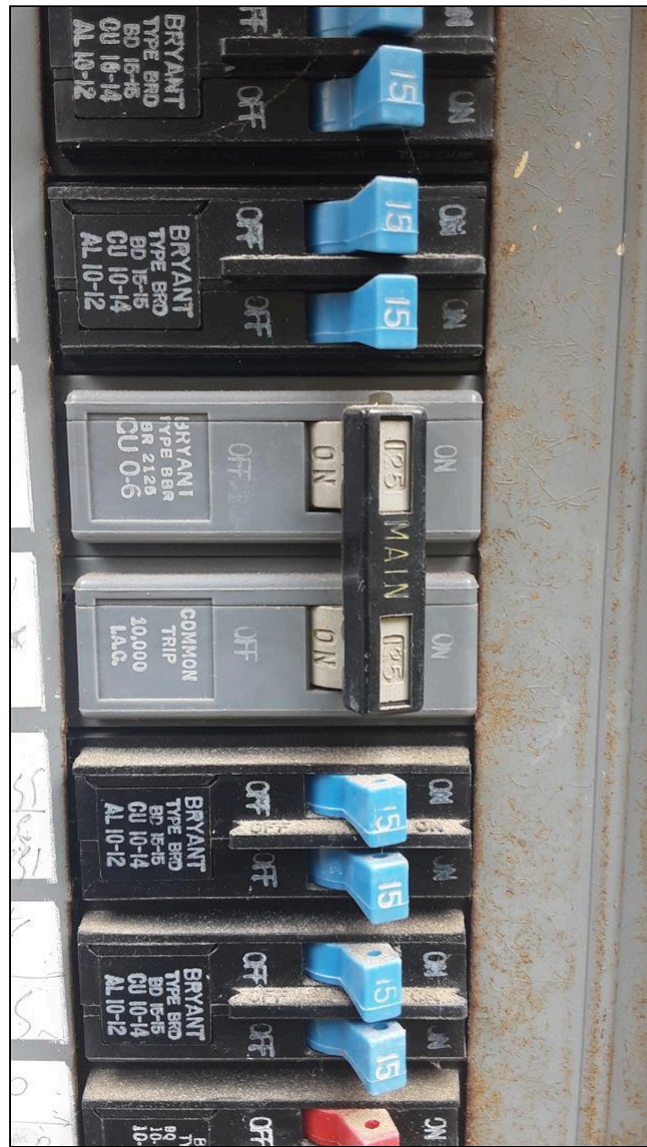
5.3 (2) Square footage of home exceeds two thousand square feet. Panel main shut off is 125 amps. This can be considered undersized for this size home. Recommend a qualified electrician further inspect and perform load test for proper amp requirements.

5.3 Item 2(Picture) 125 amp main shut off

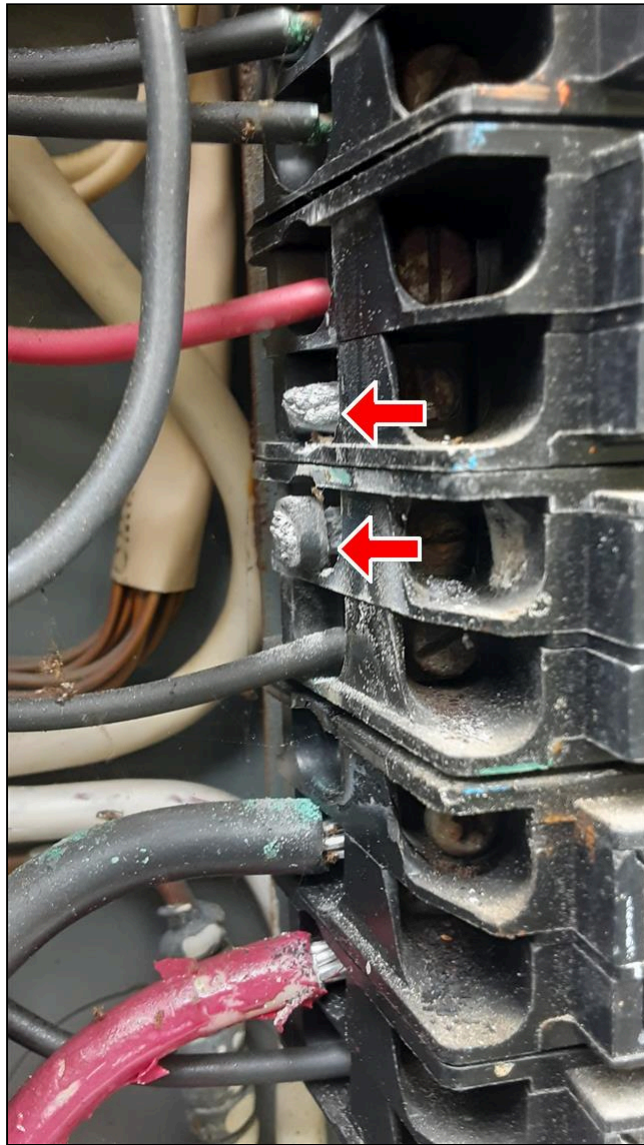
**5.3 (3)** Damaged wire leads were found inside circuit breakers at time of inspection. Recommend a qualified person further inspect circuit breakers and wiring leads for removal or repair recommendations.

5.3 Item 3(Picture) Damaged wire leads

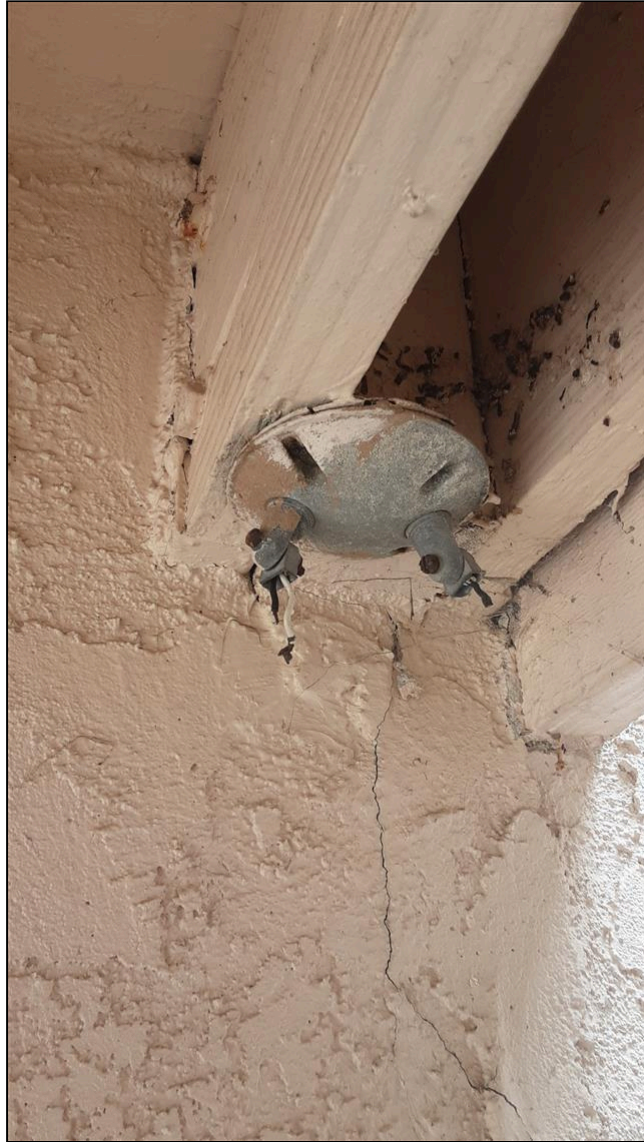
**5.5 (1)** Damaged fixture below main entry bridge. Exposed wiring is present. Recommend a qualified person further inspect fixture and exposed wiring for repair or replacement recommendations.

5.5 Item 1(Picture) Damaged fixture/exposed wiring, below main entry bridge

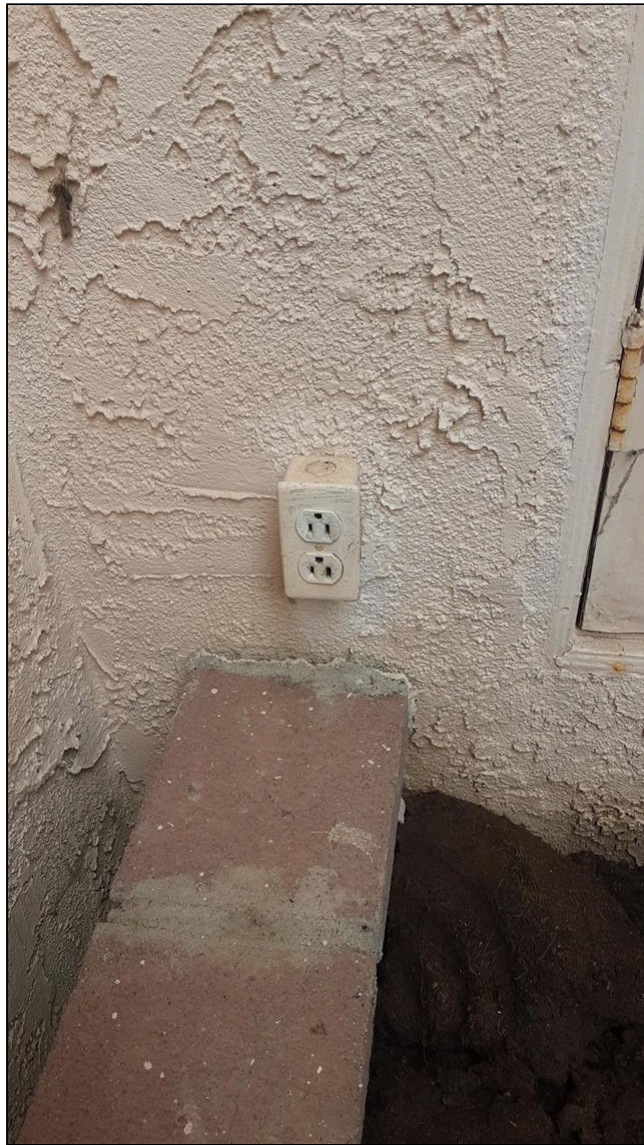
210.8(A)(3), all 15A and 20A, 125V receptacles outside of a dwelling unit, including receptacles installed under the eaves of roofs, shall be GFCI-protected.

5.5 Item 2(Picture) Exterior outlet, front patio

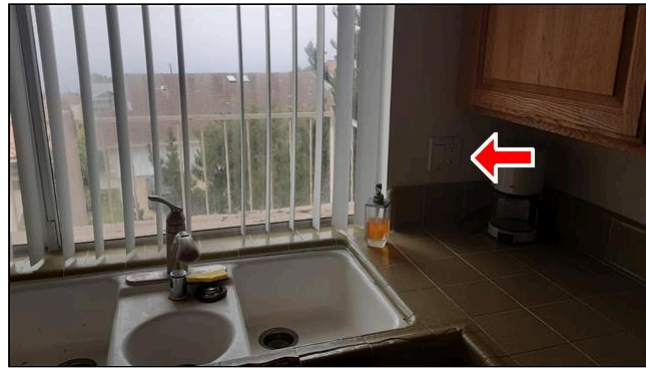
5.5 Item 3(Picture) Kitchen outlet

**5.5 (3)** The kitchen outlets next to kitchen sink are non protected outlets. Receptacles within six feet of a water source are required to be GFCI protected. These outlets are outdated and considered a safety issue until corrected. Recommend a qualified electrician further inspect and repair or replace as needed.

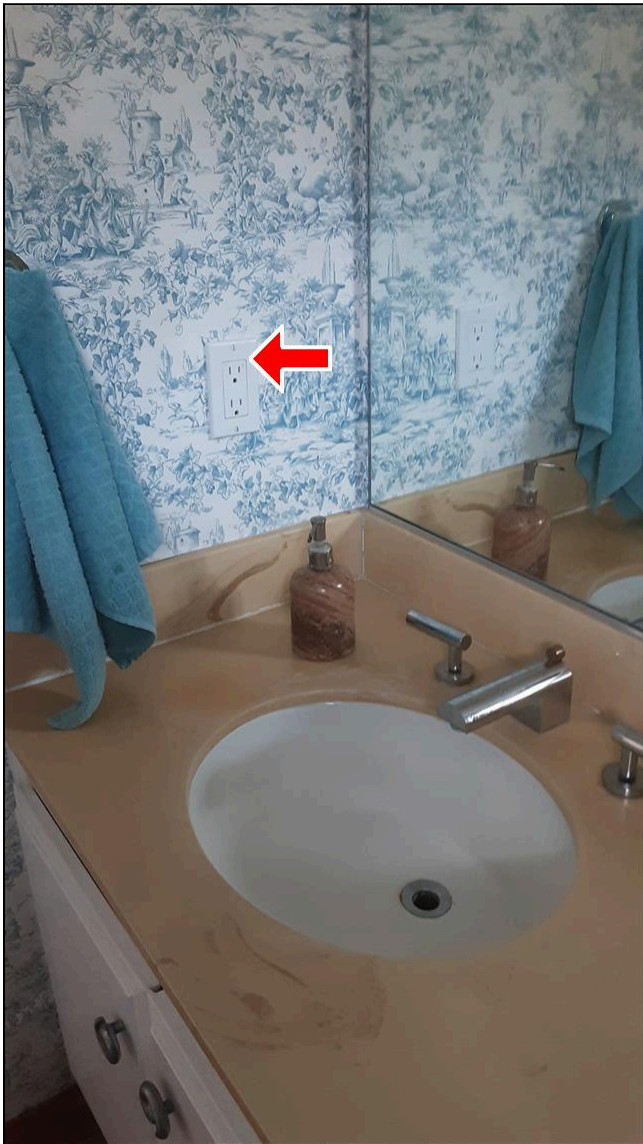
The section titled Ground-Fault Circuit Protection debuted in 1975 for residential occupancies and construction sites. That year, because of the potential shock hazard, residential bathroom receptacles joined the list of locations requiring GFCI protection. Rather than periodically adding locations where a sink might be present, receptacles within 6 feet of any sink (other than in a kitchen) required GFCI protection in the 2011 edition. In keeping with tradition, new GFCI protection requirements were added during the 2014 revision cycle. GFCI protection is now required in laundry areas. This is not restricted to a laundry room since it is common to find the appliances in hall closets or master bedroom. A tub or shower stall is not always located in a bathroom so receptacles within 6 feet of any tub or shower stall are required to be protected. Kitchen dishwasher branch circuits have been added whether they are hard wired or for cord-connected appliances.

5.5 Item 4(Picture) Powder room outlet

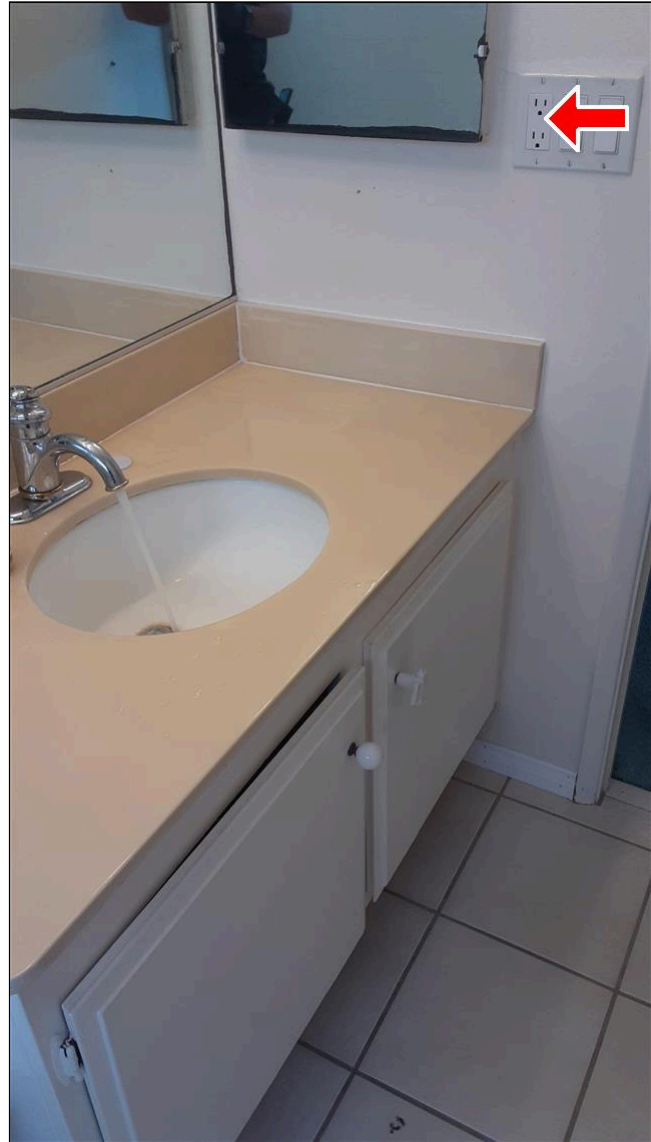
5.5 Item 7(Picture) hall bathroom outlet

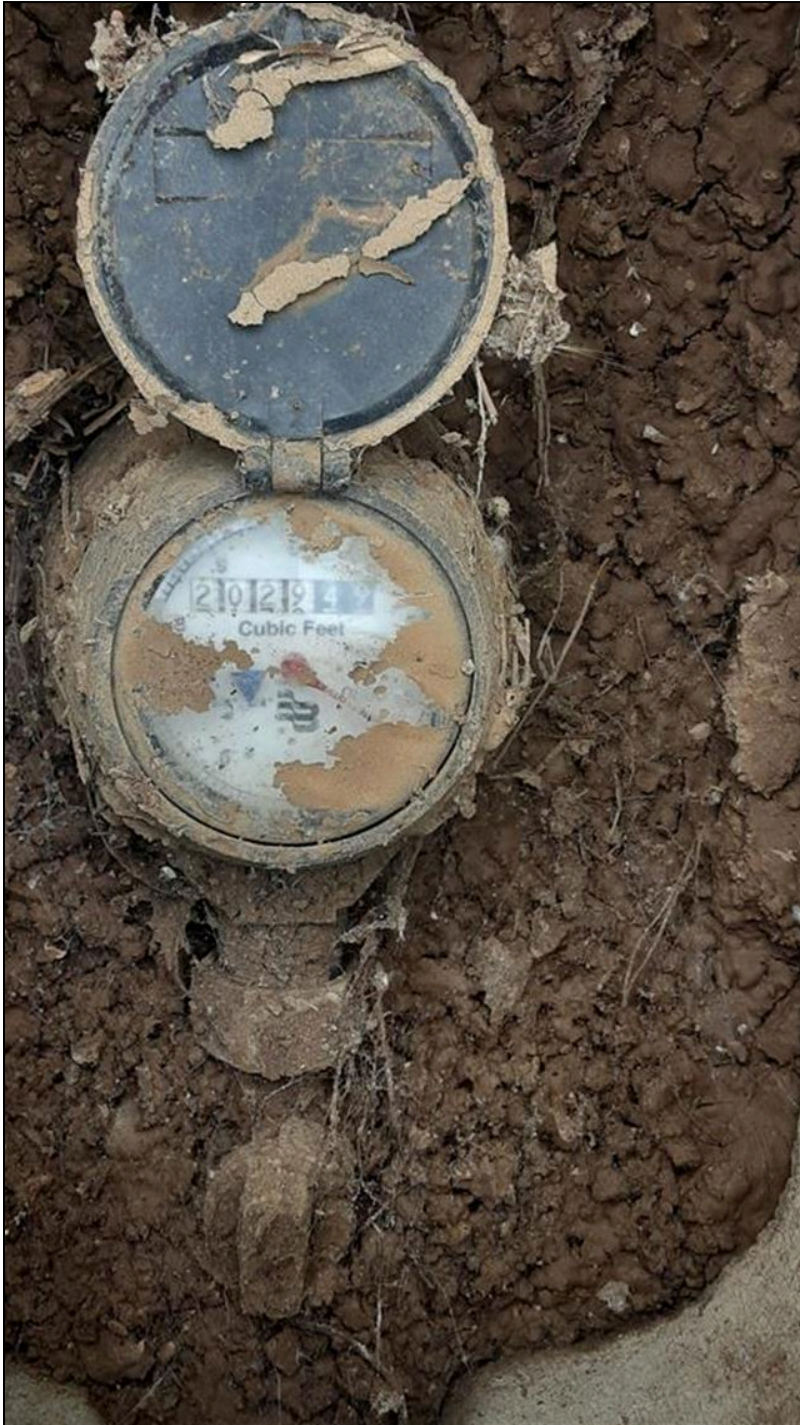
Water pressure at time of inspection was 75 PSI.

6.0 Item 1(Picture) Water meter

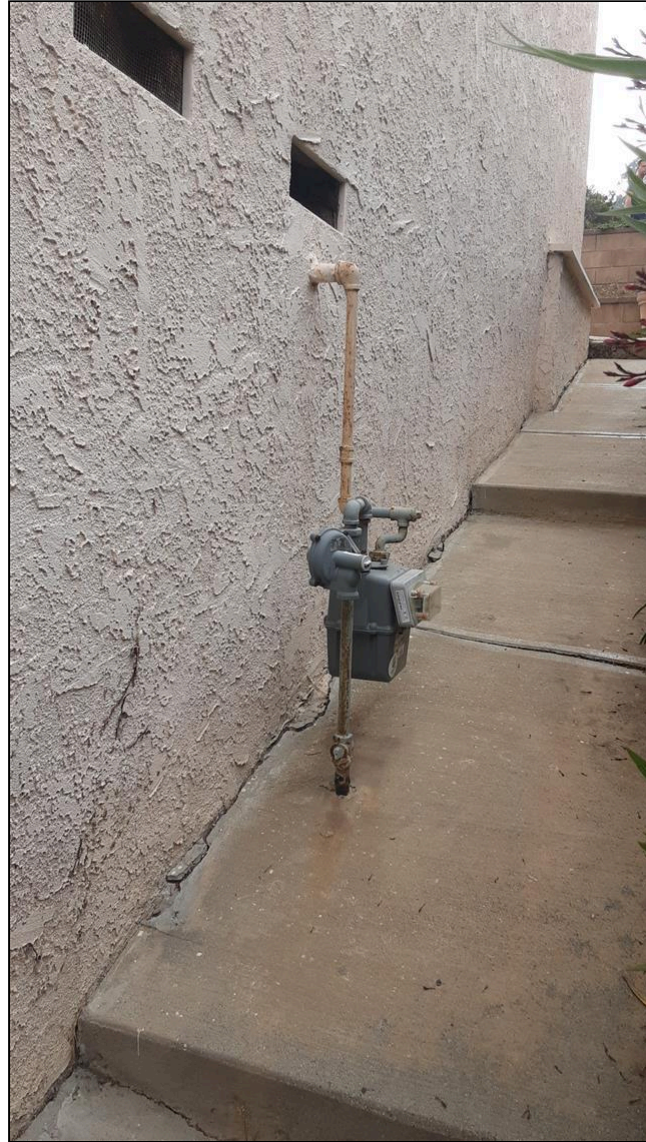
6.1 Item 1(Picture) Gas meter/main shut off

6.1 The gas meter and main shutoff is located on the south side of home.
