# Inspection Report

**Property Address:**  
30924 Rue De La Pierre  
Rancho Palos Verdes CA 90275

<b>Property Address</b> 30924 Rue De La Pierre Rancho Palos Verdes CA 90275	<b>Date of Inspection</b> 6/28/2021	<b>Report ID</b> 210628-01
<b>Customer(s)</b> Nicholas Mack	<b>Time of Inspection</b> 09:00 AM	<b>Real Estate Agent</b> Thomas Royds Redfin

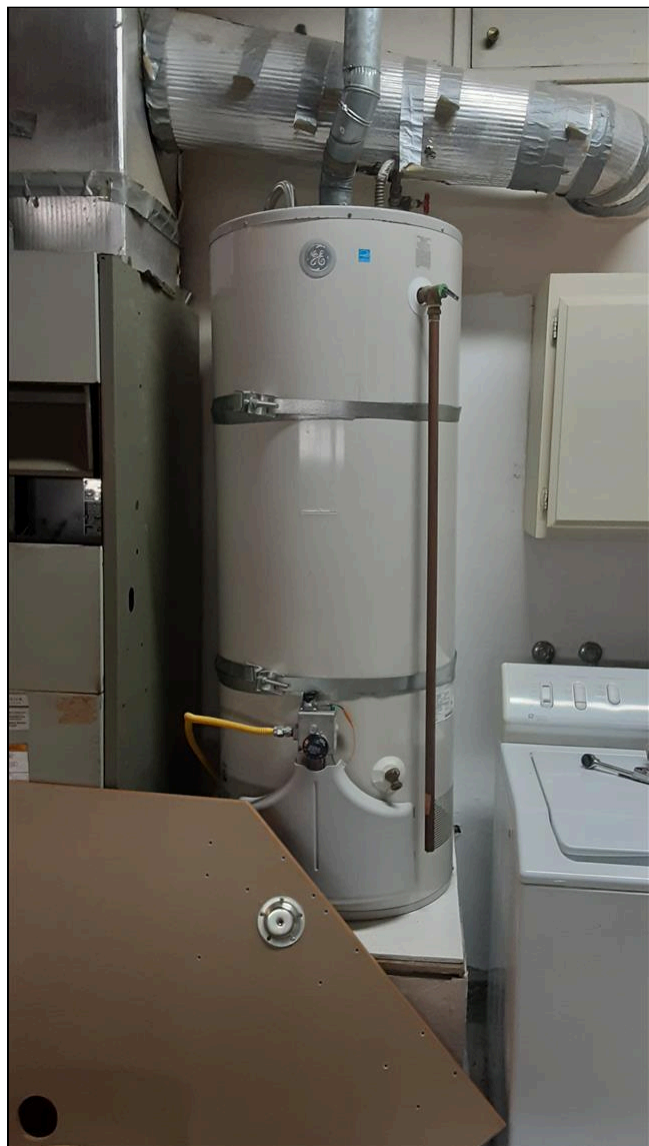
6.2 Item 1(Picture) Water heater

6.2 (1) Water heater is located inside the garage.

Manufacture date: October 14, 2009 (Water heater has reached its average life span of 8-12 years. Water heater is approx 12 years old. Water heater operated at time of inspection but may fail in the near future.)

Hot water temperature was 116 degrees at time of inspection.

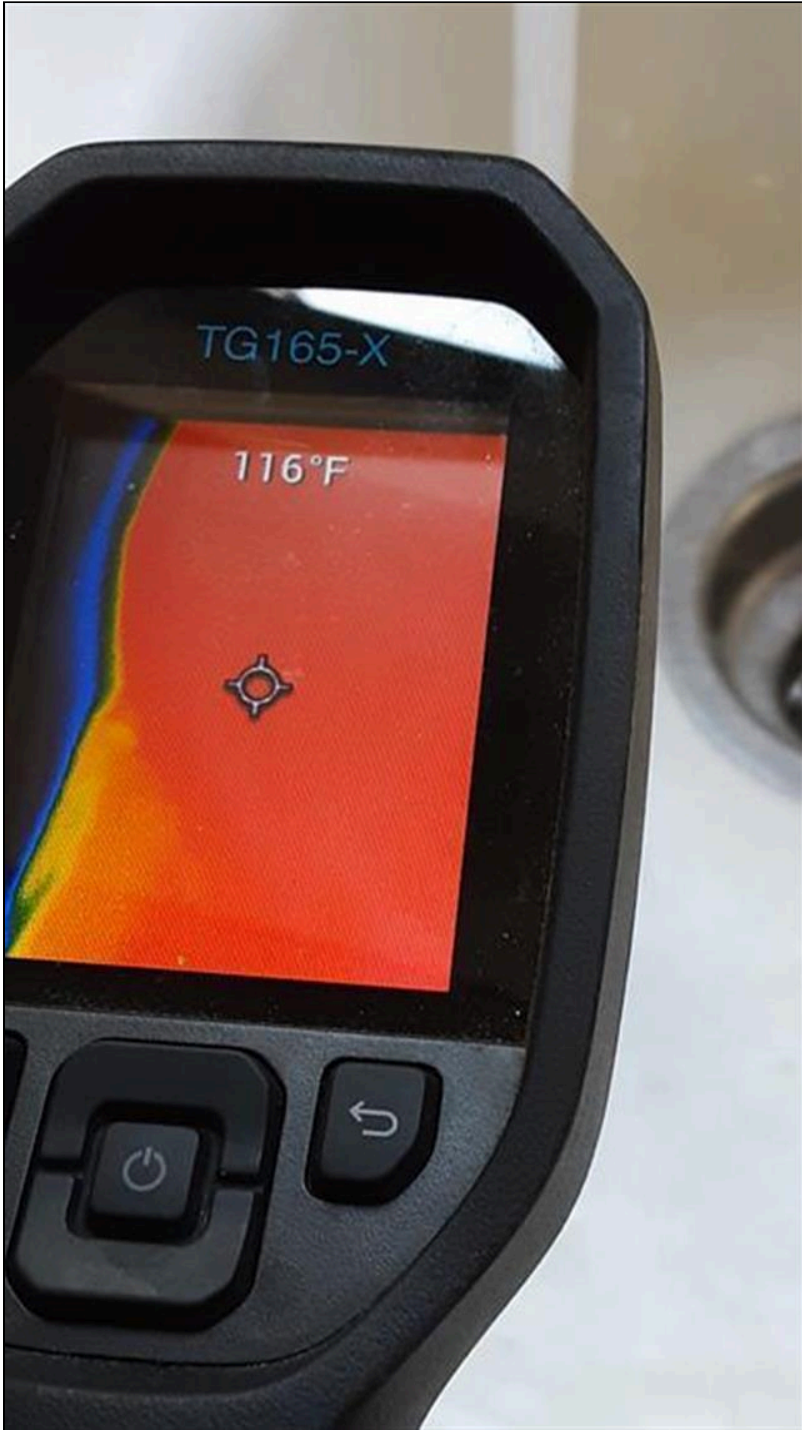
6.2 Item 3(Picture) Hot water temp

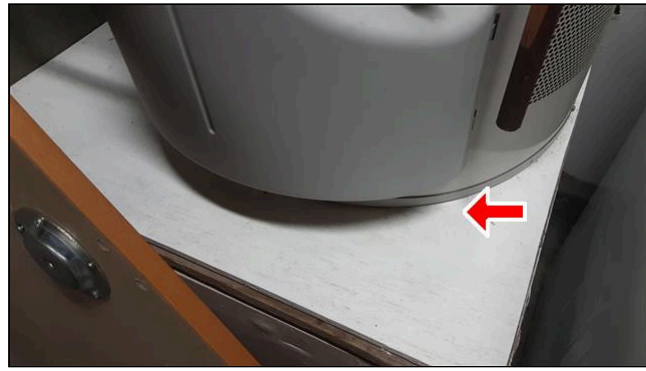
6.2 Item 4(Picture) Missing drip pan

**6.2 (2)** Water heater is not placed inside a drip pan. While it is not required, it is encouraged to place water heater into a drip pan with proper hose to drain water to a safe place if water heater was to leak. This is to prevent water damage to flooring and walls that are surrounding water heater in closet. Recommend a qualified plumber install drip pan as needed.

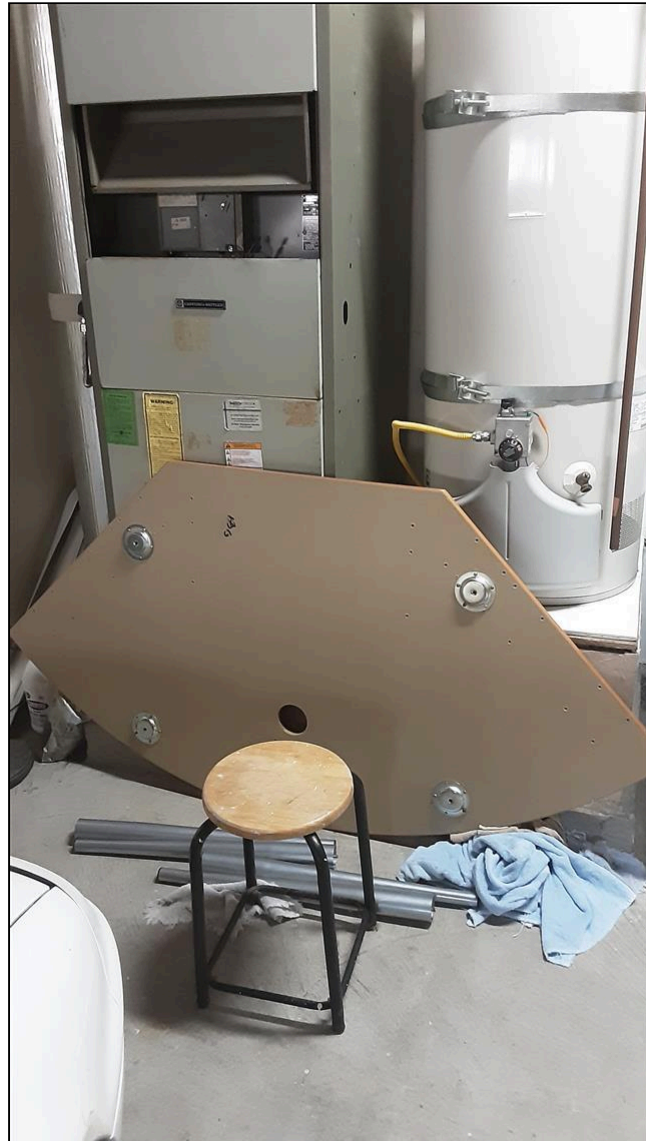
**6.2 (3)** Post or bollard was not present inside garage at front of water heater and furnace. Post or bollard should be installed to protect gas appliances from possible impact damage.

6.2 Item 5(Picture) No protection for appliances in garage

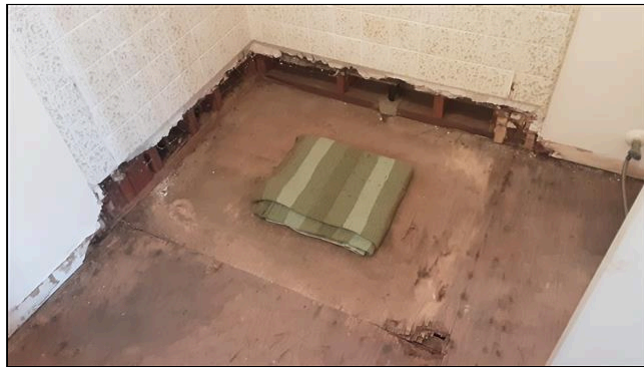
6.4 Item 1(Picture) Removed shower pan, lower level hall bathroom

**6.4 (1)** Bathtub or shower pan inside lower level hall bathroom has been removed. Recommend a qualified contractor further inspect for repair recommendations.

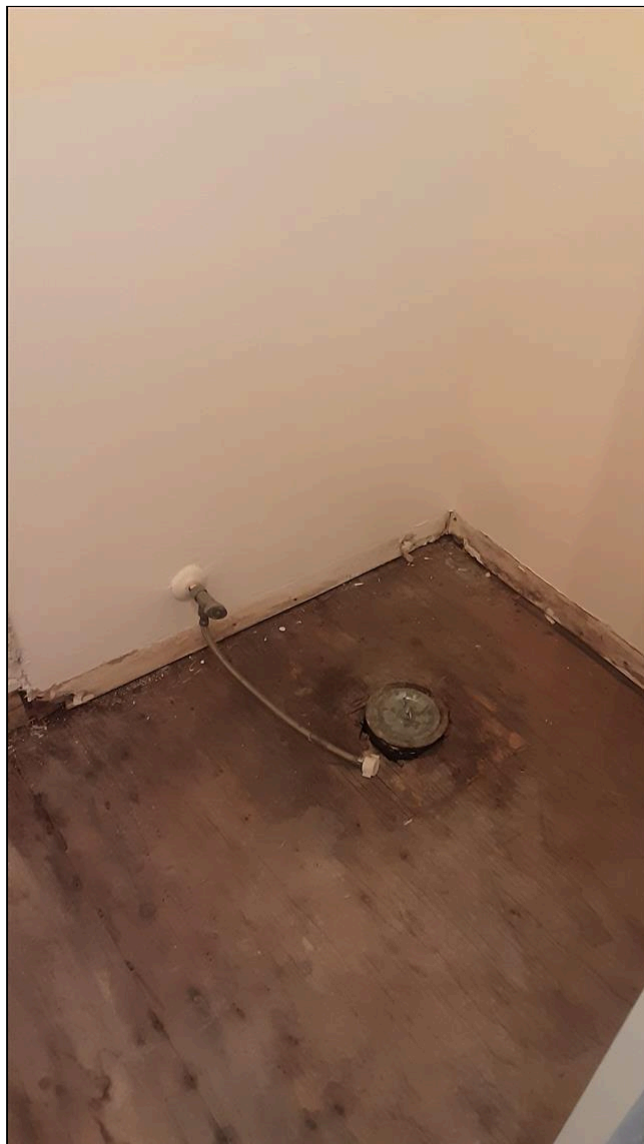
**6.4 (2)** Missing toilet inside lower level hall bathroom. Recommend a qualified person further inspect and install as needed.

6.4 Item 2(Picture) Missing toilet, lower level hall bathroom

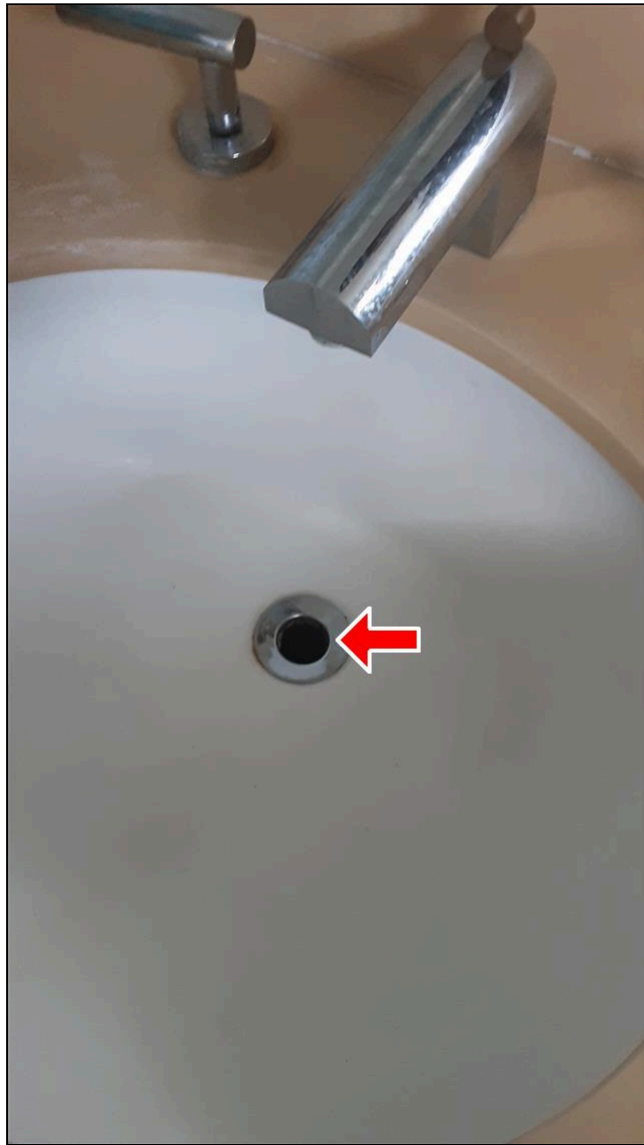
**6.5 (1)** Multiple bathroom sinks are missing drain stops. Recommend installing drain stops to prevent foreign objects from entering into drain line and causing restriction.

6.5 Item 1(Picture) Drain stop missing, powder room sink

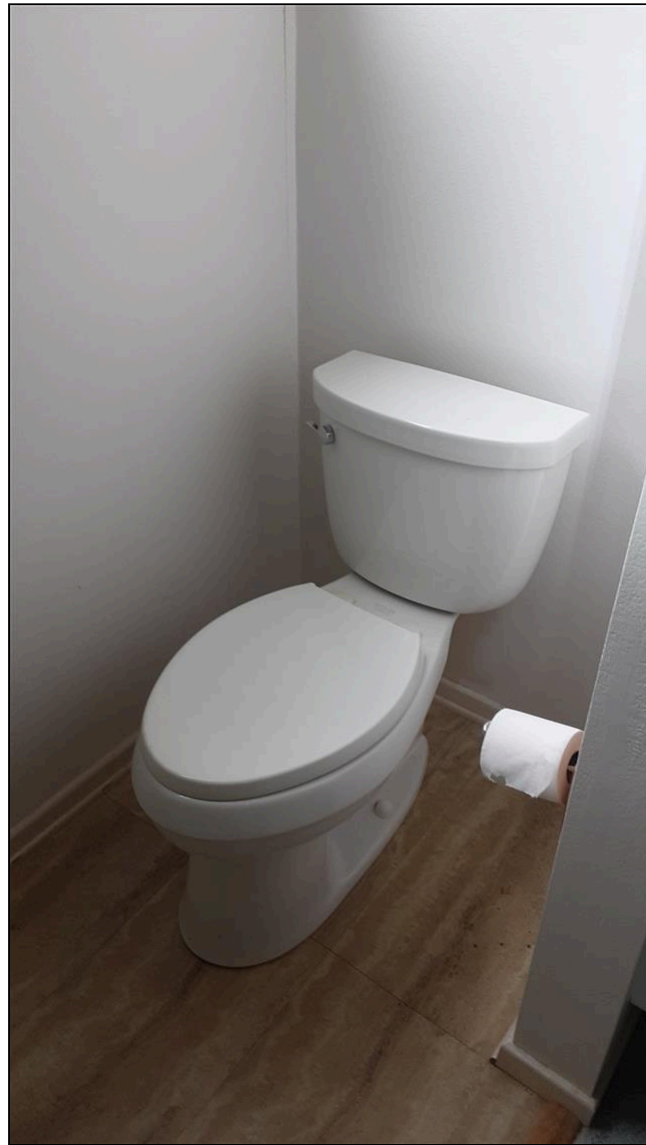
6.5 (2) The toilet is loose at floor in the master bathroom. Repairs may involve re-setting the toilet on a new wax seal. Recommend a qualified licensed plumber repair or correct as needed.

6.5 Item 2(Picture) Loose toilet, master bathroom

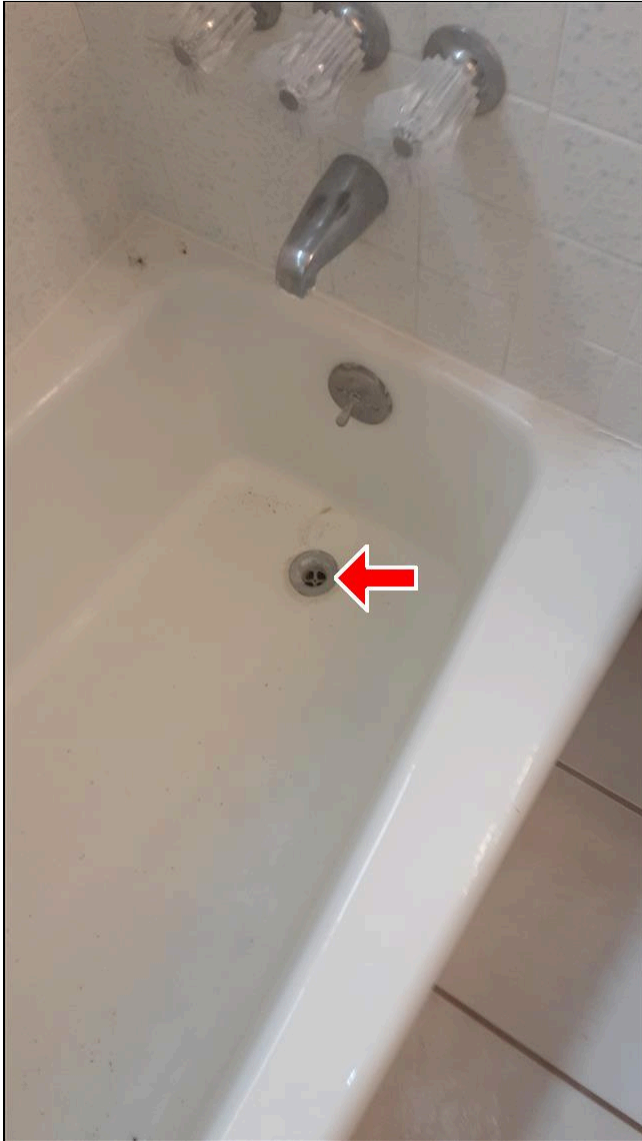
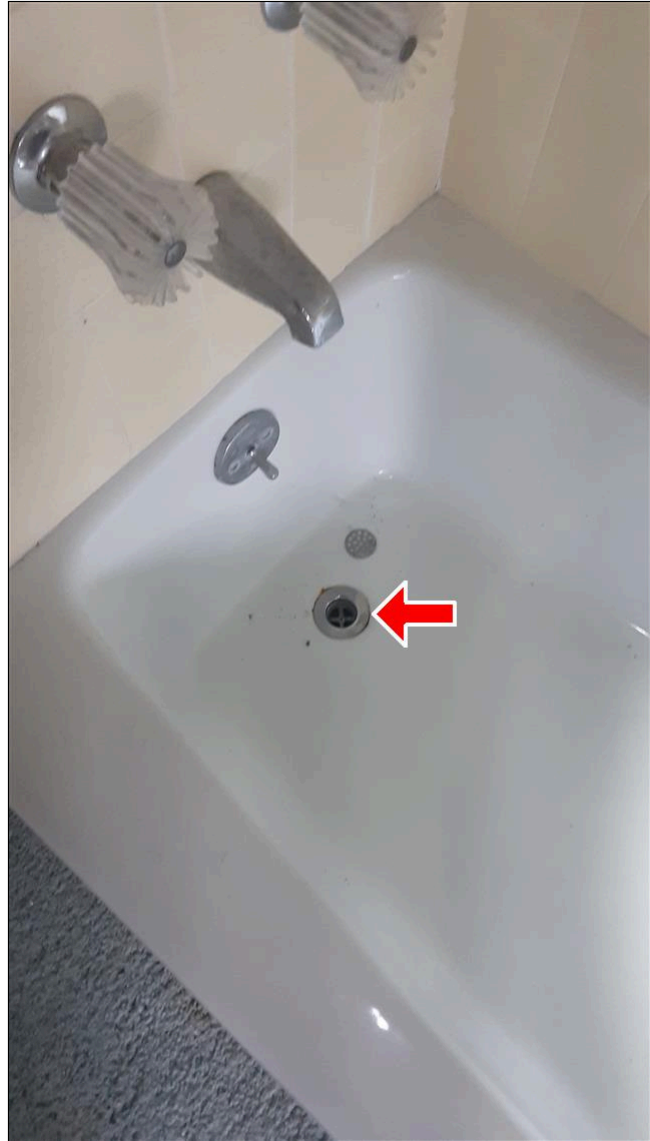
**6.5 (3) Multiple bath tubs are missing a drain stop. Recommend a qualified person install drain stops to prevent foreign objects from entering into drain line and causing restriction. Replace as needed.**

6.5 Item 3(Picture) Missing drain stop

6.5 Item 4(Picture) Missing drain stop

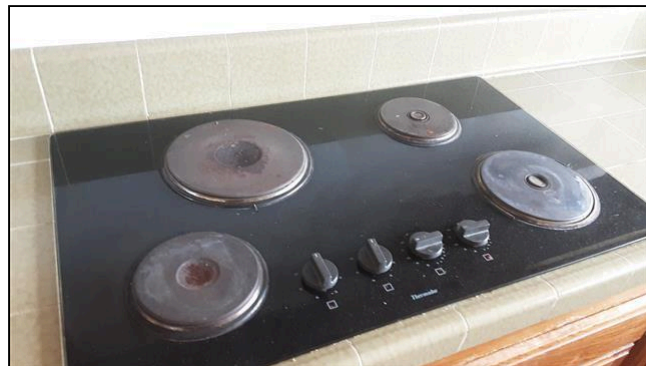
7.1 Item 1(Picture) Kitchen burners

**7.1** Cooktop burner control is damaged. Electric burners are rusted. Recommend a qualified person further inspect for repair or replacement recommendations.

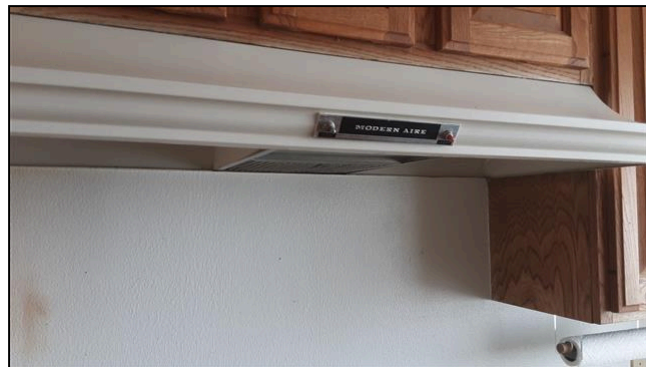
7.2 Item 1(Picture) Range hood

**7.2** Range hood is dated but did operate. Light did not operate at time of inspection. Recommend a qualified person further inspect for repair or replacement recommendations.

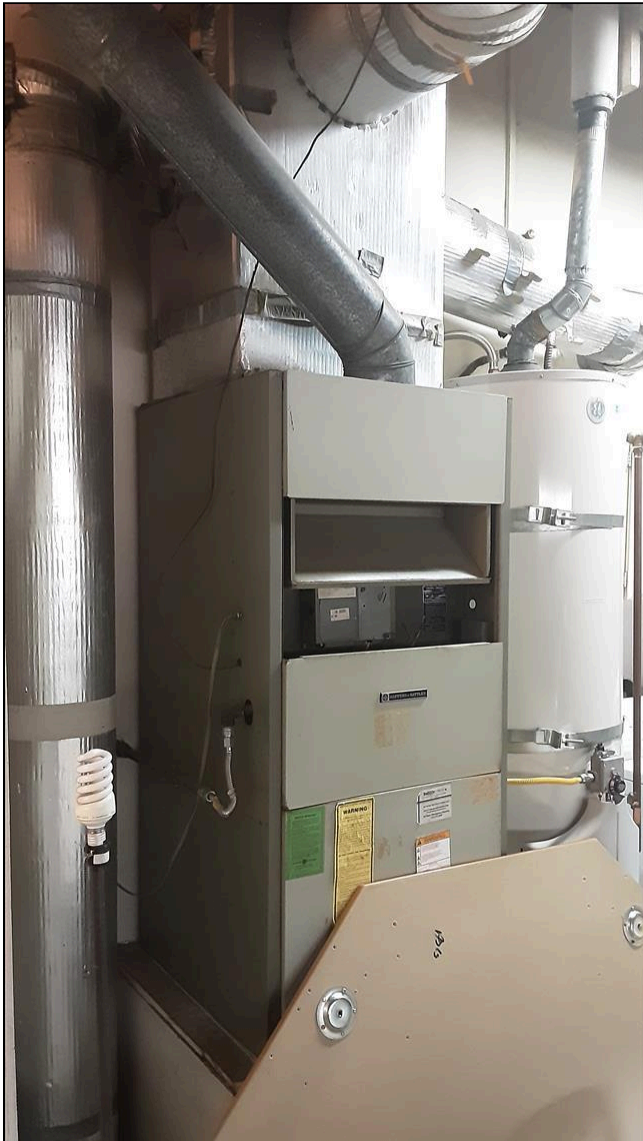
9.0 Item 1(Picture) Heat system

Model: U150

Serial: 942A J

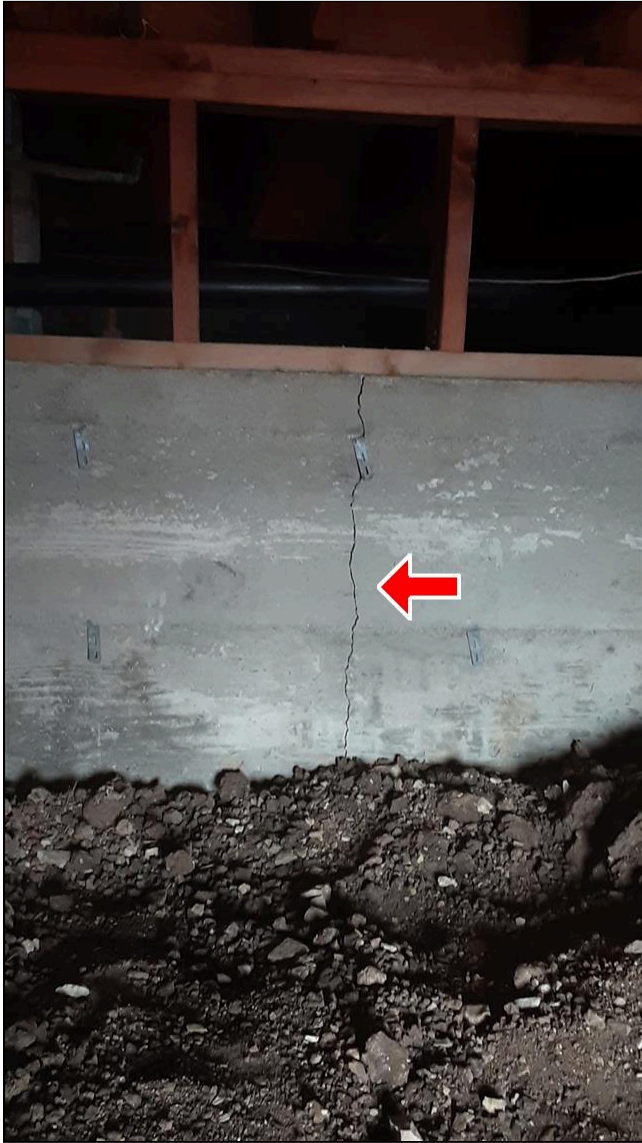
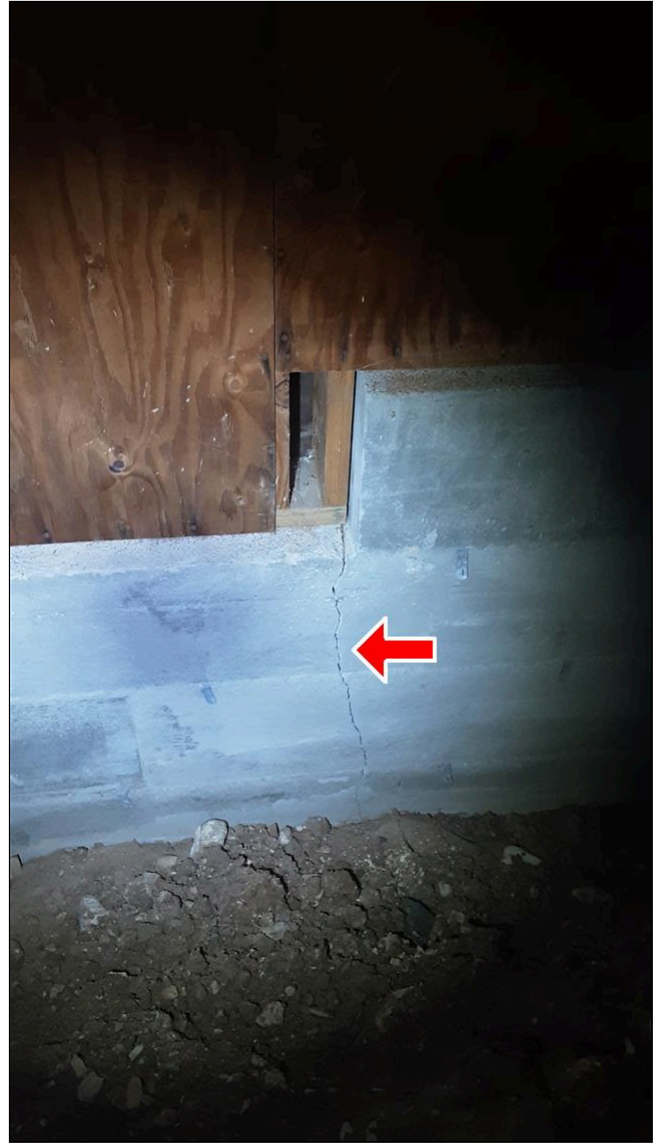
**11.0** Minor cracking found on foundation walls inside the crawlspace. Recommend a qualified person further inspect cracking for further repair recommendations.

11.0 Item 1(Picture) Minor cracking

11.0 Item 2(Picture) Minor cracking

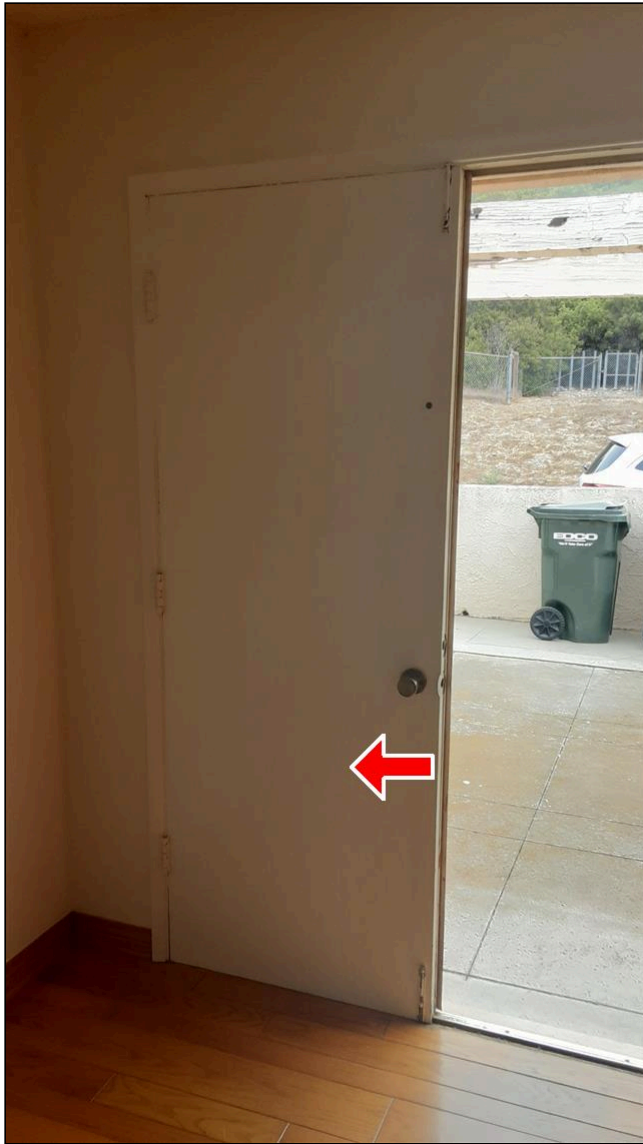
(1) Front entry stationary door would not open properly at time of inspection. Recommend a qualified person further inspect for repair or replacement recommendations.

1.2 Item 1(Picture) Front entry door

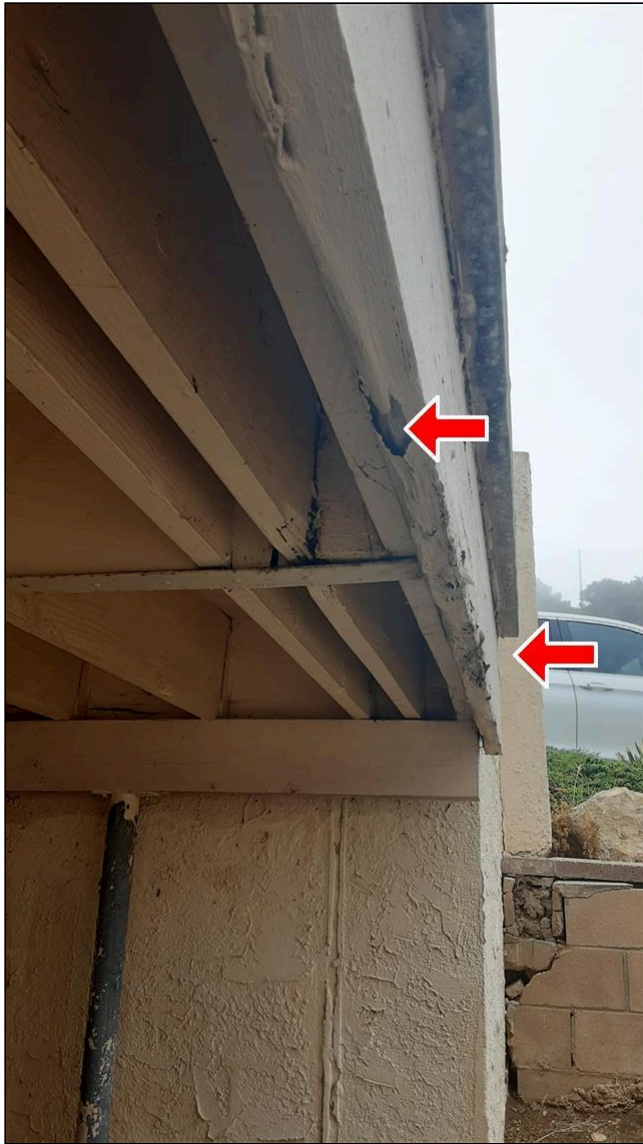
Wood damage found to bridge structure on main entry walkway. Recommend a qualified person further inspect for repair or replacement recommendations.

1.5 Item 1(Picture) Wood damage, main entry bridge

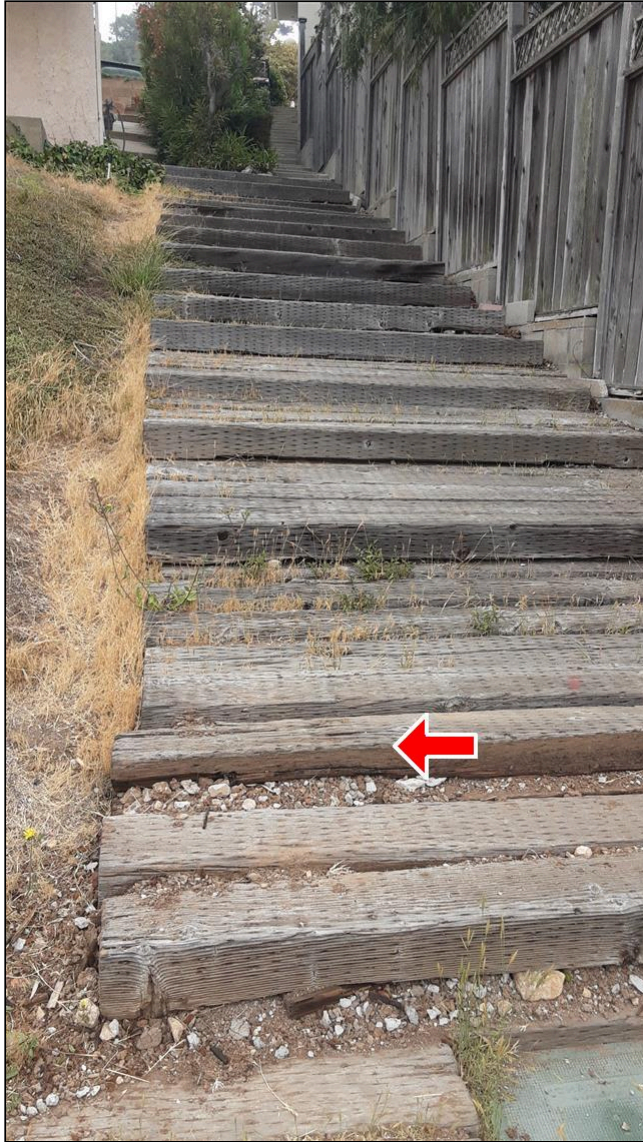
(1) Wood planks used as steps leading to west side of property are loose and unstable. Steps have potential tripping hazards. Recommend a qualified person further inspect for repair or replacement recommendations.

1.6 Item 1(Picture) Steps leading to west side

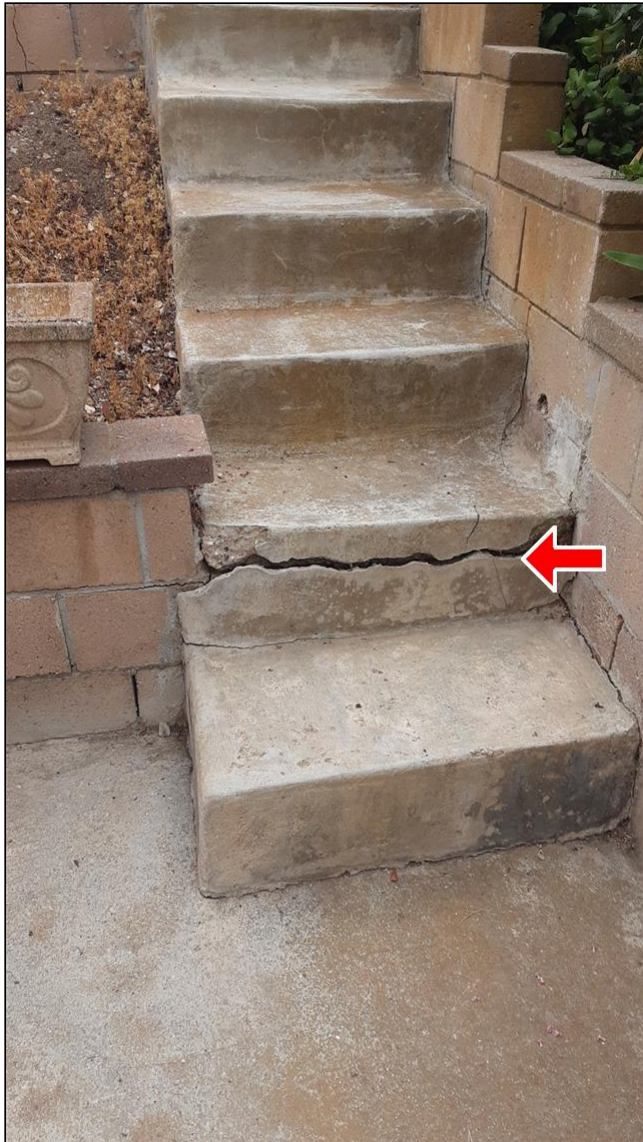
(2) Concrete steps leading to front patio are cracked and settling. Recommend a qualified person further inspect for repair recommendations.

1.6 Item 2(Picture) Cracking steps leading to front patio

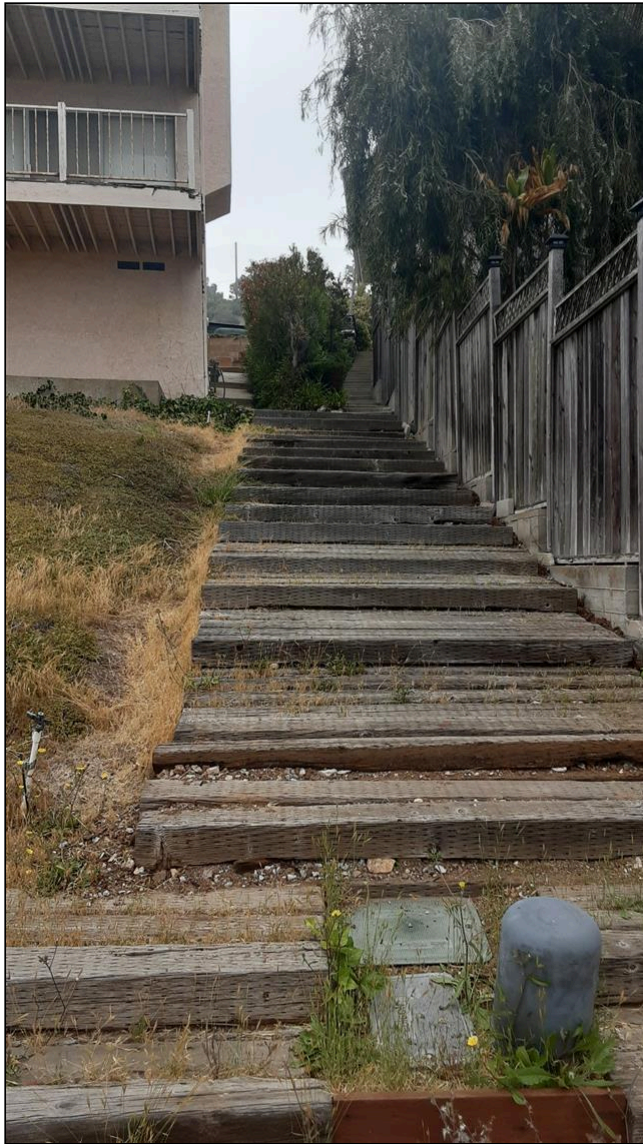
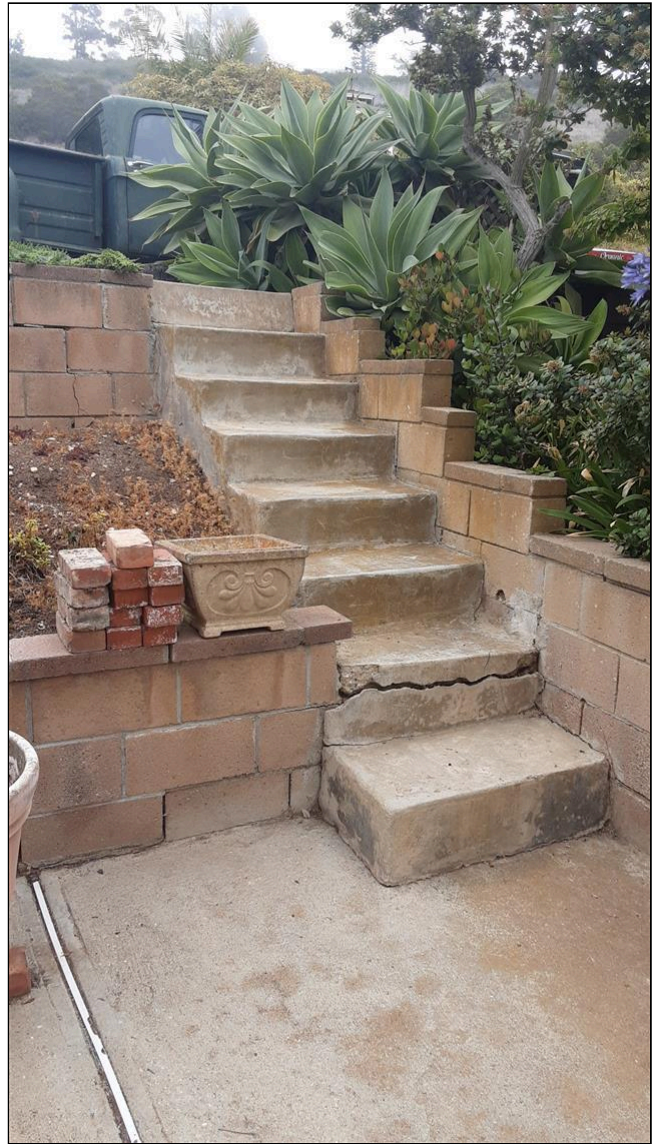
(1) Shared steps leading to the west side of property and steps leading to front patio do not have a railing. All steps with three or more risers should have a railing. Recommend a qualified person further inspect for installation recommendations.

1.7 Item 1(Picture) Missing railing, steps leading to west side

1.7 Item 2(Picture) Missing railing leading to front patio

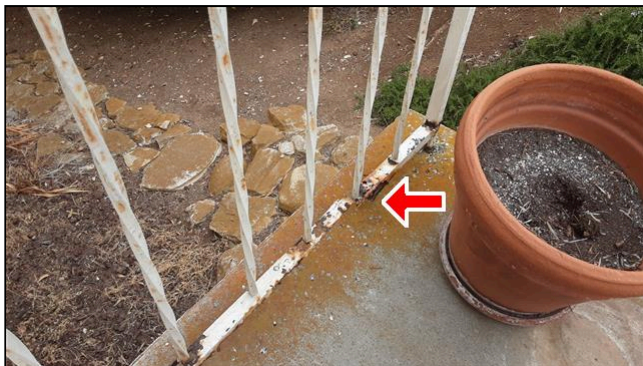
1.7 Item 3(Picture) Damaged railing

(2) Railings throughout property (front entry and balcony) are rusted and deteriorated in multiple areas. Recommend a qualified person further inspect all railings for repair or replacement recommendations.

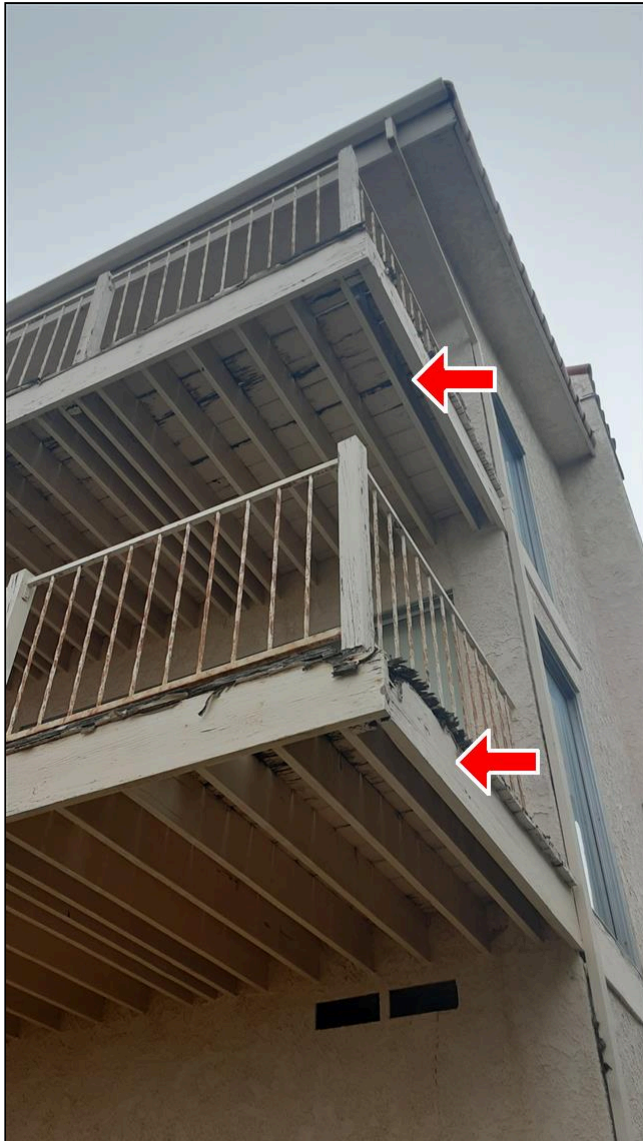
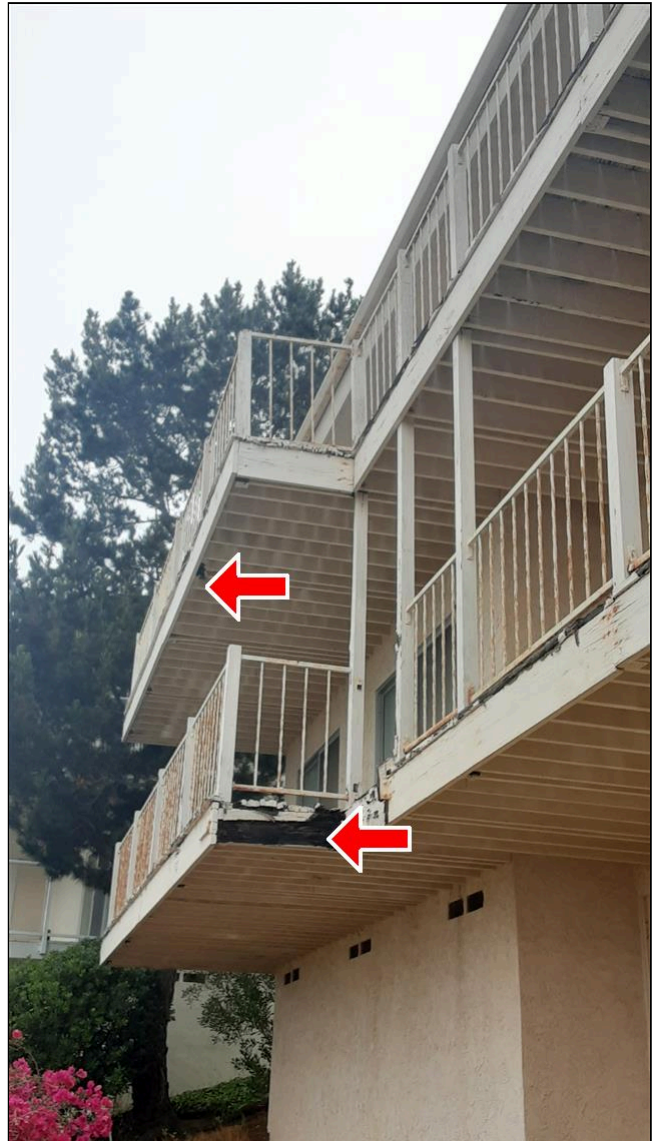
(1) Balcony structure on west side of home has significant wood damage. Wood structure and deck boards are in damaged condition and were not safe to walk on. Recommend a qualified person further inspect balcony structure for repair or replacement recommendations.

1.8 Item 1(Picture) Wood damage, balcony

1.8 Item 2(Picture) Wood damage, balcony

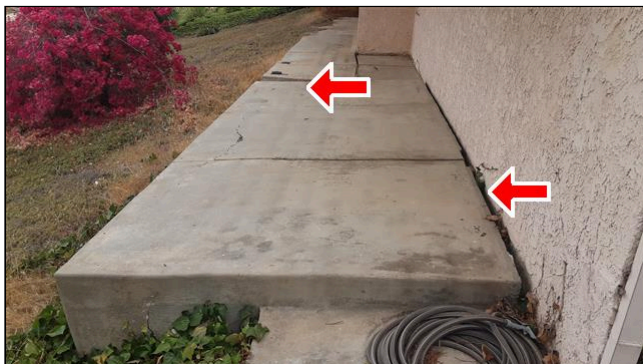
1.8 Item 3(Picture) Concrete damage, west side

(2) Concrete patio/landing at west side of home has significant settlement and separation from exterior siding. Possible tripping hazards are present. Recommend a qualified person further inspect concrete slab for repair or replacement recommendations.

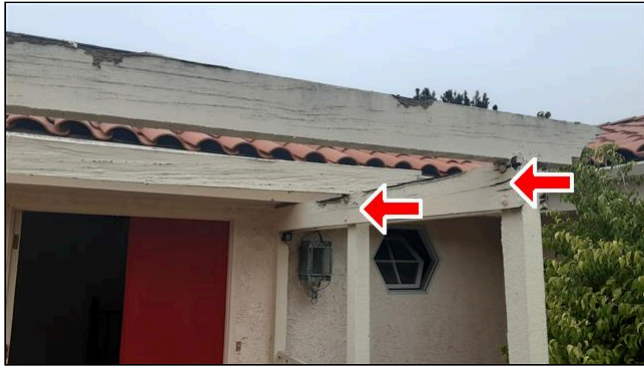
1.8 Item 4(Picture) Wood damage, front entry

(3) Front entry structure has visible wood damage. Recommend a qualified person further inspect wood structure for repair or replacement recommendations.

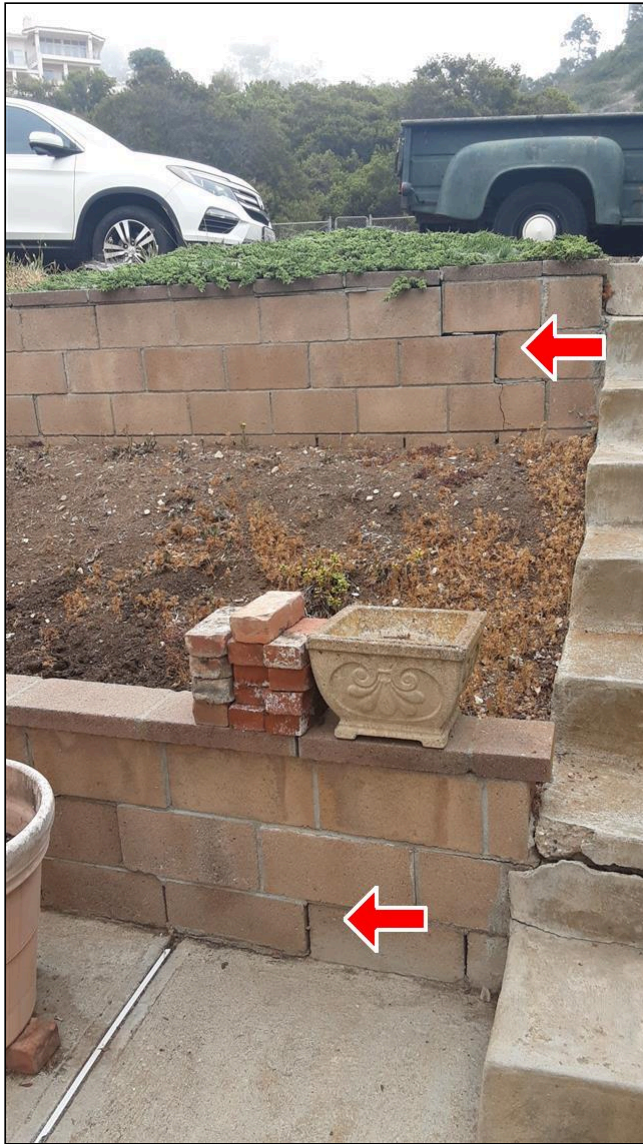
Multiple retaining walls throughout property are settling and have visible damage. Recommend a qualified person further inspect for repair or replacement recommendations.

1.9 Item 1(Picture) Retaining walls

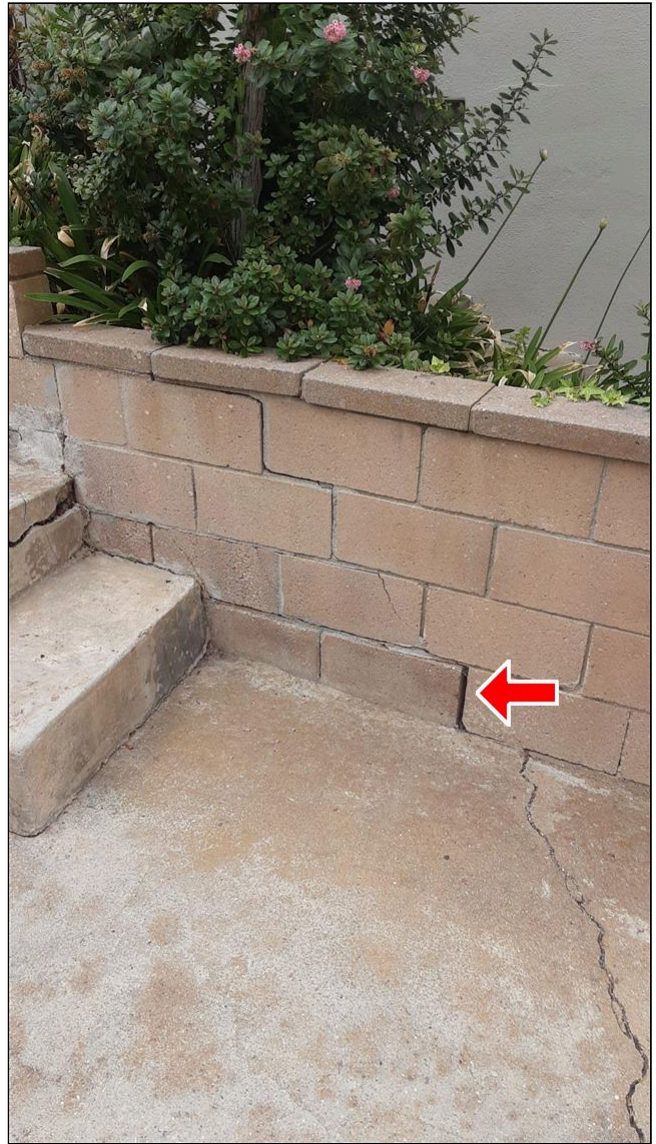
1.9 Item 2(Picture) Retaining wall

**1.9 Multiple retaining walls throughout property are settling and have visible damage. Recommend a qualified person further inspect for repair or replacement recommendations.**

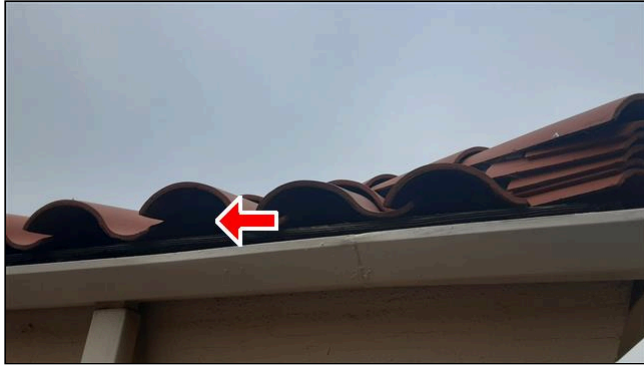
2.0 Item 1(Picture) Missing bird stops

(1) Roof tiles are missing bird stops at roof edge. Bird stops prevent birds and insects from entering below roof covering and nesting. Recommend a qualified person further inspect for repair recommendations.

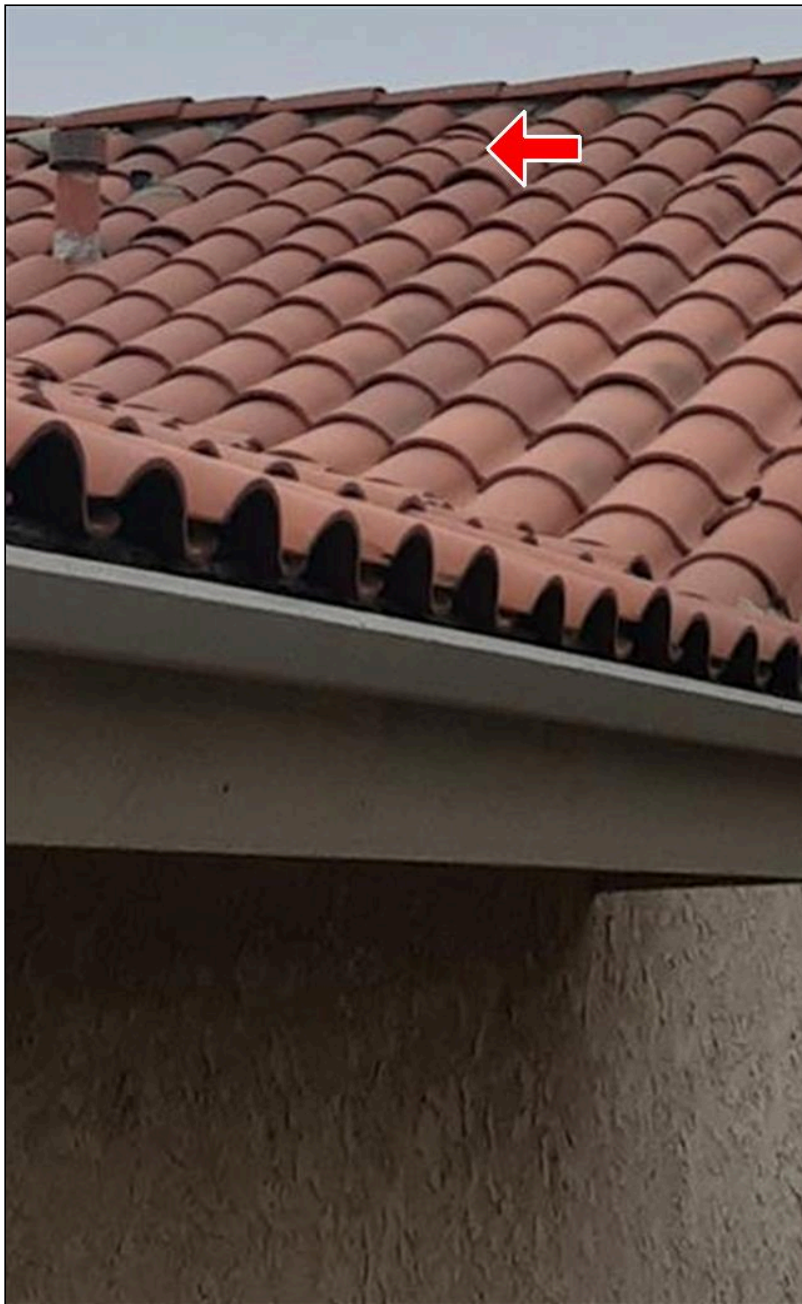
(2) Multiple roof tiles are cracked or damaged. Recommend a qualified roof specialist further inspect for repair recommendations.

2.0 Item 2(Picture) Cracked roof tile

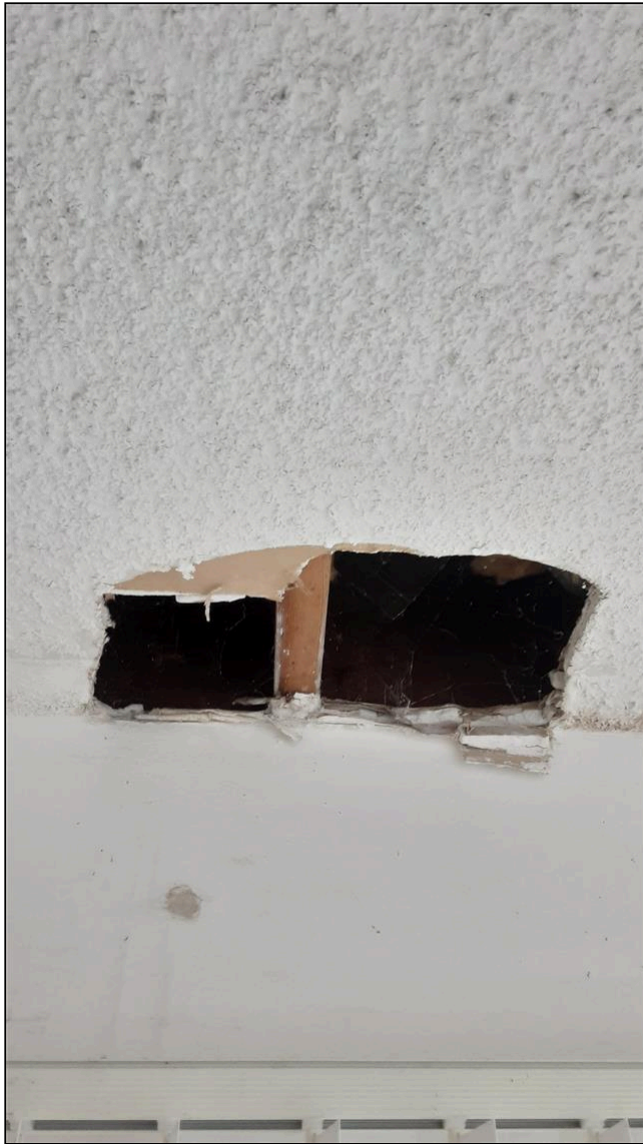
(2) Damaged ceiling inside lower level northwest bedroom. Recommend a qualified person further inspect for repair or replacement recommendation.

4.0 Item 1(Picture) Ceiling damage, lower level northwest bedroom

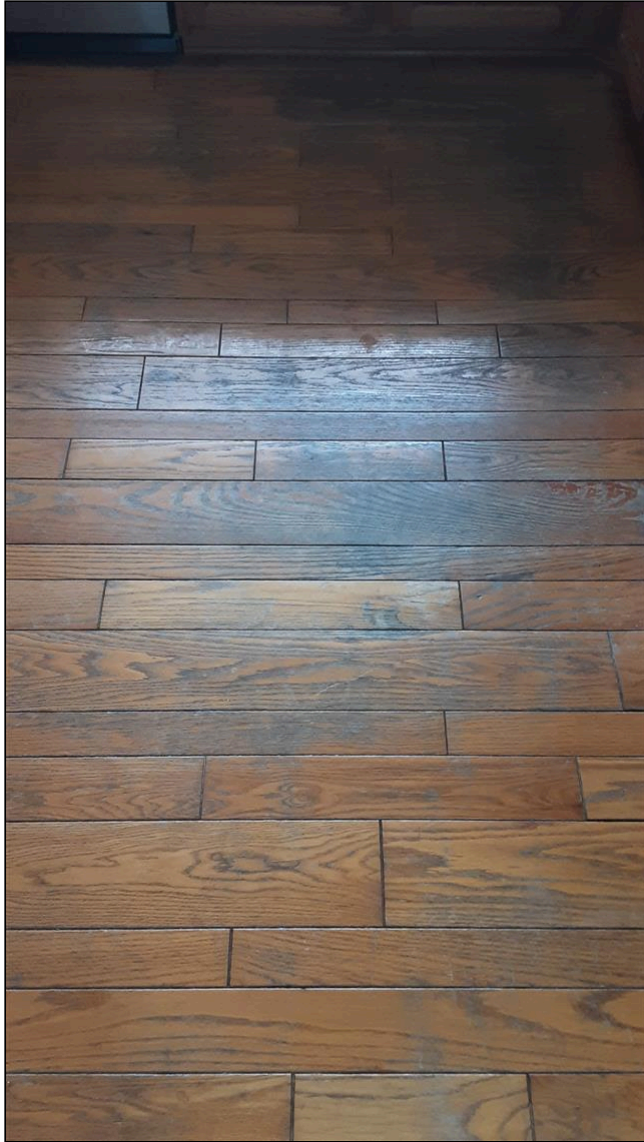
(1) Hardwood floors have multiple marks and significant wear and tear. Recommend a qualified flooring specialist further inspect for repair recommendations.

4.2 Item 1(Picture) Wear and tear

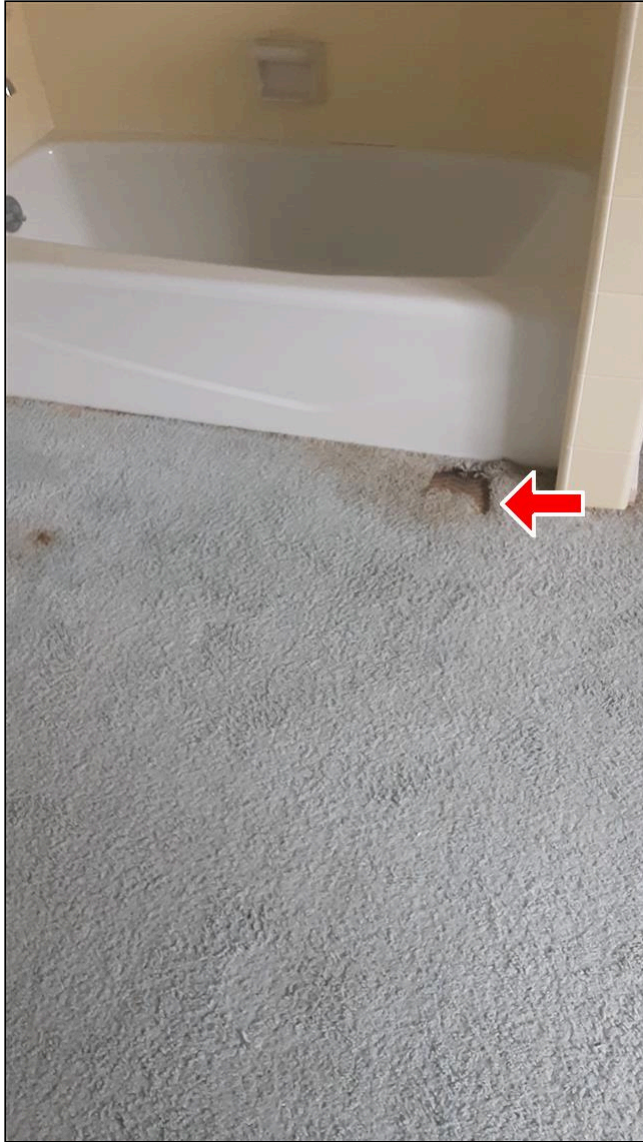
(2) Carpet throughout home is dated, damaged, or stained in areas throughout. Recommend a qualified floor specialist repair or replace carpeting as needed.

4.2 Item 2(Picture) Damaged carpet
