# Inspection Report

**Property Address:**  
30924 Rue De La Pierre  
Rancho Palos Verdes CA 90275

<b>Property Address</b> 30924 Rue De La Pierre Rancho Palos Verdes CA 90275	<b>Date of Inspection</b> 6/28/2021	<b>Report ID</b> 210628-01
<b>Customer(s)</b> Nicholas Mack	<b>Time of Inspection</b> 09:00 AM	<b>Real Estate Agent</b> Thomas Royds Redfin

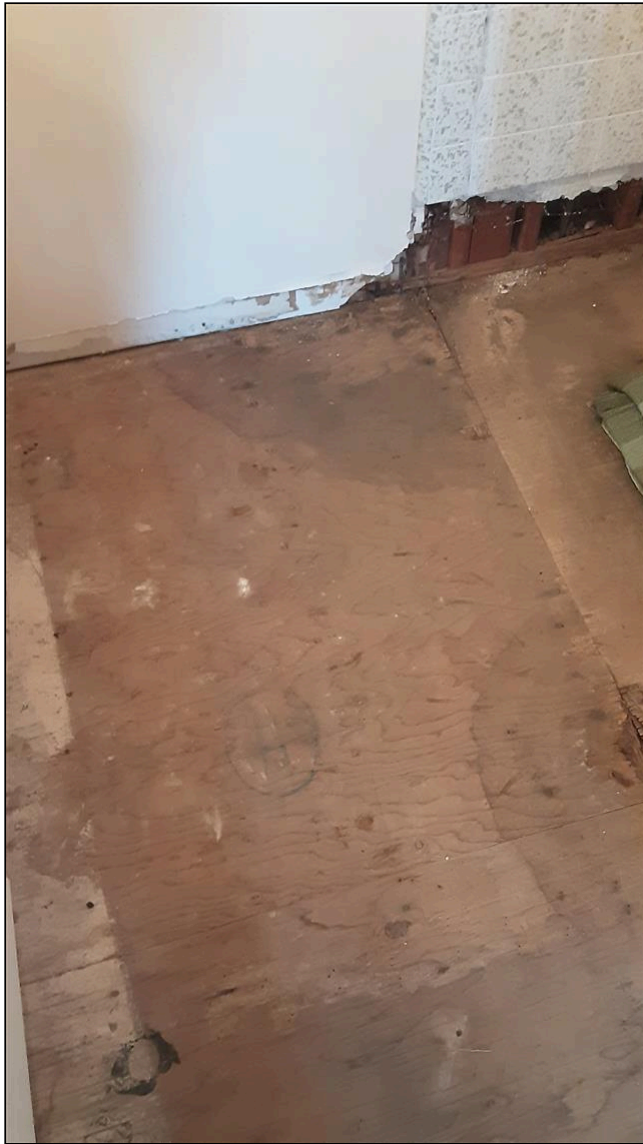
(3) Lower level hall bathroom is missing flooring. Recommend a qualified person further inspect for repair recommendations.

4.2 Item 3(Picture) Missing flooring, lower level hall bathroom

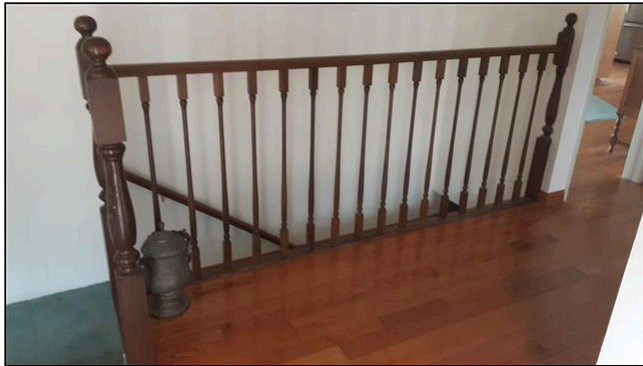
4.4 Item 1(Picture) Baluster on stairwell

Balusters on stairwell railing are spaced more than four inches apart. This is a safety issue. Spacing between balusters should be no more than four inches. Recommend a qualified person further inspect and repair as needed

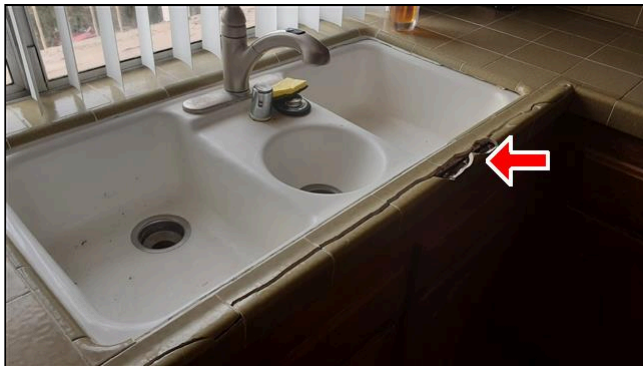
4.5 Item 1(Picture) Kitchen countertop, tile damage

(1) Significant damage to tile countertop inside the kitchen. Tile is a possible lead material. Recommend a qualified licensed environmental specialist further inspect prior to repairs or disturbing.

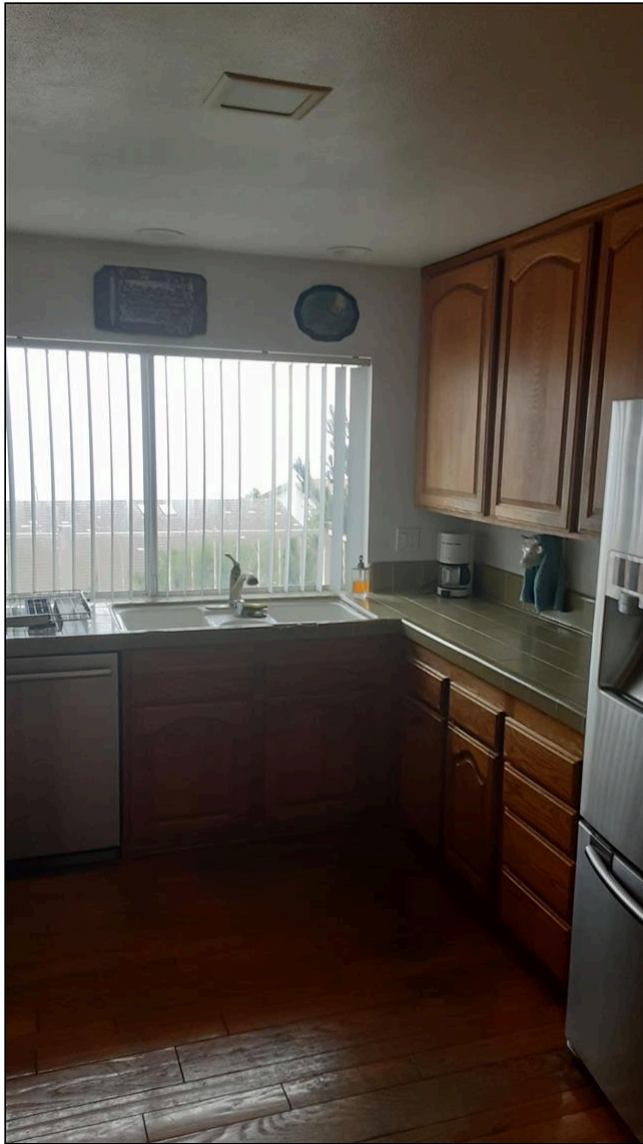
(2) Significant wear and tear on kitchen base and upper wall wood cabinets and on base cabinets in bathrooms. Recommend a qualified person further inspect for repair or replacement recommendations.

4.5 Item 2(Picture) Kitchen cabinets

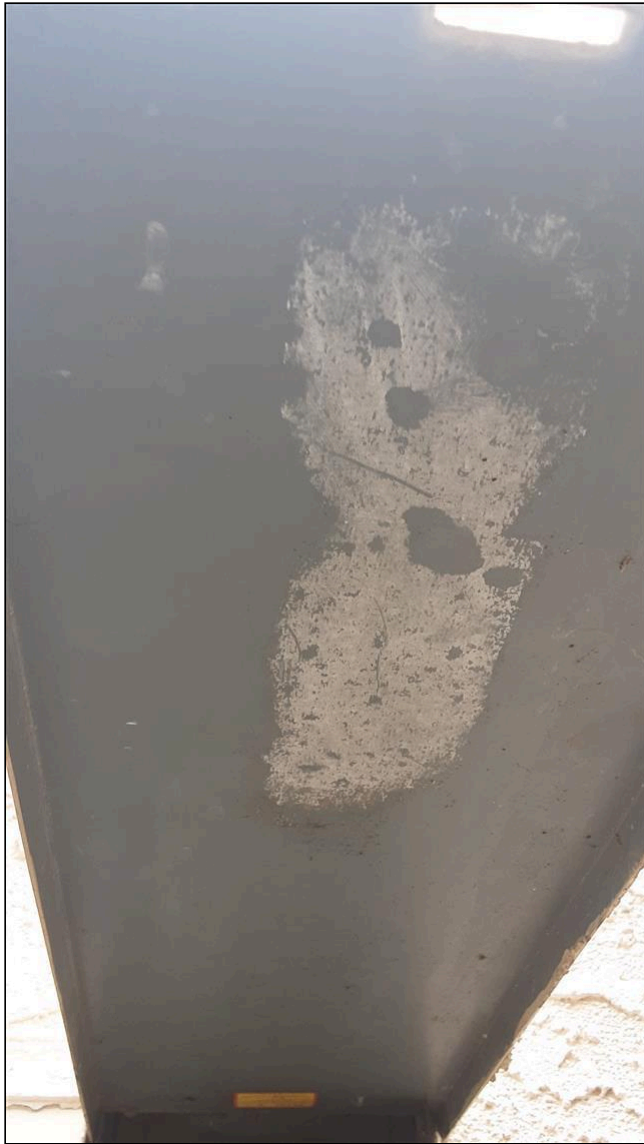
Main distribution panel is missing panel manufacturer identification label. Multiple brands of circuit breakers are present in main panel. Recommend a qualified electrician further inspect panel to confirm panel is in proper operating condition.

5.2 Item 1(Picture) Missing panel information

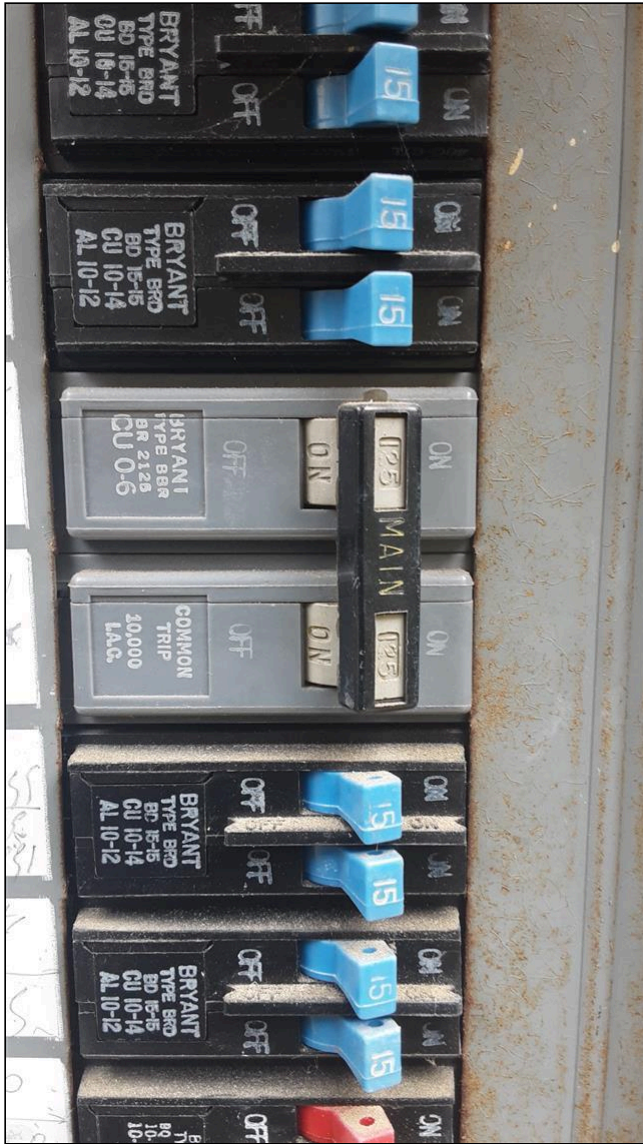
(2) Square footage of home exceeds two thousand square feet. Panel main shut off is 125 amps. This can be considered undersized for this size home. Recommend a qualified electrician further inspect and perform load test for proper amp requirements.

5.3 Item 2(Picture) 125 amp main shut off

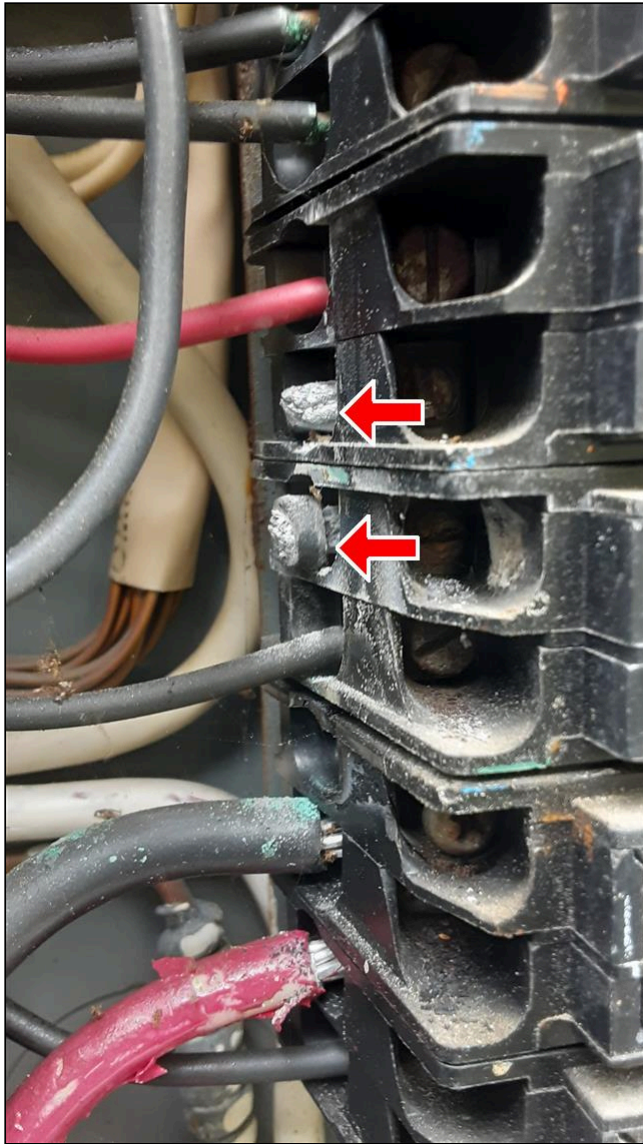
5.3 Item 3(Picture) Damaged wire leads

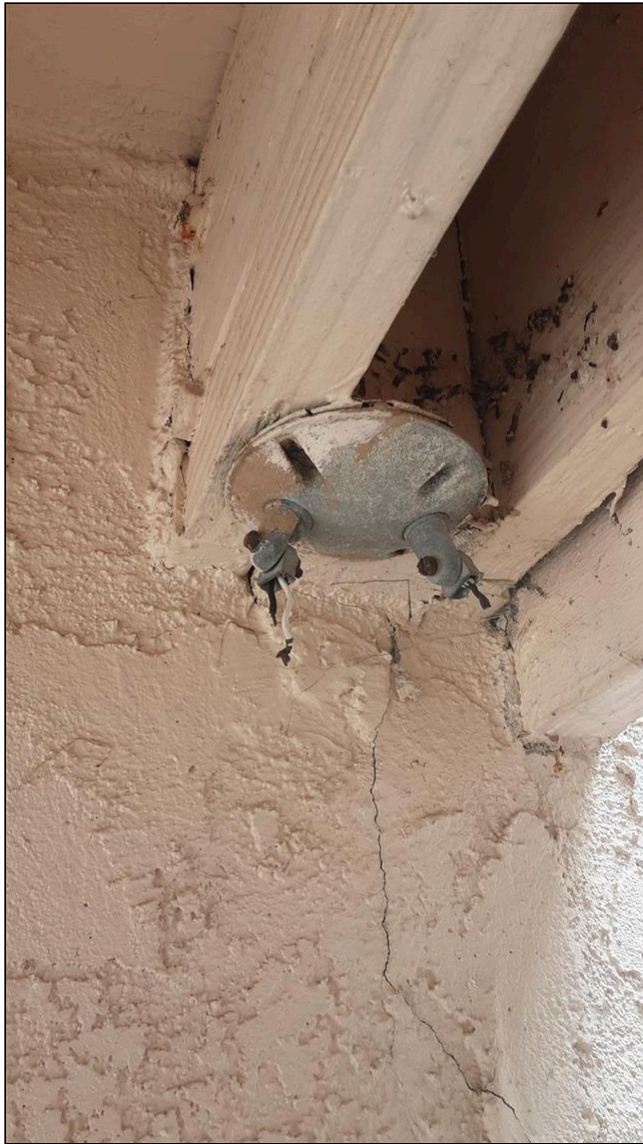
5.5 Item 1(Picture) Damaged fixture/exposed wiring, below main entry bridge

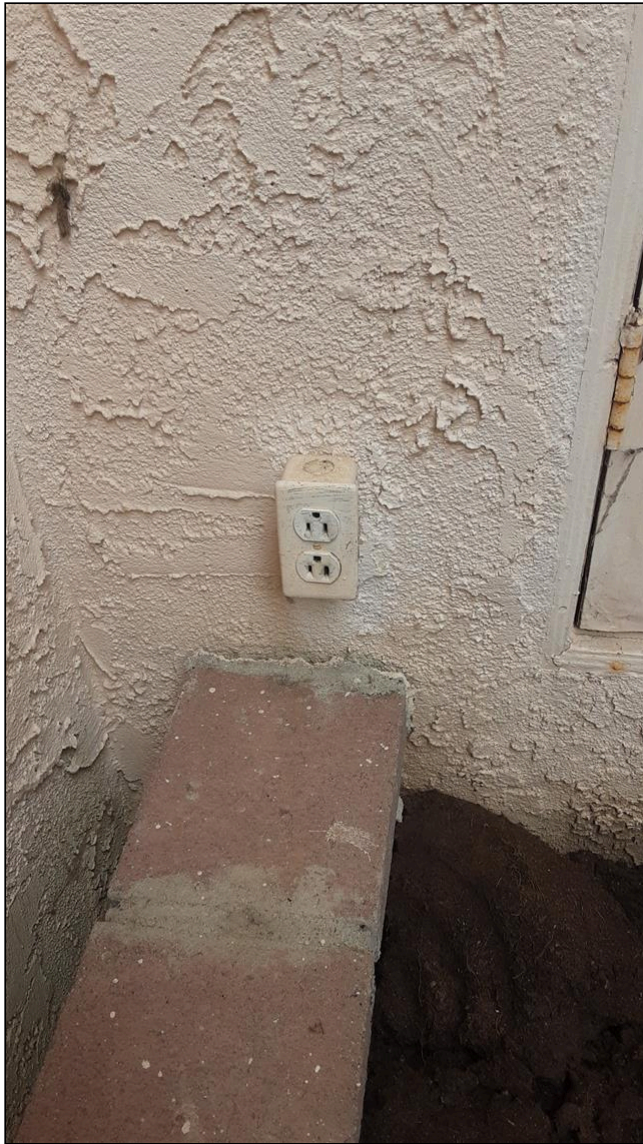
5.5 Item 2(Picture) Exterior outlet, front patio

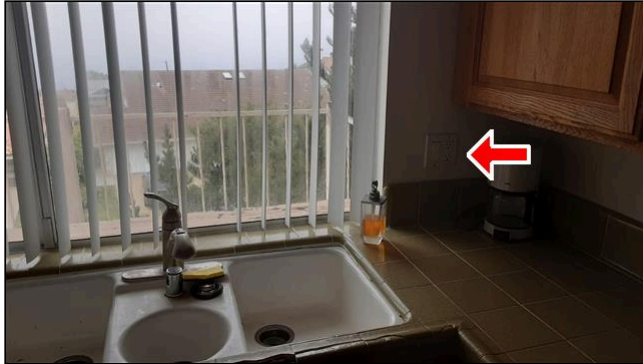
5.5 Item 3(Picture) Kitchen outlet

**5.5 (3)** The kitchen outlets next to kitchen sink are non protected outlets. Receptacles within six feet of a water source are required to be GFCI protected. These outlets are outdated and considered a safety issue until corrected. Recommend a qualified electrician further inspect and repair or replace as needed.

Section 210-8(a)(5) was modified in 1993 to apply to receptacles that serve " as opposed to being above " the kitchen countertop, and to add wet bar sinks. In the 1996 NEC, dwelling unit grade-level unfinished accessory buildings, and every kitchen counter-top receptacle (not just those within 6 feet of the sink), were added to the list of locations requiring GFCI protection. A 2005 revision removed the countertop criteria for wet bar, laundry, and utility sinks, thereby requiring GFCI protection for any receptacle within 6 feet of these dwelling unit sinks. Commercial and institutional were added as qualifiers for application of the GFCI requirements in other than dwelling unit kitchens. These kitchens were distinguished from others by adding what was to become the definition of a kitchen (an area with a sink and permanent facilities for food preparation and cooking). In keeping with tradition, new GFCI protection requirements were added during the 2014 revision cycle. GFCI protection is now required in laundry areas. This is not restricted to a laundry room since it is common to find the appliances in hall closets or master bedroom. A tub or shower stall is not always located in a bathroom so receptacles within 6 feet of any tub or shower stall are required to be protected. Kitchen dishwasher branch circuits have been added whether they are hard wired or for cord-connected appliances.

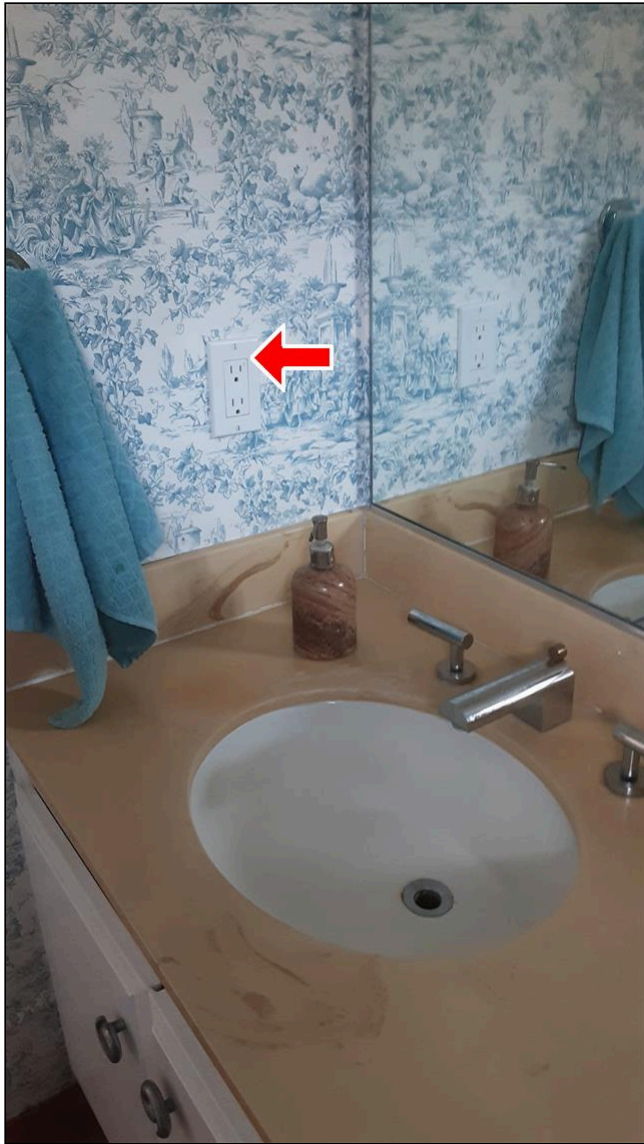
5.5 Item 4(Picture) Powder room outlet

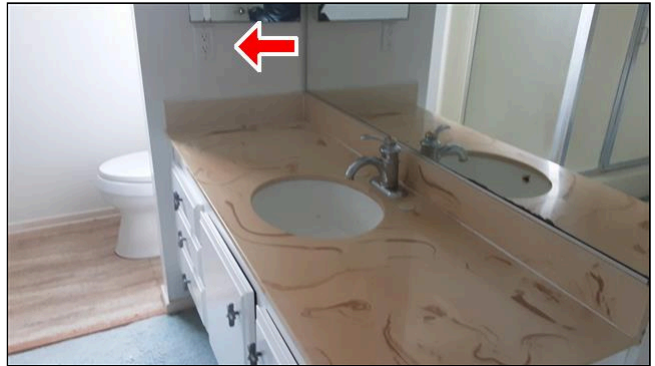
5.5 Item 5(Picture) Master bath outlet

(4) Bathroom outlets are non protected outlets. All outlets within six feet of a water source are to be GFCI protected. All electrical issues are considered safety issues until corrected. Recommend a qualified electrician further inspect and repair as needed.

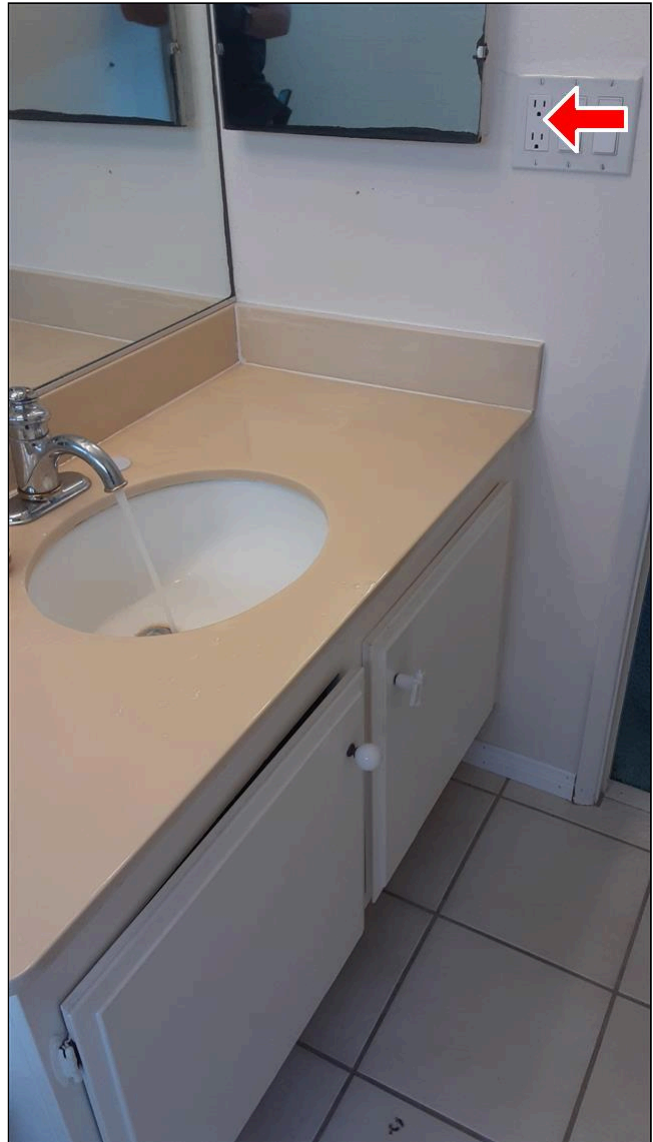
5.5 Item 7(Picture) hall bathroom outlet

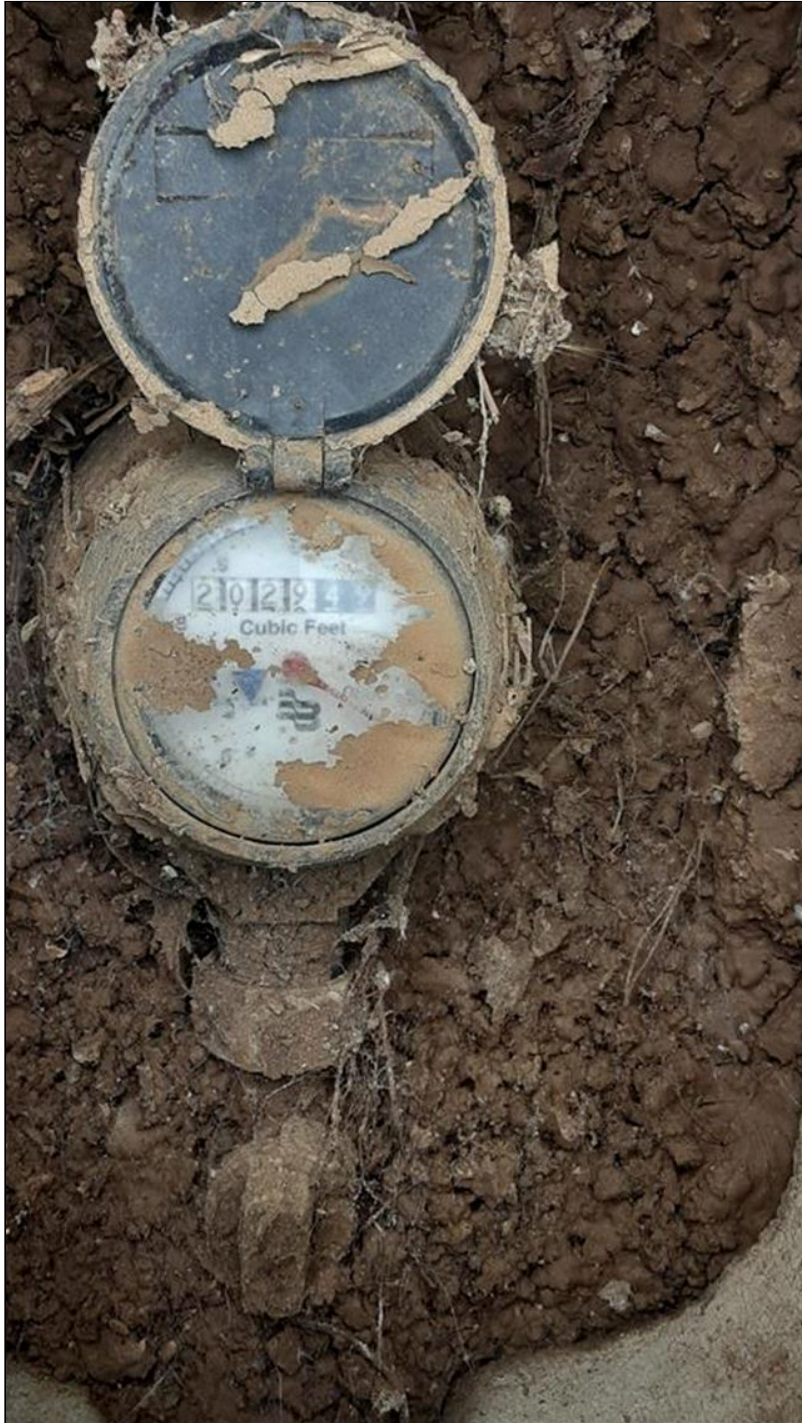
6.0 Item 1(Picture) Water meter

home. When water supply was left on water meter low flow indicator was rotating. No leaking was found at time of inspection. Recommend a qualified person further inspect as needed.)

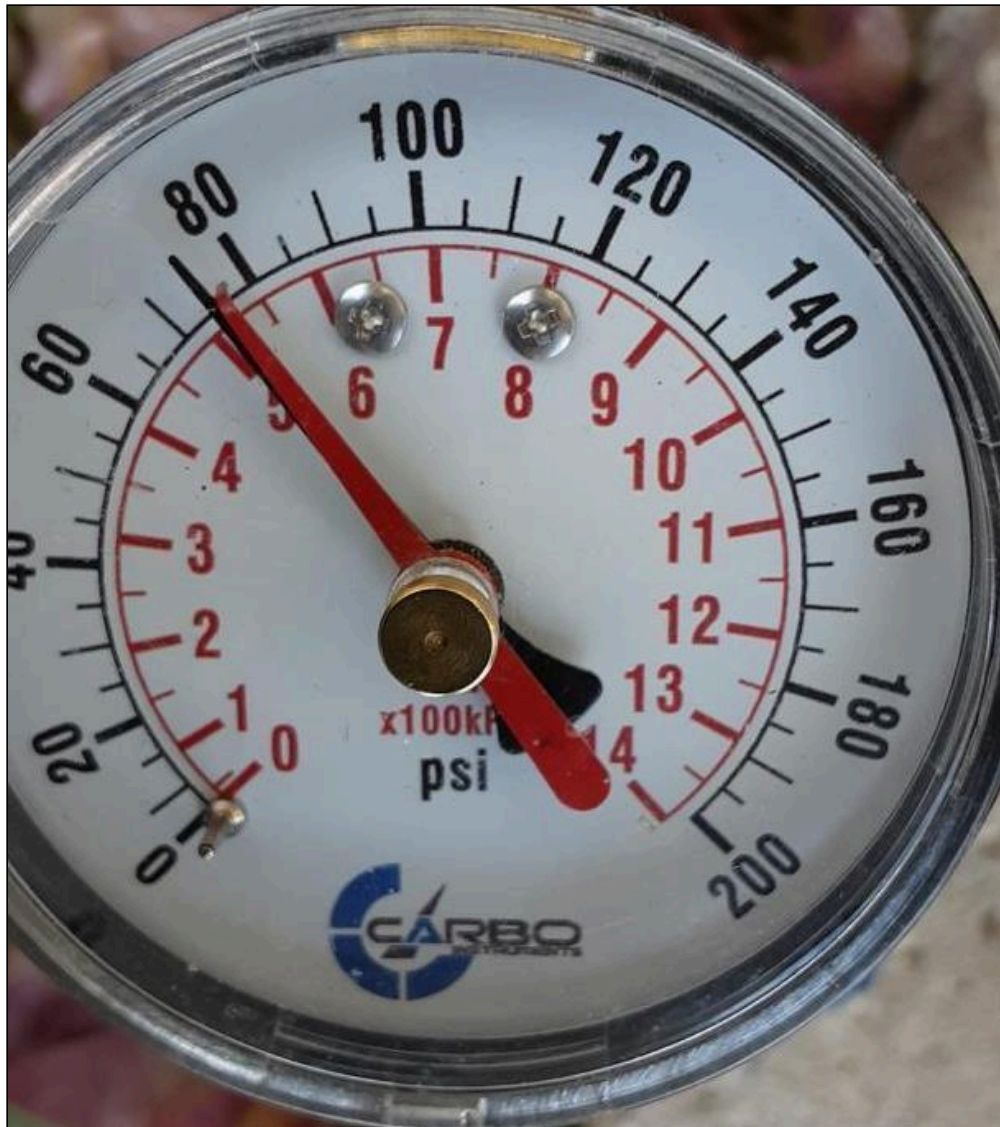
6.0 Item 3(Picture) Water pressure

Water pressure at time of inspection was 75 PSI.

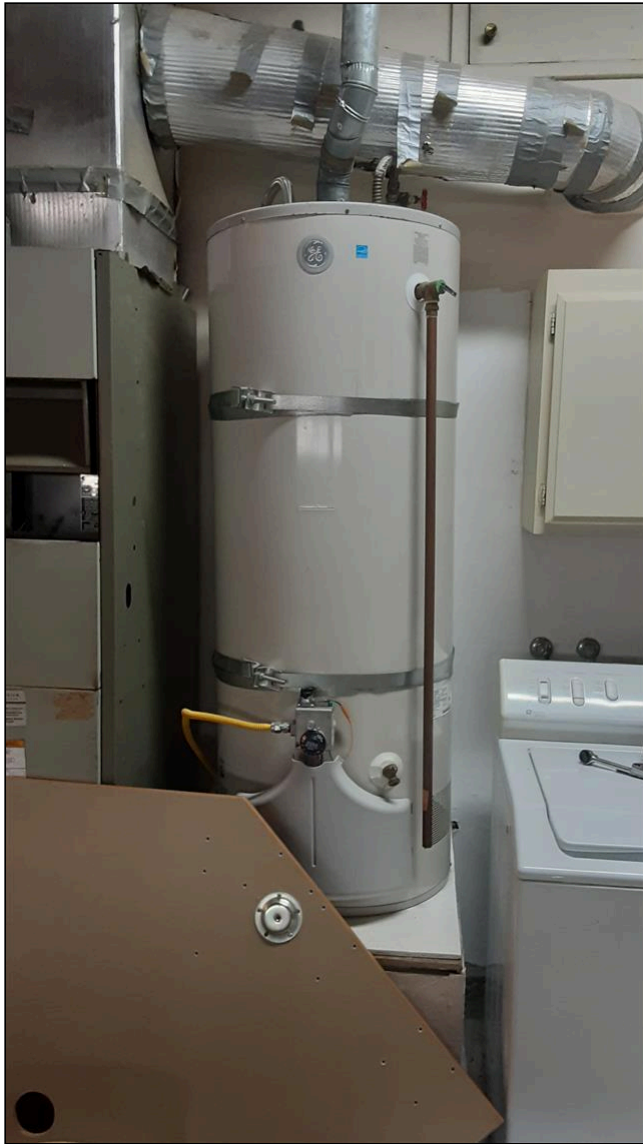
6.2 Item 1(Picture) Water heater

Manufacture date: October 14, 2009 (Water heater has reached its average life span of 8-12 years. Water heater is approx 12 years old. Water heater operated at time of inspection but may fail in the near future.)

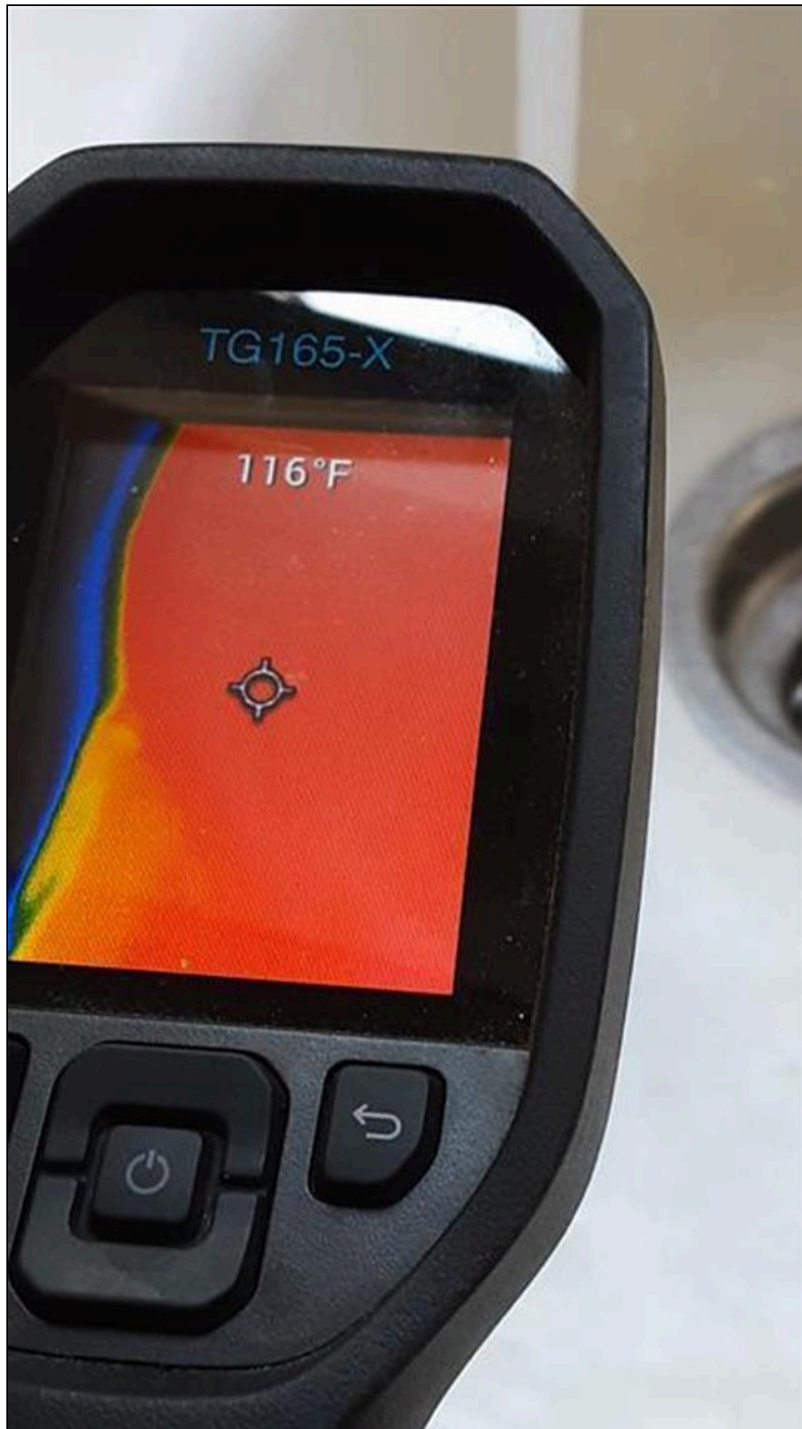
6.2 Item 3(Picture) Hot water temp

Hot water temperature was 116 degrees at time of inspection.

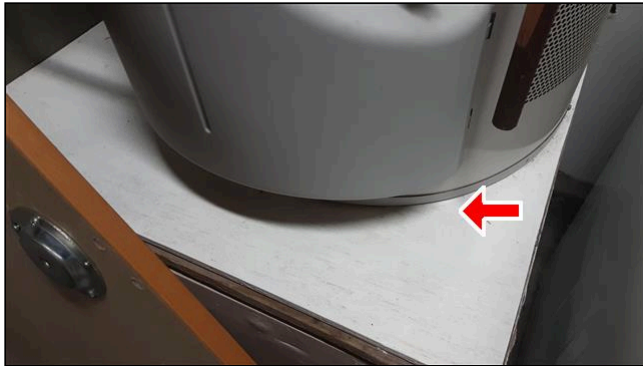
6.2 Item 4(Picture) Missing drip pan

(2) Water heater is not placed inside a drip pan. While it is not required, it is encouraged to place water heater into a drip pan with proper hose to drain water to a safe place if water heater was to leak. This is to prevent water damage to flooring and walls that are surrounding water heater in closet. Recommend a qualified plumber install drip pan as needed.

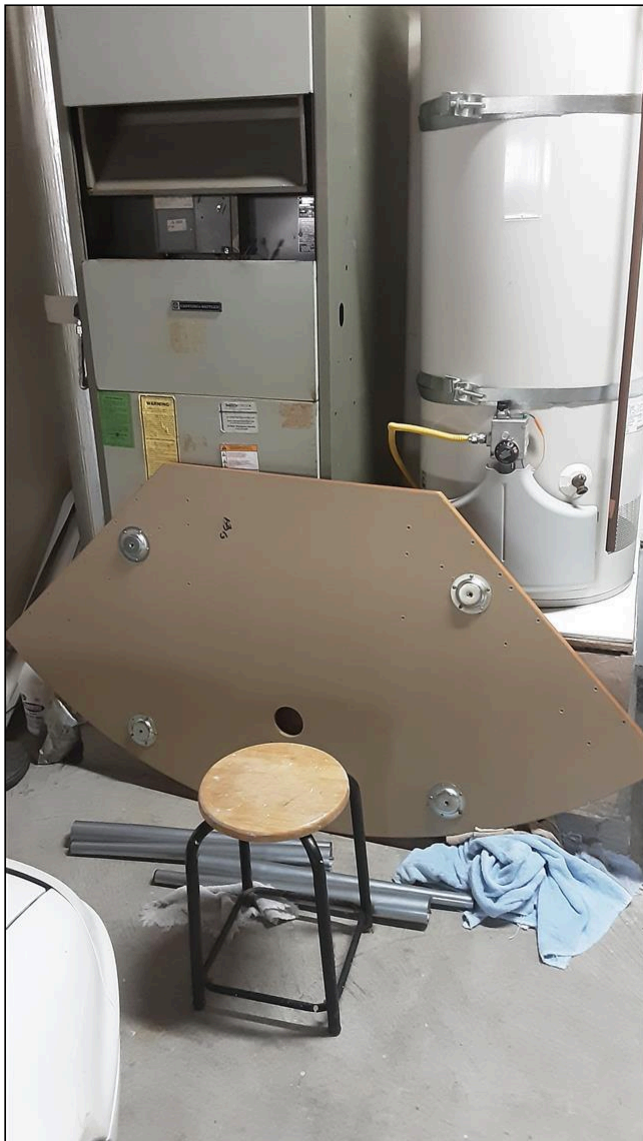
6.2 Item 5(Picture) No protection for appliances in garage

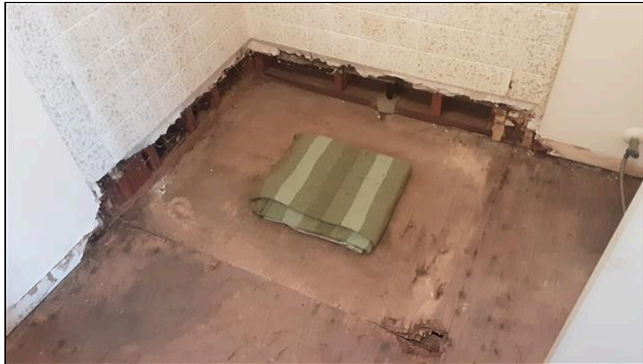
6.4 Item 1(Picture) Removed shower pan, lower level hall bathroom

(1) Bathtub or shower pan inside lower level hall bathroom has been removed. Recommend a qualified contractor further inspect for repair recommendations.

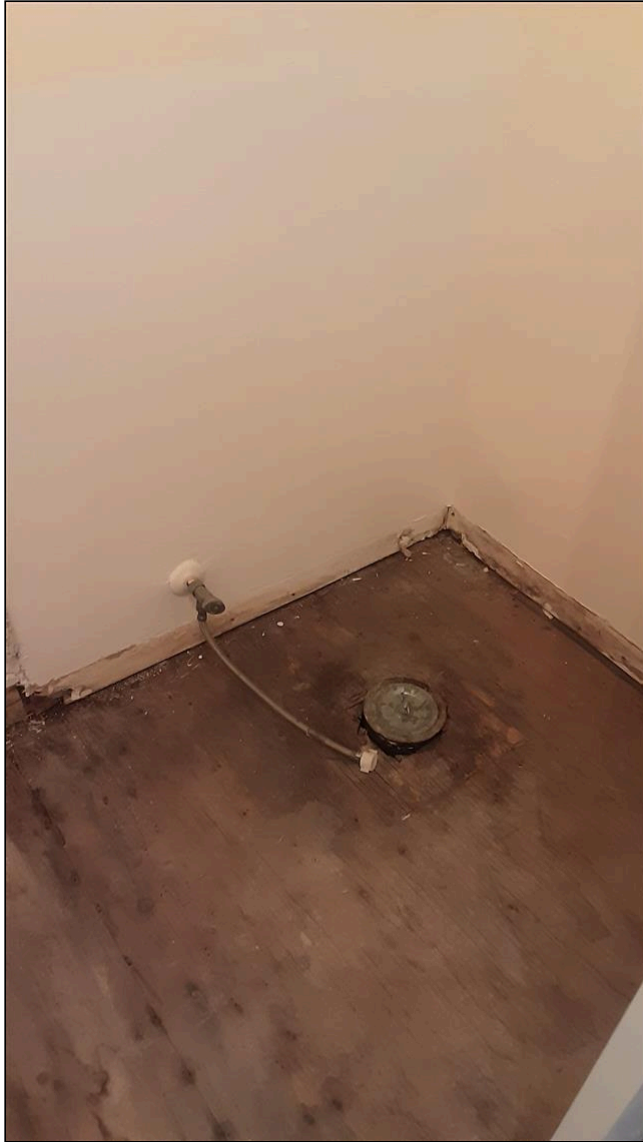
6.4 Item 2(Picture) Missing toilet, lower level hall bathroom

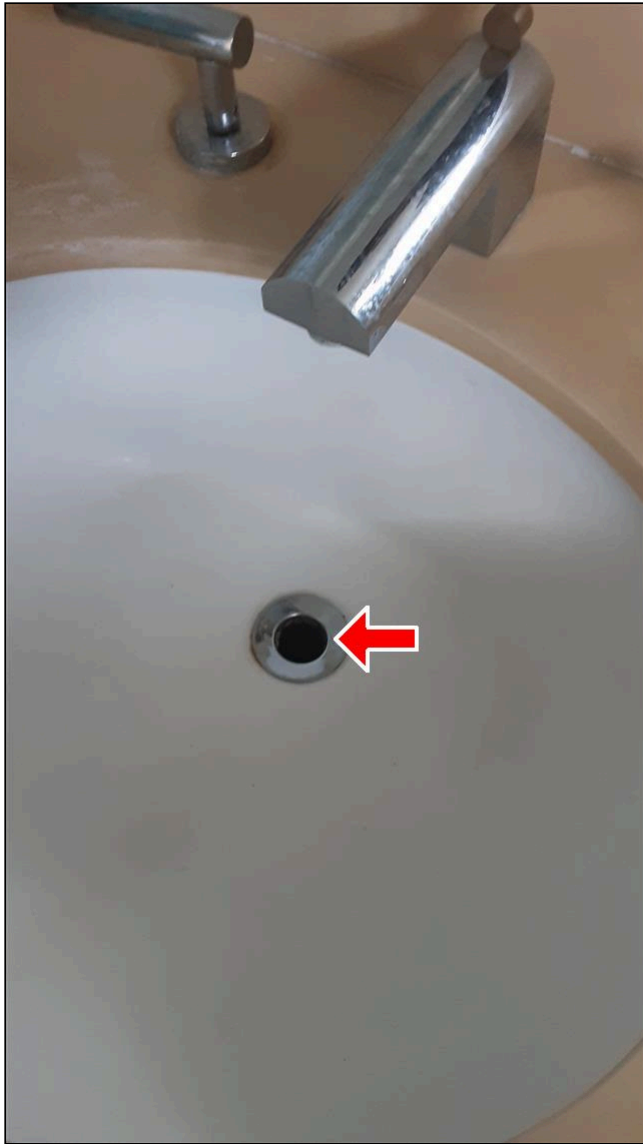
6.5 Item 1(Picture) Drain stop missing, powder room sink

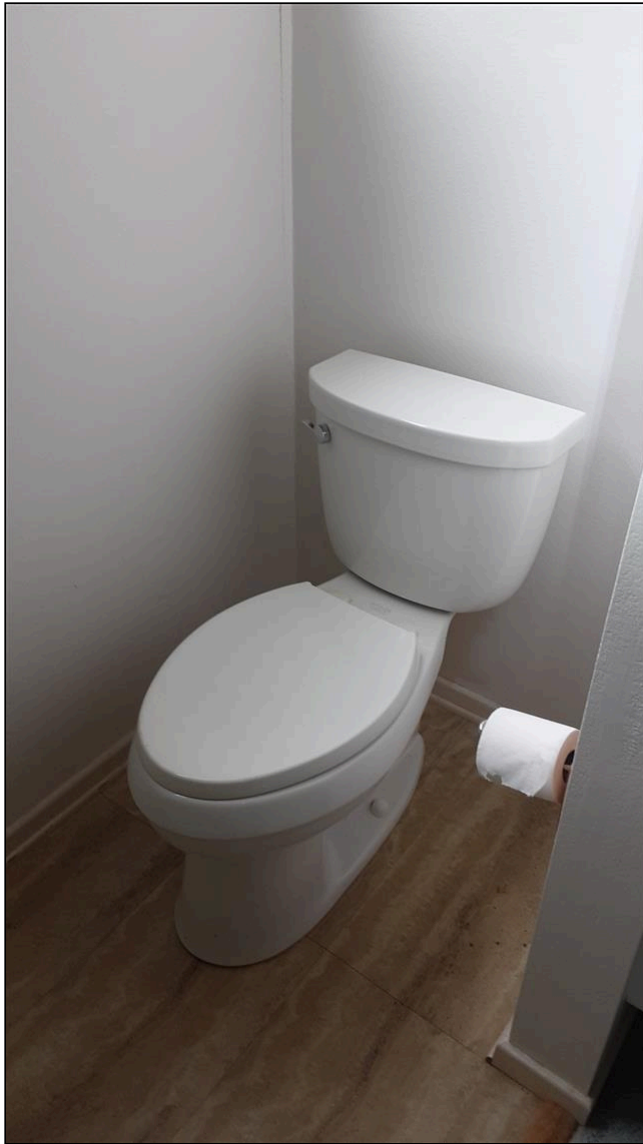
6.5 Item 2(Picture) Loose toilet, master bathroom

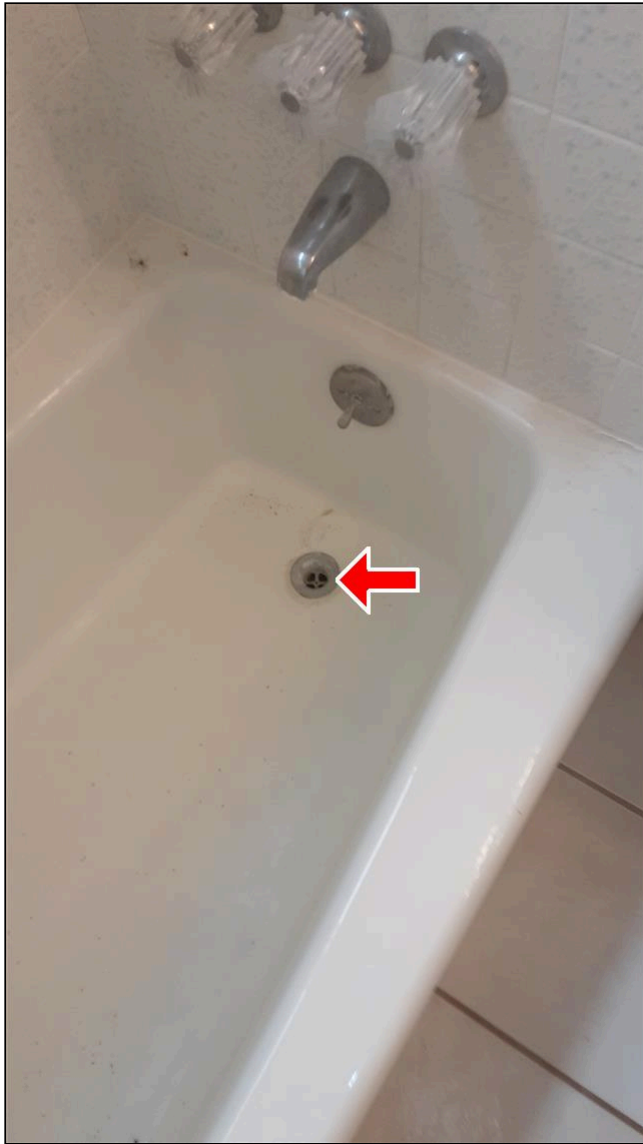
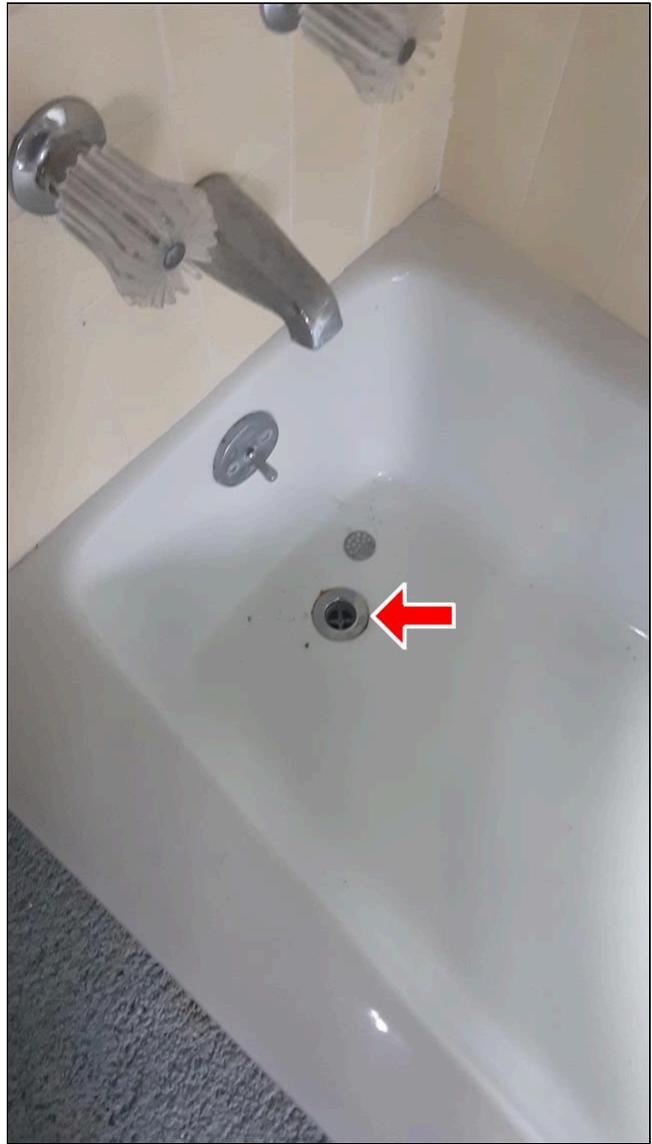
6.5 Item 3(Picture) Missing drain stop

6.5 Item 4(Picture) Missing drain stop

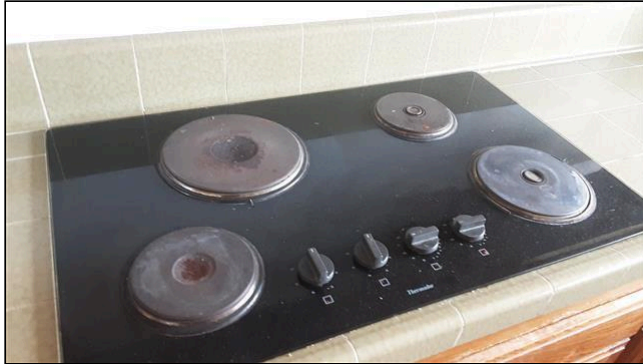
7.1 Item 1(Picture) Kitchen burners

Cooktop burner control is damaged. Electric burners are rusted. Recommend a qualified person further inspect for repair or replacement recommendations.

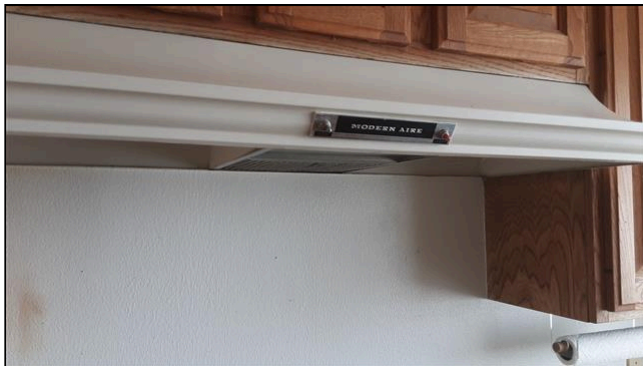
7.2 Item 1(Picture) Range hood

Range hood is dated but did operate. Light did not operate at time of inspection. Recommend a qualified person further inspect for repair or replacement recommendations.

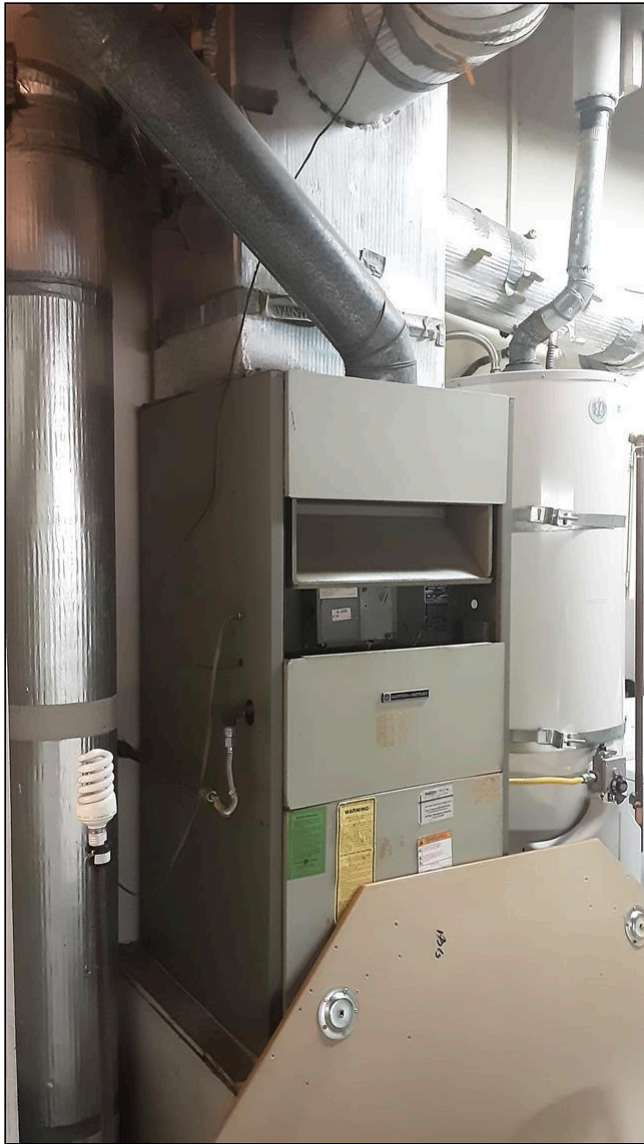
9.0 Item 1(Picture) Heat system

Model: U150

Serial: 942A J

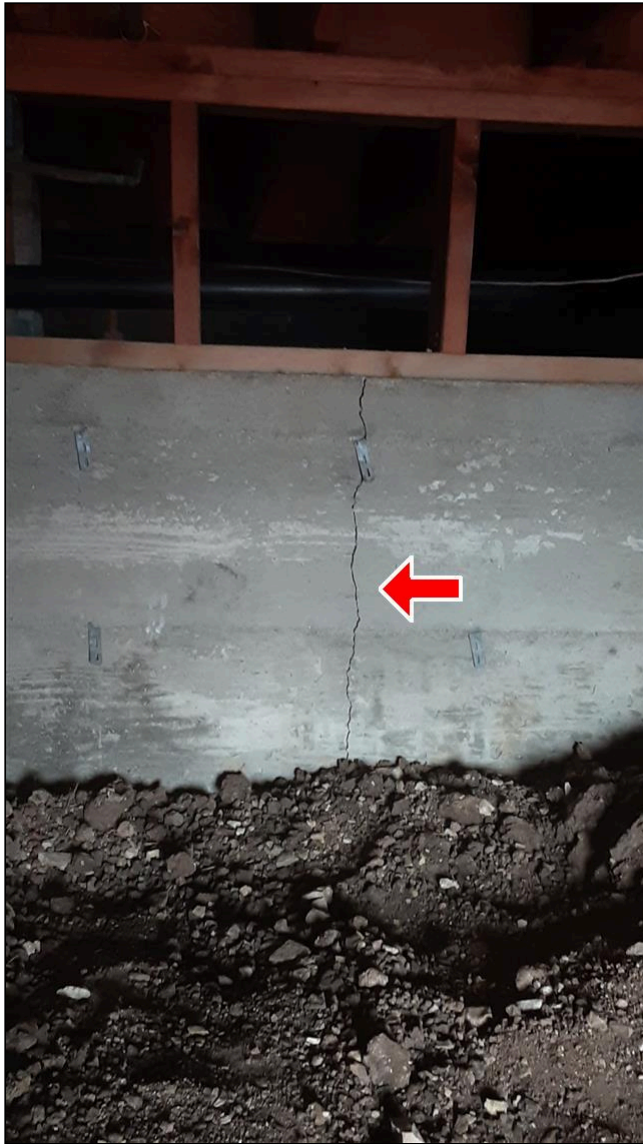
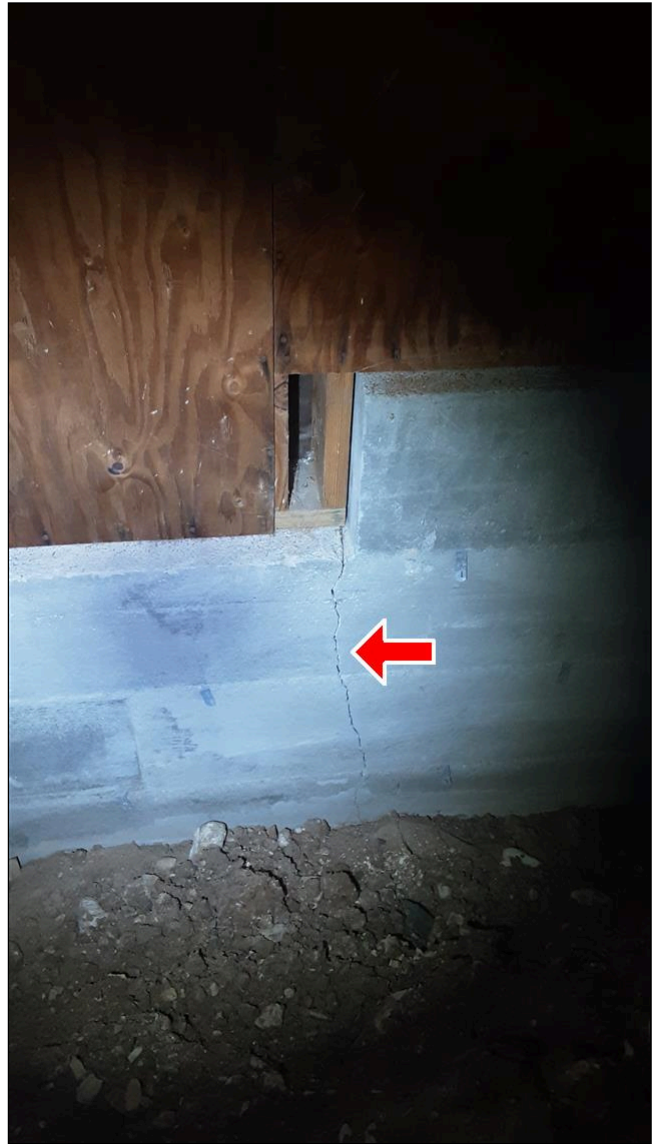
11.0 Item 1(Picture) Minor cracking

11.0 Item 2(Picture) Minor cracking
