Preliminary Inspection Report

Client: Nathaniel Berenstein-Cervera
Inspection Address: 6953 Purple Ridge Drive
Rancho Palos Verdes, CA 90275
Date of Inspection: October 27, 2020

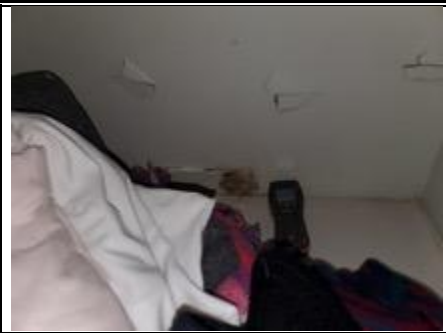
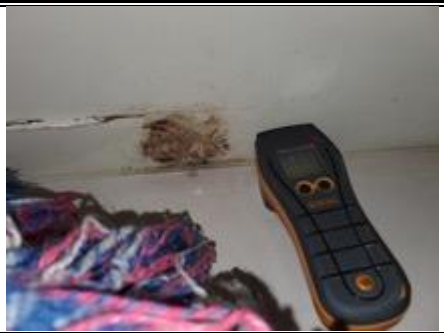
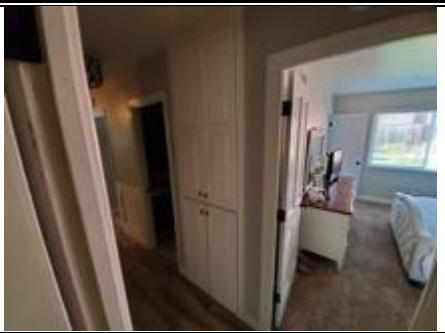
Concern #1: Hallway

There is mold growth and elevated moisture on the lower north wall inside the north built-in cabinet. This cabinet and wall back up to the hallway bathroom tub.	There is mold growth and elevated moisture on the lower north wall inside the north built-in cabinet. This cabinet and wall back up to the hallway bathroom tub.	Overview image of the north built-in cabinet.

- **Remove the lower 2-3 feet of the north wall inside the north built-in cabinet.**
 - **Remove the base of the north built-in cabinet.**
 - **Upon removal, further investigate areas to determine if more mold or water damage is present. Continue removal if more damage exists.**

- Any and all insulation that is present upon the removal of the above mentioned areas should be removed and discarded.
- When performing any removal, a HEPA vacuum should be used to remove all dust and debris that exists.

- Upon removal of the areas of concern, an additional 12 inches of wall materials should be removed in order to reduce the likelihood of additional contamination nearby.

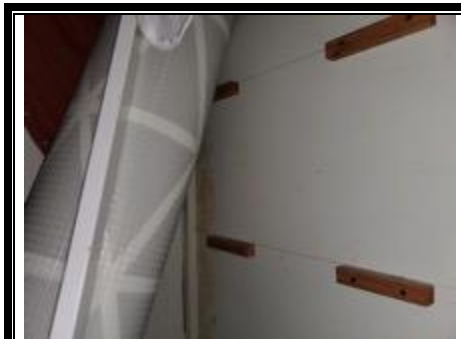
Concern #3: SE Bedroom

There is visible mold growth on the north and east walls of the closet.

- The following areas of concern should be addressed:
 - Remove all excessive contents from the closet.
 - Clean the mold growth on the walls.
 - If concerned- remove a 1x1 foot section of the walls where the mold growth is present so the wall cavity can be investigated for damage.
 - Upon removal, further investigate areas to determine if more mold or water damage is present. Continue removal if more damage exists.
 - If concerned- intrusive wall cavity samples can be taken to determine if mold growth exists.

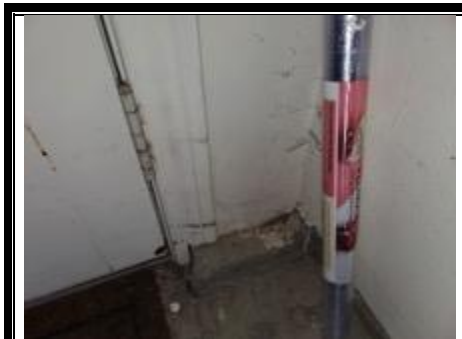
Concern #1: Garage

The lower west wall on both sides of the west exit door has some damage. No moisture today.

- Remove the lower 1-foot of the west wall on both sides of the west exit door.
- Clean any dry stains on the wood ceiling.

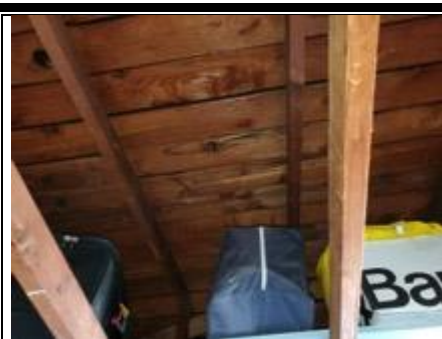
There are some minor dry stains on the wood ceiling.

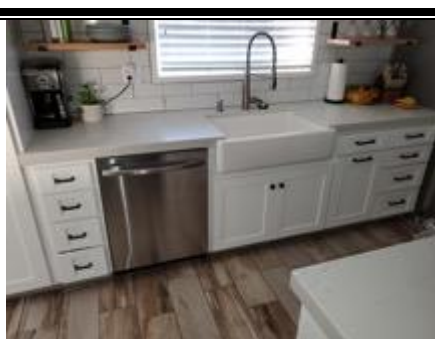
Overview image of the sink vanity area of the kitchen. There are some visible minor dry stains on drywall inside the lower cabinets.

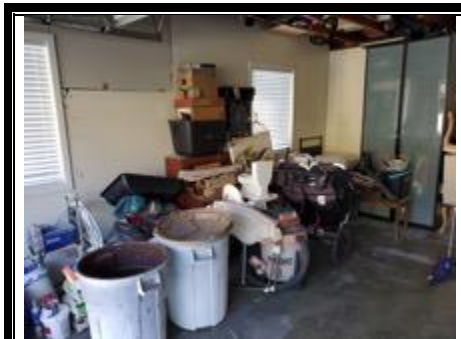
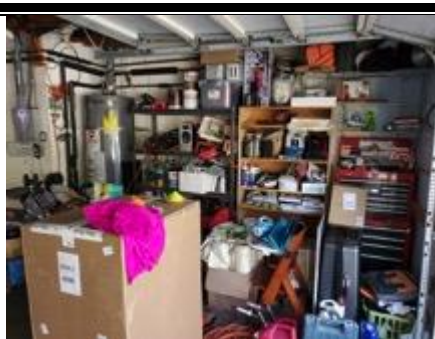
Concern #3: General Areas of the Home

Excessive contents are present inside the garage structure today. The contents are covering some sections of walls. Areas that were visible had no signs of damage unless noted otherwise in this report.

- Please contact NU Environmental if any water damage or mold growth is detected once all contents have been removed from the property.

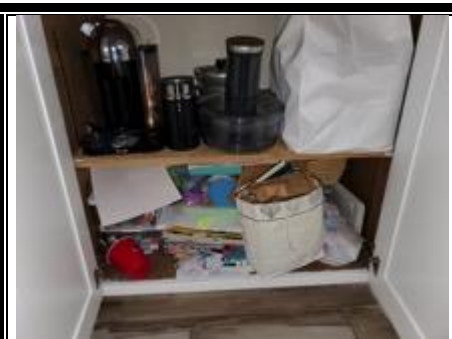
Excessive contents are present inside built-in cabinets and closets during our inspection. Areas visible had no signs of damage unless noted otherwise in this report. Image of the kitchen cabinet next to the microwave.

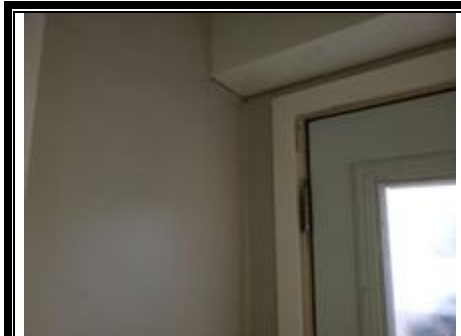
There is patchwork, nails popping, and ripping to visible seams throughout the home. No signs of damage or moisture to these areas today. Image of the laundry room seam between the south and west walls.

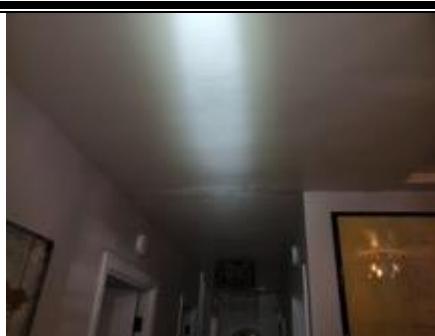
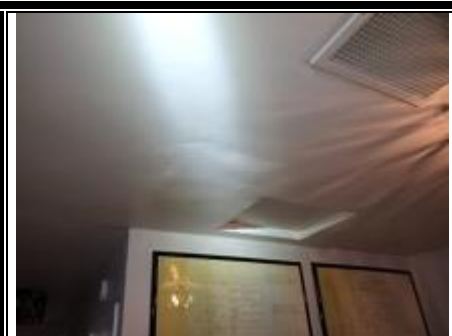
There is patchwork, nails popping, and ripping to visible seams throughout the home. No signs of damage or moisture to these areas today. Image of the entry ceiling around the attic access hatch area.

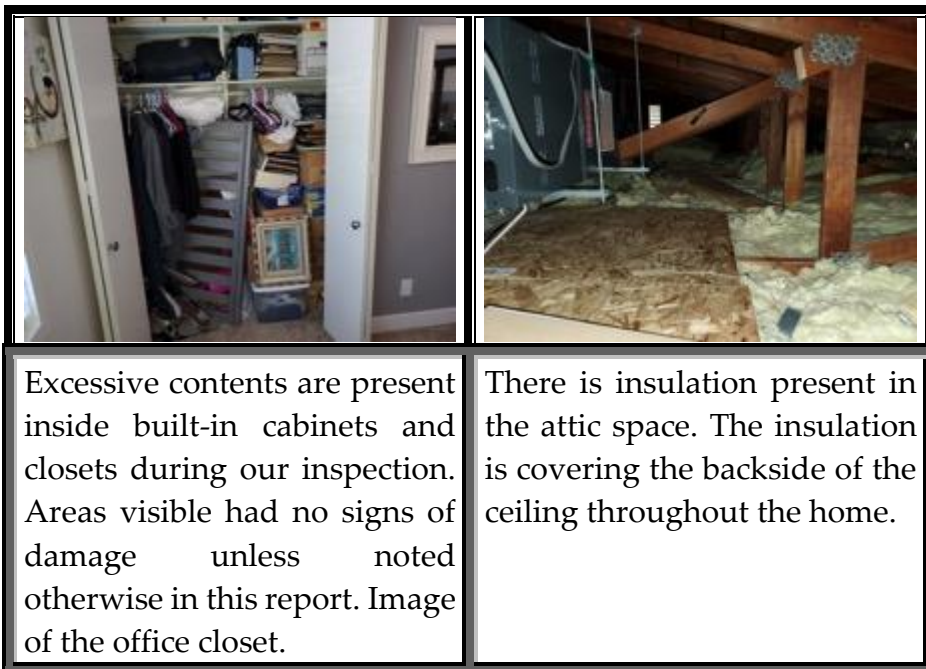
Excessive contents are present inside built-in cabinets and closets during our inspection. Areas visible had no signs of damage unless noted otherwise in this report. Image of the office closet.
