Property Inspection Report

555 Vallombrosa Ave #20, Chico, CA
Inspection prepared for: Alek Palmersmith & Belen Vivero
Real Estate Agent: Jayme Foster - City of Trees Realty

Date of Inspection: 4/12/2018 Time: 12:45pm
Age of Home: approx 45 yrs Size: approx 900 sf
Weather: Sunny but Damp

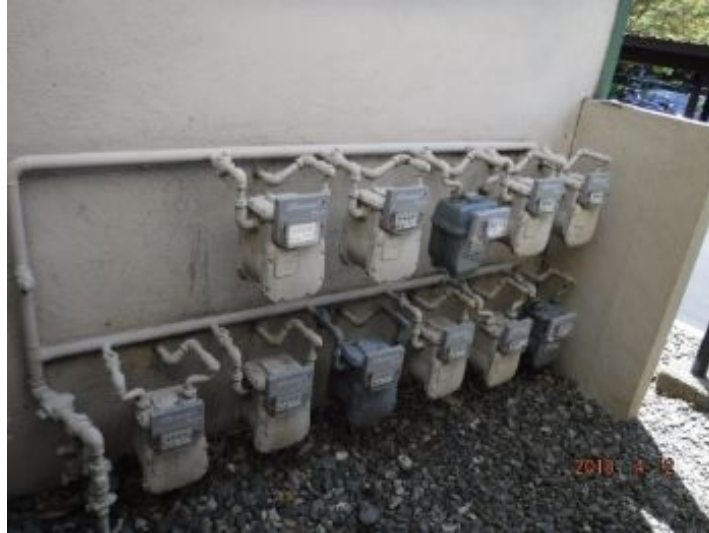
- The inspector was unable to determine which gas meter belonged to unit 20.

Gas meters for complex

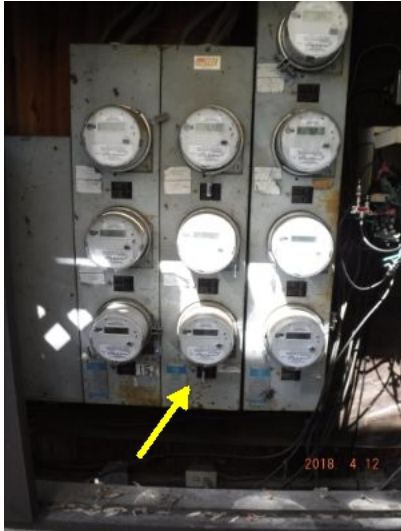
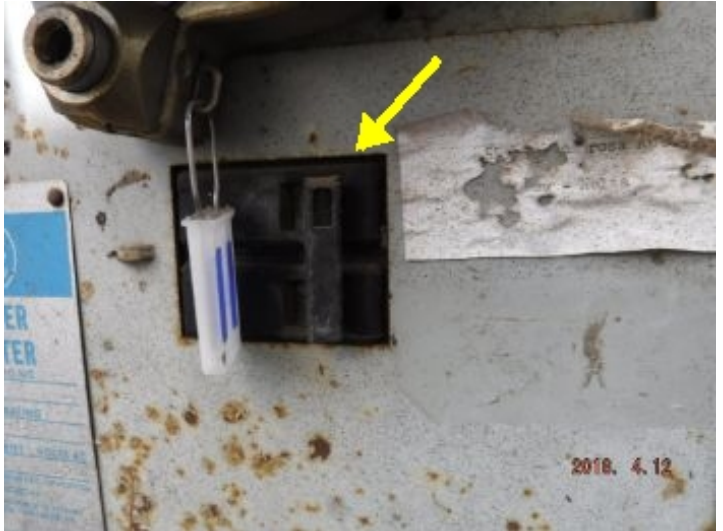
Location: Main Location: On west side of the complex
 Location: Sub Panel Location: In the entryway hallway
 Observations:
 • Appeared functional at time of inspection.

Main breaker

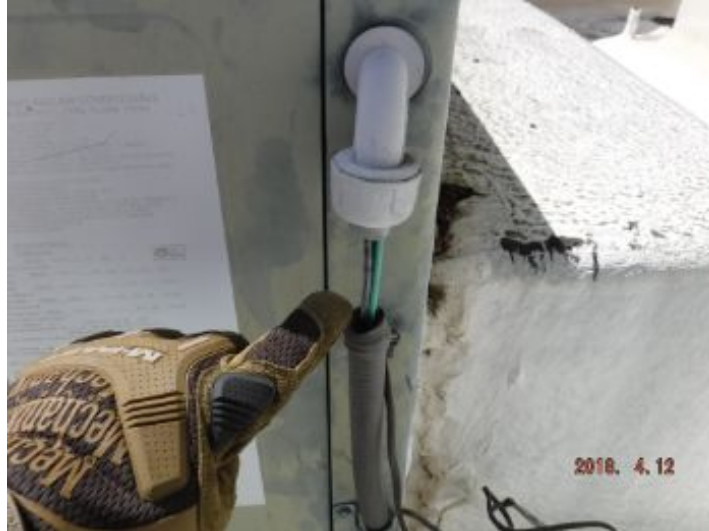
- Appeared functional at the time of inspection.
- Make: Amana (same unit as heater).
- **The conduit that protects the electrical feeds to the HVAC unit has separated from the strain relieve.**

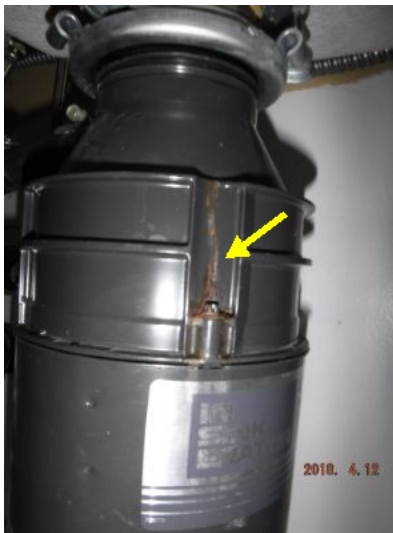
Observations:
 • Crack noted in the side of the disposal body.

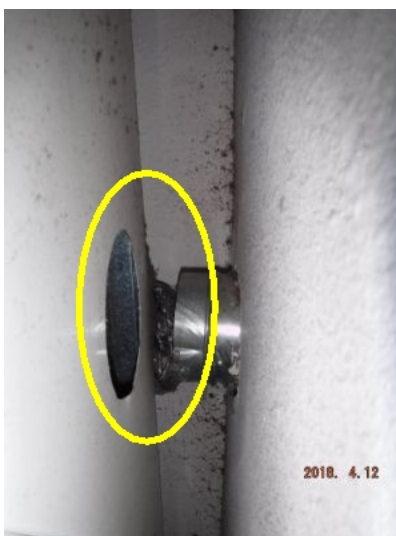
- The dryer vent duct has separated in the laundry closet.
