Inspection Report

Property Address:
1 Golden Spar Place
Rolling Hills Estates Ca

South Bay Home Inspections

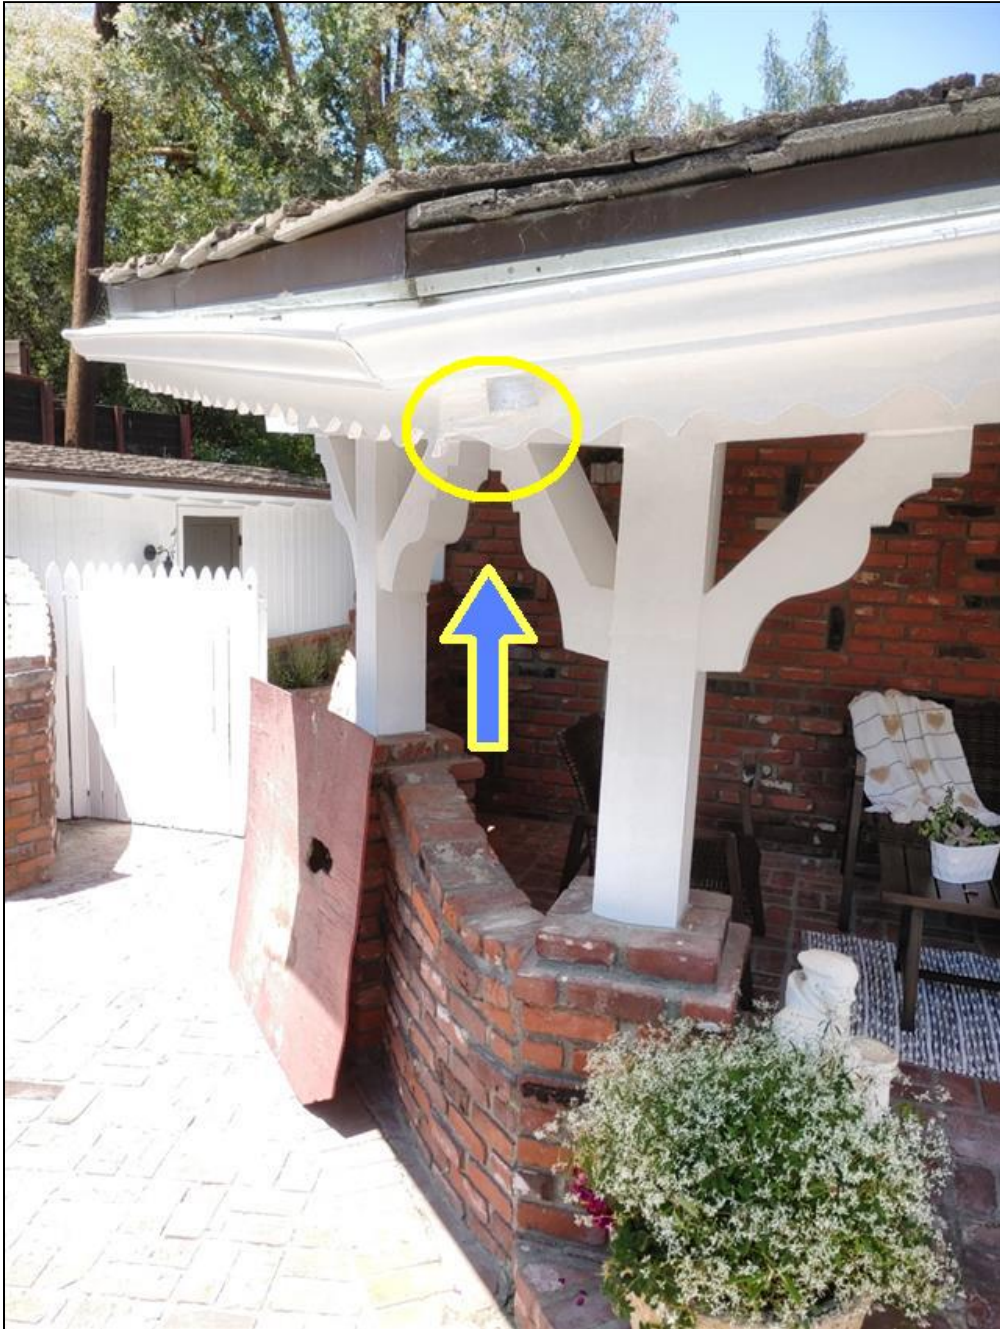
2.3 Item 1(Picture) The rain gutter at the rear of the house is missing a downspout. We recommend further evaluation and services necessary.

- The rain gutter at the rear of the house is missing a downspout. We recommend further evaluation and services necessary.

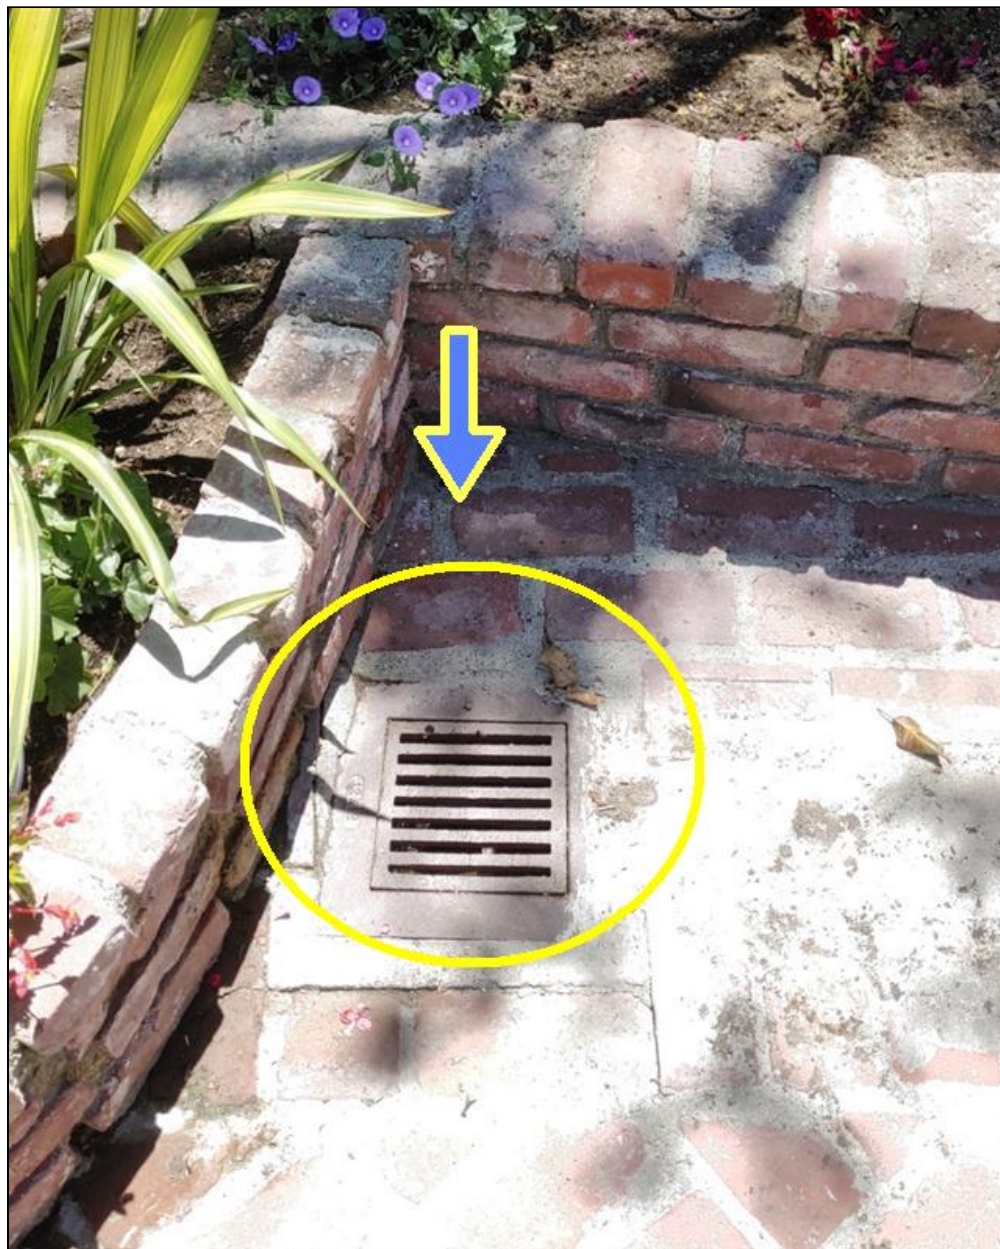
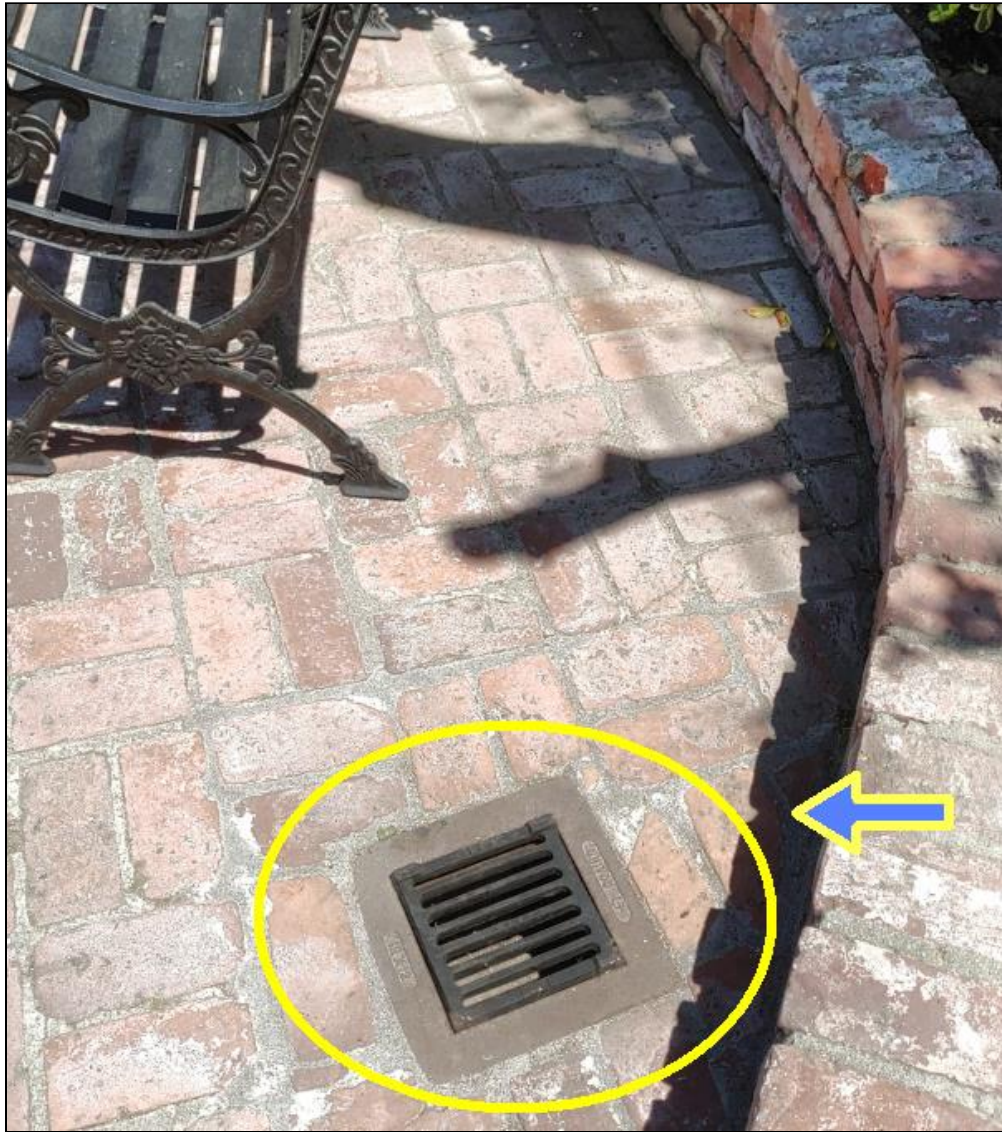
2.4 Item 1(Picture) The area drains were in acceptable condition at the time of inspection.

2.4 Item 2(Picture) The area drains were in acceptable condition at the time of inspection.

2.4 The area drains were in acceptable condition at the time of inspection.

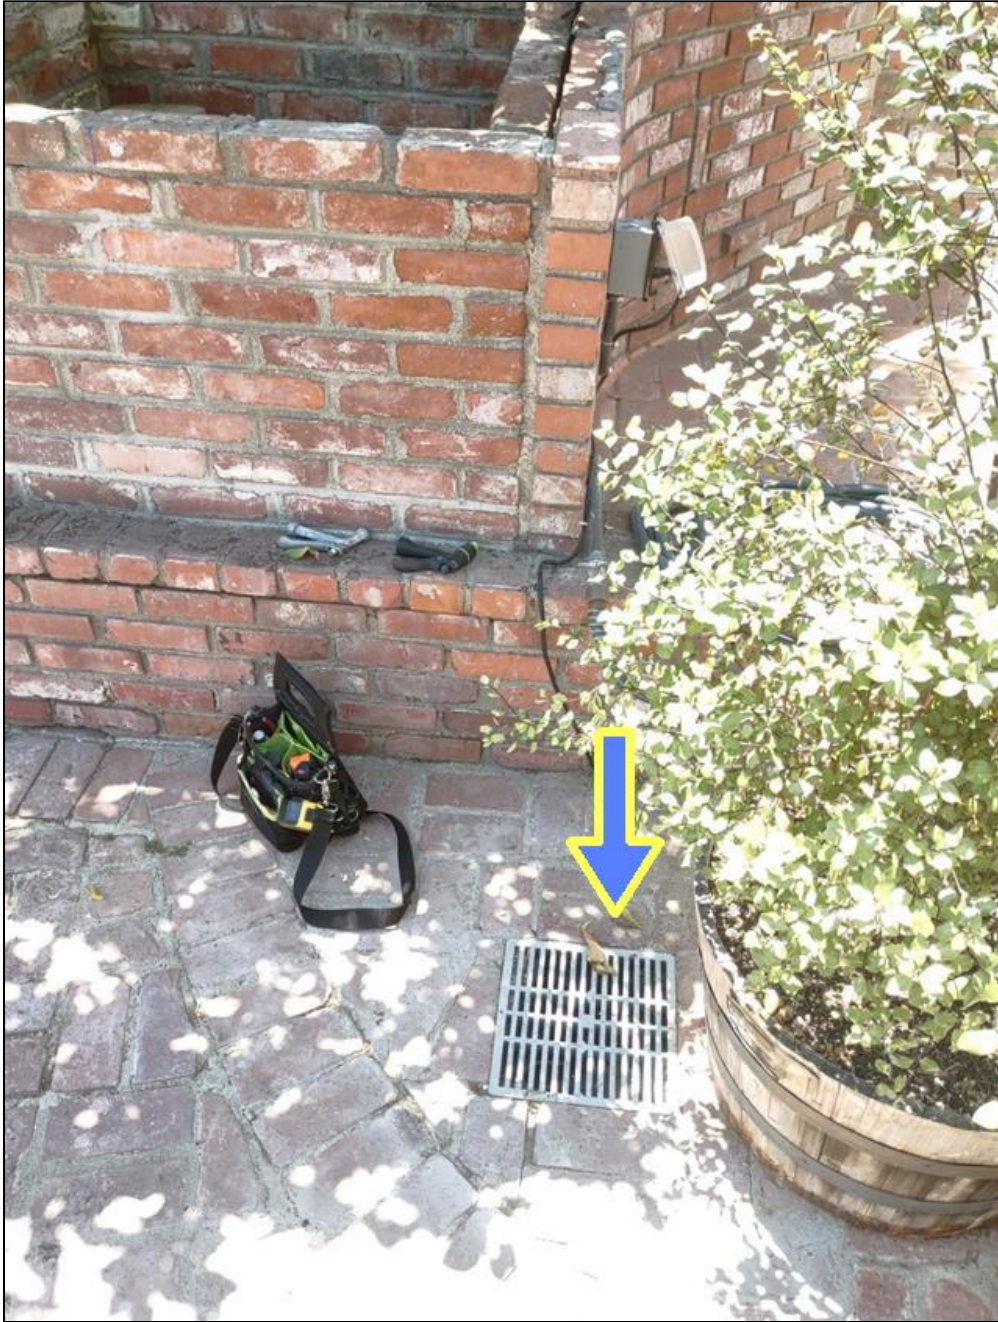
2.5 Item 1(Picture) There is a sump pump located at the rear of the residence. The sump pump was not tested at the time of inspection. We recommend you have to tell us about this or have it further evaluated and serviced if necessary.

- There is a sump pump located at the rear of the residence. The sump pump was not tested at the time of inspection. We recommend you have to tell us about this or have it further evaluated and serviced if necessary.

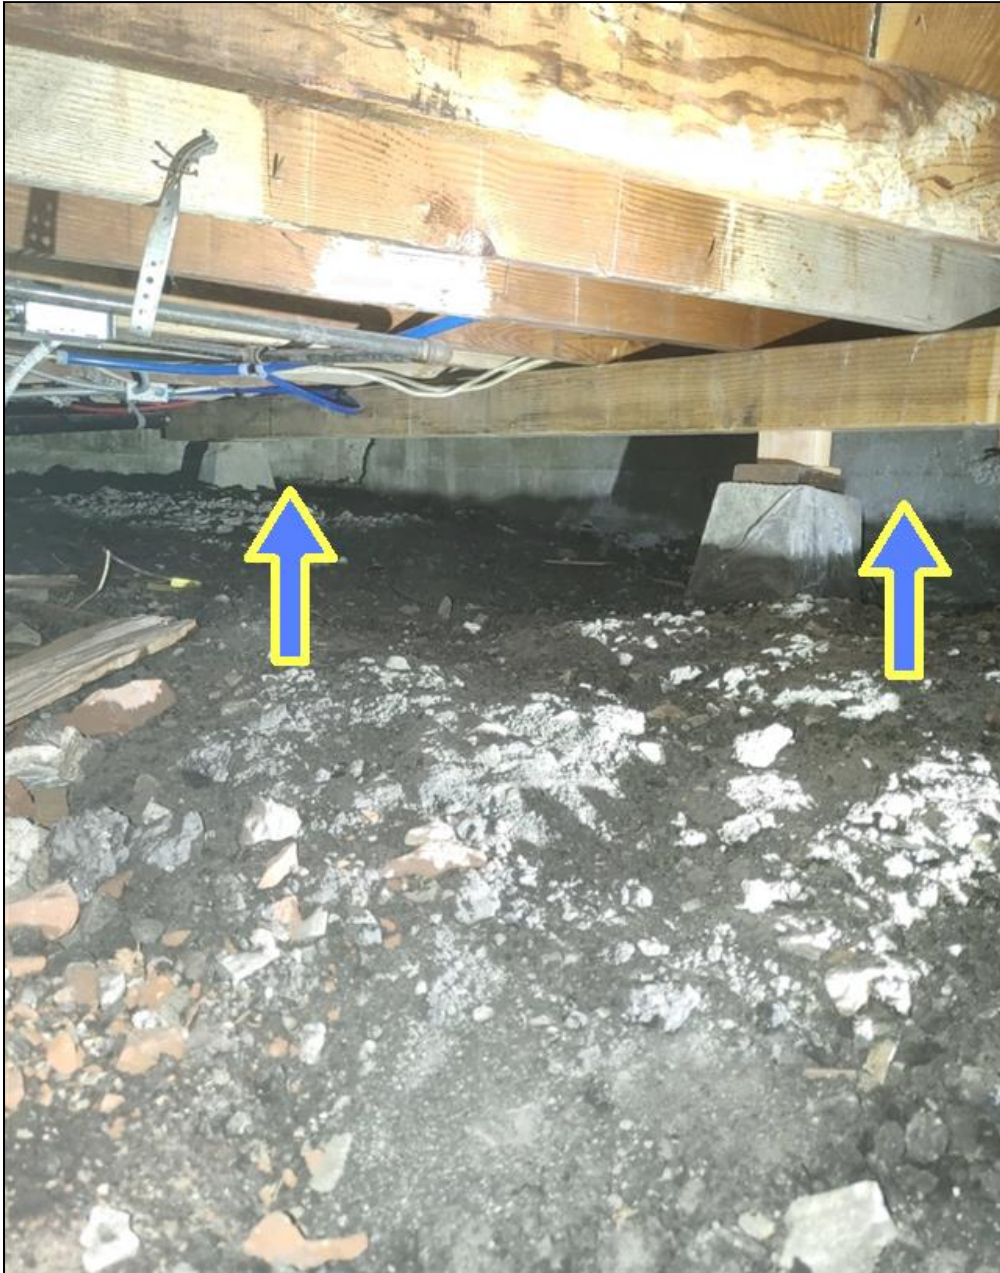
4.0 Item 1(Picture) There is a newer section of the foundation that has been recently added. You may wish to ask the Sellers if they have any documents that pertain to this.

4.0 There is a newer section of the foundation that has been recently added. You may wish to ask the Sellers if they have any documents that pertain to this.

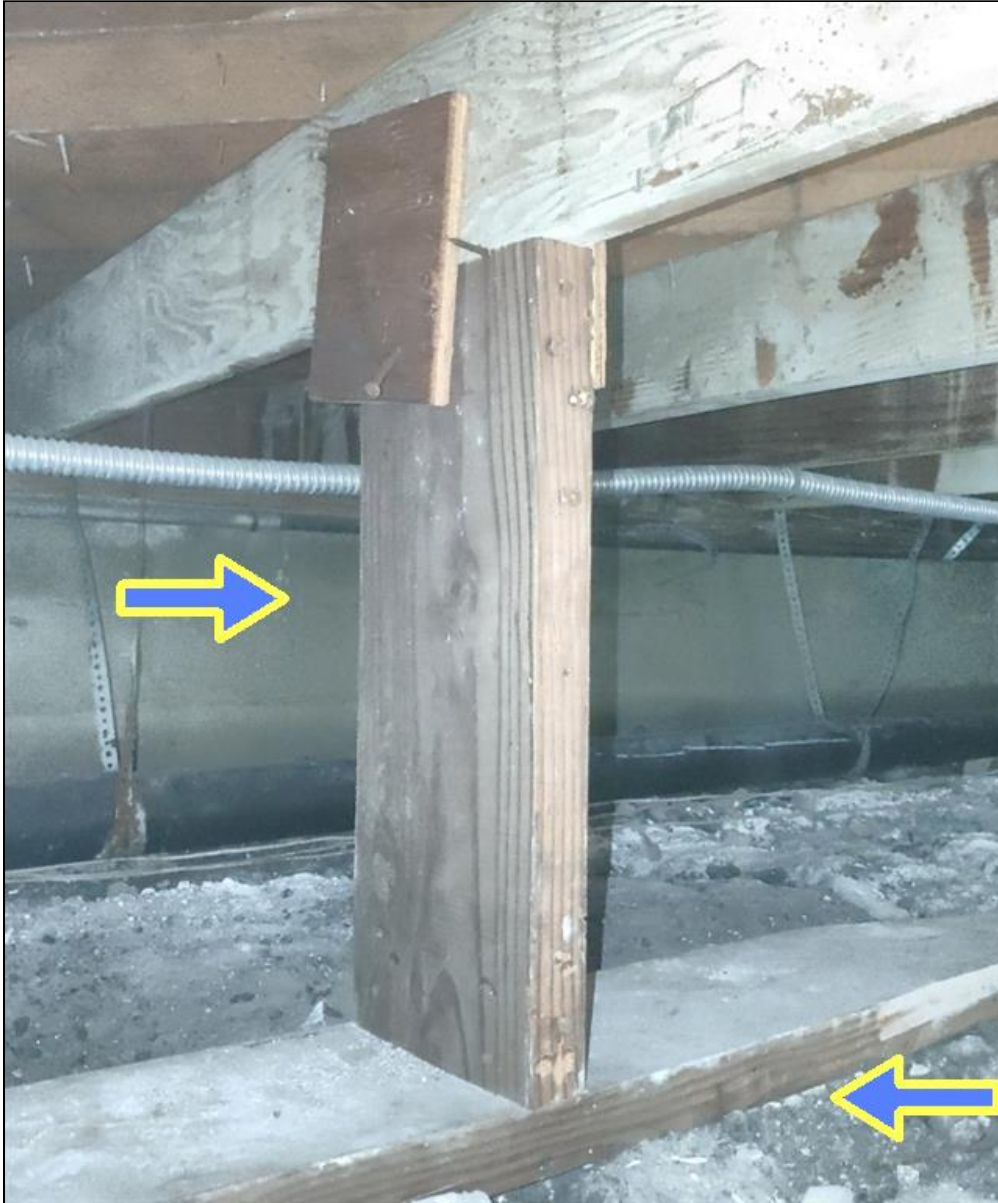
4.3 Item 1(Picture) There is a temporary pier that has Earth to wood contact. We recommend that you have the Termite Company further address this situation.

- There is a temporary pier that has Earth to wood contact. We recommend that you have the Termite Company further address this situation.

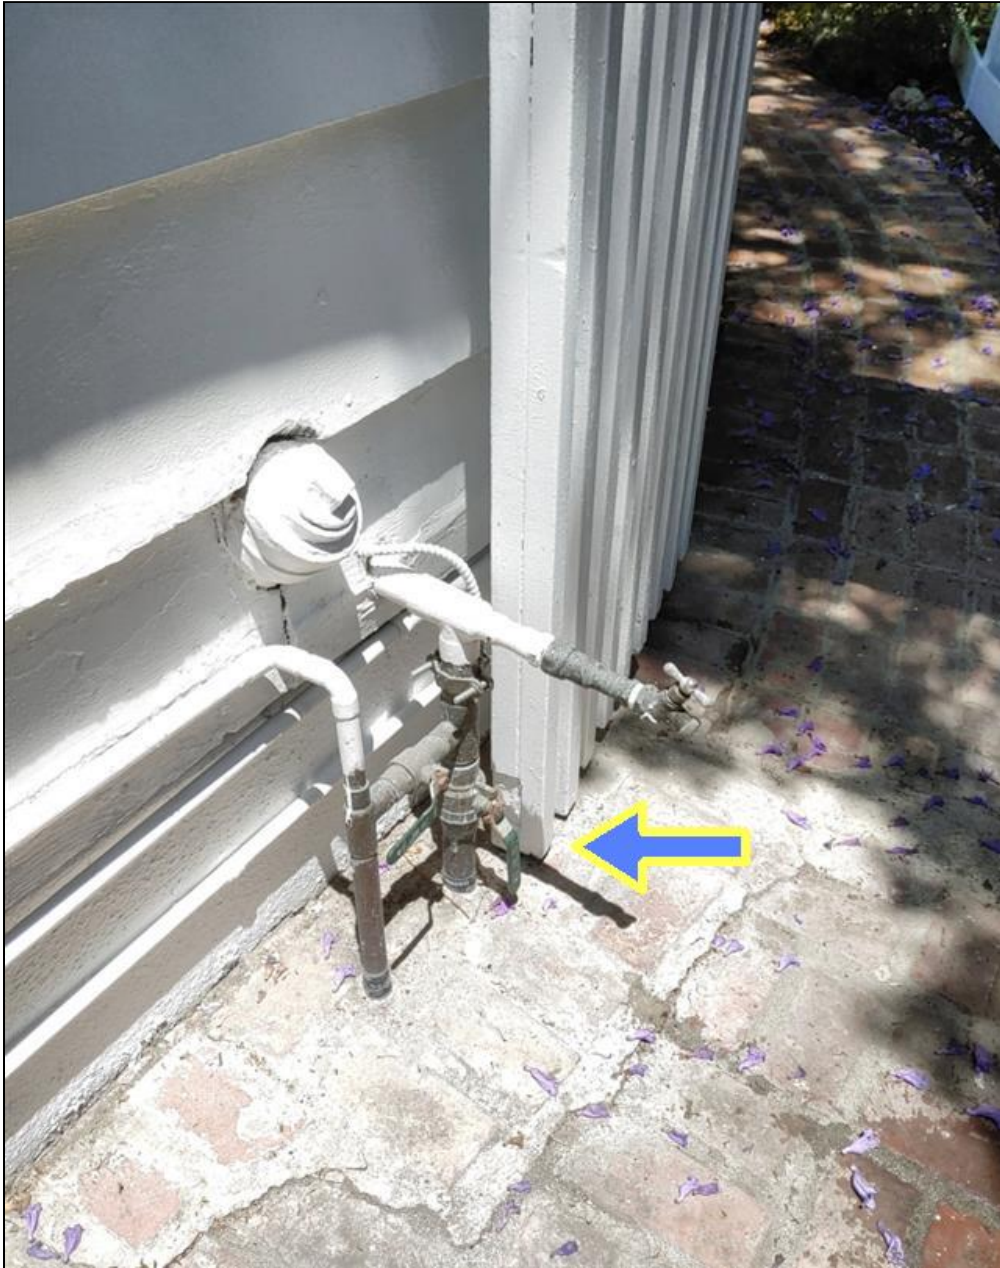
5.0 Item 1(Picture) The Water Main Shut-Off at the side of the Residence.

5.0 The Water Main Shut-Off at the side of the Residence.

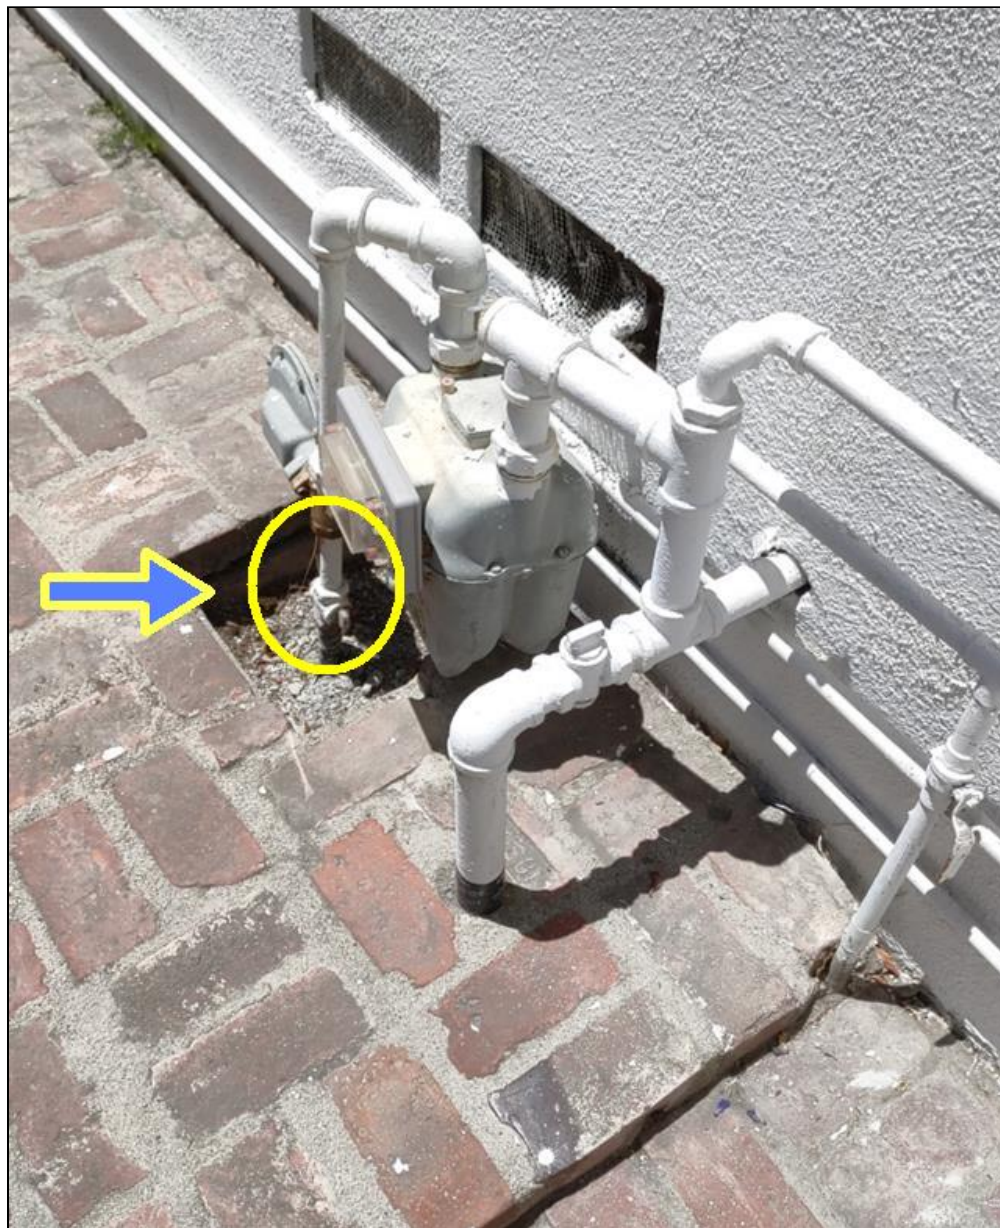
5.1 Item 1(Picture) The Gas Main Shut-Off without seismic shut off device.

5.1 The Gas Main Shut-Off without seismic shut off device.

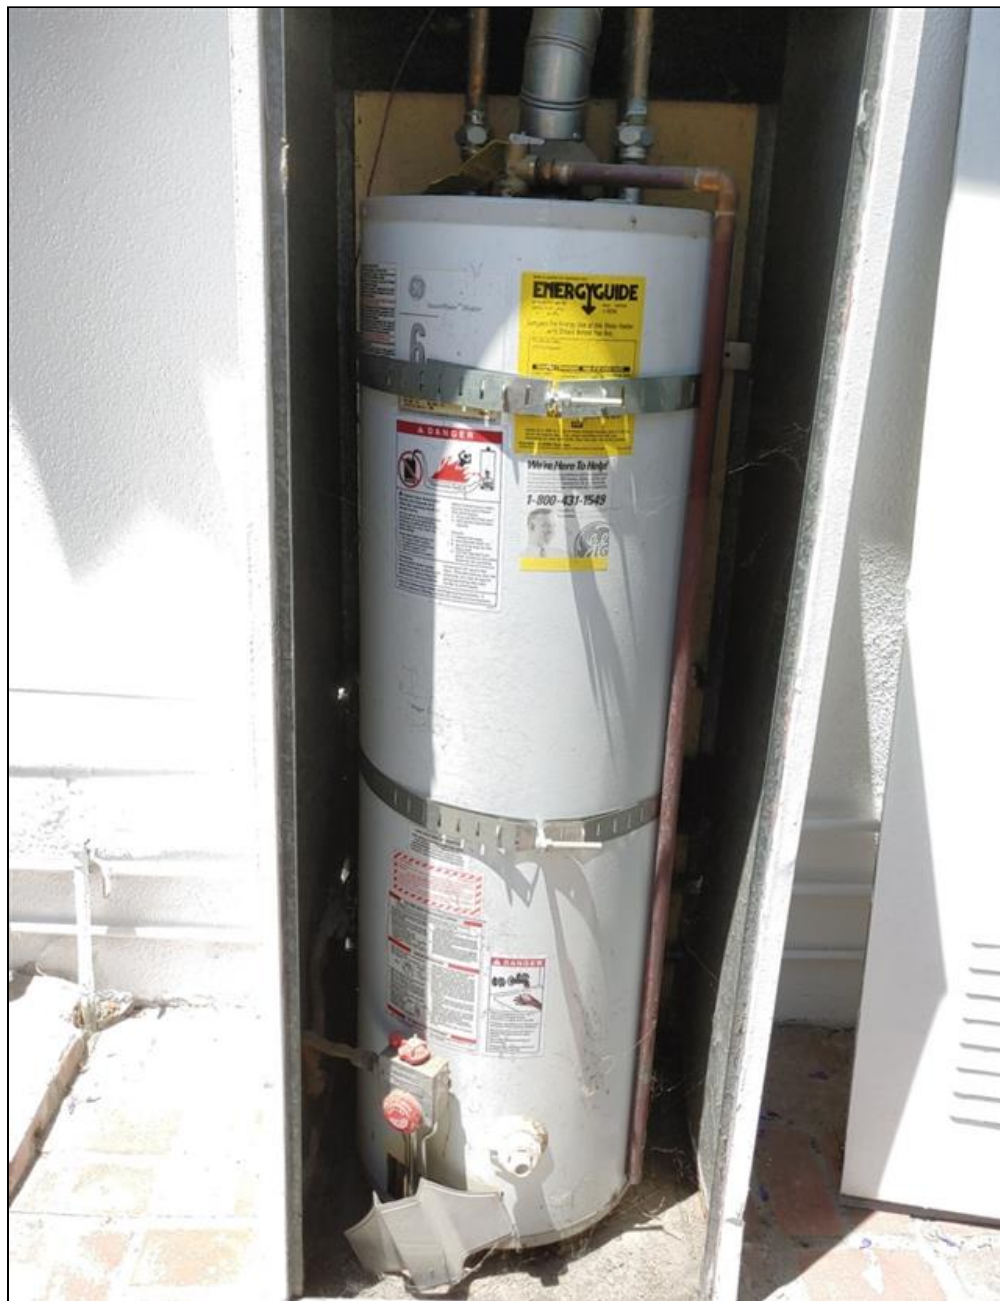
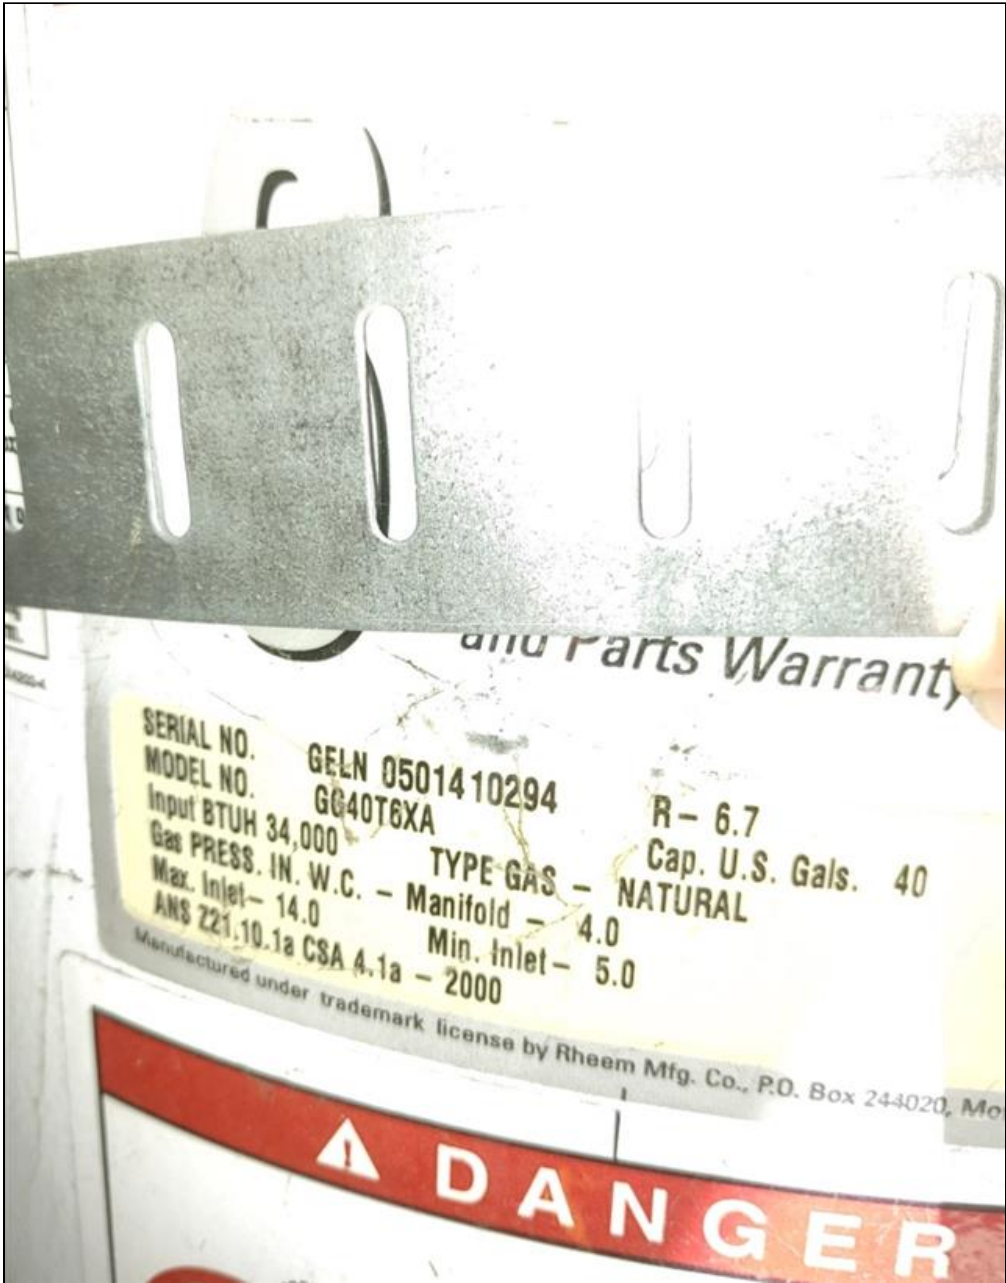
5.2 Item 1(Picture) The water heater in the exterior closet is 16 years old in 40 gallons.

5.2 Item 2(Picture) manufacture data plate

5.2 The water heater in the exterior closet is 16 years old in 40 gallons.

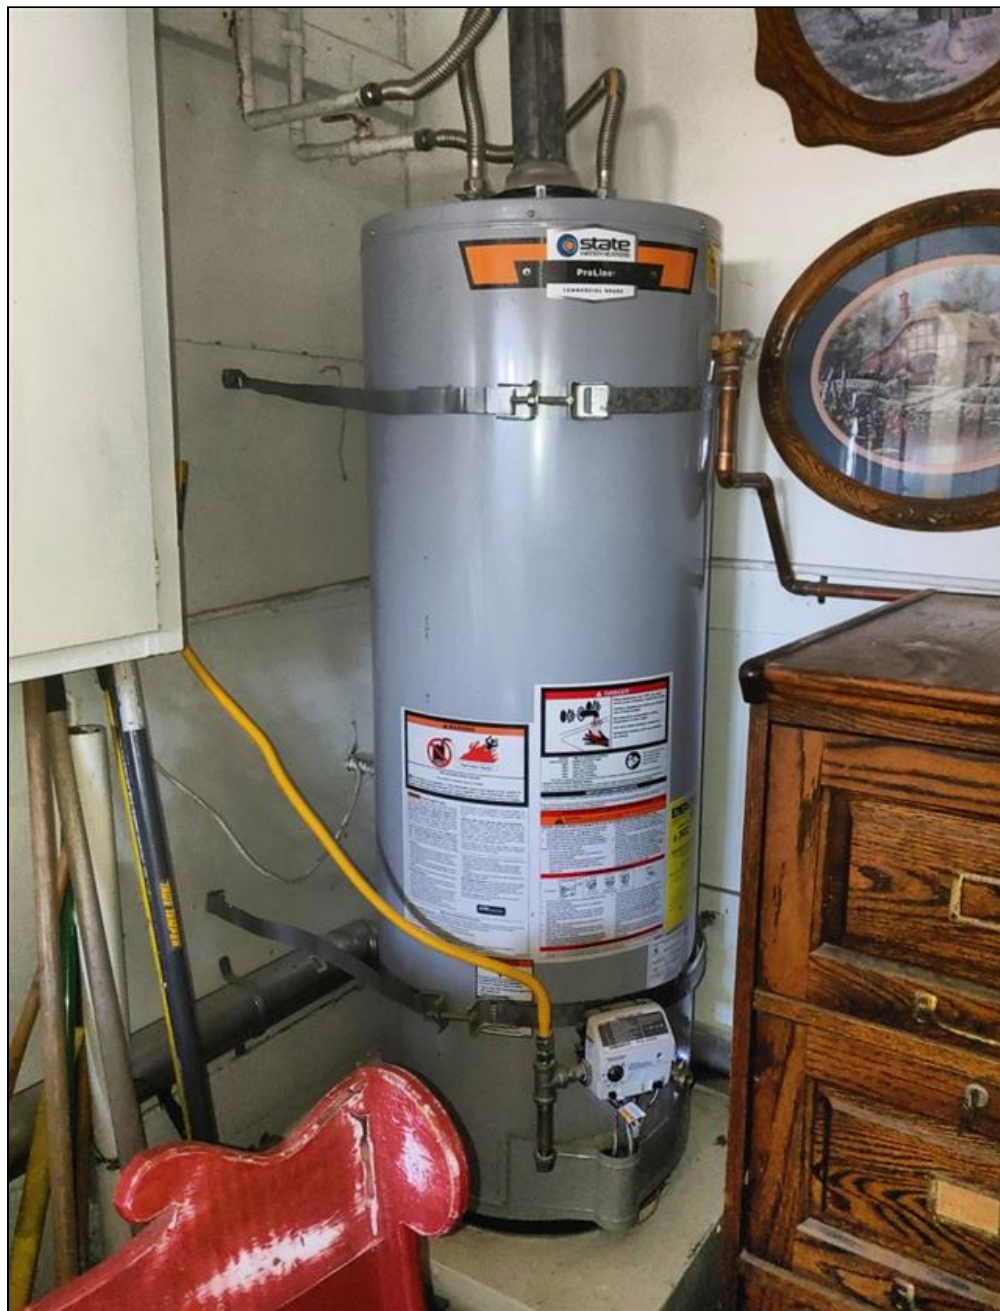
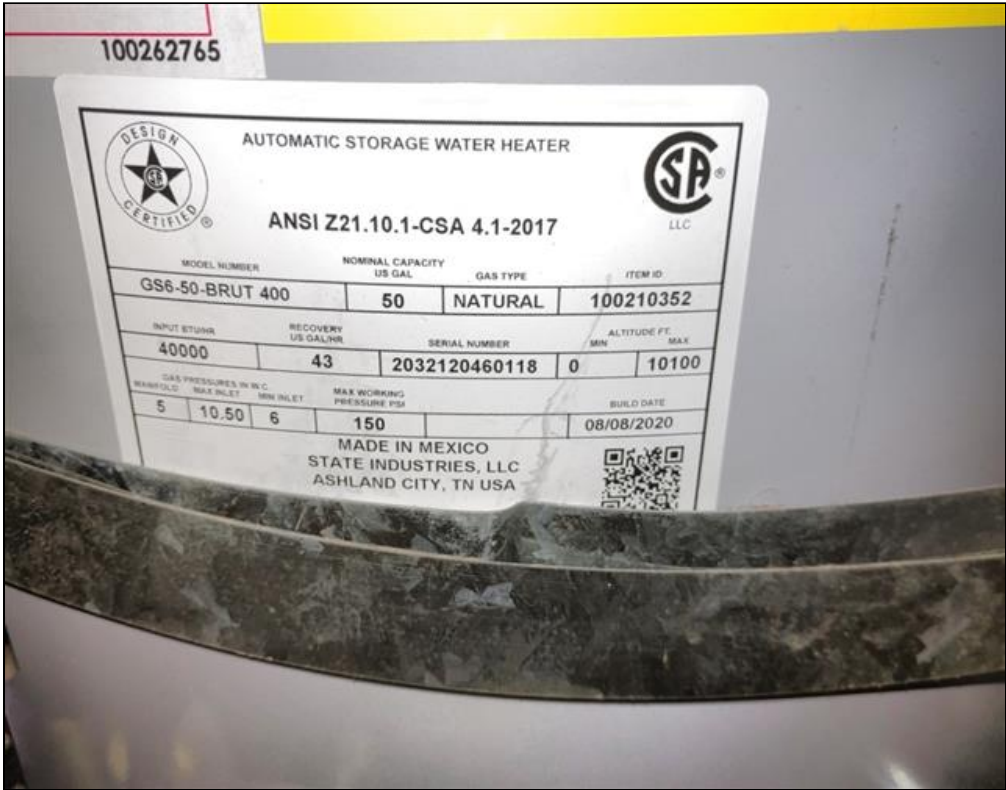
5.2 Item 3(Picture) The Water Heater in the garage is one year old and 50 gallons.

5.2 Item 4(Picture) manufacturers data plate

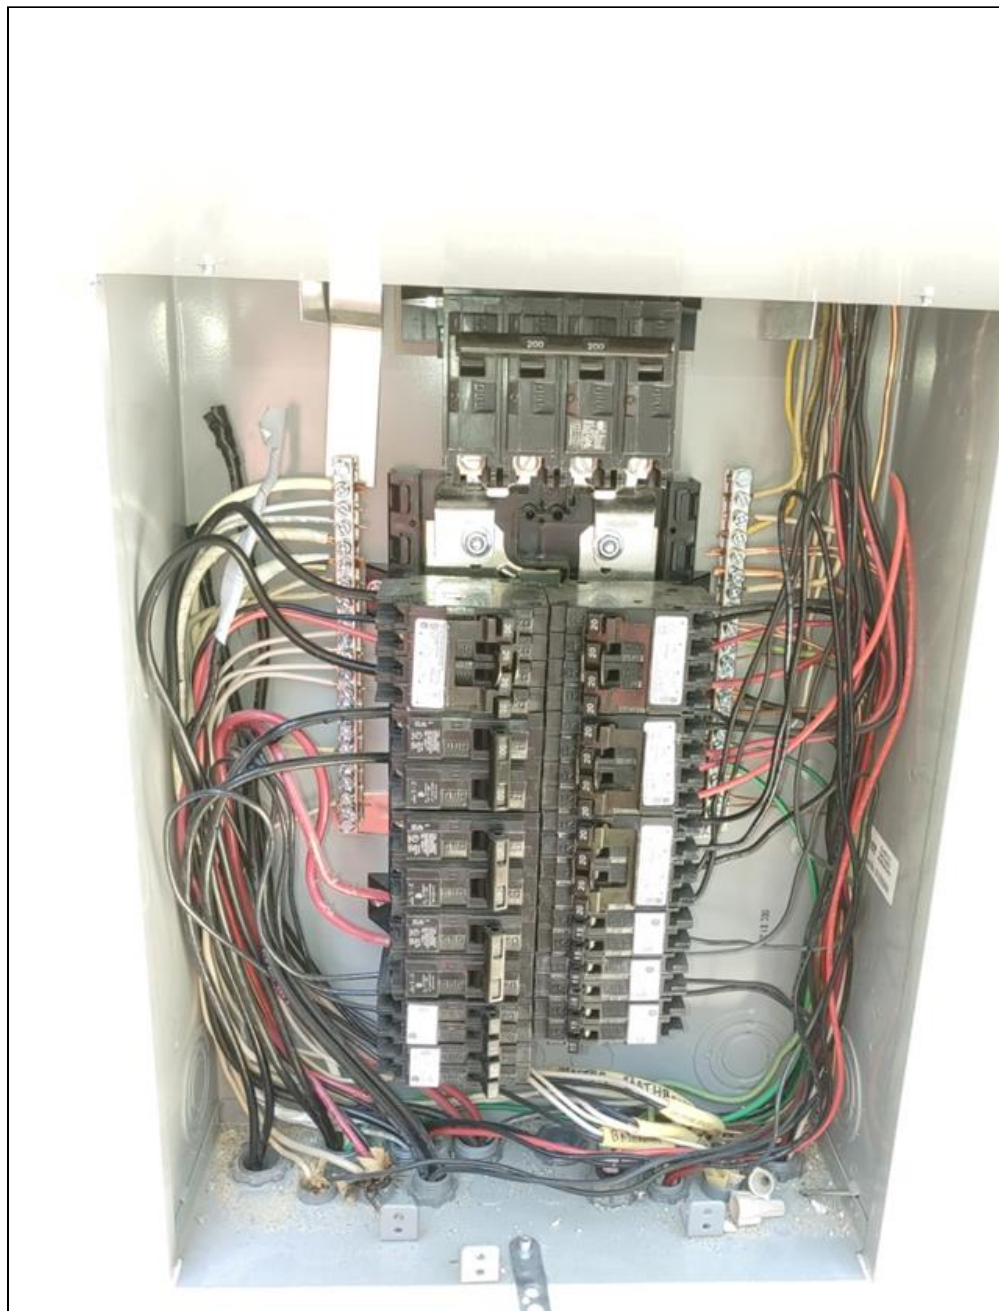
6.1 Item 2(Picture) Electrical Main without cover.

6.1 The Electrical Main is 200 amps located at the rear of the residence

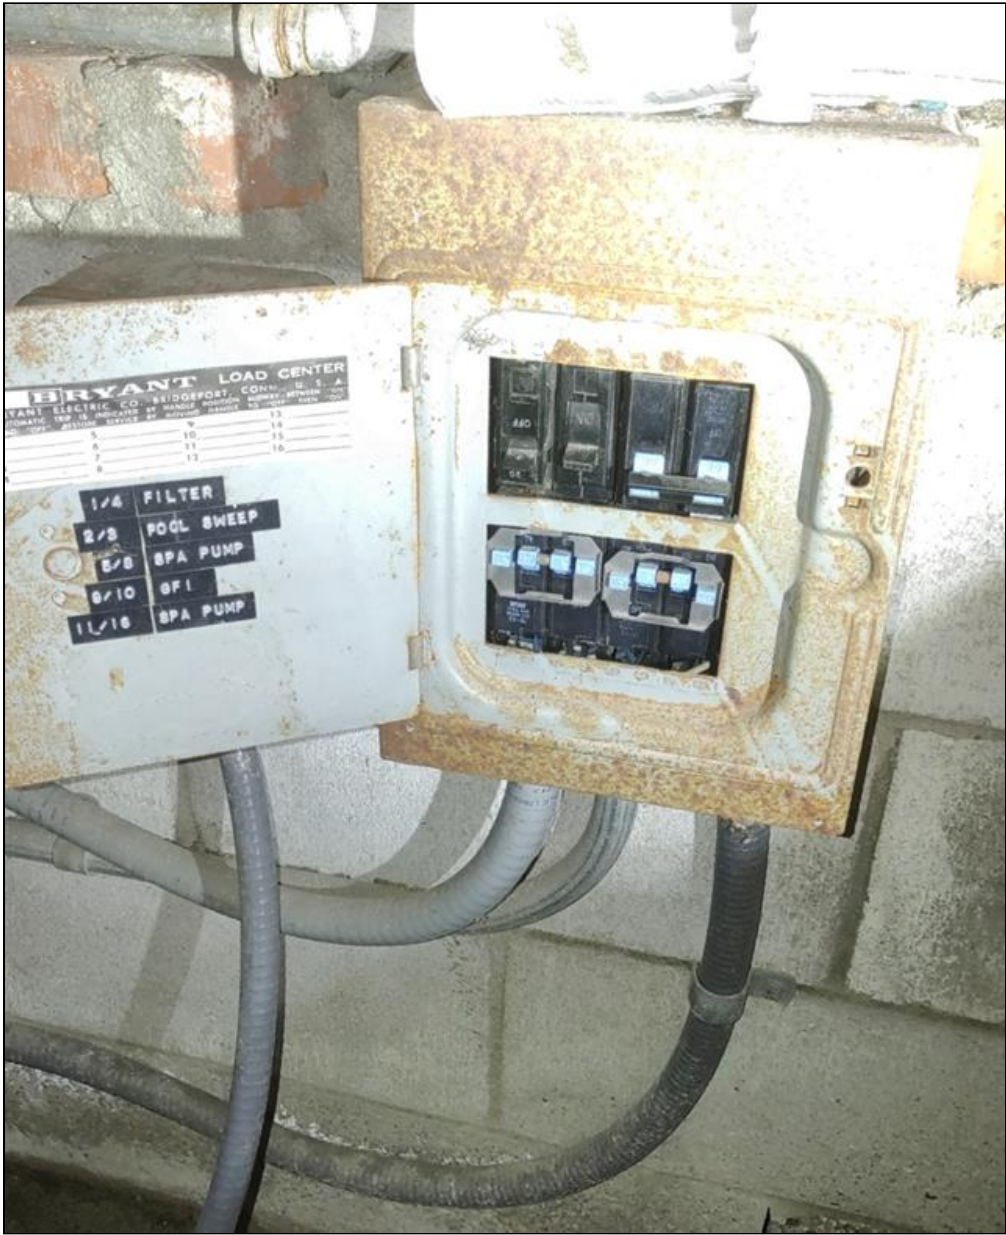
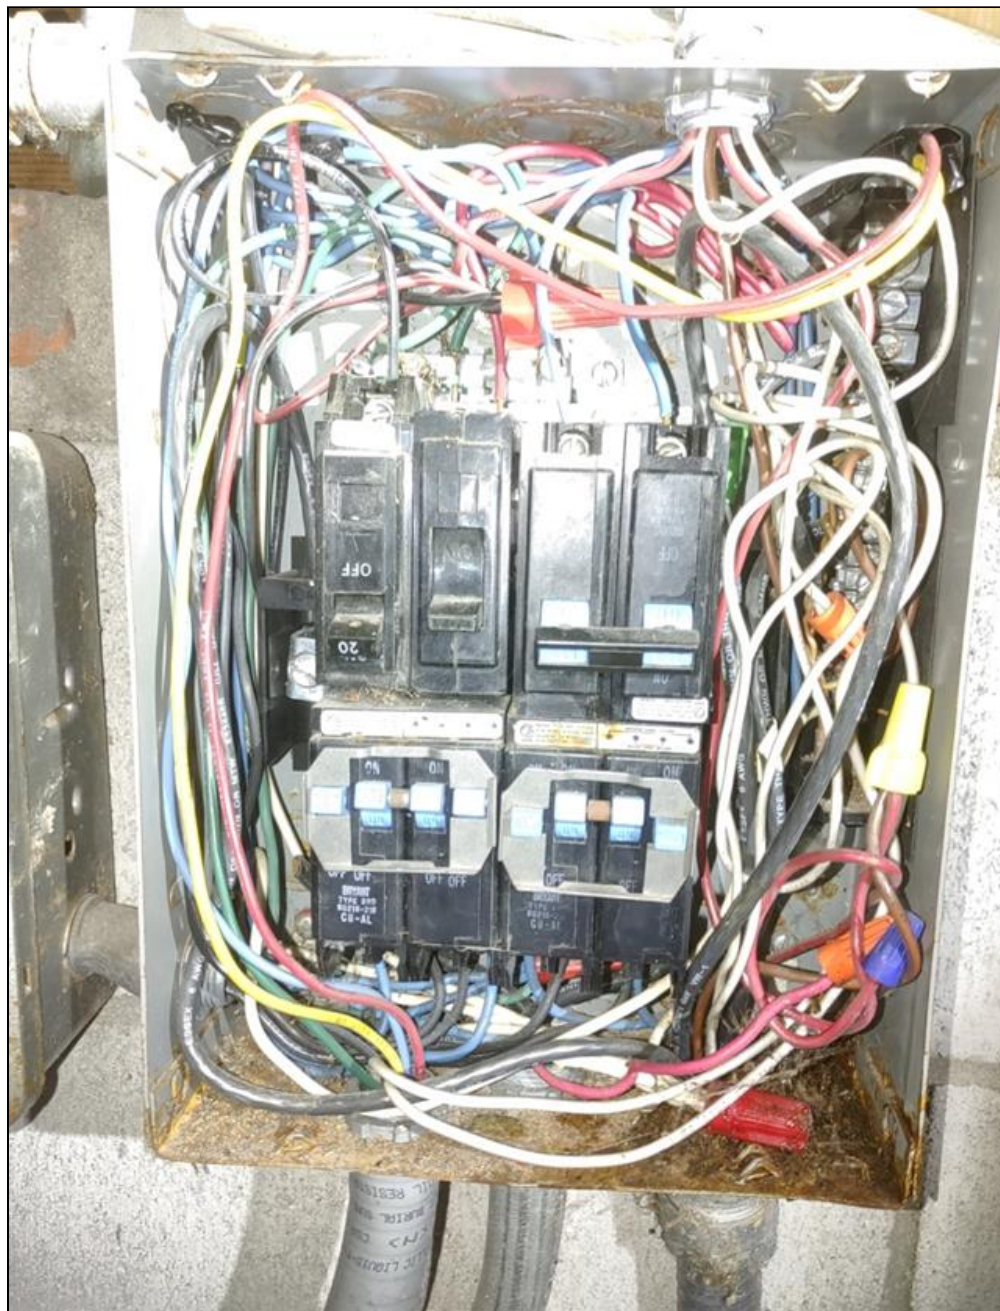
6.2 Item 1(Picture) sub panel in pool equipment room.

6.2 Item 2(Picture) sub panel without cover.

6.2 Sub-Panel in Pool Equipment Room.

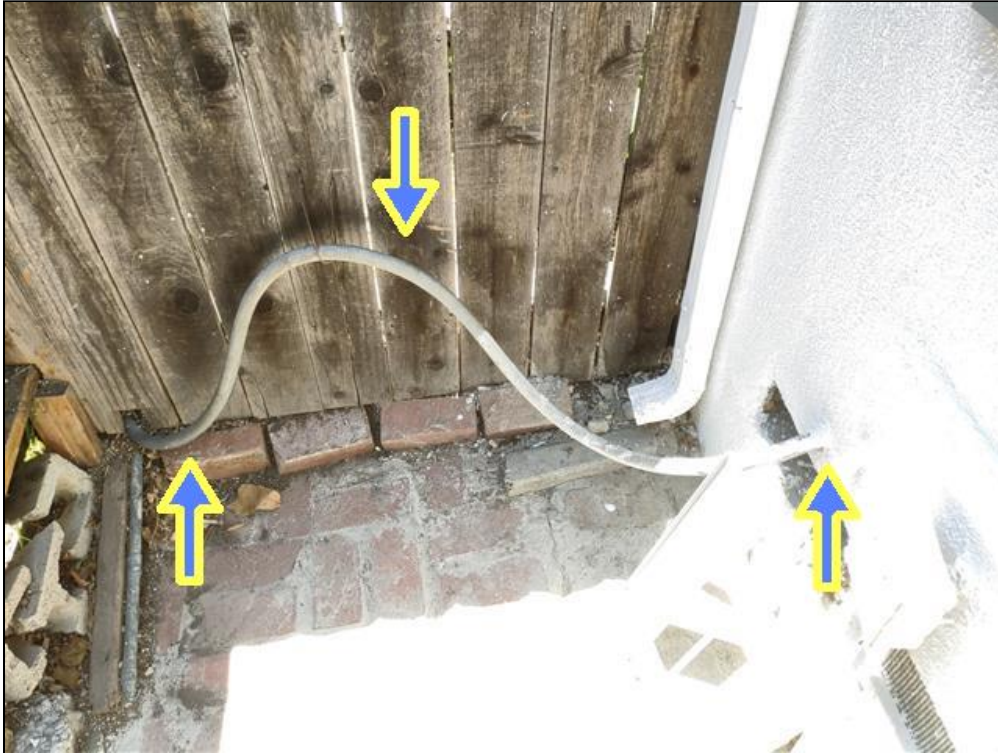
6.4 Item 1(Picture) There is electrical conduit near the main panel and that should be properly installed. We recommend further evaluation and services necessary.

- There is electrical conduit near the main panel and that should be properly installed. We recommend further evaluation and services necessary.

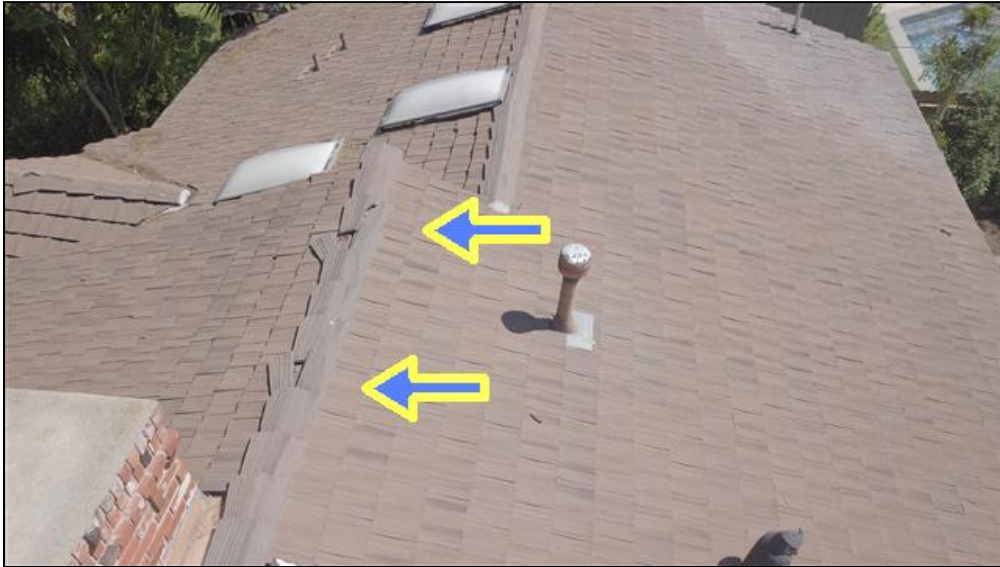
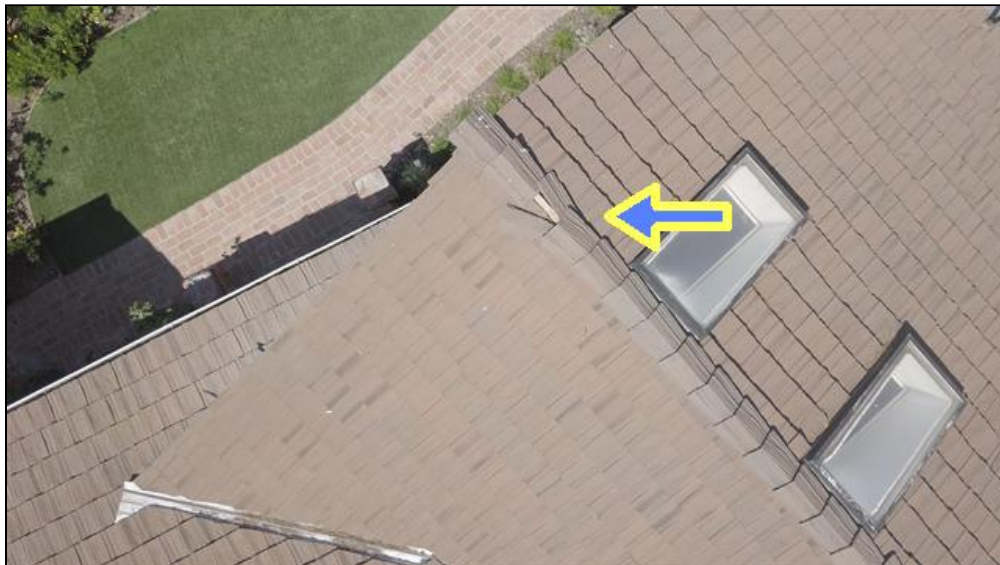
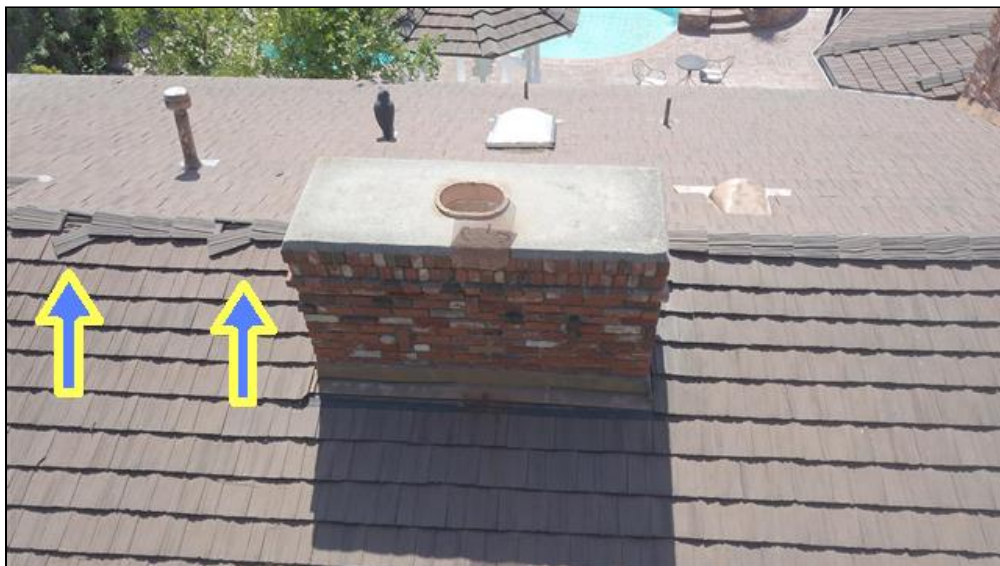
7.0 Item 1(Picture) There are several roof tiles that are loose and should be serviced.

7.0 Item 2(Picture) There are several roof tiles that are loose and should be serviced.

7.0 Item 3(Picture) There are several roof tiles that are loose and should be serviced.

- There are several roof tiles that are loose and should be serviced.

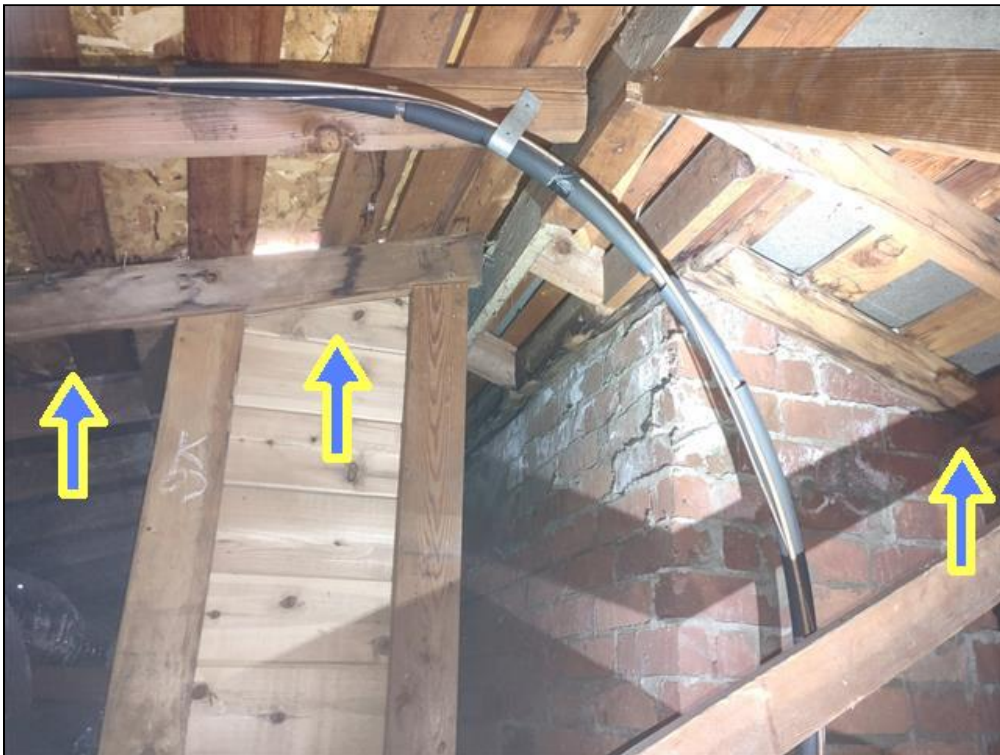
7.5 Item 1(Picture) There are several areas in the Attic that have moisture stains. We are unable to confirm these as active. We recommend further evaluation and service as necessary.

- There are several areas in the Attic that have moisture stains. We are unable to confirm these as active. We recommend further evaluation and service as necessary.
