Inspection Report

Property Address:
1 Golden Spar Place
Rolling Hills Estates Ca

South Bay Home Inspections

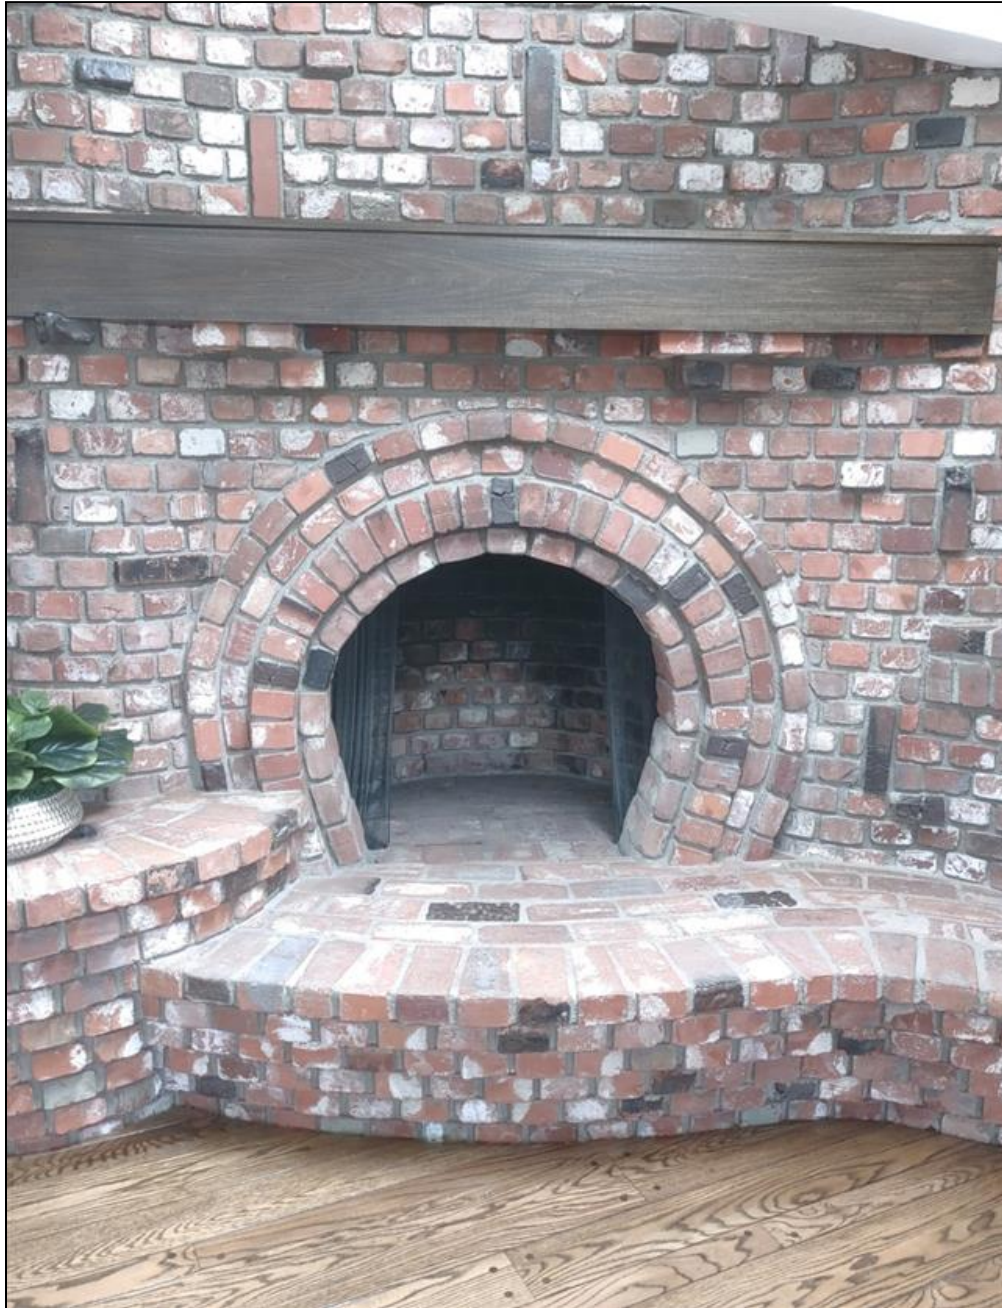
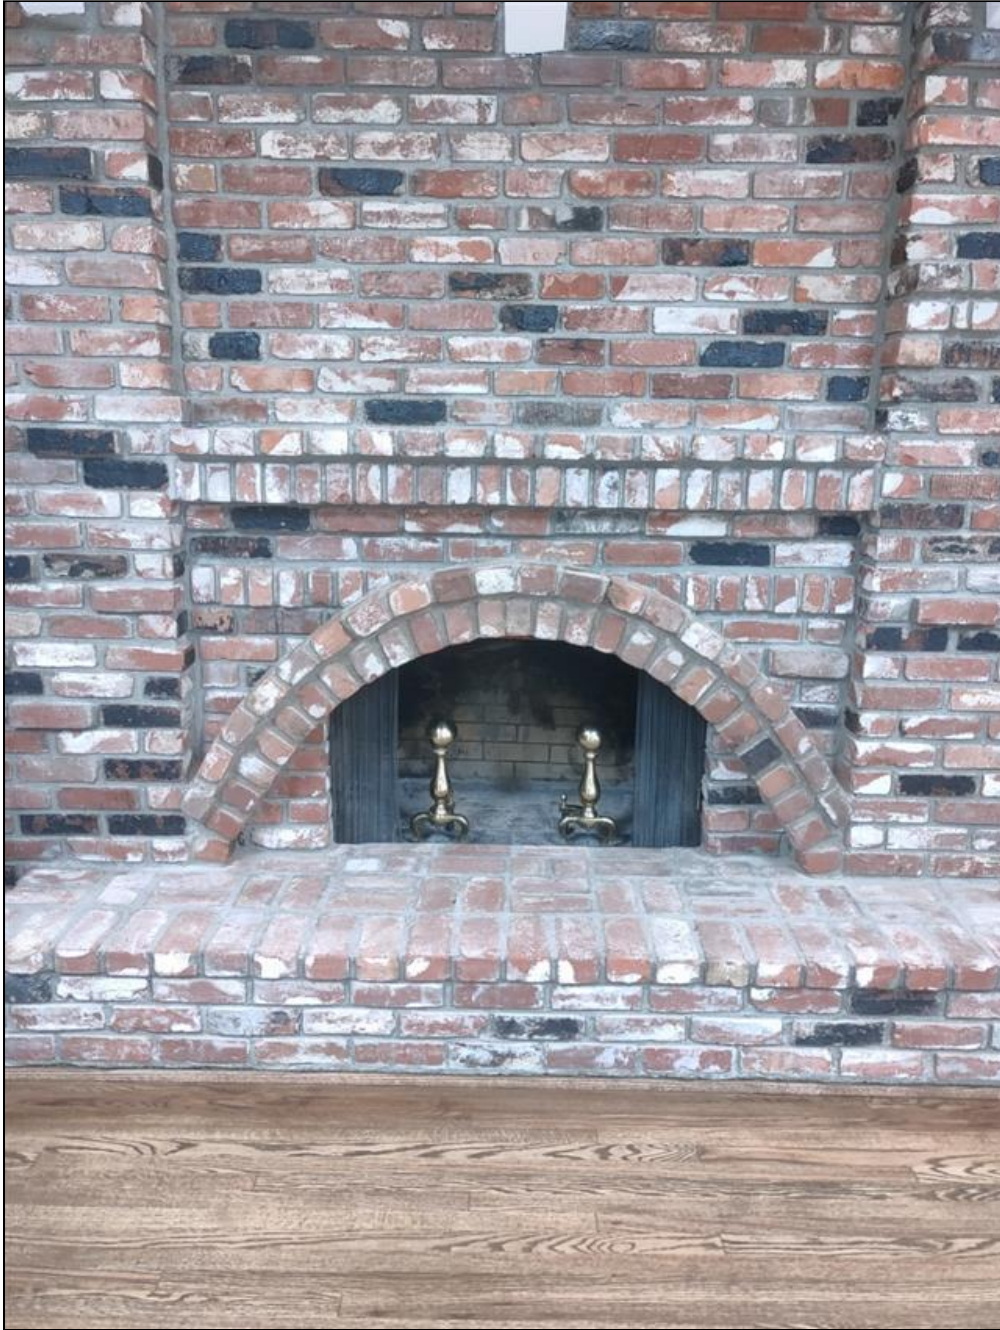
8.0 Item 1(Picture) Living Room Fireplace

8.0 Item 2(Picture) third guest bedroom fireplace.

8.0 The liners for furnace or fireplaces were not inspected by our company. I recommend a qualified chimney sweep inspect for safety.

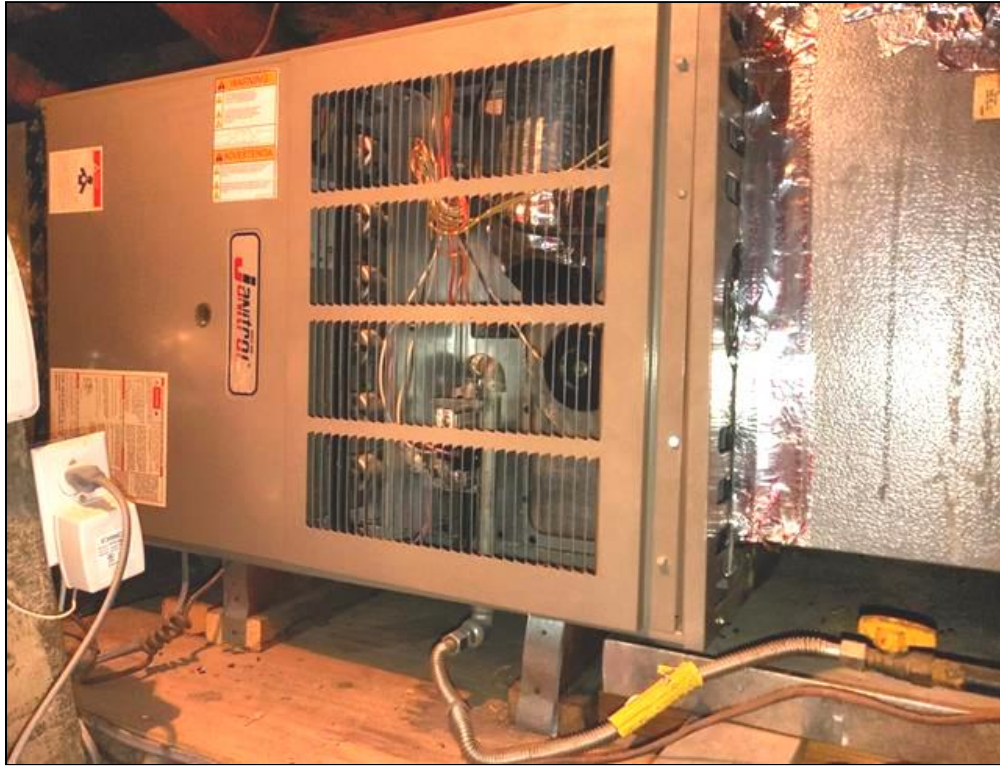
9.0 Item 1(Picture) The Force-Air Furnace was functional at the time of inspection.

9.0 The Force-Air Furnace was functional at the time of inspection.

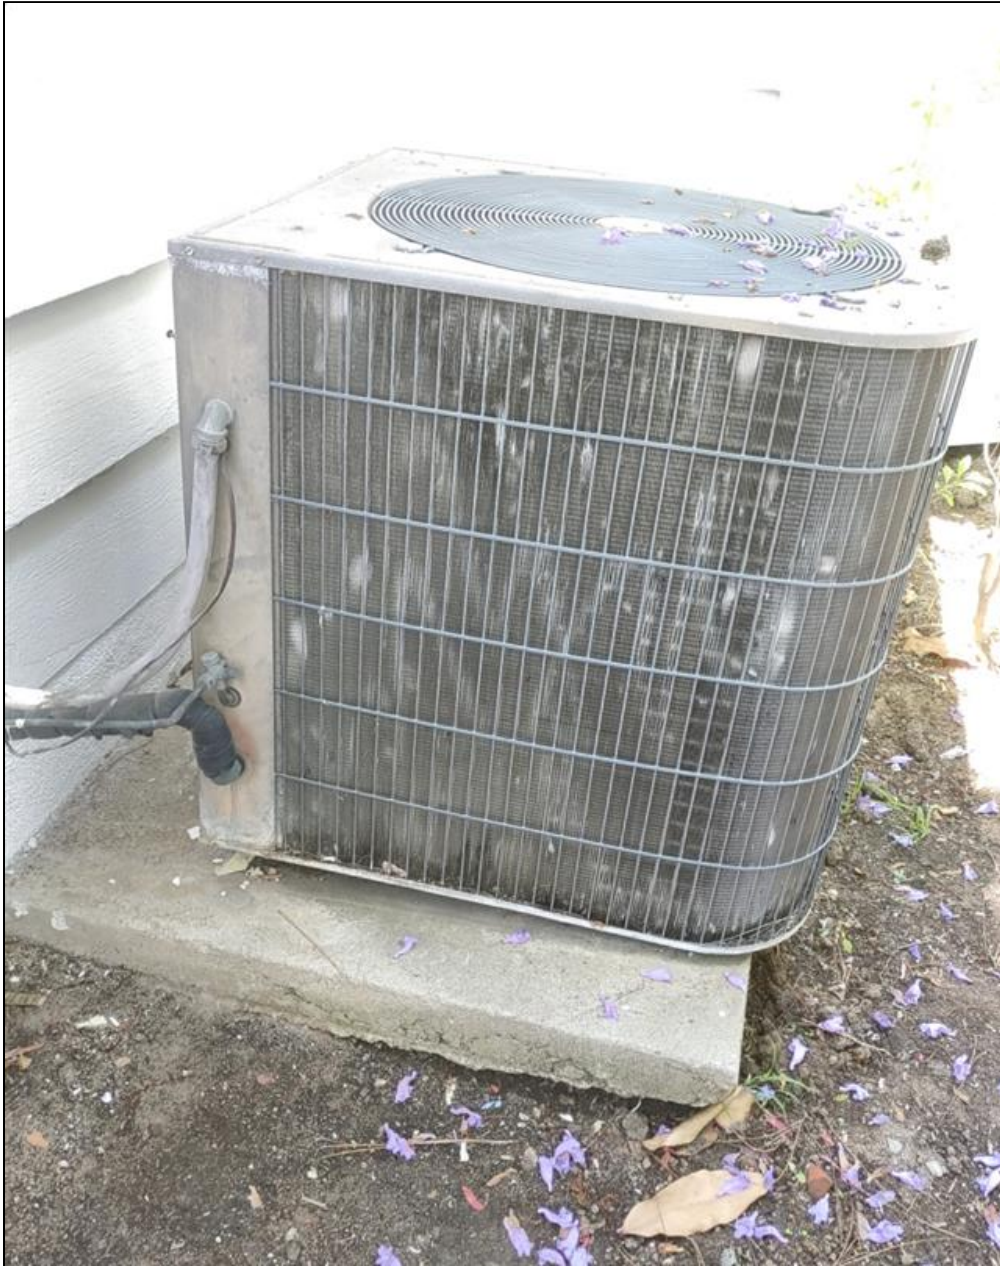
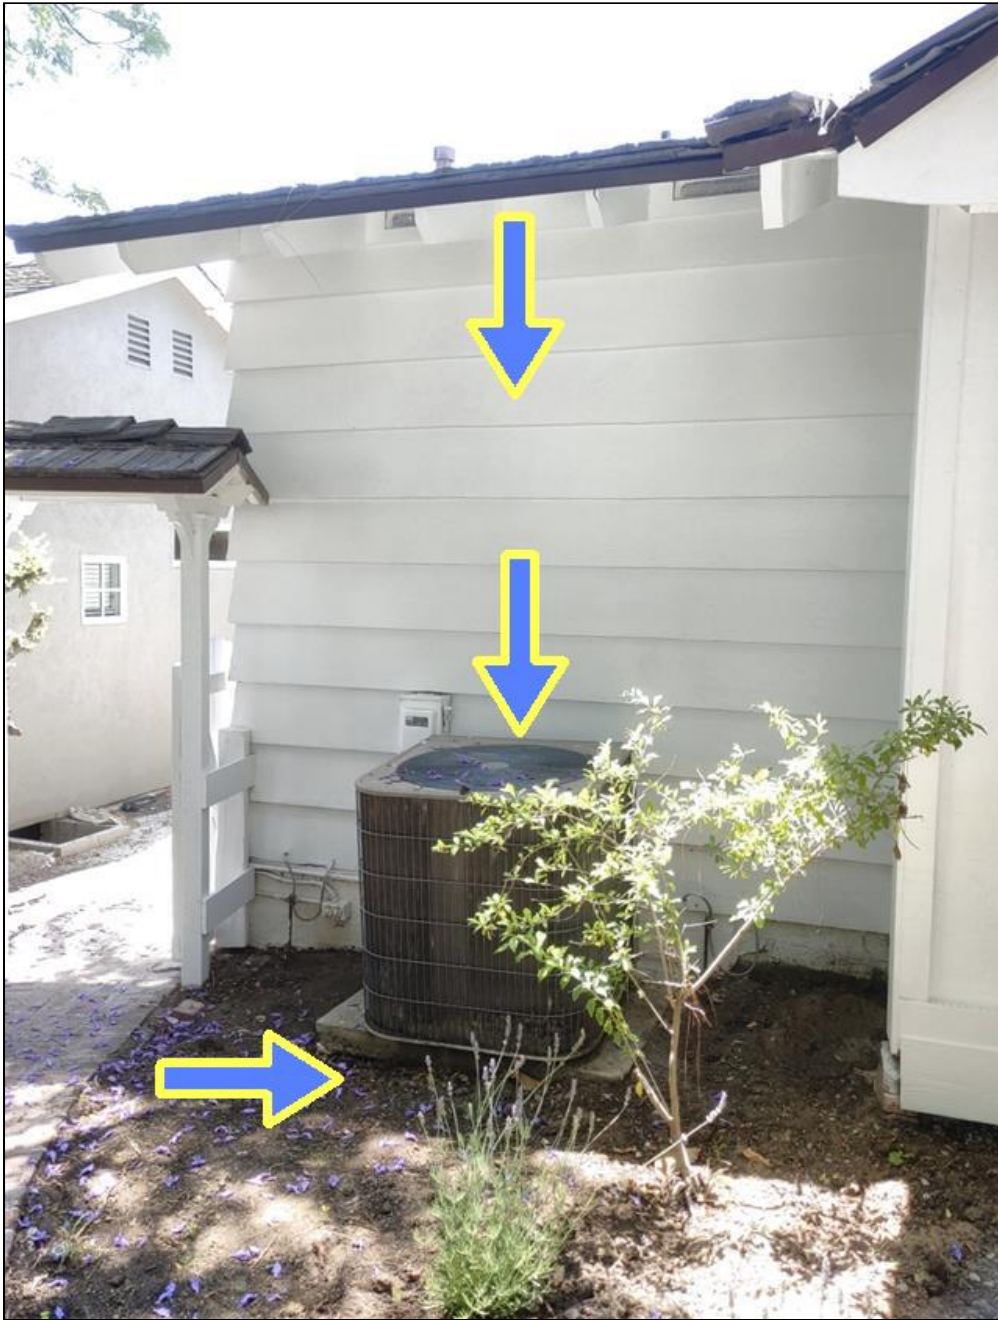
10.0 Item 1(Picture) HVAC system - condensing coil was functional at the time of inspection. The condensing coil is not sitting level and is also underneath the drip line of a roof. We recommend further evaluation and services necessary.

10.0 Item 2(Picture) The condensing coil is not sitting level and is also underneath the drip line of a roof. We recommend further evaluation and services necessary.

- The condensing coil is not sitting level and is also underneath the drip line of a roof. We recommend further evaluation and services necessary.

**10.0 HVAC System - The condensing coil was functional at the time of inspection.**
- The condensing coil is not sitting level and is also underneath the drip line of a roof. We recommend further evaluation and services necessary.

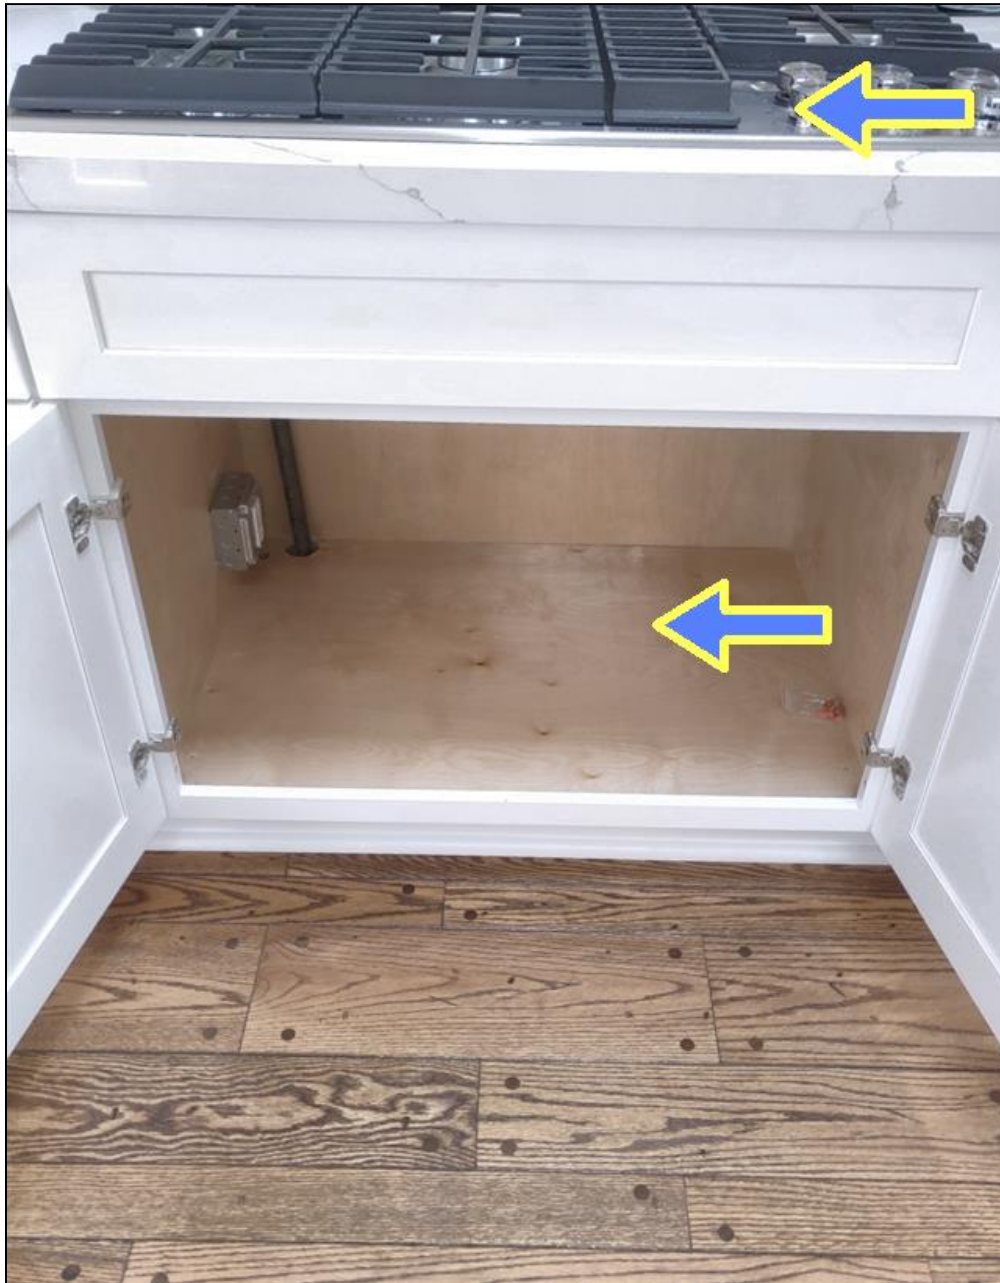
11.9 Item 1(Picture) The cooktop was not fully installed. The down-draft was missing too.

- The Cooktop was not fully installed. The Down-Draft was missing too.

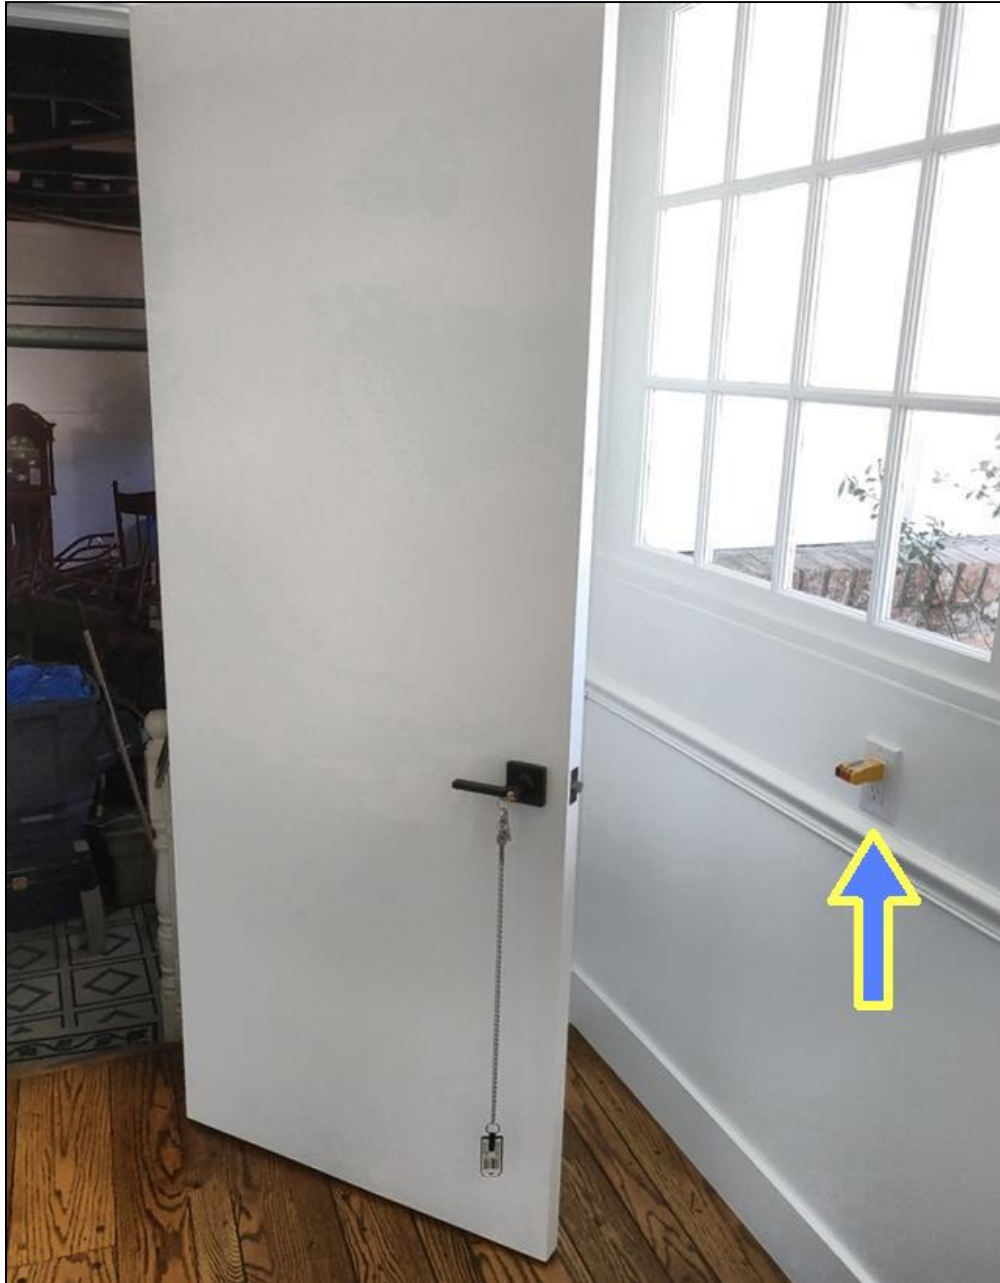
13.4.D Item 1(Picture) The outlet in the Ante Room did not respond. We recommend further evaluation and service as necessary.

- The outlet in the Ante Room did not respond. We recommend further evaluation and service as necessary.

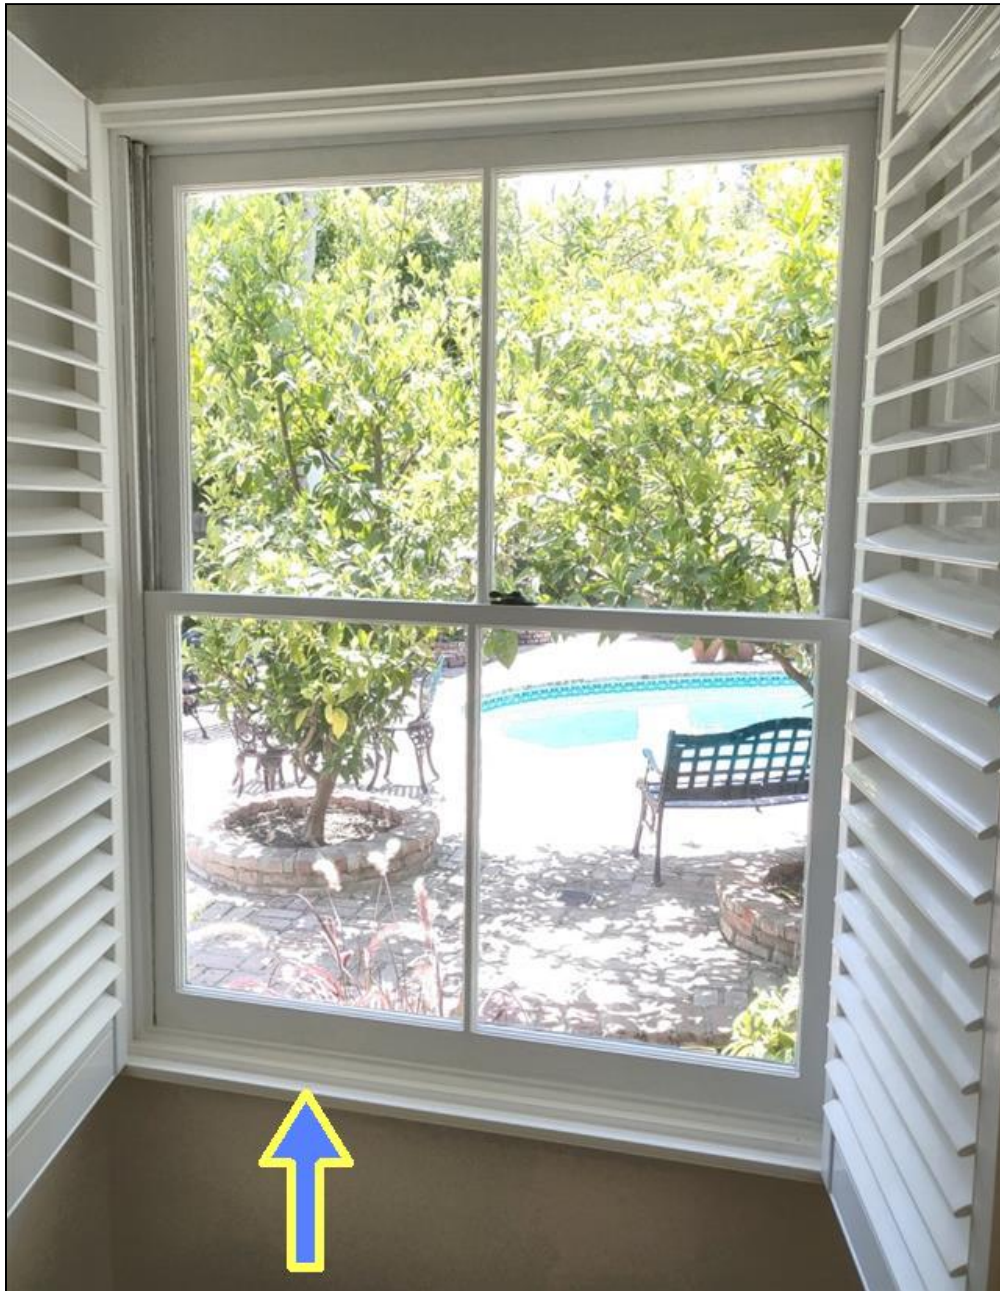
14.4.B Item 1(Picture) The window is stuck shut and should be further evaluated and services necessary.

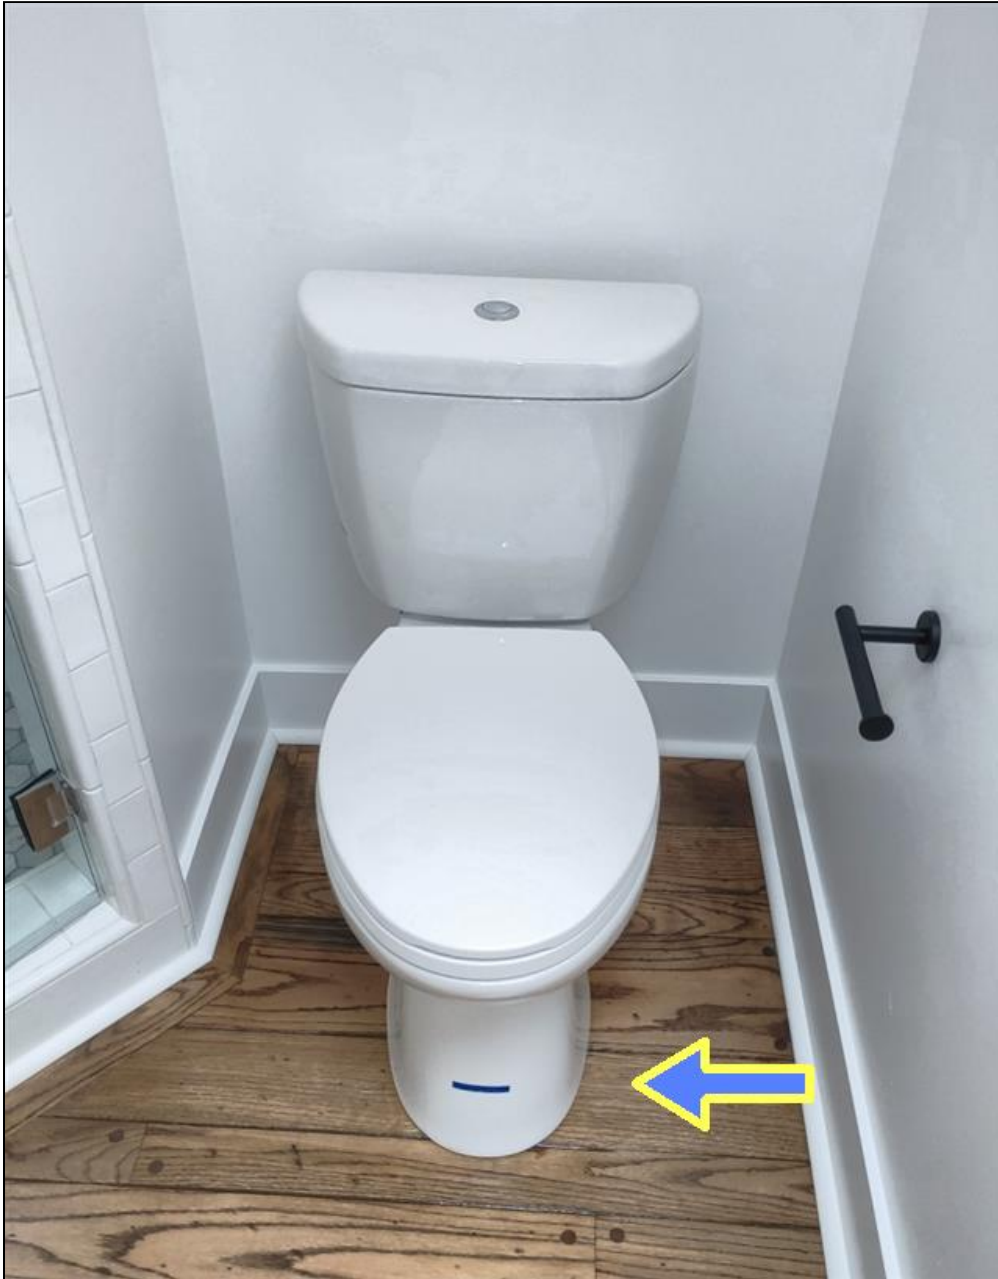
15.6.B Item 1(Picture) The hallway bathroom toilet is loose and should be serviced.

- The hallway bathroom toilet is loose and should be serviced.

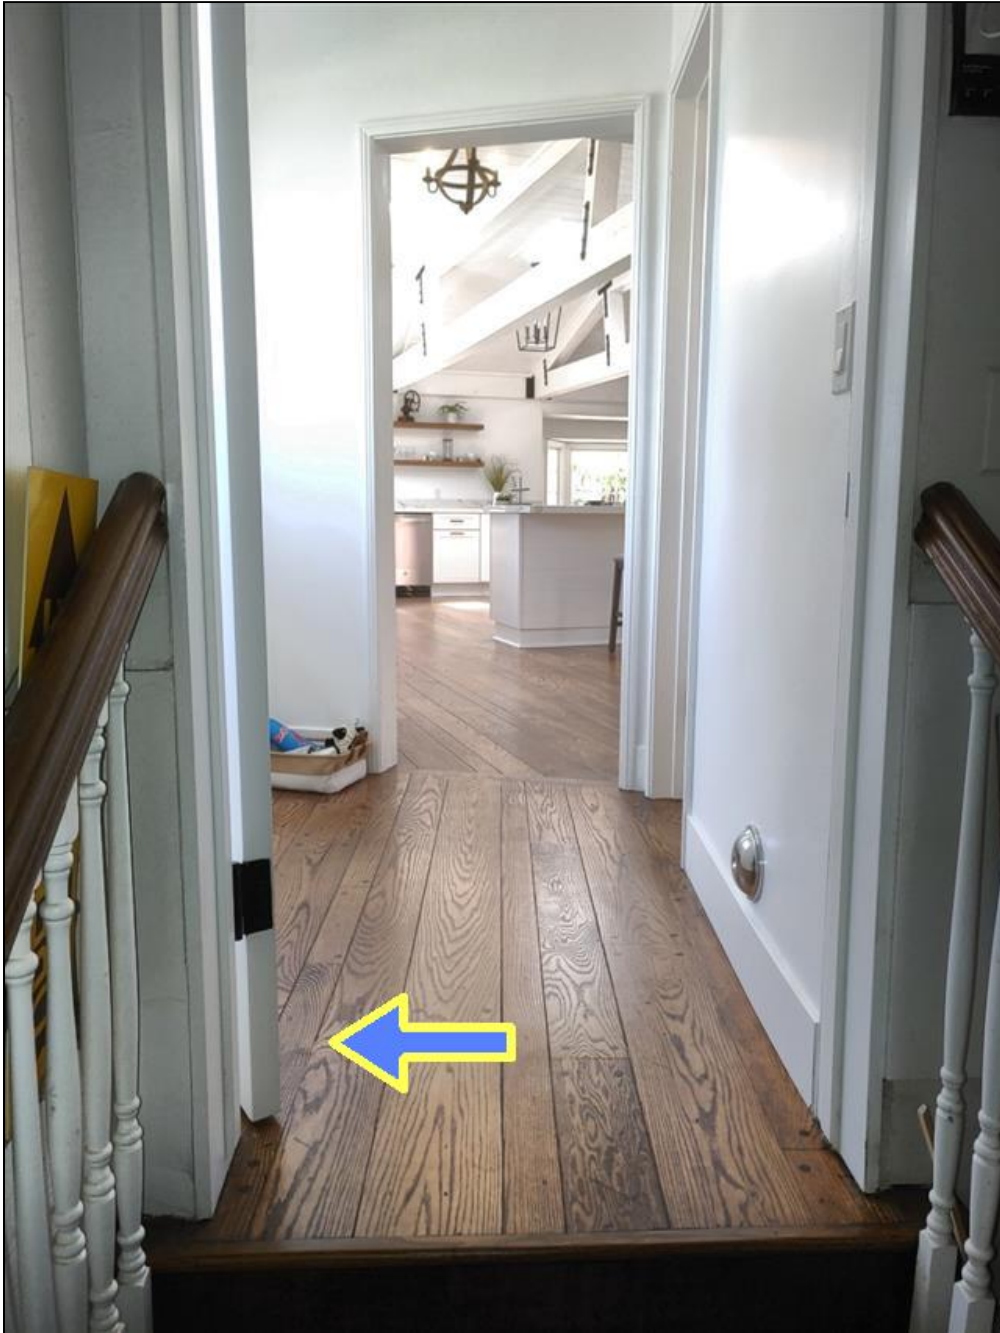
16.1 Item 1(Picture) The garage door is not self-closing. We recommend further evaluation and services necessary.

- The garage door is not self-closing. We recommend further evaluation and services necessary.

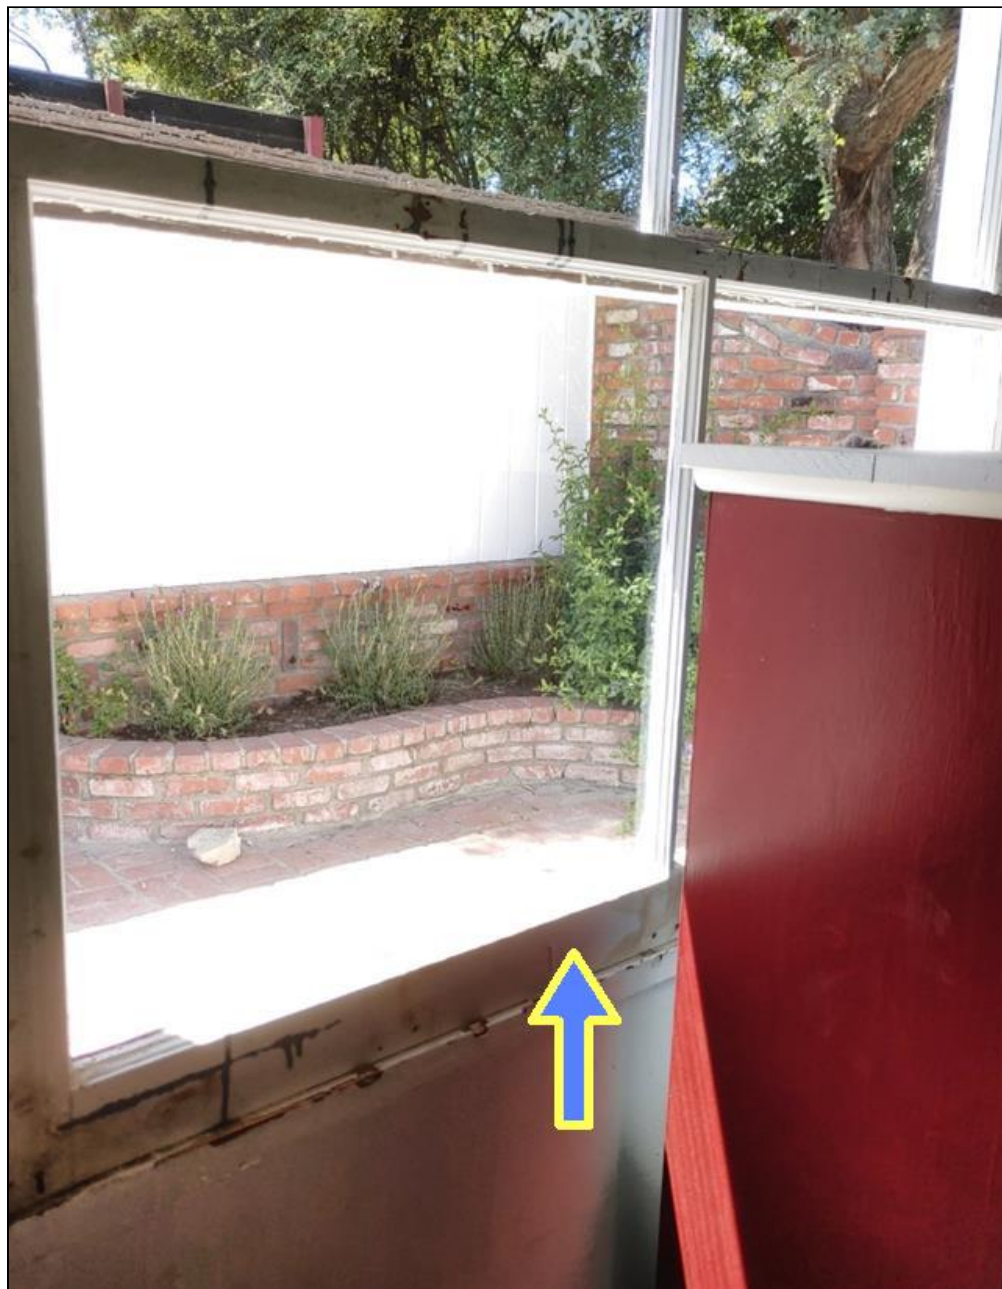
16.6 Item 1(Picture) The garage window is stuck shut. We recommend further evaluation and services necessary.

- The garage window is stuck shut. We recommend further evaluation and services necessary.

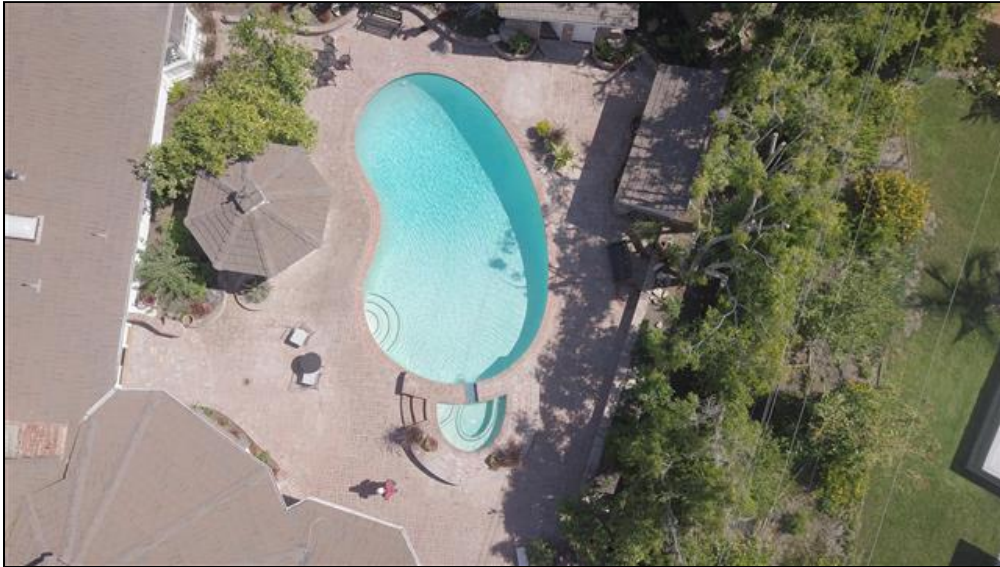
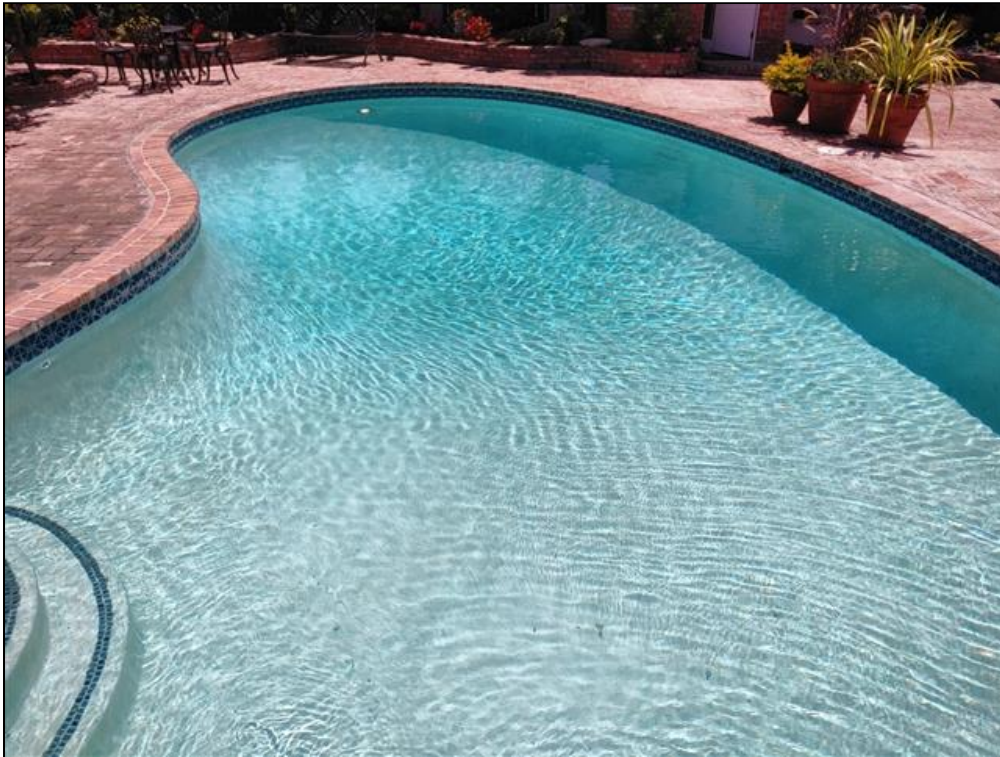
17.0 Item 1(Picture) The swimming pool was functional at the time of inspection.

17.0 Item 2(Picture) The swimming pool was functional at the time of inspection.

17.0 The swimming pool was functional at the time of inspection.

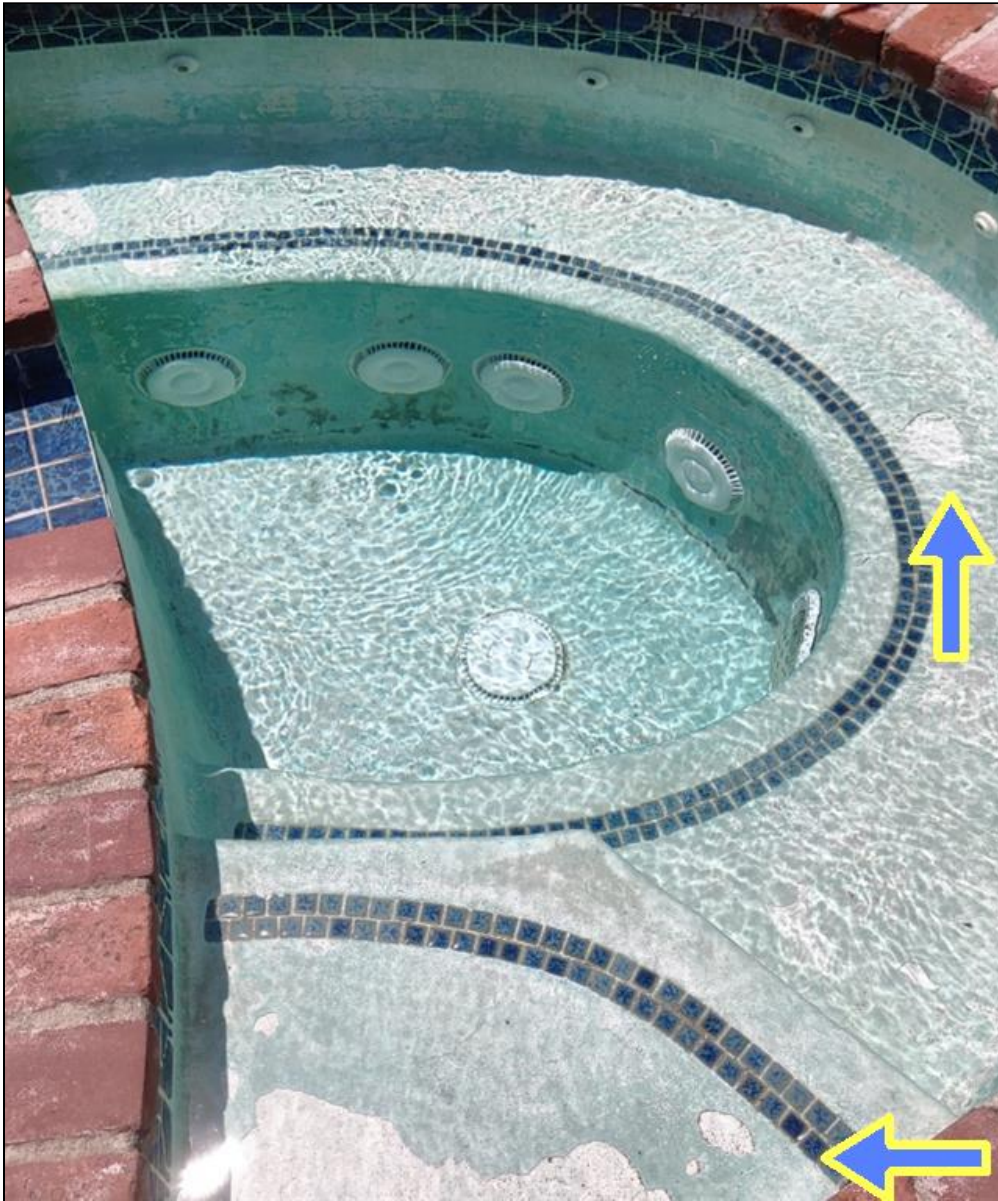
17.1 Item 1(Picture) The pool finish is deteriorated in various areas. We recommend that you have this further evaluated and serviced as necessary.

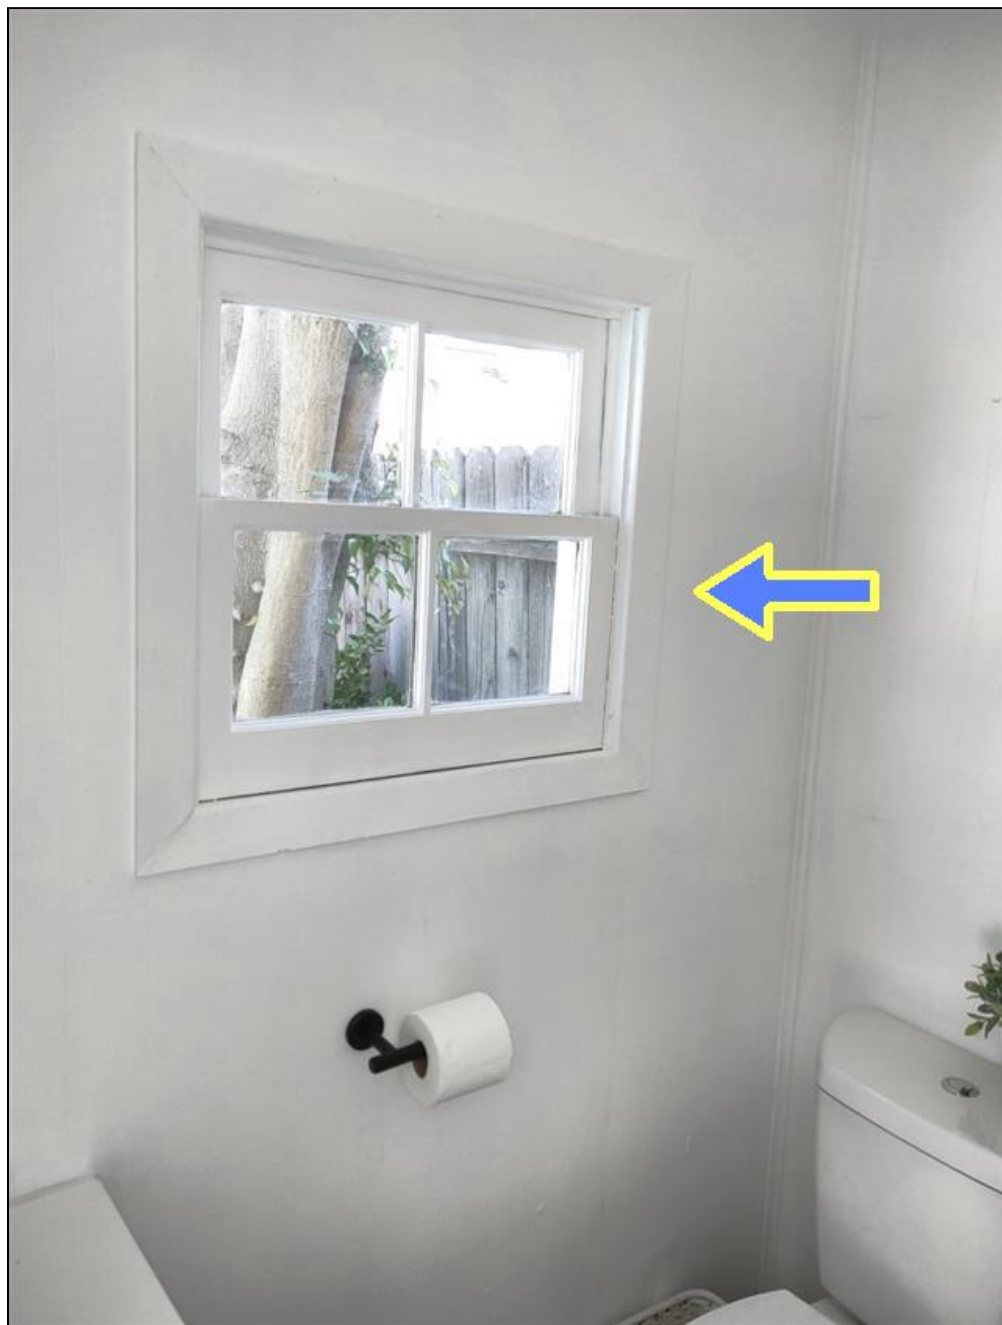
18.2 Item 1(Picture) The window is stuck shut. We recommend further evaluation and services necessary.

- The window is stuck shut. We recommend further evaluation and services necessary.
