Confidential Inspection Report

INSPECTION ADDRESS
1707 10th St
Manhattan Beach, CA 90266

Wednesday, May 2, 2018

Inspector, Michael Boeger, ACI, CCI
Equity Building Inspection

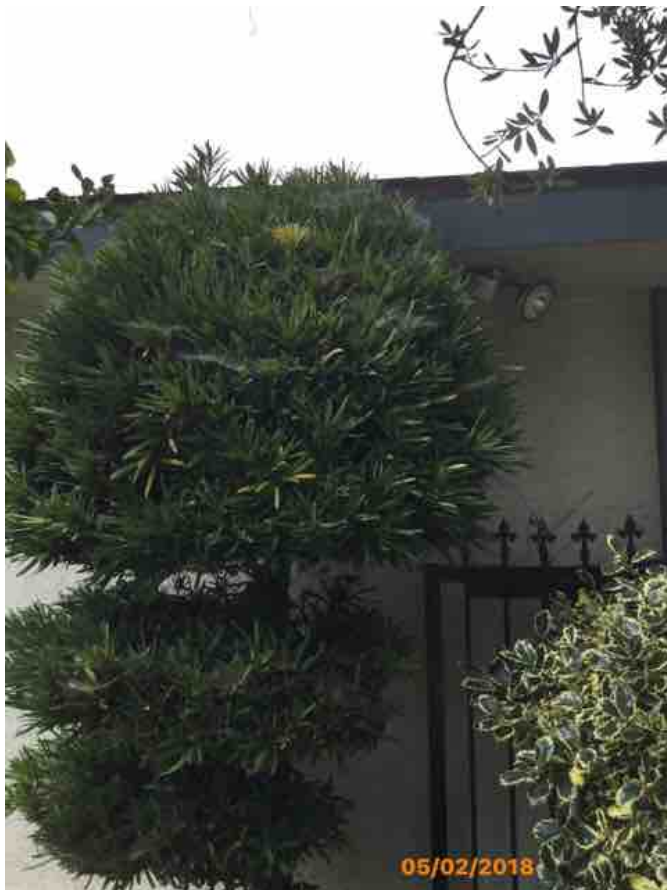
CR s-1: - A tree is touching the structure at the front. We consider this a potential threat to the structure. To eliminate the potential for damage, we recommend modification of the structure to accommodate the tree or removal of the tree.

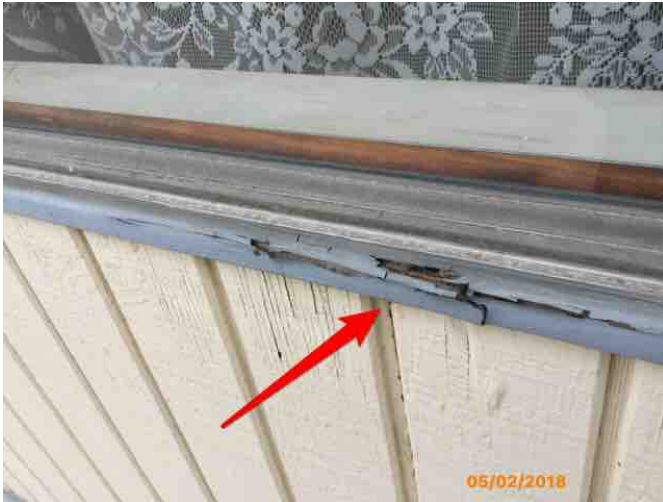
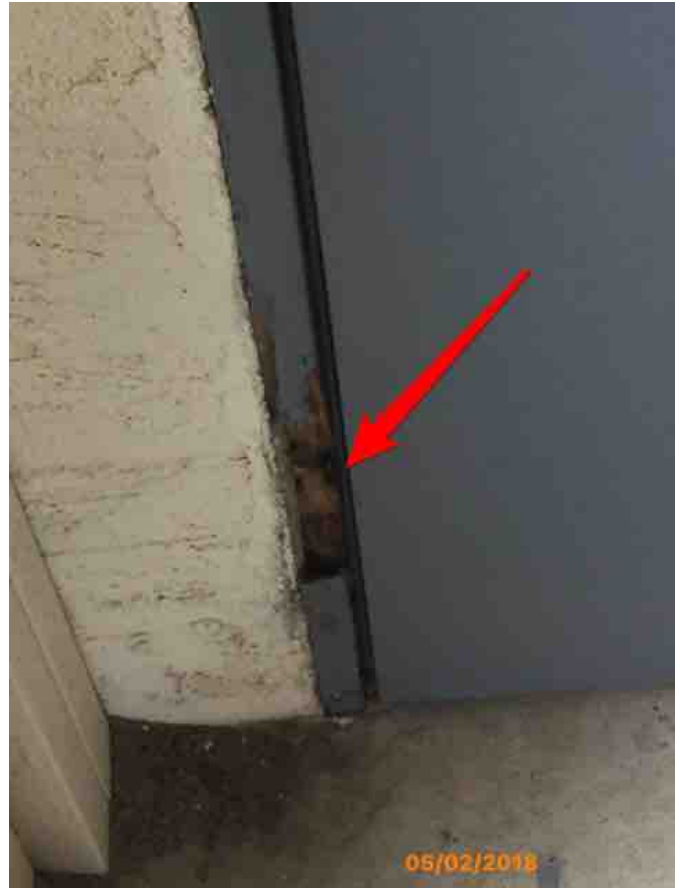
Water heater closet

FE CR s-2: - One or more section of trim are damaged. We recommend they be repaired or replaced and to refer to your termite report for further information. (Numerous locations)

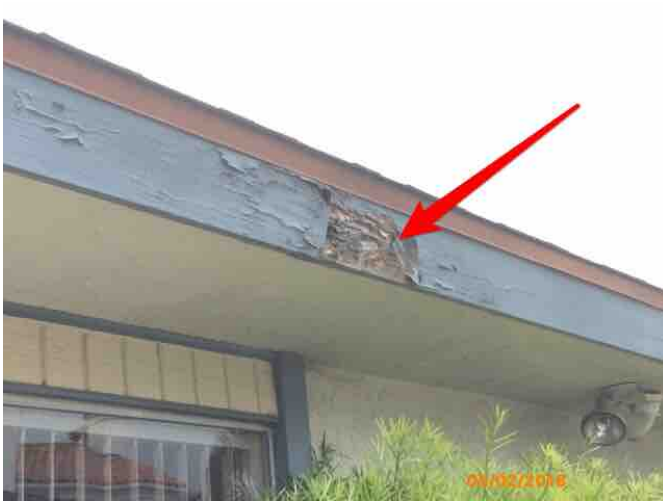
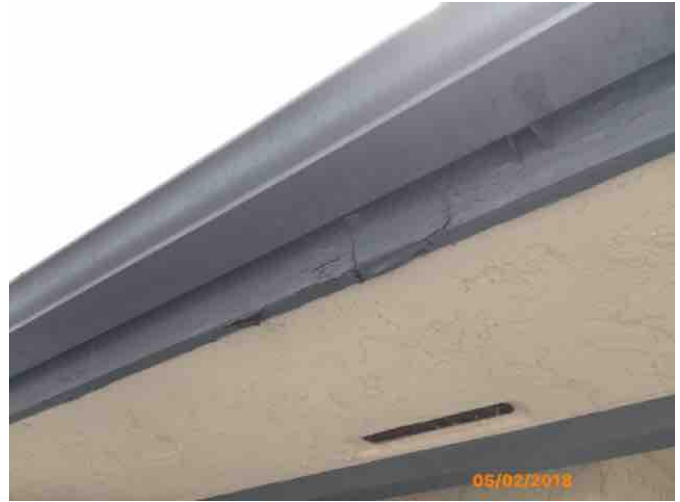
Right side

FE CR s-3: - Sections of the fascia at numerous are damaged. We recommend they be repaired or replaced.(numerous locations)

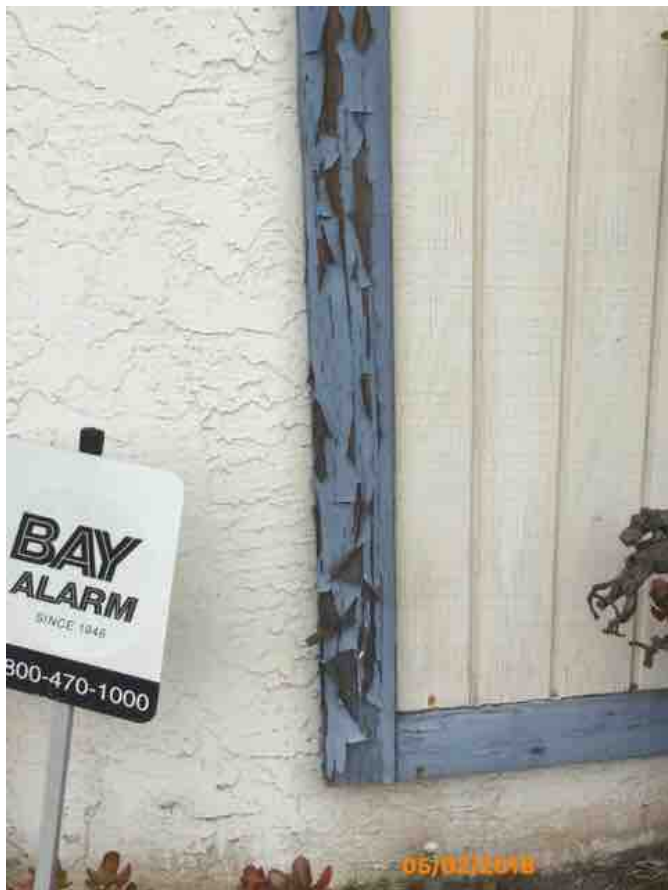
CR s-4: - There is peeling paint at numerous locations. We recommend this area be prepared and refinished.

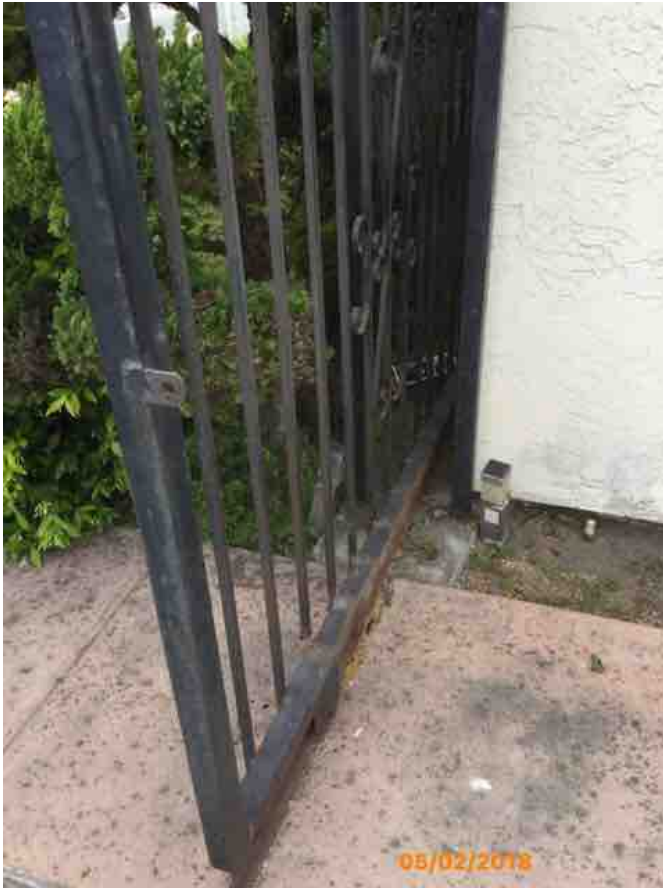
CR s-5: - The gate at the front (sliding) is damaged. We recommend it be repaired or replaced.

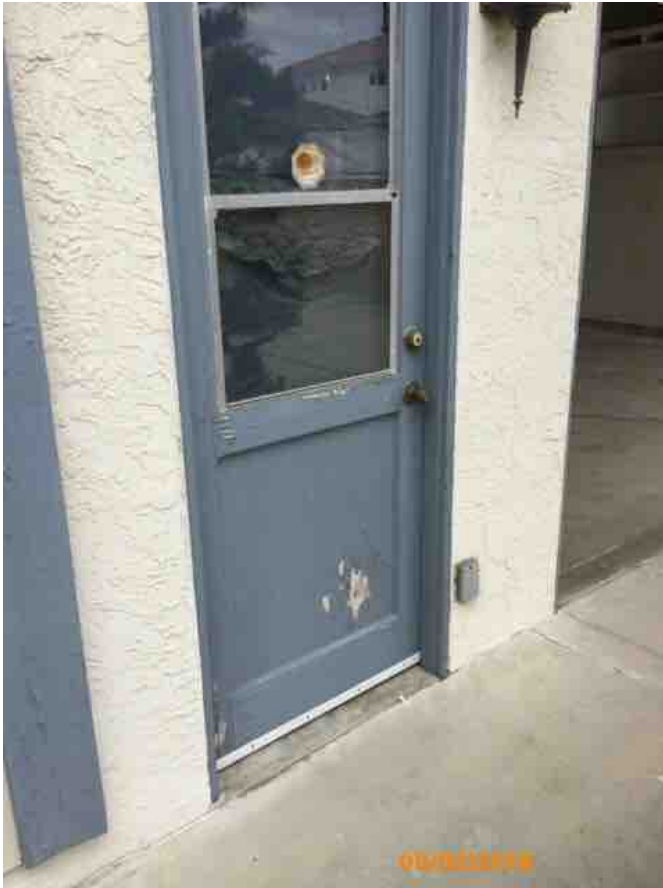
CR s-6: - The garage door is deteriorated. We recommend it be repaired or replaced.

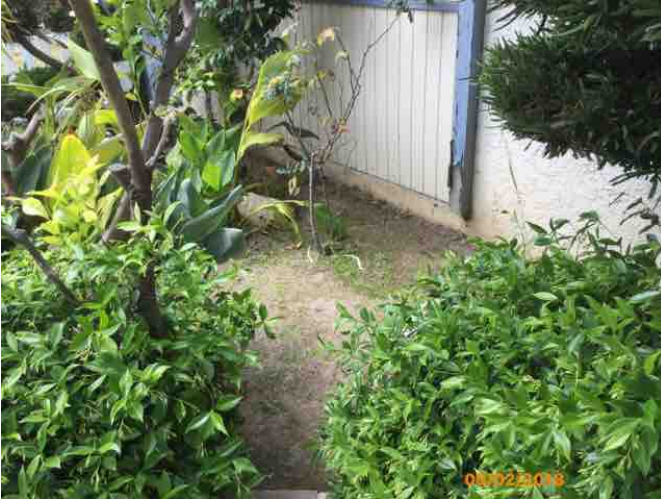
Front planter

FE CR s-7: - Grading is sloped toward the structure in some areas. Low spots and negative grading promote water accumulation near the building, leading to foundation problems. The slope should fall away from the foundation at a rate of one quarter of an inch per foot for at least 6 feet to prevent moisture accumulation next to the foundation. Regrading would help ensure that surface water flows away from the structure.

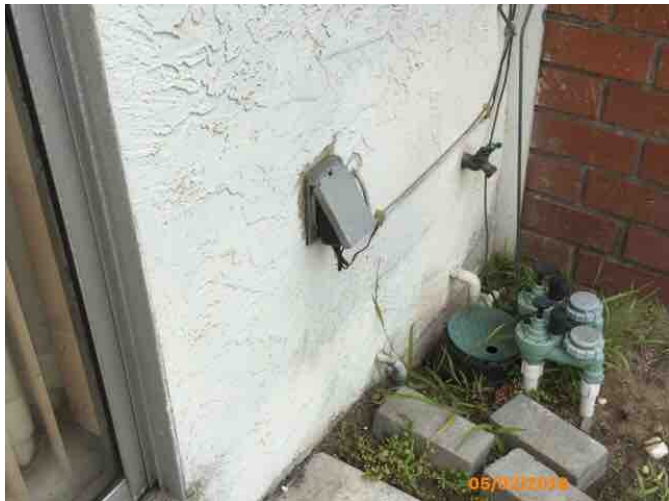
Rear

SC CR s-8: - The receptacle outlet does not have a protective weather cover to be installed when using this outlet full time. This is required when you have a permanent plug installed. To prevent deterioration and potential electrical shock, we recommend replacement with an approved weathertight box.

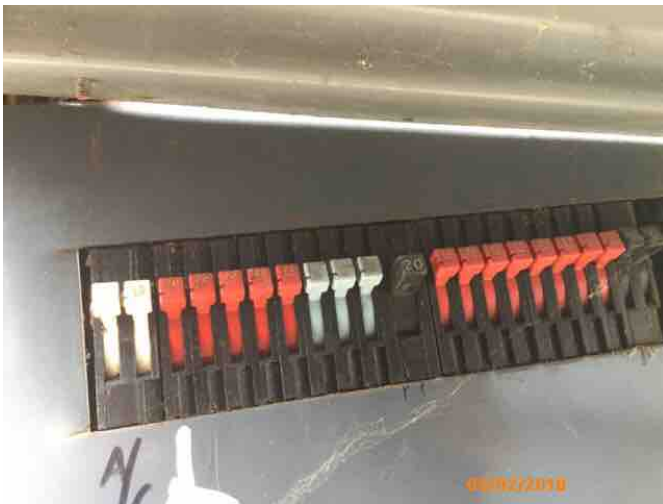
SC FE CR s-9: - Federal Pacific, Zinsco, Sylvania, Bulldog, Stab-lok, etc. panels and/or breakers have a long history of performance and safety issues. This panel has been known to present latent hazards by malfunctioning under certain conditions resulting in arcing, overheating and fire. The breakers may not trip under imposed load conditions. Failure can also occur at the connections to the busbars. Because one of these panels was seen during our inspection, we did not open it to further inspect it. We recommend further evaluation and replacement by an electrical contractor.

This service panel is outdated and of hazardous design. We made no attempt to remove the dead front cover and recommend further evaluation by an electrical contractor.

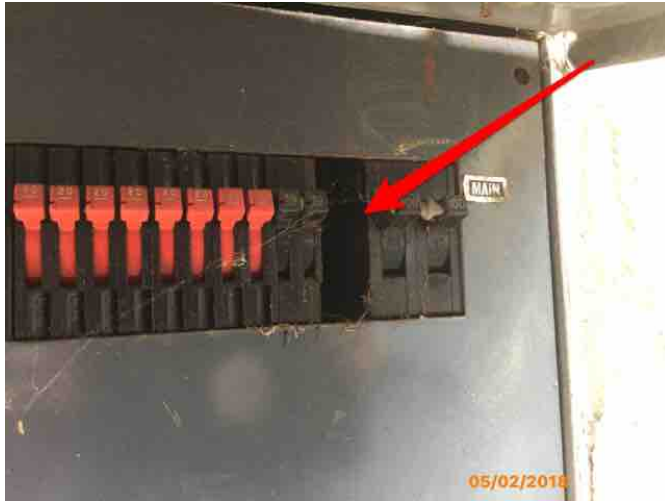
SC CR s-10: - There are holes in the service panel where 'knockouts' have been removed and left open. This is not an approved practice and we recommend the holes be closed with approved filler plates.

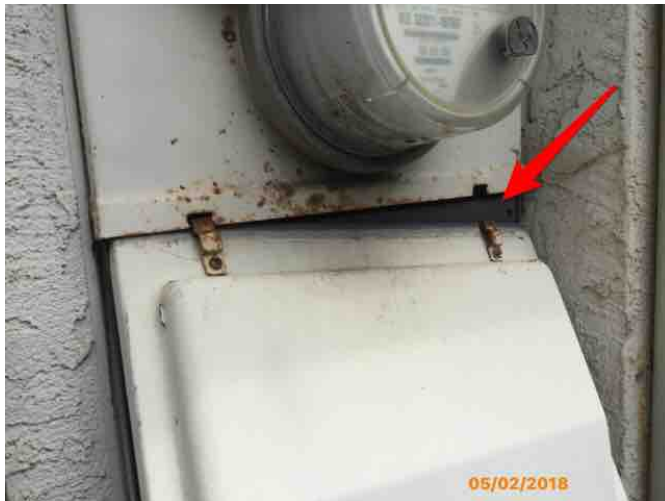
SC CR s-11: - The electrical panel door is either missing or damaged. We recommend repair or replacement.

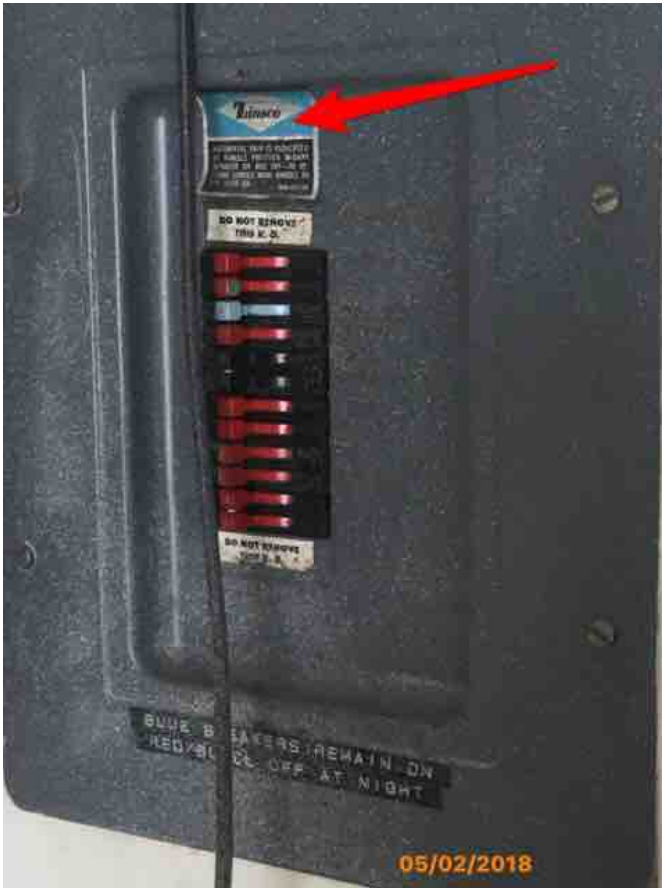
SC FE CR s-12: - Zinsco panels and/or breakers have a long history of performance and safety issues. Because one of these panels was seen during our inspection, we recommend further evaluation by an electrical contractor. NOTE: because of the potential defect in these panels we do not open the panel itself. We recommend having a licensed electrician further evaluate them. They will most likely recommend a replacement panel. For more information on these panels you can go here. <http://inspectapedia.com/electric/Zinsco.htm>

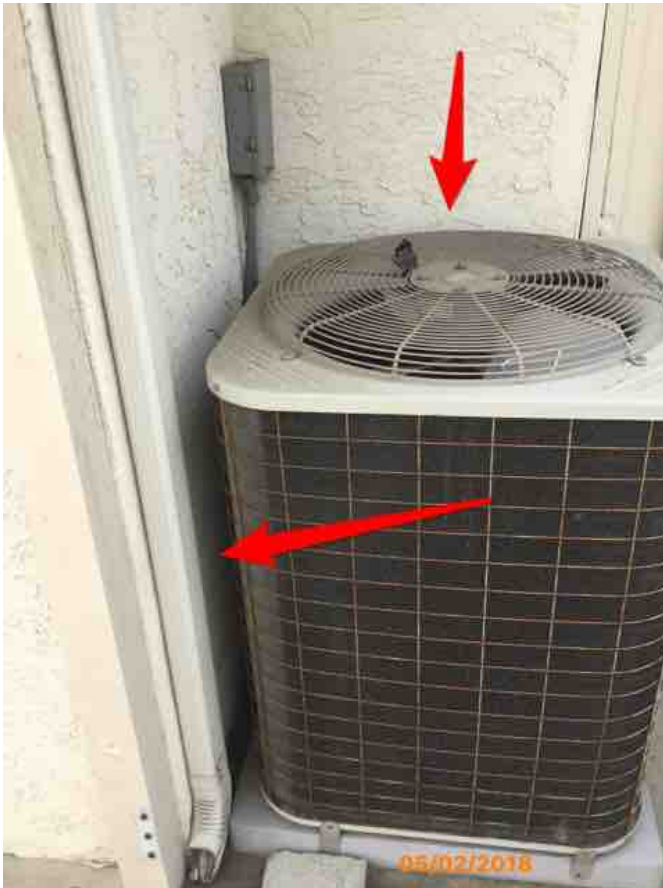
CR RU s-16: - This unit must have at least 24 inches of clearance around the unit. We recommended repair by a qualified contractor prior to the close of escrow.

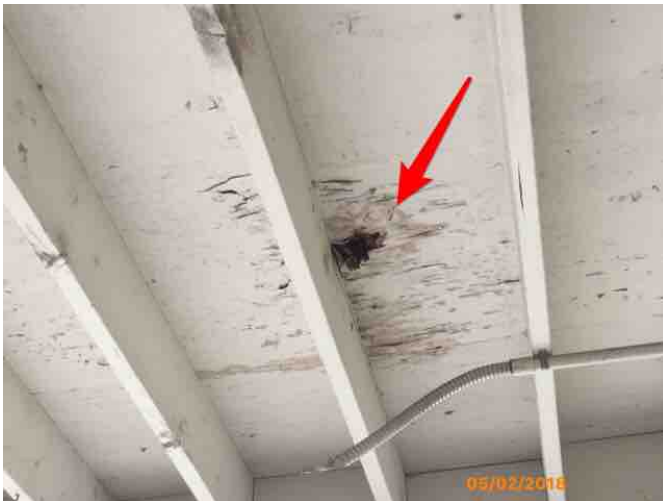
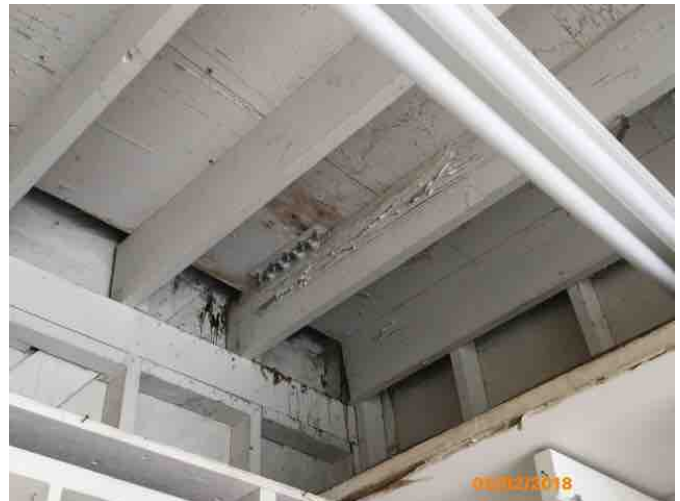
FE CR s-19: - We noted water staining and surface damage. The source of the moisture should be identified and corrected, and the surface prepared and refinished to restore its appearance.(Numerous)

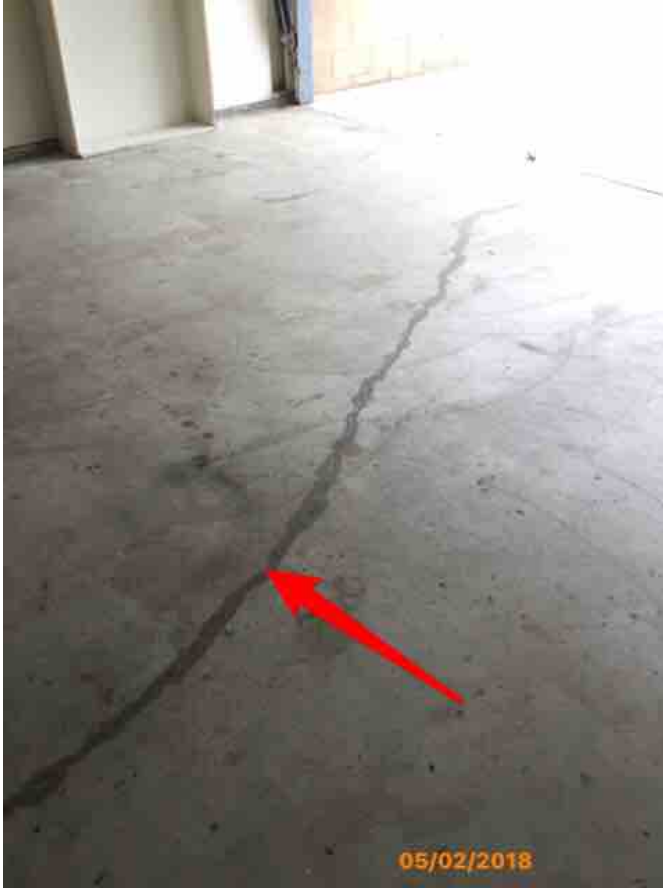
s-20: - There are cracks in the floor slab with minor vertical displacement of the slab toward the middle of the garage. This is not a reflection on the condition of the rest of the building. We recommend monitoring this area and making repairs if necessary in the future.

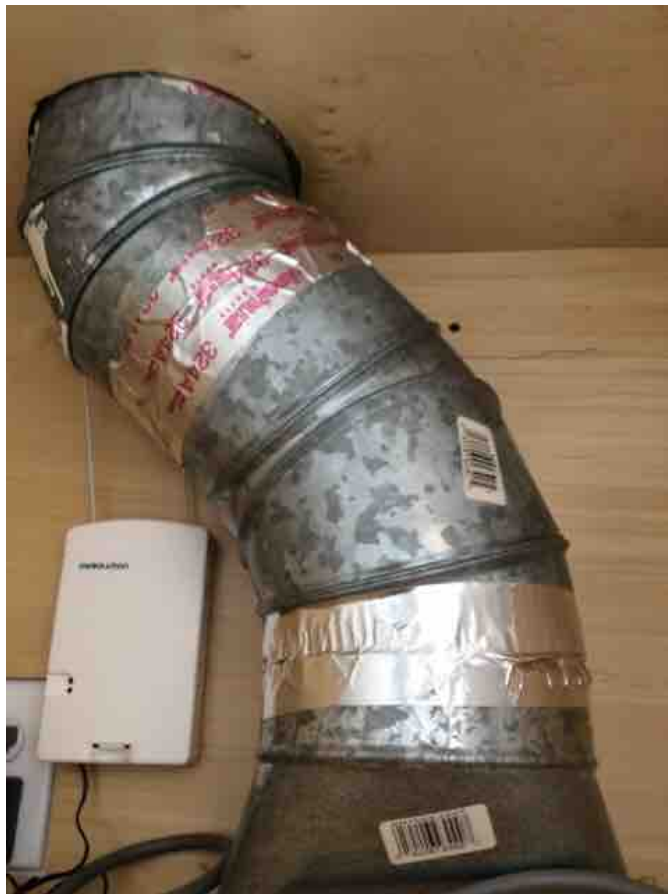
CR s-24: - The corrugated aluminum 'flex duct' visible at the fan, is not permitted for kitchen exhaust fans as it can be a fire hazard. Replacement of this duct with an approved material is recommended.

Example of proper material.

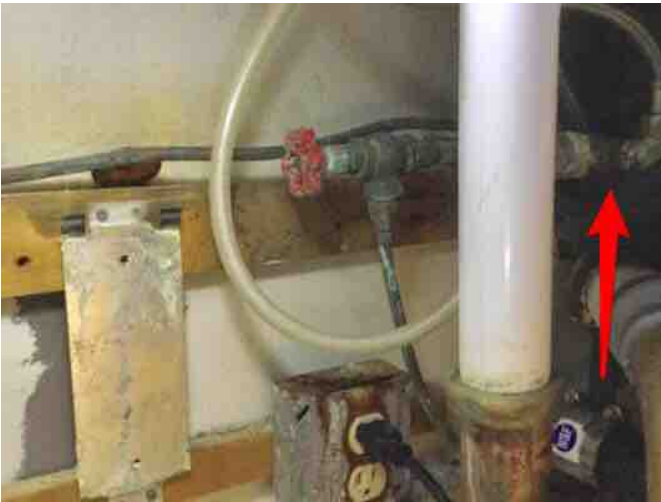
CR RU s-27: - There was evidence of surface corrosion at the exposed and accessible supply piping. We recommend that all corroded or leaking piping be repaired or replaced.

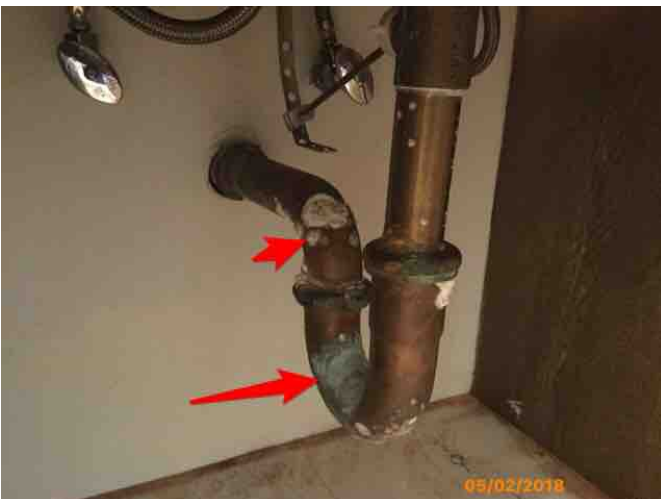
CR s-28: - Although we observed no leakage, the drain trap is very deteriorated and its remaining life is limited. We recommend consideration be given to replacing it now before it leaks.

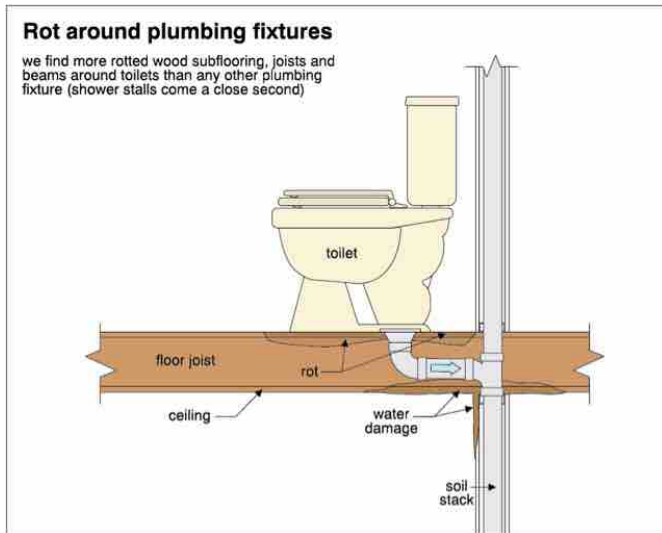
CR s-29: - The toilet tank is leaking. We recommend that it be repaired or replaced.

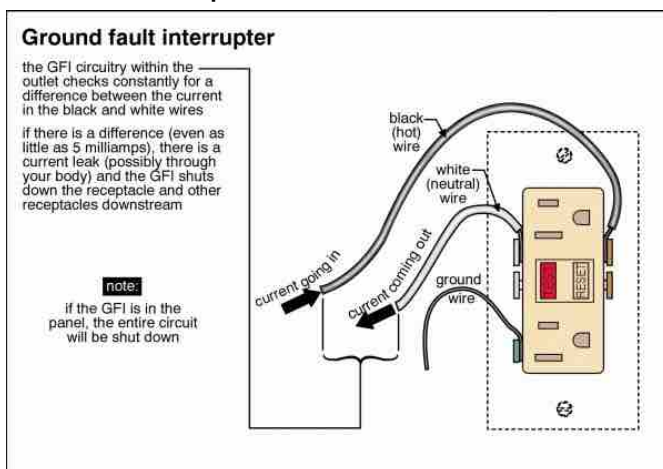
SC CR RU s-32: - There is no GFCI (ground fault circuit interrupter) protection for this bathroom. For an increased margin of safety, we recommend the installation of a GFCI receptacle.

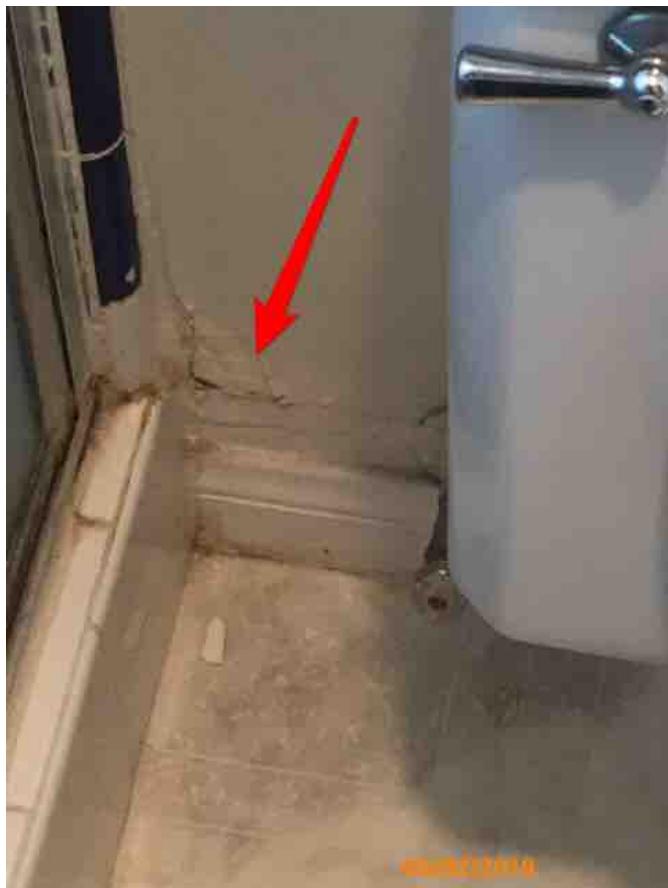
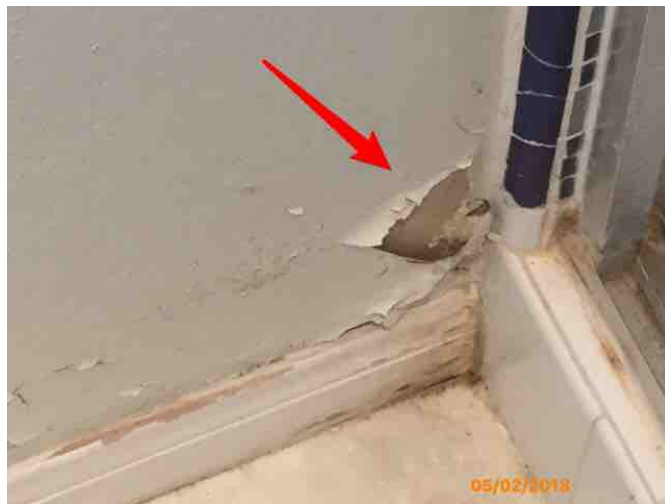
FE CR s-33: - We noted water staining and minor surface damage. The area was moist when tested. The source of the moisture should be identified and corrected, and the surface prepared and refinished to restore its appearance.

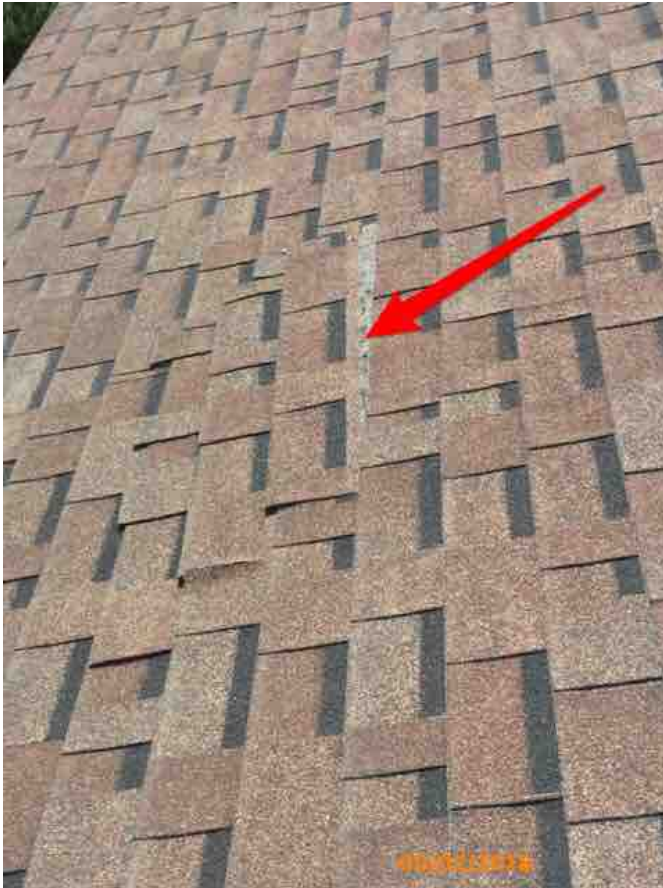
FE CR s-37: - There are some minor individual shingles which are either missing or damaged. We recommend having these shingles replaced by a qualified roofing contractor which will prolong the life of the remainder of the roofing surface.

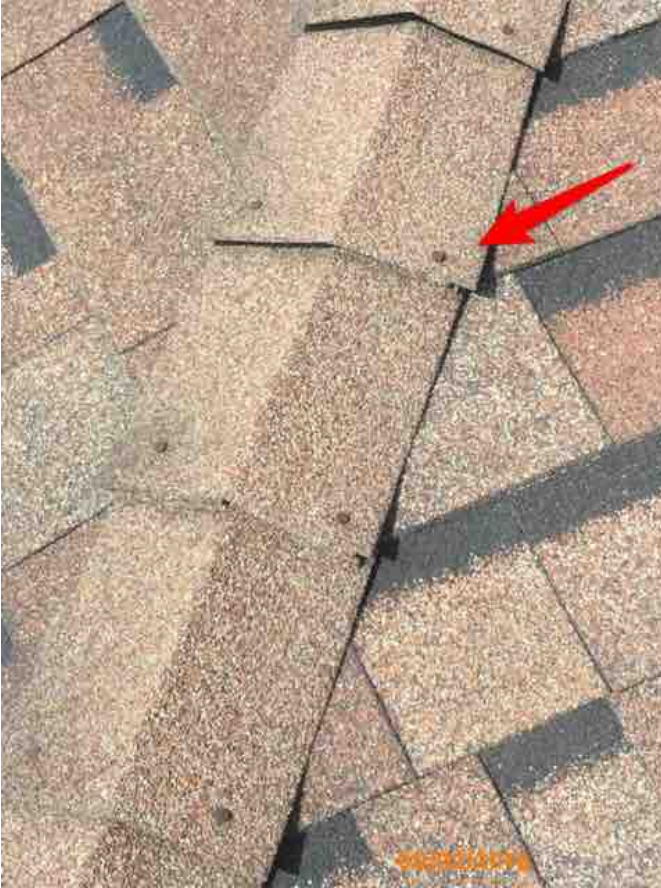
FE CR s-38: - The ridge shingle fasteners are exposed. This is not the recommended method of installation and indicates that the roof may have been installed by a non-professional. No problems were noted and no action is recommended.

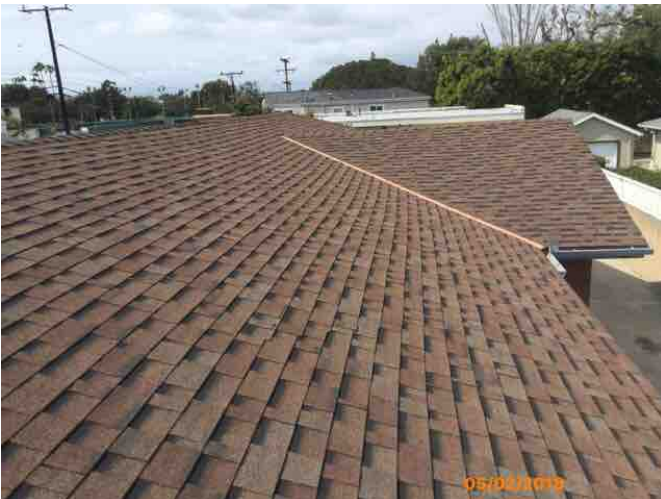
FE CR s-39: - Portions of the surface granulation are deteriorated and there are surface cracks developing. These are normal signs of aging and no action is needed at this time however you should expect to have to replace the roof within the next 2-5 years.

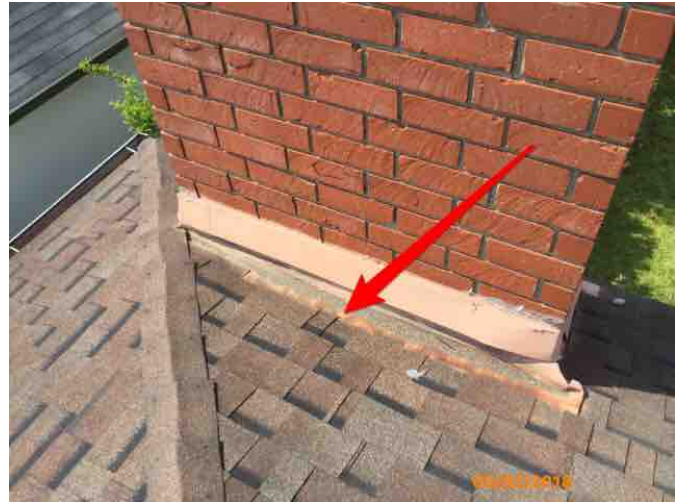
Chimney saddle flashings

chimneys require a saddle flashing (cricket) when their width is 30" or more the saddle flashing can be metal or be covered with roofing material

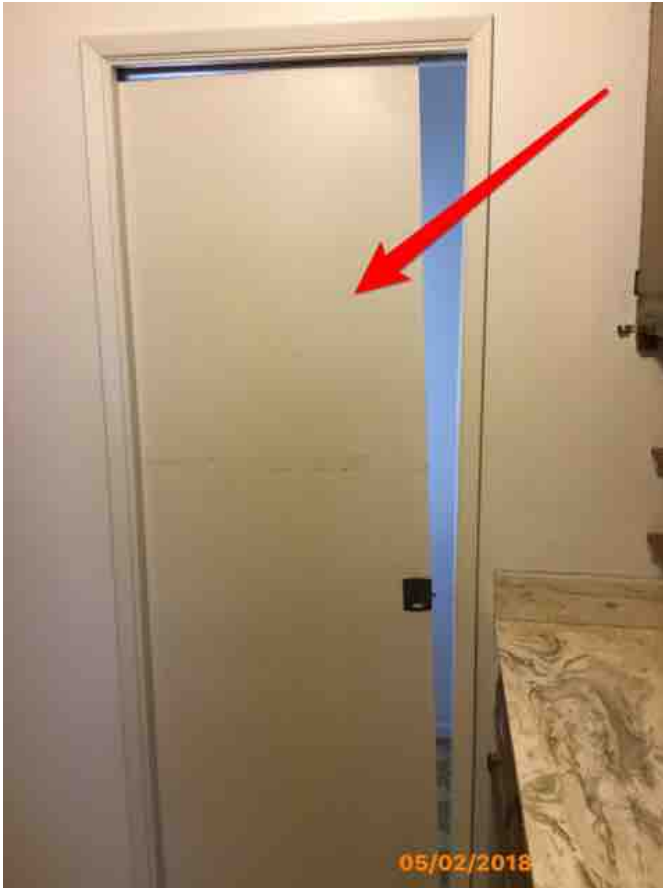
CR s-42: - The sliding door is not square in its frame, causing uneven margins at the top and bottom which has caused the door to be stuck and up useable. . We recommend repair or replacement.

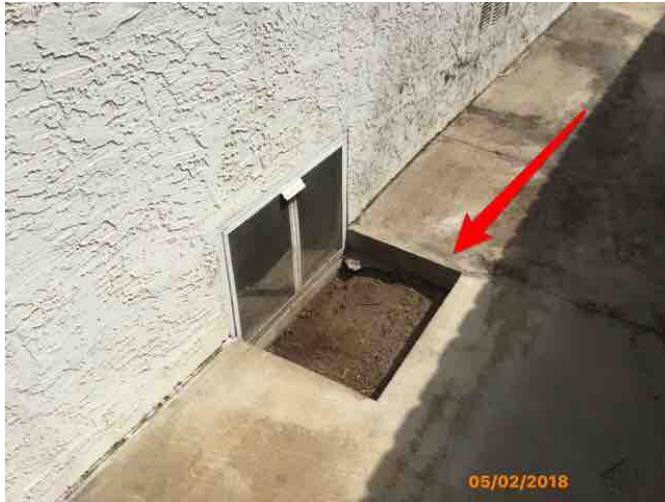
CR **RU** **s-44:** - There was no curb installed around the opening to the crawl space. This is required to keep water from draining down directly into the crawl space. We recommend repair.

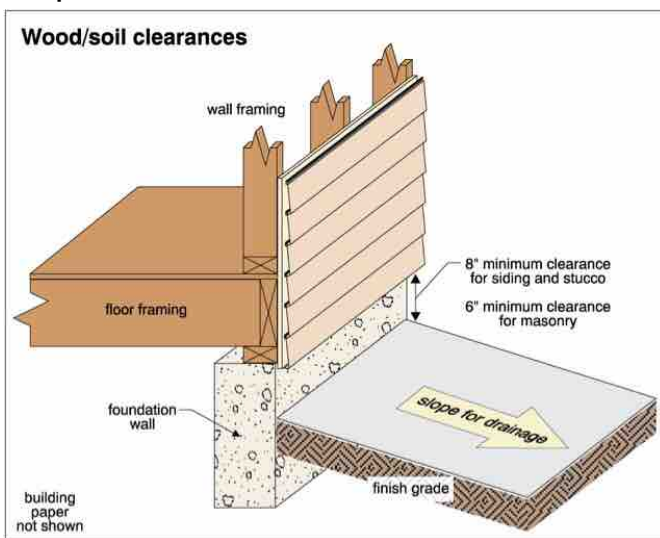
20: - The stucco extends over the foundations below the finished grade. This configuration is no longer approved but was accepted practice when installed. Because hidden fissures may facilitate infestation, a periodic pest inspection would be prudent.

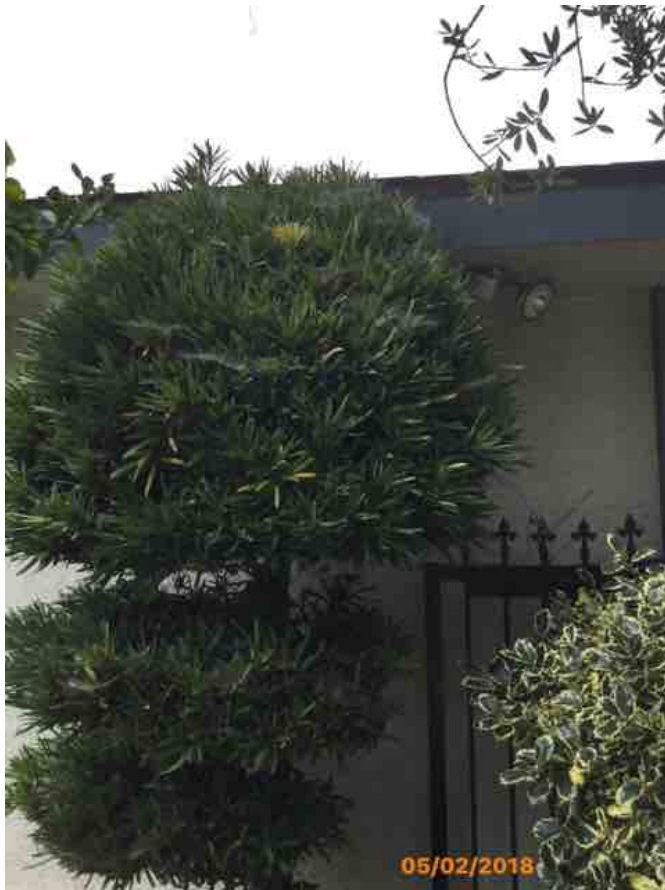
CR 24: - A tree is touching the structure at the front. We consider this a potential threat to the structure. To eliminate the potential for damage, we recommend modification of the structure to accommodate the tree or removal of the tree.

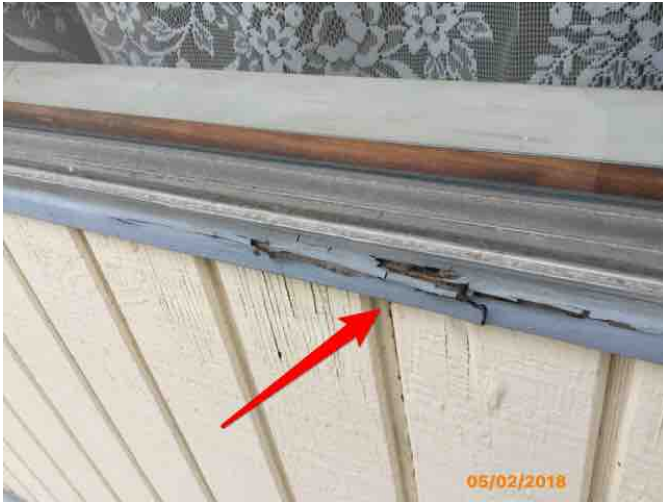
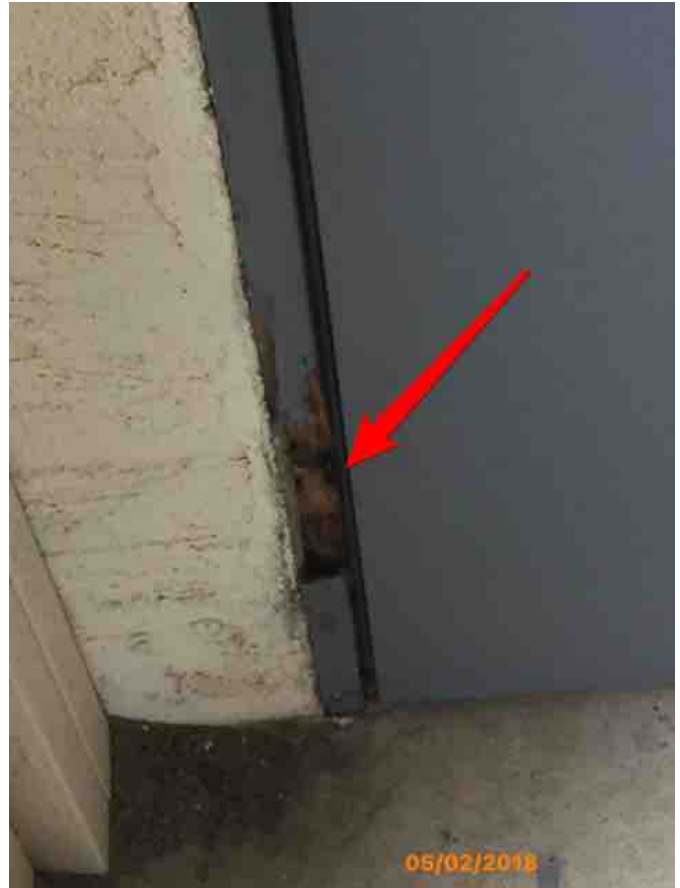
Water heater closet

FE CR 25: - One or more section of trim are damaged. We recommend they be repaired or replaced and to refer to your termite report for further information. (Numerous locations)

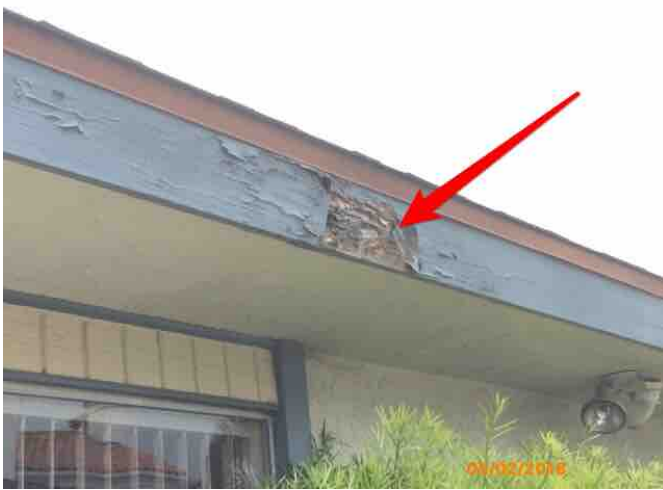
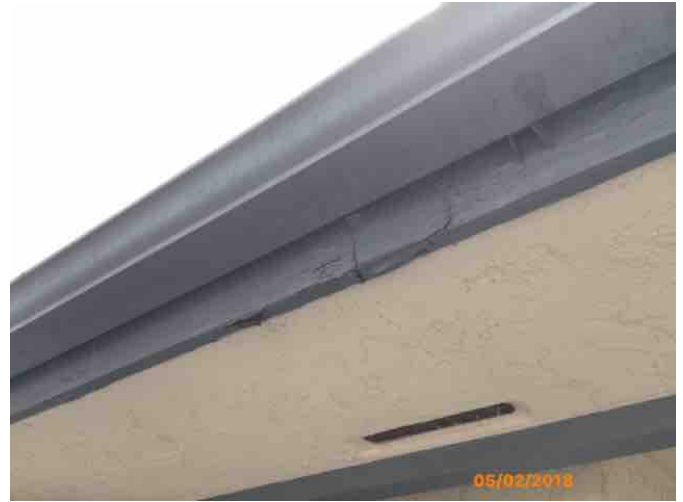
Right side

FE CR 26: - Sections of the fascia at numerous are damaged. We recommend they be repaired or replaced.(numerous locations)

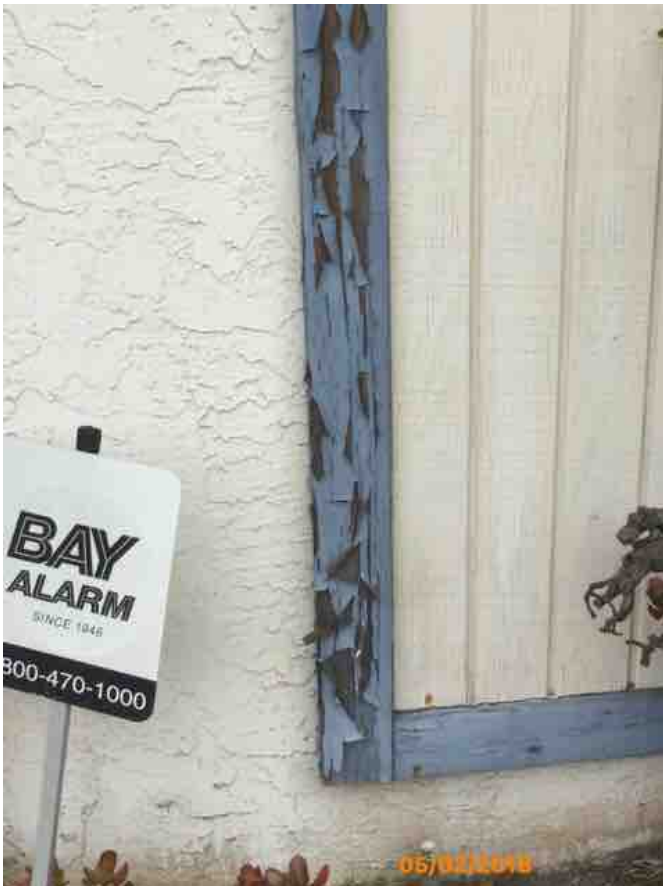
CR 27: - There is peeling paint at numerous locations. We recommend this area be prepared and refinished.

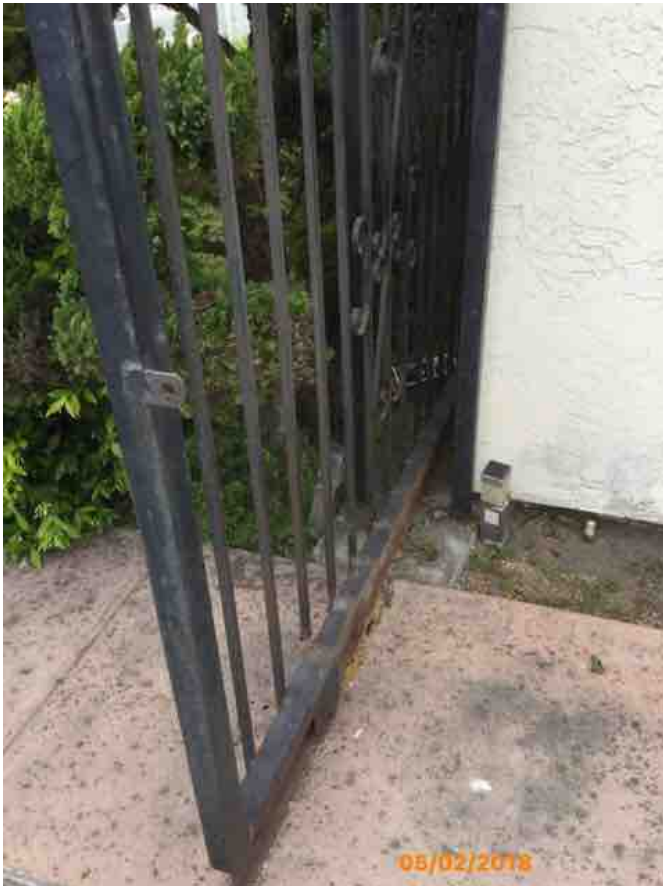
CR 29: - The gate at the front (sliding) is damaged. We recommend it be repaired or replaced.

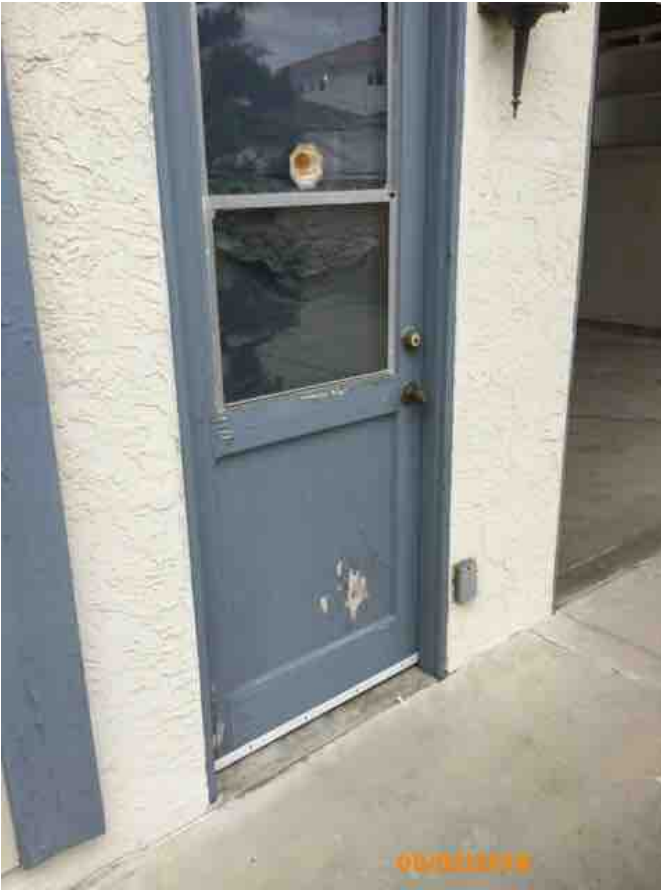
CR 33: - The garage door is deteriorated. We recommend it be repaired or replaced.

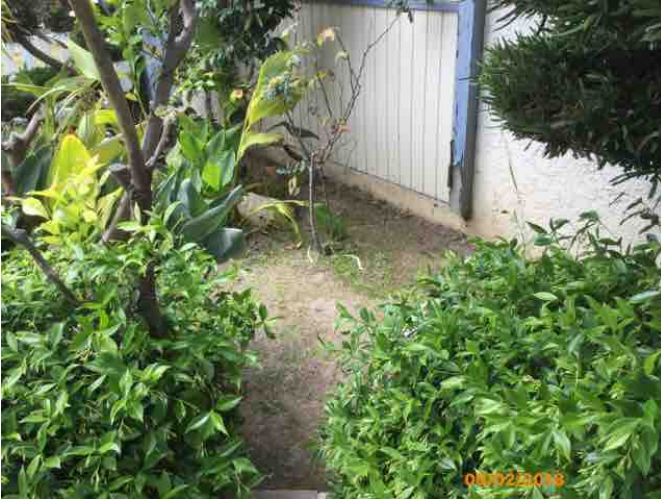
Front planter

FE CR 35: - Grading is sloped toward the structure in some areas. Low spots and negative grading promote water accumulation near the building, leading to foundation problems. The slope should fall away from the foundation at a rate of one quarter of an inch per foot for at least 6 feet to prevent moisture accumulation next to the foundation. Regrading would help ensure that surface water flows away from the structure.

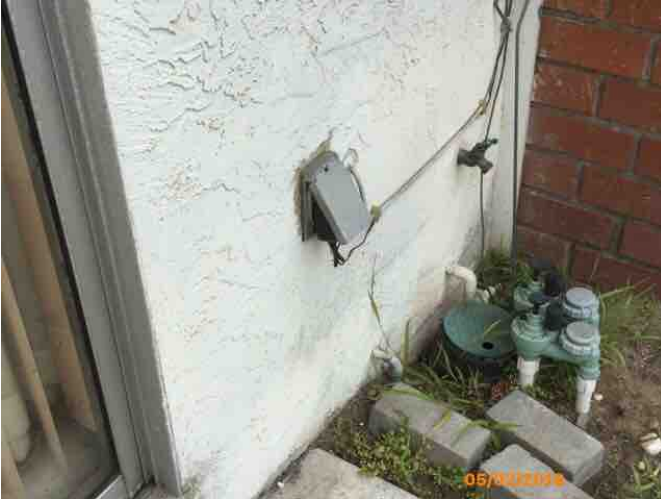
Rear

SC CR 37: - The receptacle outlet does not have a protective weather cover to be installed when using this outlet full time. This is required when you have a permanent plug installed. To prevent deterioration and potential electrical shock, we recommend replacement with an approved weathertight box.

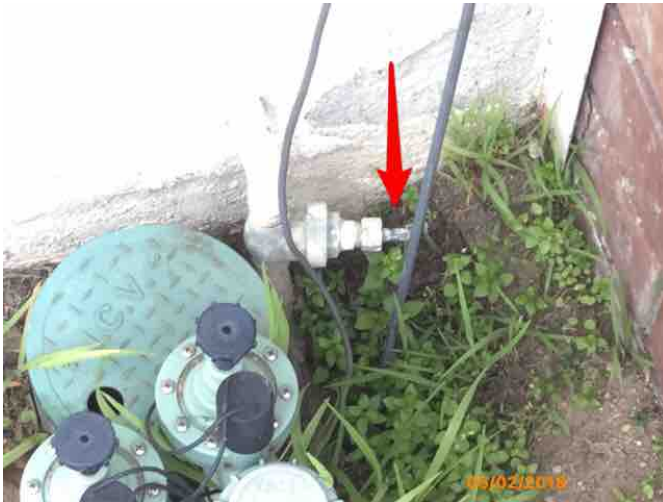
Rear

CR 42: - One or more of the plumbing handles is damaged/missing. We recommend replacement for full usage of this feature.

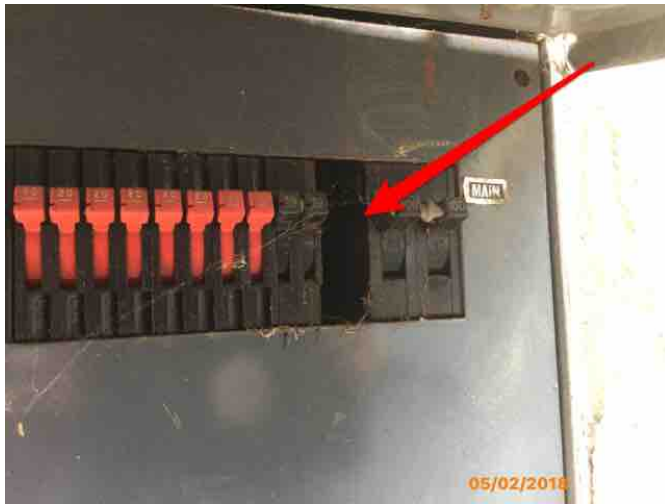
SC CR 55: - There are holes in the service panel where 'knockouts' have been removed and left open. This is not an approved practice and we recommend the holes be closed with approved filler plates.

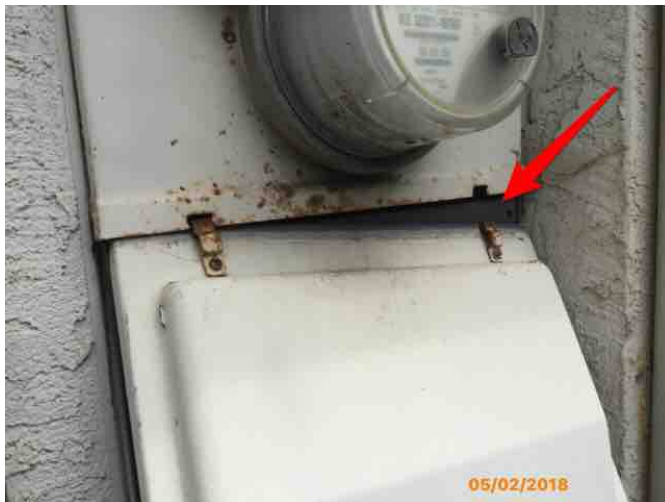
SC CR 56: - The electrical panel door is either missing or damaged. We recommend repair or replacement.

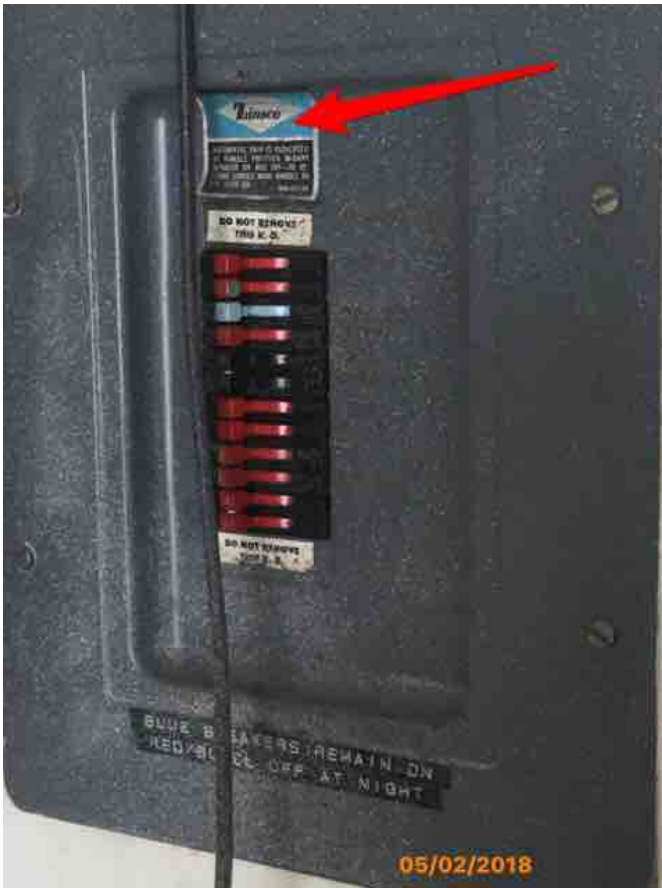
SC FE CR 60: - Zinsco panels and/or breakers have a long history of performance and safety issues. Because one of these panels was seen during our inspection, we recommend further evaluation by an electrical contractor. NOTE: because of the potential defect in these panels we do not open the panel itself. We recommend having a licensed electrician further evaluate them. They will most likely recommend a replacement panel. For more information on these panels you can go here. <http://inspectapedia.com/electric/Zinsco.htm>
