Confidential Inspection Report

INSPECTION ADDRESS
1707 10th St
Manhattan Beach, CA 90266

Wednesday, May 2, 2018

Inspector, Michael Boeger, ACI, CCI
Equity Building Inspection

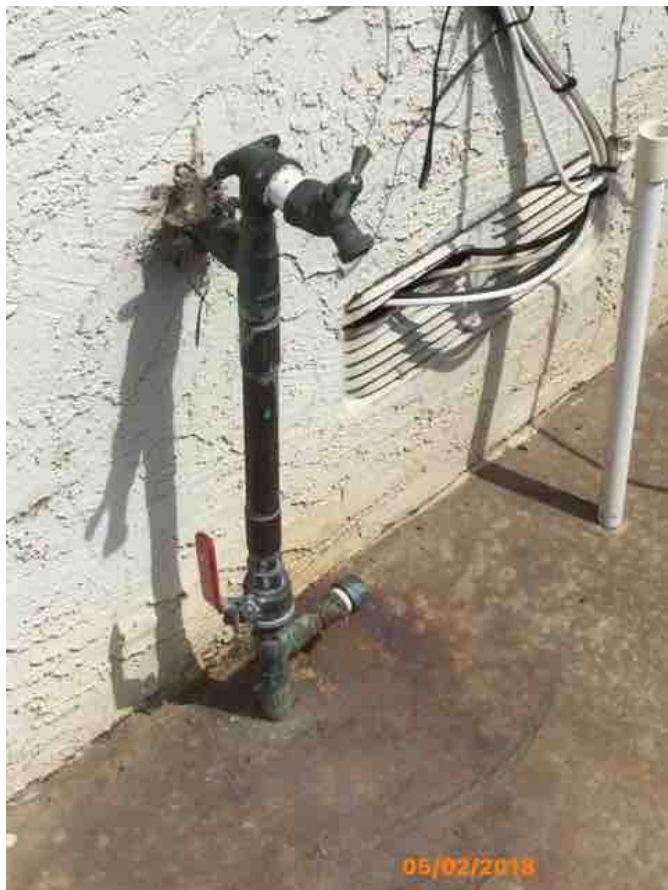
WATER SHUTOFF LOCATION

75: - The domestic water supply main shut-off valve is outside at the left side of the building.

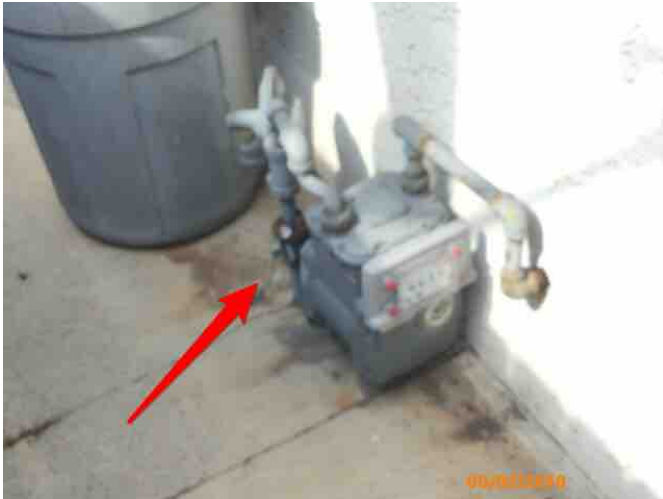
87: - The gas meter is outside on the left side of the building. The main gas supply shutoff valve is located on the riser pipe between the ground and the meter. This valve should be turned 90 degrees (either way) in order to shut off the gas.

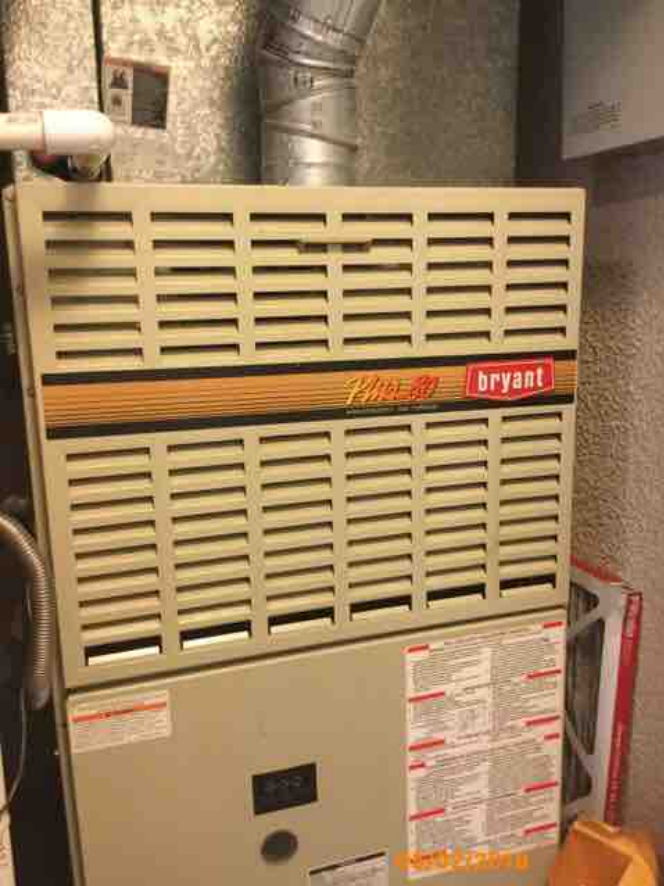
91: - Furnace location: Hall closet

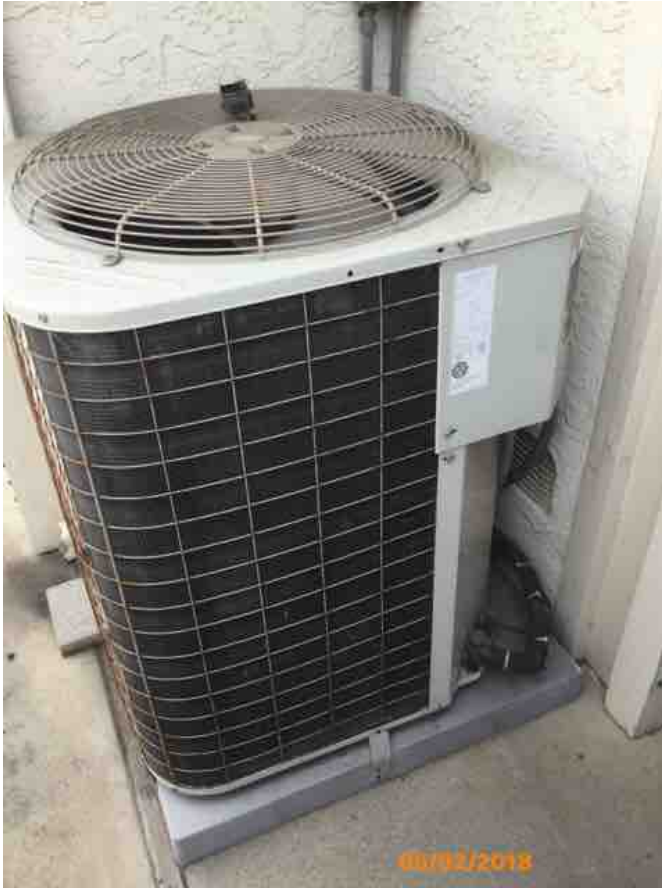
113: - Condenser location: Exterior

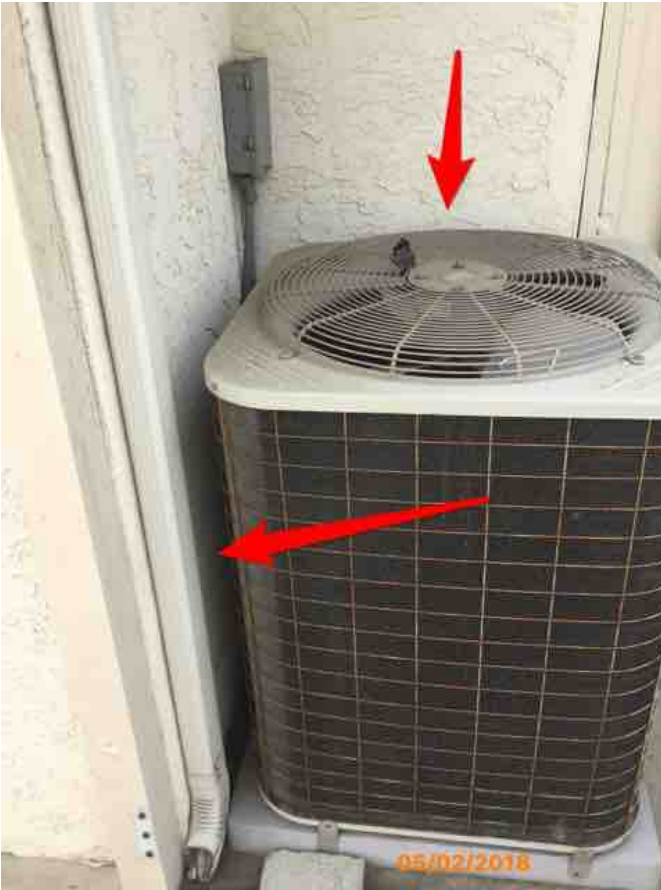
CR RU 118: - This unit must have at least 24 inches of clearance around the unit. We recommended repair by a qualified contractor prior to the close of escrow.

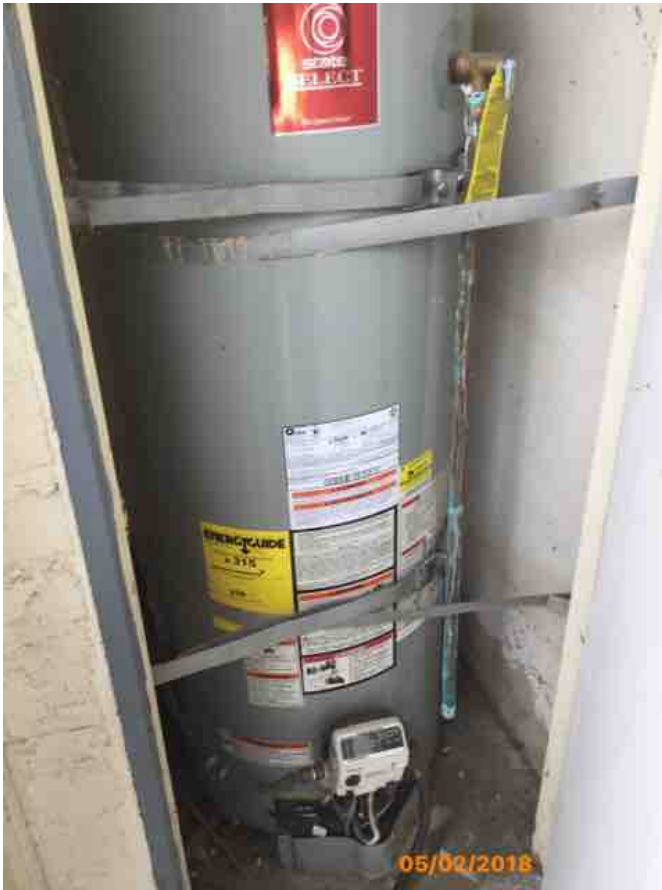
120: - Location: In an outdoor closet

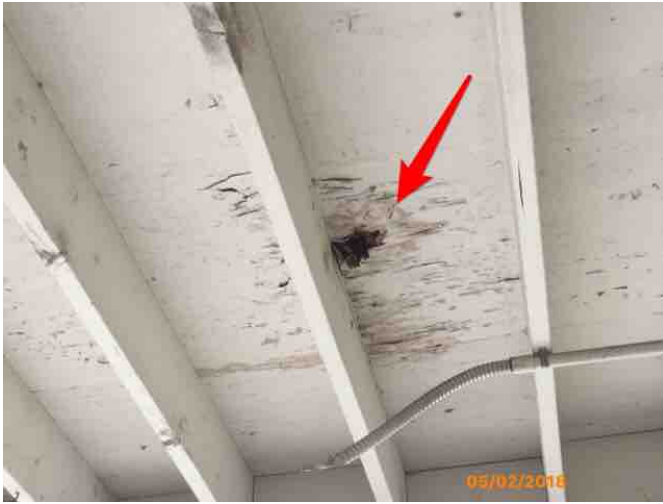
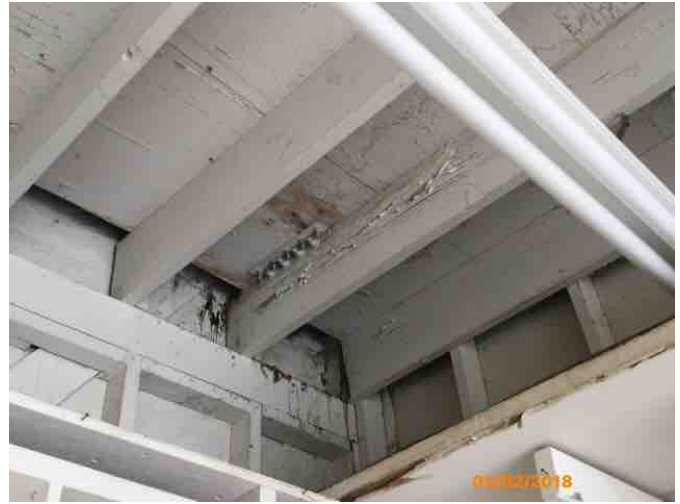
FE CR 141: - We noted water staining and surface damage. The source of the moisture should be identified and corrected, and the surface prepared and refinished to restore its appearance.(Numerous)

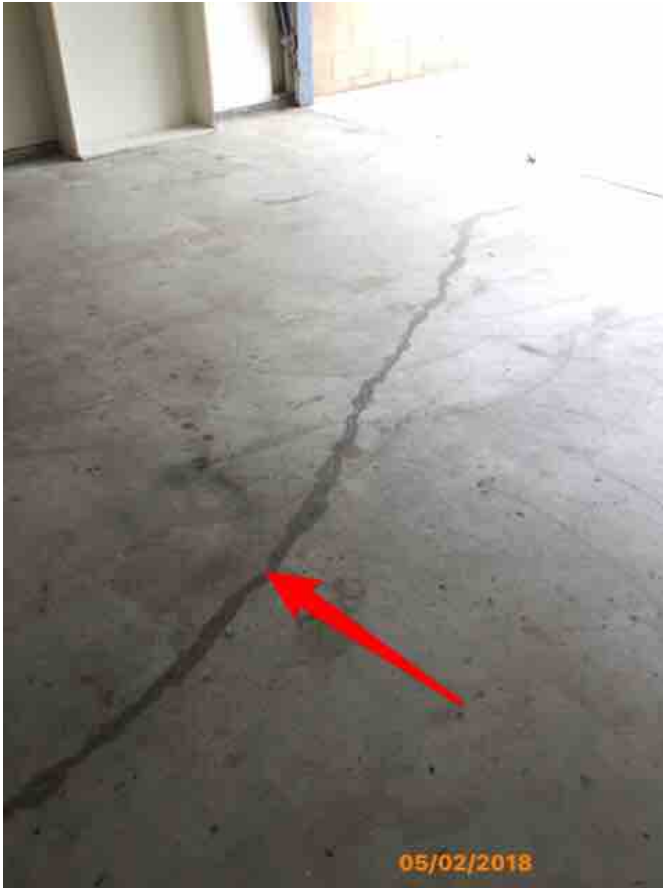
143: - There are cracks in the floor slab with minor vertical displacement of the slab toward the middle of the garage. This is not a reflection on the condition of the rest of the building. We recommend monitoring this area and making repairs if necessary in the future.

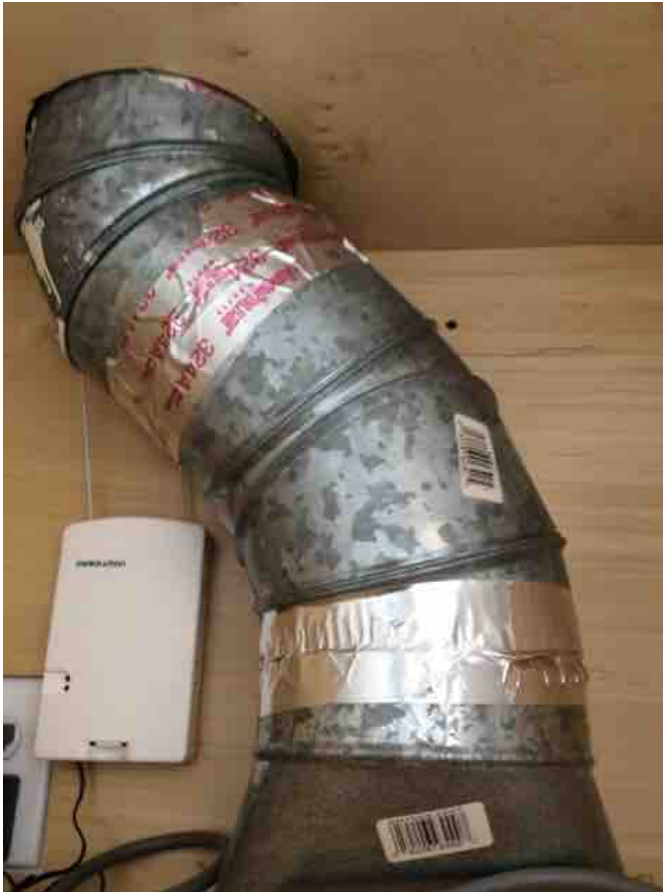
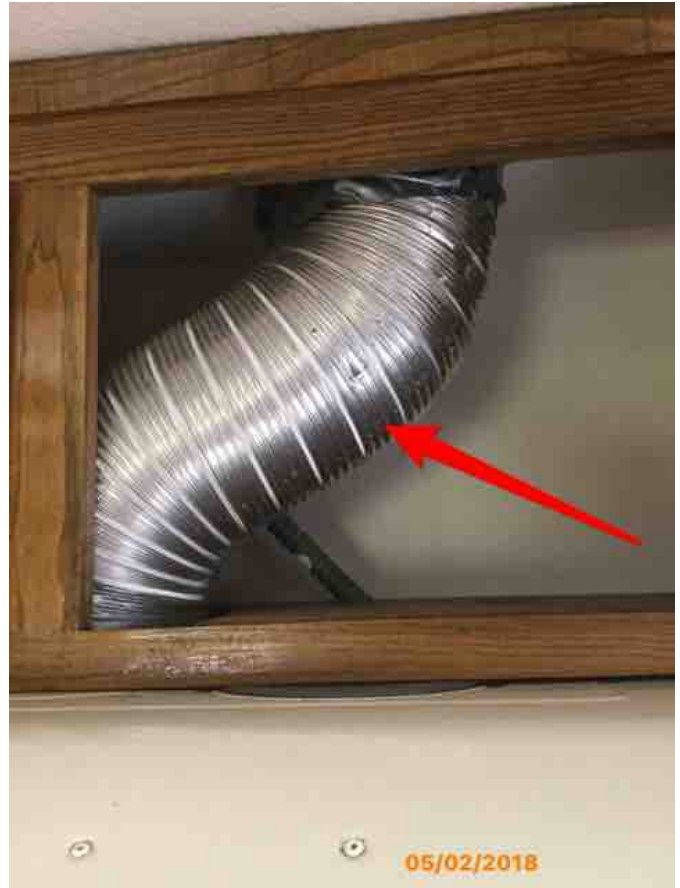
CR 170: - The corrugated aluminum 'flex duct' visible at the fan, is not permitted for kitchen exhaust fans as it can be a fire hazard. Replacement of this duct with an approved material is recommended.

Example of proper material.

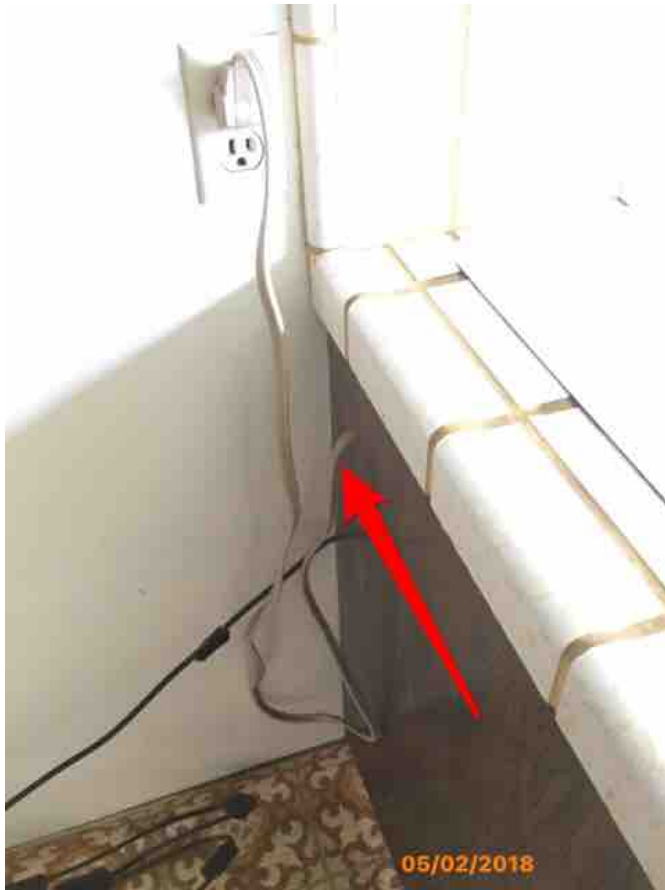
SC CR 172: - Improper wiring methods have been employed. We recommend all substandard wiring be removed and approved wiring installed.

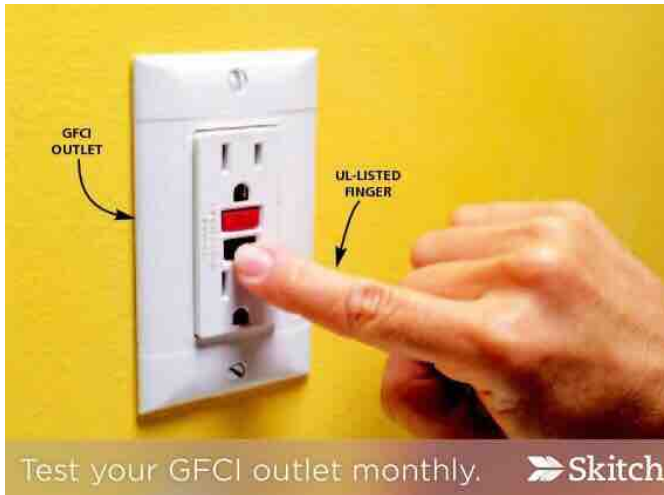
173: - GFCI (ground fault circuit interrupter) protection has been installed providing an increased margin of safety. We recommend testing the device on a monthly basis.

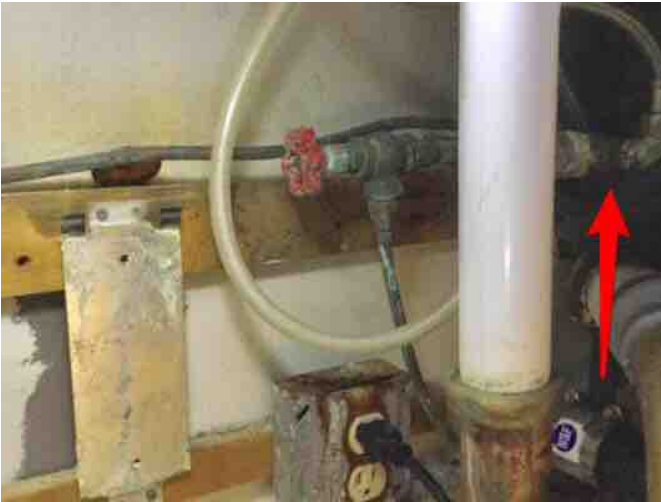
CR RU 176: - There was evidence of surface corrosion at the exposed and accessible supply piping. We recommend that all corroded or leaking piping be repaired or replaced.

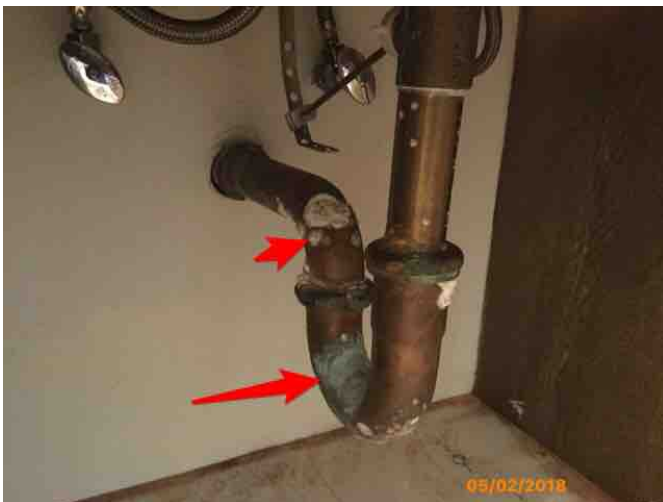
CR 187: - Although we observed no leakage, the drain trap is very deteriorated and its remaining life is limited. We recommend consideration be given to replacing it now before it leaks.

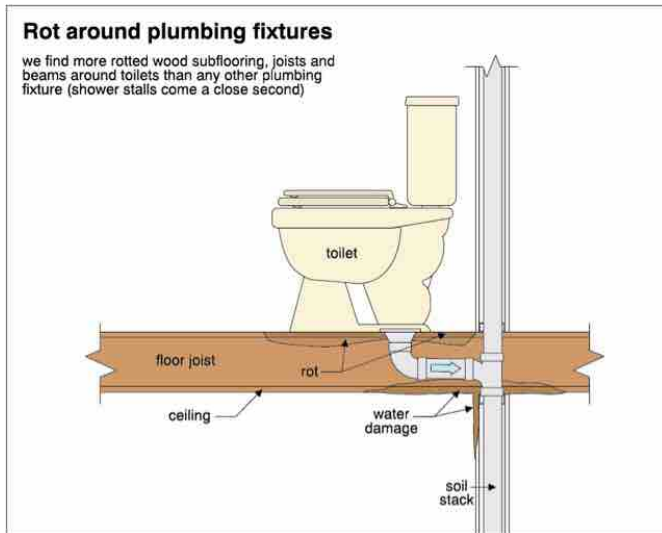
CR 189: - The toilet tank is leaking. We recommend that it be repaired or replaced.

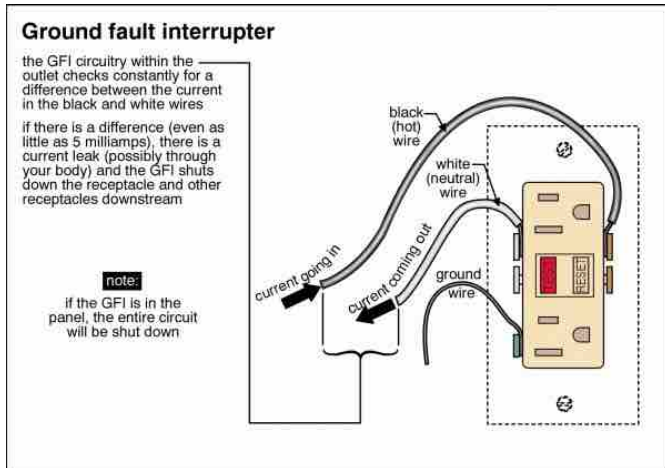
SC CR RU 200: - There is no GFCI (ground fault circuit interrupter) protection for this bathroom. For an increased margin of safety, we recommend the installation of a GFCI receptacle.

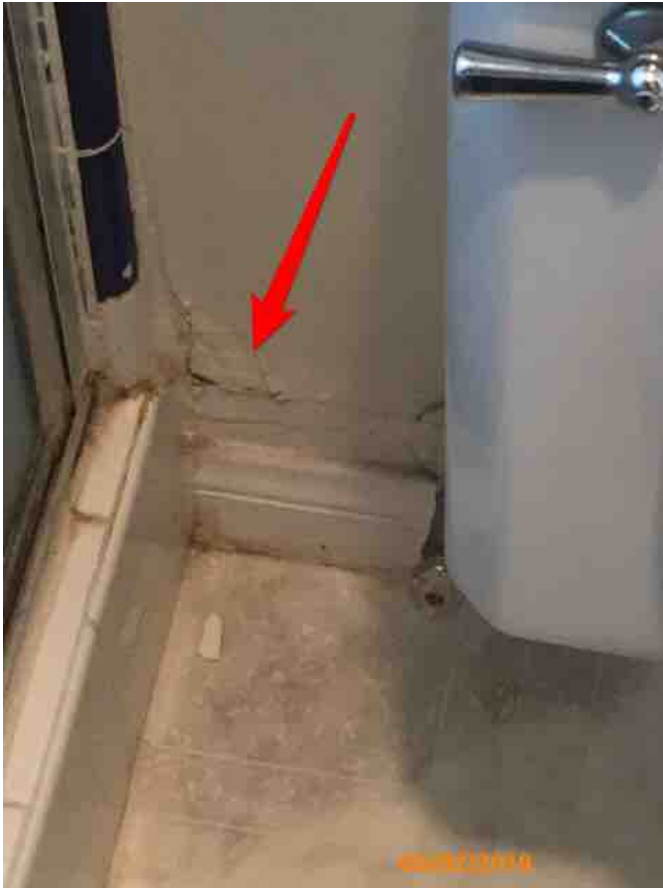
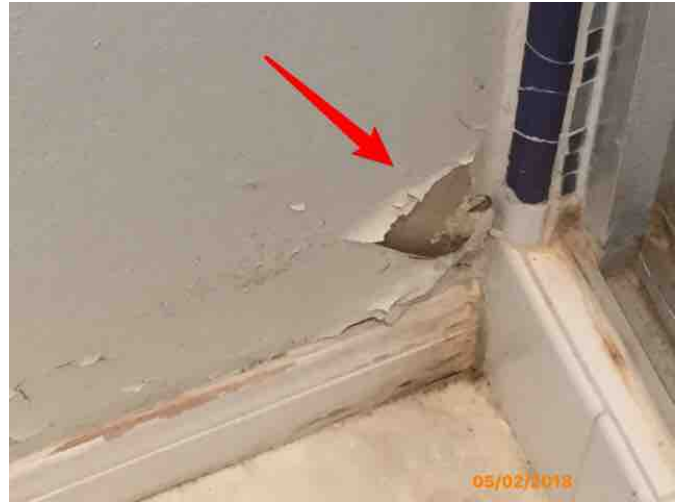
FE CR 201: - We noted water staining and minor surface damage. The area was moist when tested. The source of the moisture should be identified and corrected, and the surface prepared and refinished to restore its appearance.

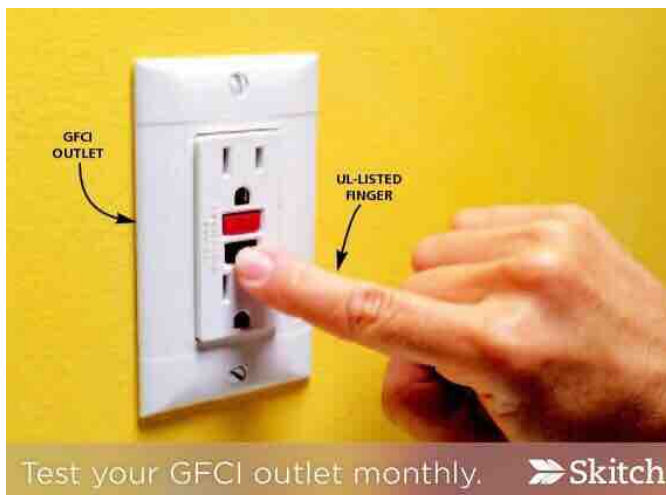
211: - GFCI (ground fault circuit interrupter) protection has been installed providing an increased margin of safety. We recommend testing the device on a monthly basis.

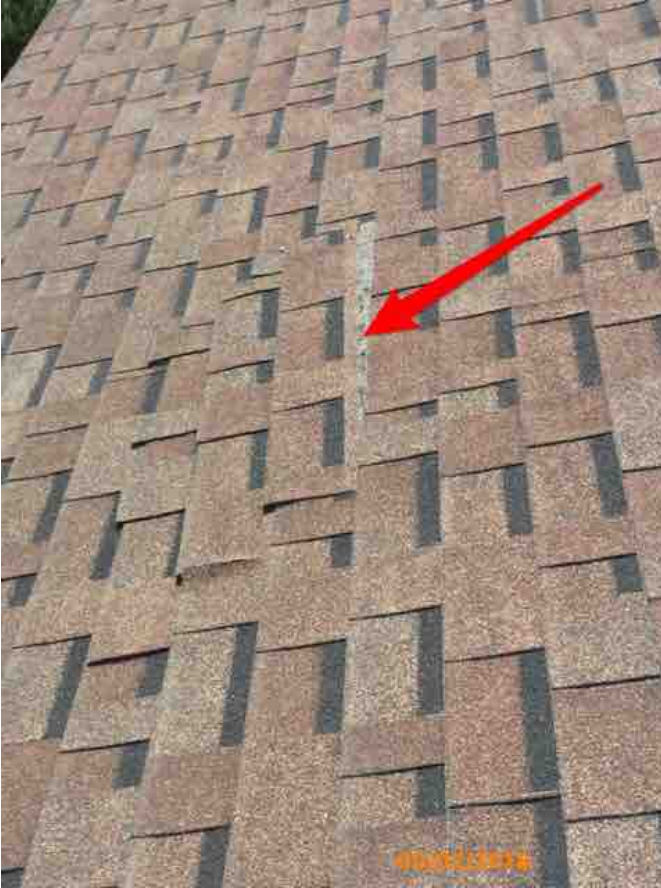
FE CR 218: - There are some minor individual singles which are either missing or damaged. We recommend having these shingles replaced by a qualified roofing contractor which will prolong the life of the remainder of the roofing surface.

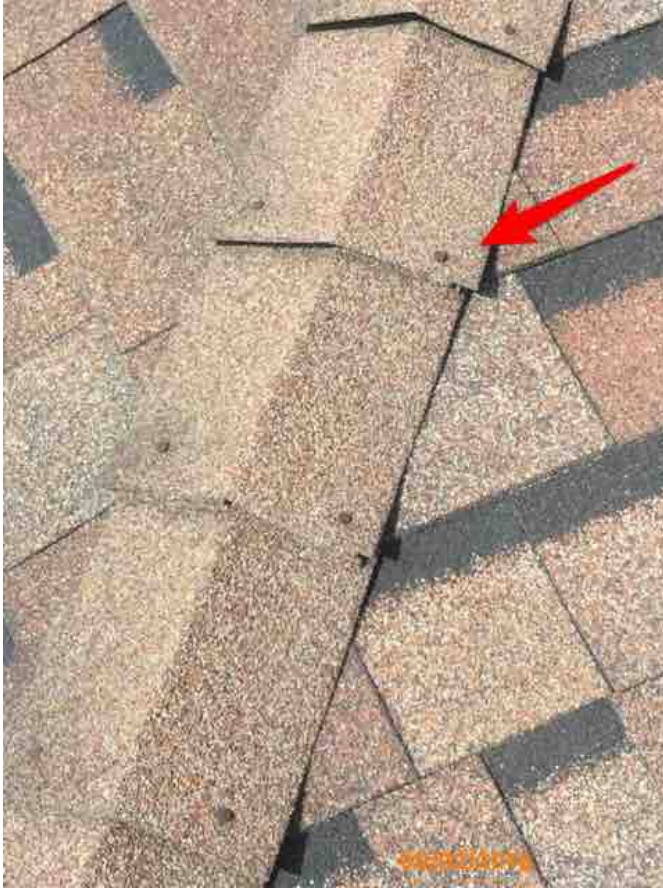
FE CR 219: - The ridge shingle fasteners are exposed. This is not the recommended method of installation and indicates that the roof may have been installed by a non-professional. No problems were noted and no action is recommended.

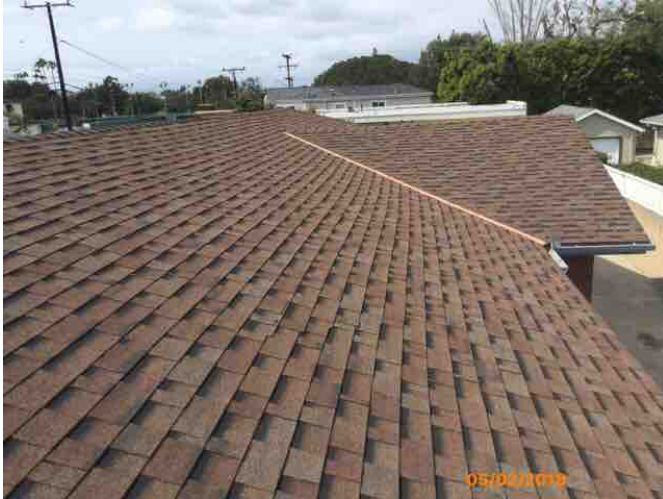
FE CR 220: - Portions of the surface granulation are deteriorated and there are surface cracks developing. These are normal signs of aging and no action is needed at this time however you should expect to have to replace the roof within the next 2-5 years.

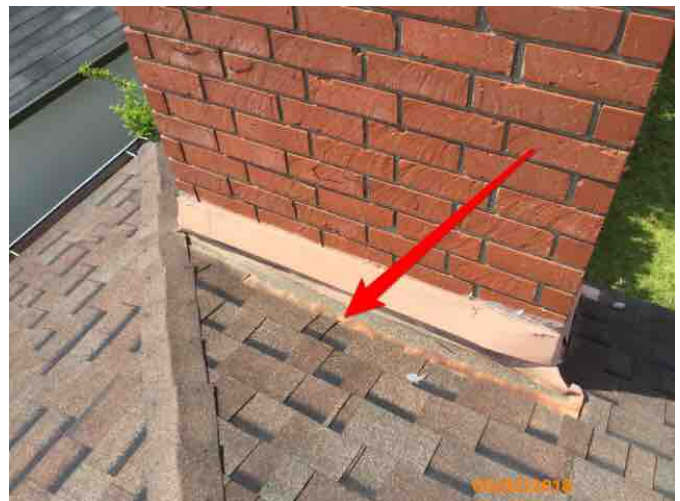
chimneys require a saddle flashing (cricket) when their width is 30" or more the saddle flashing can be metal or be covered with roofing material

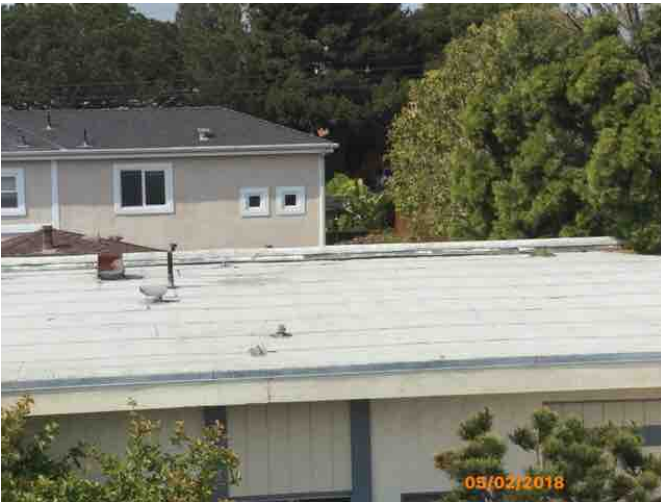
FE CR 236: - We found surface granulation failure at numerous areas. This is an indication of a roof that is beginning to reach the end of its service life. Recommend budgeting for a new roof surface within the next 2 to 4 years.

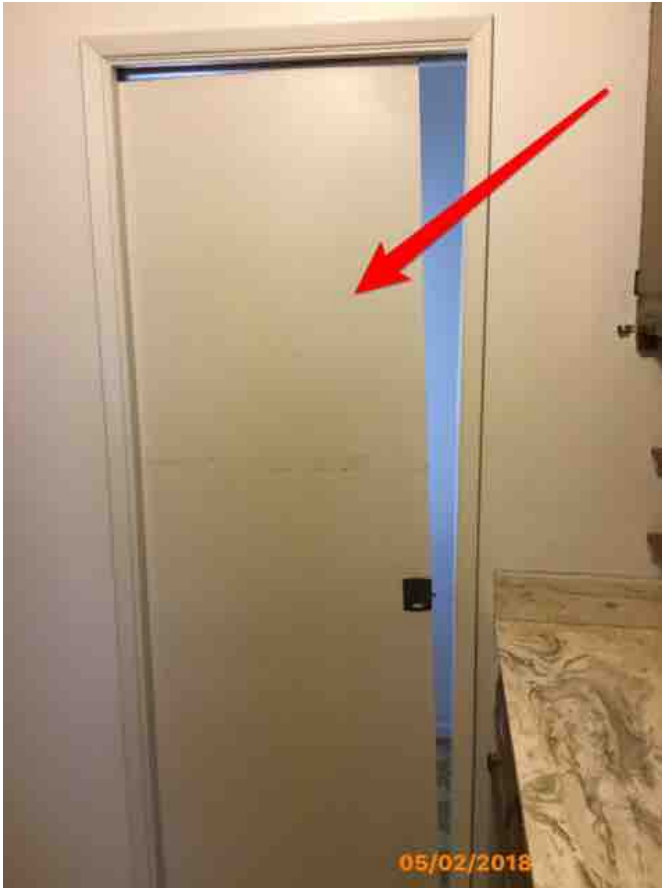
CR 255: - The sliding door is not square in its frame, causing uneven margins at the top and bottom which has caused the door to be stuck and up useable. . We recommend repair or replacement.

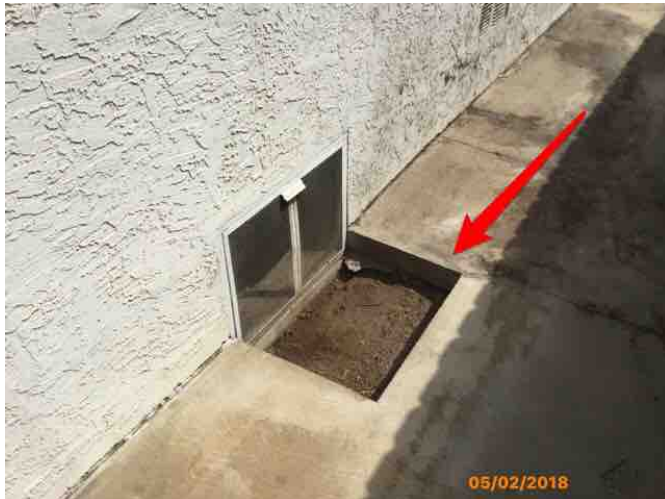
CR RU 270: - There was no curb installed around the opening to the crawl space. This is required to keep water from draining down directly into the crawl space. We recommend repair.

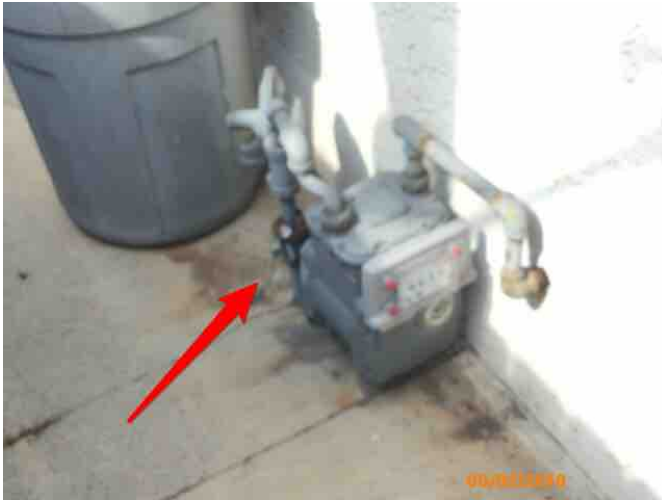
304: - The gas meter is outside on the left side of the building. The main gas supply shutoff valve is located on the riser pipe between the ground and the meter. This valve should be turned 90 degrees (either way) in order to shut off the gas.
