# *1 Day Home Inspection*

## Property Inspection Report

28068 Braidwood Dr, Rancho Palos Verdes, CA 90275

Date of Inspection: 4/2/2019 Time: 3:00 PM

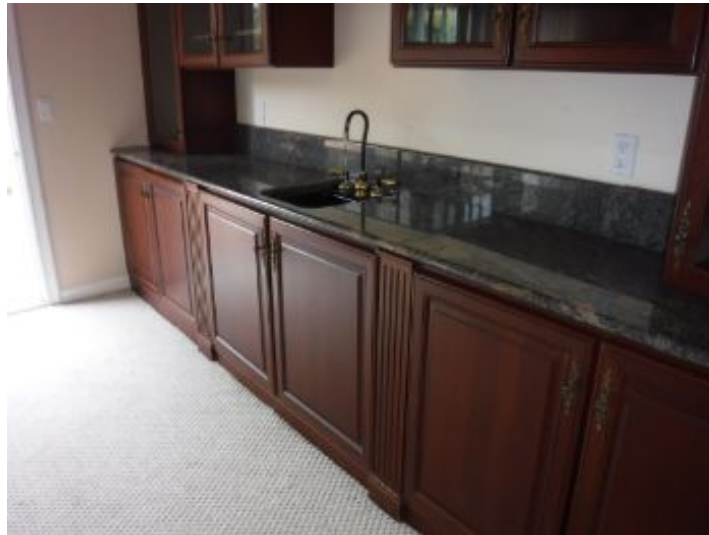
Interior Areas Bar

- The bar area appears functional at the time of inspection.

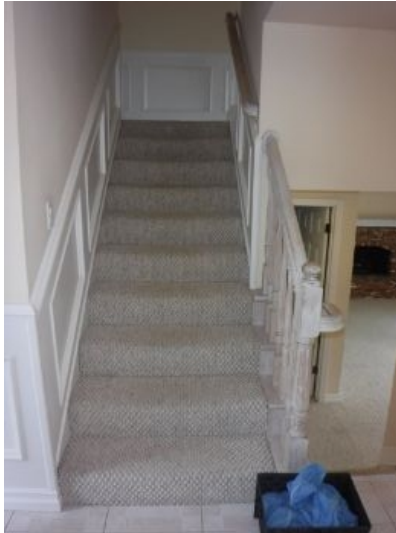
Interior Areas Stairs & Handrail

Observations:  
 • Appears serviceable

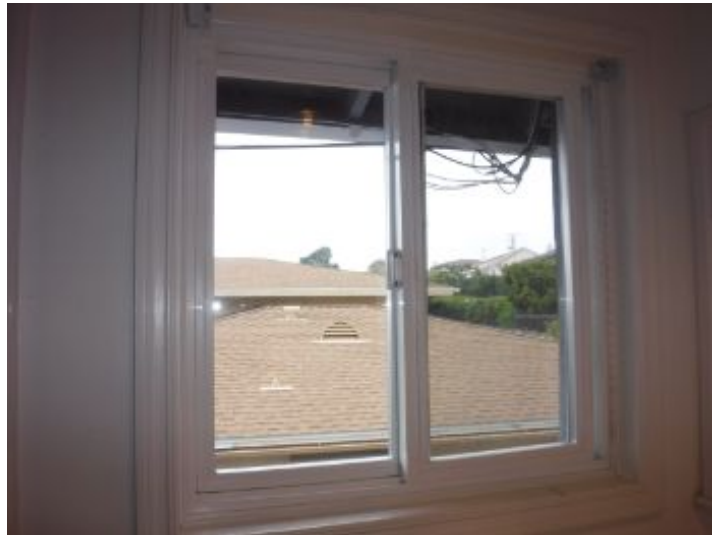
Interior Areas Window Condition

- In accordance with NACHI Standards, we do not test every window in the house, and particularly if it is furnished. We do test every unobstructed window in every bedroom to ensure that at least one provides and emergency exit.
- One or more windows appear to slide somewhat rough. New rollers/glidens and/or lubrication is recommended.
- Difficult to operate at one or more locations. Recommend review and repair as needed by qualified window contractors
- Single pane windows observed, recommend budgeting for replacement for added efficiency of home.
- **One or more windows did not lock/latch properly, recommend repairs for enhanced security/safety to occupants.**

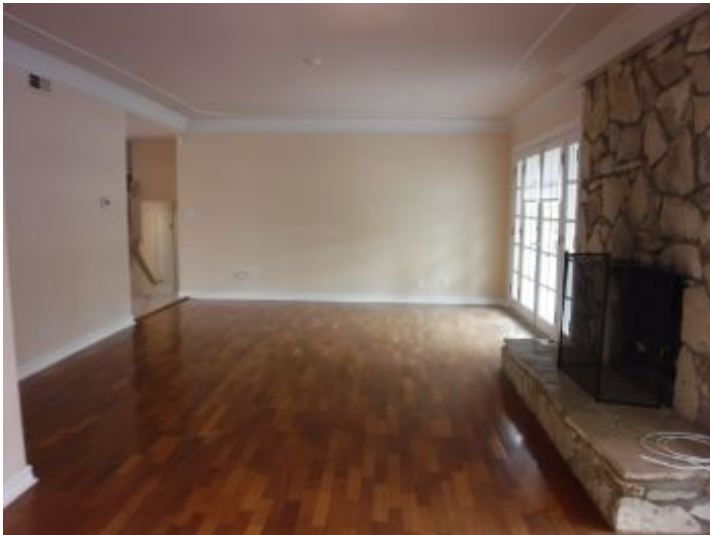
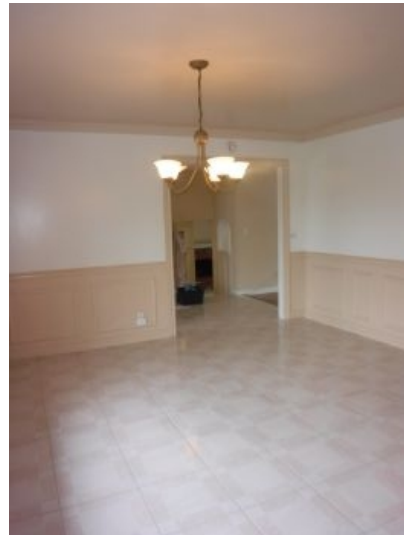
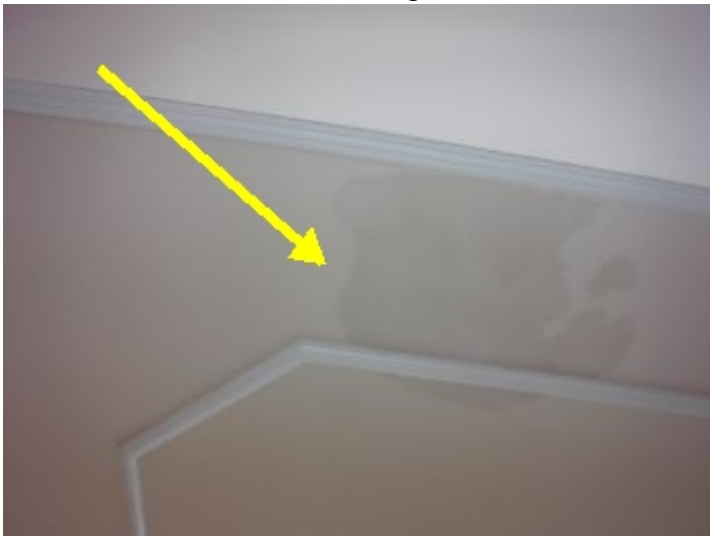
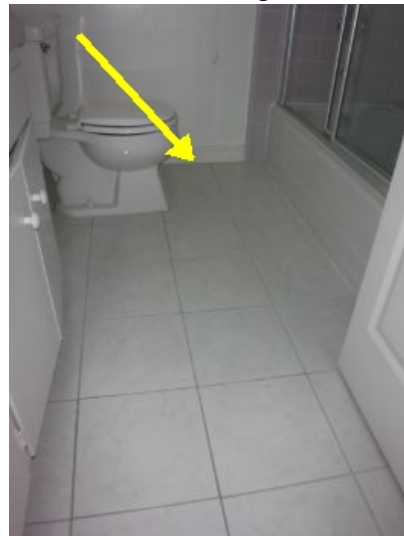
Interior Areas Walls/Ceilings/Floors Condition

- Cracks/damage was noted on the wall(s)/ceiling. We recommend correcting the condition(s) noted.
- Past repairs were noted on the wall(s)/ceiling. We recommend inquiring about the condition(s) noted.

- The floor squeaked when walked on. We recommend correcting the condition(s) noted.
- Upstairs Hallway Bathroom- The floor tiles sounded hollow when walked or tapped on as if they are not bonded to the floor. We recommend further evaluation and corrections by a specialist in the appropriate trade.

- Moisture oder noted inside living room closet. There was evidence of what appeared to be mold/mildew present. We recommend further evaluation and corrections by a specialist in the appropriate trade.

- Indications of past or present water leaks, seeps, or condensation at living room ceiling.
- Upstairs Hallway Bathroom- Uneven in areas, causing finished floor covering to have high and low spots. Further review and repairs are recommended to be performed by Qualified Contractor.

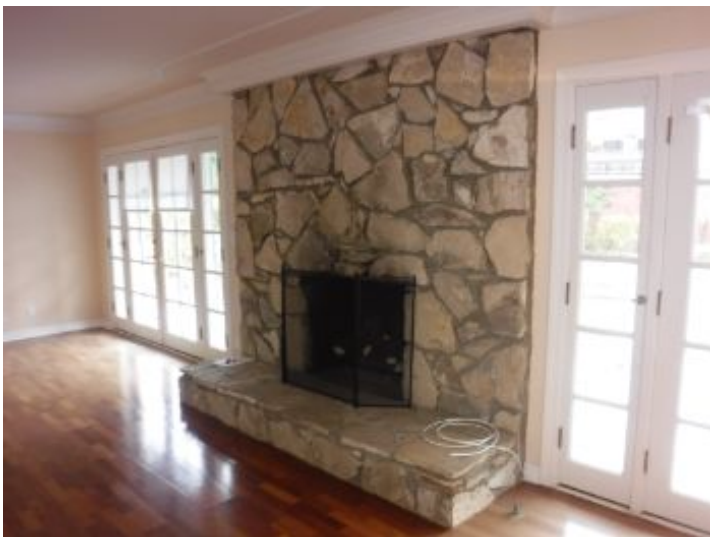
Interior Areas Fireplace

- Have chimneys swept by professional.
- There were smoke stains on the face of the fireplace, indicating poor draft or improper care in lighting fires. We recommend actual testing or evaluation by a qualified specialist in this regard.

- An aluminum or brass flexible gas connector has been used, these are no longer approved as the possibility for cracking existed. As an upgrade an approved stainless steel flex line could be installed.

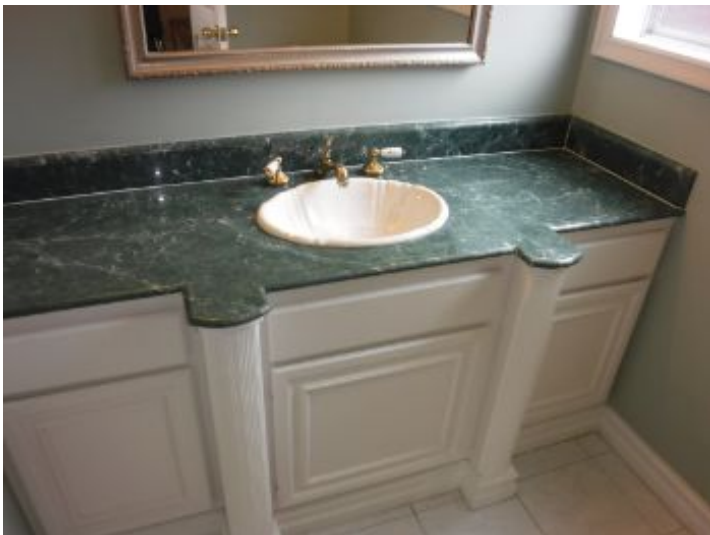
Bathroom Cabinets

- Older cabinetry in typical condition for the age. Anticipate repair / replacement needs.

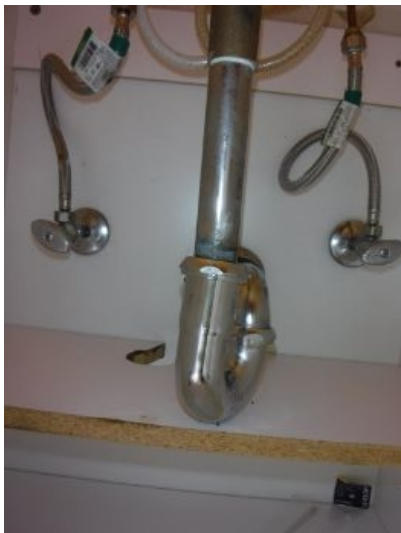
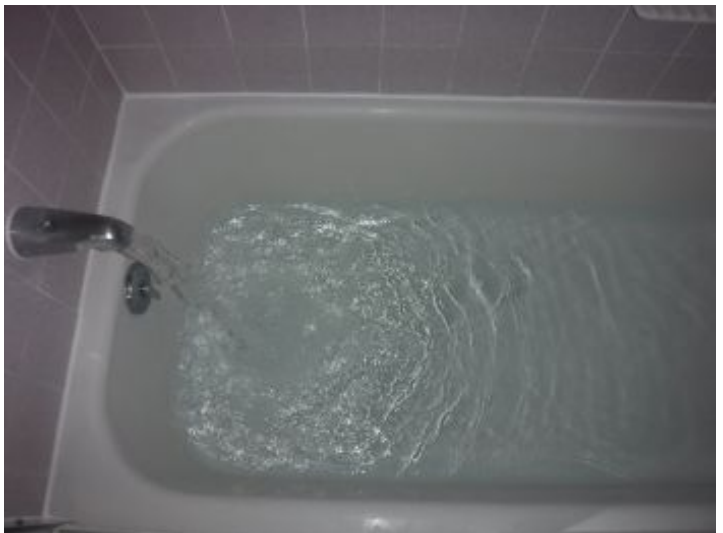
Bathroom Plumbing

- **Both Bathrooms Upstairs- Visible leaking noted under the sink/tub. We recommend contacting a licensed plumbing contractor for repair options.**

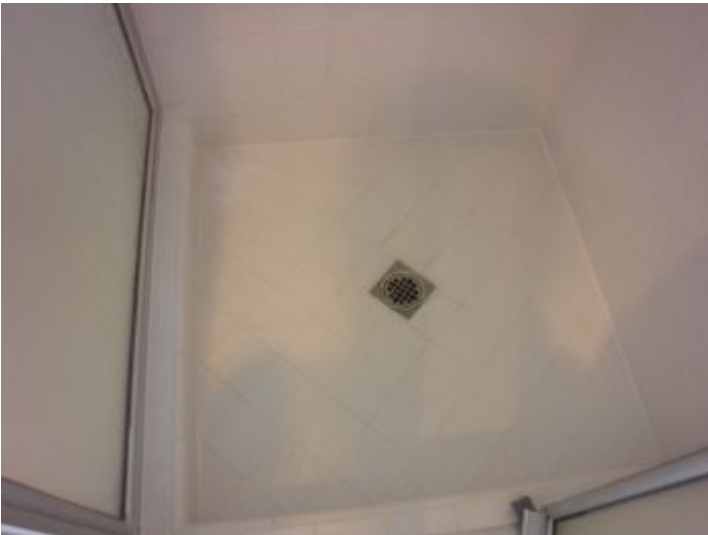
Bathroom Showers

- Shower pans are visually checked for leakage, but leaks often do not show except when the shower is in actual use. Determining whether shower pans, tub/shower surrounds are water tight is beyond the scope of this inspection. It is very important to maintain all grouting and caulking in the bath areas. Very minor imperfections can allow water to get into the wall or floor areas and cause damage. Proper ongoing maintenance will be required in the future.
- Caulk and seal all gaps, cracks and openings.
- Older shower fixtures. Anticipate repair / replacement needs due to age.
- Defective shower diverter at the tub spout. Recommend plumbing repair with replacement of the spout.

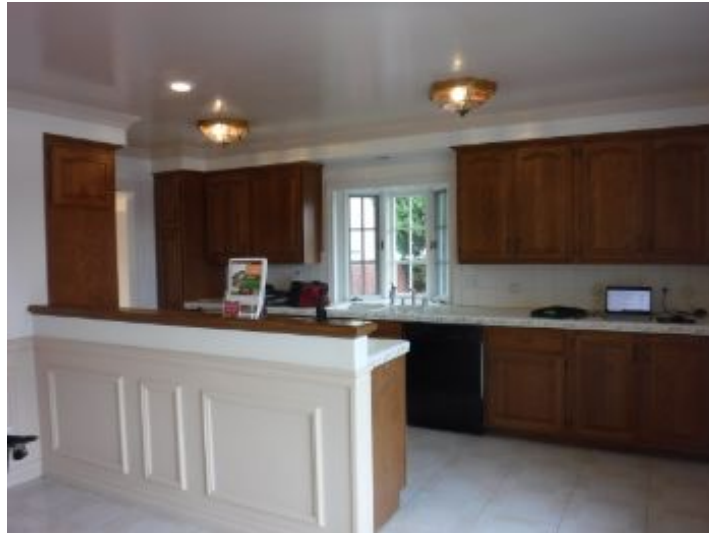
Kitchen Cabinets

- Built-in appliances are visually inspected and operated briefly, by using their normal controls to determine whether or not the appliance is functional. Appliances are not moved and testing of timers, clocks, thermostats, cooking functions, self cleaning functions or other controls is not performed. Inspection of non-built-in appliances is outside the scope of the inspection including portable dishwashers. No opinion is offered as to the actual adequacy, accuracy or effectiveness of appliance operation. The oven temperature is not verified or tested for accuracy. Refrigerators, ice makers, the water line to the refrigerator and water purifiers are not inspected. Washers and dryers are considered personal property and they and their connections are not tested or moved as part of this inspection.
- Older cabinetry in typical condition for the age. Anticipate repair / replacement needs.

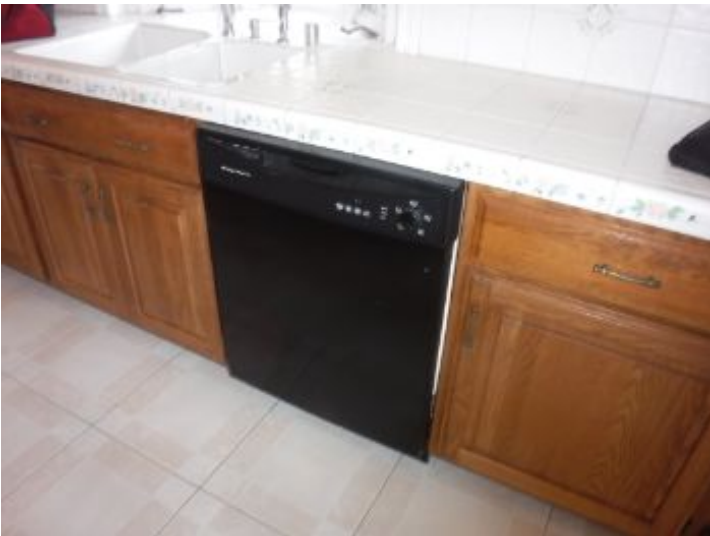
Kitchen Dishwasher

• Needs Attention, the dishwasher makes unusual noise when in use. This is not standard and it needs to be serviced and any repairs made to ensure that it is operating properly.

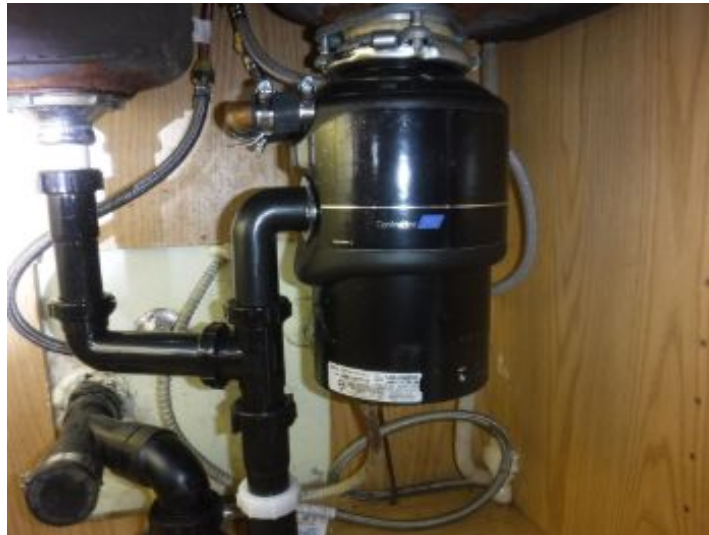
Kitchen Garbage Disposal

• Operated - appeared functional at time of inspection.

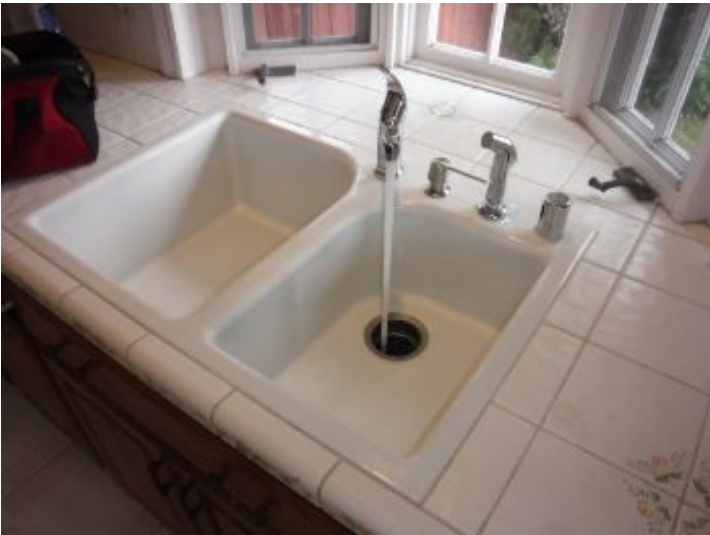
Kitchen Sinks

- Older faucet fixture. Anticipate repair / replacement needs due to age.
- Sink rusted. Monitor for developing leaks (none found during inspection).

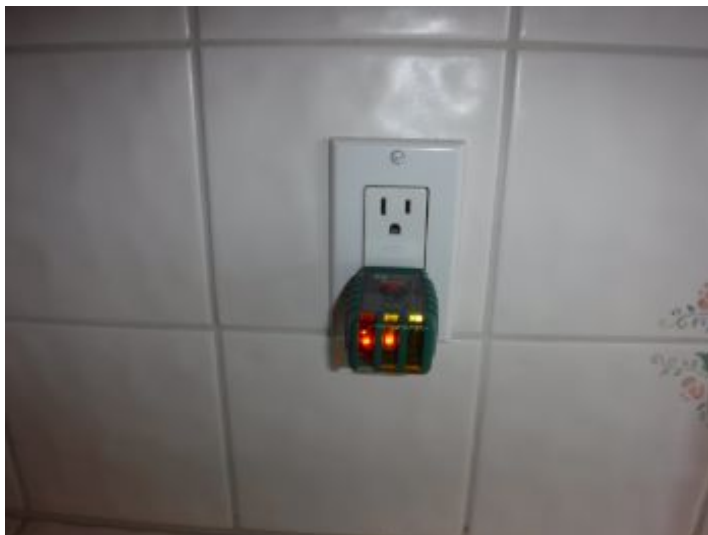
Kitchen Electrical

- Open ground (or 2-wire) outlets present. This means that the 3rd (round) part of an appliance plug is not getting ground protection. This may be a concern with items such as computers and electronic devices.
- Hot-neutral reversed outlets present. This means that the black and white wires in the circuit have been reversed, and may be a concern with items such as computers and electronic devices.

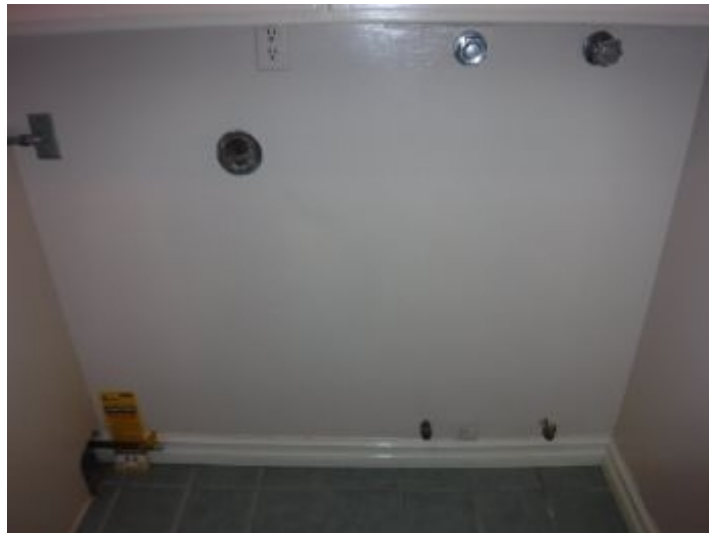
Laundry Plumbing

- Indications of past or present water leaks, seeps, or condensation at garage wall. further evaluation is needed for repair/replacement.

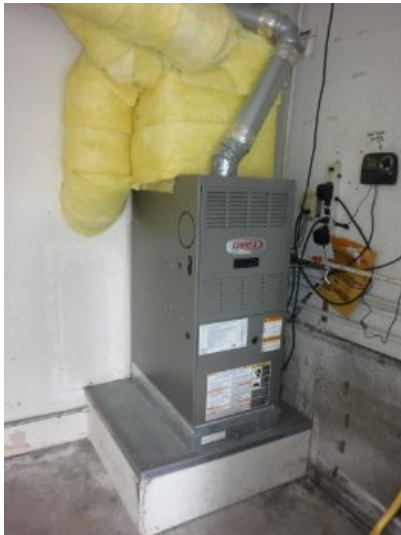
Heat/AC Heater/Ductwork Condition

- Fuel Furnace: Last service date is over one year ago, or is unable to be determined. Although this unit appears to be operating properly from controls, there are areas which cannot be seen without specialized equipment and training. One such area is the combustion chamber / heat exchanger where cold air blows across the "fire box", becoming the hot air that circulates throughout your home. During the life span of any furnace, this metal wall may develop a crack or a broken weld, allowing carbon monoxide to circulate throughout the home. This is why furnace specialists recommend a complete inspection annually; consider having unit inspected by certified HVAC technician.

- There are abandoned ductwork in the building. During a general inspection it is not fully possible to tell which ones are still in use, and which ones are disconnected from the system. Recommend removing all older ductwork as needed.

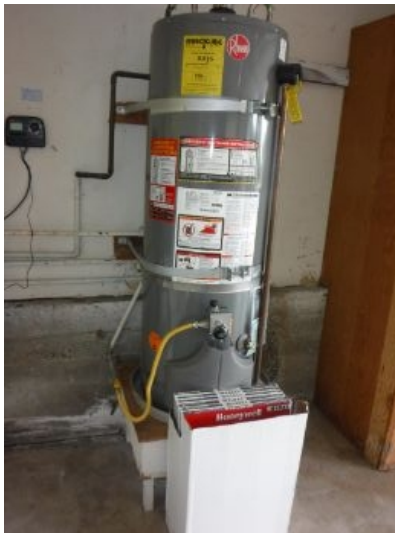
Water Heater Water Heater Condition

- Tank appears to be in satisfactory condition -- no concerns. Year 2013

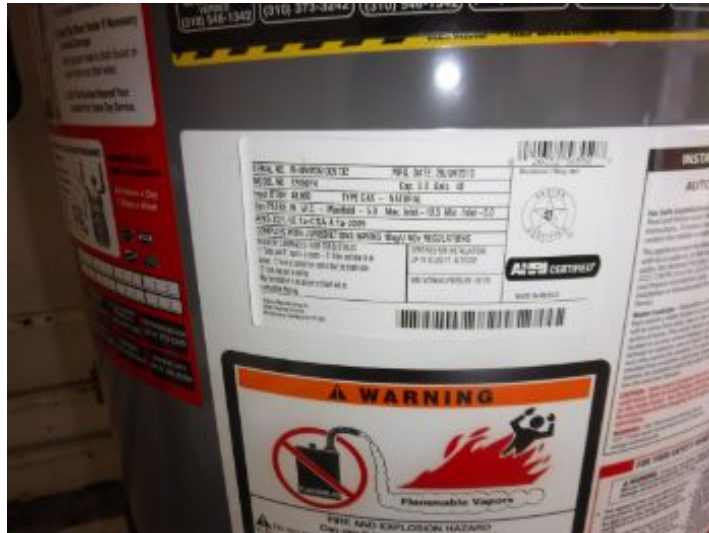
Water Heater Number Of Gallons

Observations:  
 • 48 gallons

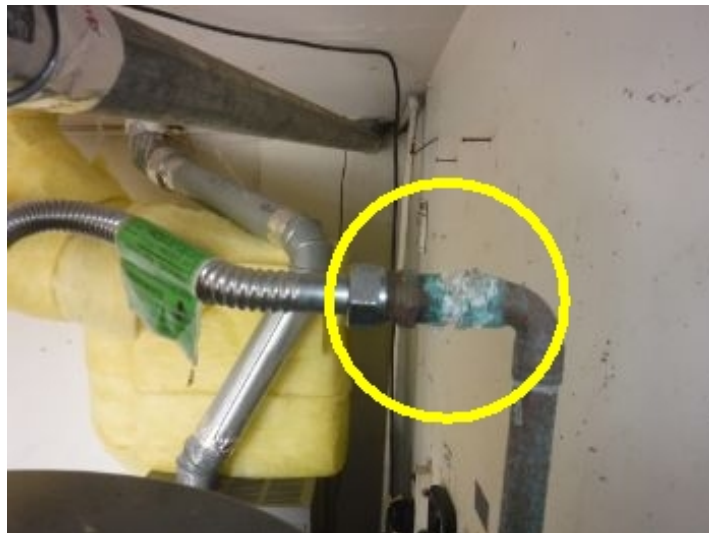
Water Heater Plumbing

• Significant corrosion was found in some water supply pipes or fittings. Leaks can occur as a result. Recommend that a qualified plumber evaluate and replace components as necessary.

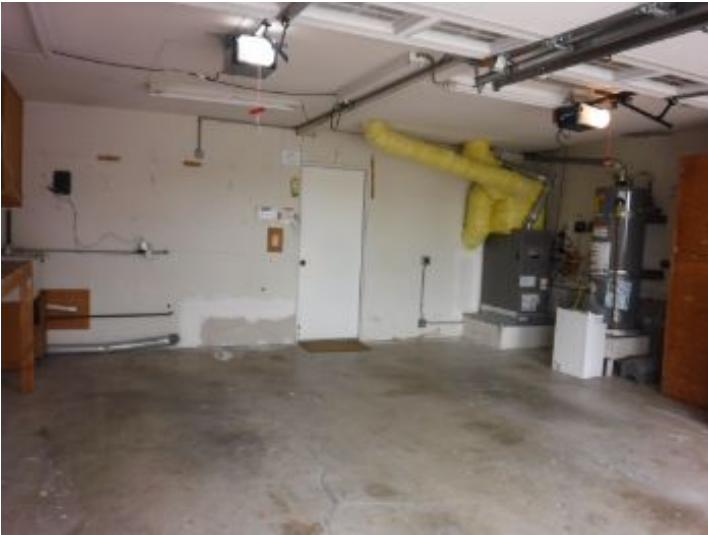
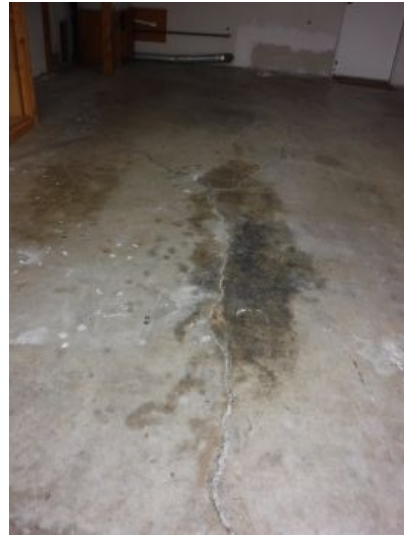
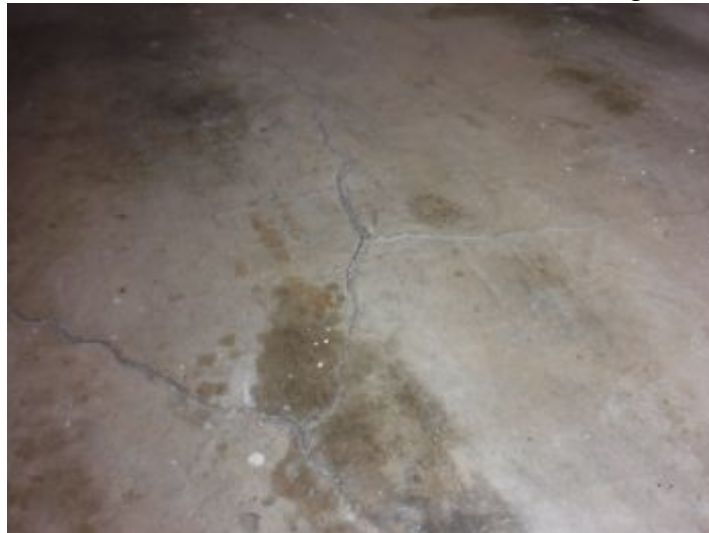
Garage Floor Condition

- The slab floor is cracked. Does not seem to be a major defect. Such cracks are common and result as a consequence of the curing process or ordinary settling.

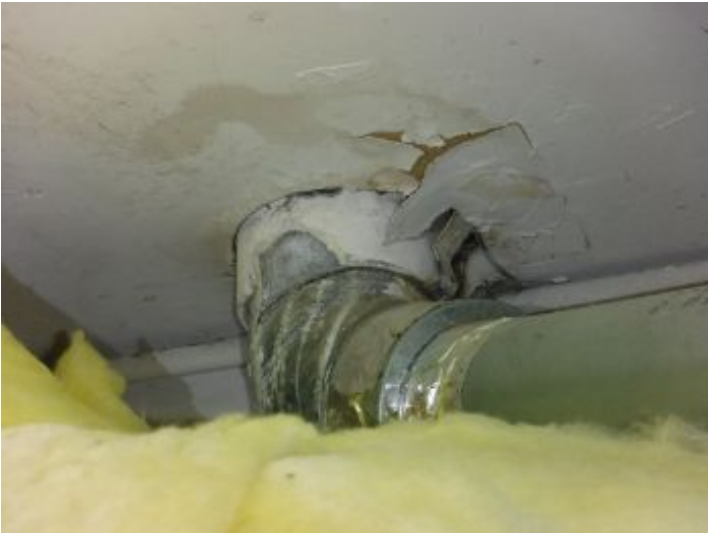
Garage Rafters & Ceiling

- Needs Attention: There are stored items in the garage that limit the ability to do a full visual inspection.
- Cracks/damage was noted on the wall(s)/ceiling. We recommend correcting the condition(s) noted.
- The paint is weathered, cracked and deteriorated in areas. We advise repainting to protect the wood. Any damaged areas should be corrected.
- Past repairs were noted on the wall(s)/ceiling. We recommend inquiring about the condition(s) noted.
- **Indications of present water leaks, seeps, or condensation at garage ceiling from upstairs hallway bathroom. We recommend correcting the condition(s) noted.**

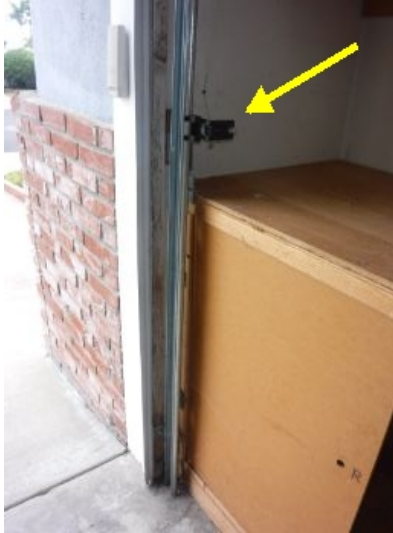
Garage Electrical

- The receptacles in the garage should be upgraded to have GFCI or ground-fault protection, which is required by current standards and is an important safety feature.

- The electronic safety sensors on each side of the garage door exceed the minimum 6 inch height. Objects in the doors closing path may not trip the sensors. We suggest for safety you lower them to the manufactures recommended height.

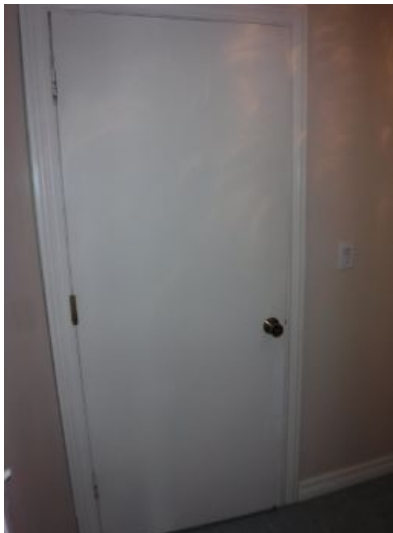
Garage Fire Door

- Appeared functional, at time of inspection.

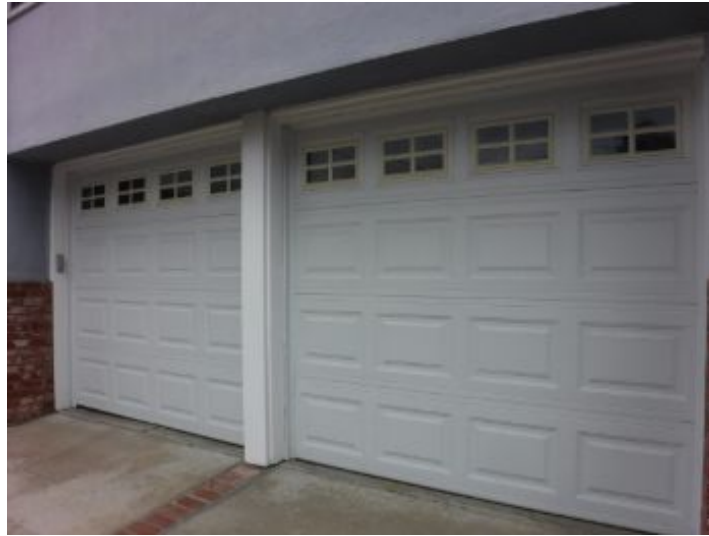
Garage Garage Door Condition

- Garage doors, starting in 1992, were required to have an electronic beam installed across the garage door opening to automatically reverse the garage door if there was a blockage of the beam. This prevents the door from closing and damaging people or objects that may be in the garage door opening when the door is operated. Prior to the above date, some garage doors had an automatic reverse feature that operated on pressure. If while descending, the door met resistant, it would automatically reverse and not continue to close. The pressure feature of the garage door will not be checked by the inspector as it may damage the garage door to stop it during its operation. It is advised to have all garage doors upgraded with an electronic beam to ensure the safe operation of the door.

Page 34 Item: 4	Electrical	<ul style="list-style-type: none"> <li>The electronic safety sensors on each side of the garage door exceed the minimum 6 inch height. Objects in the doors closing path may not trip the sensors. We suggest for safety you lower them to the manufactures recommended height.</li> </ul>
Roof		
Page 39 Item: 1	Roof Condition	<ul style="list-style-type: none"> <li>There are a few cracked/chipped tiles Correction and further evaluation by a professional roofer is recommended.</li> </ul>
Attic		
Page 43 Item: 1	Structure	<ul style="list-style-type: none"> <li>Evidence of past or present leaks, dry at time of the inspection. Monitor for leaks &amp;/or have roofing contractor evaluate.</li> </ul>
Page 44 Item: 4	Electrical	<ul style="list-style-type: none"> <li>Older deteriorated wiring noted at one or more area. Full review is needed by a licensed electrician.</li> <li>Electrical Box Covers missing or damaged, which is a potential shock or electrocution hazard.</li> </ul>

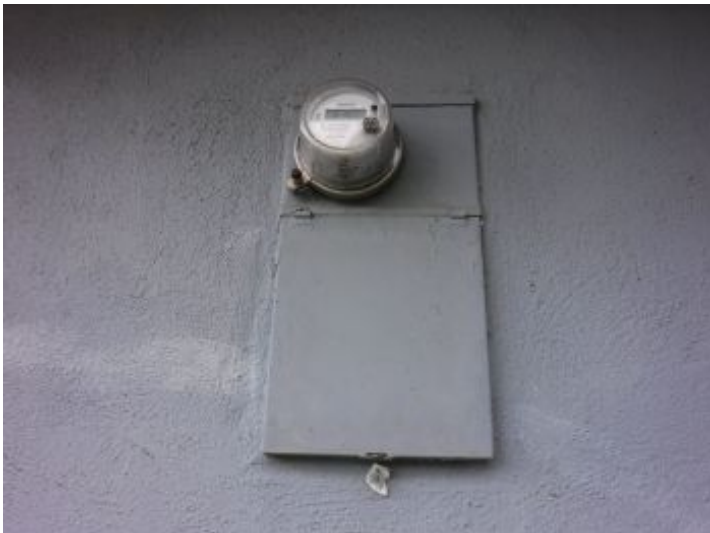
Electrical Electrical Panel

- The panel is not clearly labeled and should be in order to properly identify circuits in the event a emergency disconnect is required.
- Serviceable, the panel appears to be intact and in acceptable condition. The panel is not dismantled to evaluate the power rails or wire lug connections. This could be done by a qualified electrician if further information is desired.

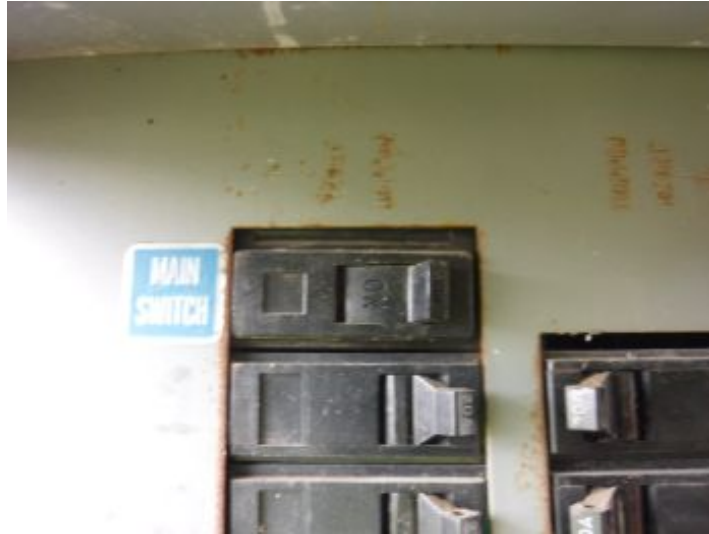
Electrical Main Amp Breaker

- Needs Attention: The amount of amperage in the main electrical panel may possibly be insufficient for a building this size. In some cases a property this size needs and has larger electrical panel. This panel was installed at a time when the amount of power consumed and the number of electrical appliances a building used were a lot less. please consult with an electrician for more information concerning this and have him determine if upgrade is necessary.
- 100 amp

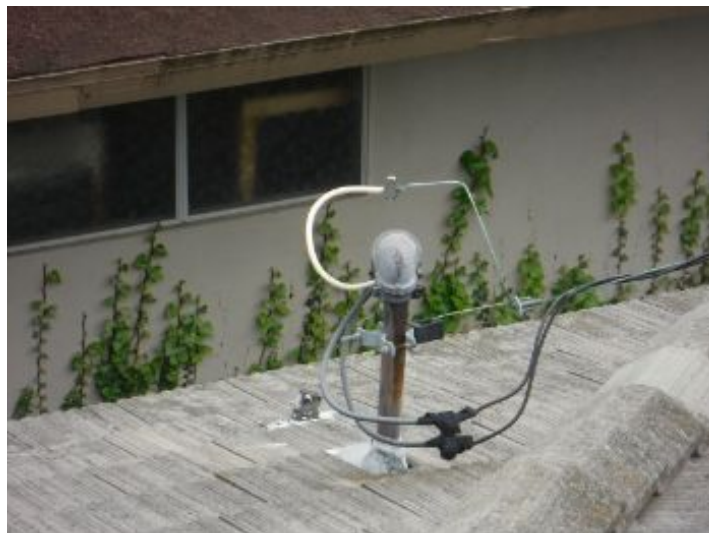
Electrical Cable Feeds

- There is an overhead service drop noted.

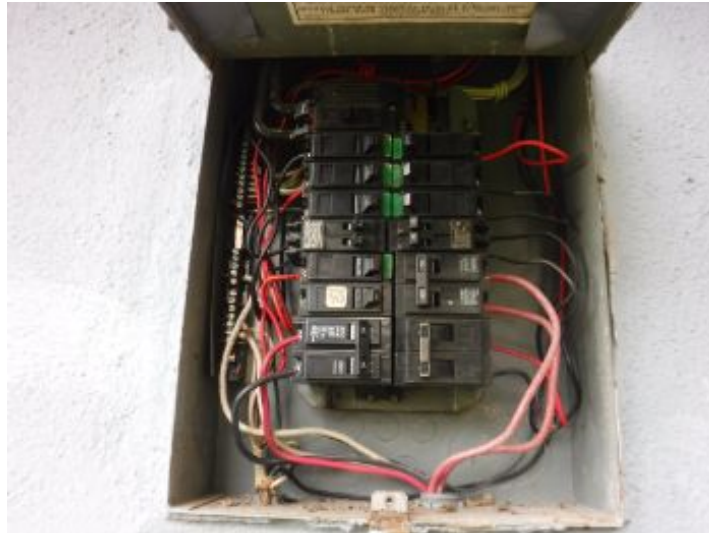
Electrical Breakers

- Panel box appears to be older than the projected effective life (25 years) of breakers. Recommend electrician evaluation of panel box and associated wiring.
- Serviceable, the breakers in the panel are in visually acceptable condition, appear intact and free of damage, however are not tested or removed from the panel to inspect contacts.

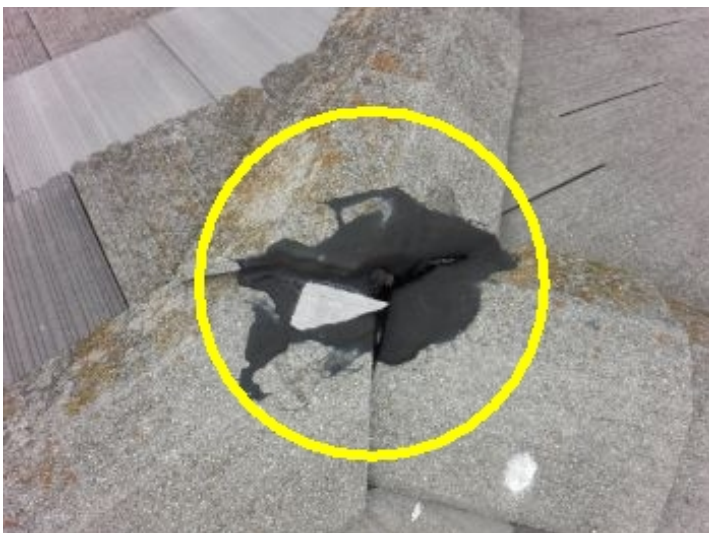
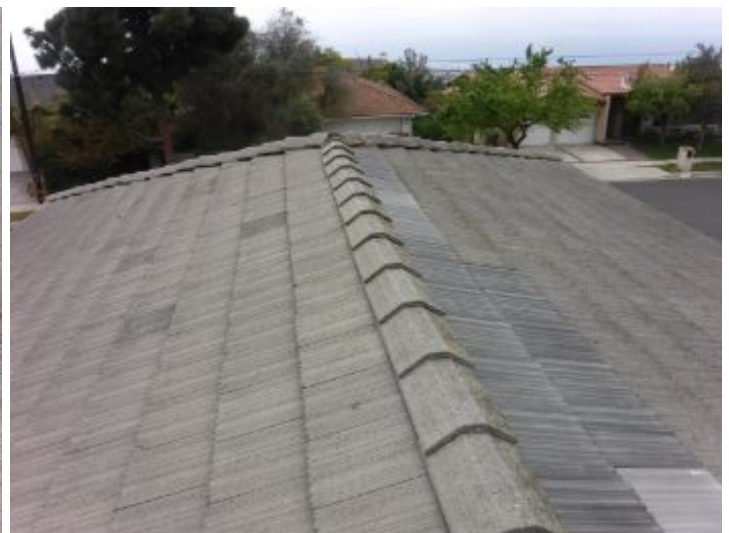
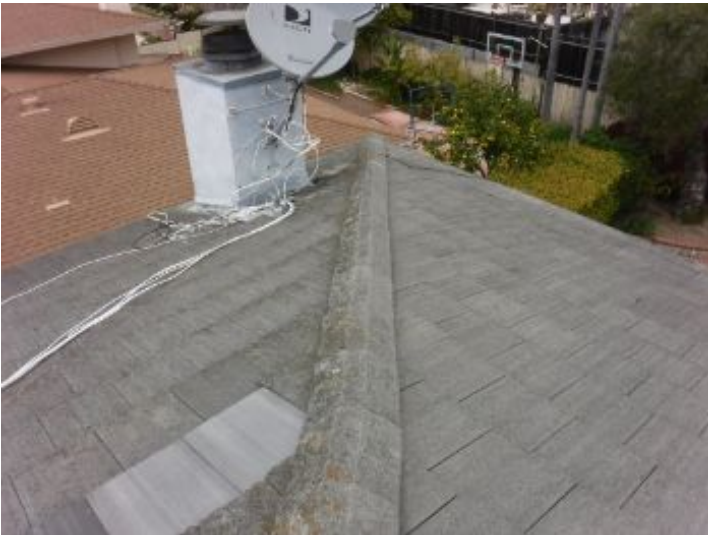
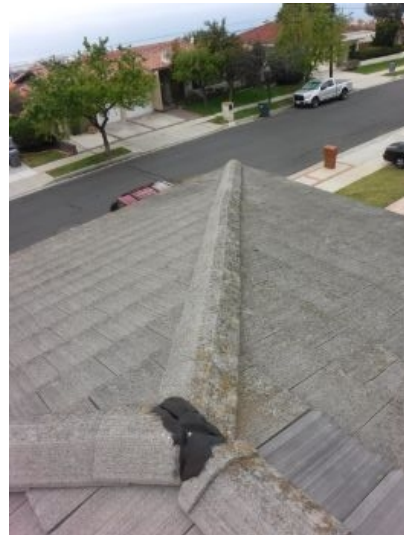
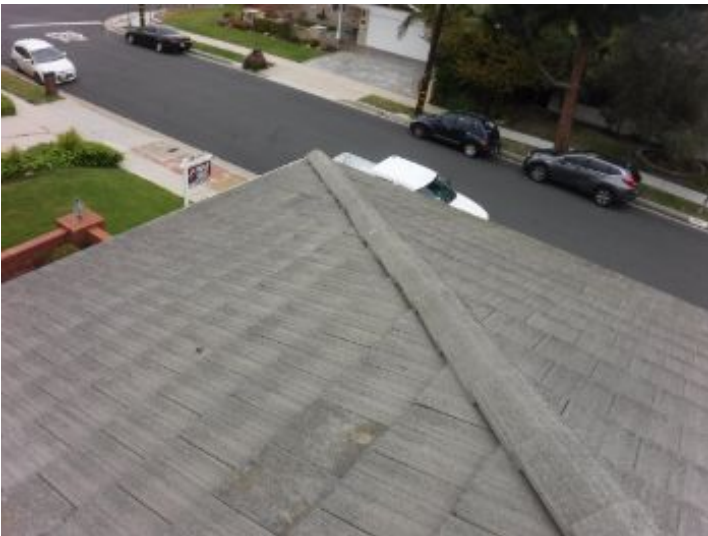
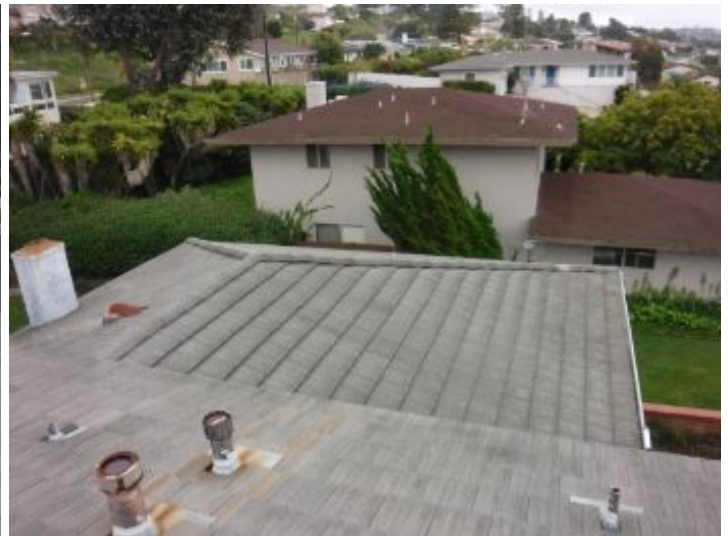
Roof Roof Condition

- The roof has many patches at one or more area but these repairs do not appear reliable.
- **There are a few cracked/chipped tiles Correction and further evaluation by a professional roofer is recommended.**

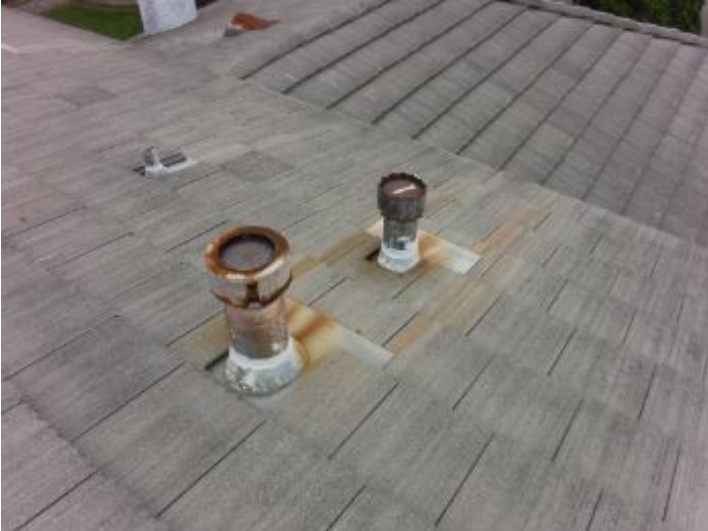
Roof Flashing

- Typical maintenance necessary, now and on an annual or semi-annual basis. This generally consists of resealing gaps at through-the-roof projections and at the parapet walls as necessary.
- One or more roof flashings were lifting, substandard, or missing. Leaks can occur as a result. This is a conducive condition for wood-destroying organisms. Recommend that a qualified person repair as necessary.

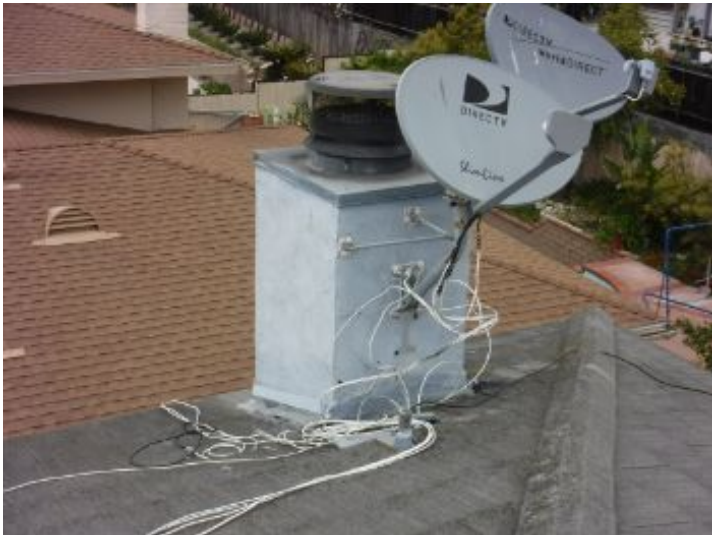
Roof Chimney

- No chimney cap visible from inspection level. Recommend installation to prevent premature weathering, water intrusion, and nesting of wildlife.

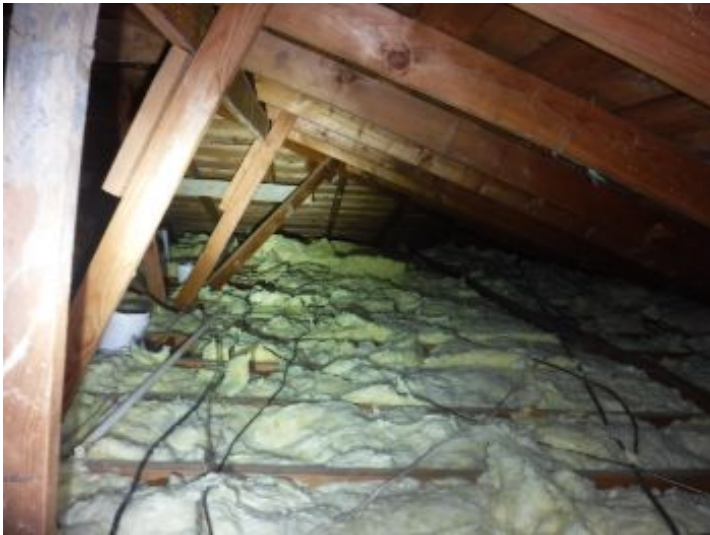
Attic Structure

- This inspection is not a structural pest control inspection, otherwise known as a termite inspection. The "termite" inspection also covers such things as dryrot and wood damage and deterioration as well as wood destroying organisms. Any and all of these items need to be examined and any repairs completed before the close of escrow by the "termite" company and they usually have a guarantee on their work. Please refer to the structural pest control report for any information concerning them.
- Evidence of past or present leaks, dry at time of the inspection. Monitor for leaks &/or have roofing contractor evaluate.

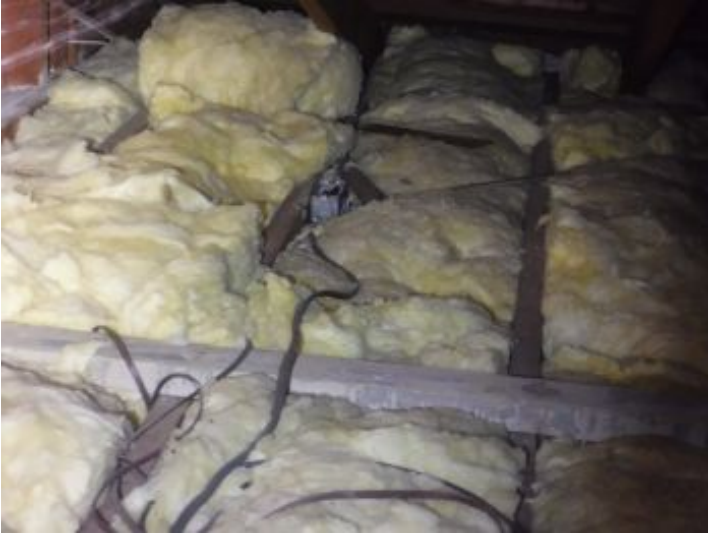
Attic Electrical

Observations:  
 • Older deteriorated wiring noted at one or more area. Full review is needed by a licensed electrician.  
 • Electrical Box Covers missing or damaged, which is a potential shock or electrocution hazard.

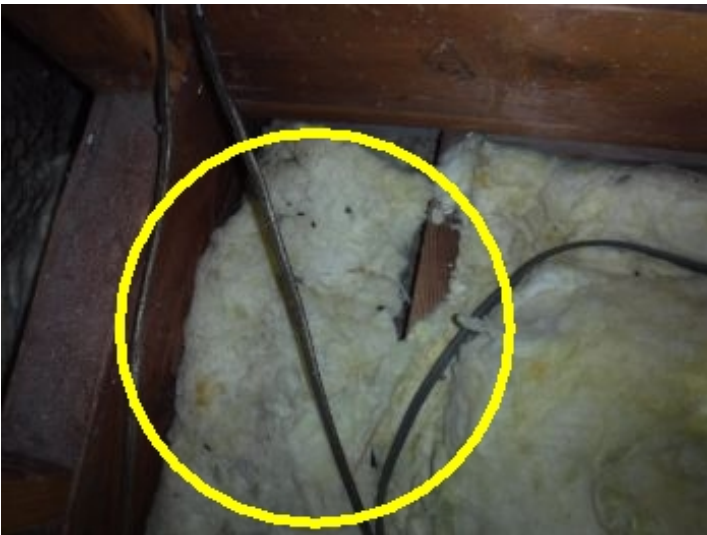
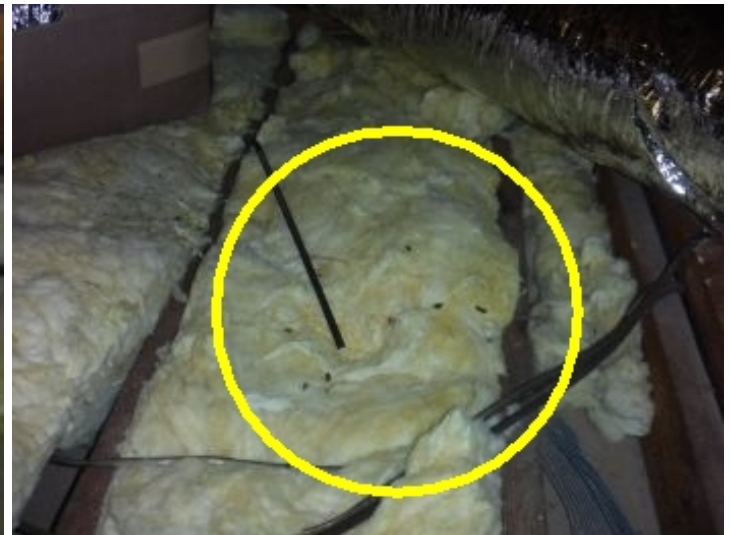
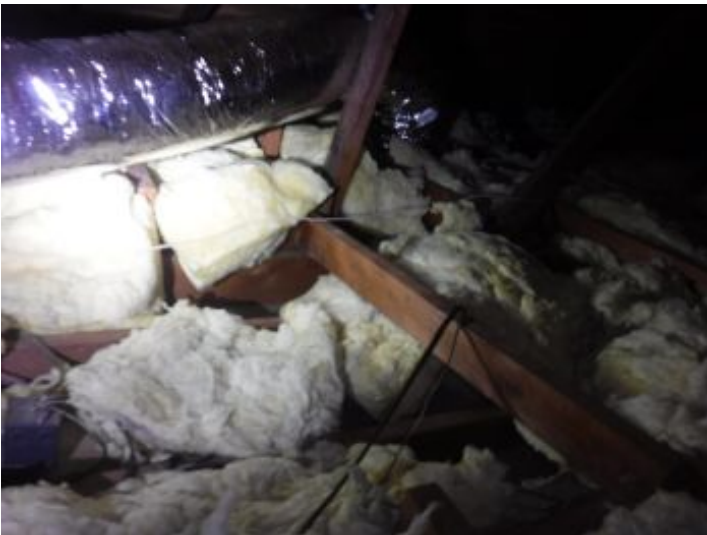
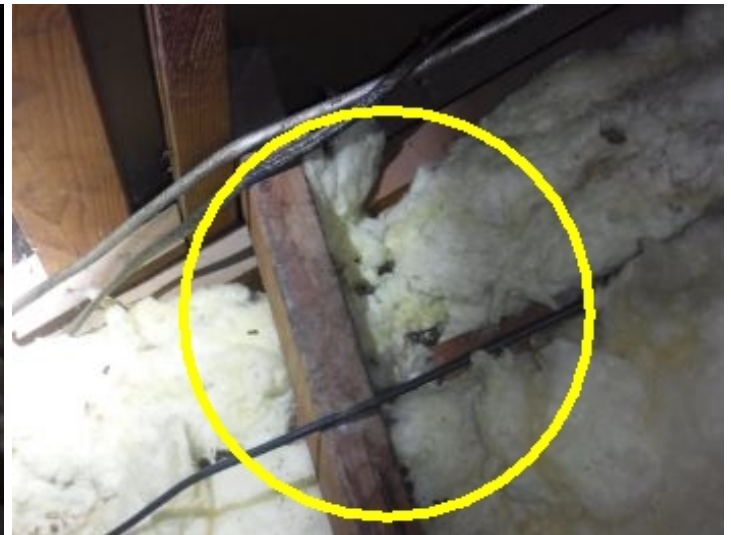
Attic Insulation Condition

- **Rodent damage or activity suspected. Recommend further evaluation by a licensed exterminator.**

Page 45 Item: 6	Insulation Condition	<ul style="list-style-type: none"> <li>Rodent damage or activity suspected. Recommend further evaluation by a licensed exterminator.</li> </ul>
Exterior Areas

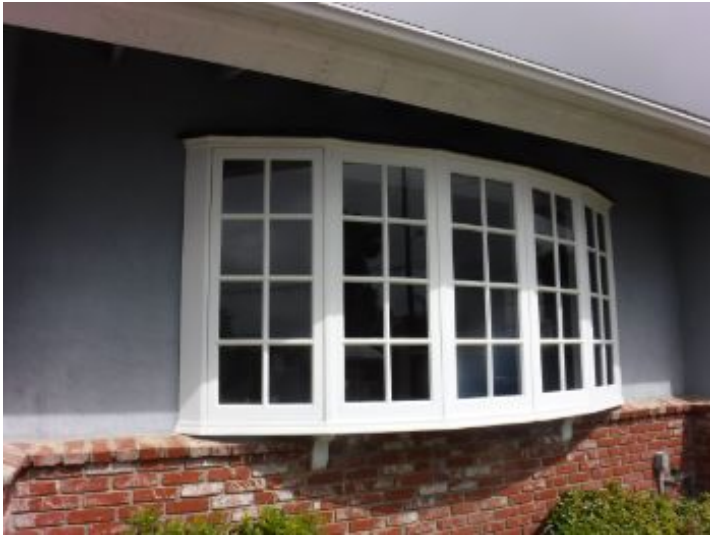
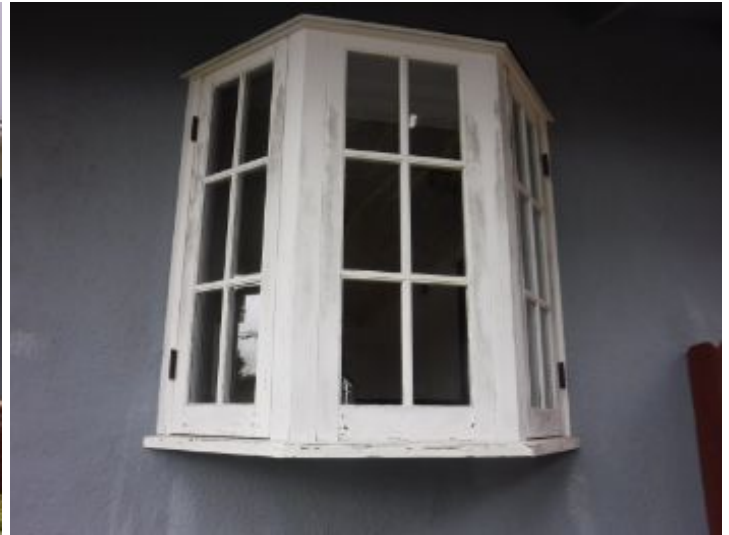
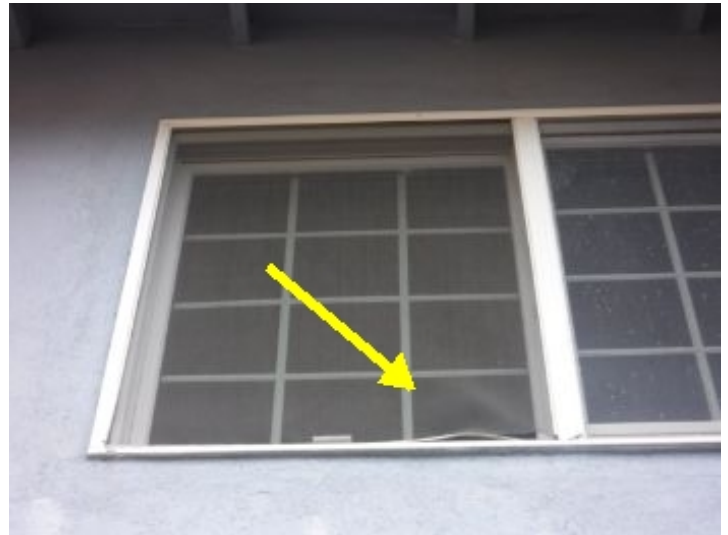
Exterior Areas Window Condition

• Most windows in this home do not meet modern standards. Upgrade would greatly enhance overall comfort and efficiency.

Page 46 Item: 2	Window Condition	<ul style="list-style-type: none"> <li>• Most windows in this home do not meet modern standards. Upgrade would greatly enhance overall comfort and efficiency.</li> </ul>
Foundations and Floors		
Page 54 Item: 5	Patio and Porch Deck	<ul style="list-style-type: none"> <li>• Deteriorated/Damaged handrail/guardrail. We recommend correcting the condition(s) noted.</li> <li>• Loose floor boards observed at one or more area.</li> </ul>
Page 56 Item: 7	Grounds Electrical	<ul style="list-style-type: none"> <li>• Open ground (or 2-wire) outlets present. This means that the 3rd (round) part of an appliance plug is not getting ground protection. This may be a concern with items such as computers and electronic devices.</li> <li>• Hot-neutral reversed outlets present. This means that the black and white wires in the circuit have been reversed, and may be a concern with items such as computers and electronic devices.</li> <li>• Front right exterior outlet not functional. Recommend licensed electrician for further evaluation.</li> </ul>

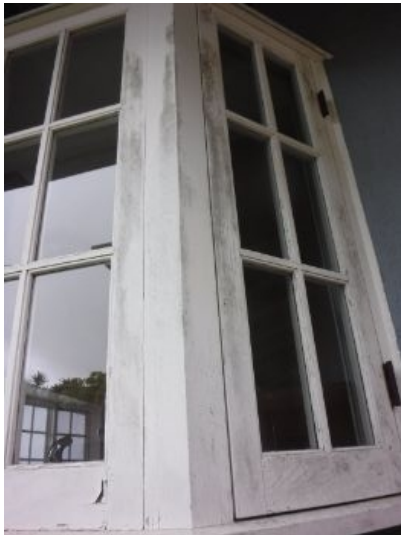
Exterior Areas Window Condition

- Some window screens missing and some damaged.
- Suggest caulking and refinishing of doors and window frames as necessary.
- Deterioration of wooden frames noted. While basic maintenance may prolong the life of these window frames, replacement may be necessary at some point.
- There was evidence of what appeared to be mold/mildew present. We recommend further evaluation and corrections by a specialist in the appropriate trade.

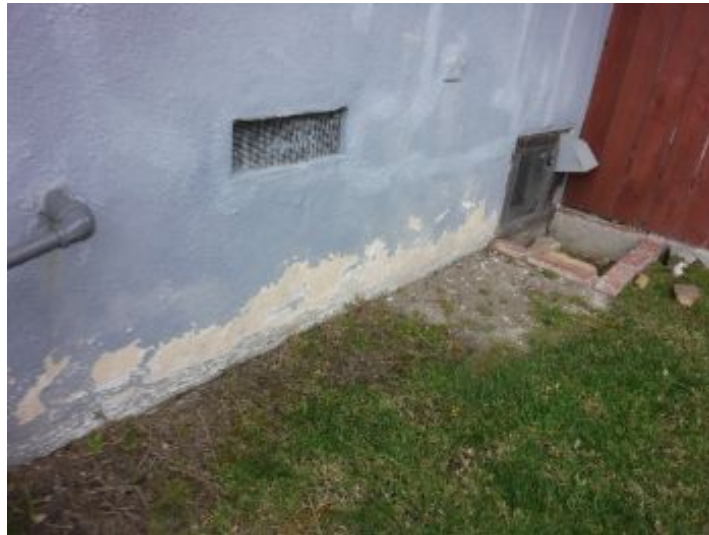
Exterior Areas Siding Condition

- The paint is weathered, cracked and deteriorated in areas. We advise repainting to protect the wood. Any damaged areas should be corrected.
- Gaps at any penetrations through the building exterior wall can promote moisture leaking and damage. We recommend that all penetrations be kept very well sealed.

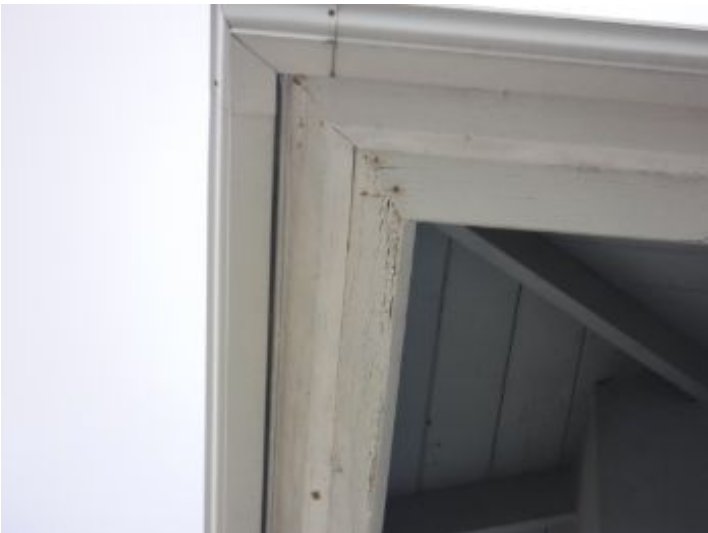
Exterior Areas Eaves & Facia

- This inspection is not a structural pest control inspection, otherwise known as a termite inspection. The "termite" inspection also covers such things as dryrot and wood damage and deterioration as well as wood destroying organisms. Any and all of these items need to be examined and any repairs completed before the close of escrow by the "termite" company and they usually have a guarantee on their work. Please refer to the structural pest control report for any information concerning them.
- Moisture damage, wood rot, observed. Recommend review for repair/replacement as necessary.
- Peeling paint observed, suggest scraping and painting as necessary.
- There was evidence of what appeared to be mold/mildew present. We recommend further evaluation and corrections by a specialist in the appropriate trade.
