# *1 Day Home Inspection*

## Property Inspection Report

28068 Braidwood Dr, Rancho Palos Verdes, CA 90275

Date of Inspection: 4/2/2019 Time: 3:00 PM

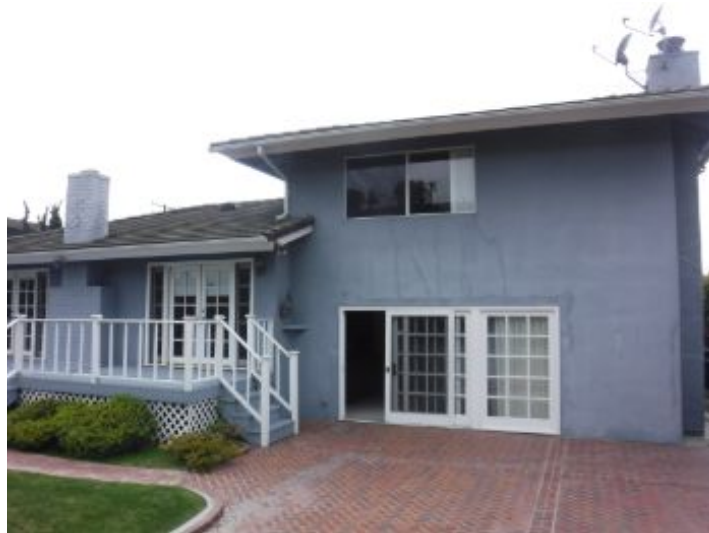
Foundation Slab Foundation

- Part of the building is on a concrete slab on earth and part of it is on a raised foundation. There were no observable signs of significant settlement or deflection in the slab portion by observing the finish flooring. It appears to be performing its function of supporting the structure however the actual slab was not seen and it may appear different once the finish flooring was removed. By the nature of the slab construction the structure would be bolted to this concrete slab per the standards at the time of construction.
- Concrete slab not visible due to floor coverings.

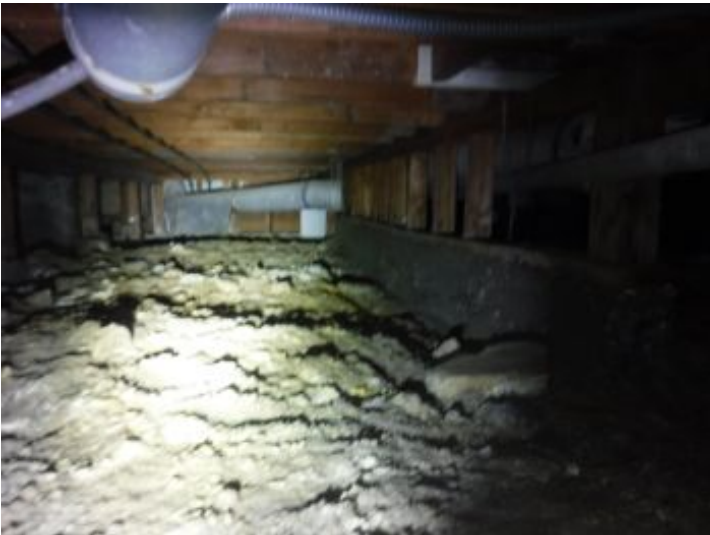
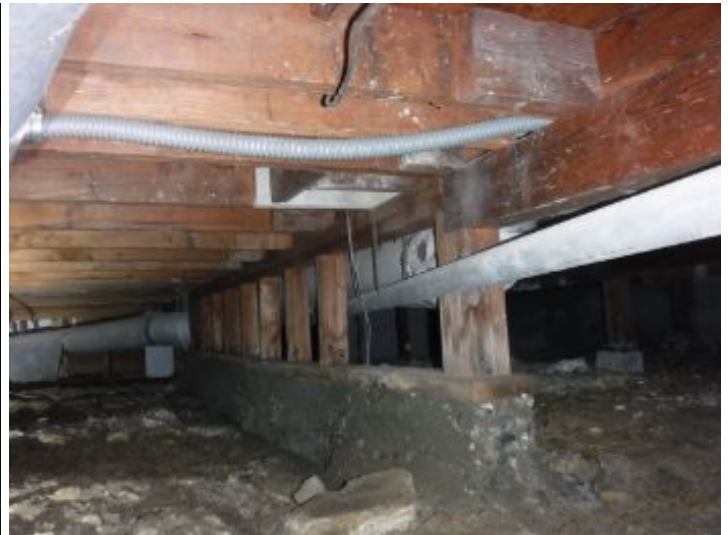
Foundation Cripple Walls

- Inspector found cripple wall appears to be damaged from either wood rot, or wood destroying pest.

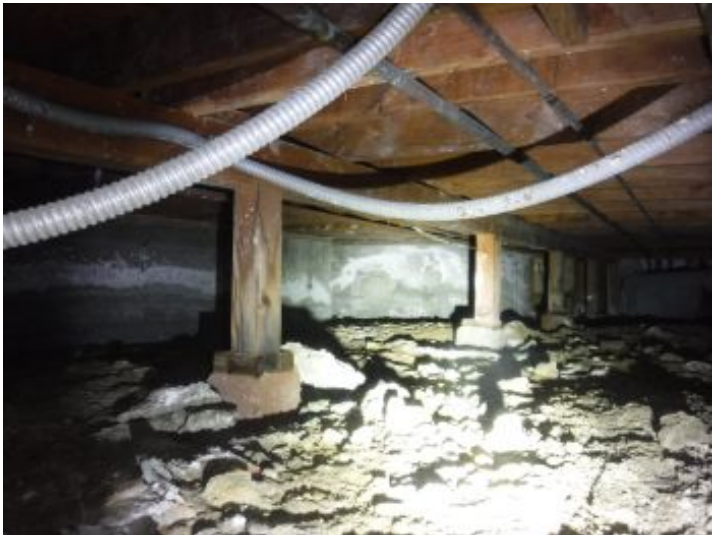
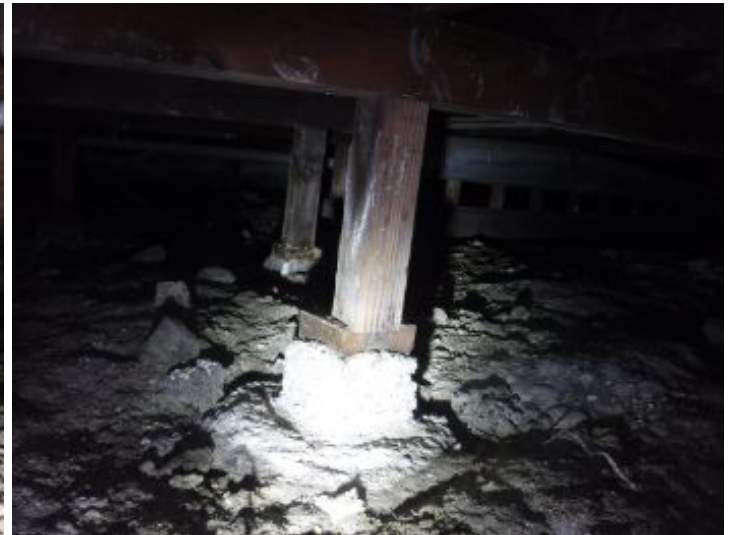
Foundation Post and Girders

Observations:  
 • Wooden support posts are not securely fastened to beam above. This is a safety hazard since they can separate during a seismic event. A qualified contractor should evaluate and make repairs as necessary, such as installing metal ties, bracing with lumber and/or plywood gussets as per standard building practices.

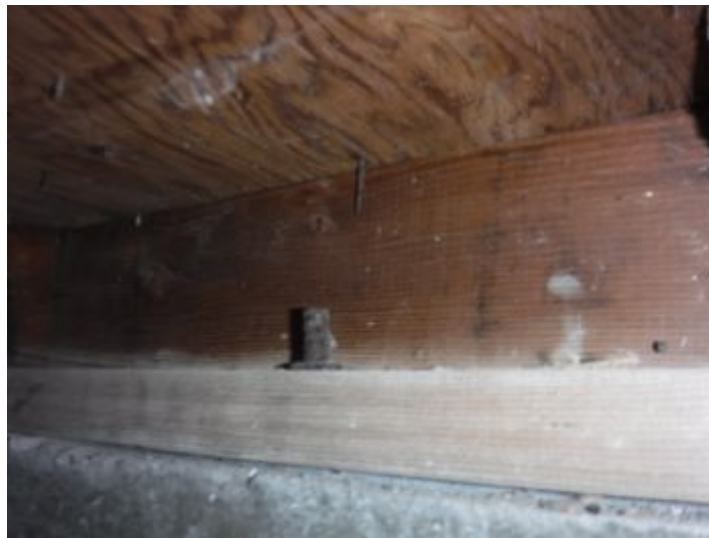
Foundation Anchor Bolts

Observations:  
• Appears serviceable

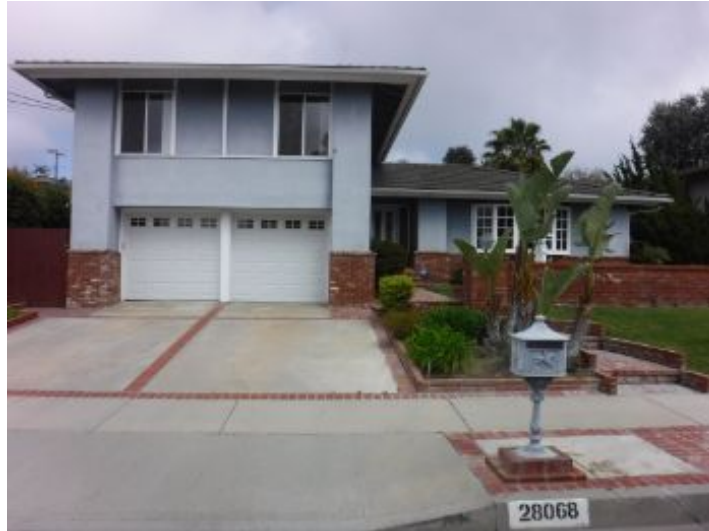
Foundations and Floors Driveway and Walkway Condition

- Driveway/Walkway in fair shape. Recommend sealing cracks to extend life.
- Minor cracks and deterioration noted.

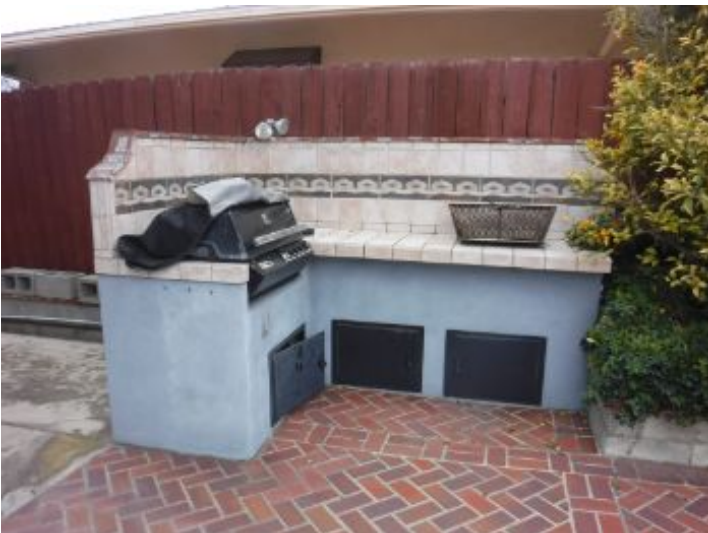
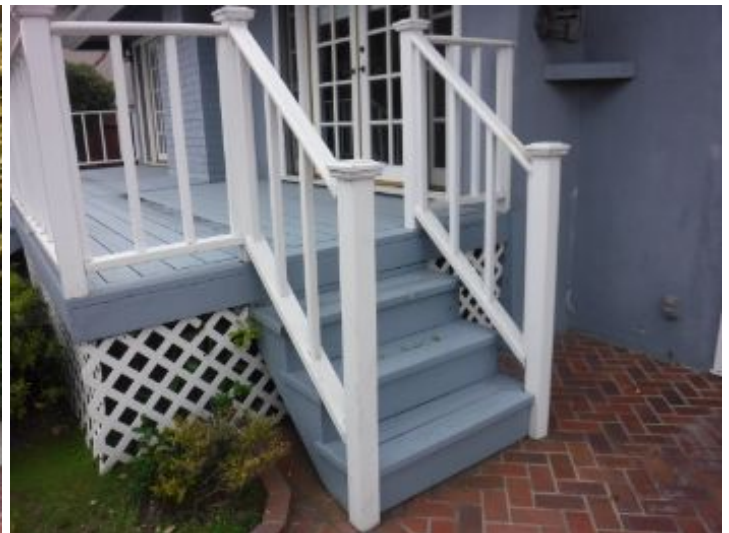
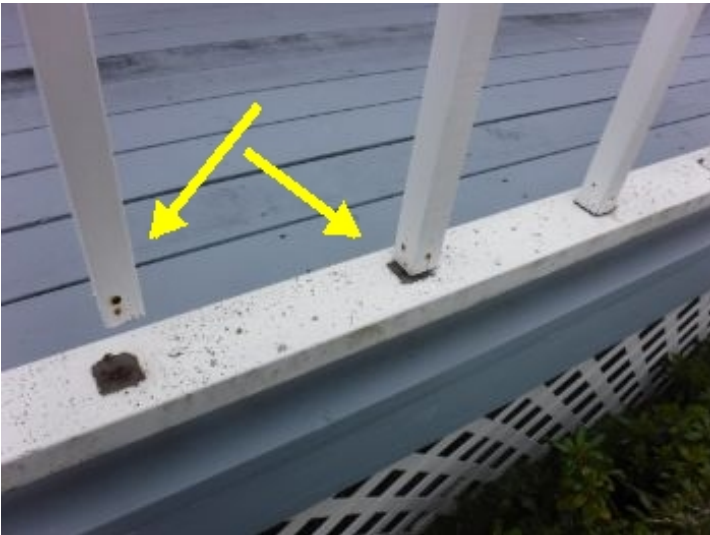
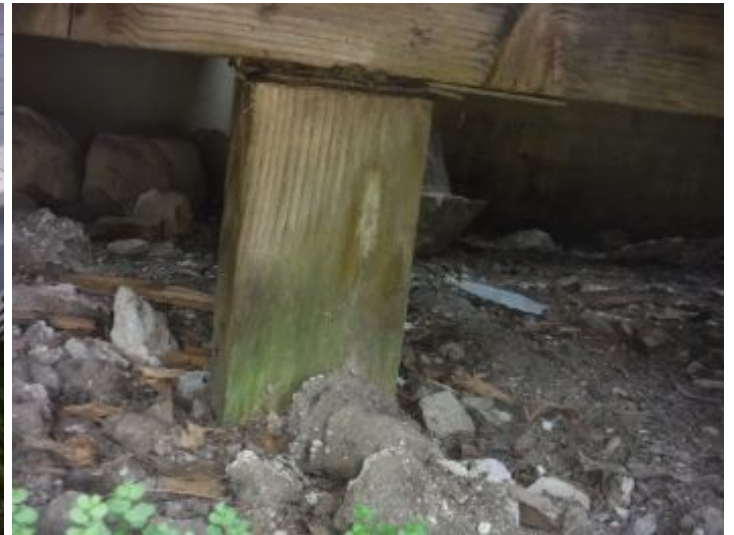
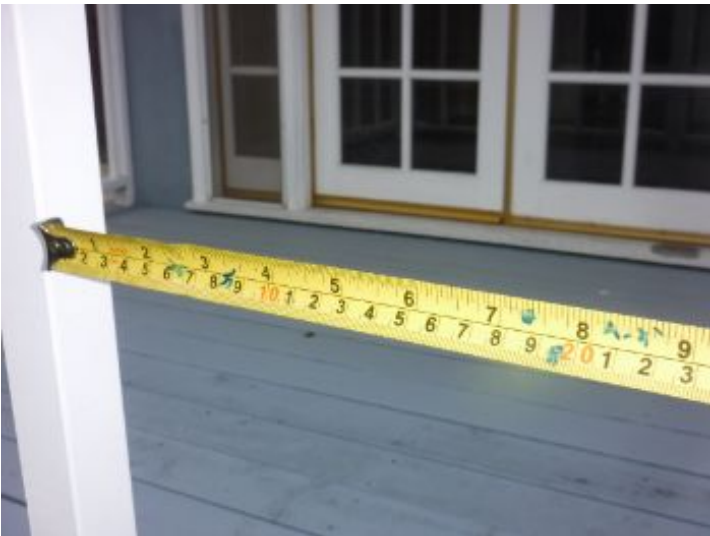
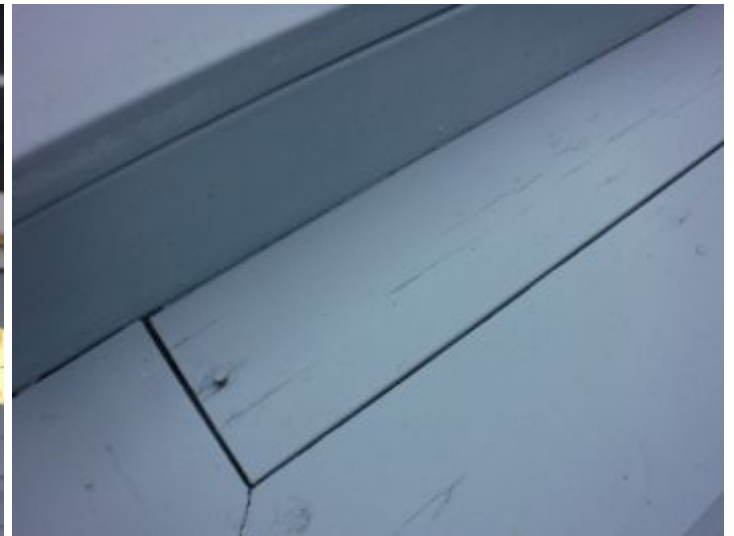
Foundations and Floors Patio and Porch Deck

- **Loose floor boards observed at one or more area.**

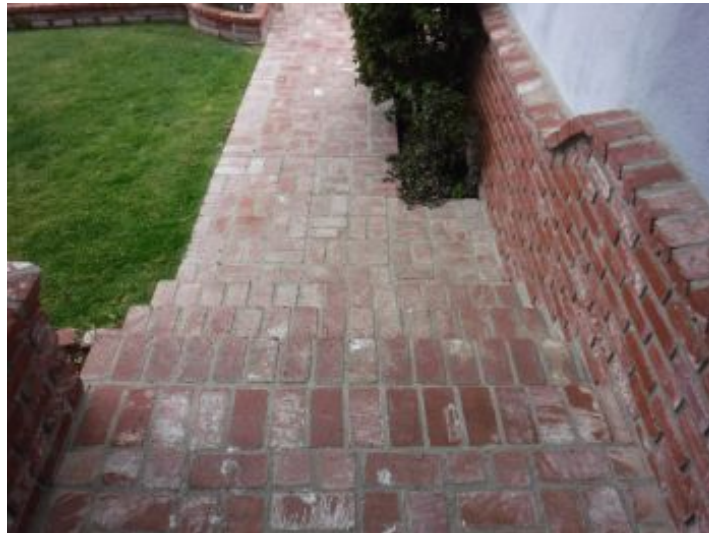
Foundations and Floors Stairs & Handrail

- There were no railings installed. This is a potential tripping hazard. Recommend installing protective railings.

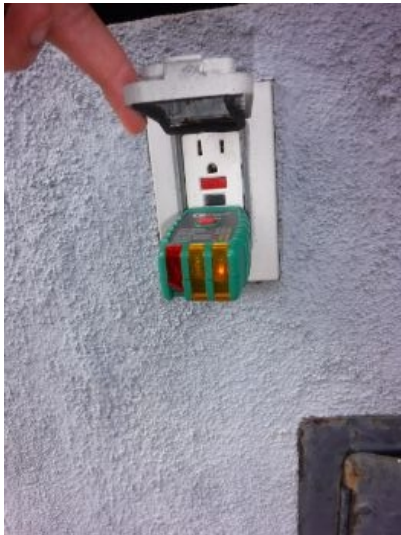
Foundations and Floors Grounds Electrical

- Hot-neutral reversed outlets present. This means that the black and white wires in the circuit have been reversed, and may be a concern with items such as computers and electronic devices.

- Front right exterior outlet not functional. Recommend licensed electrician for further evaluation.

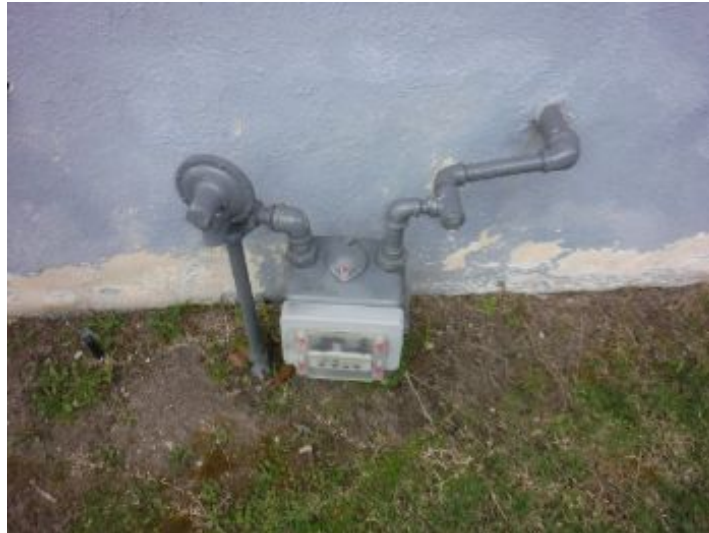
Foundations and Floors Main Gas Valve Condition

- Depending on your county it may be mandatory to install an earthquake shut off valve. Attention may be needed.
- It is advised to have the gas provider inspect the gas system to determine its condition and check all the gas appliances and fixtures. This is usually a free service.

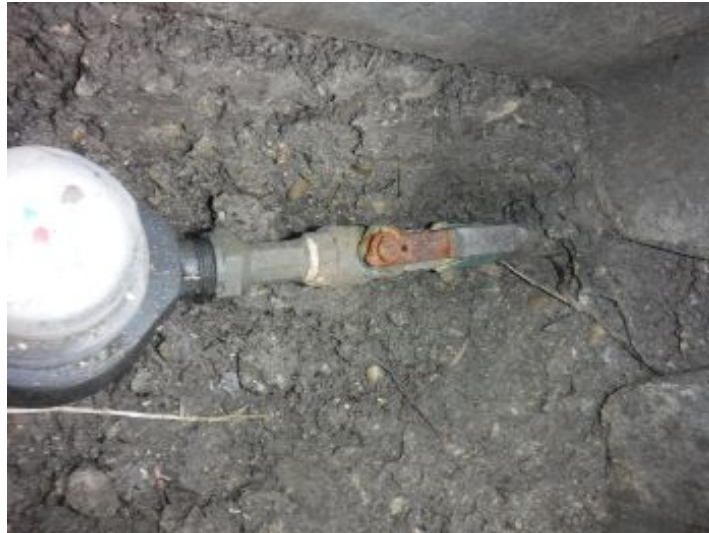
Foundations and Floors Plumbing

- It is advisable to have a licensed qualified plumber examine the entire plumbing system and make all needed repairs to ensure a properly installed and correctly operating plumbing system. This investigation of the system should be done prior to the expiration of the contingency period so the repair or replacement costs are known and unwanted expenses are avoided. It is expected that when the plumbing specialist fully examines the system he will find more problems as this is a general inspection and not designed to list every fault but refer it over when problems show up in the system.
- Galvanized pipes present and has an average service life of 30 years. Pipes rust from the inside reducing the diameter and causing loss of pressure and rust in water. Recommend budgeting for replacement of galvanized piping in the near future.

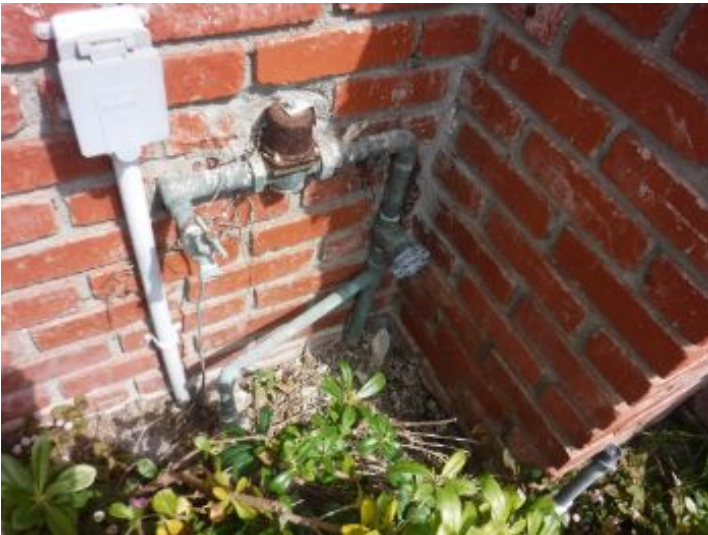
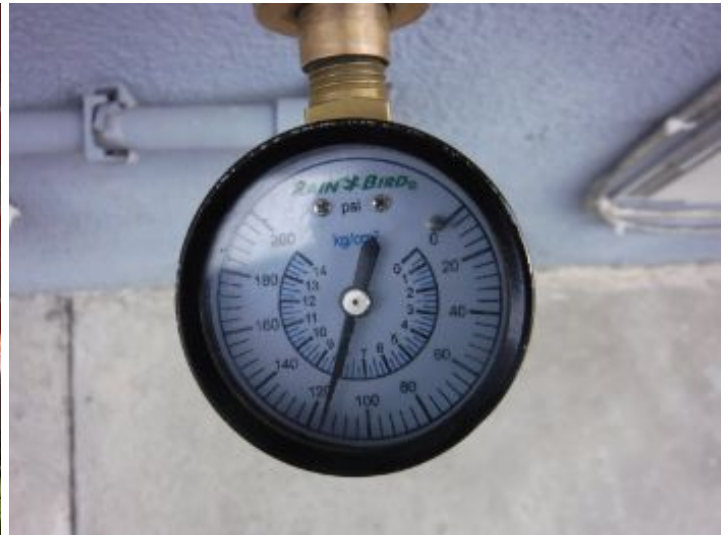
Foundations and Floors Main Water Shut Off/Water Pressure

- The water supply pressure was greater than 80 pounds per square inch (PSI). Pressures above 80 PSI may void warranties for some appliances such as water heaters or washing machines. Flexible supply lines to washing machines are likely to burst with higher pressures. 40-80 PSI is considered the normal range for water pressure in a home, and most plumbers recommend 50-60 PSI . Typically, the pressure cannot be regulated at the water meter. Recommend that a qualified plumber evaluate and make modifications to reduce the pressure to below 80 PSI . Installing a pressure reducing valve on the main service pipe is a common solution to this problem. If one exists, then it should be adjusted, repaired or replaced as necessary to maintain lower pressures. Note that installing a pressure reducing valve creates a "closed system," which may require installing an expansion tank at the water heater if one is not already installed.

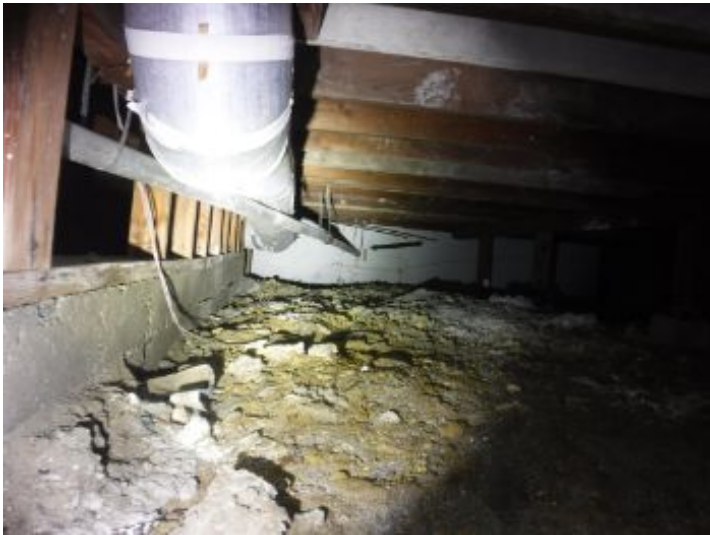
Basement/Crawlspace Walls

- Shrinkage cracking noted. This cracking is common and usually no reason for concern. Recommend monitoring and consultation with qualified contractor should condition worsen or if water intrusion occur.

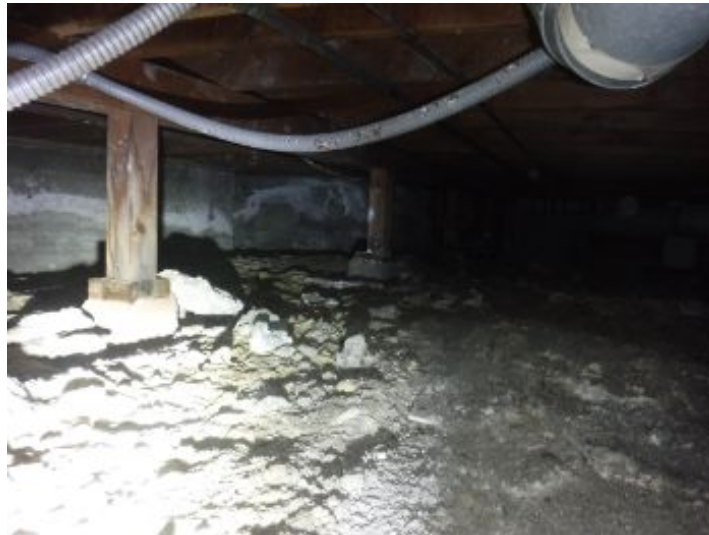
Basement/Crawlspace Drainage

- The soils in the crawlspace are moist or desiccated which could indicate a chronic drainage problem and we recommend that the drainage of the property be addressed as soon as possible.

Basement/Crawlspace		
Page 63 Item: 6	Drainage	<ul style="list-style-type: none"> <li>• The soils in the crawlspace are moist or desiccated which could indicate a chronic drainage problem and we recommend that the drainage of the property be addressed as soon as possible.</li> </ul>

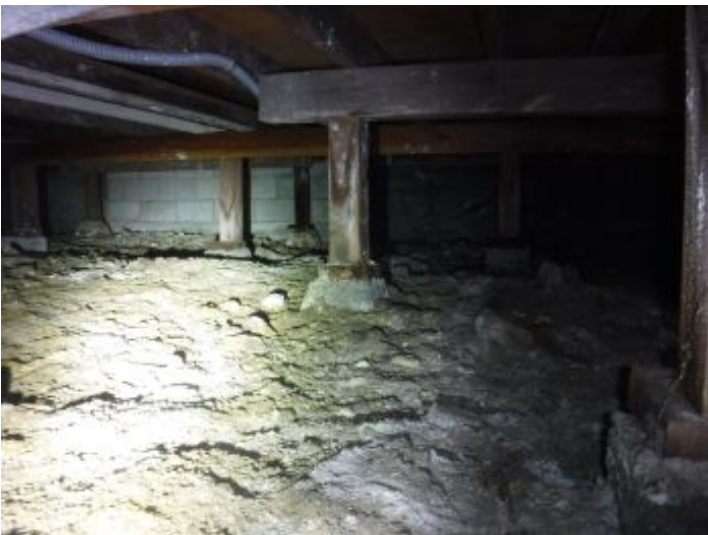
Basement/Crawlspace Framing

- This inspection is not a structural pest control inspection, otherwise known as a termite inspection. The "termite" inspection also covers such things as dryrot and wood damage and deterioration as well as wood destroying organisms. Any and all of these items need to be examined and any repairs completed before the close of escrow by the "termite" company and they usually have a guarantee on their work. Please refer to the structural pest control report for any information concerning them.
- Needs Attention: There are some stained and deteriorated areas of floor framing, such as under the kitchen/bathrooms - it is advisable to consult the structural pest control operator report for more information on this situation.

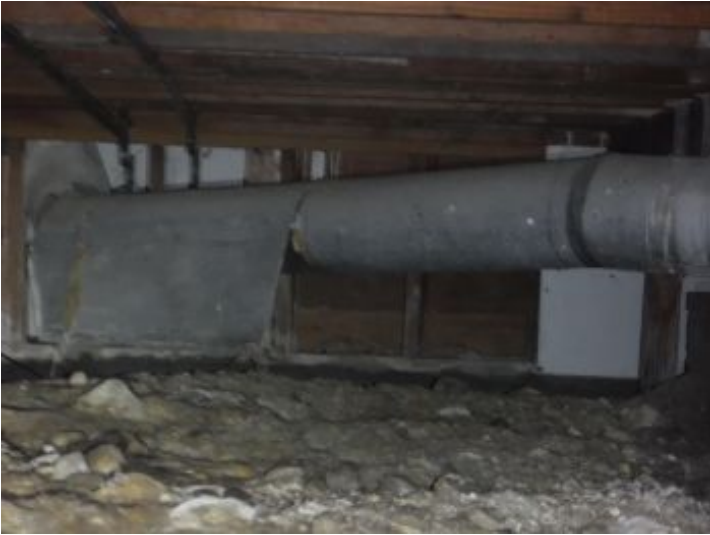
- Older/Abandon- Asbestos "type" tape is noted to be in poor condition and should only be removed by a professional abatement contractor, due to the possible health hazards that exist.

Page 65 Item: 12	Basement/Crawlspace Ductwork	<ul style="list-style-type: none"><li>• Older/Abandon- Asbestos "type" tape is noted to be in poor condition and should only be removed by a professional abatement contractor, due to the possible health hazards that exist.</li></ul>
------------------	------------------------------	--
