All Seasons Home Inspection Report

Client(s): **Leslie Wilkinson**
Property address: **493 Silver Lake Drive, Chico, CA**
Inspection date: **Friday, May 19, 2017**

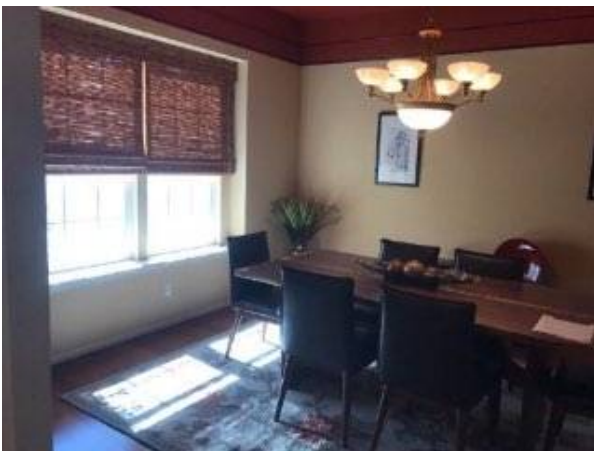
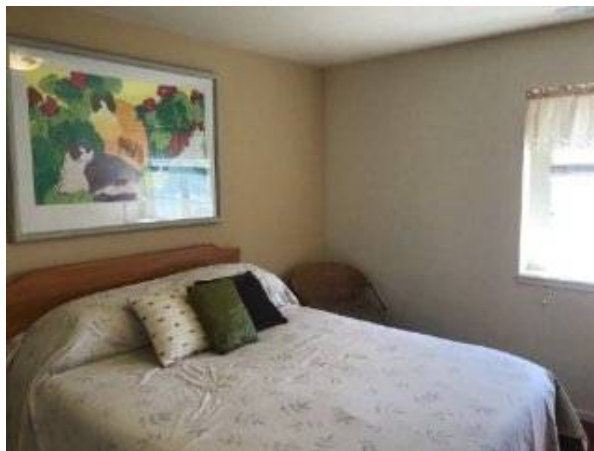
1) Comment - Home was completely furnished at time of inspection and some areas and items at this property were obscured by furniture or stored items. This often includes but is not limited to walls, floors, windows, inside and under cabinets, under sinks, on counter tops, in closets, behind window coverings, under rugs or carpets, and under or behind furniture. Areas around the exterior, under the structure, in the garage and in the attic may also be obscured by stored items. The inspector in general does not move personal belongings, furnishings, carpets or appliances. When furnishings, stored items or debris are present, all areas or items that are obscured, concealed or not readily accessible are excluded from the inspection. The client should be aware that when furnishings, stored items or debris are eventually moved, damage or problems that were not noted during the inspection may be found.

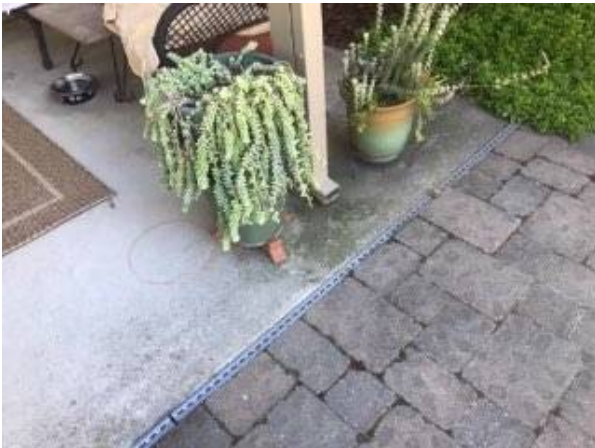
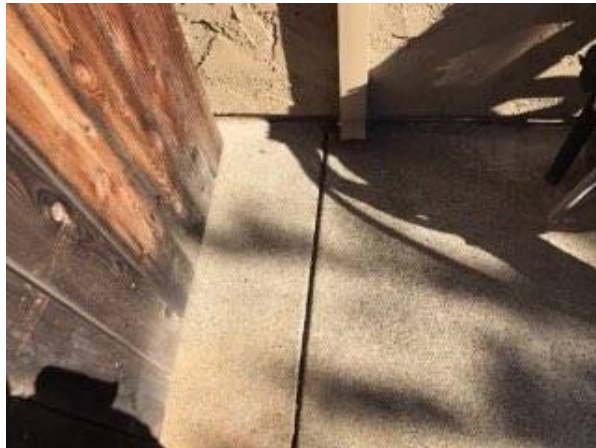
2) Safety, Monitor - One or more downspouts or downspout extensions drained onto walkways. This can result in ice or moss forming on walkways, and can pose a fall hazard.

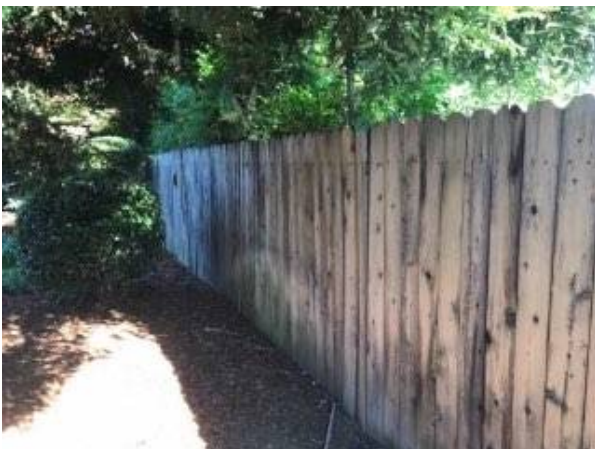
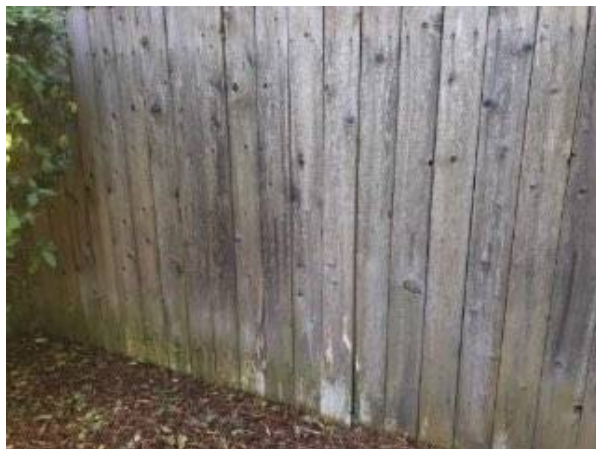
3) Evaluate, Monitor - The fencing around home is intact but showing signs of age. Its shared with neighboring properties when time comes to replace hopefully its a shared expense.

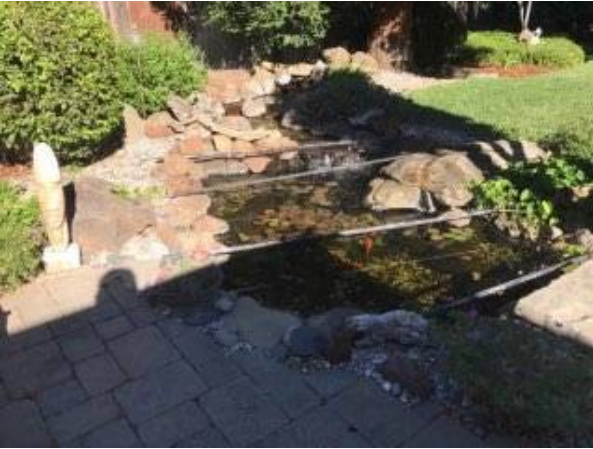
Photo 4-1

4) Evaluate, Comment - The outdoor ponds and associated plumbing and electrical systems were not evaluated recommend having current owners go over the operation and any required maintenance that is required to keep aquatic life alive and water clean.

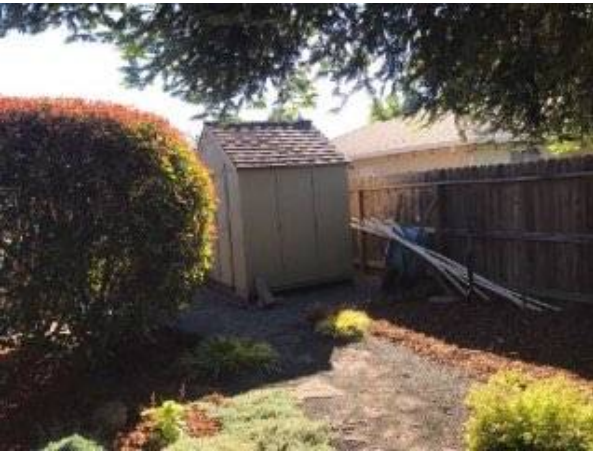
Photo 5-1

5) **Comment** - The small storage shed on property was not evaluated and was excluded from this report.

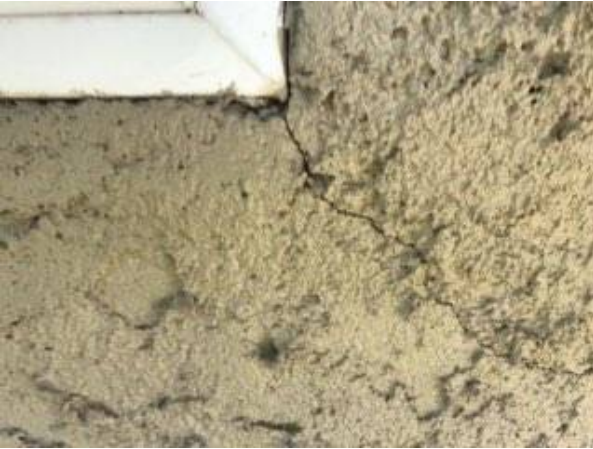
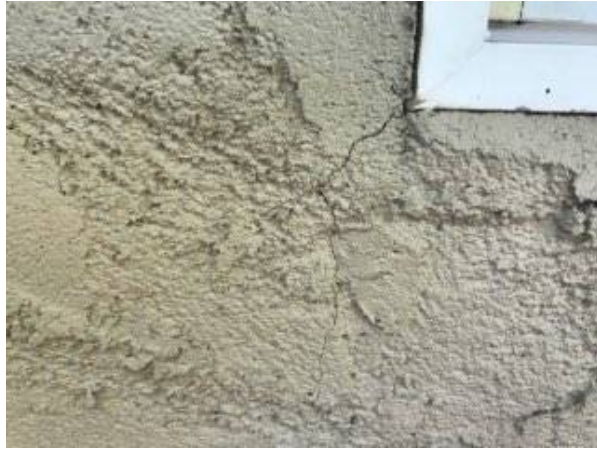
6) **Minor defect, Evaluate, Monitor** - Min or cracking found in one or more areas of the exterior stucco finish. This is a common defect with this type of wall covering. Note that areas behind the stucco are inaccessible and excluded from this inspection if concerned with the condition of siding have further evaluation by qualified contractor.

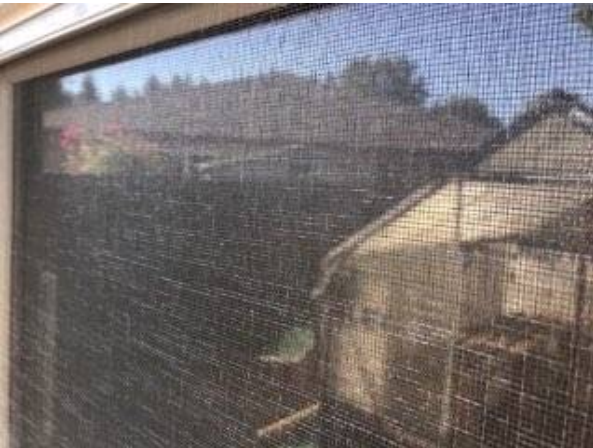
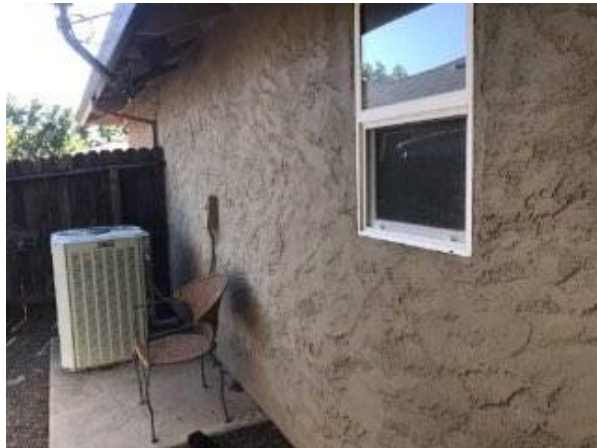
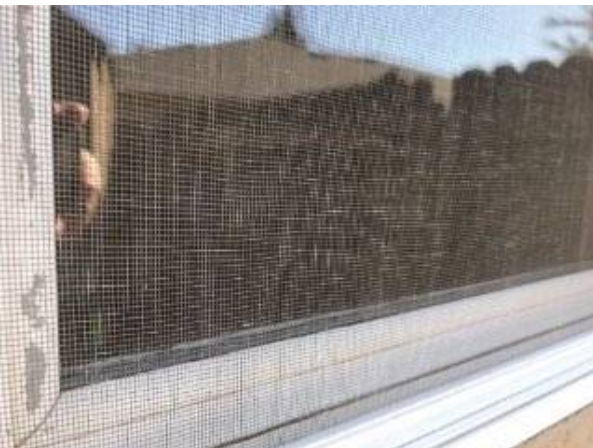
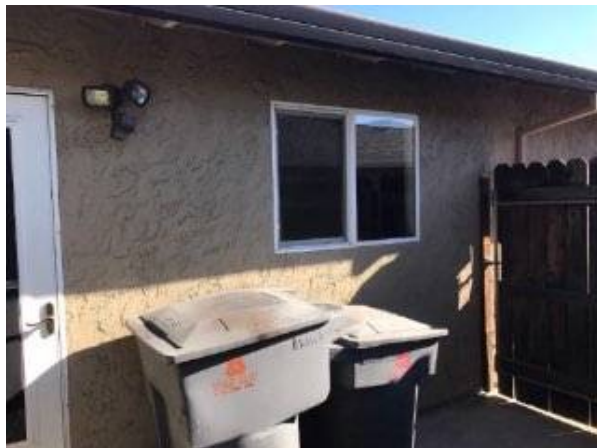
7) **Minor defect, Evaluate** - Two of the window screens were showing signs of age and have become sunburnt . These screens will eventual come apart but for now its just a visual defect.

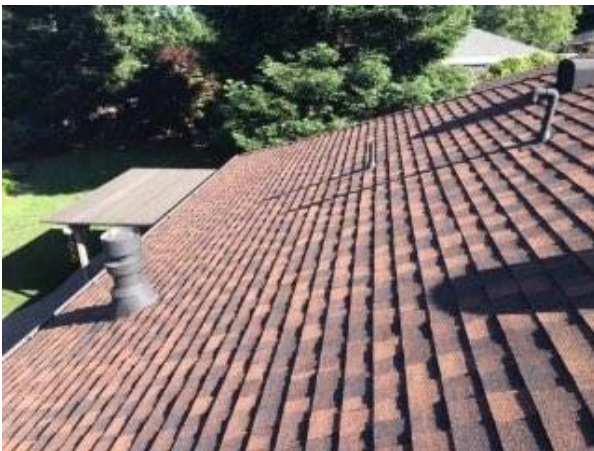
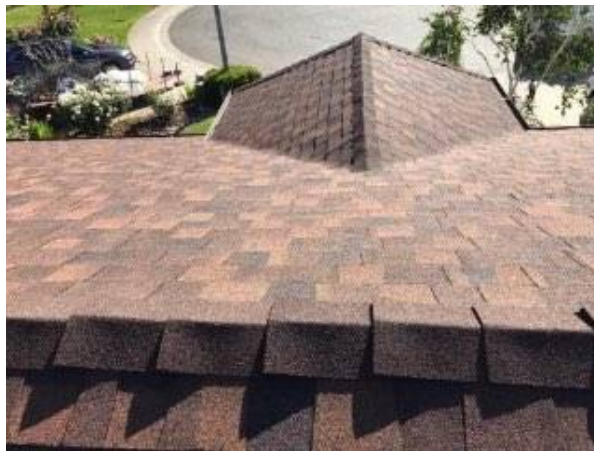
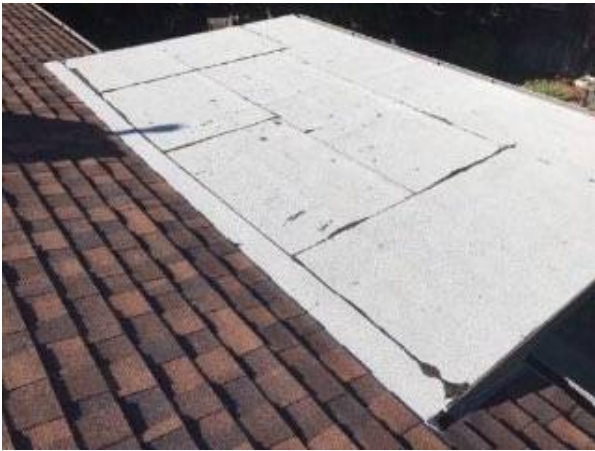
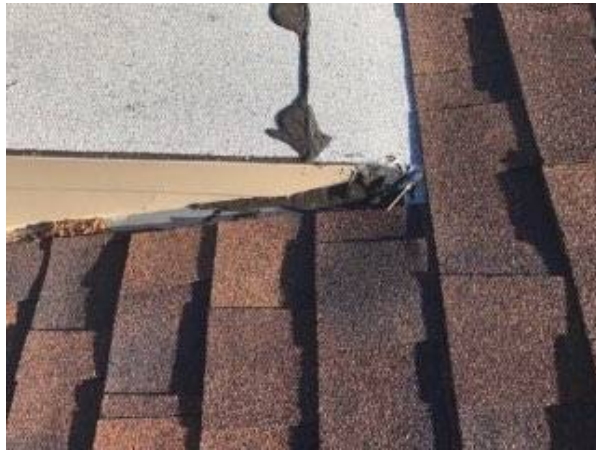
9) Evaluate, Monitor - The roof over home is in good shape is with out damage or any areas or concern to note at time of evaluation.

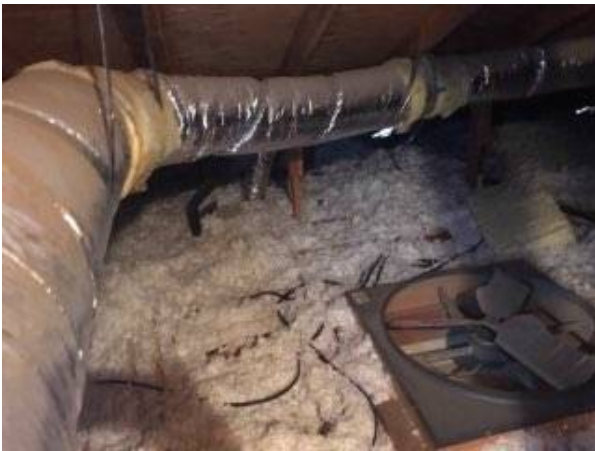
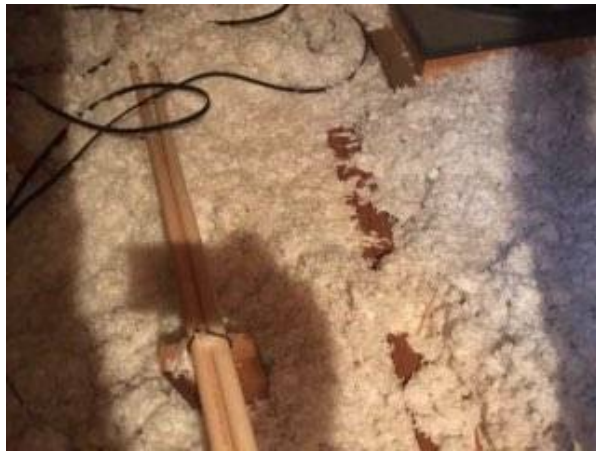
10) Repair/Maintain, Minor defect - The ceiling insulation in one or more areas of the attic was compacted or uneven where its been crawled through after home was built. If concerned have a qualified person repair, replace or install insulation as necessary to bring improve R value in attic.

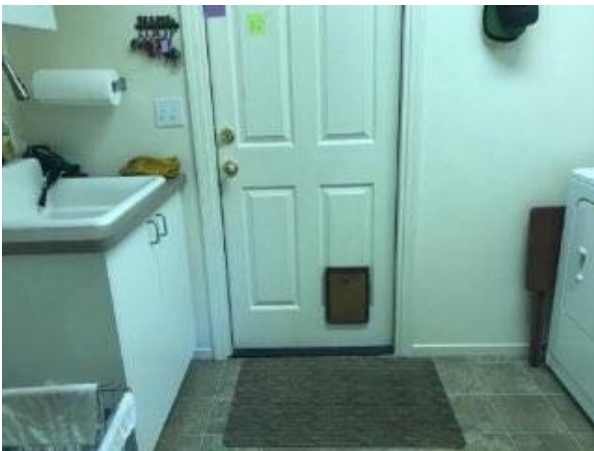
Photo 11-1

11) Safety, Repair/Replace - The door between the garage and the house has been modified with a , and is no longer fire-resistant. This is a potential safety hazard. House to garage doors, to prevent fire and fumes from spreading from the garage into interior living space, should be constructed of fire-resistant materials. Doors, generally considered to be suitable for the purpose, are solid core wood, steel, honeycomb steel or a door that has been factory labeled as fire rated. Recommend that a qualified contractor replace or repair the door and, at that time, make any other corrections that might be required to provide suitable fire resistance between the garage and the dwelling per standard building practices. For more information, visit:

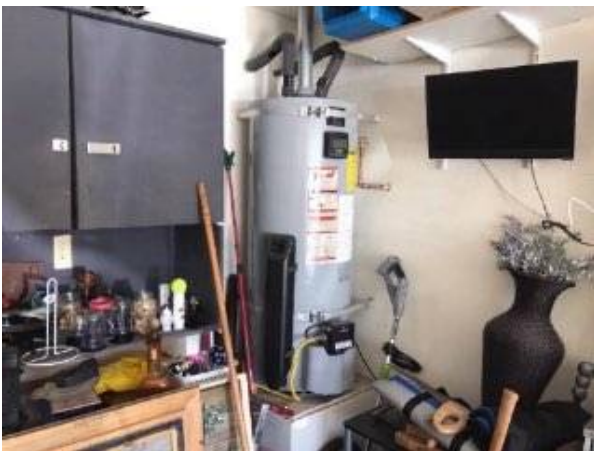
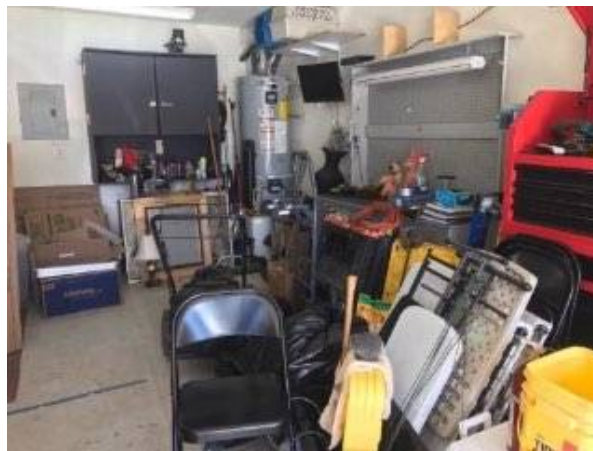
12) Repair/Replace, Evaluate - Appliances such as the water could be subject to damage from vehicles because no protective barrier was installed in front of it. Not sure if it was a requirement when home was built. If concerned have a qualified contractor install a steel post barrier per standard building practices.

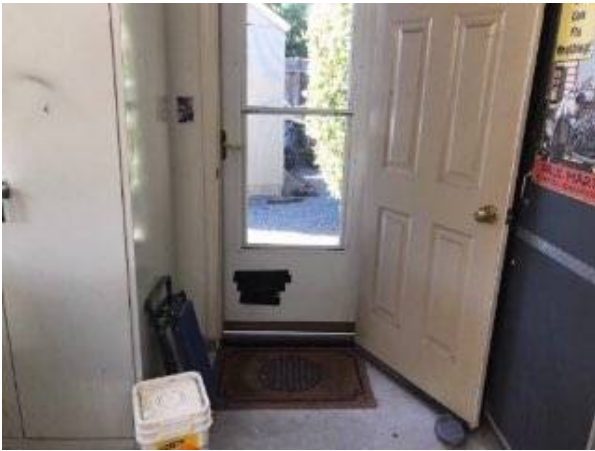
Photo 13-1

13) Minor defect, Evaluate - There was a pet door installed in screen door installed on man door off garage that was sealed up and is no longer in use. If concerned with this defect have further evaluation for replacement cost estimates.

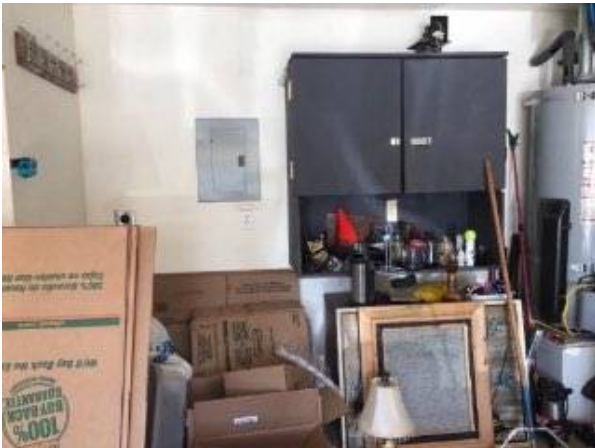
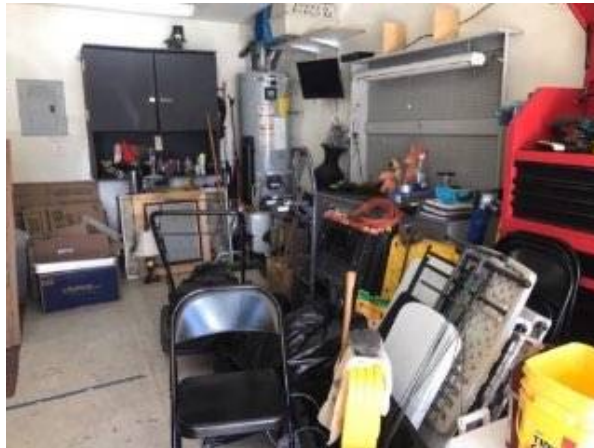
14) Evaluate, Comment - The inside of garage was full of current owners stored items and as a result a full evaluation of interior space could not be completed.

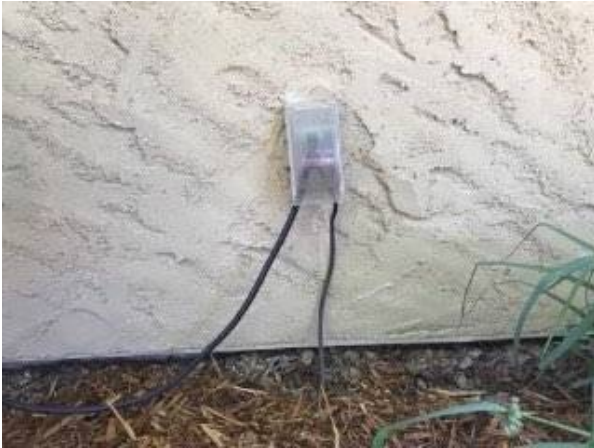
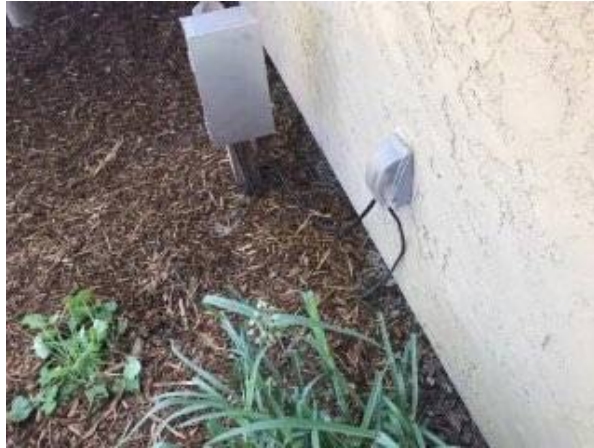
15) Safety, Repair/Replace - One of the standard exterior electric receptacles (outlets) were being used for appliances or systems that were constantly in use. Recommend that a qualified person install "while in use" receptacle covers as necessary. For more information, visit:

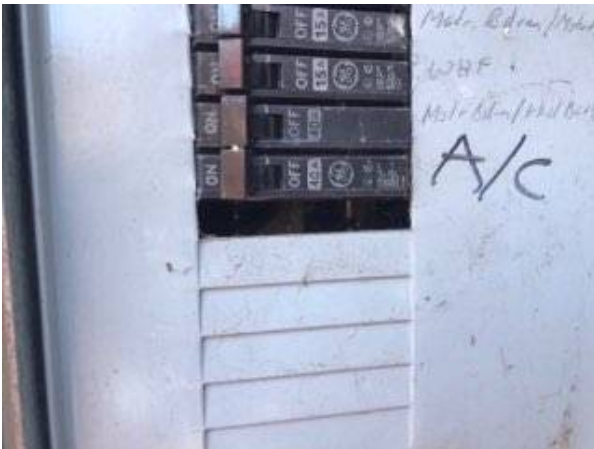
Photo 16-1

16) Minor defect, Evaluate - One or more slots where circuit breakers are normally installed were open in panel. Recommend that a qualified person install closure covers where missing.

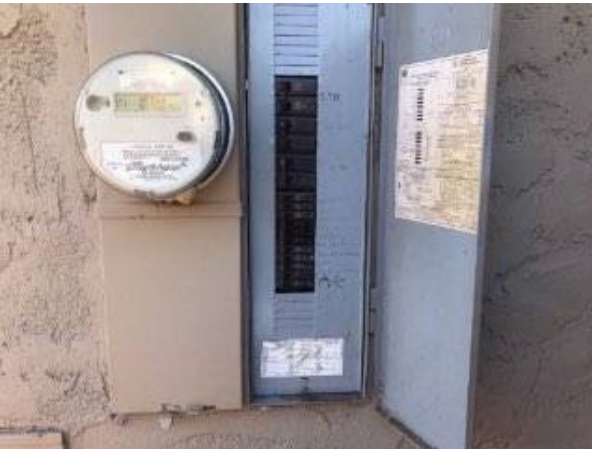
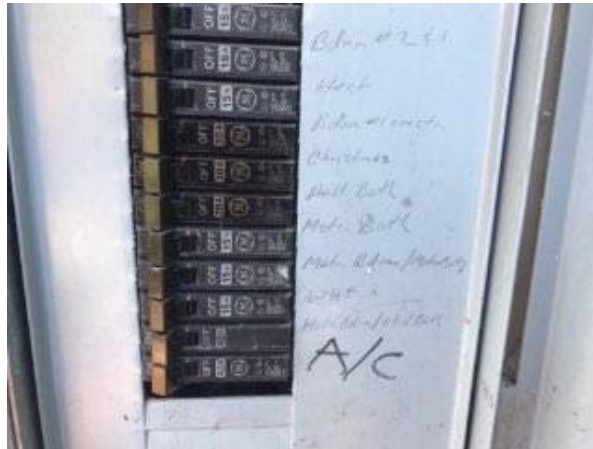
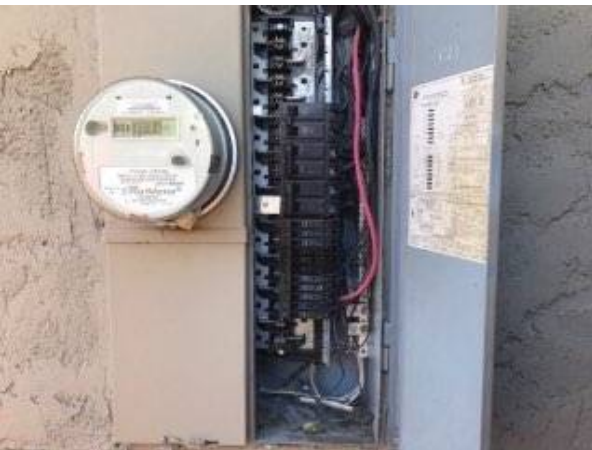
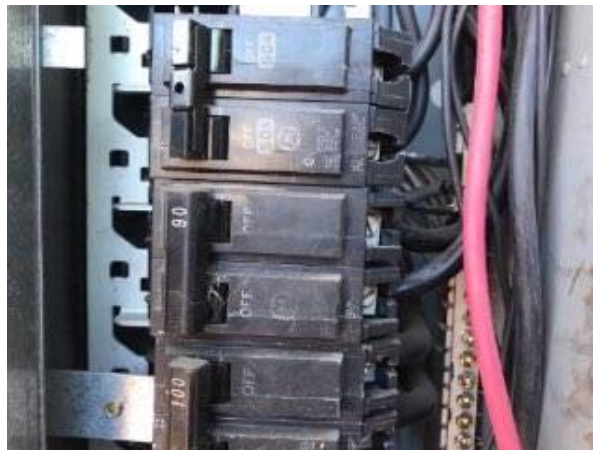
17) Evaluate, Comment - The main electrical panel on home is in good shape wiring is intact and breakers are with out any damage to note at time of homes evaluation.

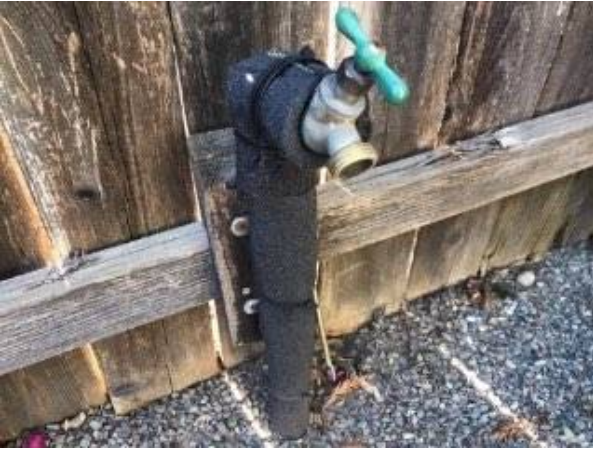
Photo 18-1

18) Safety, Minor defect - One or more hose bibs (outside faucets) were missing backflow prevention devices. These devices reduce the likelihood of gray water entering the potable water supply. Recommend installing backflow prevention devices on all hose bibs where missing. They are available at most home improvement stores and are easily installed. For more information, visit: <http://www.google.com/search?q=why+hose+bib+backflow+prevention>

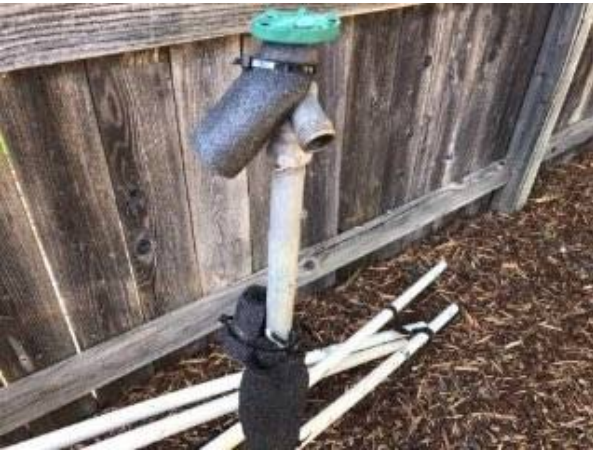
Photo 19-1

19) Repair/Maintain, Minor defect, Evaluate - Water supply pipes were routed outside have insulation that has fallen off and is subject to freezing and should be insulated.

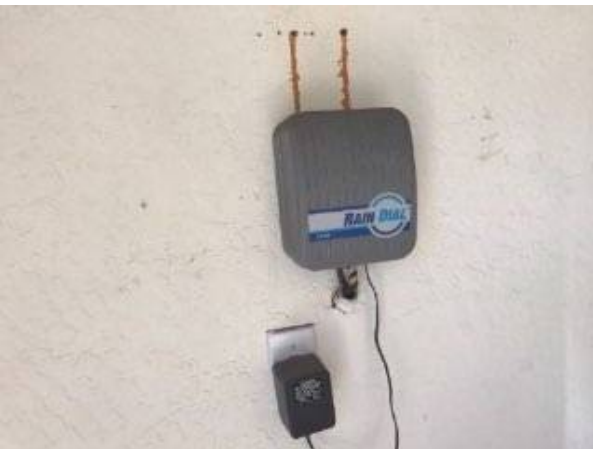
Photo 20-1

20) - Based on visible equipment to the inspector this property appeared to have a yard irrigation (sprinkler) system. These are specialty systems and are excluded from this inspection.

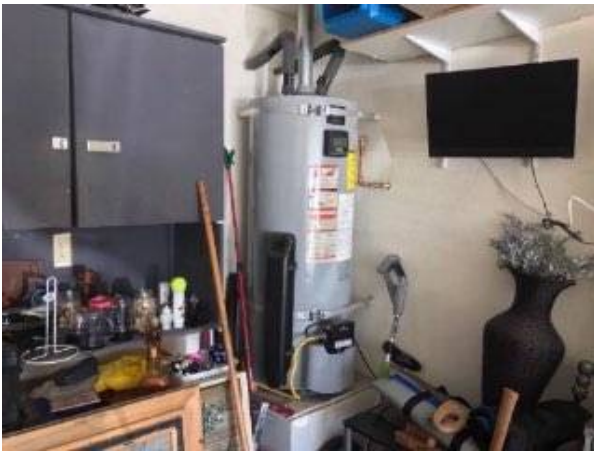
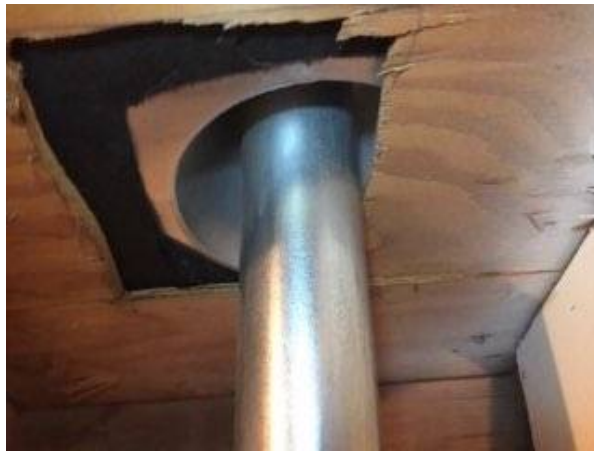
21) Safety, Repair/Maintain, Evaluate - The water heater in garage is functional and is not original to home. When it was installed or when roof was replaced the water heaters flue piping was pushed up against the roof sheathing a combustible material. The piping used to vent flue gases requires a minimum clearance of 1" be maintained in the event that the unit was to malfunction.

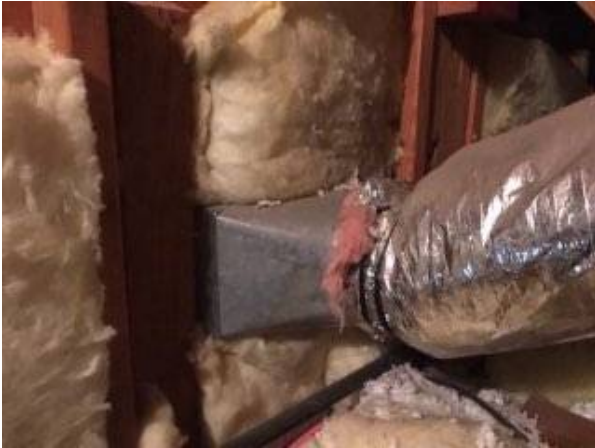
Photo 22-1

22) Repair/Replace, Minor defect, Evaluate - One of the heating & cooling ducts in attic space is not insulated. This can result in reduced energy efficiency, moisture inside heating ducts, and/or "sweating" on cooling ducts. Recommend that a qualified person repair per standard building practices. For example, by wrapping ducts in insulation with an R-value of R-4.

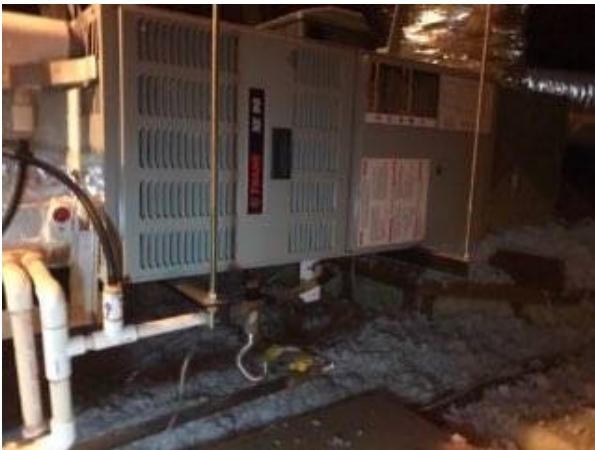
Photo 23-1

23) Repair/Replace, Evaluate - A high-efficiency furnace was installed in an attic space and no catch pan was installed under it. These systems produce condensation which is normally eliminated via a primary drain line. However, condensate water can leak if the primary drain line clogs. A catch pan should be installed below the furnace. Recommend that a qualified HVAC contractor install a catch pan per standard building practices.

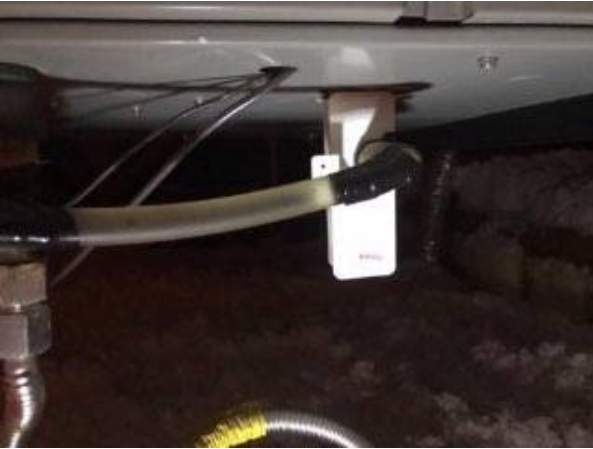
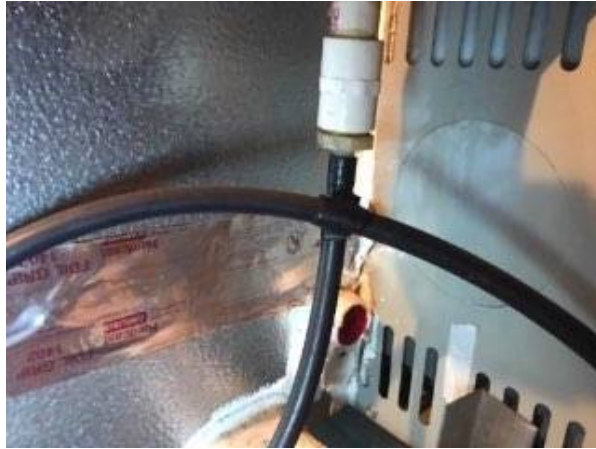
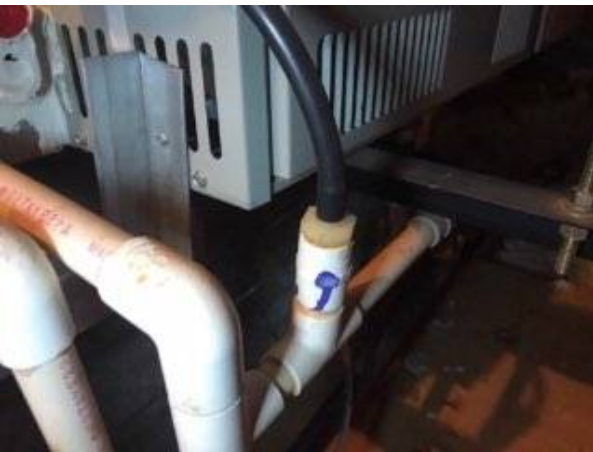
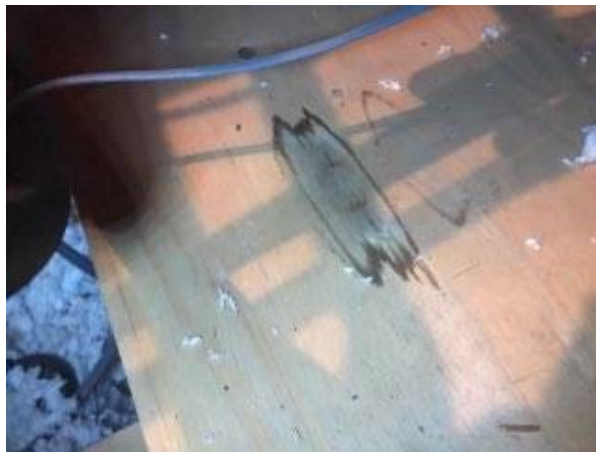
24) Repair/Maintain, Evaluate - The Furnaces have rubber or plastic condensate drain lines that are not clamped and have been this way since 1st installed. There is some staining under unit that could indicate that one if the hoses may be leaking. Condensate drain water may accumulate and could cause water damage to surrounding areas. Recommend that a qualified HVAC contractor repair as necessary.

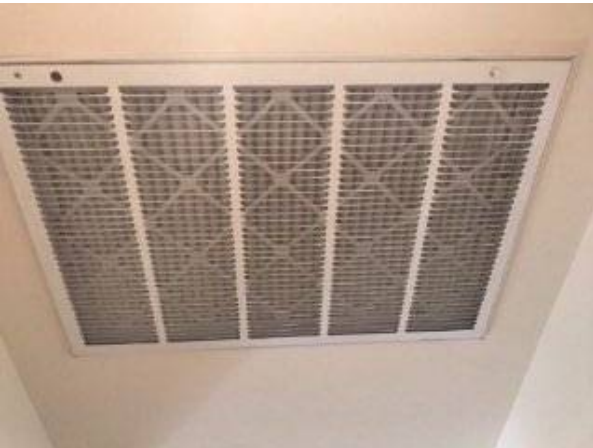
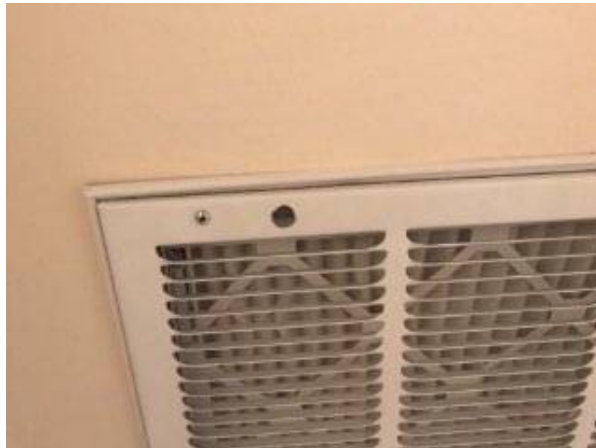
25) Minor defect, Evaluate - The return air grill in hall is missing one of its knobs and a screw was driven into cover to hold it up. This means that a tool is required to open the cover to access filter an inconvenience and visual defect.

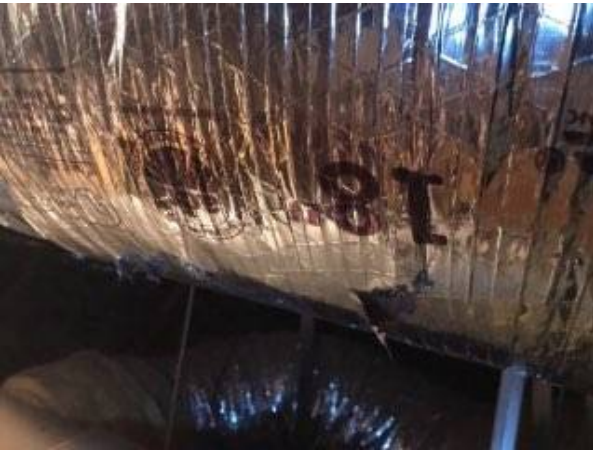
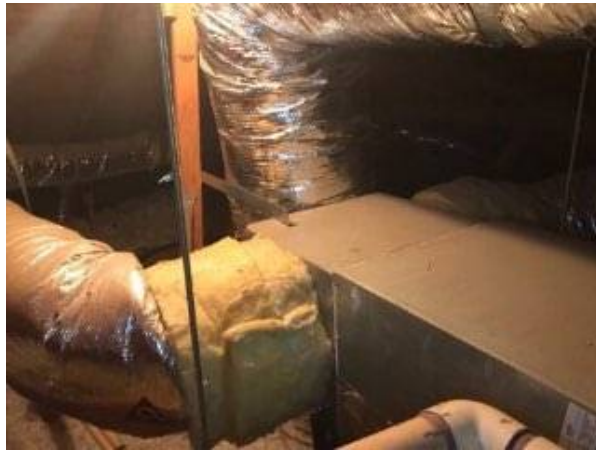
26) Minor defect, Comment - The ducting in attic is in its original configuration and when installed had to meet an minimum rate of leakage as homes were certified energy star rated when 1st built. There is a hard turn on the supply duct going to bedroom areas that doesn't appears to be effecting any thing as its total length is small compared to other system. There is also a small hole in the outer membrane of return ducting in attic.

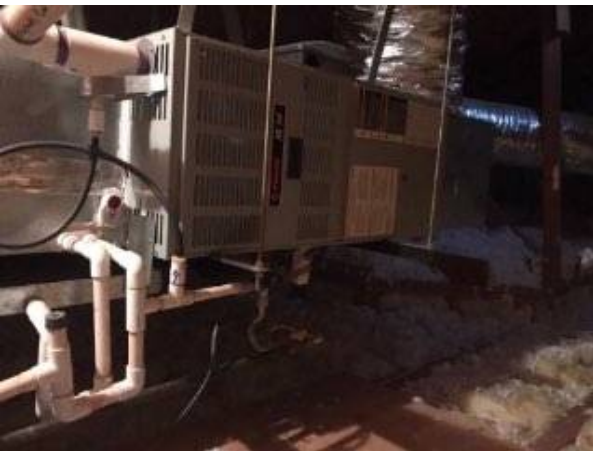
Photo 27-1

27) Maintain, Evaluate - The inspector was unable to determine the last service date of forced air unit in attic. If this system was serviced more than 1 year ago, recommend that a qualified HVAC contractor inspect, clean, and service this system, and make repairs if necessary. For safety reasons, and because this system is fueled by gas or oil, this servicing should be performed annually in the future. Any needed repairs noted in this report should be brought to the attention of the HVAC contractor when it's serviced. For more information visit:

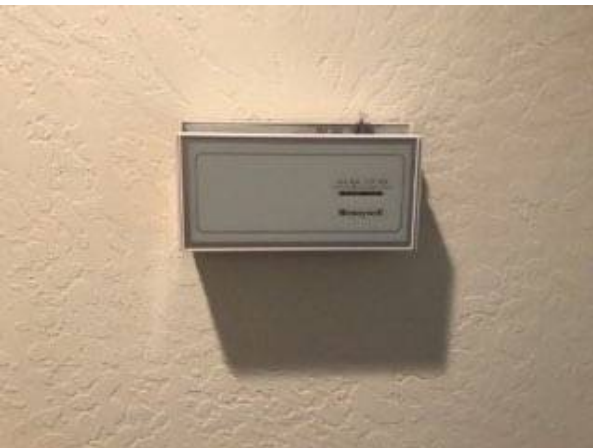
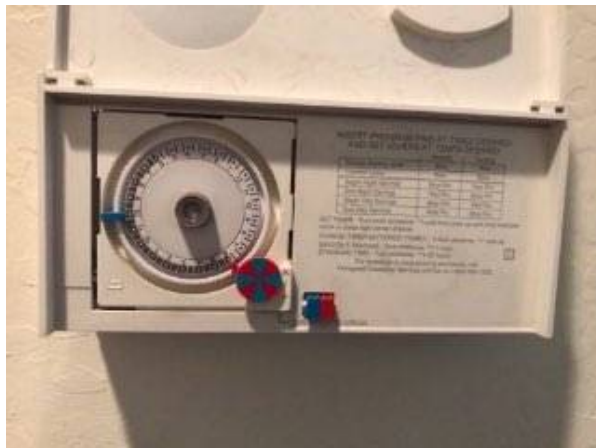
28) Evaluate, Comment - The thermostat on home is in its original configuration is still functional with the old dial clock timer installed.

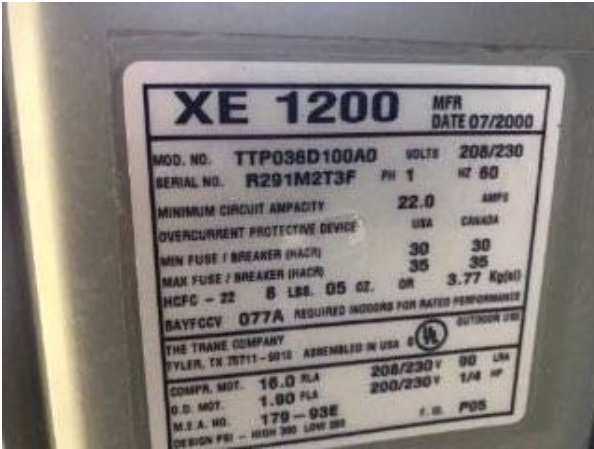
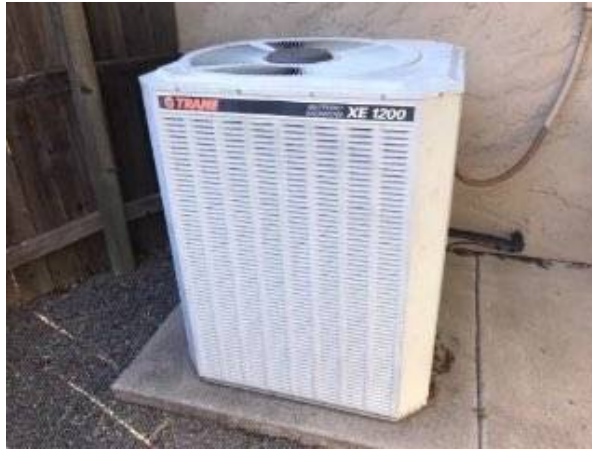
29) Comment - The HVAC equipment and ducting installed on home is original equipment and approaching the end of its useful service life. This equipment is functional but due to age it might be wise to purchase home warranty that covers replacement of major components.

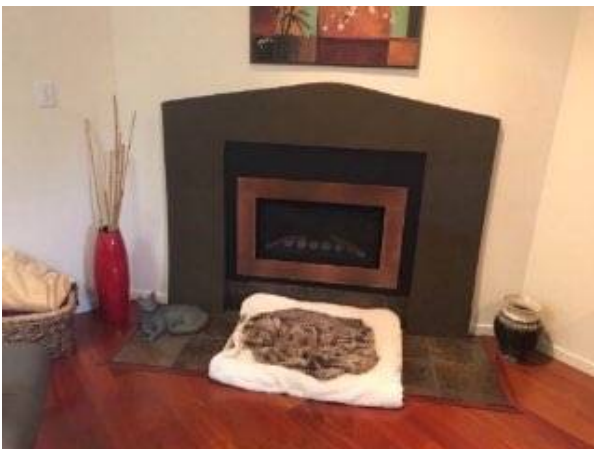
Photo 30-1

30) Safety, Maintain, Evaluate - Gas fire place was functional but only ran a short time as its summer and hot out. I recommend that buyer review all available documentation for gas-fired fireplaces and stoves. Depending on how they are operated (for routine heating versus ambiance), such appliances normally need servicing annually or every few years. Consult with the property owner and/or a qualified specialist to determine if service is needed now.

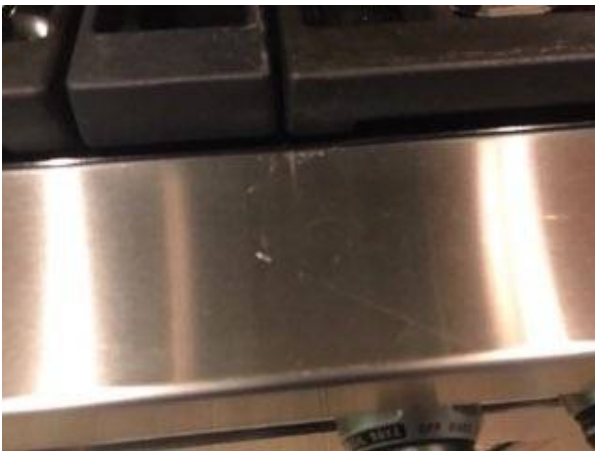
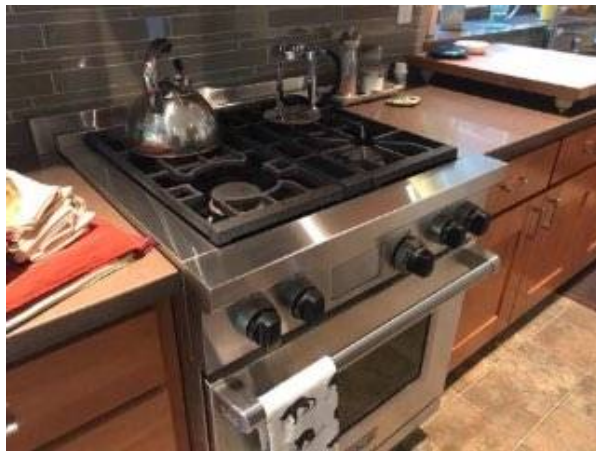
31) **Minor defect** - Minor surface scratching found on top of stove install in kitchen a visual defect only.

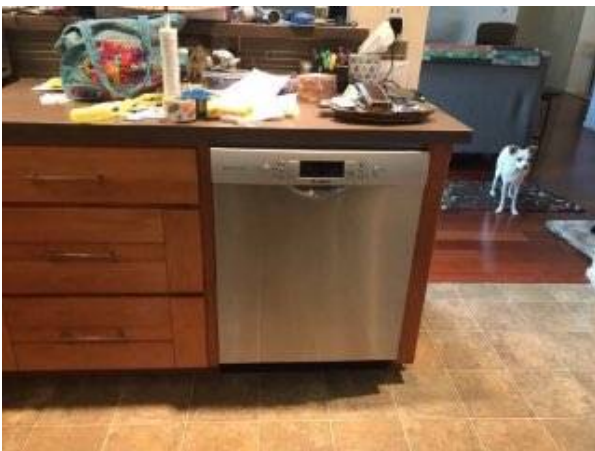
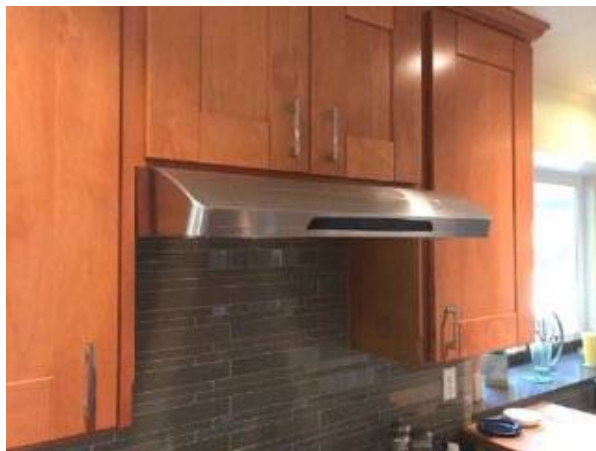
32) **Evaluate, Monitor, Comment** - The kitchen in home is in good shape appliances were all in good functional condition cabinetry is in like new condition and drawers and cupboard doors were all functional.

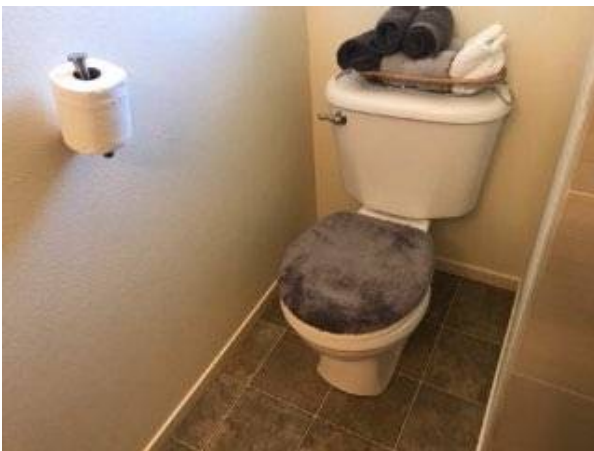
Photo 33-1

33) Repair/Replace, Evaluate - The toilet in hall bathroom was loose where it attached to the floor and leaks can occur and flooring may get damaged. Recommend that a qualified contractor remove the toilet for further evaluation and repair if necessary. A new wax ring should be installed and toilet should be securely anchored to the floor to prevent movement and leaking.

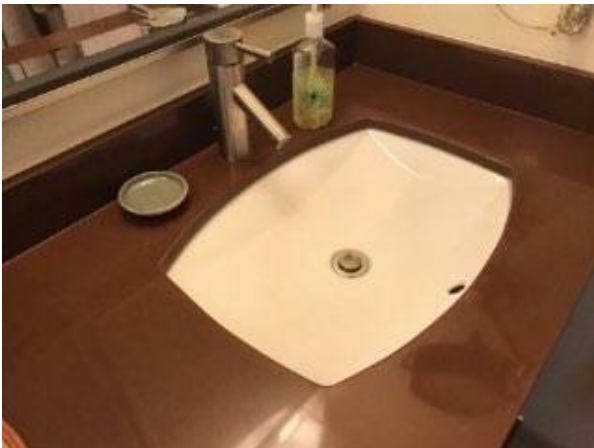
Photo 34-1

34) Repair/Maintain, Evaluate - The sink drain stopper mechanism in master bathroom sink on the right side was inoperable. Recommend that a qualified person repair or replace as necessary.

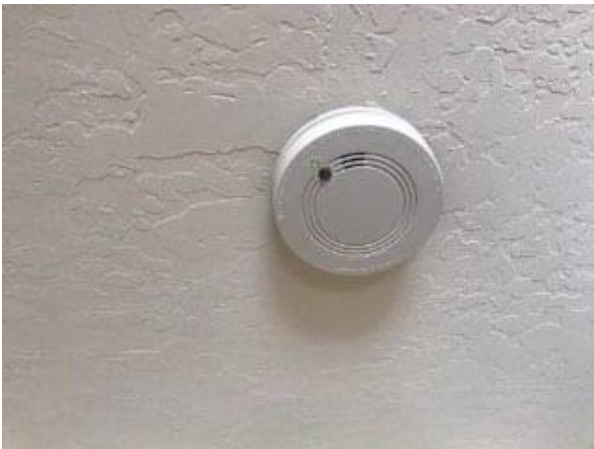
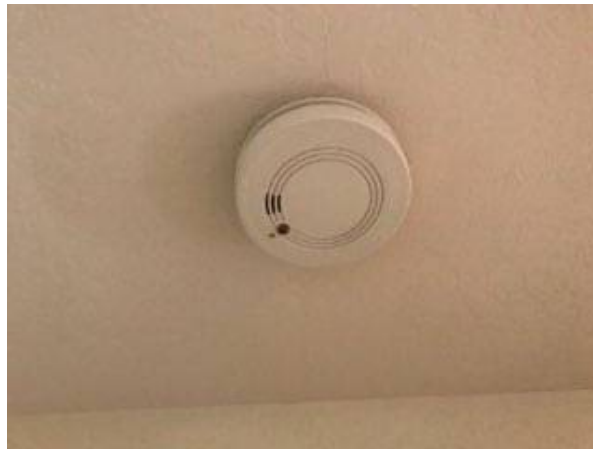
35) Repair/Replace, Evaluate - Based on the age of this structure its possible that existing smoke alarms may have been installed more than 10 years ago. According to [National Fire Protection Association](http://www.nfpa.org), aging smoke alarms don't operate as efficiently and often are the source for nuisance alarms. Older smoke alarms are estimated to have a 30% probability of failure within the first 10 years. Newer smoke alarms do better, but should be replaced after 10 years. Unless you know that the smoke alarms are new, replacing them when moving into a new residence is also recommended by NFPA. For more information, visit:

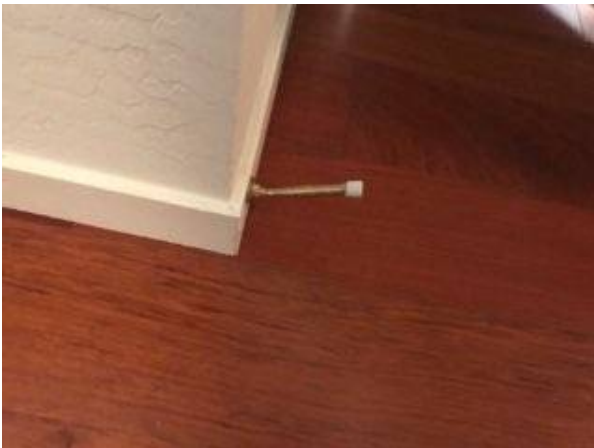
Photo 36-1

36) Repair/Replace - The door stop in master bedroom is a little bent but still holding the door back from hitting wall just a visual defect at the time.

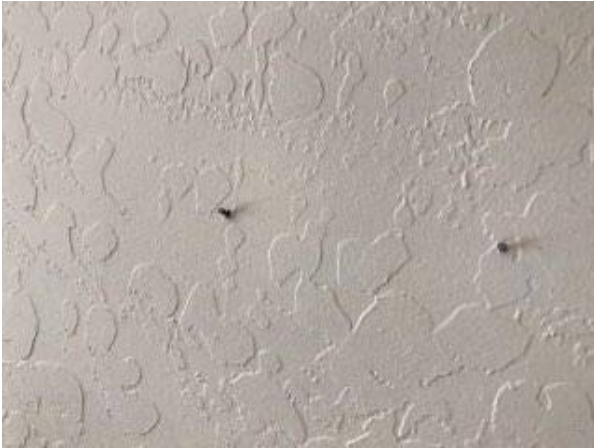
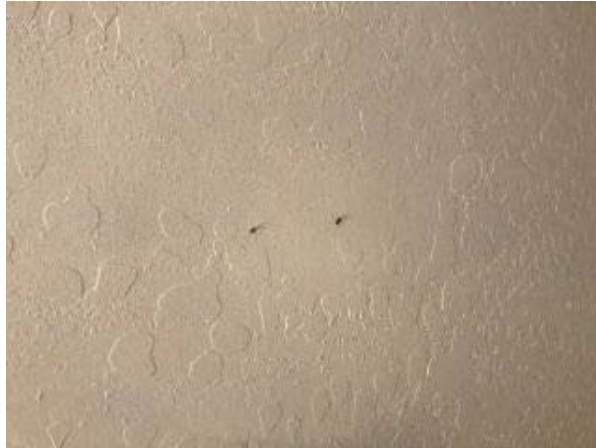
37) Minor defect, Maintain - There will be minor surface defects in the drywall where pictures were removed that will require patching and or paint to conceal where nails and fasteners were placed.

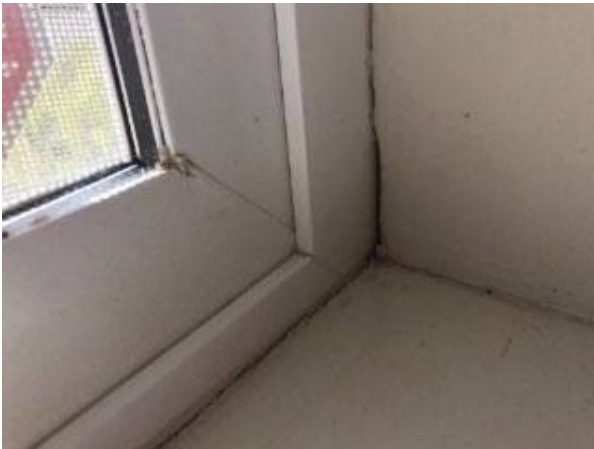
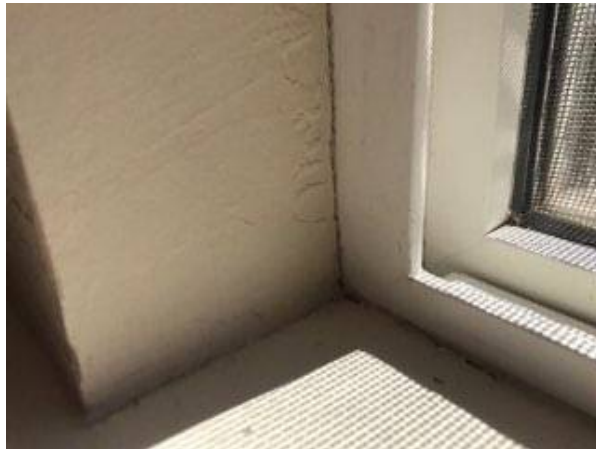
38) Minor defect, Comment - There is minor separation in between one or more windows and the drywall. this separation is a visual defect only most likely cause by material shrinkage and or settlement in home.
