# WOOD DESTROYING PESTS AND ORGANISMS INSPECTION REPORT

| Building No.<br>4275 | Street<br>Blue Road | City<br>Creston | Zip<br>93432 | Date of Inspection<br>06/20/2017 | Number of Pages<br>1 of 5 |

| General Description:<br>Single story; Single family residence; Wood siding; Composition shingle roof; Vacant. | Inspection Tag Posted:<br>GARAGE |

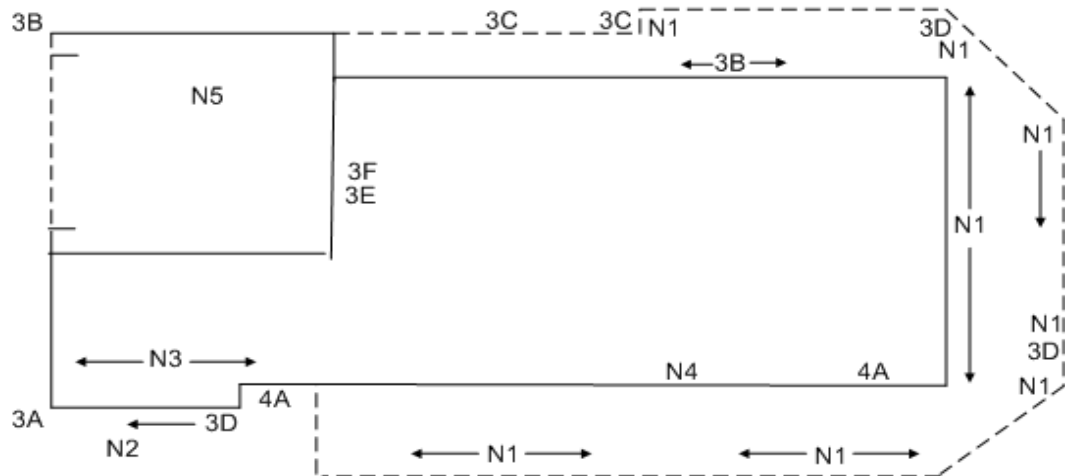
Diagram not to scale-Finding locations approximate

| Finding: | 3A | Fungus damage was found at the fascia of the eave area. |
| Finding: | 3B | Fungus damage was found at the exterior wood trim. |
| Finding: | 3C | Fungus damage was found at the fascia runner. |
| Finding: | 3D | Fungus damage was found at the roof sheathing of the eave area. |
| Finding: | 3E | Fungus damage was found at the wood siding at chimney box. |
| Finding: | 3F | Fungus damage was found at the exterior wood trim at the chimney box. |

| Finding: | 4A | An excessive moisture condition exists due to broken window glass. |

| Recommendation: | | Replace the fungus damaged portions of fascia as needed. |
| Recommendation: | | Replace the damaged portions of the trim as necessary. |
| Recommendation: | | Remove and replace the damaged portions of the fascia runner as needed to eliminate the fungus infection and damage. |
| Recommendation: | | Replace the fungus damaged portions of roof sheathing as needed. |
| Recommendation: | | Replace the damaged portions of the wood siding. Note: In cases of plywood siding, repair may involve installing wood trim in place of siding removed and/or metal flashing at cut sections of siding replacement. Additional costs will apply if replacement of full sheet(s) of plywood siding is desired by the parties in interest. |

| Recommendation: | | Replace the broken glass to eliminate the excessive moisture condition |
