Confidential Inspection Report

LOCATED AT:
5043 Rolling Meadows Rd
Rolling Hills Estates, CA 90274

INSPECTED ON:
Monday, August 11, 2014

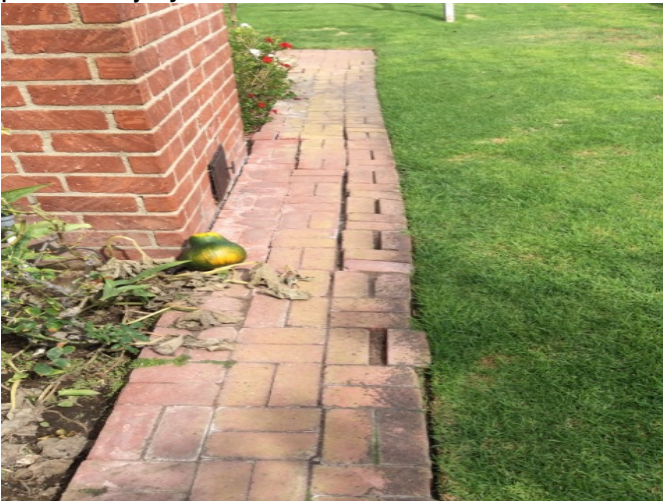
WALKWAYS

SC CR 1: - There are trip hazards in the walkways. We recommend they be patched or repaired to prevent injury.

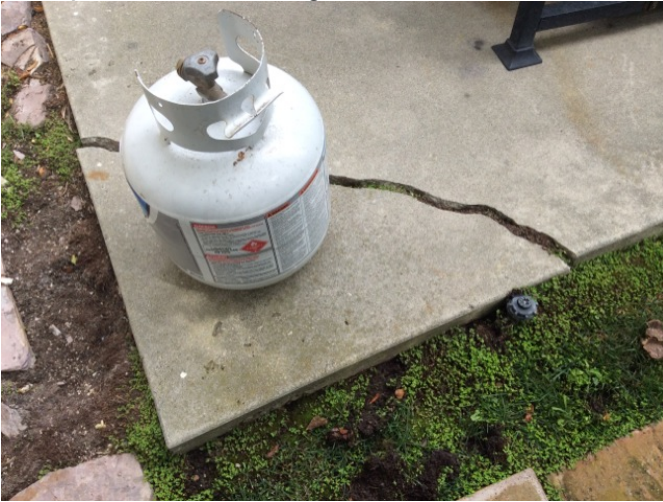
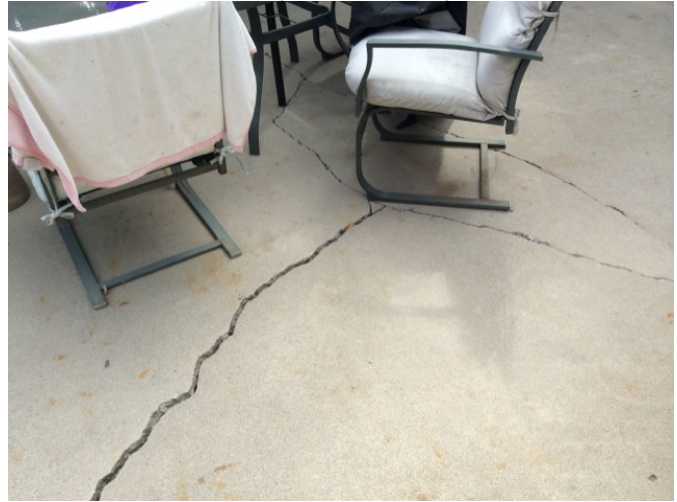
PATIO SURFACE

CR 2: - The concrete patio surface has cracked and/or settled to the point that trip hazards exist and, in our opinion, it is no longer serviceable. We recommend it be removed, repaired, or replaced.

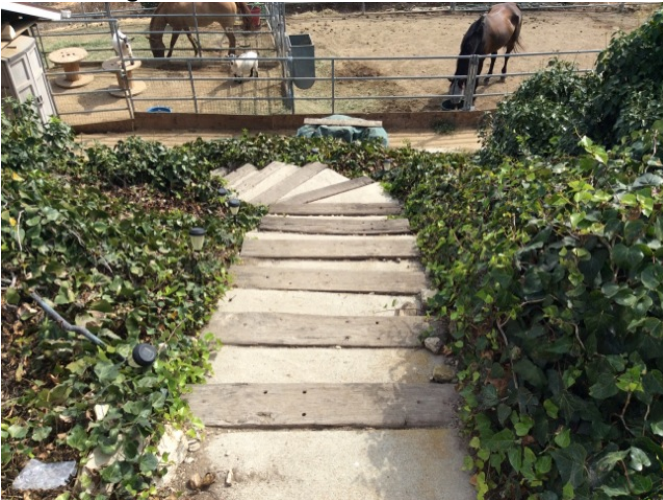
HAND RAILS

SC CR 3: - There are no railings where needed at the rear stairs. As a safety measure, we recommend that railings be installed.

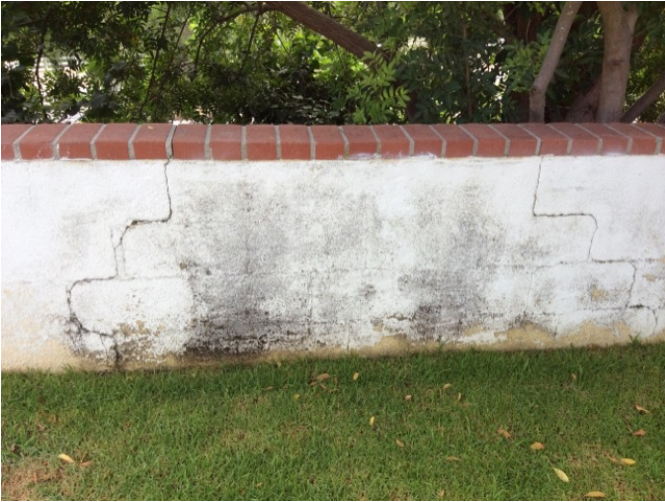
BLOCK WALLS

CR 4: - The cement block wall is cracked and damaged and in need of repair.

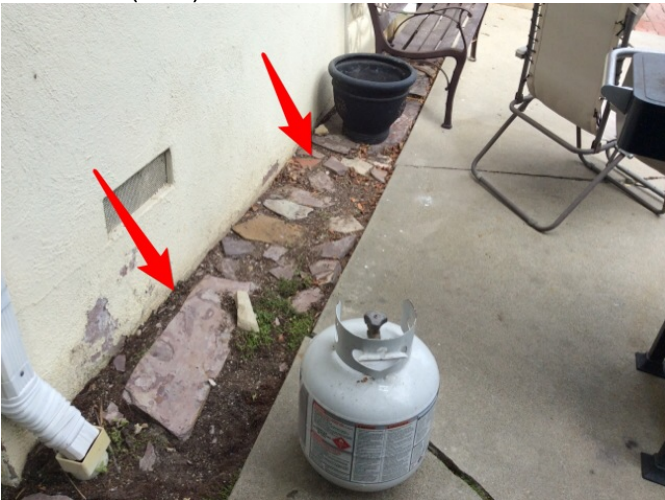
GRADING

FE CR 5: - Grading is sloped toward the structure in some areas. Low spots and negative grading promote water accumulation near the building, leading to foundation problems. The slope should fall away from the foundation at a rate of one quarter of an inch per foot for at least 6 feet to prevent moisture accumulation next to the foundation. Regrading would help ensure that surface water flows away from the structure.(rear)

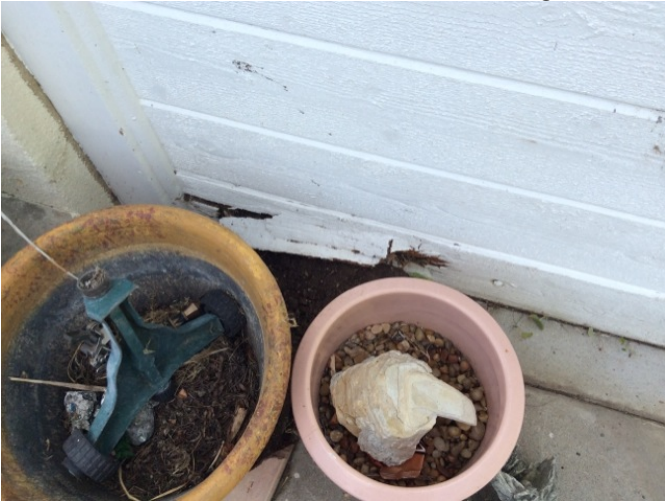
FENCING

CR 6: - There are sections of the fencing that are damaged. We recommend repair or replacement.

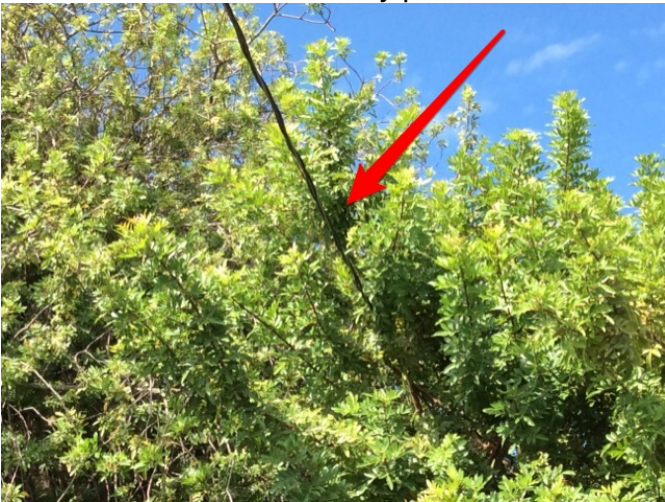
ELECTRICAL SYSTEM

CR 8: - The overhead service wires are deflected by trees. We recommend the trees be trimmed clear of the wires or the service be reconfigured. To reduce shock hazard during this procedure, the work should be coordinated with the utility provider.

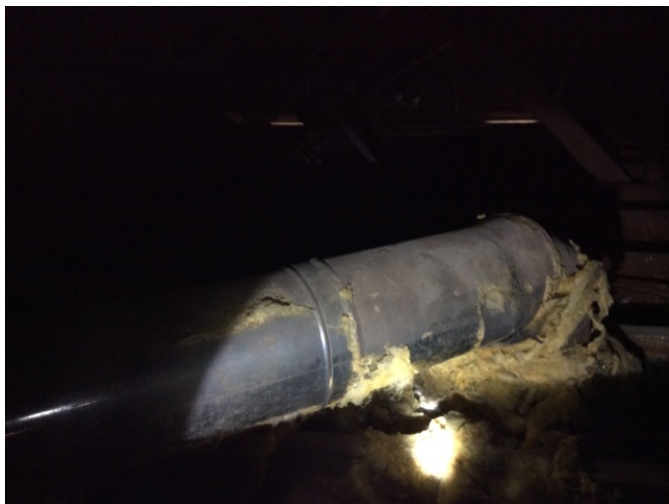
FORCED HOT AIR HEATING SYSTEM

CR 12: - The insulation on several of the ducts is missing and/or loose. We recommend repair to minimize heat loss.

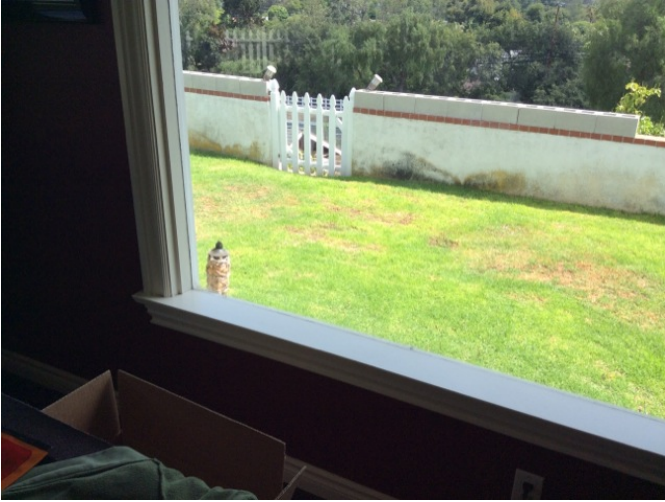
SC CR RU 24: - Some of the windows are not safety glass, as required by present standards, and could be hazardous if broken. Safety glass is more impact-resistant and less likely to cause an injury. Upgrading to present standards should be considered.

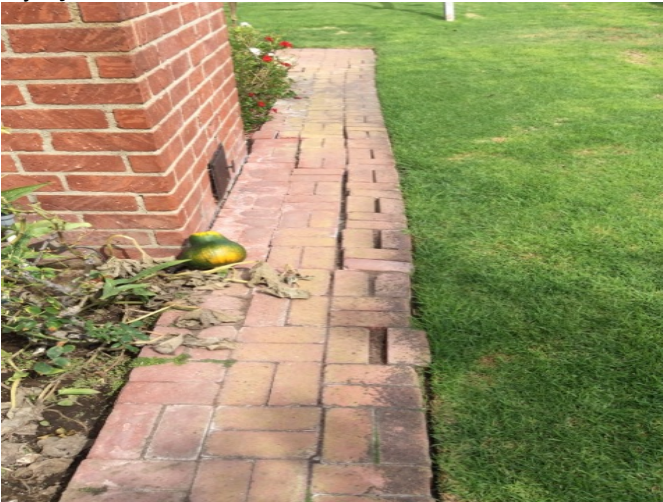
WALKWAYS

SC **CR** There are trip hazards in the walkways. We recommend they be patched or repaired to prevent injury.

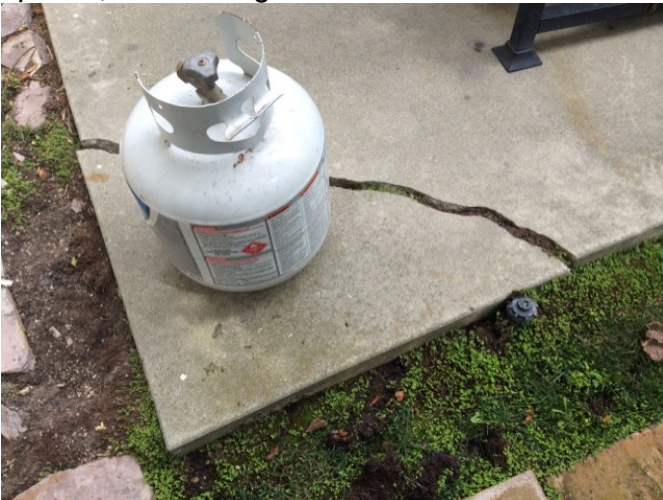
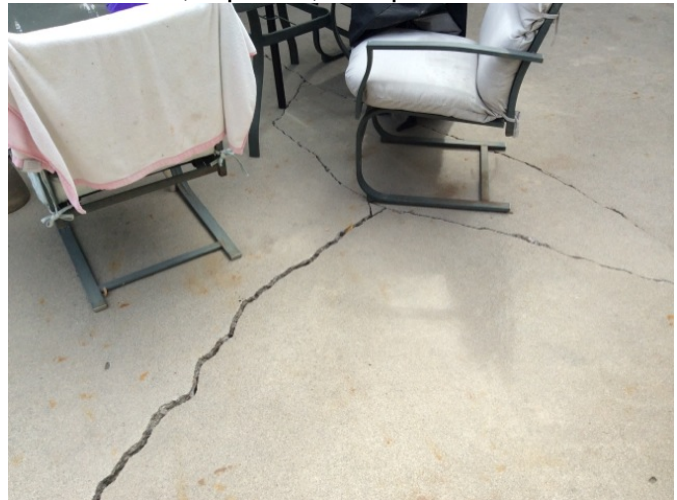
PATIO SURFACE

CR The concrete patio surface has cracked and/or settled to the point that trip hazards exist and, in our opinion, it is no longer serviceable. We recommend it be removed, repaired, or replaced.

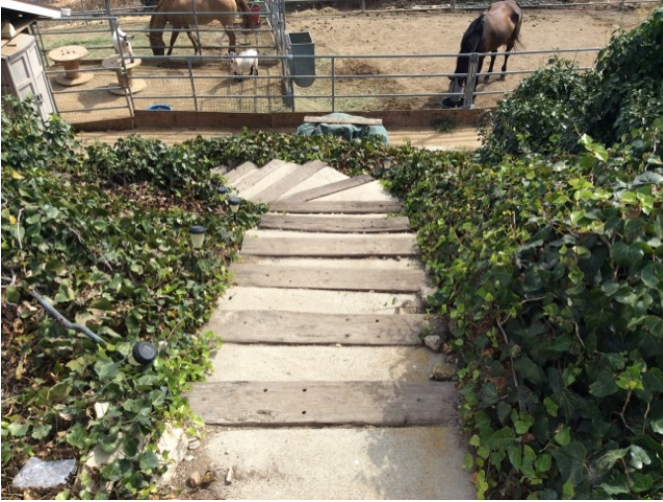
HAND RAILS

SC **CR** There are no railings where needed at the rear stairs. As a safety measure, we recommend that railings be installed.

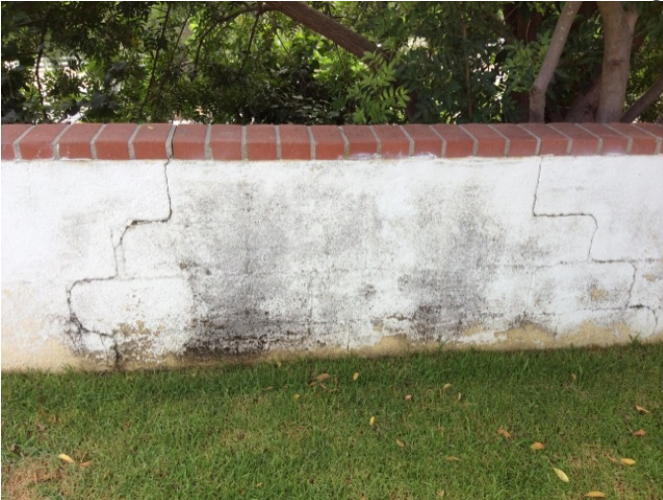
BLOCK WALLS

CR The cement block wall is cracked and damaged and in need of repair.

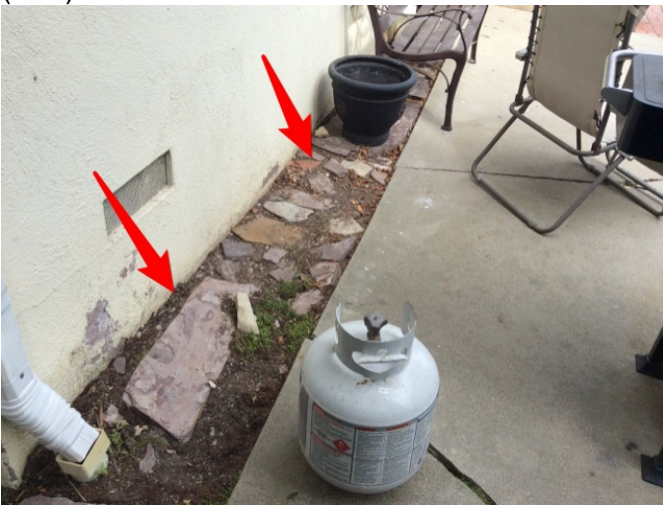
(rear)

FE CR Grading is sloped toward the structure in some areas. Low spots and negative grading promote water accumulation near the building, leading to foundation problems. The slope should fall away from the foundation at a rate of one quarter of an inch per foot for at least 6 feet to prevent moisture accumulation next to the foundation. Regrading would help ensure that surface water flows away from the structure.

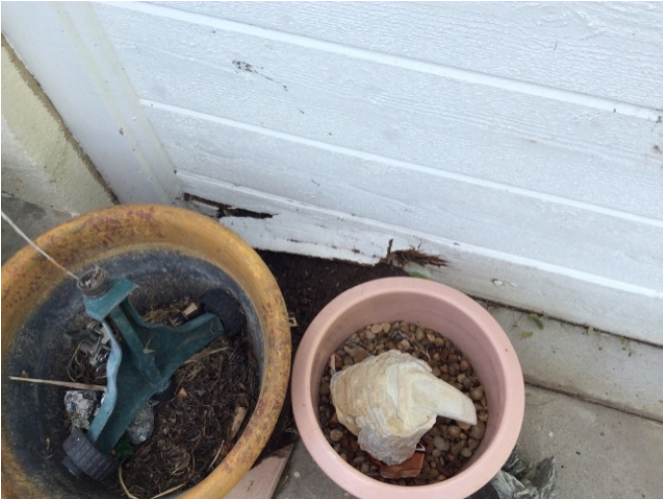
FENCING

CR There are sections of the fencing that are damaged. We recommend repair or replacement.

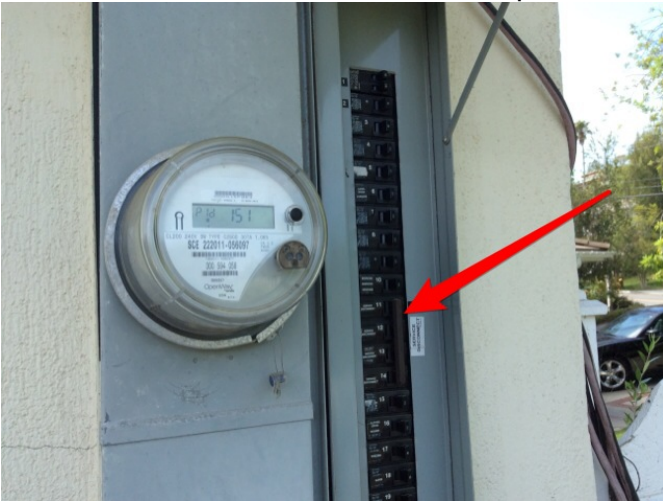
METER&MAIN

The meter and main electrical service panel are outside on the left side of the building.

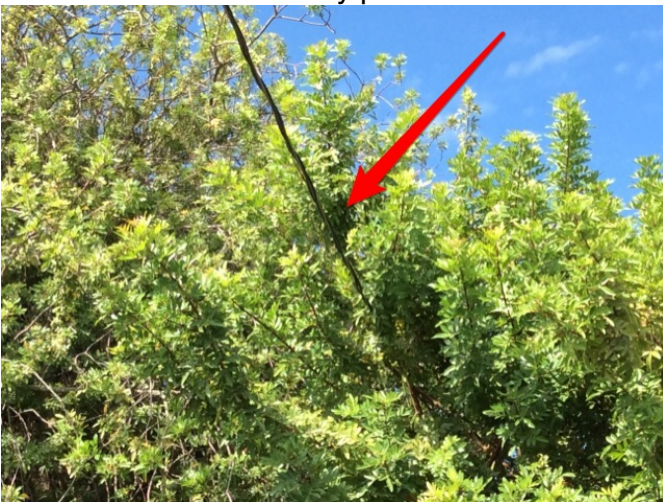
SERVICE DROP

CR The overhead service wires are deflected by trees. We recommend the trees be trimmed clear of the wires or the service be reconfigured. To reduce shock hazard during this procedure, the work should be coordinated with the utility provider.

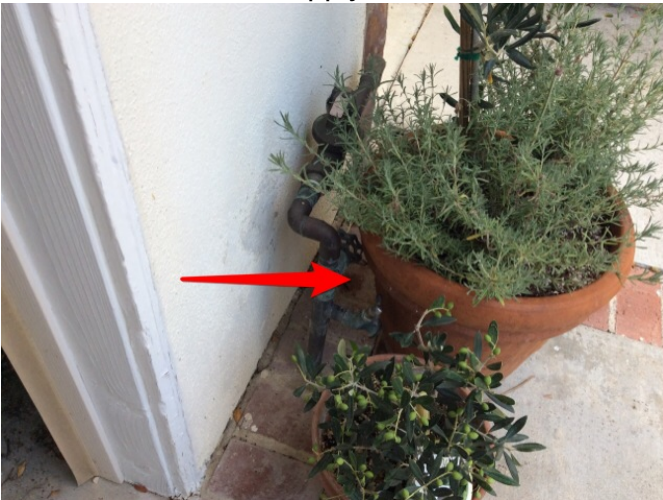
WATER SHUTOFF LOCATION

The domestic water supply main shut-off valve is outside at the front of the building.

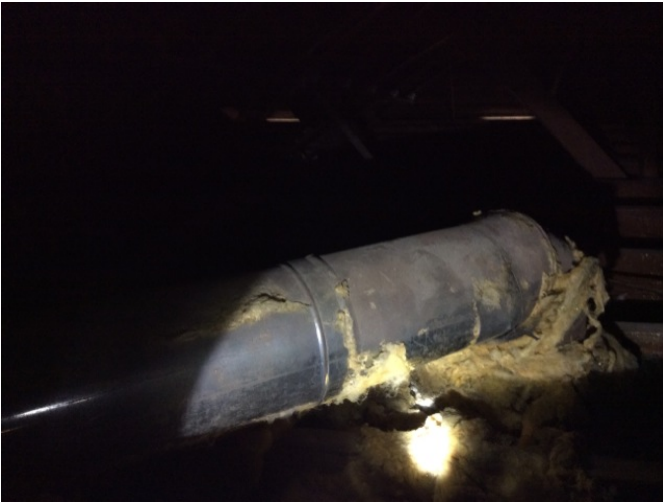
DUCT INSULATION

CR The insulation on several of the ducts is missing and/or loose. We recommend repair to minimize heat loss.

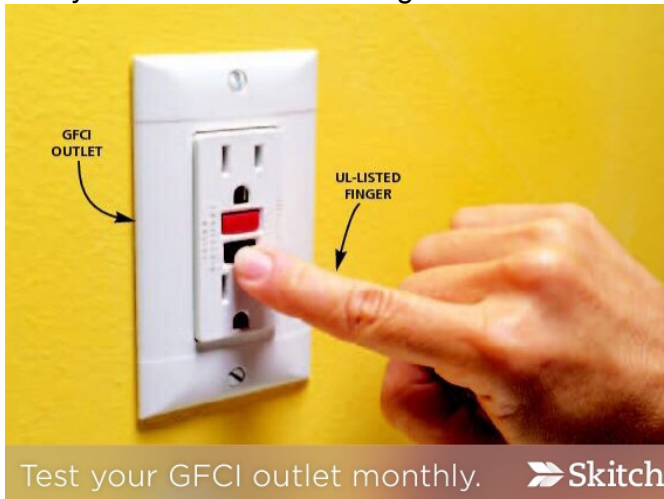
RECEPTACLES

GFCI (ground fault circuit interrupter) protection has been installed providing an increased margin of safety. We recommend testing the device on a monthly basis.

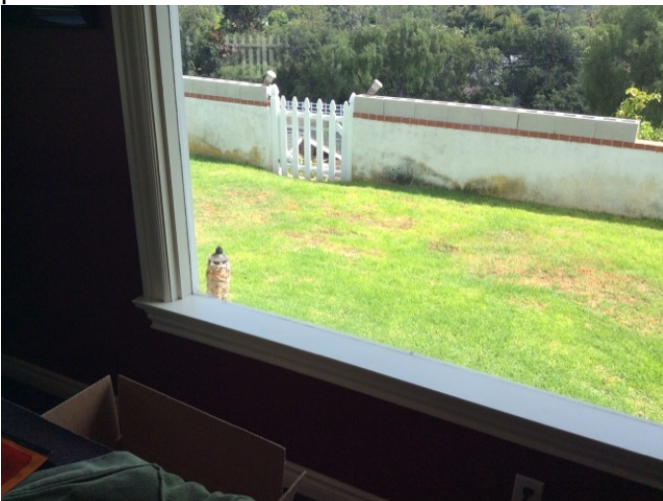
SC CR RU Some of the windows are not safety glass, as required by present standards, and could be hazardous if broken. Safety glass is more impact-resistant and less likely to cause an injury. Upgrading to present standards should be considered.

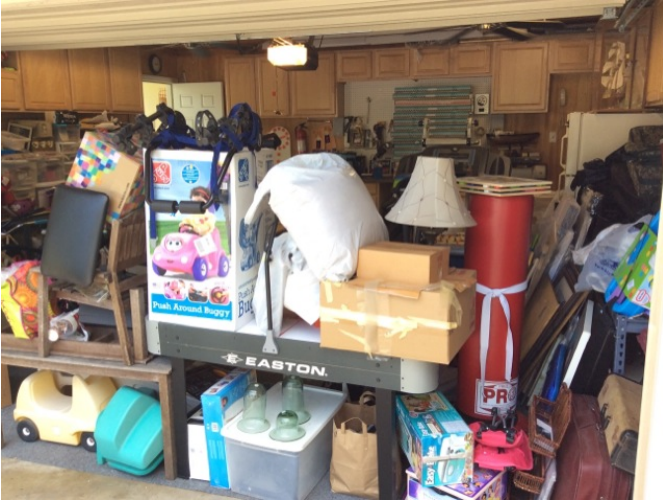
GENERAL COMMENT

FE Due to the presence of personal belongings, access to portions of the area were effectively blocked at the time of our inspection. A 'walk-through' is recommended when the area is cleared and accessible.

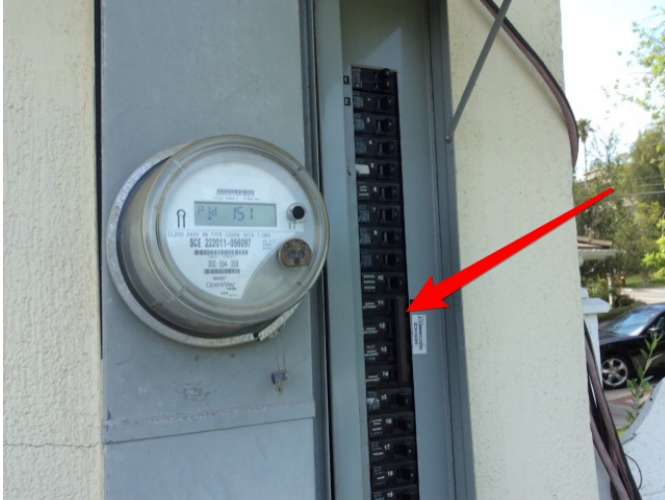
ELECTRICAL SYSTEM

The meter and main electrical service panel are outside on the left side of the building.

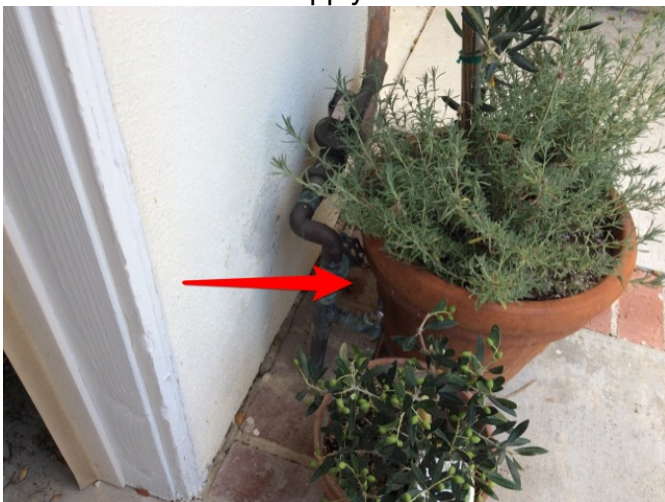
PLUMBING

The domestic water supply main shut-off valve is outside at the front of the building.
