Inspection Report

Property Address:
1807 Clark Ln Unit B
Redondo Beach CA 90278

Property Address 1807 Clark Ln Unit B Redondo Beach CA 90278	Date of Inspection 1/28/2021	Report ID 20210128-1807-Clark-Ln-Unit-B
Customer(s) Sheila Podgurski	Time of Inspection 12:30 PM	Real Estate Agent Joseph Safranek SouthBayLA Realty, Inc.

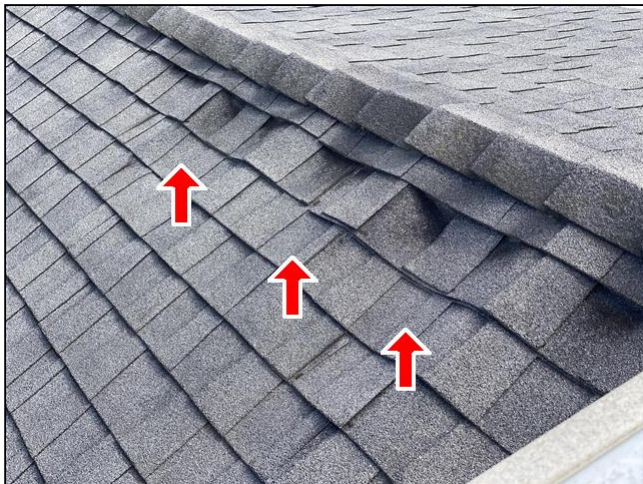
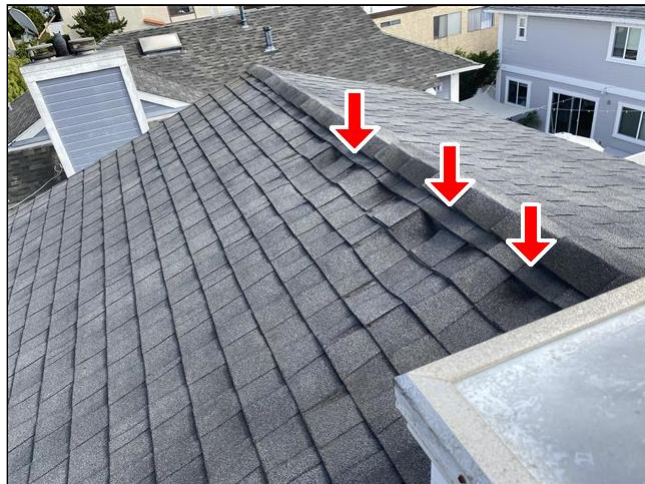
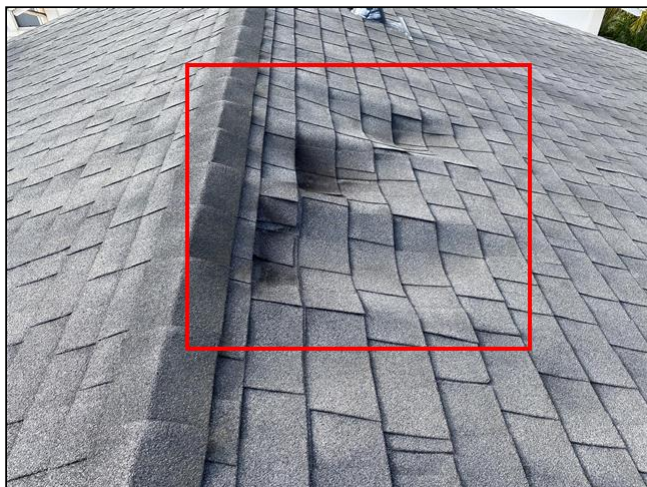
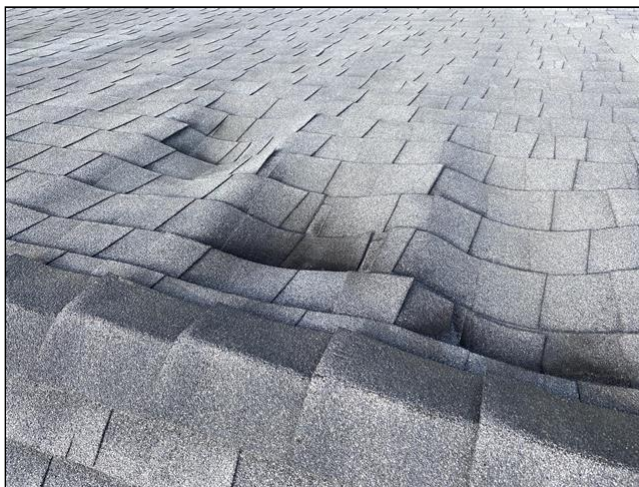
- 1. Major Concern:** The sheathing for the roofing at the rear North slope of the roof has sagged between the rafters of the roofing structure. This would suggest that the sheathing is deteriorated and/or missing. It is suggested that the shingles be removed to view the sheathing to determine how much is in need of replacement. A qualified roofing contractor should inspect the roofing to provide replacement options and costs.

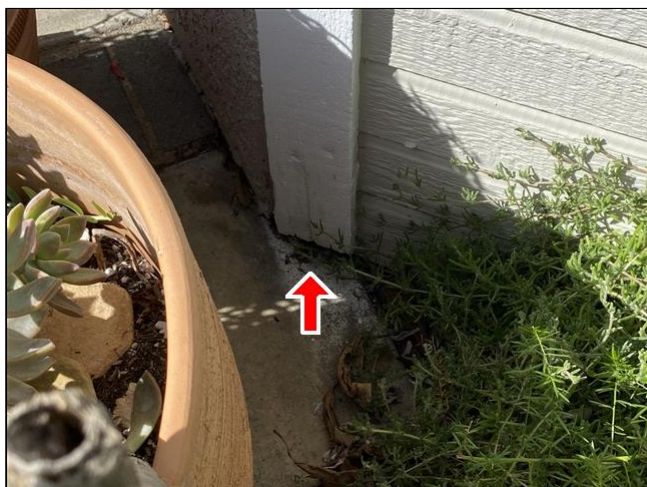
Item 2 - Item 1(Picture) Exterior

2. (1) **Repair or Replace:** Wood deterioration was observed at the base of the siding at the front East exterior wall. If the home inspection reveals signs of damage you should have a pest control company inspect further for activity and possible hidden damage. Suggest repair/replacement of all deteriorated wood by a licensed contractor.

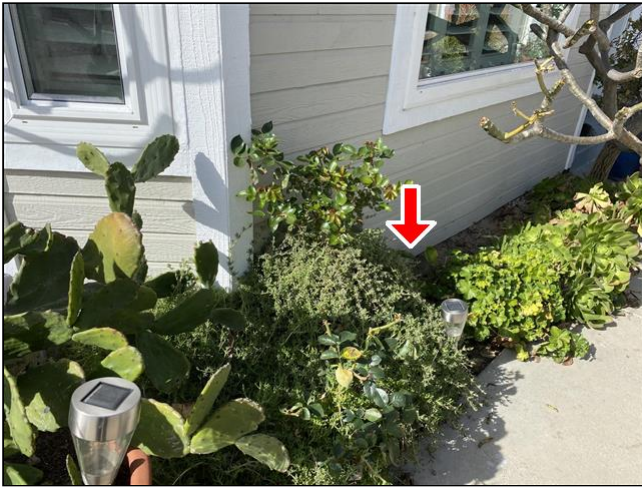
Item 3 - Item 1(Picture) Exterior

3. (2) **Improve:** The siding is in contact with ground at East wall of the home. Because the siding is in contact with ground it is possible for framing to be deteriorated. We did not inspect behind this siding. Recommend a ground clearance to prevent damage to the siding.

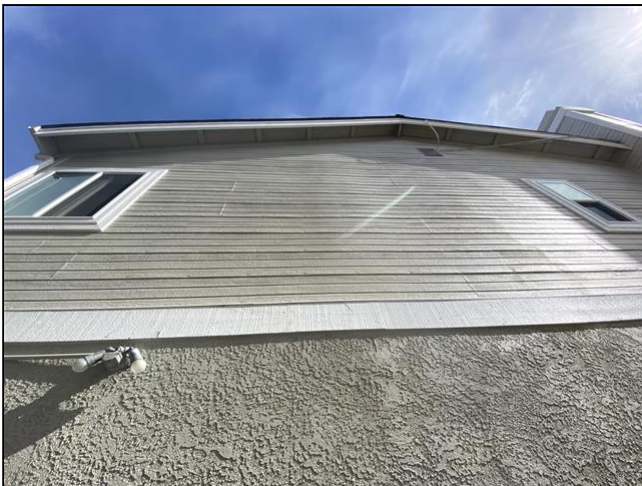
Item 4 - Item 1(Picture) Exterior

4. (3) **Repair/Replace/Monitor:** The siding at the exterior is warped in various locations. Further warping of siding can occur if loose nails are not tightened. A qualified person should repair or replace as needed.

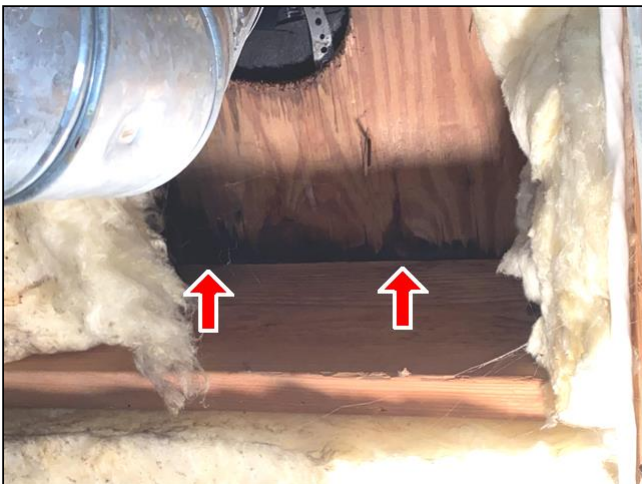
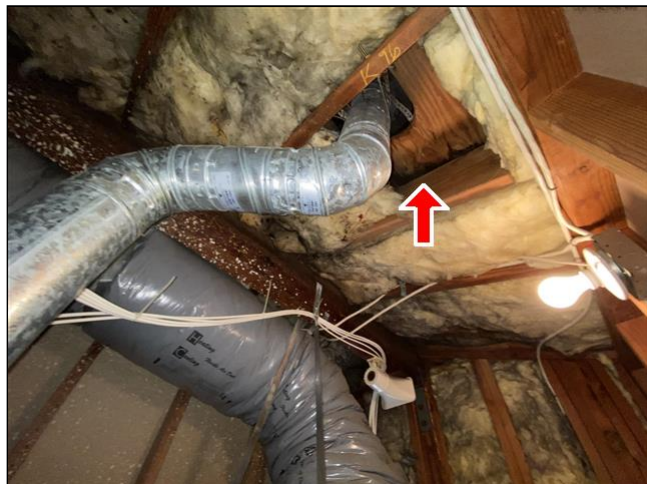
5. **Repair/Replace/Monitor:** Water staining was observed on the underside of the roof sheathing. The insulation on the underside of the sheathing prevents full view of the sheathing. Suggest referring to the "Roof" section of this regarding additional information and concerns regarding the roofing.

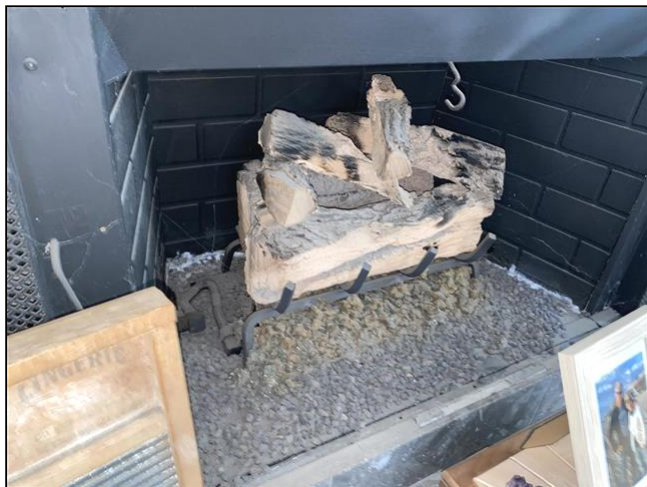
Item 6 - Item 1(Picture) Fireplace

6. **Safety Issue:** The wire mesh screens for the gas fireplace have been removed. It is suggested that the screens be replaced by a qualified professional for safety reasons.

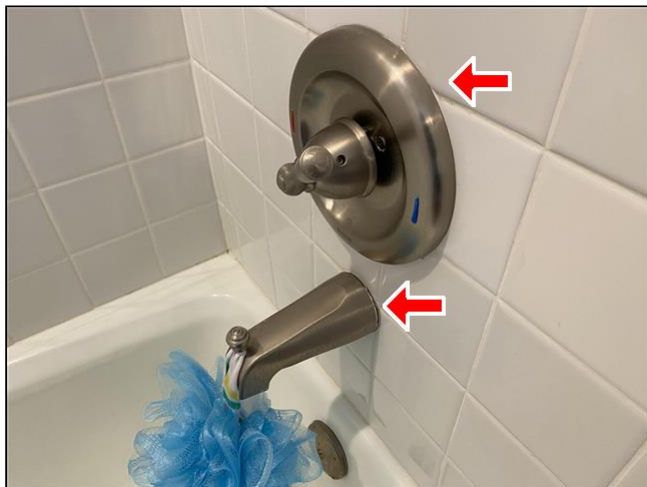
Item 7 - Item 1(Picture) Plumbing System

7. **Repair or Replace:** Suggest the application of caulking between the bathroom tub spout and operation valve cover plates to prevent moisture damage.

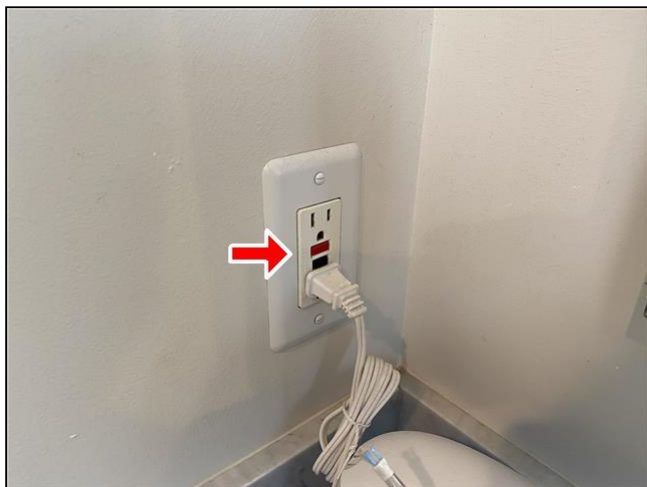
Item 8 - Item 1(Picture) Electrical System

8. **Safety Issue:** The GFCI (Ground Fault Circuit Interrupter) outlet at the master bathroom did not "trip" when tested. Suggest further investigations and repair/replacement of the GFCI outlet by a qualified electrician.

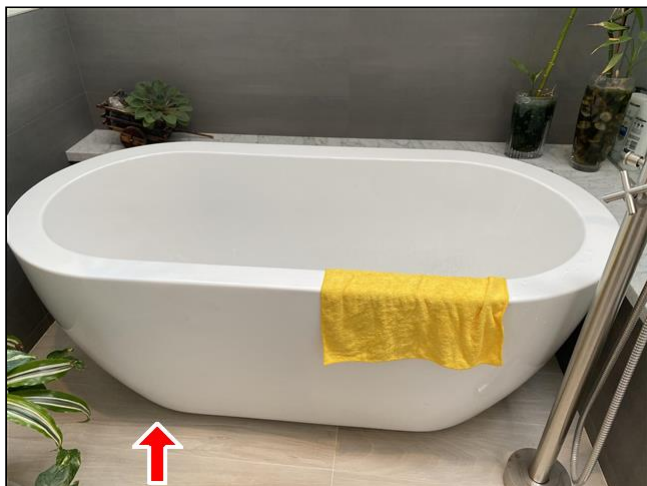
Item 9 - Item 1(Picture) Interiors

9. **Repair or Replace:** The master bathroom tub is loose at the floor. Suggest repair.

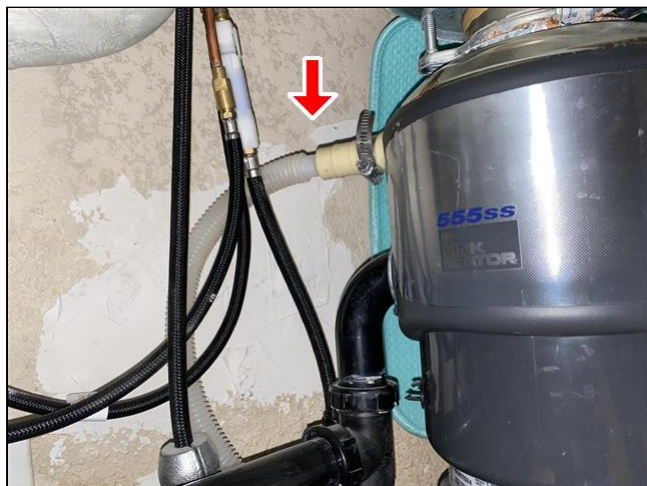
Item 10 - Item 1(Picture) Appliances

10. **Repair or Replace:** The dishwasher drain hose has been attached directly into the waster disposal unit. The air gap has been bypassed. It is suggested that the air gap for the dishwasher be installed so that waste water does not drain back into the dishwasher.

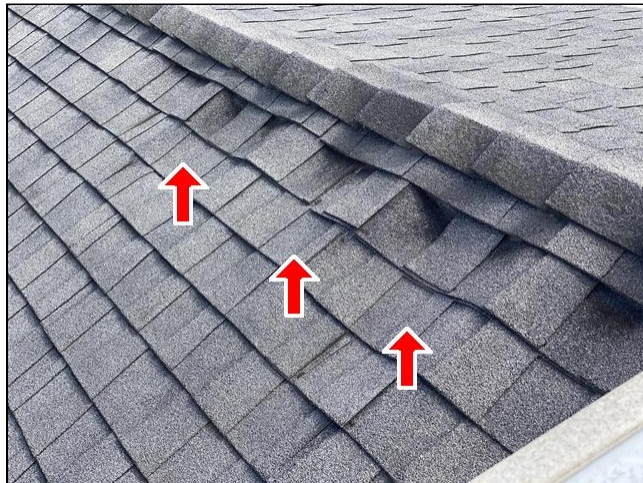
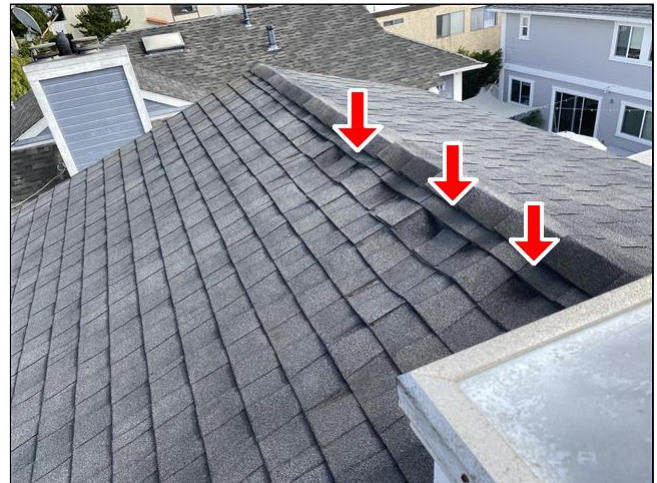
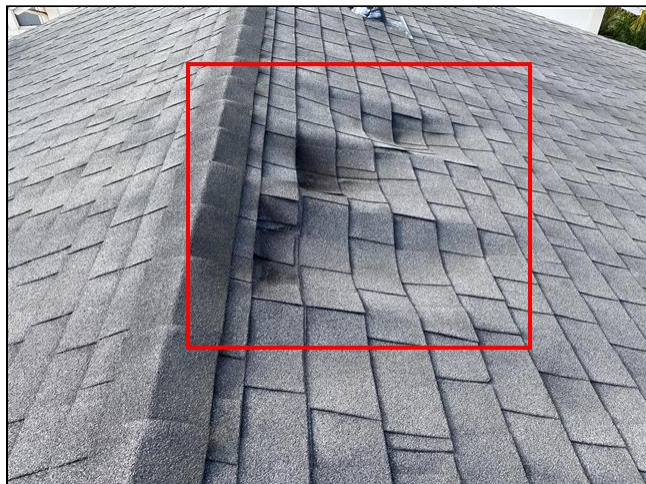
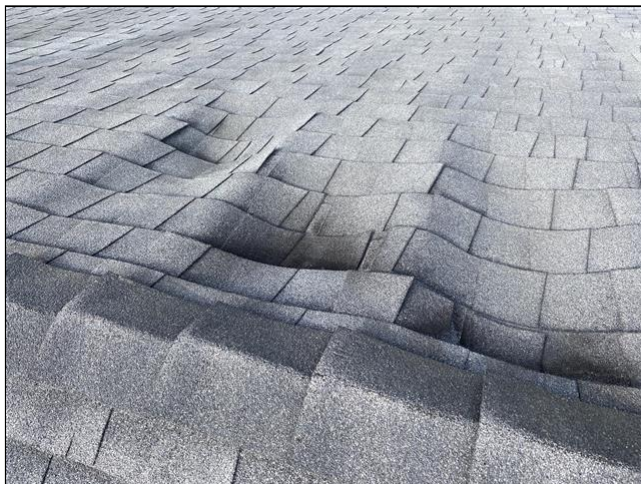
Major Concern: The sheathing for the roofing at the rear North slope of the roof has sagged between the rafters of the roofing structure. This would suggest that the sheathing is deteriorated and/or missing. It is suggested that the shingles be removed to view the sheathing to determine how much is in need of replacement. A qualified roofing contractor should inspect the roofing to provide replacement options and costs.

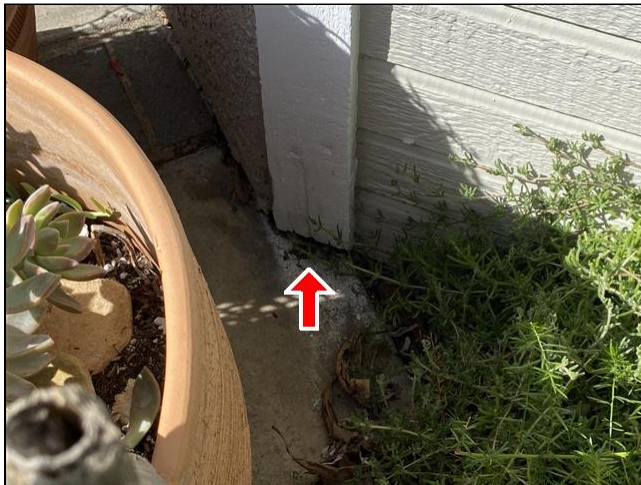
2.0 Item 1(Picture) Exterior

(1) **Repair or Replace:** Wood deterioration was observed at the base of the siding at the front East exterior wall. If the home inspection reveals signs of damage you should have a pest control company inspect further for activity and possible hidden damage. Suggest repair/replacement of all deteriorated wood by a licensed contractor.

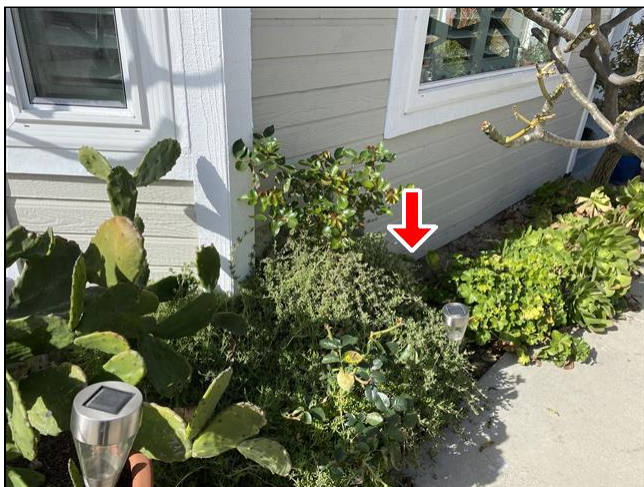
2.0 Item 2(Picture) Exterior

(2) **Improve:** The siding is in contact with ground at East wall of the home. Because the siding is in contact with ground it is possible for framing to be deteriorated. We did not inspect behind this siding. Recommend a ground clearance to prevent damage to the siding.

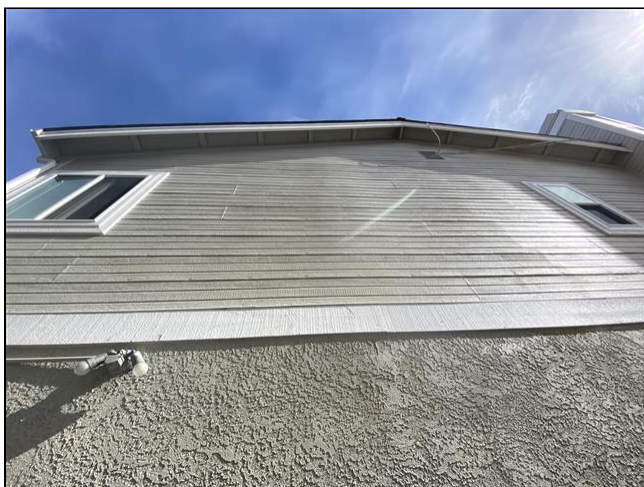
2.0 Item 3(Picture) Exterior

(3) **Repair/Replace/Monitor:** The siding at the exterior is warped in various locations. Further warping of siding can occur if loose nails are not tightened. A qualified person should repair or replace as needed.

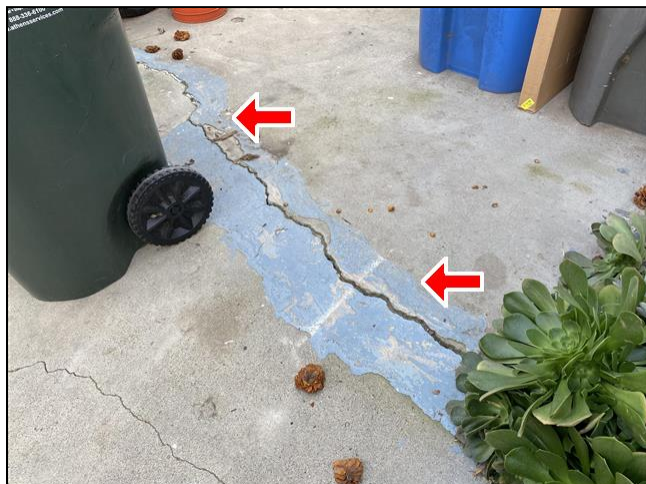
2.4 Item 1(Picture) Exterior

(1) **Repair or Replace:** The rear concrete patio is cracked. It appears that the patio is cracked due to settlement. Suggest repair/replacement by a qualified professional as needed.

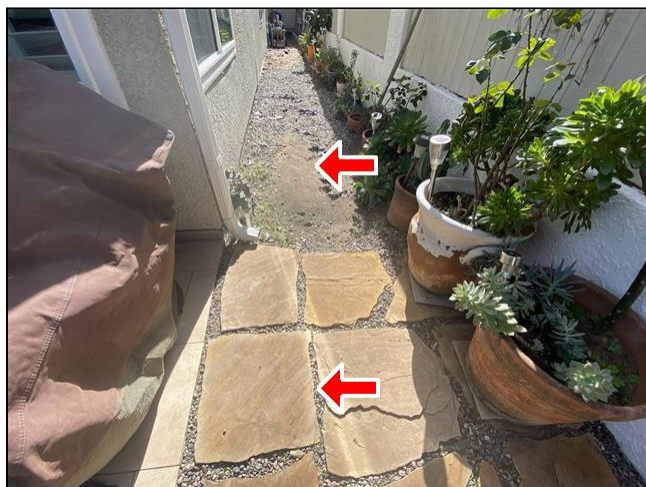
2.4 Item 2(Picture) Exterior

(2) **Improve/Monitor:** There is a negative slope towards the home at the rear wall. This configuration can cause or contribute to water intrusion or deterioration of the foundation. It is recommend that the landscape be corrected to drain water away from home.

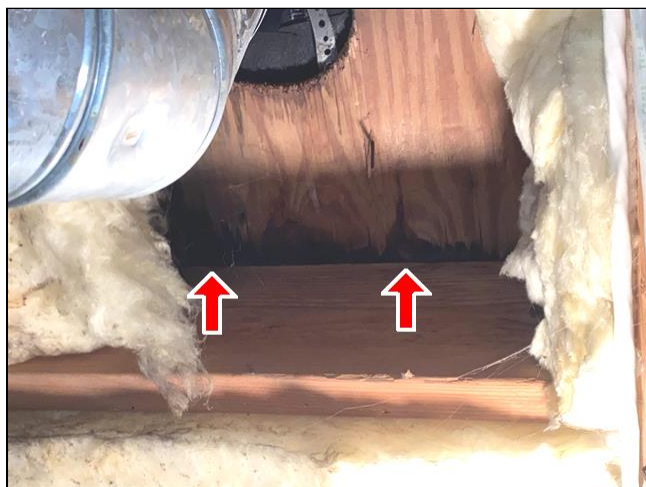
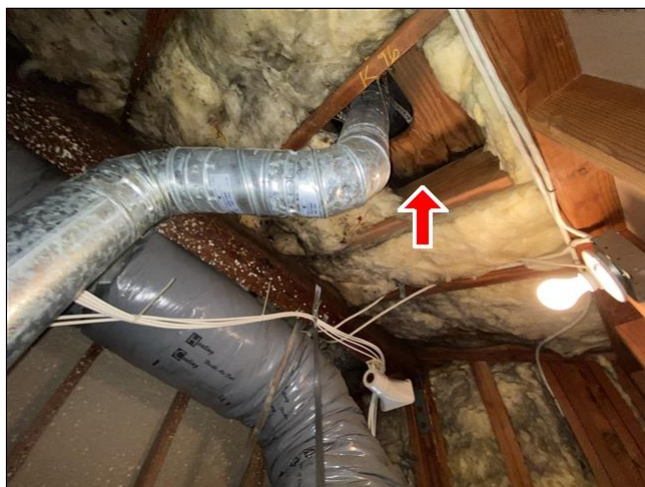
Repair/Replace/Monitor: Water staining was observed on the underside of the roof sheathing. The insulation on the underside of the sheathing prevents full view of the sheathing. Suggest referring to the "Roof" section of this regarding additional information and concerns regarding the roofing.

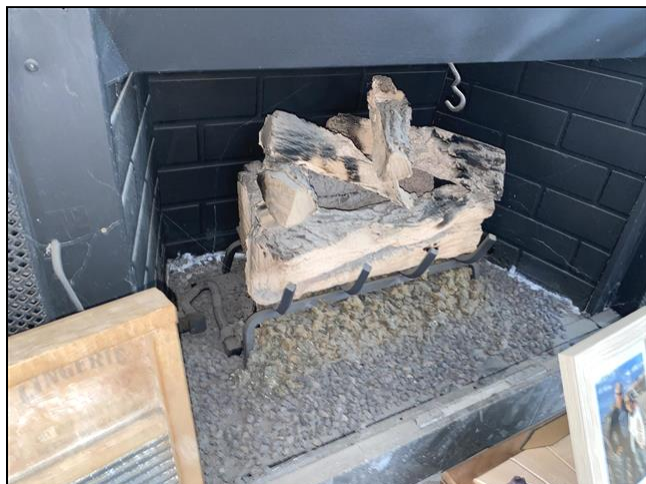
4.13 Item 1(Picture) Fireplace

Safety Issue: The wire mesh screens for the gas fireplace have been removed. It is suggested that the screens be replaced by a qualified professional for safety reasons.

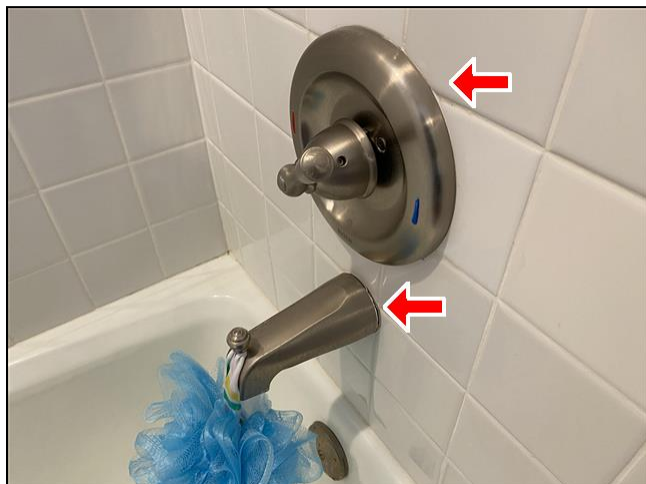
5.1 Item 1(Picture) Plumbing System

Repair or Replace: Suggest the application of caulking between the bathroom tub spout and operation valve cover plates to prevent moisture damage.

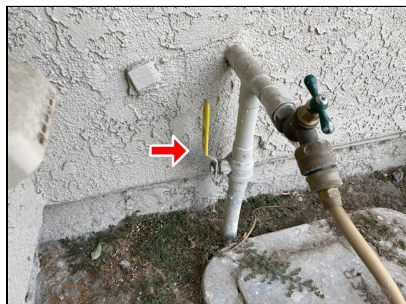
5.4 Item 1(Picture) Plumbing System

Inspected: The main water shut off valve is located at the front wall of the home.

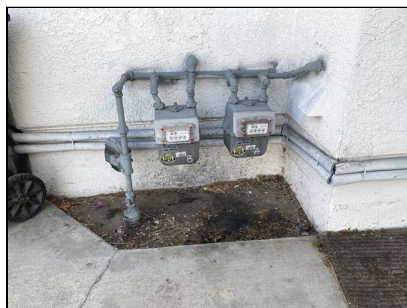
5.5 Item 1(Picture) Plumbing System

(1) **Inspected:** The main gas meter is located at the East wall of the home.

(2) **Improve:** The main gas meter lacks a seismic shut off valve. It is suggested that one be installed by a licensed plumber as needed and required.

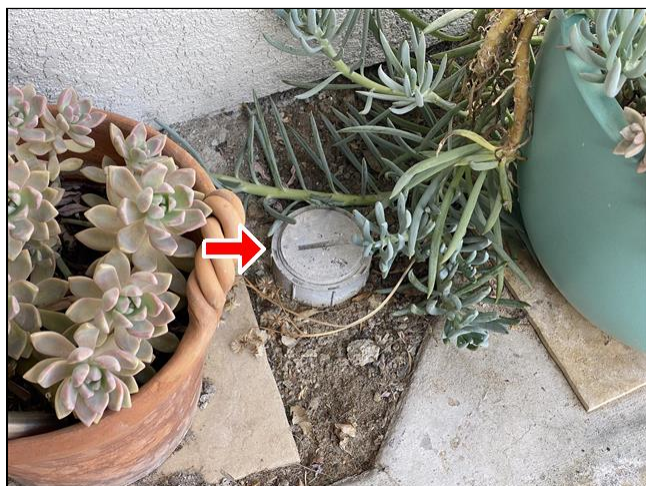
5.6 Item 1(Picture) Plumbing System

Inspected: The main clean out for the sewer line is located at the front South exterior wall.

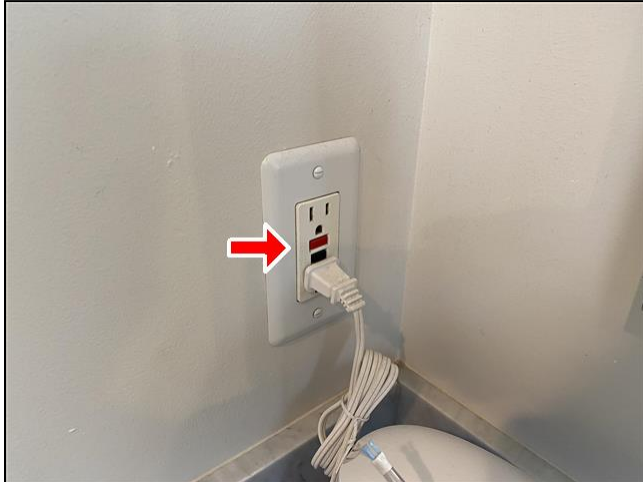
6.2 Item 1(Picture) Electrical System

Safety Issue: The GFCI (Ground Fault Circuit Interrupter) outlet at the master bathroom did not "trip" when tested. Suggest further investigations and repair/replacement of the GFCI outlet by a qualified electrician.

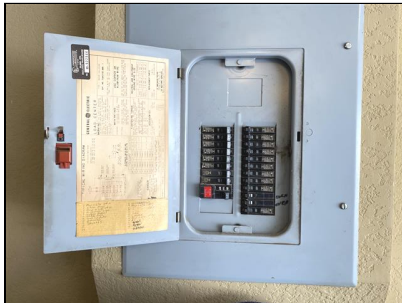
6.5 Item 1(Picture) Electrical System

Inspected: The main service disconnect is located at the front building. The electrical sub-panel is located at the garage.

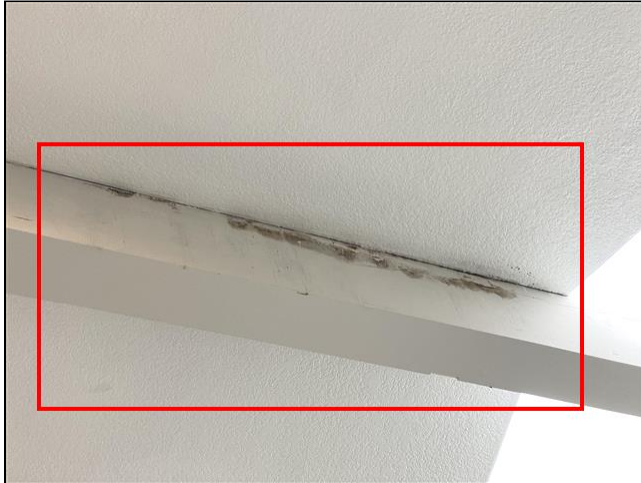
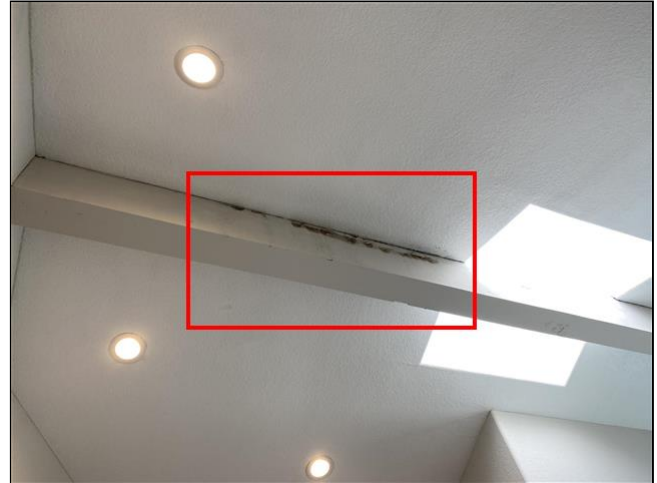
Safety Issue/Improve/Monitor: Water staining was observed at the second floor ridge beam. Also, there is surface growth on the interior surface of the ridge beam. This may indicate the presence of a roof leak(s), mold, fungus or other microbial organisms. The identification of molds, fungus and other microbial organisms is outside the scope of this inspection. We suggest a qualified environmental specialist should be retained to evaluate the surfaces and make further recommendations. Testing and remediation of mold growth can only be accomplished by a qualified environmental specialist. If strict protocol is not followed, spores can be released into the interior of the building and may create a health hazard for those with low tolerances to such organisms.

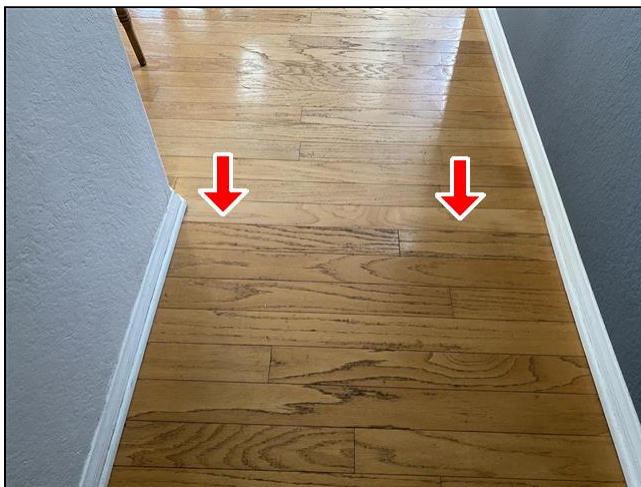
8.2 Item 1(Picture) Interiors

Monitor: The floor at the North first floor hallway between the kitchen and dining room have an apparent slope. Unable to determine the reason for the sloped for in this location at the time of the inspection.

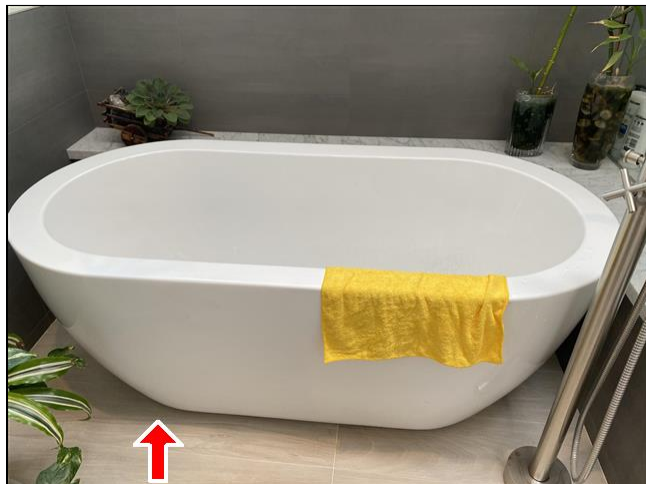
8.9 Item 1(Picture) Interiors

Repair or Replace: The master bathroom tub is loose at the floor. Suggest repair.

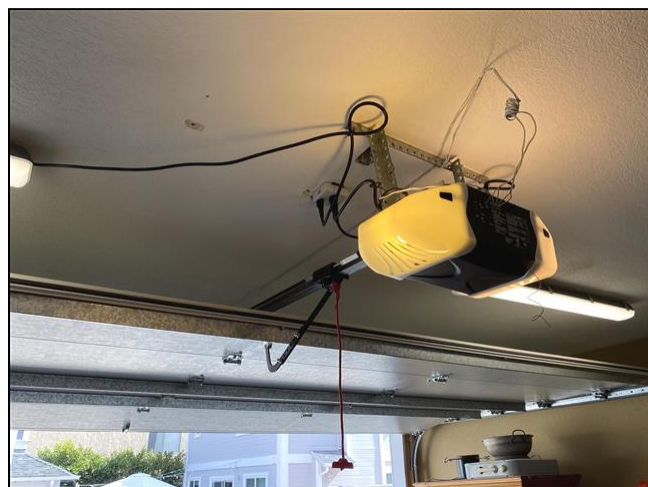
9.2 Item 1(Picture) Garage

Monitor: The garage door and opener were functional and opened and closed the door. The light beams responded when tested and caused the door(s) to stop and auto reverse. Testing of the downward force (pressure test) was not performed as this can damage the door and is outside the scope of this inspection. Proper operation of the reversing mechanism should be verified prior to the close of the inspection contingency period. Information on garage door openers is available from the Consumer Product Safety Commission at www.cpsc.gov.

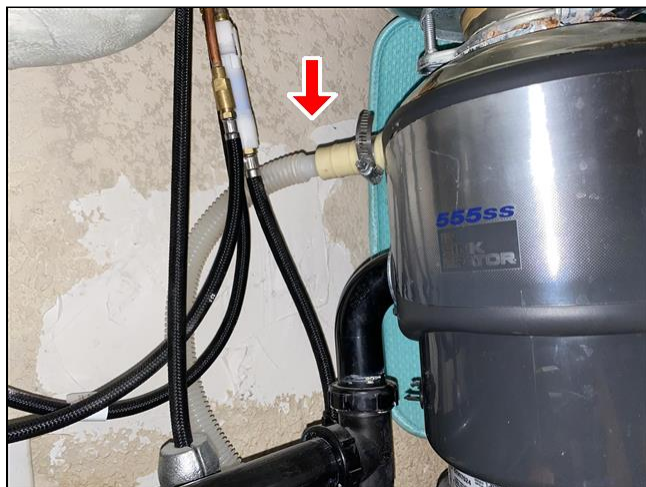
10.0 Item 1(Picture) Appliances

Repair or Replace: The dishwasher drain hose has been attached directly into the waster disposal unit. The air gap has been bypassed. It is suggested that the air gap for the dishwasher be installed so that waste water does not drain back into the dishwasher.
