WOOD DESTROYING PESTS AND ORGANISMS INSPECTION REPORT

Building No. 33313	Street Iris	City Green Valley Lake	ZIP	Date of Inspection 02/22/2018	Number of Pages 4
-----------------------	----------------	---------------------------	-----	----------------------------------	----------------------

Report # : 44512
 Registration # : PR3942
 Escrow # :
 CORRECTED REPORT

GENERAL DESCRIPTION: Two-story single family residence.	Inspection Tag Posted: Subarea Other Tags Posted: none noted
--	---

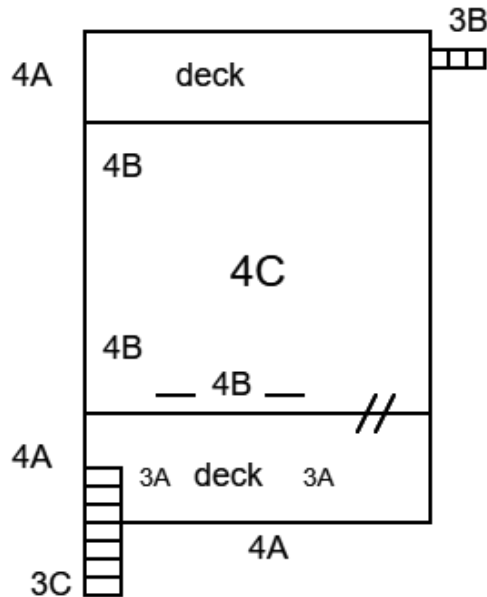
Diagram Not To Scale

FINDING - Surface fungus noted at joist beams under front deck. RECOMMENDATION - Scrape and treat surface fungus with Timbor (Disodium Octaborate Tetrahydrate), a product registered with the State of California for the control of fungus. This treatment may reveal additional findings.

FINDING - Wood decay noted at one 4x6 joist beam on rear deck. RECOMMENDATION - Remove decayed wood and/or damaged portion(s) and replace with new material. (This bid excludes priming, painting or staining. If any party to the transaction wishes the wood primed, painted or stained, they should contact Home Defenders for a bid to prime, paint or stain repaired wood. Home Defenders assumes no responsibility for damage to bare wood.) This repair may reveal additional findings.

FINDING - Wood decay noted at entry steps construction. RECOMMENDATION - Remove decayed wood and/or damaged portion(s) and replace with new material. (This bid excludes priming, painting or staining. If any party to the transaction wishes the wood primed, painted or stained, they should contact Home Defenders for a bid to prime, paint or stain repaired wood. Home Defenders assumes no responsibility for damage to bare wood.) This repair may reveal additional findings.

FINDING - Earth to wood contact noted at post construction siding and deck by back.

FINDING - Evidence of carpenter ants noted at subarea and at T and G construction by back.

FINDING - Cellulose debris (wood, paper scraps, etc.) noted in the subarea.

RECOMMENDATION - Re-grade the soil level to break earth to wood contact. Removal of earth from wood members may reveal additional findings.

RECOMMENDATION - Chemically treat the area with Cykick (Cyflurin), and/or Dagnet (Permethrin), and/or Suspend (Deltamethrin) and/or Talstar (Bifenthrin) and/or Termidor (Fipronil), and/or Timbor (Disodium Octaborate Tetrahydrate), products registered with the State of California for the control of carpenter ants. Remove or cover all accessible frass. (90 day guarantee). *****This is a Section 1 item.*****

RECOMMENDATION - Remove to outside of structure all cellulose debris of a size that can be raked or larger. Removal of cellulose debris may reveal additional findings.
