# EQUITY BUILDING INSPECTION

## PROPERTY INSPECTION REPORT

2505 MacKay Ln  
Redondo Beach CA 90278

Bill Baird  
MARCH 20, 2019

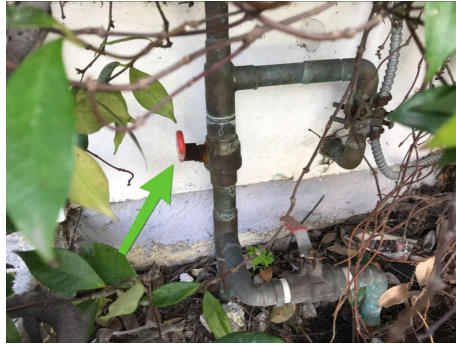
Front

**Water Shut Off**

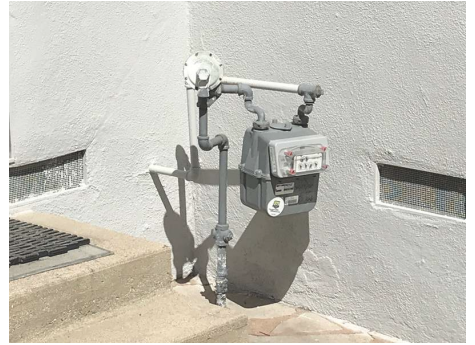
Rear

**Gas Shutoff**

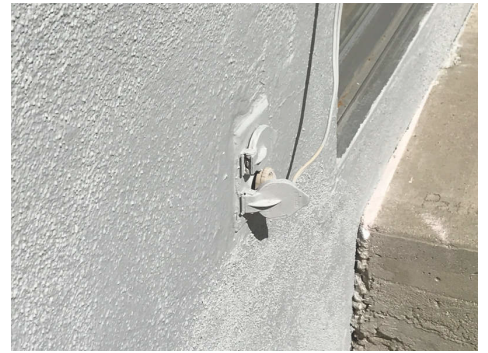
Left side

There is one or more outlets that are being utilized full time. This requires a weather protective cover. We recommend repair.

Contact a qualified electrical contractor.

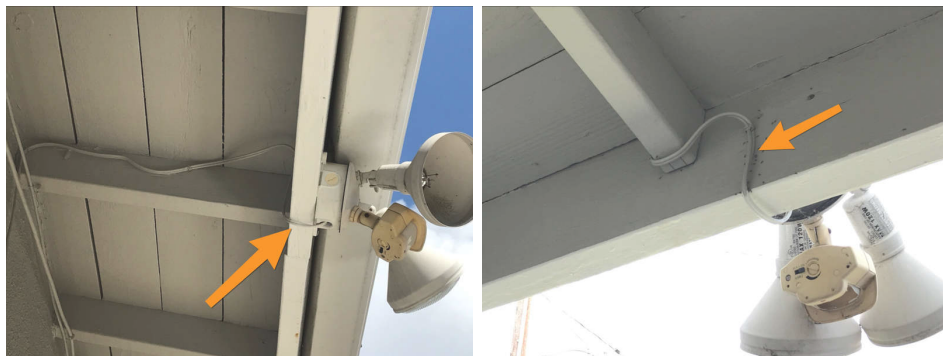
2.6.2 Electrical & Other

**IMPROPER INSTALLATION**

There is improperly installed electrical wires and or fixtures. We recommend further inspection and repair.

Contact a qualified professional.

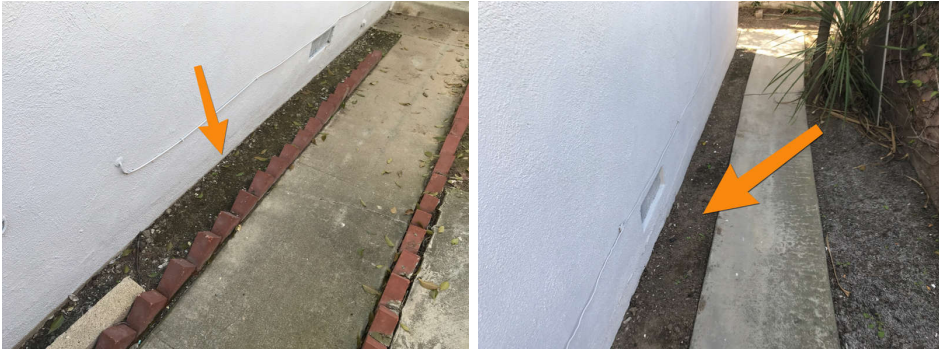
The soil or grading sloped down towards building perimeters in one or more areas. This can result in water accumulating around building foundations or underneath buildings. It can be a conducive condition for wood-destroying organisms. Recommend grading soil so it slopes down and away from buildings with a slope of at least 1 inch per horizontal foot for at least 6 feet out from buildings and/or a qualified licensed contractor install a retaining wall.

Contact a qualified landscaping contractor

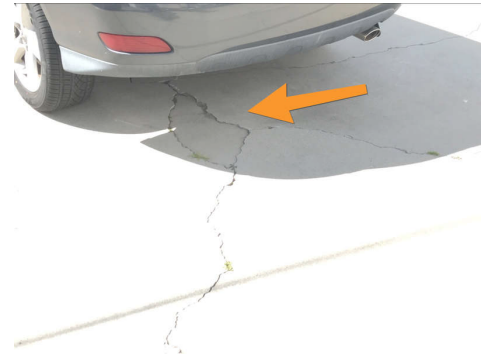
3.5.1 Driveways, Sidewalks, Patios

**DRIVEWAY CRACKS / DETERIORATION - REPAIR**

Cracks, holes, settlement, heaving and/or deterioration were found in the driveway. Recommend that qualified contractor repair as necessary.

Contact a qualified concrete contractor.

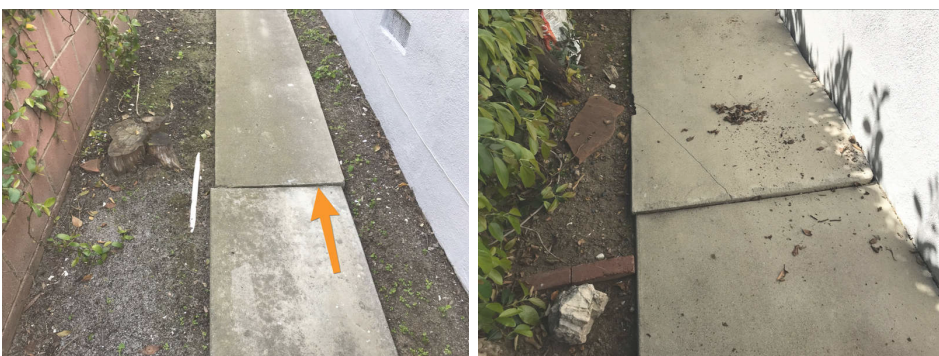
3.5.2 Driveways, Sidewalks, Patios

**WALKWAY TRIP HAZARD**

There is a trip hazard located on this walkway. We might recommend repair of this trip hazard to prevent a trip and fall hazard.

Contact a qualified professional.

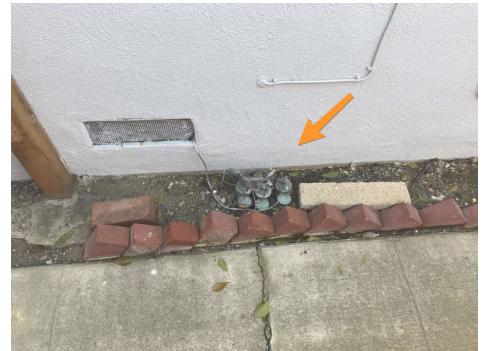
3.12.1 Irrigation

The irrigation anti-siphon valves are too low in comparison to the surrounding grade. They must be 6 inches above the highest adjacent grade. We recommend repair.

Contact a qualified professional.

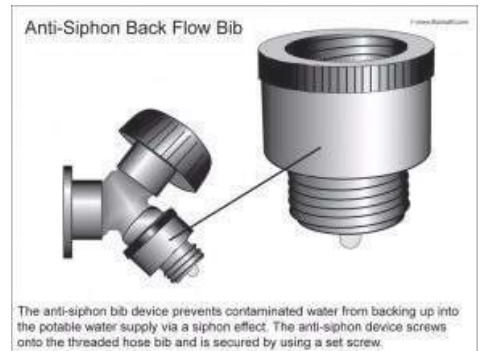
3.13.1 Plumbing Supply Lines

**HOSE BIB MISSING BACKFLOW PREVENTER**

One or more hose bibs were missing backflow prevention devices. These devices reduce the likelihood of gray water entering the potable water supply. Recommend installing backflow prevention devices on all hose bibs where missing. They are available at most home improvement stores and are easily installed.

Contact a handyman or DIY project

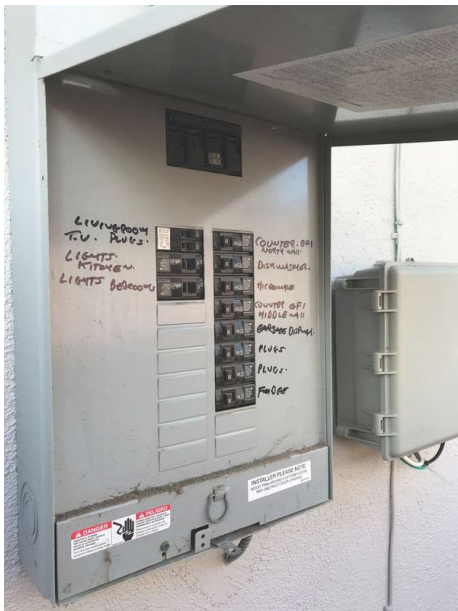
### Panel Wiring & Breakers : Panel Equipment Photographs

The main electrical panel, and its associated components, or found to be in serviceable condition with exceptions noted within.

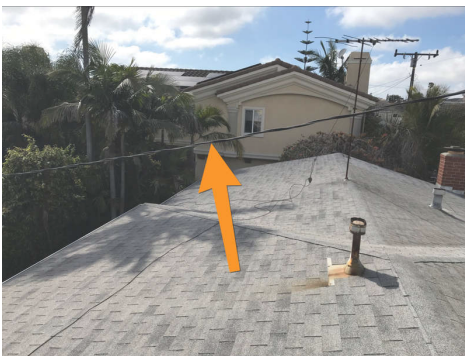
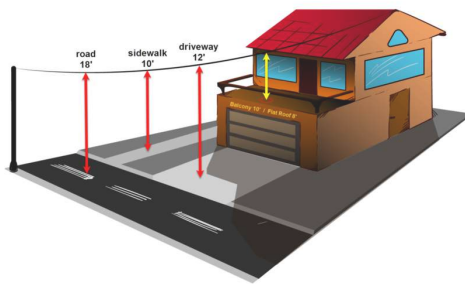
The overhead service drop conductors had inadequate clearance above the roof. The minimum clearances are as follows: -

The Inspector recommends that you consult with your electrical service provider to discuss options and costs for correction. Any work on the service conductors should be performed by a qualified personnel only.

Contact a qualified professional.

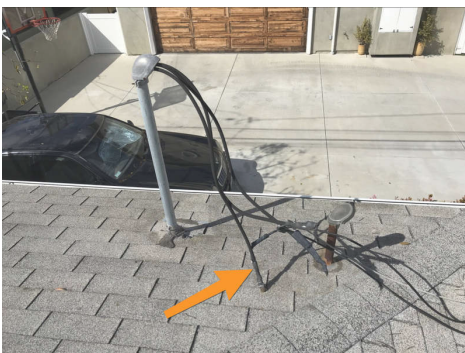
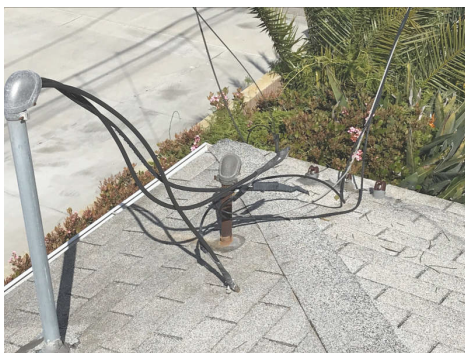
4.2.2 Service Drop, Drip Loop, Splice and Attachment

The overhead service-drop conductors were improperly installed and appeared to have been installed by persons not familiar with safe electrical practices. The Inspector recommends evaluation and correction of the electrical service by a qualified electrical contractor or the utility provider.

Contact a qualified professional.

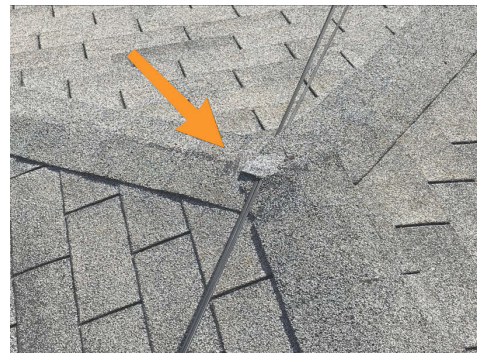
## 4.2.4 Service Drop, Drip Loop, Splice and Attachment

There are phone and or cable TV wires touching the roofing surface. This can cause damage to the wires and the roofing surface. We recommend repair by a qualified technician.

Contact a qualified professional.

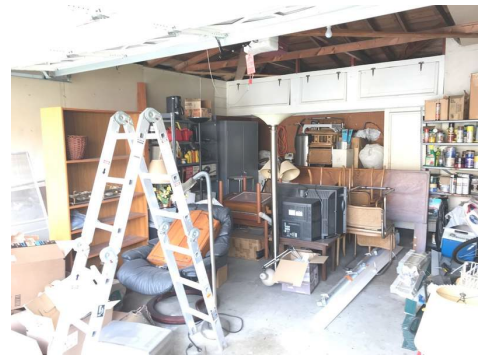
### PERSONAL BELONGINGS

We could not fully inspect the garage due to the amount of personal belongings. We recommend further inspection of the garage once it is vacant.

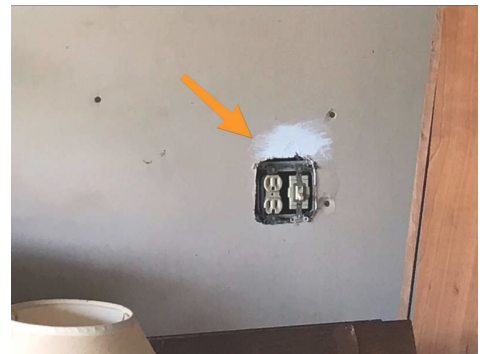
6.8.1 Switches / Receptacles

### COVER PLATE LOOSE / MISSING / DAMAGED

One or more cover plates for switches, receptacles (outlets) were missing and/or damaged. These plates are intended to contain fire and prevent electric shock from occurring due to exposed wires. Recommend that a qualified person install cover plates where necessary.

Contact a handyman or DIY project

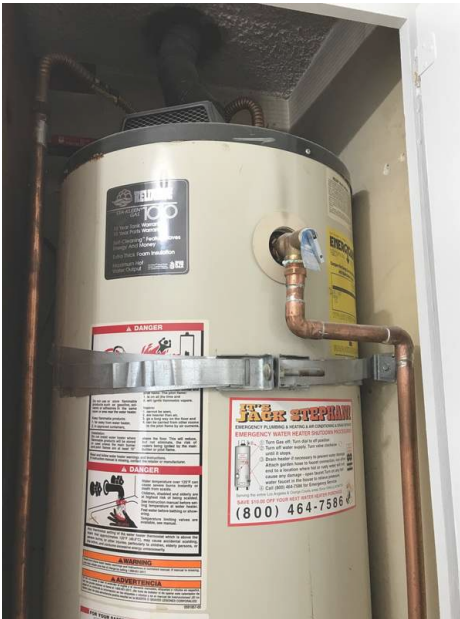
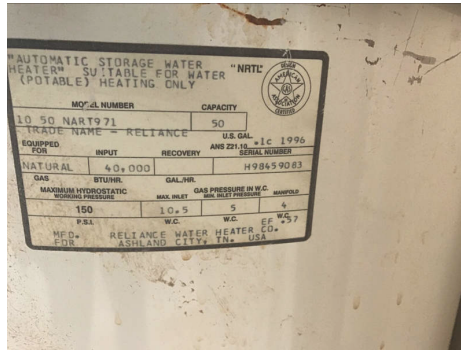
### Water Heater: Equipment Photo

**Water Heater: Earthquake straps**  
Yes

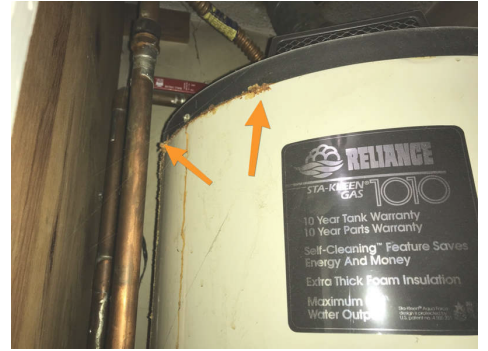
#### STAINS / DAMAGE BELOW / AROUND WATER HEATER

Contact a qualified plumbing contractor.

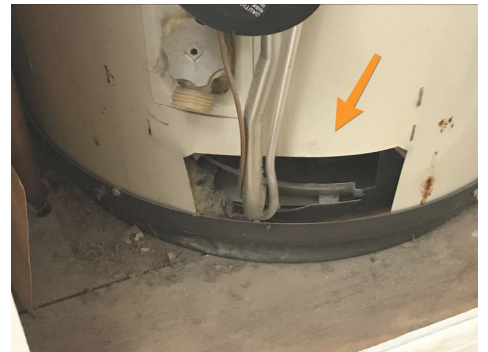
**INSPECTION DOOD MISSING**

The inspection door is either damaged or missing. We recommend repair.

Contact a qualified professional.
