Inspection Report

Property Address:
28068 Braidwood Dr
Rancho Palos Verdes CA 90275

Date: 7/23/2018	Time: 02:00 PM	Report ID: 20180723-28068-Braidwood-Dr
Property: 28068 Braidwood Dr Rancho Palos Verdes CA 90275	Customer: [REDACTED]	Real Estate Professional: [REDACTED] Coldwell Banker Wilshire Real Estate

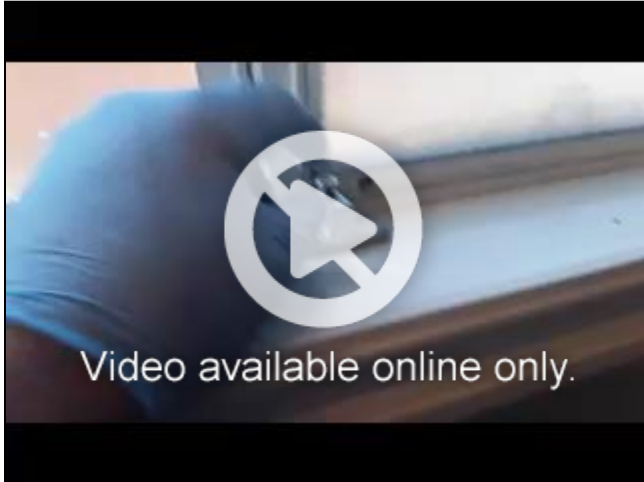
2.6 Item 1(Video)

2.6 One window is damaged at handle or lock hardware at the Private Bath Den (to downstairs). This is a small repair. A qualified person should repair or replace as needed.

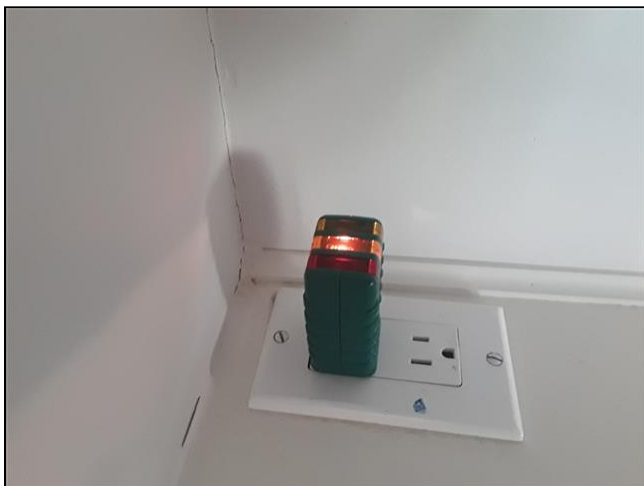
8.3 Item 1(Picture)

8.3 (1) One "three-prong" outlet is not grounded (at lower level). Electrical issues are considered a hazard until repaired This is a safety issue that needs to be corrected. A qualified licensed electrical contractor should perform repairs that involve wiring.

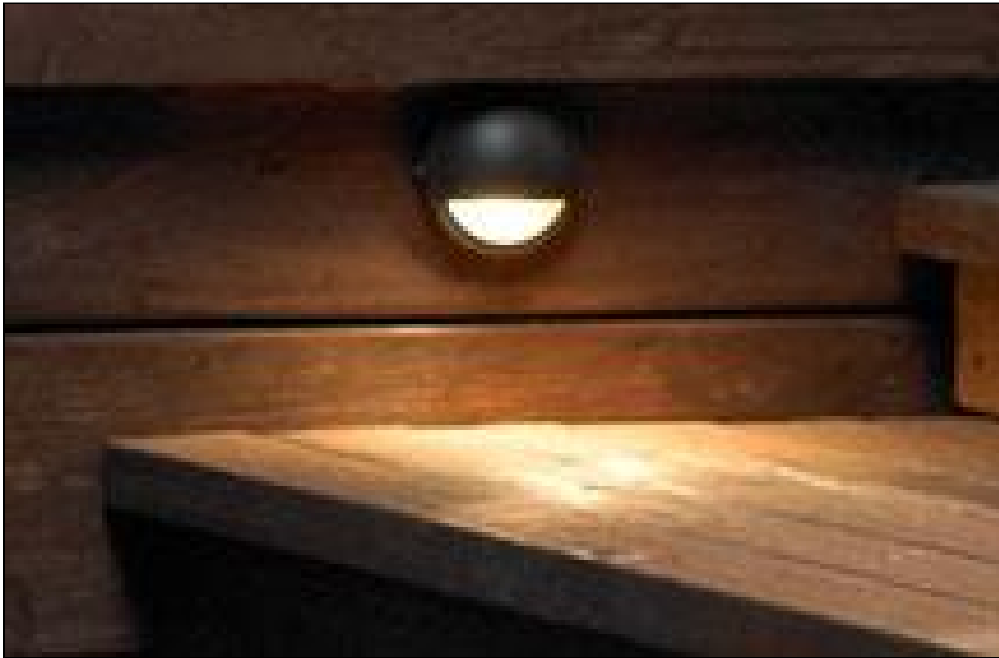
8.3 Item 5(Picture)

(2) **The exterior low profile light fixture at the landscape rear patio wall is loose. This is a safety issue that needs to be corrected. A qualified licensed electrical contractor should perform repairs that involve wiring.**

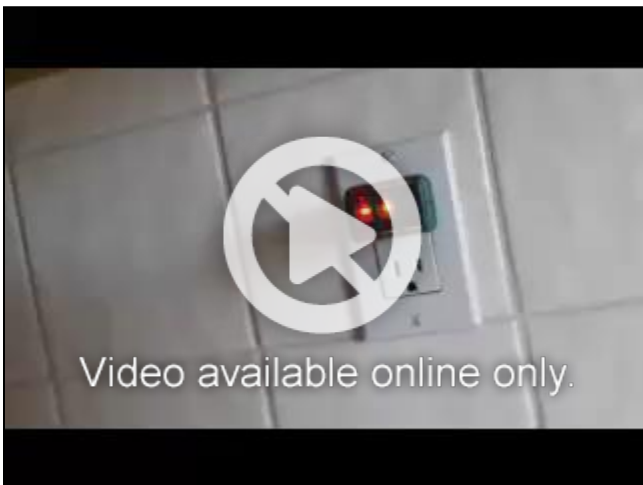
8.4 Item 1(Video)

8.4 (1) One "three-prong" outlet is incorrect "reverse polarity" and outdated and not a three-prong GFCI (Ground Fault Circuit Interrupt) in the kitchen. Electrical issues are considered a hazard until repaired This is a safety issue that needs to be corrected. A qualified licensed electrical contractor should perform repairs that involve wiring.

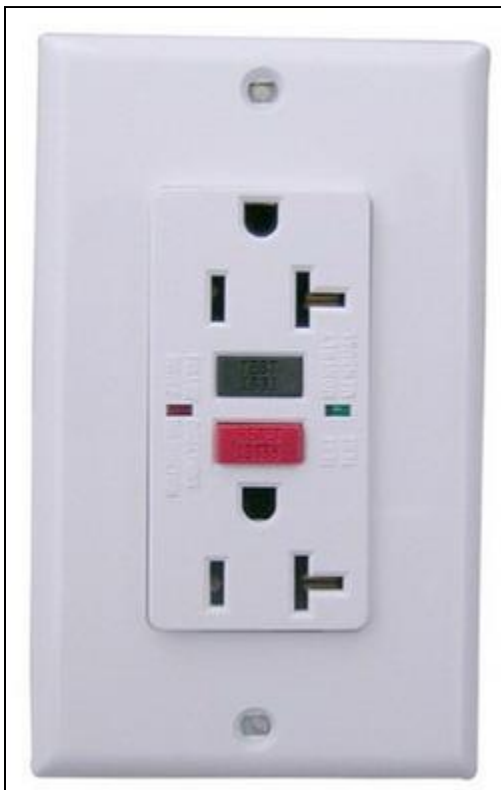
8.4 Item 5(Picture)

(4) One "three-prong" outlet is outdated and not a three-prong GFCI (Ground Fault Circuit Interrupt) (at lower level). Electrical issues are considered a hazard until repaired This is a safety issue that needs to be corrected. A qualified licensed electrical contractor should perform repairs that involve wiring.

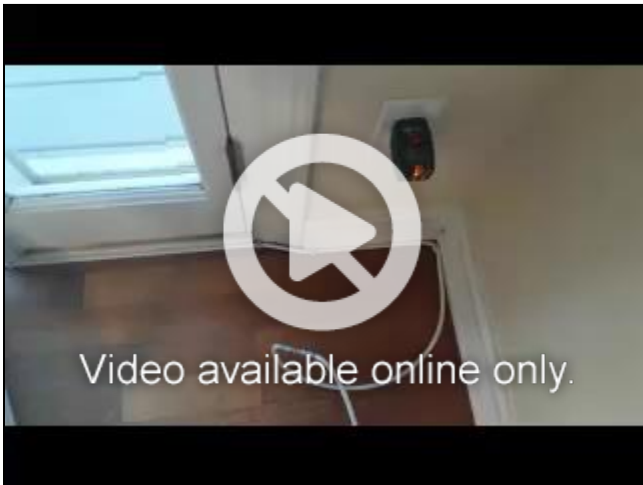
8.4 Item 6(Video)

(5) **One "three-prong" outlet is outdated and not a three-prong GFCI (Ground Fault Circuit Interrupt) (at lower level). Electrical issues are considered a hazard until repaired This is a safety issue that needs to be corrected. A qualified licensed electrical contractor should perform repairs that involve wiring.**

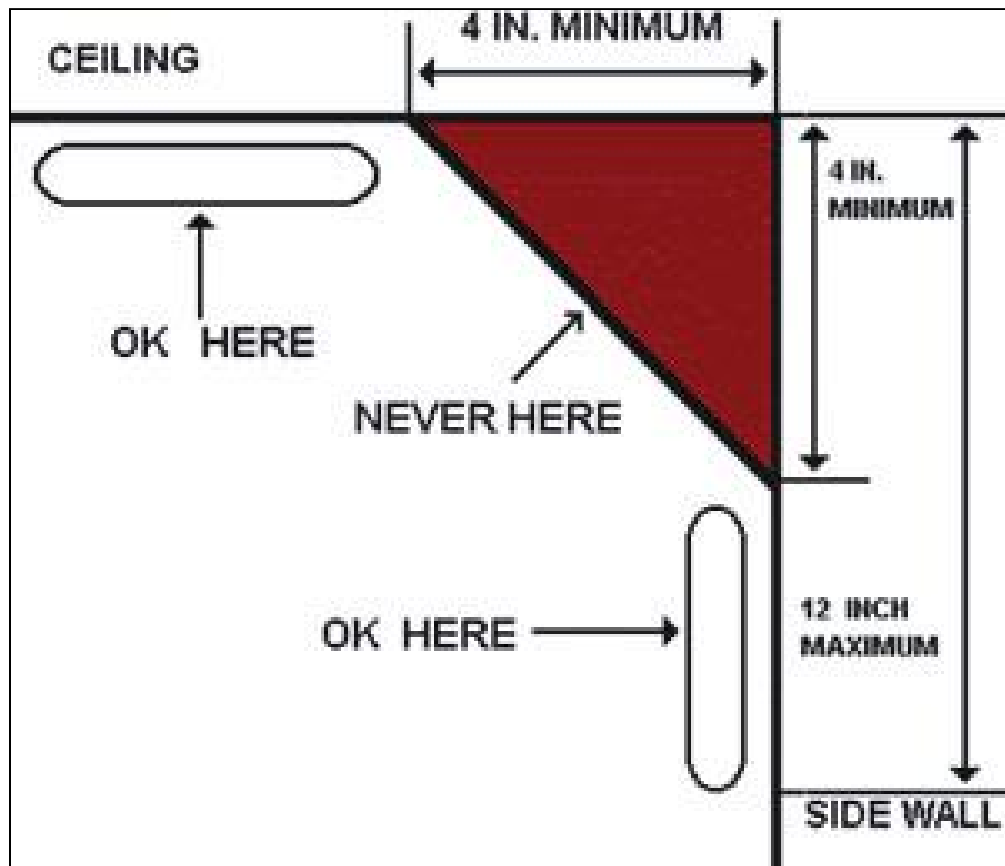
8.7 Item 1(Picture)

8.7 (1) The smoke detector needs locating at least 4 inches from ceiling/wall junction and no further than 12 inches away.

(2) A 10 year lithium battery smoke detector, approved and listed by the State Fire Marshall, shall be installed, according to the manufacturer's instructions, in each dwelling intended for human occupancy.

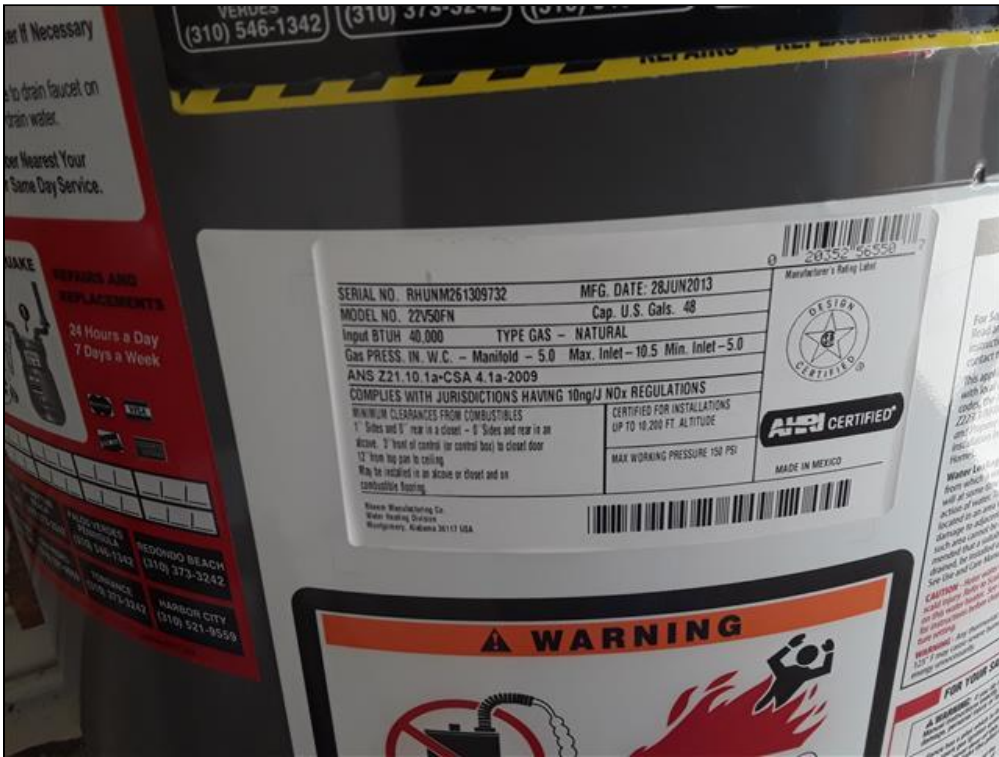
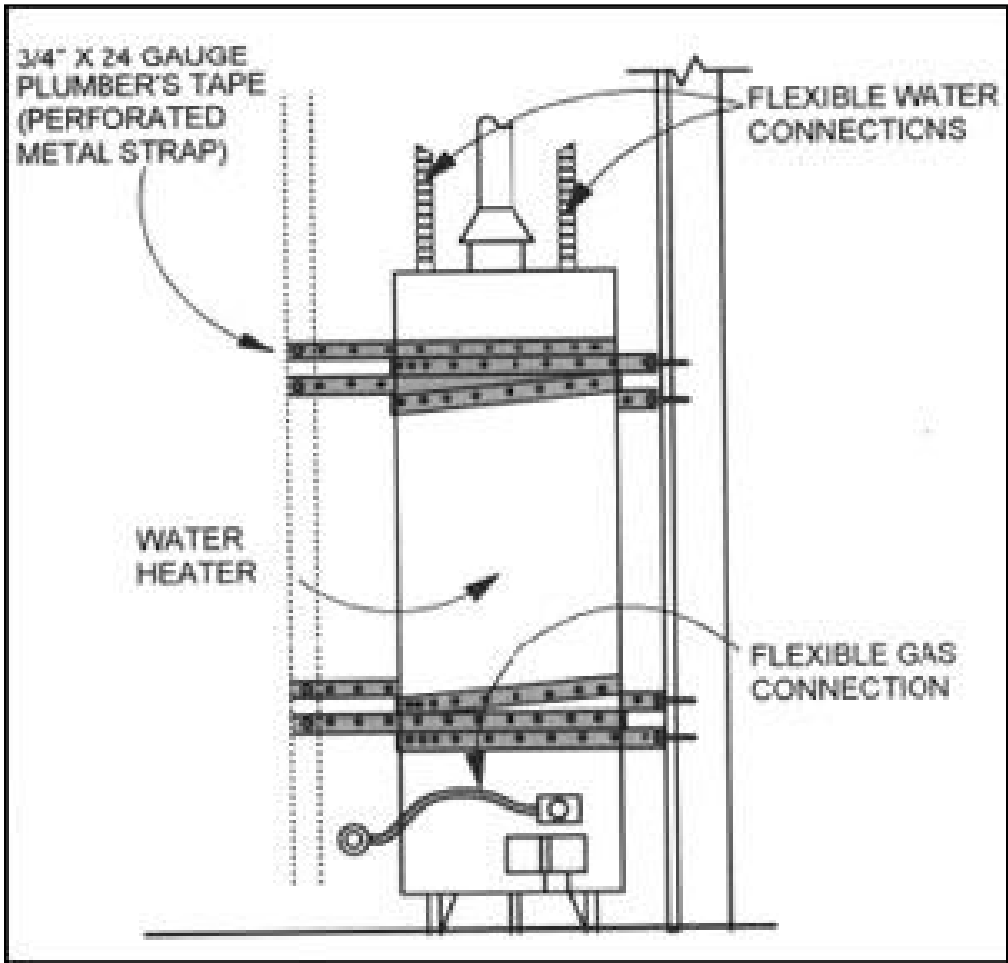
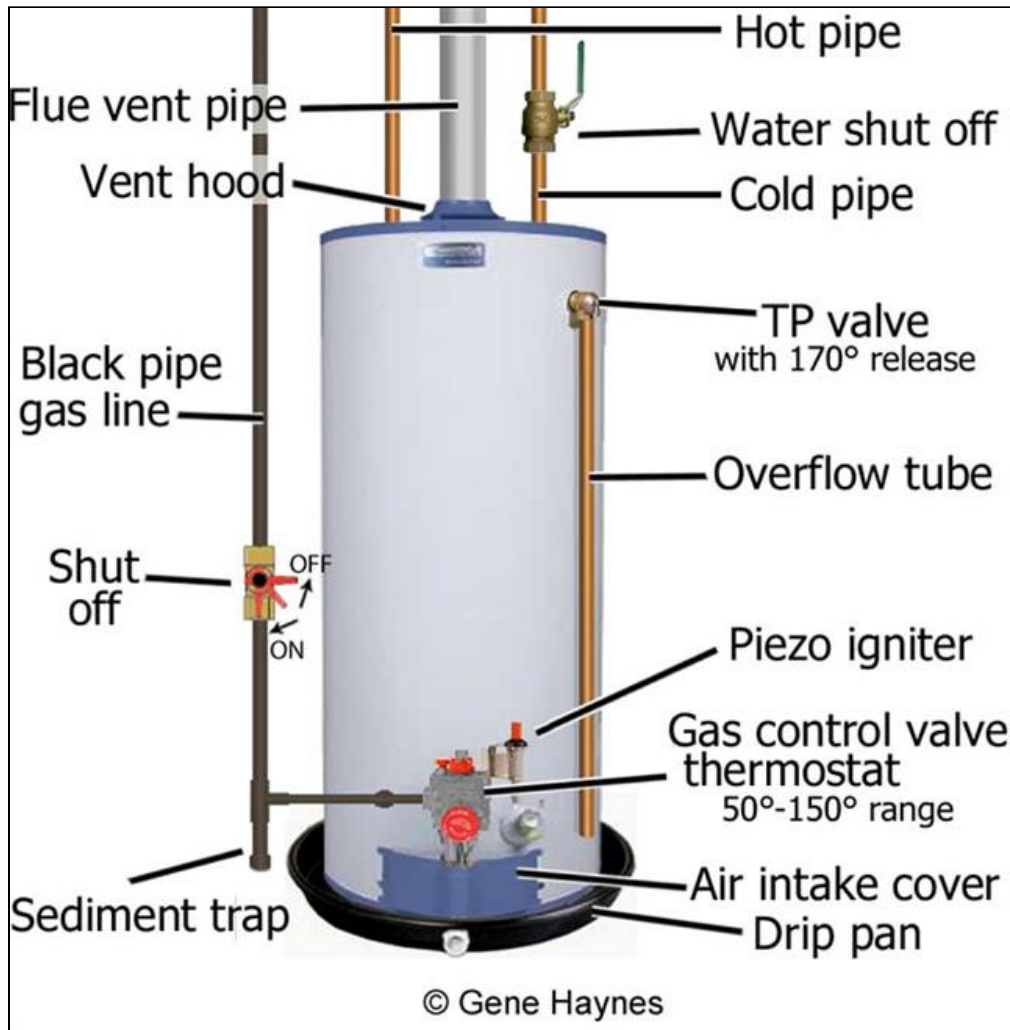
9.2 The water heater is undersized . This is for your information. No apparent problems were found.

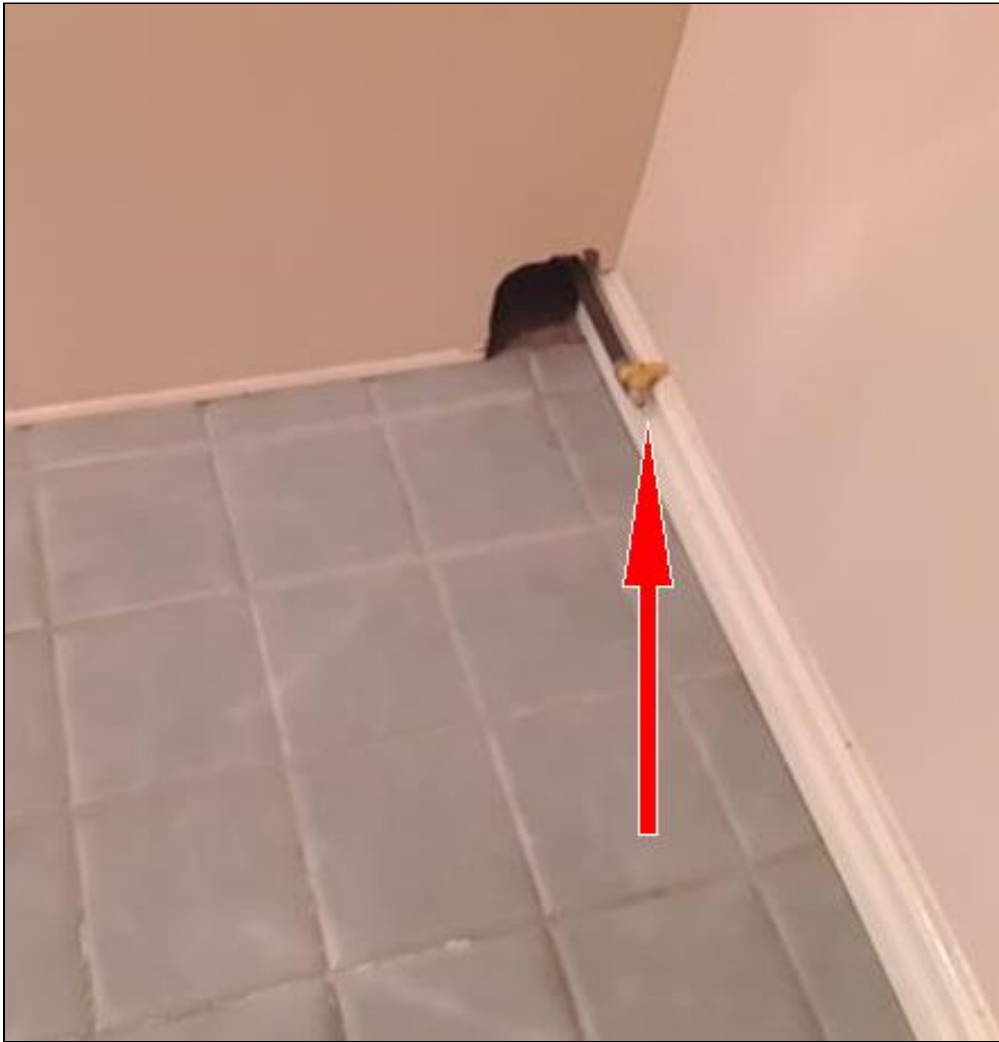
9.4 Item 1(Picture)

9.4 The gas line shut-off valve is missing a cap and can be turned on inadvertently at the dryer. This is a safety issue and should be repaired. A qualified contractor should inspect and repair as needed A qualified contractor should inspect and repair as needed

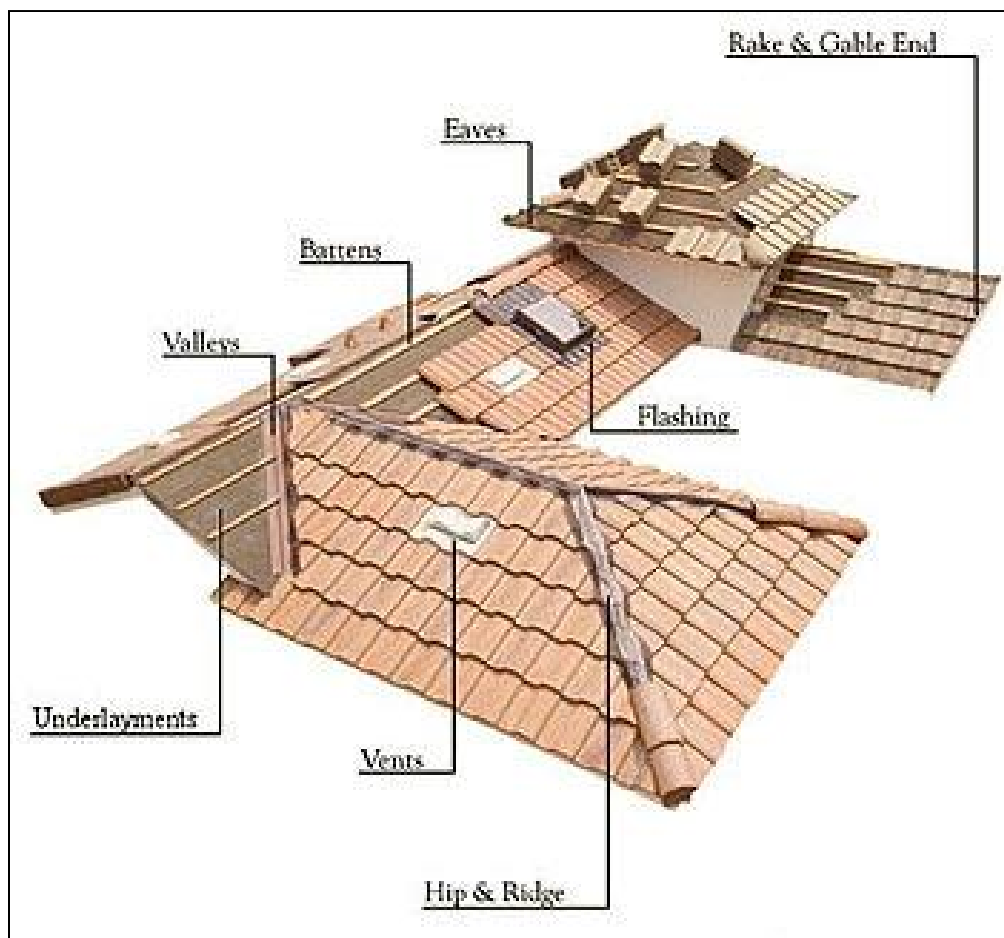
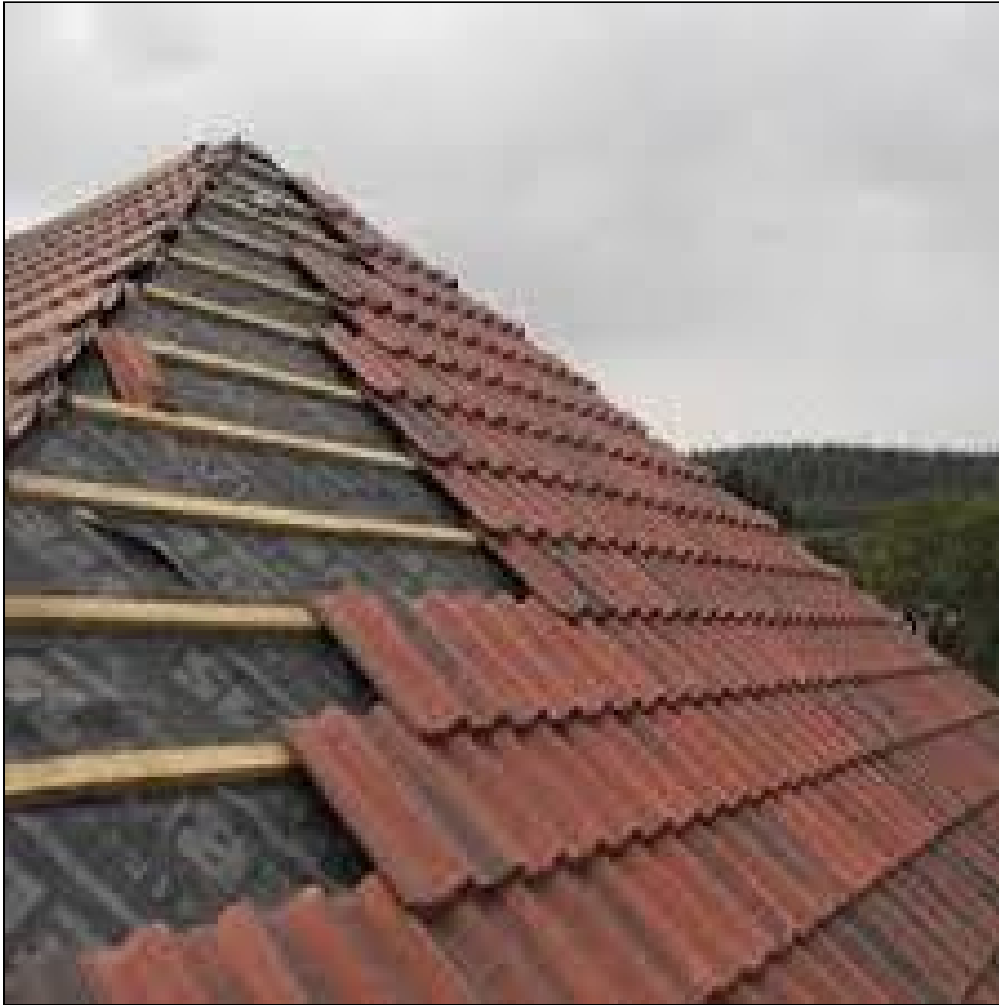
11.0 The roof covering has damaged tiles at several areas of the roof. Recommend a roof certification by a reputable licensed roofing company. It should be repaired or replaced as soon as possible. A qualified contractor should inspect and repair as needed. (Actual roof video will be sent on an addendum. Corrupt video file)

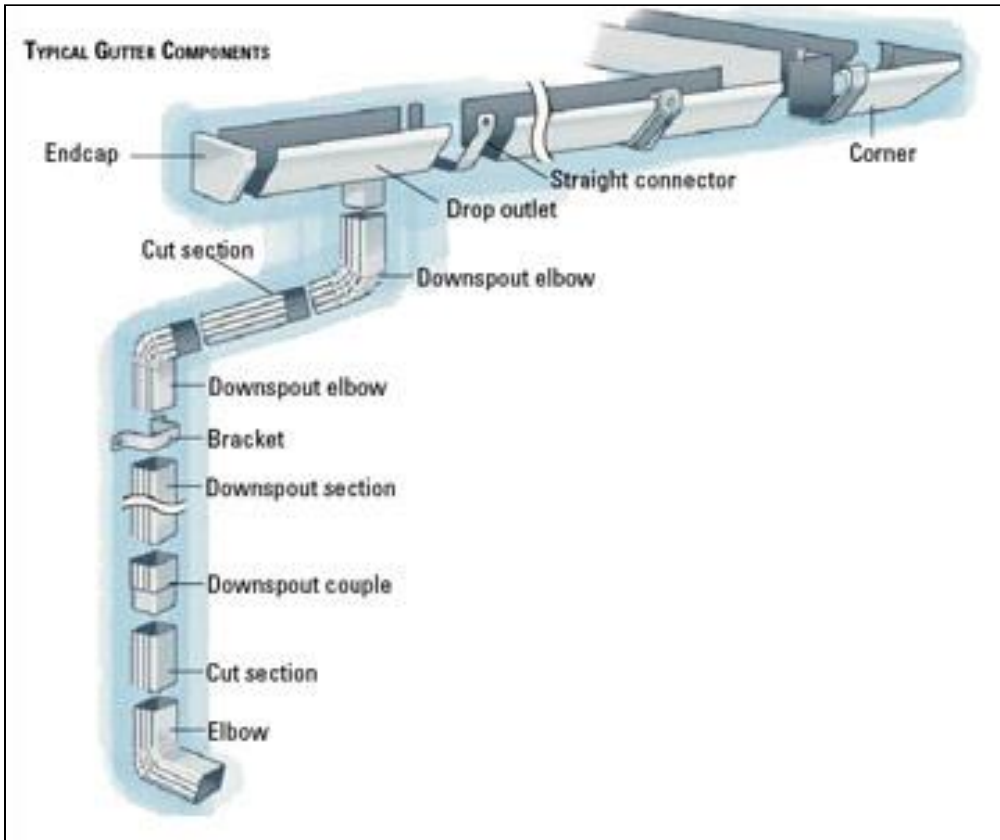
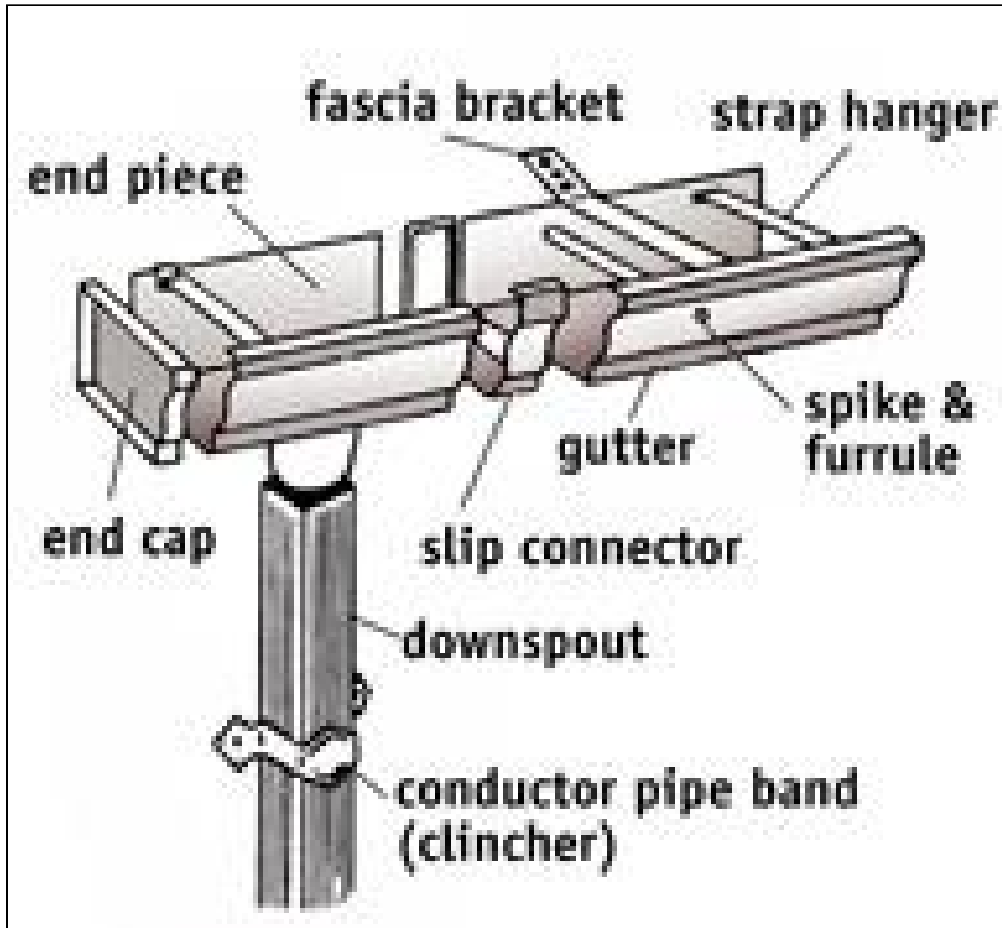
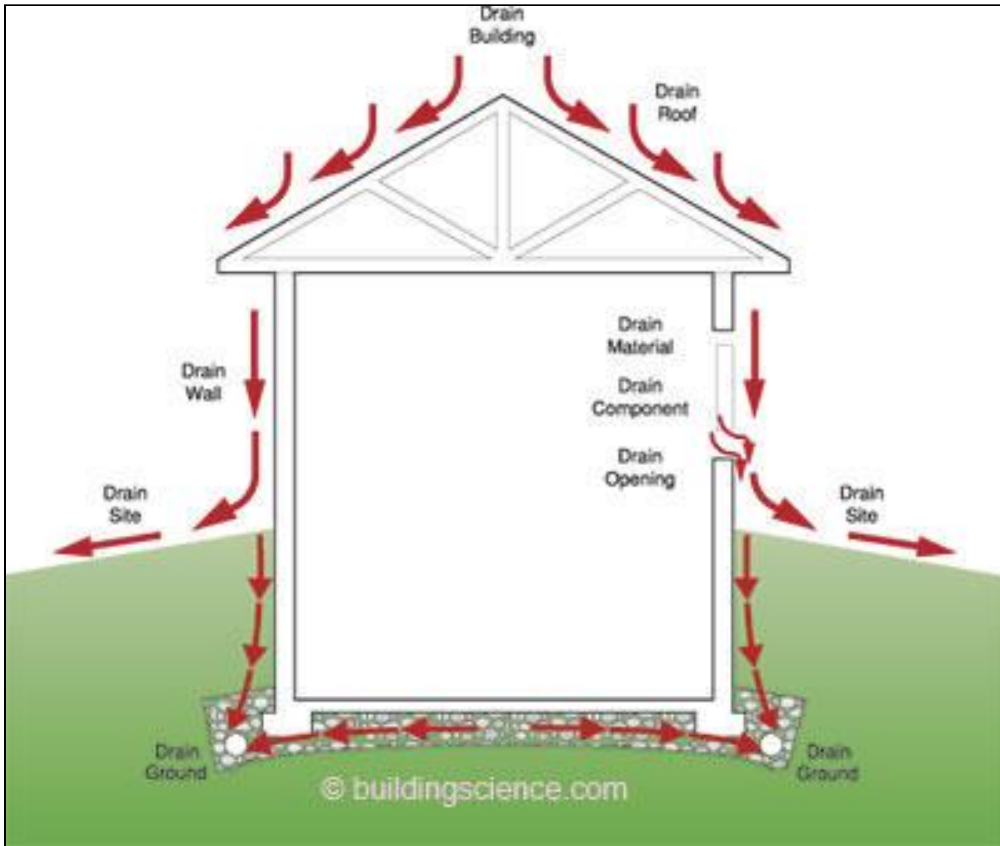
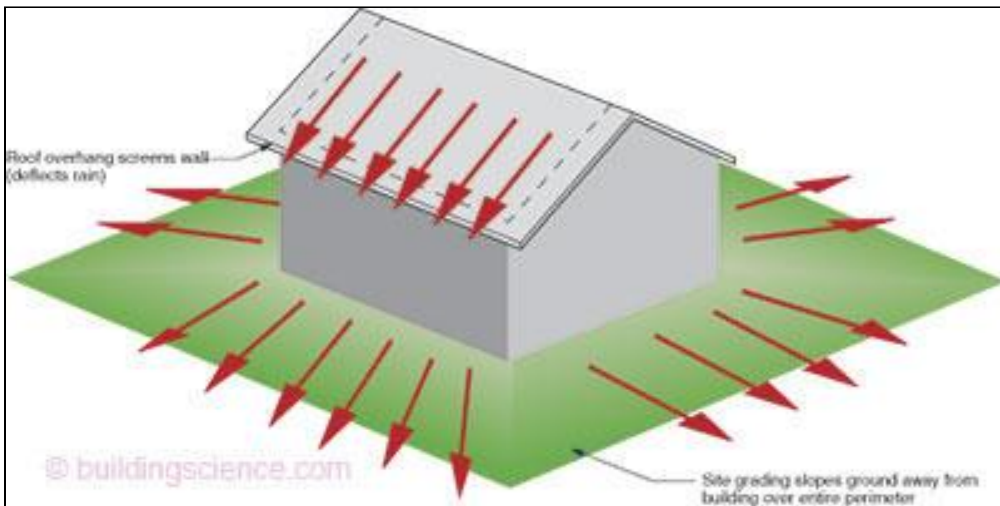
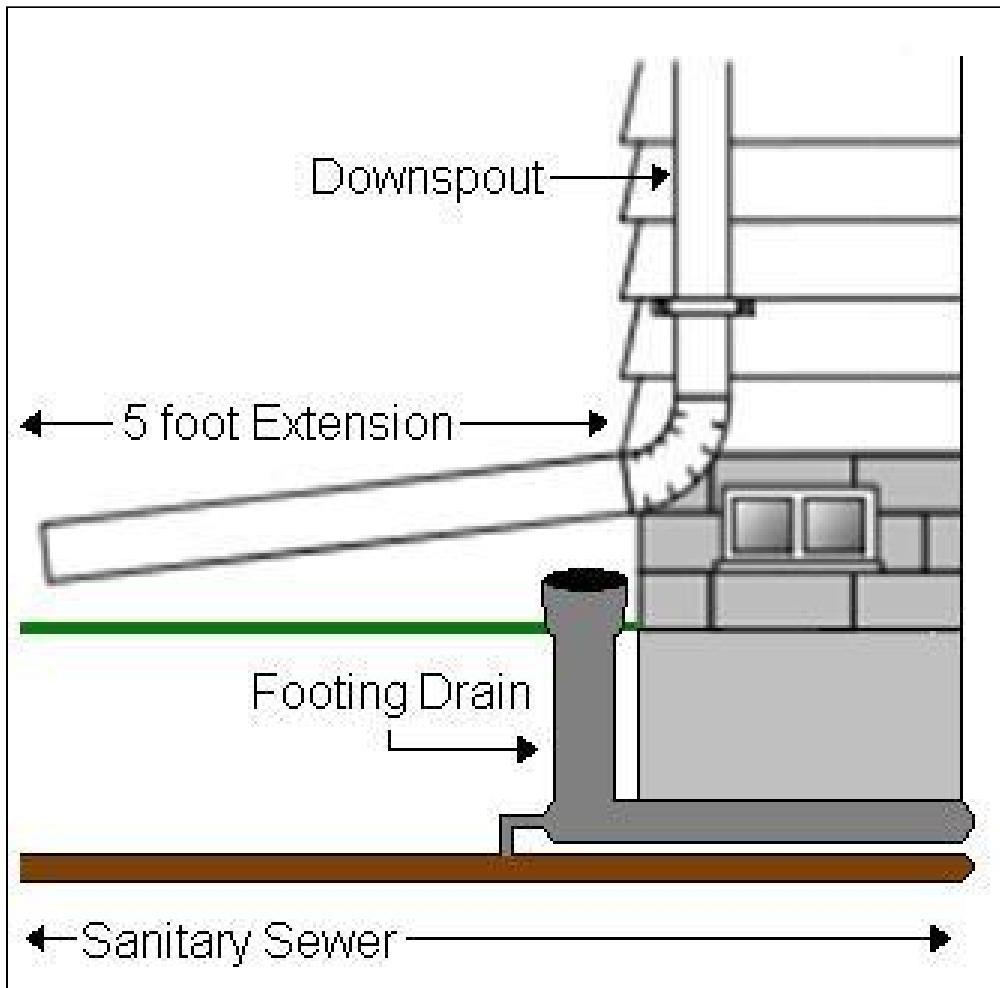
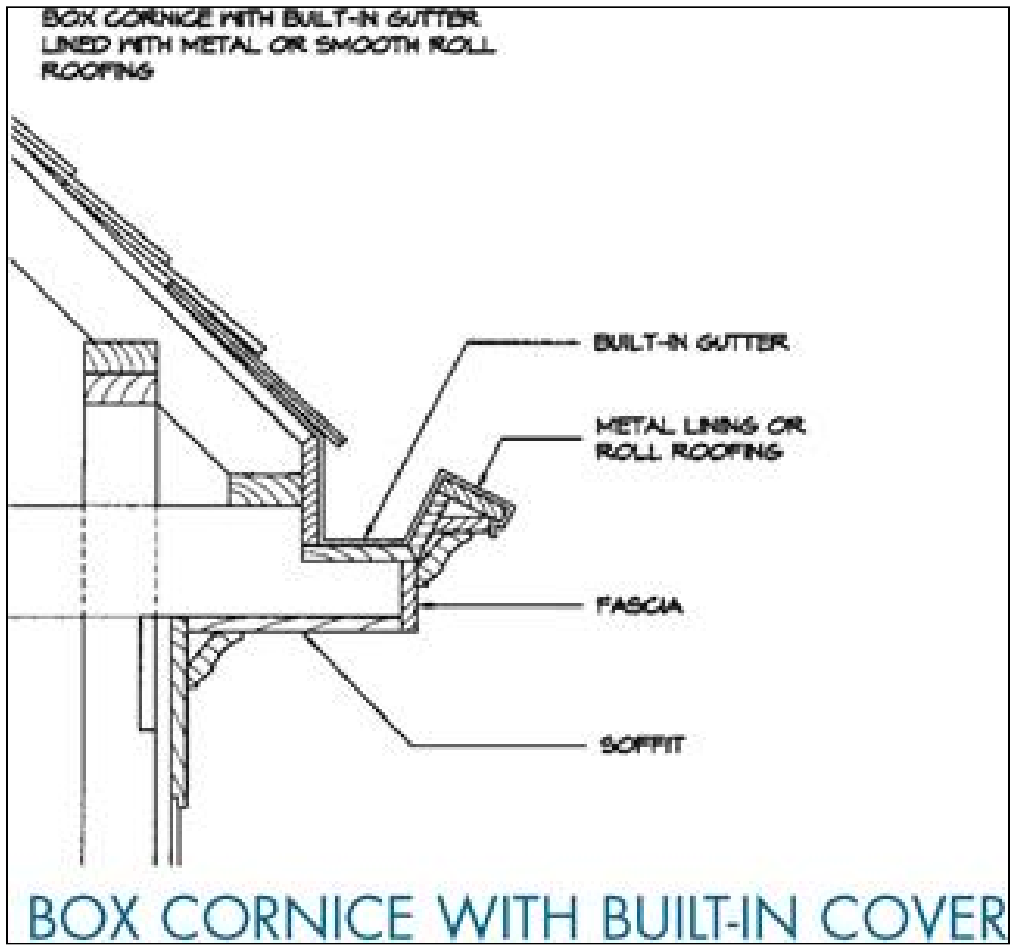
11.3 The downspout needs reconnecting to existing drain line at the front (left of main entry). Erosion can continue or become worse if not corrected. A qualified contractor should inspect and repair as needed.

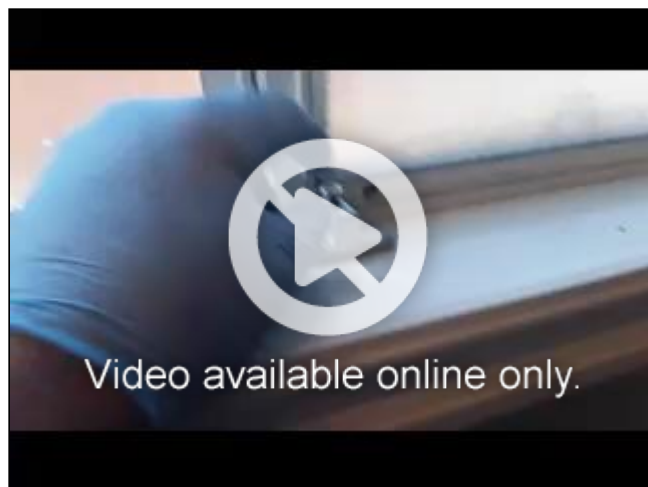
2.6 Item 1(Video)

One window is damaged at handle or lock hardware at the Private Bath Den (to downstairs). This is a small repair. A qualified person should repair or replace as needed.

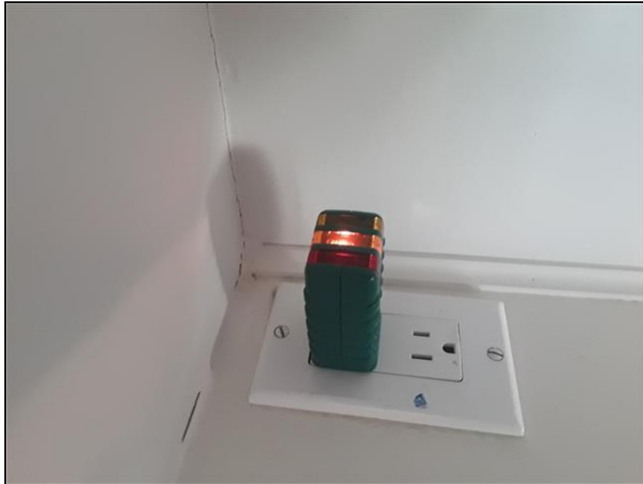
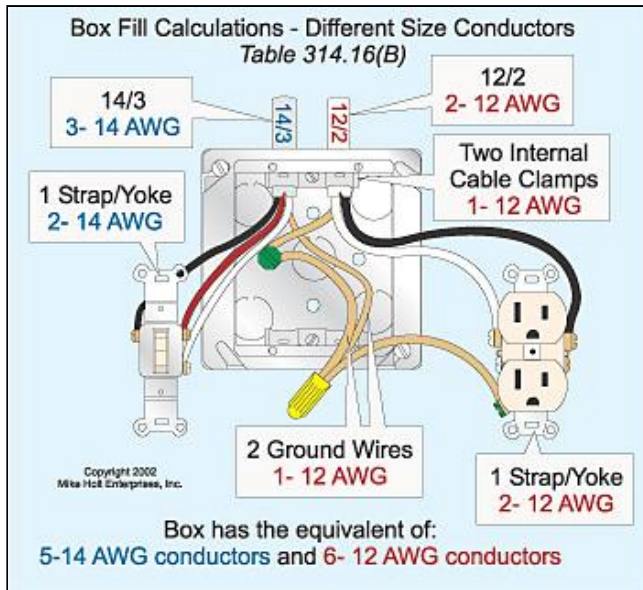
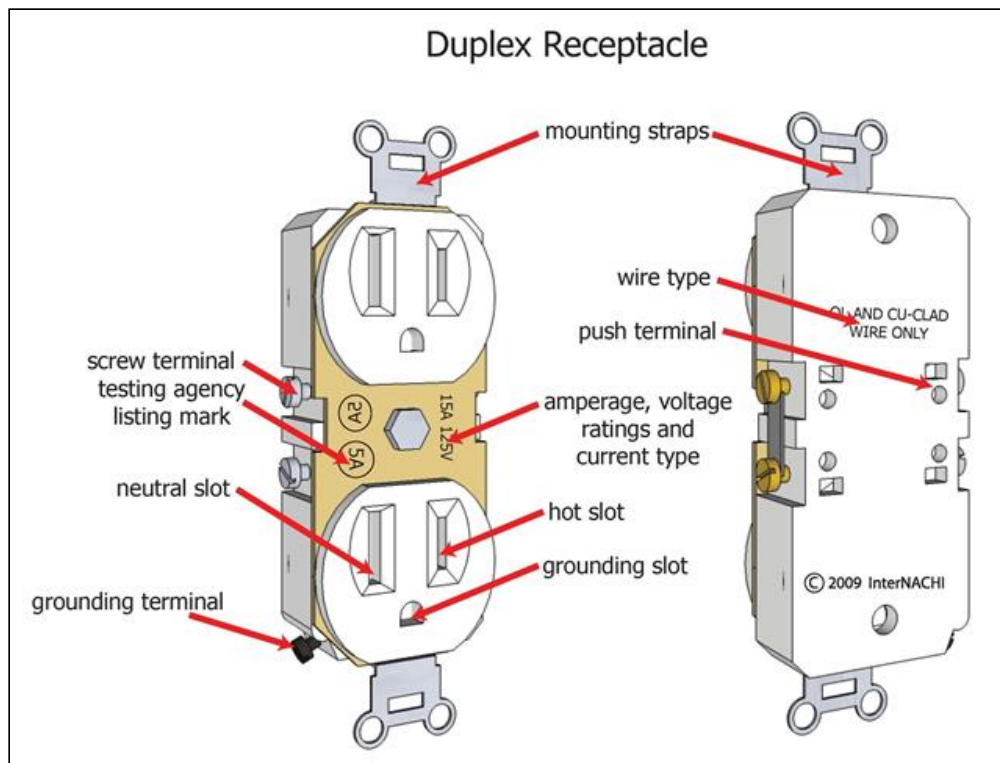
(1) **One "three-prong" outlet is not grounded (at lower level). Electrical issues are considered a hazard until repaired This is a safety issue that needs to be corrected. A qualified licensed electrical contractor should perform repairs that involve wiring.**

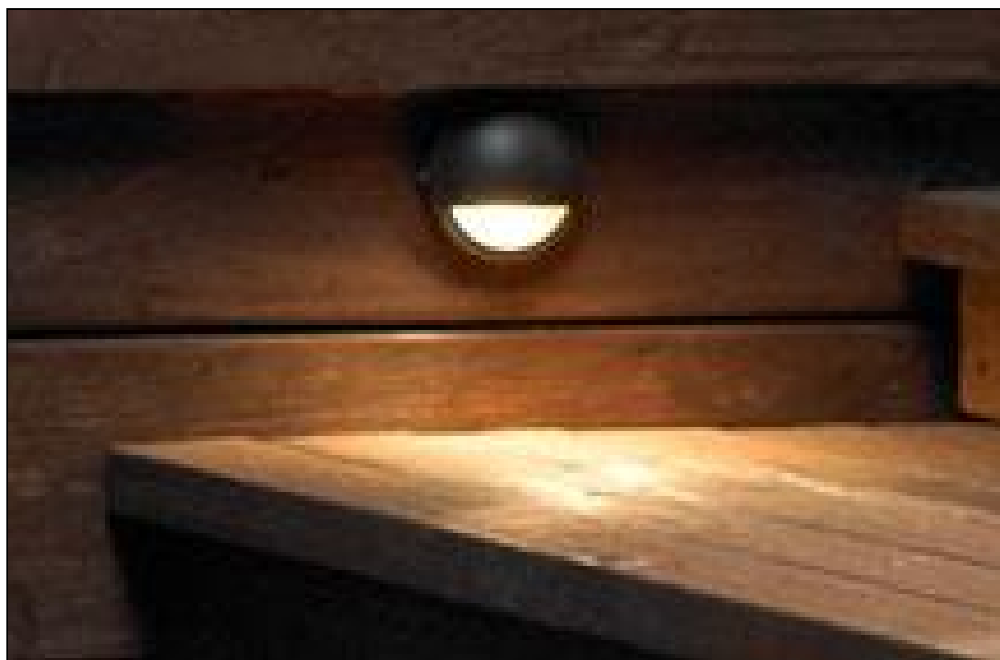
8.3 Item 5(Picture)

(2) **The exterior low profile light fixture at the landscape rear patio wall is loose. This is a safety issue that needs to be corrected. A qualified licensed electrical contractor should perform repairs that involve wiring.**

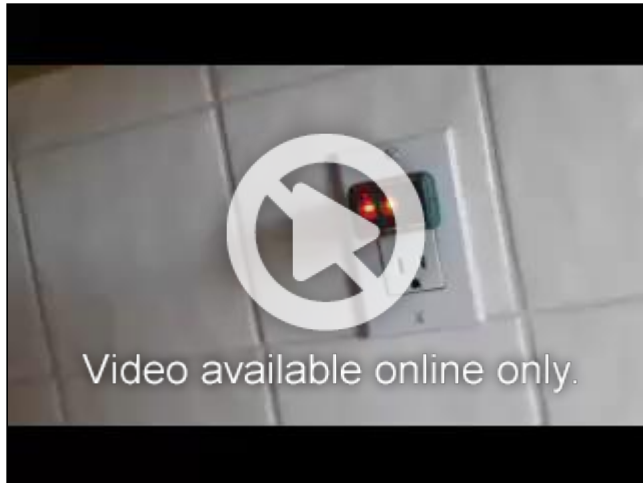
8.4 Item 1(Video)

a hazard until repaired This is a safety issue that needs to be corrected. A qualified licensed electrical contractor should perform repairs that involve wiring.

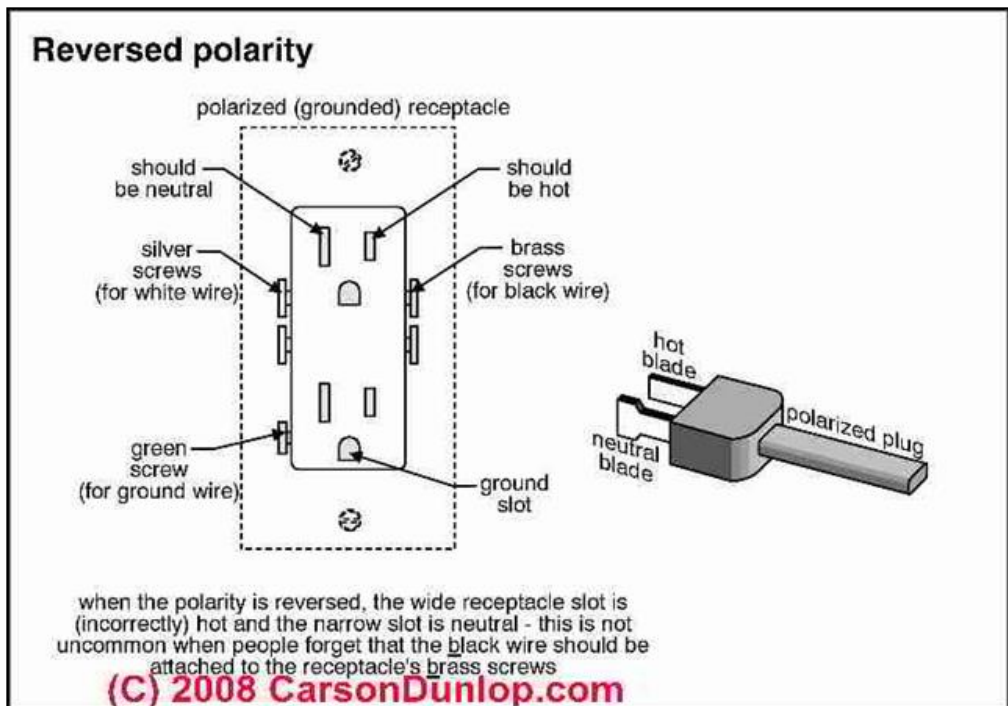
(3) One "three-prong" outlet is not grounded in the dining room. Electrical issues are considered a hazard until repaired This is a safety issue that needs to be corrected. A qualified licensed electrical contractor should perform repairs that involve wiring.

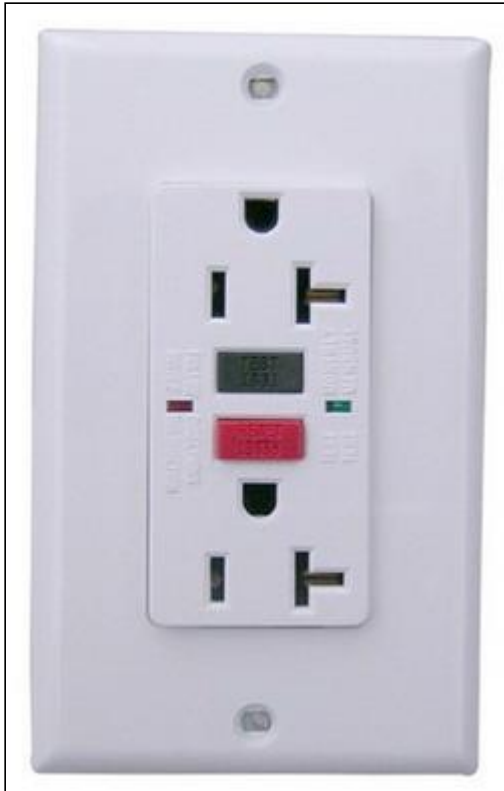
8.4 Item 5(Picture)

(4) **One "three-prong" outlet is outdated and not a three-prong GFCI (Ground Fault Circuit Interrupt) (at lower level). Electrical issues are considered a hazard until repaired This is a safety issue that needs to be corrected. A qualified licensed electrical contractor should perform repairs that involve wiring.**

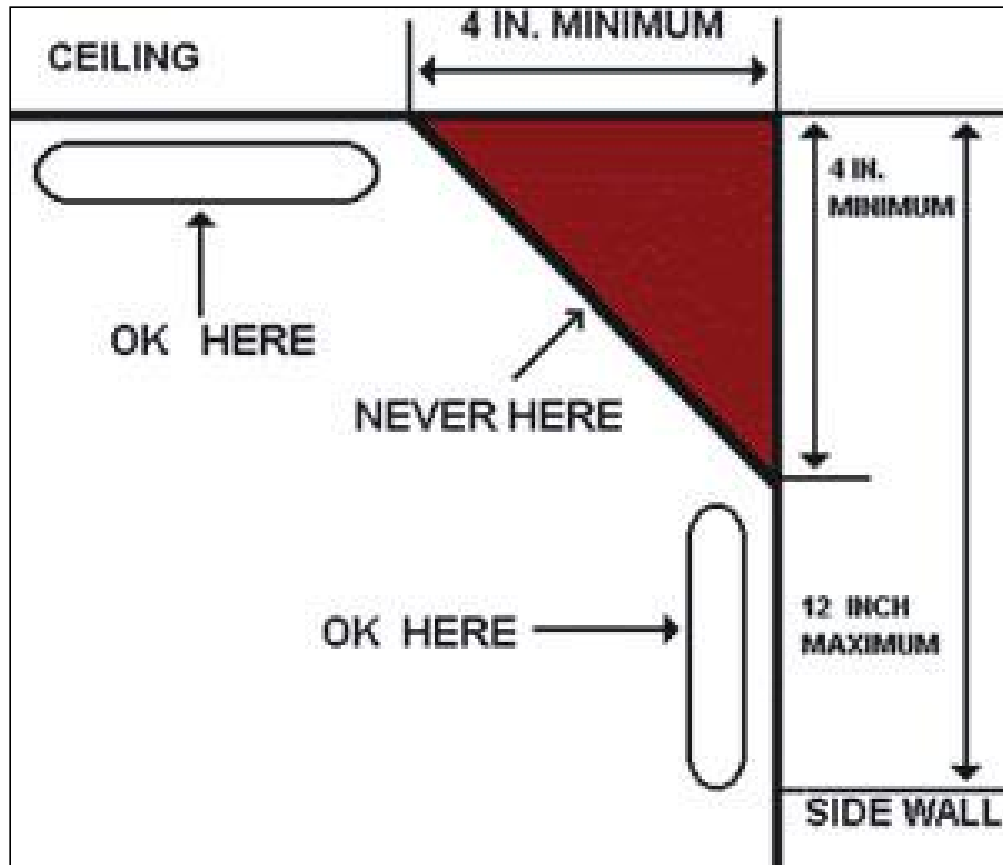
8.7 Item 1(Picture)

(1) **The smoke detector needs locating at least 4 inches from ceiling/wall junction and no further than 12 inches away.**
