Inspection Report

Property Address:
28068 Braidwood Dr
Rancho Palos Verdes CA 90275

Date: 7/23/2018	Time: 02:00 PM	Report ID: 20180723-28068-Braidwood-Dr
Property: 28068 Braidwood Dr Rancho Palos Verdes CA 90275	Customer: [REDACTED]	Real Estate Professional: [REDACTED] Coldwell Banker Wilshire Real Estate

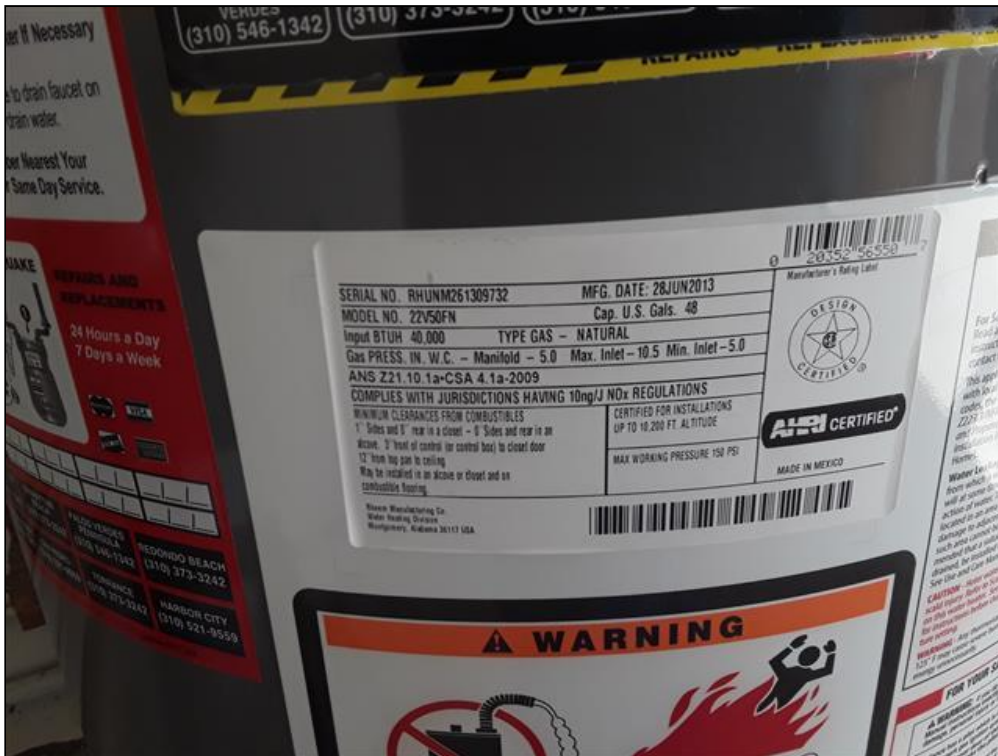
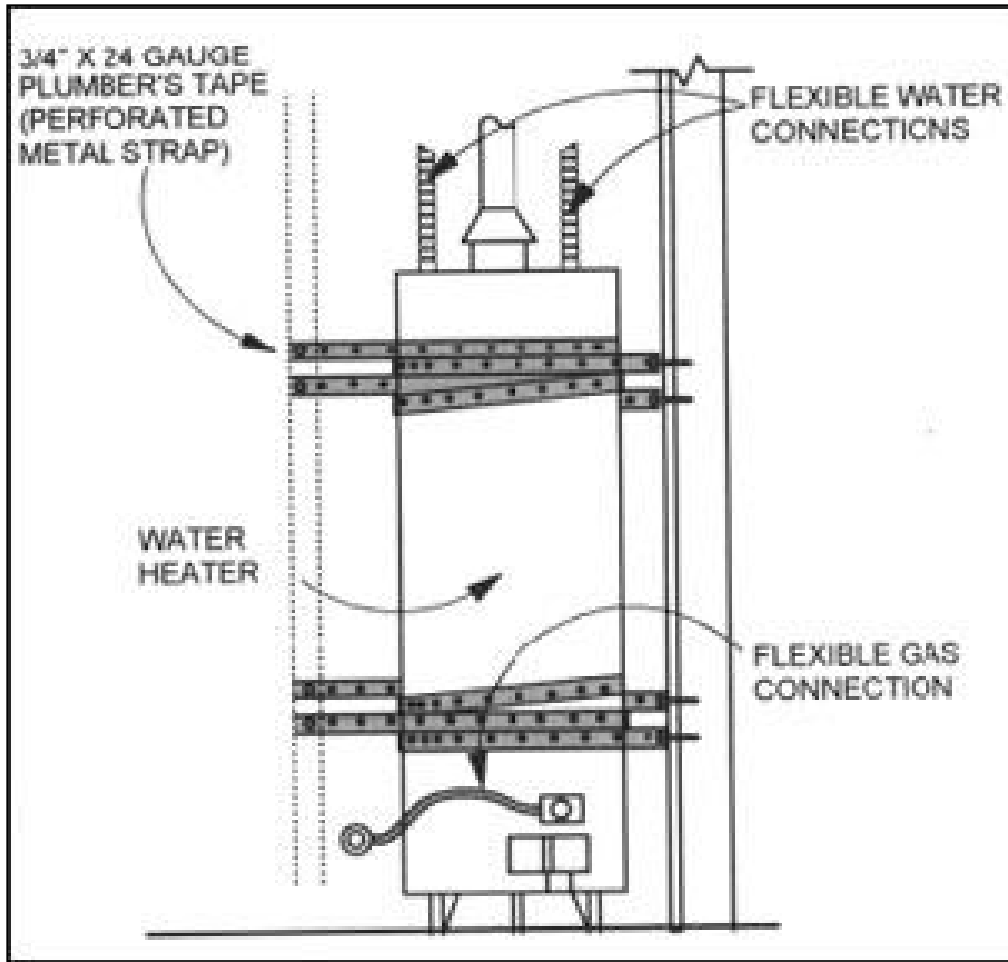
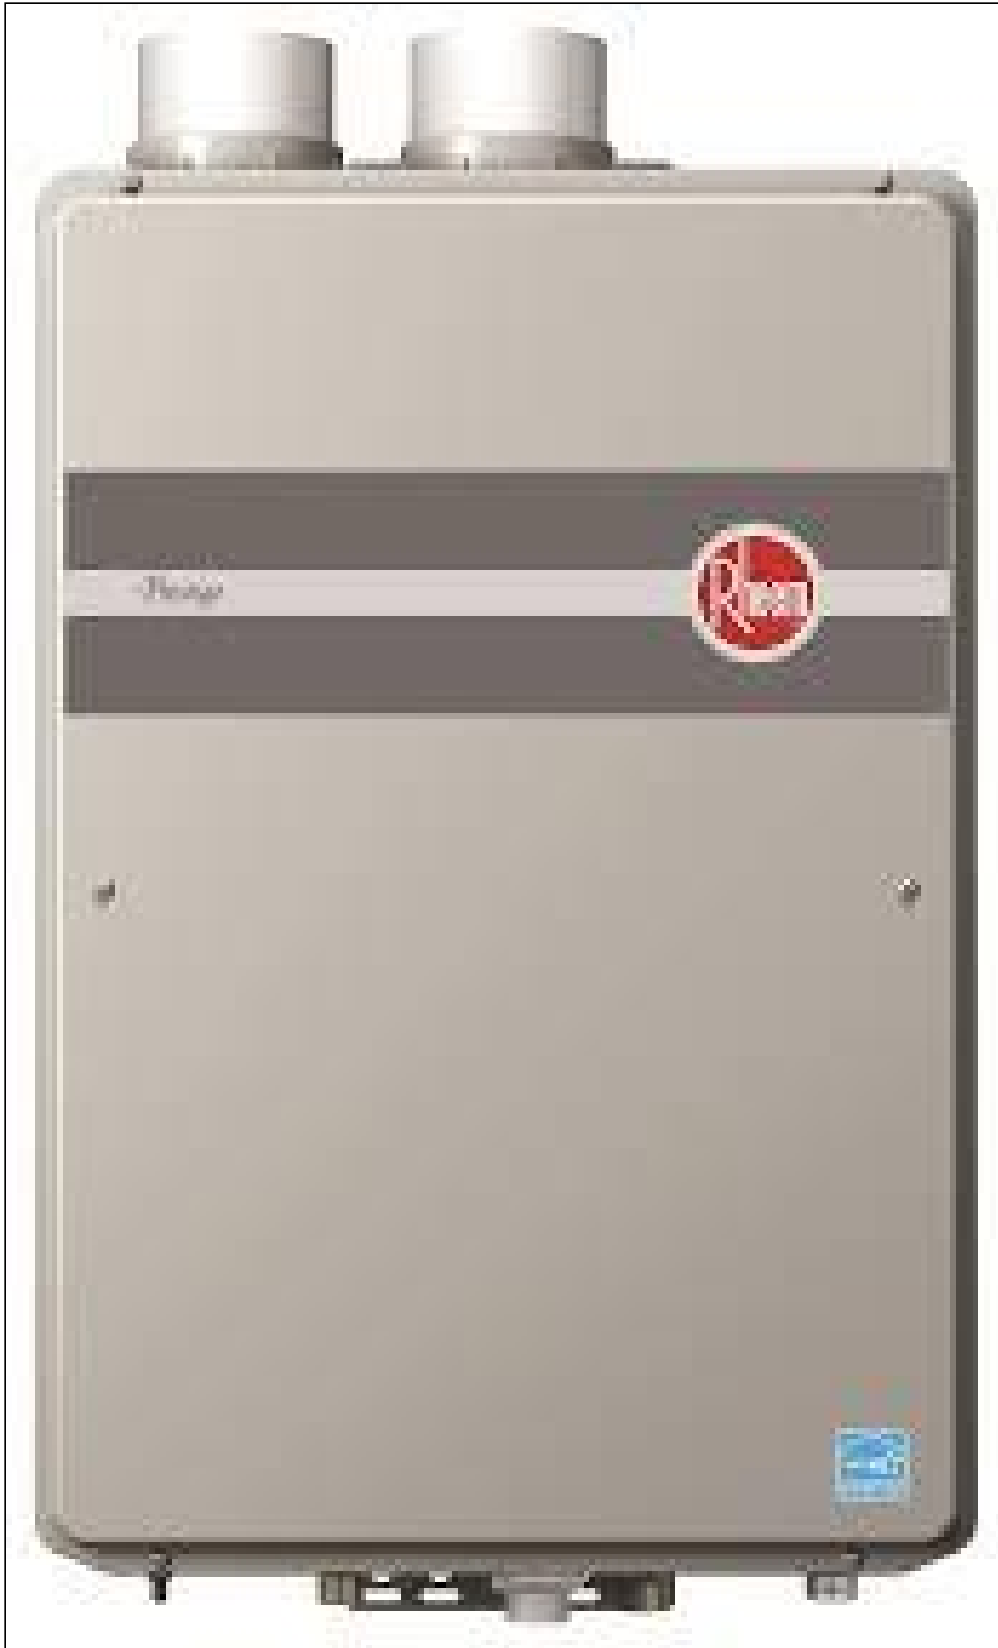
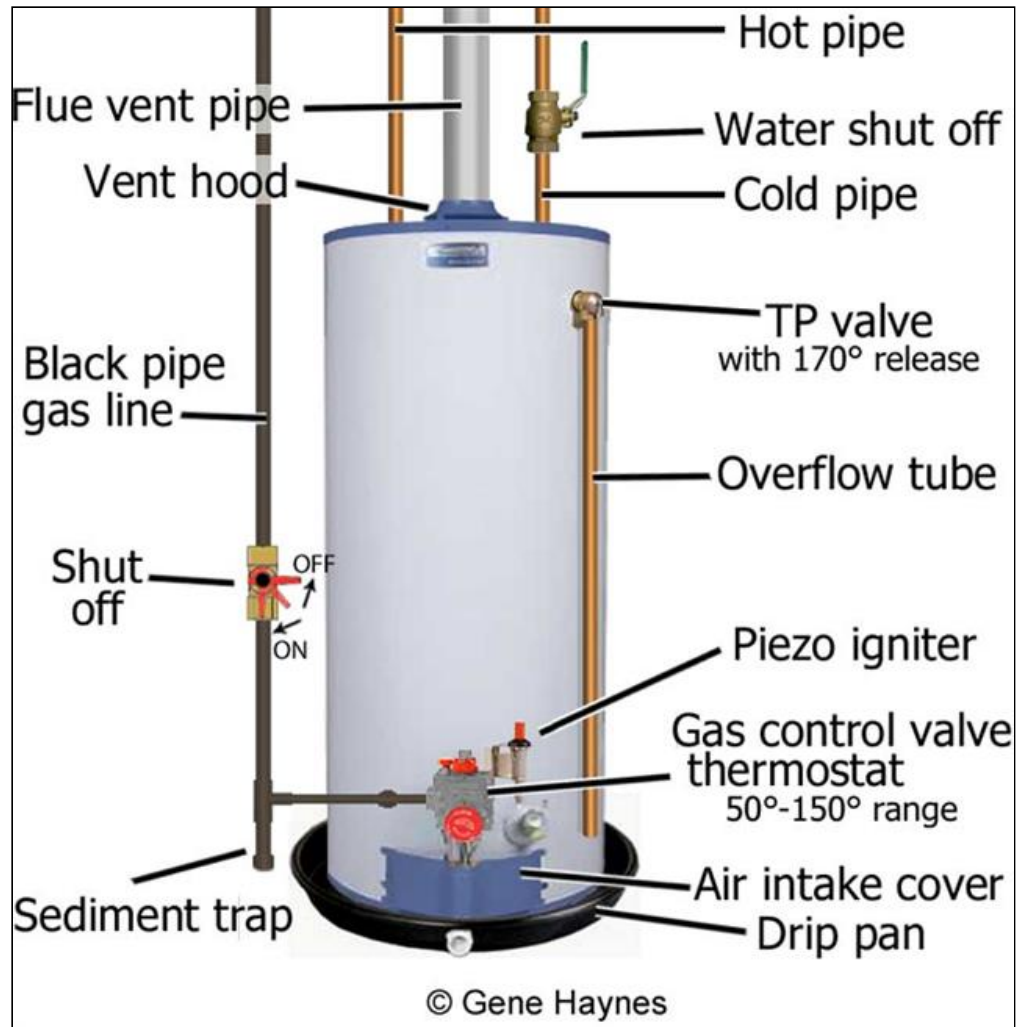
The water heater is undersized . This is for your information. No apparent problems were found.

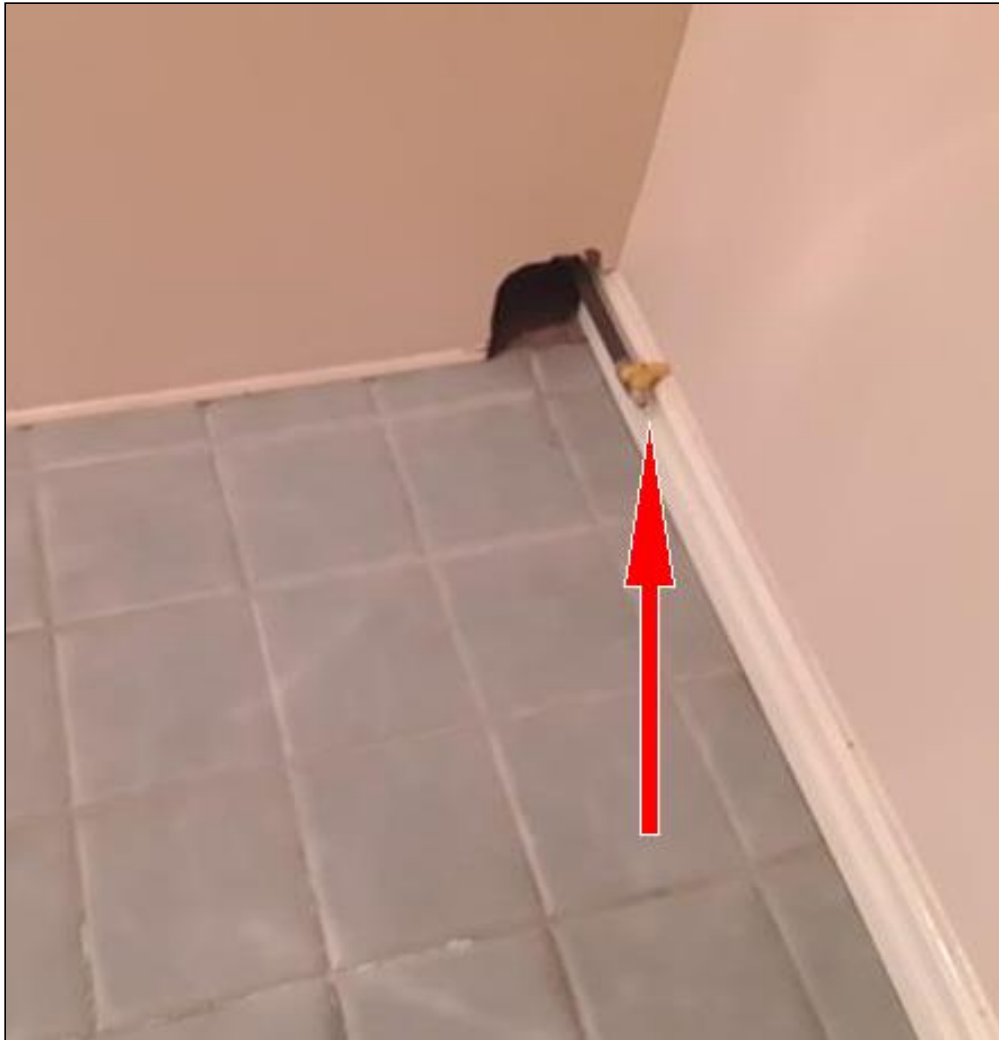
9.4 Item 1(Picture)

The gas line shut-off valve is missing a cap and can be turned on inadvertently at the dryer. This is a safety issue and should be repaired. A qualified contractor should inspect and repair as needed A qualified contractor should inspect and repair as needed

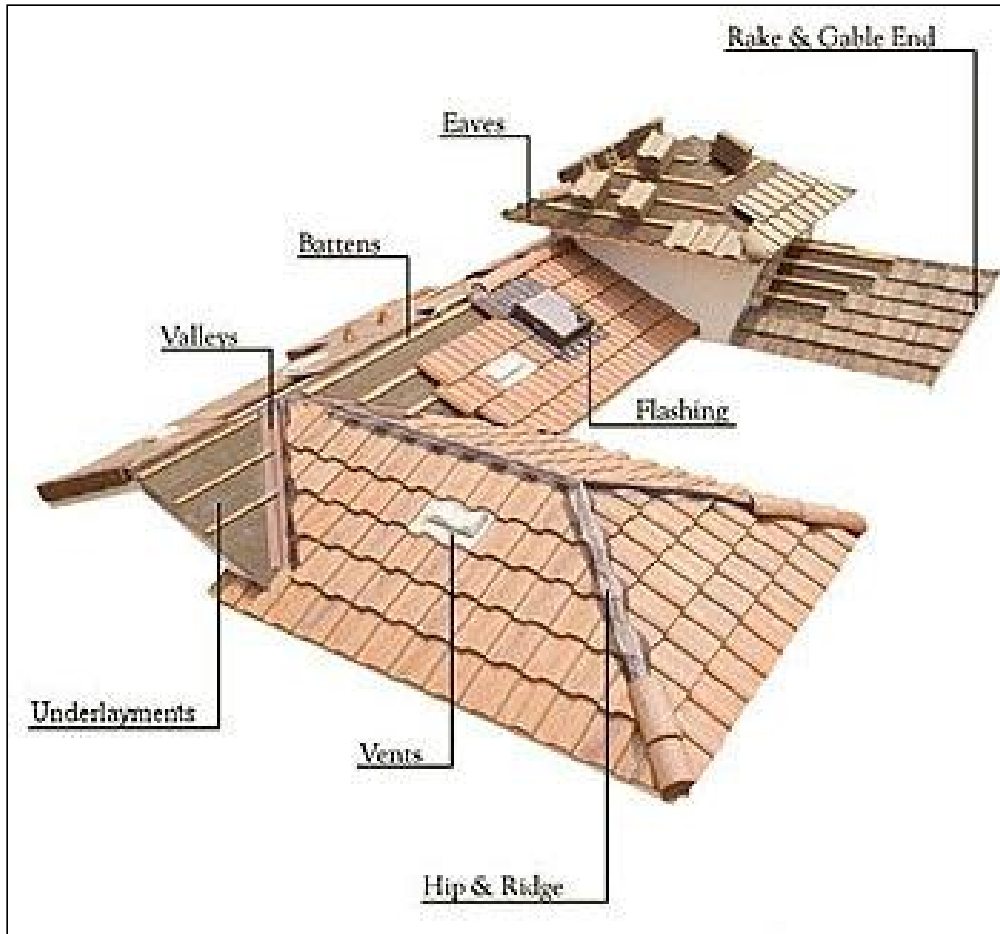
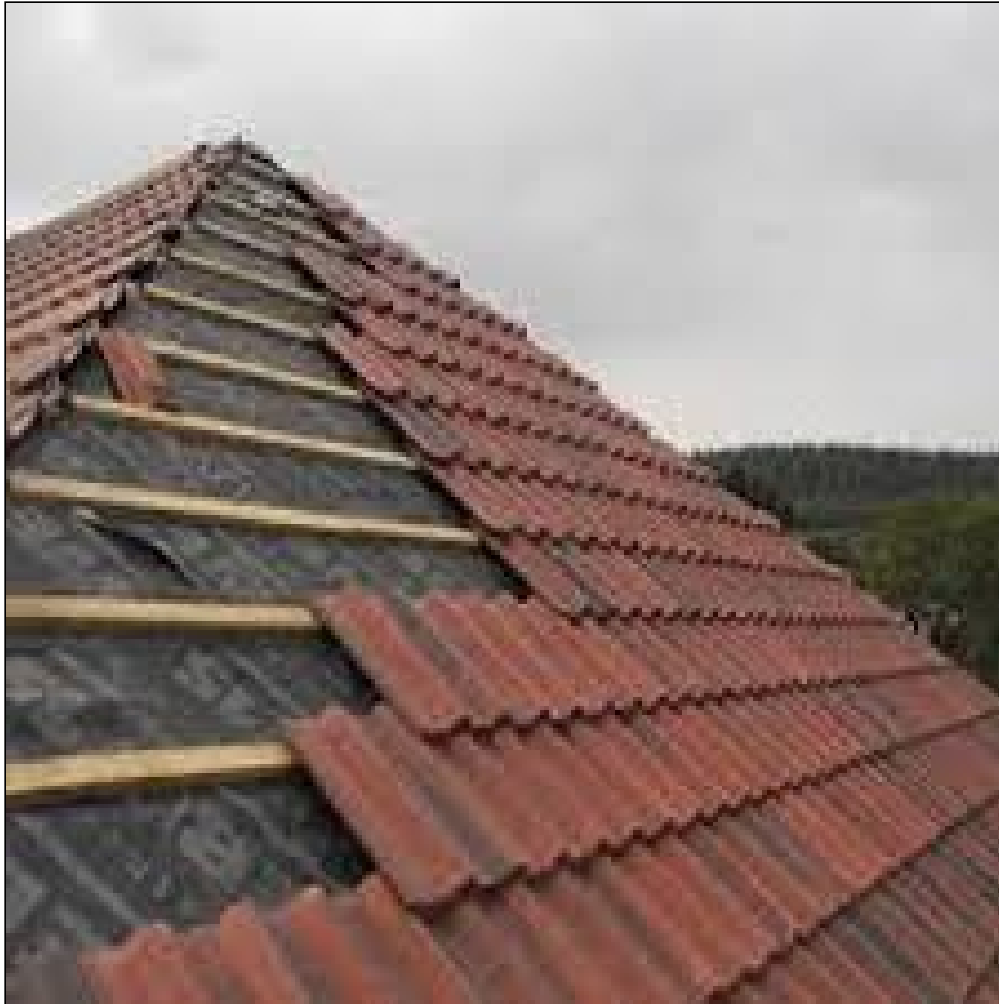
The roof covering has damaged tiles at several areas of the roof. Recommend a roof certification by a reputable licensed roofing company. It should be repaired or replaced as soon as possible. A qualified contractor should inspect and repair as needed. (Actual roof video will be sent on an addendum. Corrupt video file)

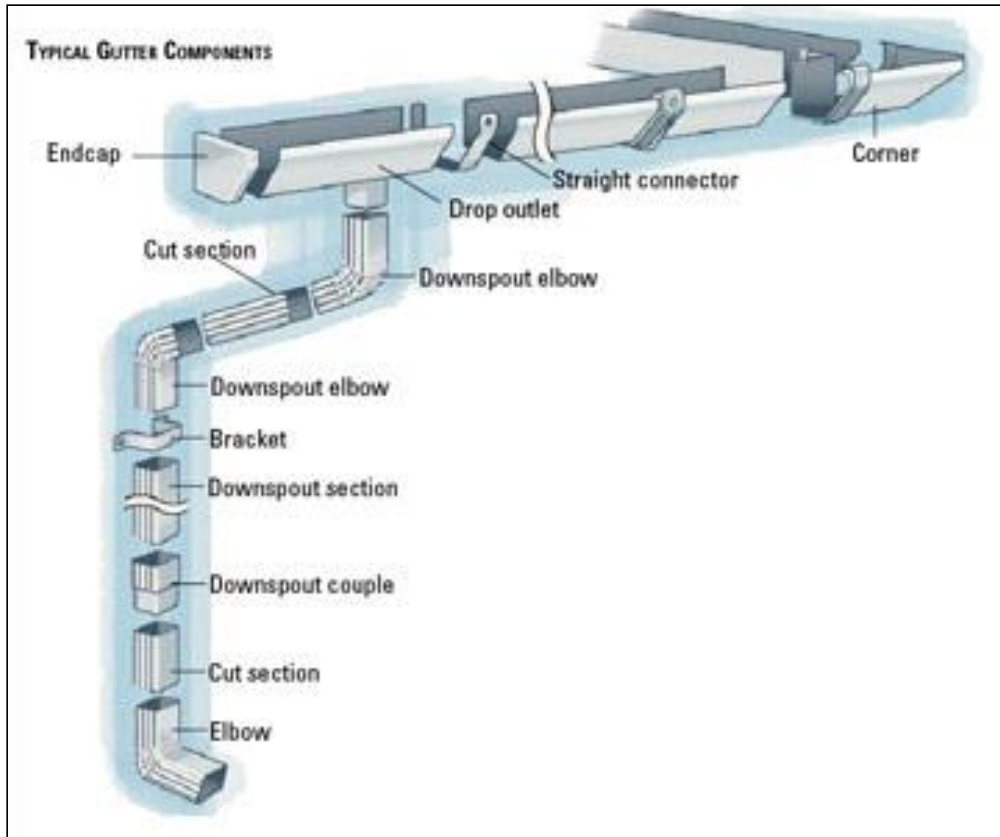
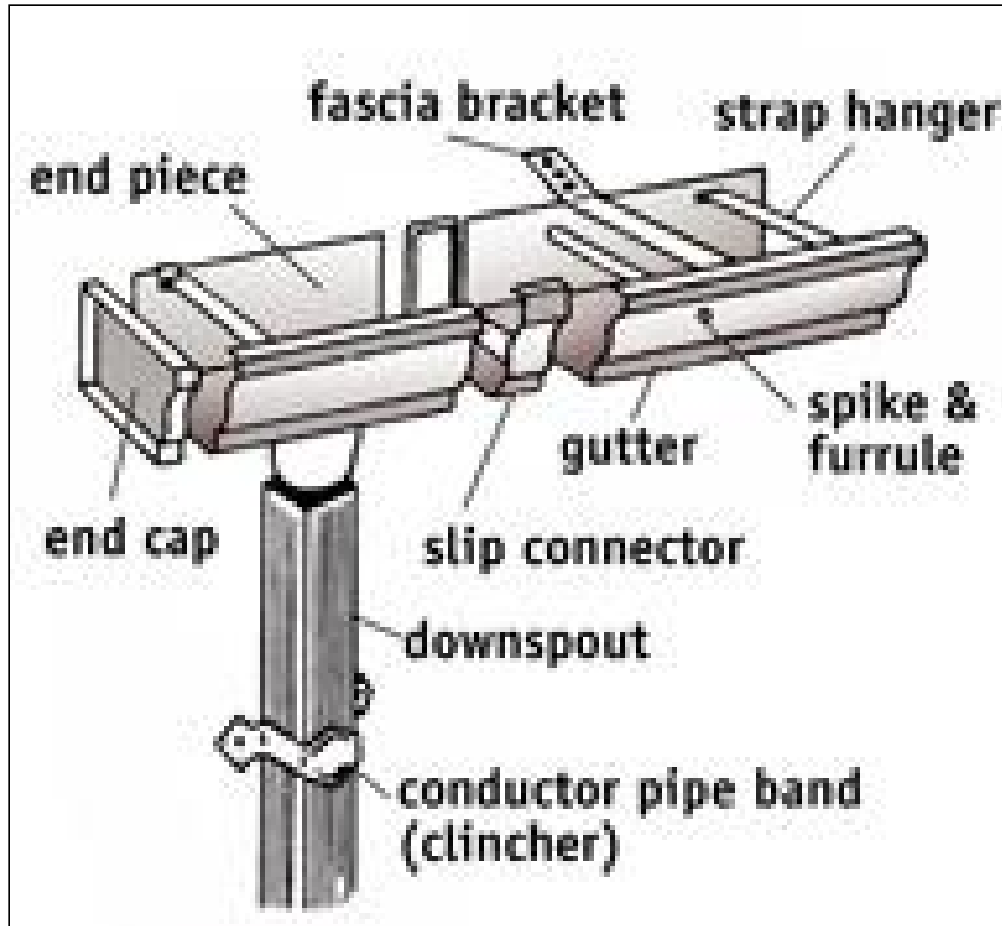
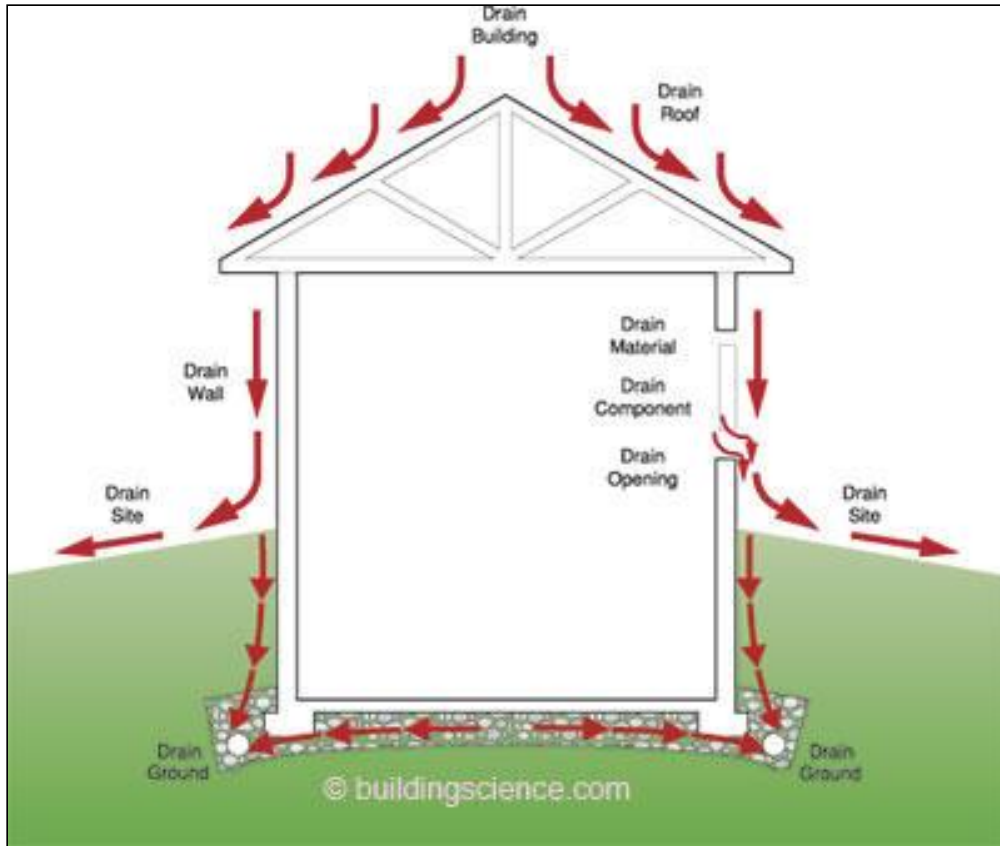
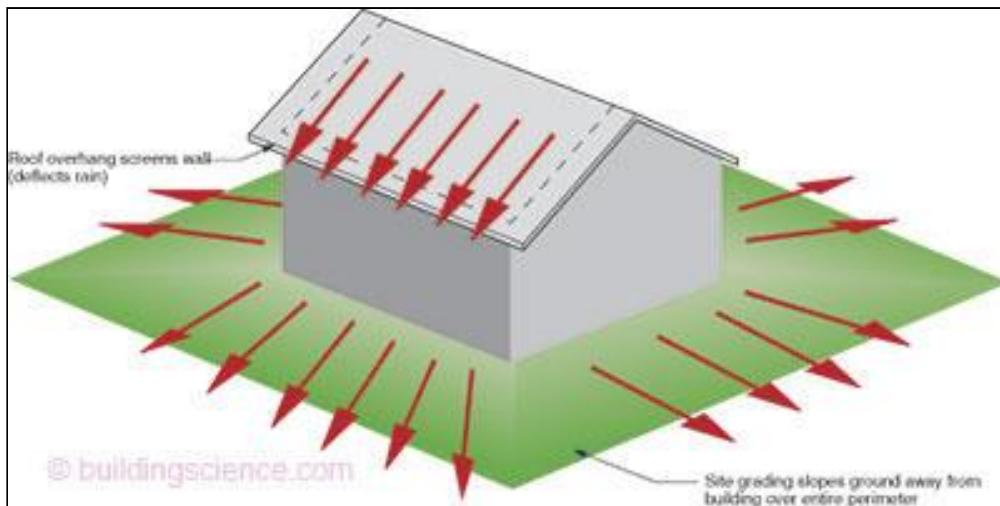
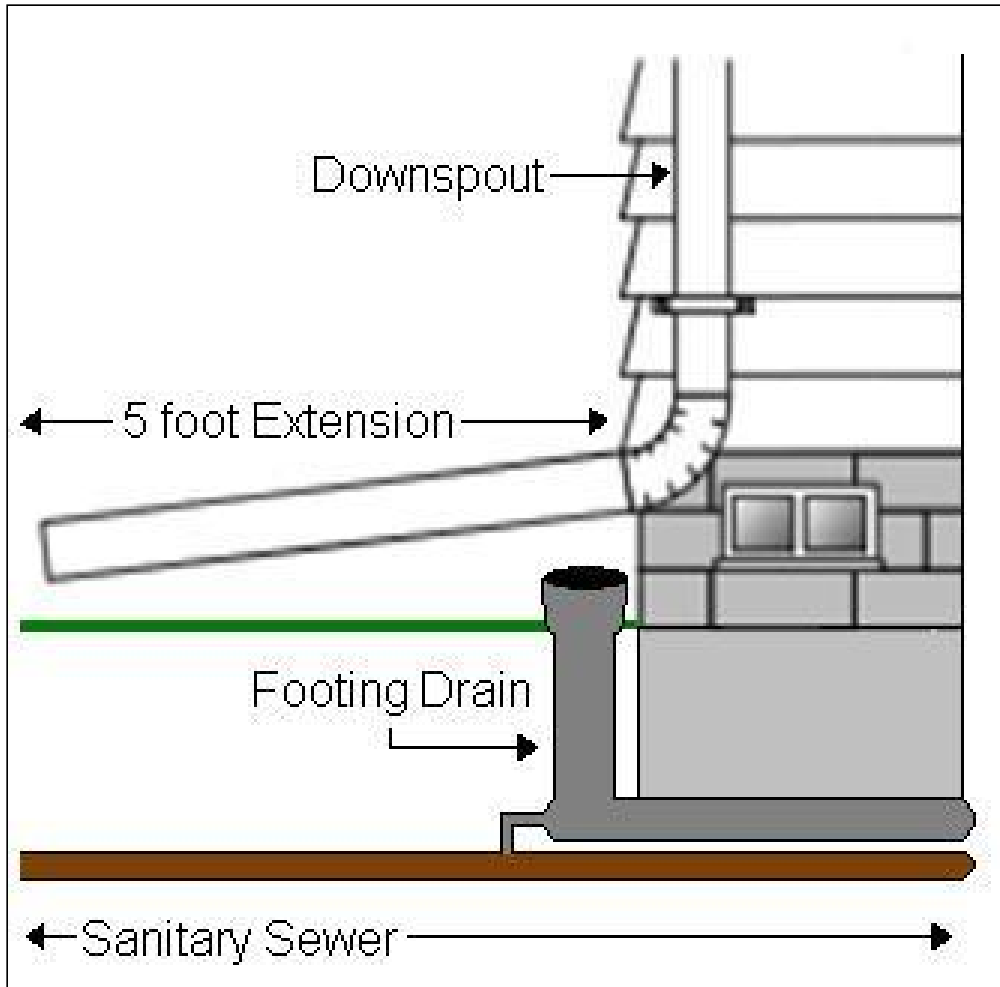
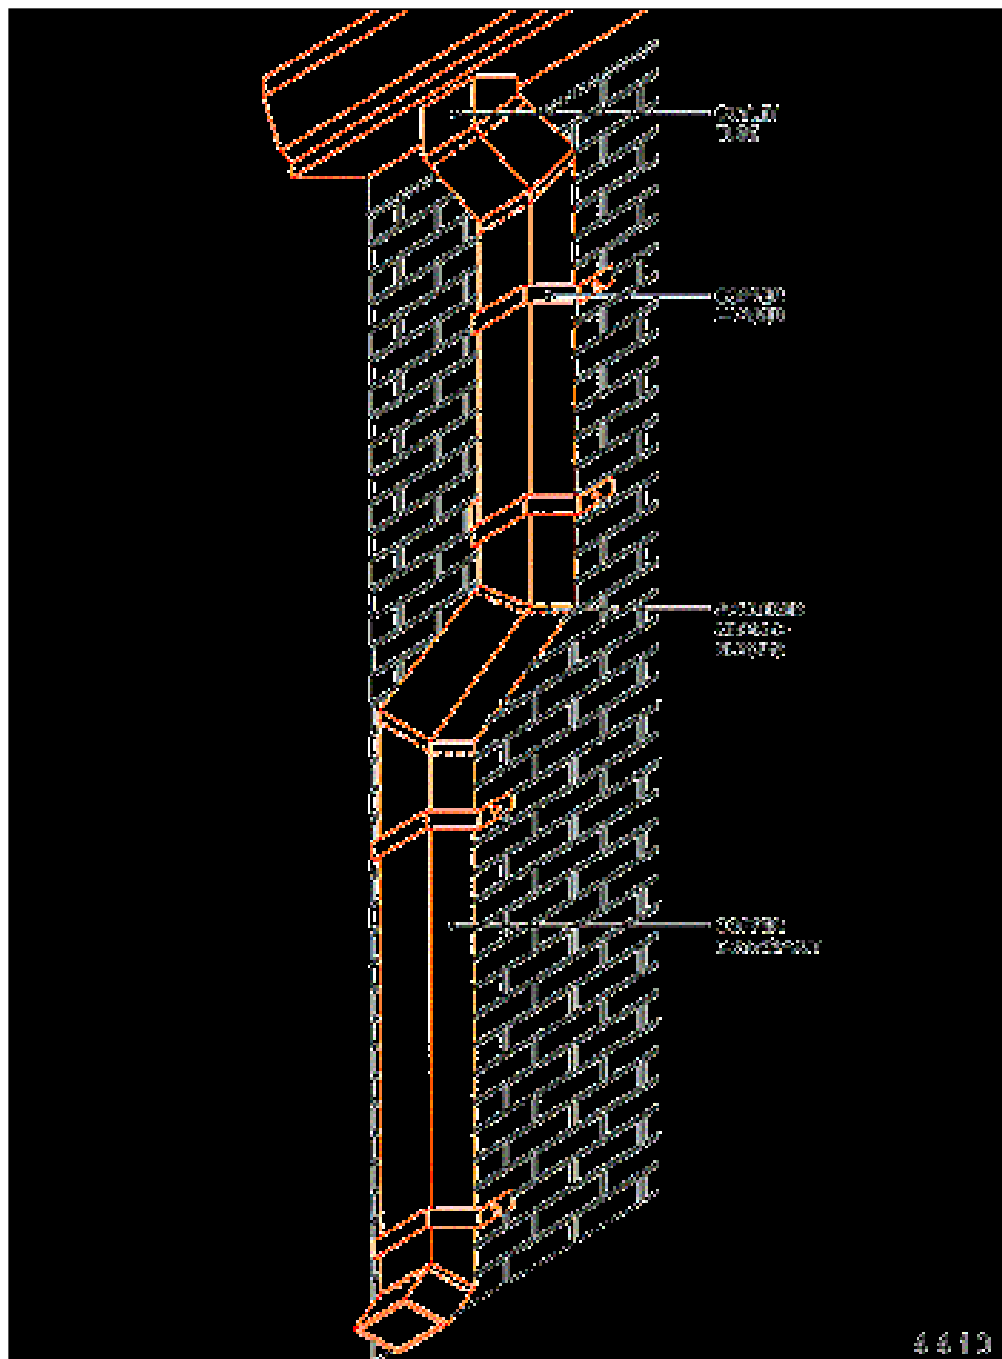
The downspout needs reconnecting to existing drain line at the front (left of main entry). Erosion can continue or become worse if not corrected. A qualified contractor should inspect and repair as needed.
