# Chimney Inspection Report

## **Eric Kim & Chan Mi Cho**

121 S Wilson Ave #106 Pasadena 91106

July 07, 2017.

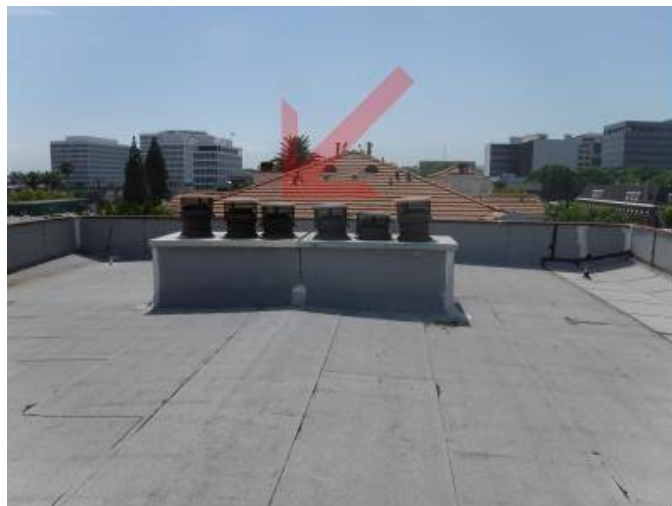
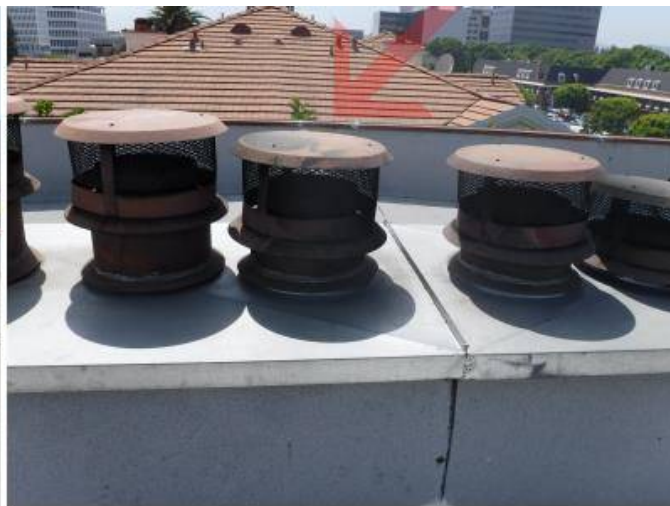
### TERMINATION CAP:

Present.

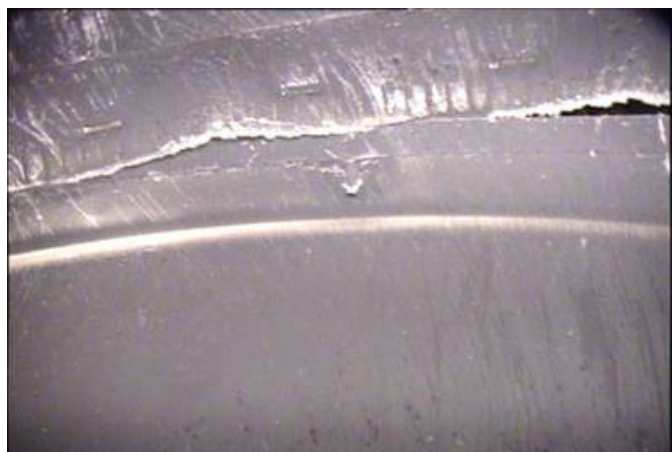
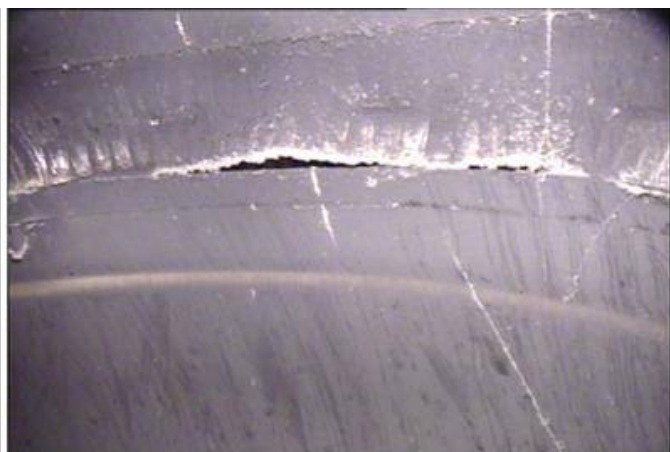
### METAL CHIMNEY CONDITION:

Not Acceptable, the inner wall of the metal flue is bent, damaged and disconnected above the firebox area.

The outer wall of the chimney could not be seen due to lack of access to the chase.

It is my recommendation (due to the age of the current system, its condition and a lack of replacement parts) that this fireplace system be fully removed and replaced with an approved unit. NOTE: More and more, the city is not allowing wood burning fireplace installations. Consult with your city for more information.

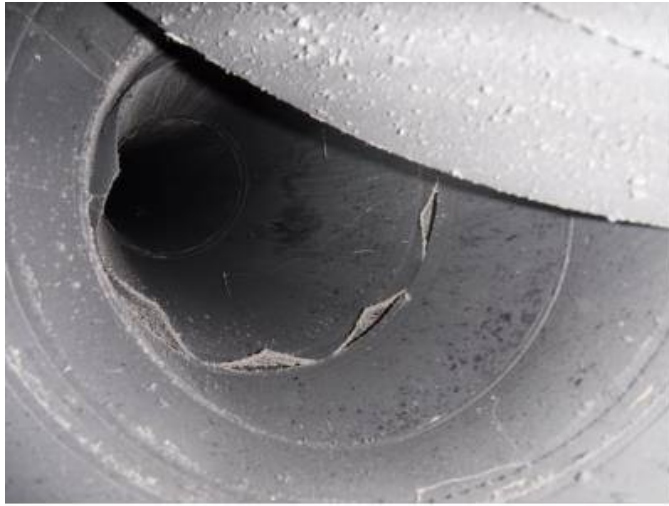
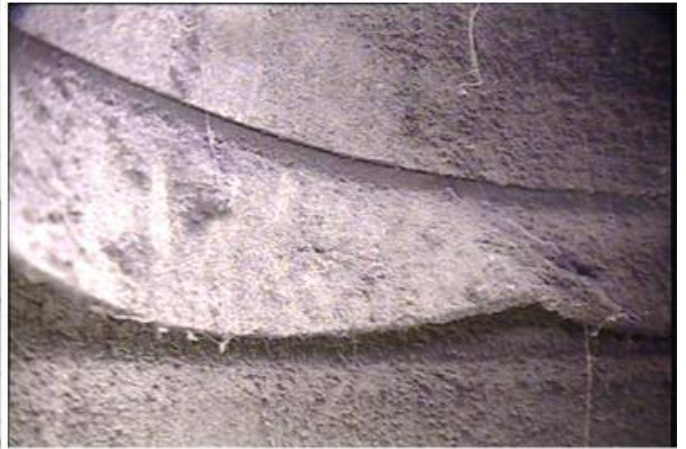
**ATTIC/CHIMNEY CHASE:**

Needs Attention, the chase cover is fairly flat and can allow for standing water during rains or wet conditions. Ideally, the chase cover would be sloped to allow for water to drain off of it.

The inside of the chase was not inspected at this time due to there not being access (in this case access would require destructive testing which is beyond this inspection). This is not uncommon and prevents observation of firestops, clearances to combustibles, proper strapping, pipe connections and etc. THE OUTER WALL OF THE CHIMNEY AND CHASE WERE NOT VISIBLE AT THIS TIME AND IS THEREFORE BEYOND OUR INSPECTION.

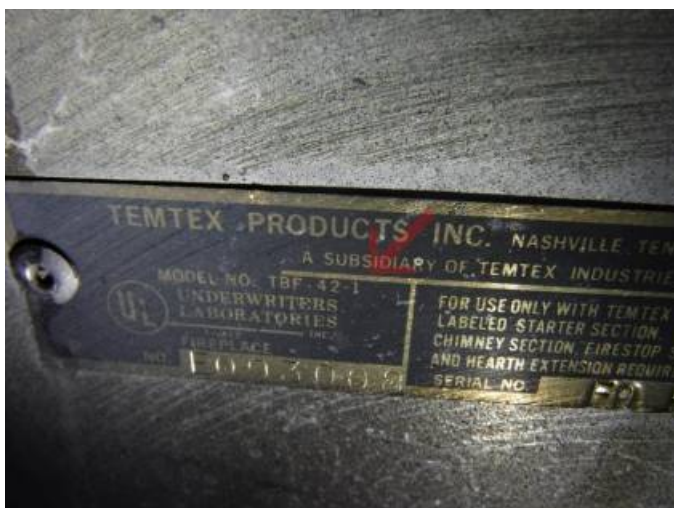
**BRAND:**

This is a masonry wood burning fireplace, with a gas log lighter.

TBF 42 I.

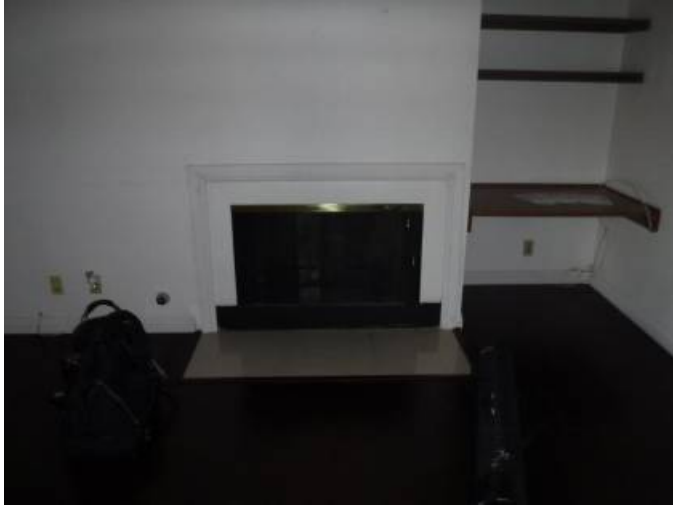
**FIREBOX:**

Operational Concern, there are smoke stains at the side walls of the firebox and just outside the firebox area which indicates improper drawing of the chimney flue (and smoke entry) during operation.

**The fireplace should not be operated in its current condition.**

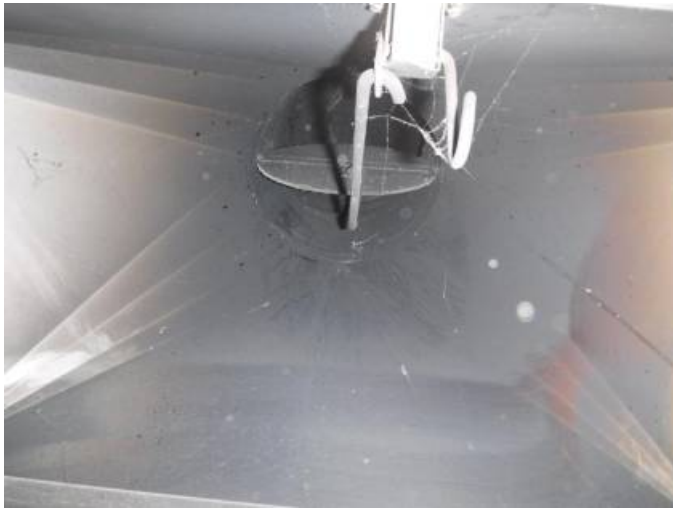
**DAMPER:**

Present.
