1204 Cinnabar Ct
Palm Springs CA 92262

6/26/2021

Home Sweet Home Inspections Inc DBA HouseMaster

INSPECTION INFORMATION**CLIENT:***Peter Smurthwaite***PROPERTY ADDRESS:***1204 Cinnabar Ct
Palm Springs CA 92262***INSPECTION DATE/TIME:***6/26/2021 - 11:00 AM***INSPECTOR:***Travis Tracy***INSPECTION COMPANY:***Home Sweet Home Inspections Inc DBA HouseMaster
PO Box 13927
Palm Desert CA 92255
(310)406-4442***INSPECTION DETAILS****STYLE OF HOUSE:***Single Family***AGE OF HOME:***0 to 3 years***TYPE OF INSPECTION:***Standard Home Inspection***STATUS OF HOME:***Occupied***TEMPERATURE:***105-110 F***WEATHER:***Sunny***PEOPLE PRESENT:***Seller, Agent***AUTHORIZED DISTRIBUTION:***Client and Client's Agent***ANCILLARY SERVICES:***Pool and Spa***INTRODUCTION**

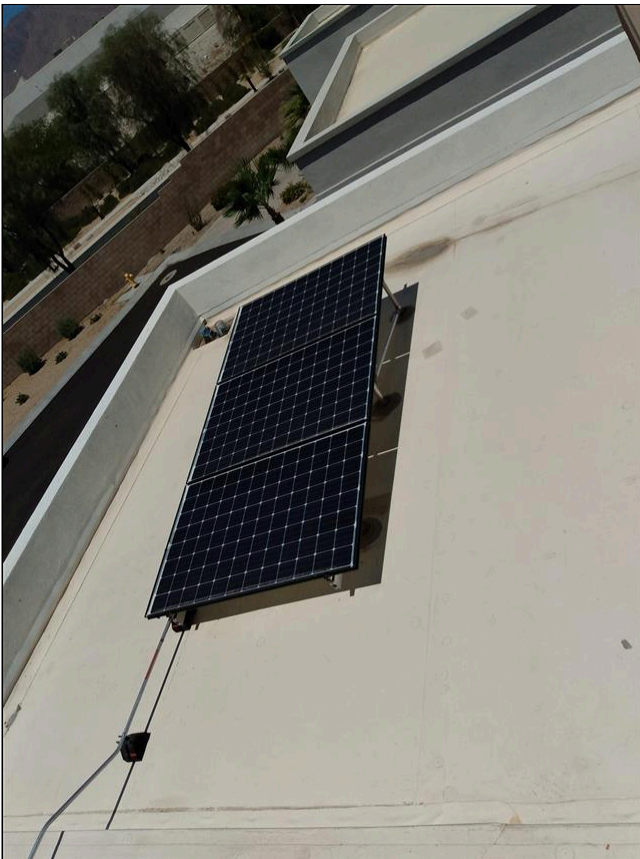
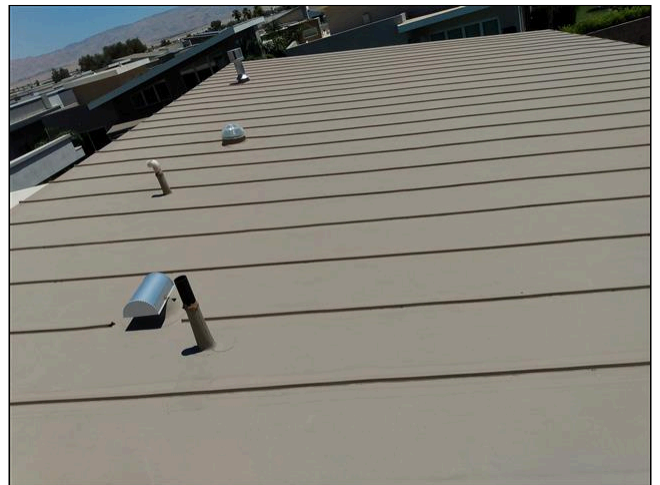
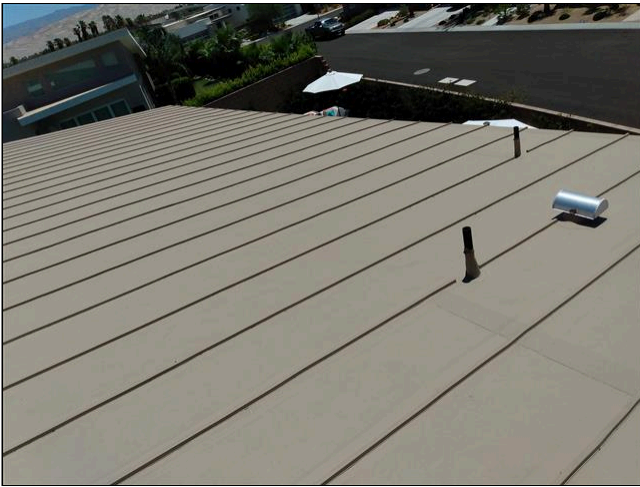
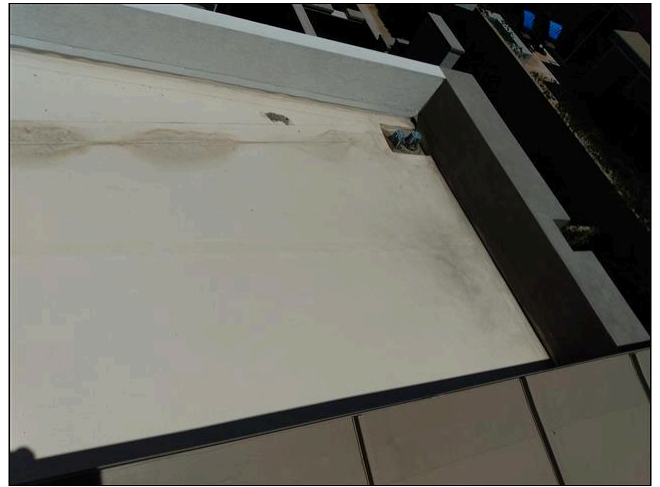
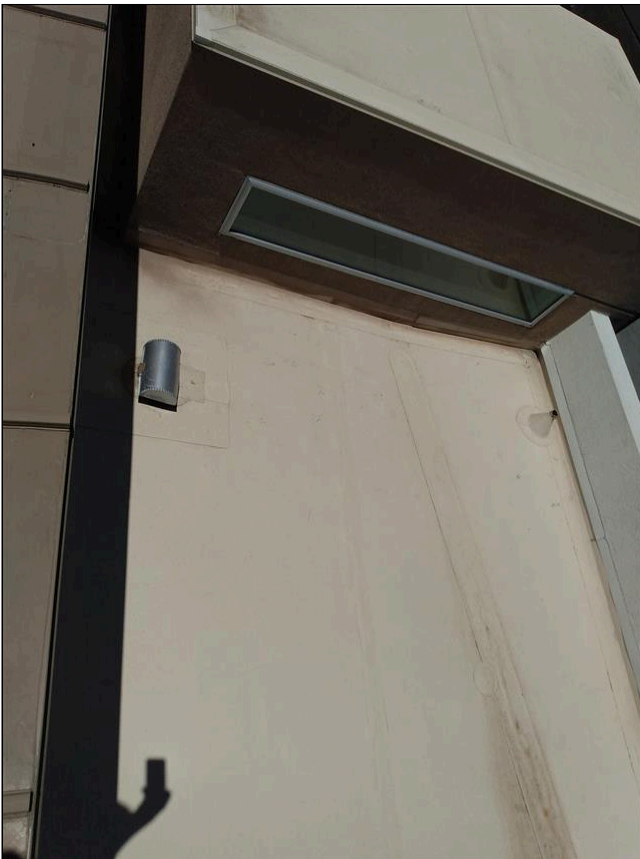
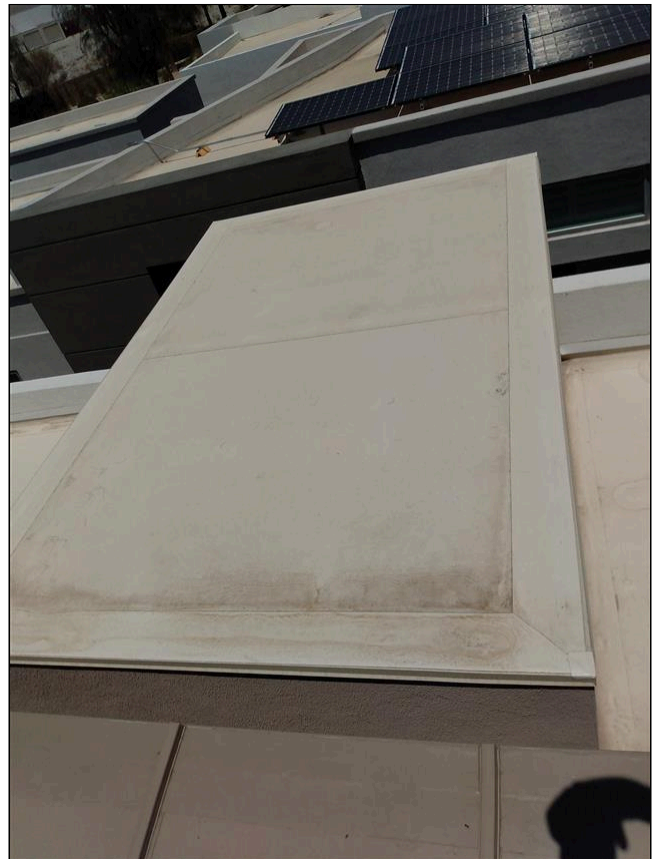
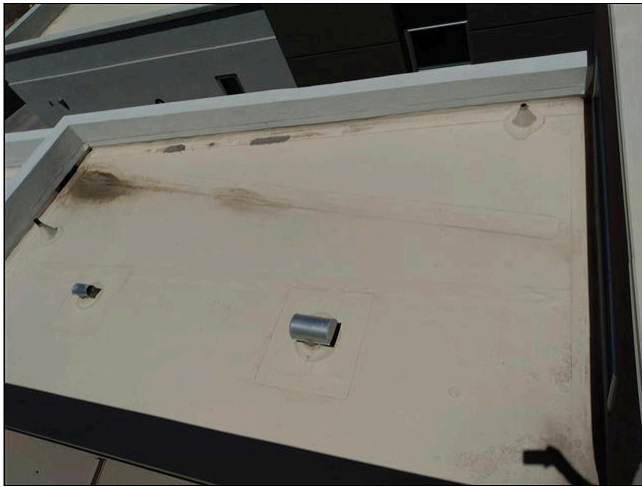
1.0(1) ROOF COVERING 1 (Picture 1)

●					1.0 ROOF COVERING 1 (1) The inspection of all roof and attic components are NOT inspected for vermin or bird intrusion. Recommend separate inspection be performed by specialist. (2) Flat and low slope roofs are particularly prone to leakage due to improper installation, water ponding, or poor maintenance. They generally require more maintenance than steep-sloped roofing and any deficiencies, even minor ones, should be attended to promptly. The membranes of certain type roofs, particularly built-up are not readily visible for inspection.
●					1.1 EXPOSED FLASHING Initial or recurring roof leakage is often due to inadequate or damaged flashing. All flashings should be checked periodically or if leakage occurs. Repair or seal as needed.
	●				1.2 PLUMBING STACKS Recommend installation of or confirmation of proper installation of hardware cloth on plumbing stack/vent covers to avoid possible vermin / bird intrusion.

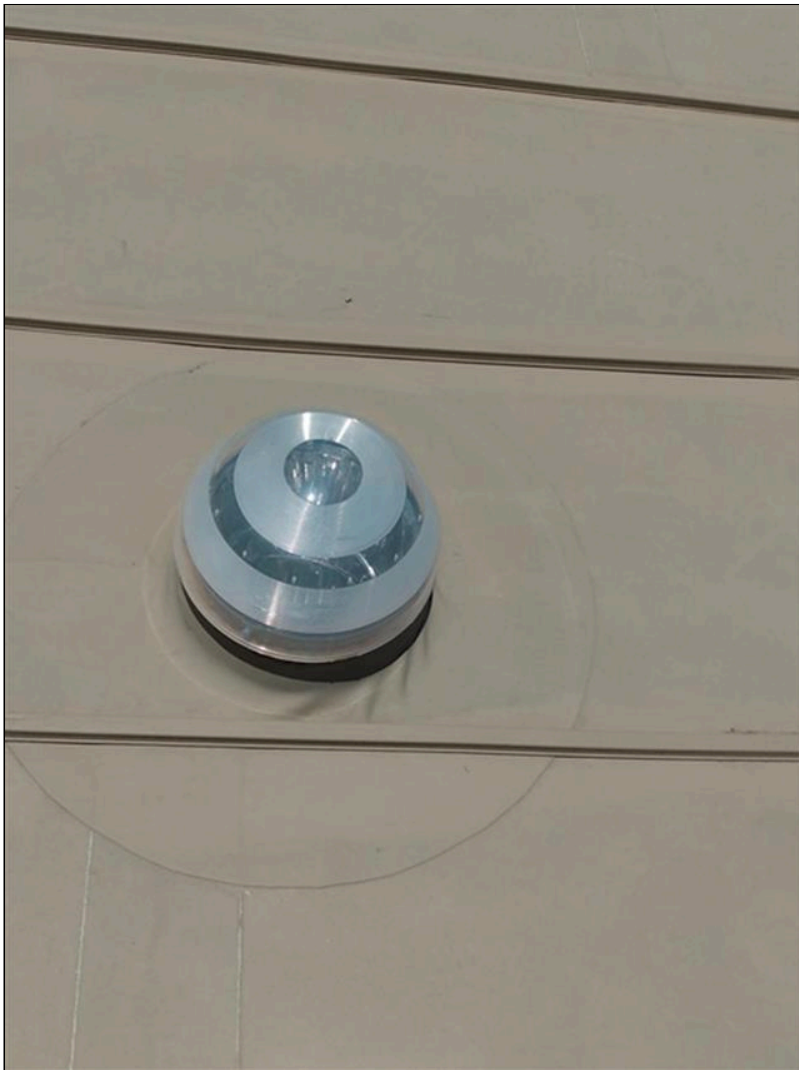
1.4 SKYLIGHT(S) / TUBE LIGHTS (Picture 1)

●				1.3 VENTILATION COVERS Recommend installation of or confirmation of proper installation of hardware cloth on plumbing stack/vent covers to avoid possible vermin / bird intrusion.
	●				1.4 SKYLIGHT(S) / TUBE LIGHTS Skylights are particularly prone to leakage and may need periodic repair and or resealing. The integrity of the flashings is generally the first point to consider when leakage occurs. Surface damage or loss of the seal on insulated glazing can occur, but such a defect may not be readily apparent during an inspection.

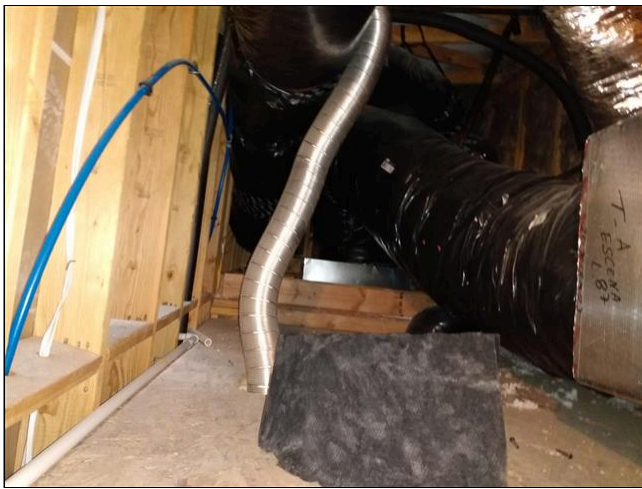
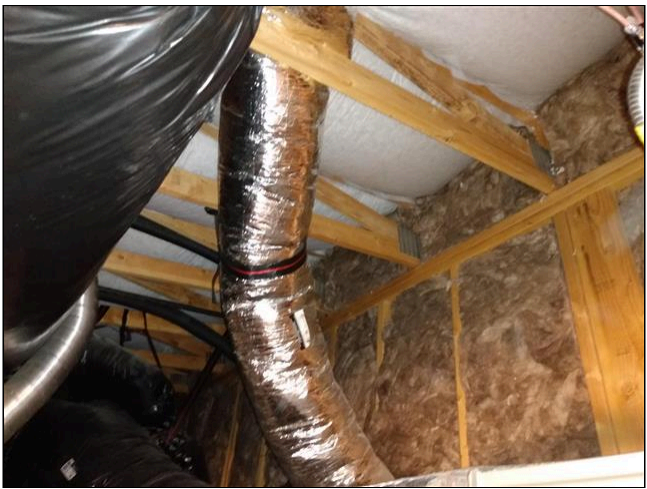
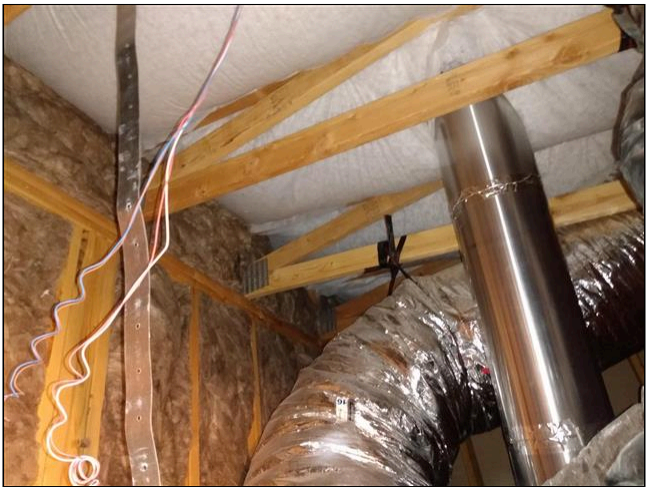
5.0 ROOF FRAMING (Picture 1)

●					5.0 ROOF FRAMING Limited access to the attic also limits the Home Inspector's ability to view all the components, therefore, the Inspector may only be able to view samples and not draw a whole conclusion. Therefore, the comments herein refer only to the components viewed by the Home Inspector. Noted multiple areas of unsecured wiring in attic space. Home inspector does not access all areas of attic space and it is recommend that further evaluation of attic be performed by electrician as desired.
●					5.1 ROOF DECK / SHEATHING The inspection of attic areas and the roof structure is limited to readily visible and accessible elements as listed herein. Due to typical design and accessibility constraints, such as insulation, storage, finished attic surfaces, roofing products, etc., many elements and areas, including major structural components, are often at least partially concealed from view and cannot be inspected.

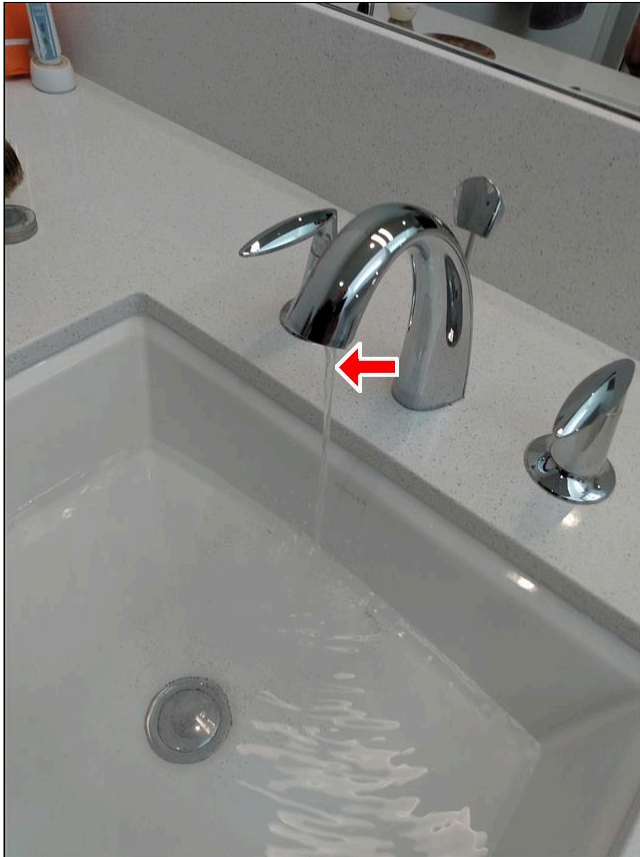
6.1 SINK(S) (Picture 1)

6.0 ----MASTER BATHROOM 1 -----
					6.1 SINK(S) Low water pressure and sediment noted. Recommend evaluation/repair by plumbing contractor.
					6.2 CABINETRY / COUNTERTOP

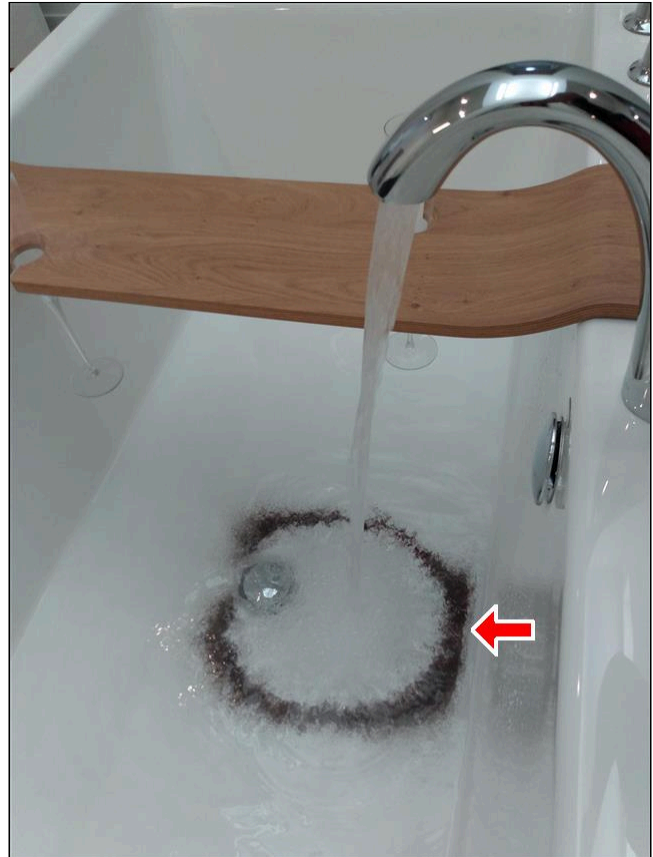
6.4 BATHTUB (Picture 1)

6.3 TOILET
					6.4 BATHTUB Low water pressure and sediment noted. Recommend evaluation/repair by plumbing contractor.
					6.5 STALL SHOWER
					6.6 SURROUNDS / ENCLOSURES (1) The waterproof covering (surround) at the tub/shower must be maintained to prevent damage. All surfaces should be checked and repaired as needed. Leakage can damage to substrate and prevent proper attachment. (2) <i>Caulking and/or grouting work is required to maintain the watertightness of tile and the tub/shower enclosures.</i> Noted tile grout cracking. Recommend repair to avoid possible moisture intrusion behind surround.
