Inspection Report

Property Address:
3480 Hoytt St
Riverside CA 92504

USA Property Inspection LLC

Property Address 3480 Hoytt St Riverside CA 92504	Date of Inspection 3/9/2025	Report ID 1213
Customer(s) Maria Vargas	Time of Inspection 12:00 PM	Real Estate Agent Adrian Villallobos

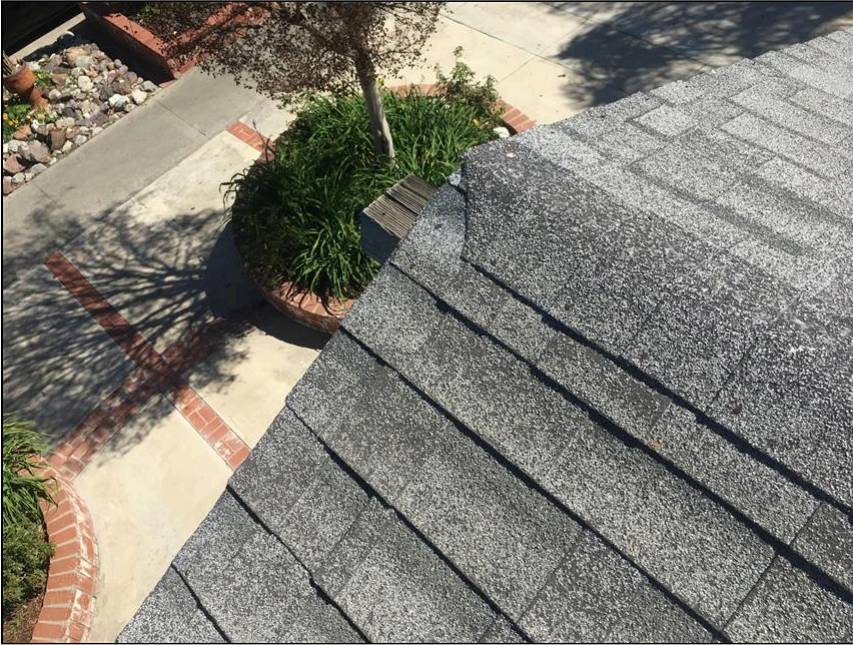
1.0 Item 1(Picture)

(3) **The Roof shingles older, deteriorated, granular loss and appeared nearing the end of its life cycle at the "entire roof". The roll roof covering bubbled, loose ends and granular loss at the rear of home. This damage should be repaired or replaced. A qualified contractor should inspect and repair as needed.**

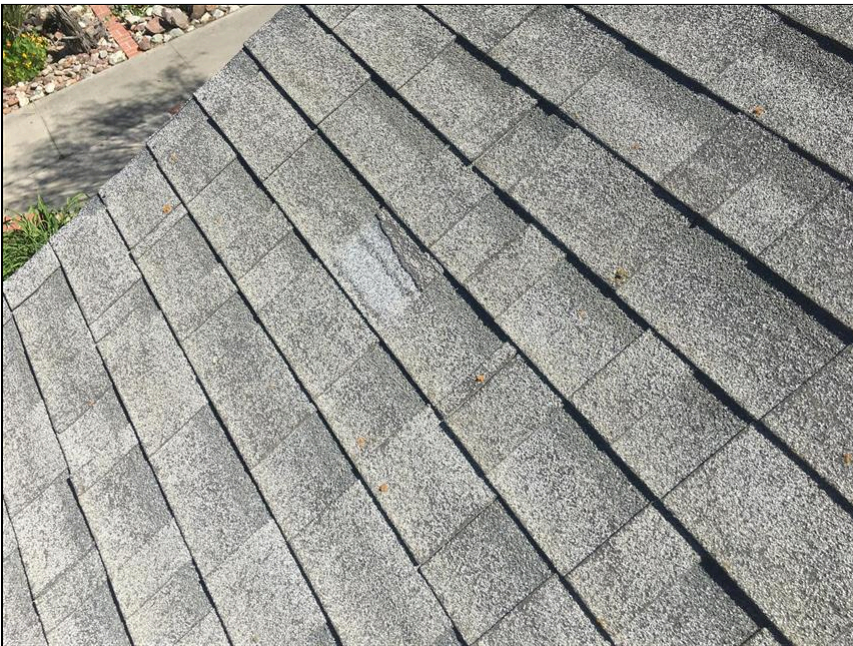
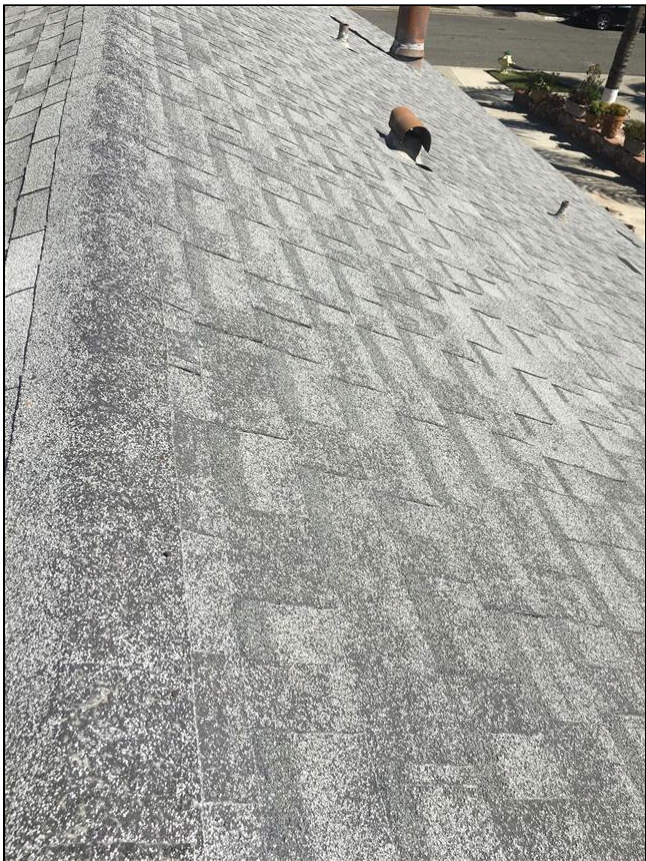
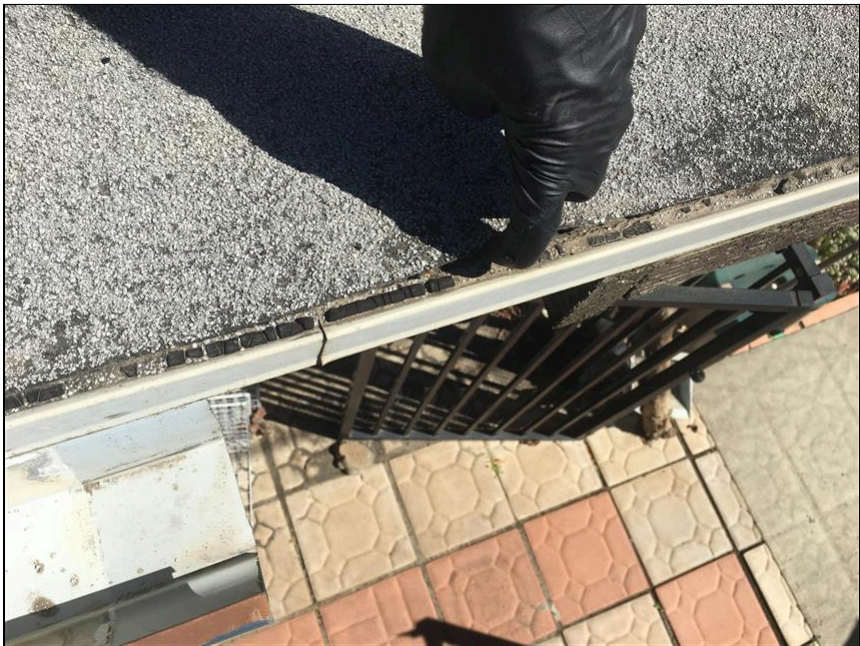
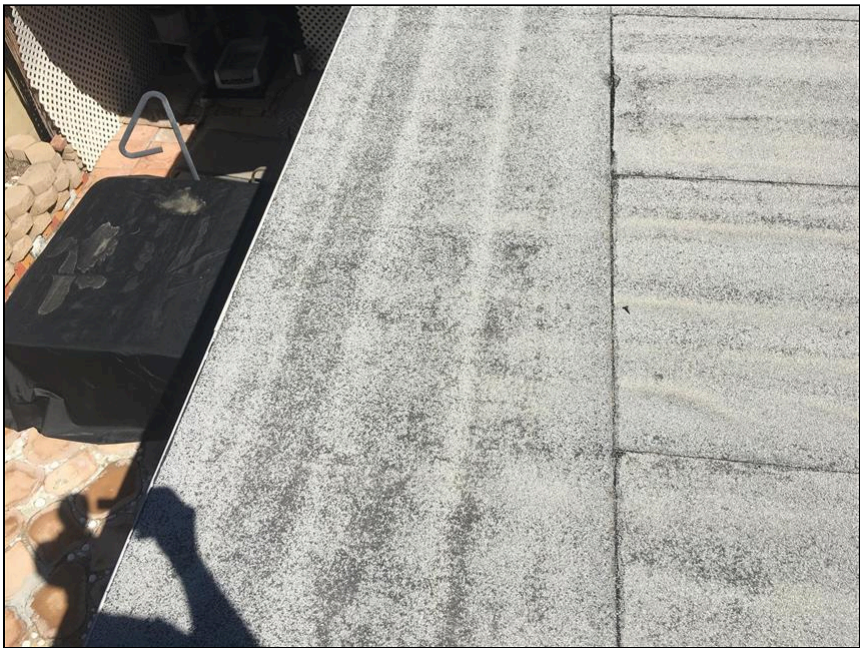
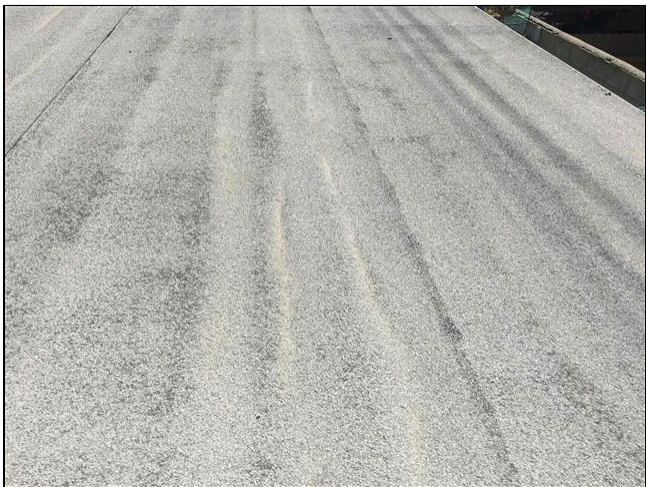
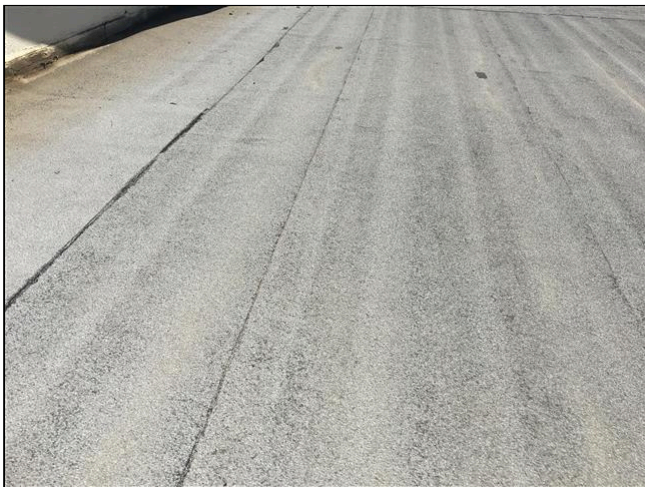
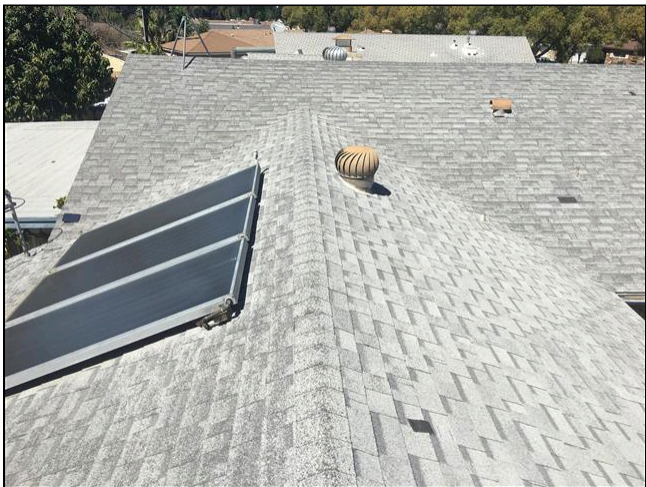
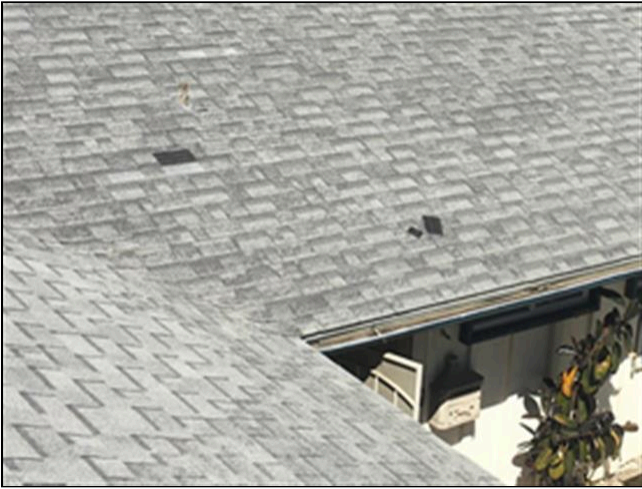
(3) **The Roof shingles older, deteriorated, granular loss and appeared nearing the end of its life cycle at the "entire roof". The roll roof covering bubbled, loose ends and granular loss at the rear of home. This damage should be repaired or replaced. A qualified contractor should inspect and repair as needed.**

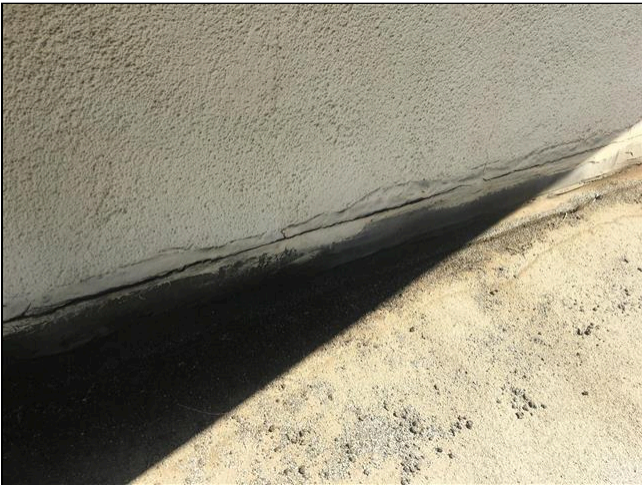
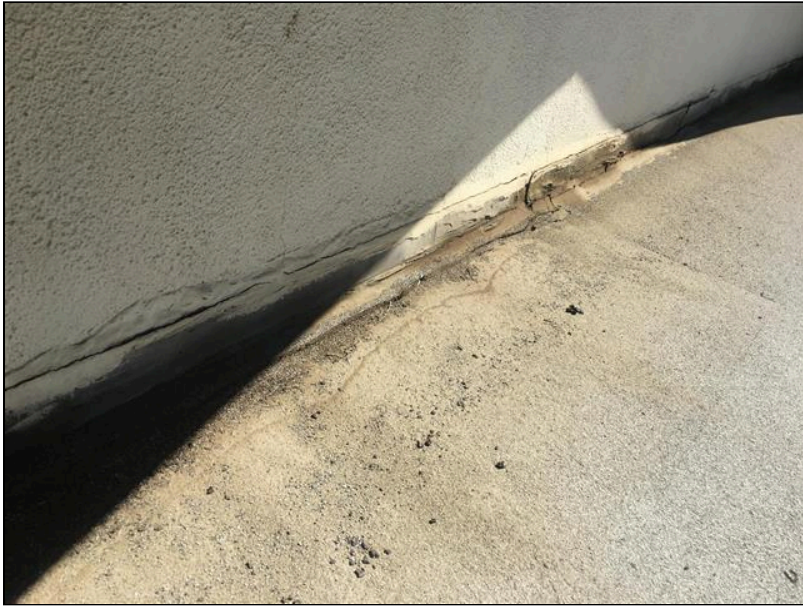
1.1 Sidewall counter-flashing was loose at rear roof and the sidewall sealant deteriorated. When the roof-covering material is replaced, sidewall flashing should be installed in a more permanent manner.

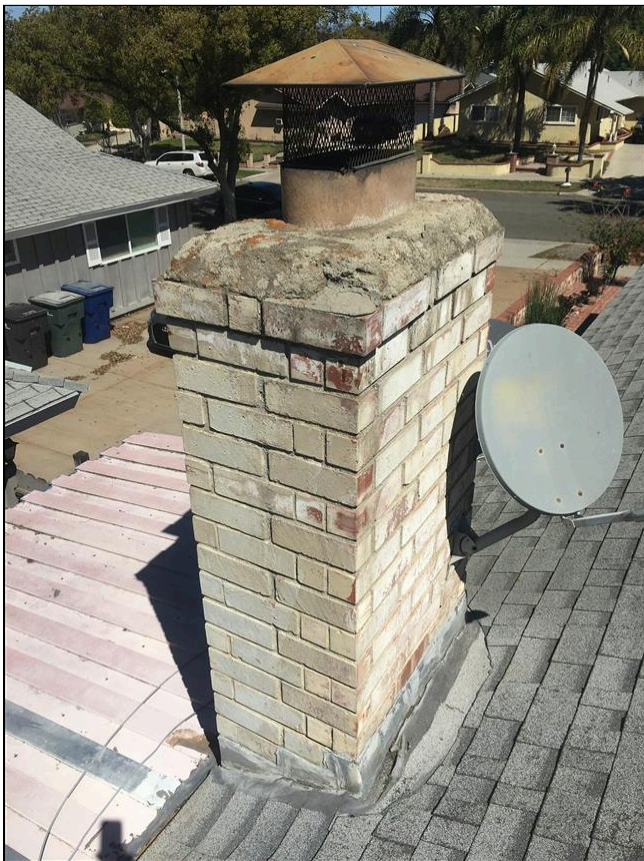
1.2 Item 1(Picture)

Accurate inspection of the chimney flue lies beyond the scope of the General Home Inspection. Although the Inspector may make comments on the condition of the portion of the flue readily visible from the roof, a full, accurate evaluation of the flue condition would require the services of a specialist. Because the accumulation of flammable materials in the flue as a natural result of the wood-burning process is a potential fire hazard, the inspector recommends that you have the flue inspected by a specialist.

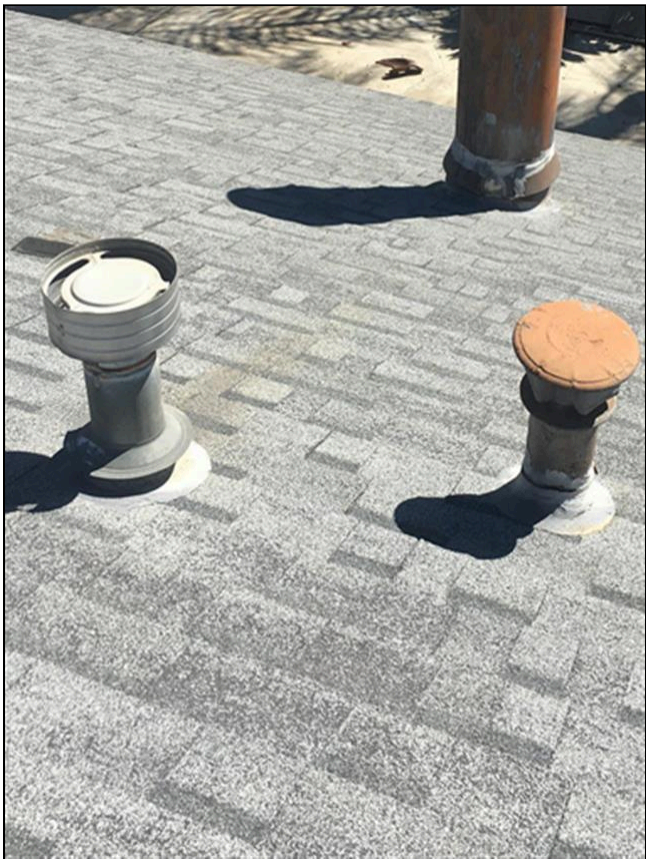
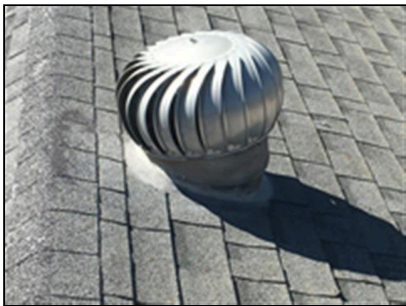
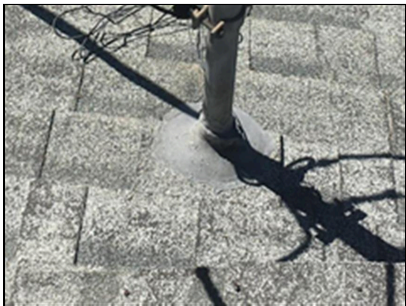
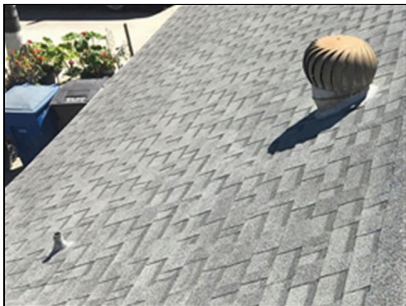
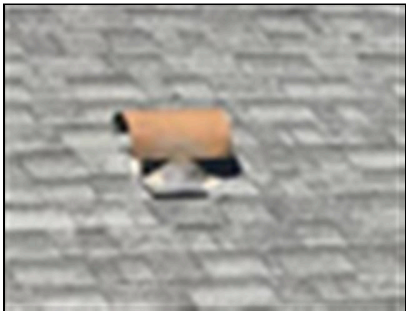
(3) **No visible roof flashing was installed on all penetrations. Roof sealant was used to seal areas that normally would be protected by metal flashing and deteriorated in areas. These areas will fail much sooner than if they were properly protected by metal flashing. Sealant will need to be examined annually and re-applied as needed. Proper flashing should be installed by a qualified roofing contractor at the first opportunity.**

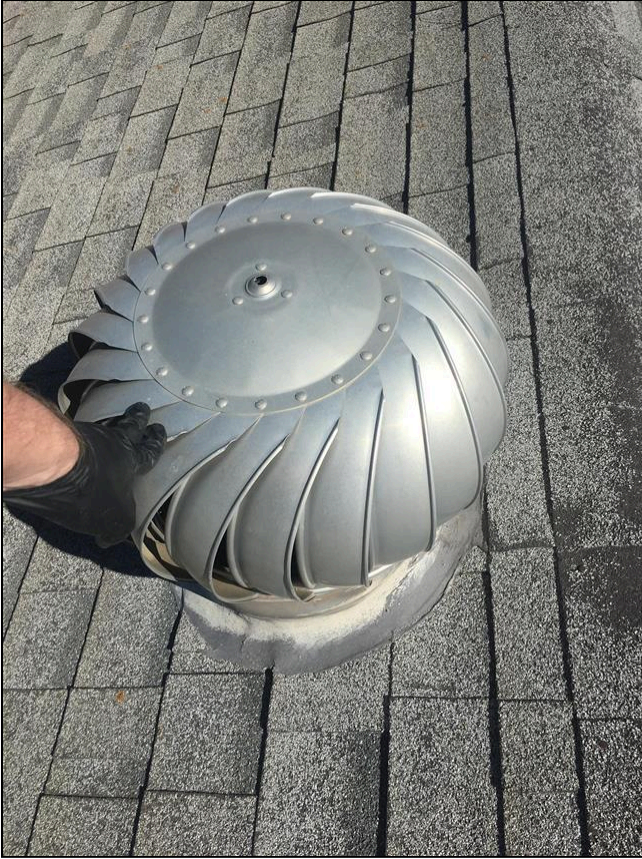
1.2 Item 10(Picture)

(4) **One turbine vent doesn't work properly at the front of home. A qualified person should repair or replace as needed.**

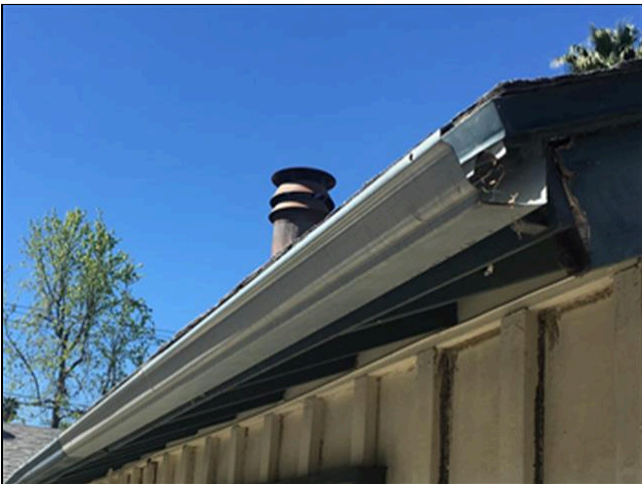
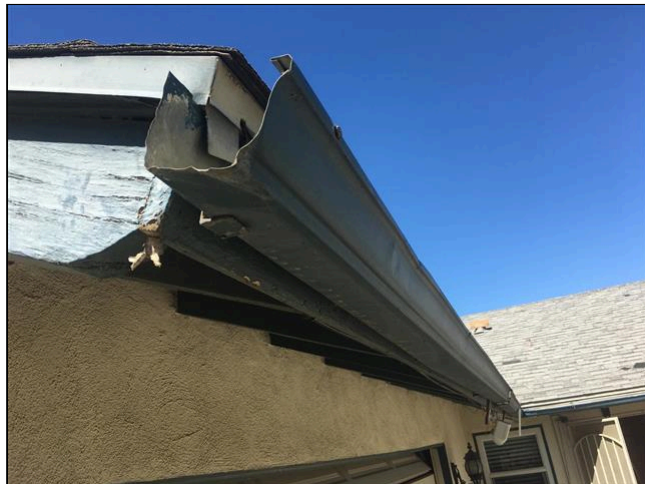
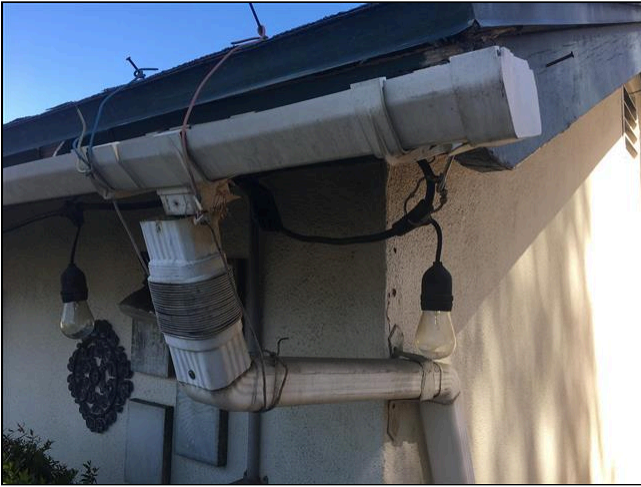
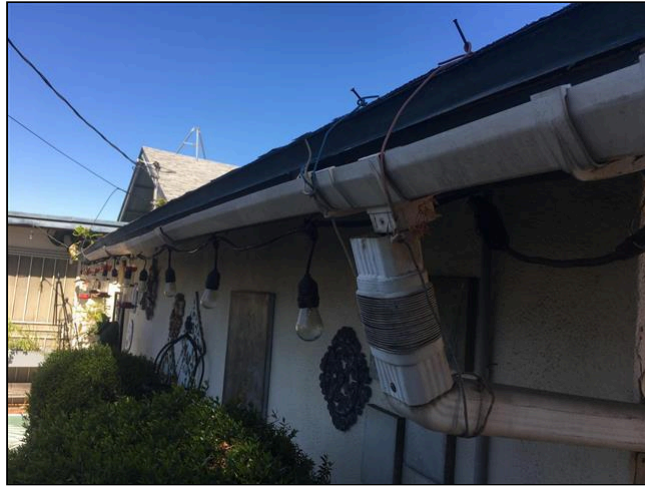
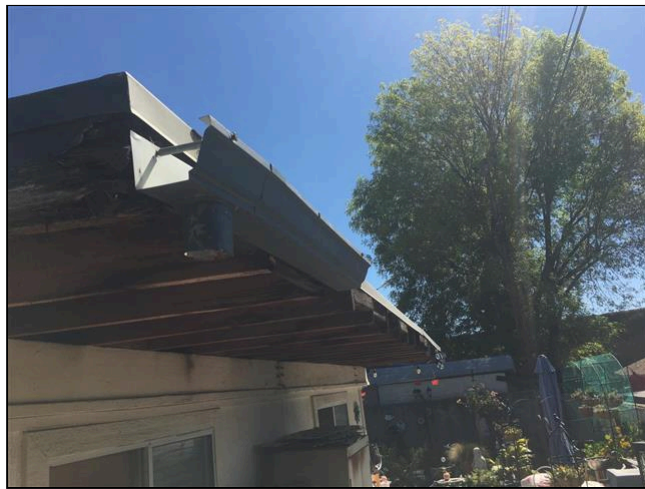
1.3 The gutter and downspouts loose, missing parts or damaged at virtually all areas where gutters are installed. A qualified person should repair or replace as needed.

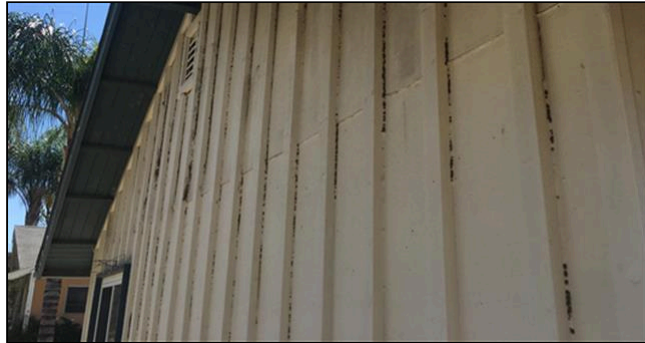
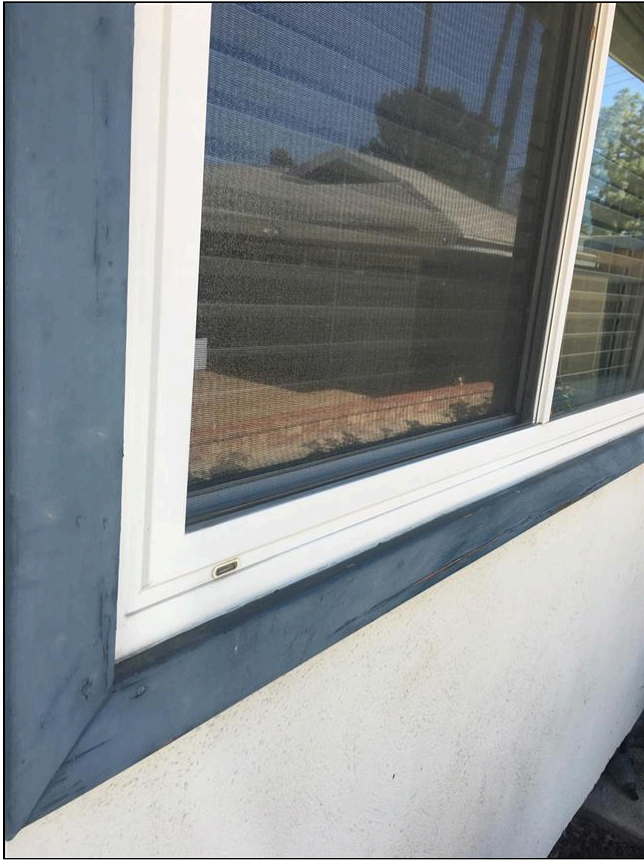
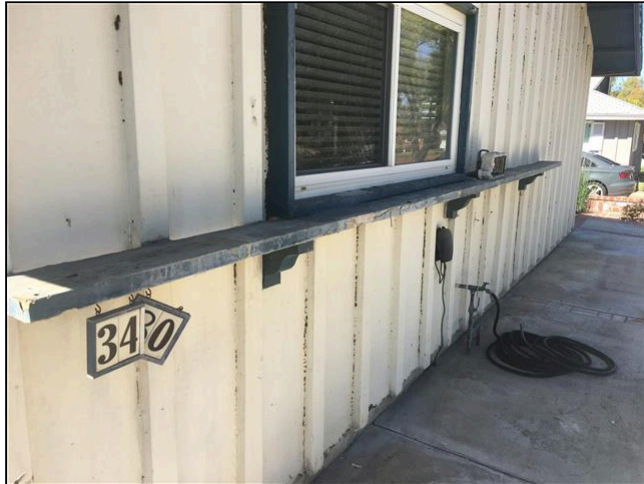
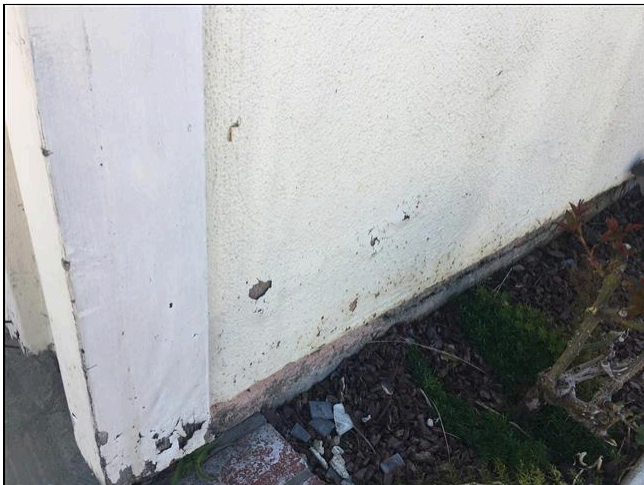
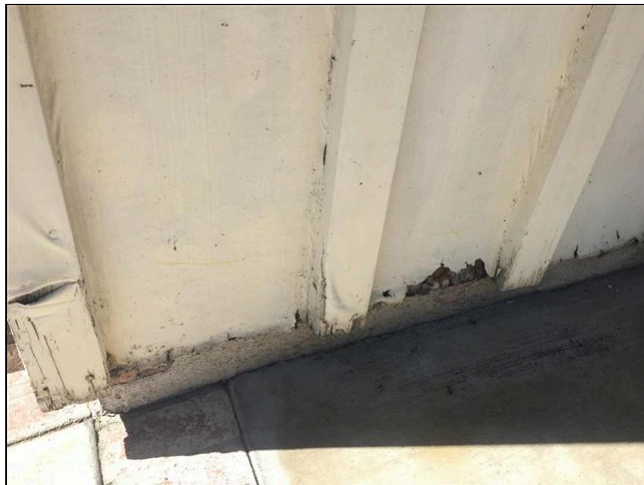
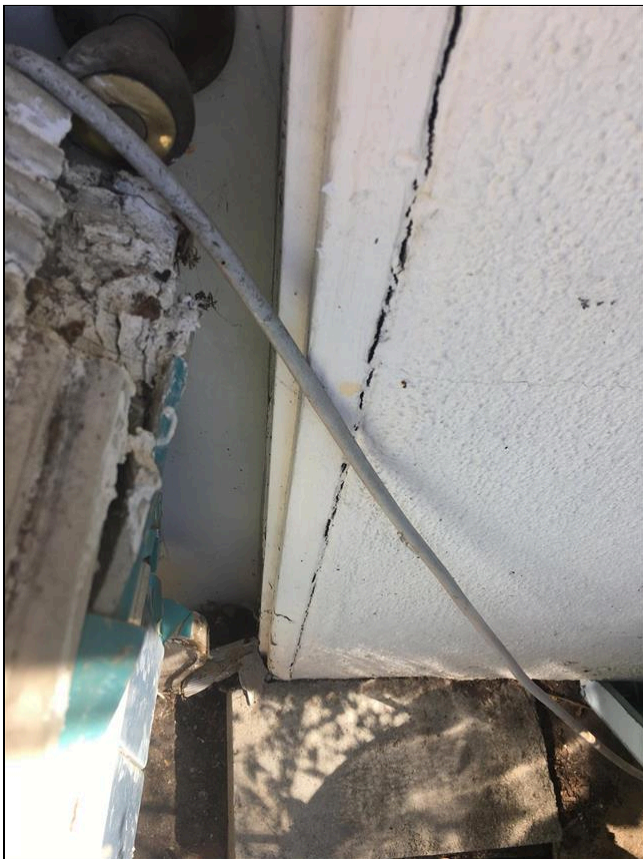
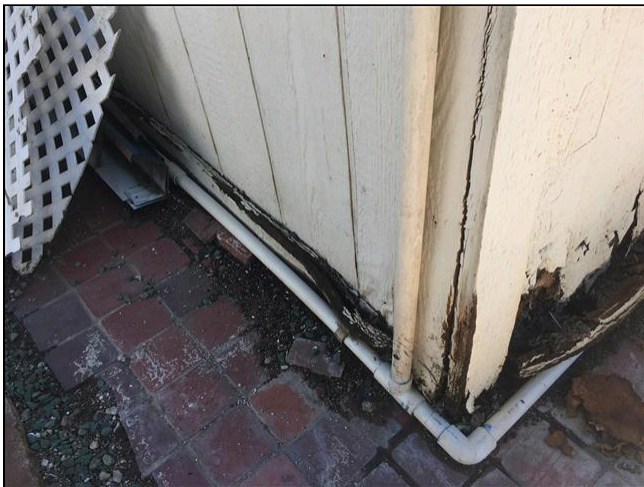
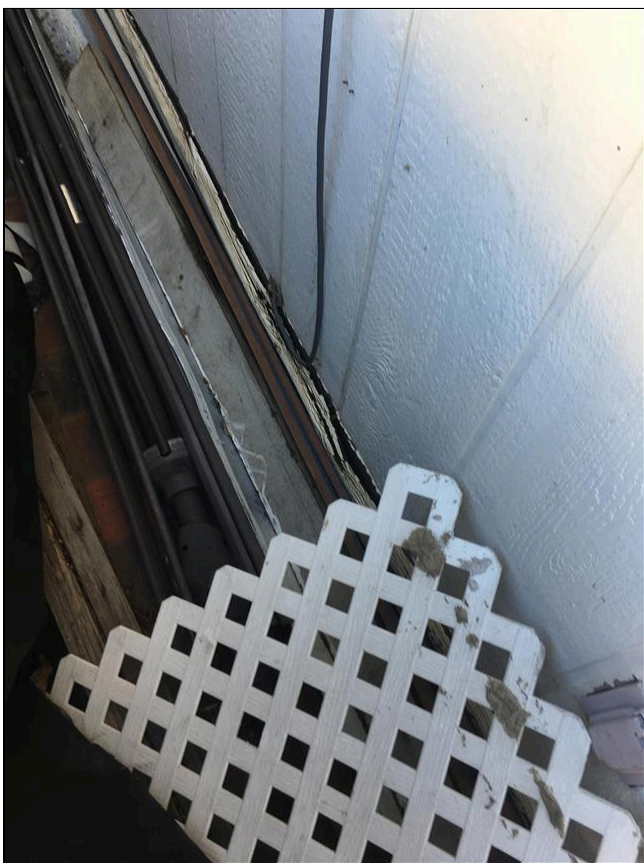
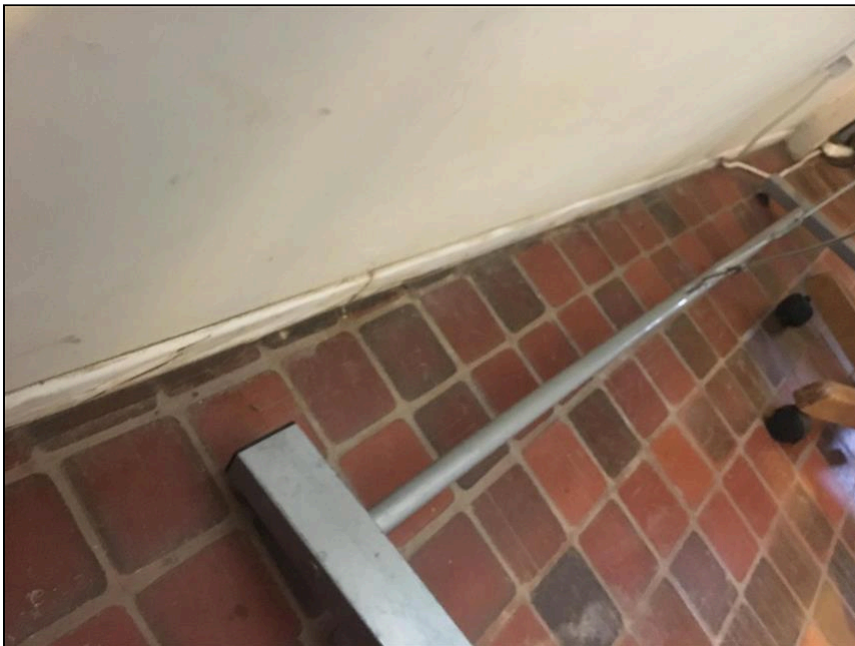
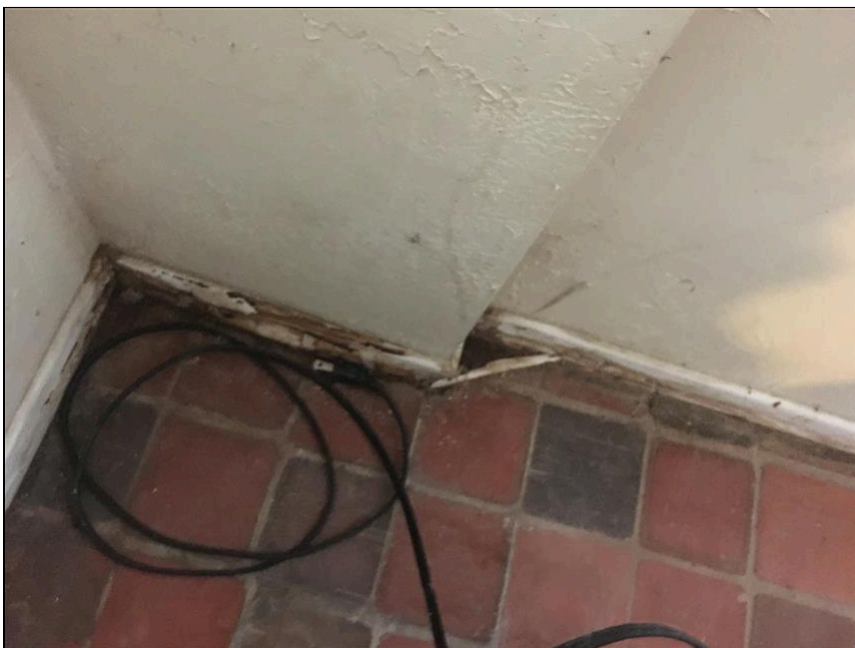
(2) **The Stucco coating, Wood siding and Wood trim at the exterior in areas deteriorated, peeling paint or failing. Further deterioration can occur if not corrected. A qualified contractor should inspect and repair as needed.**

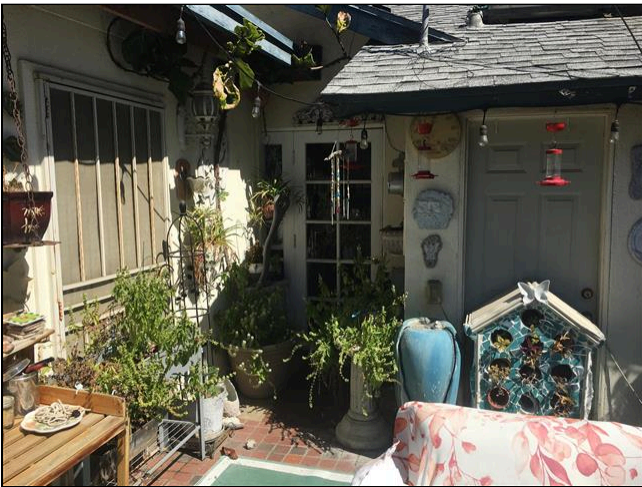
2.1 Item 1(Picture)

(2) The side entry doors rear of home obstructed. The door not inspected. For your information

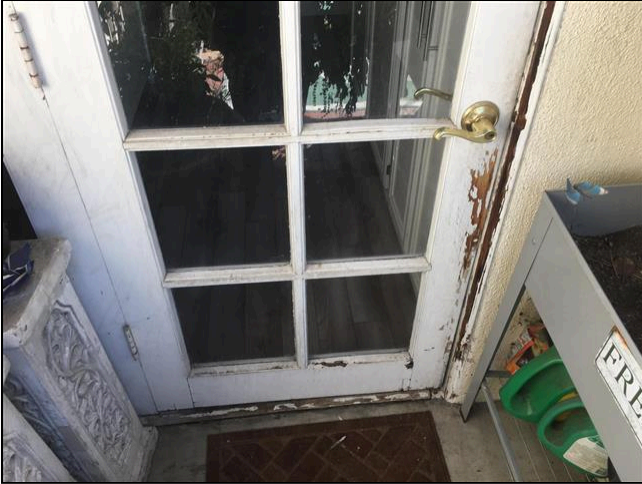
2.1 Item 2(Picture)

(3) **The side entry door rear of home rubs floor when opened and peeling/deteriorating. A qualified person should repair or replace as needed.**

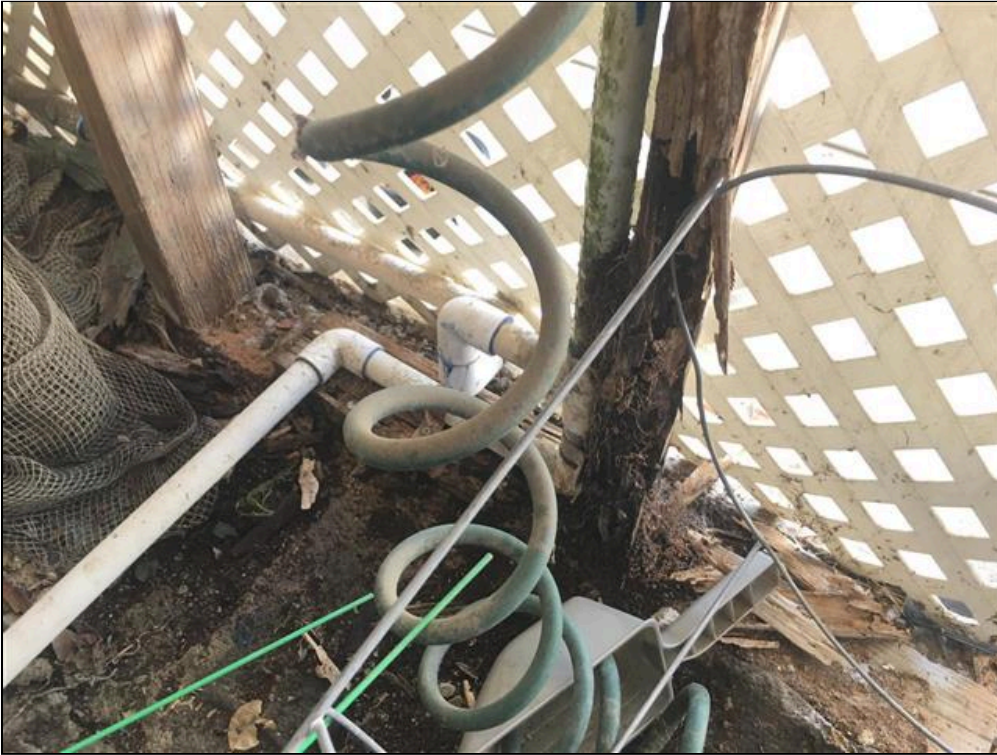
2.3 Item 1(Picture)

(2) The Patio roof cover side wall or support deteriorated at the rear of home. A qualified contractor should inspect and repair as needed.

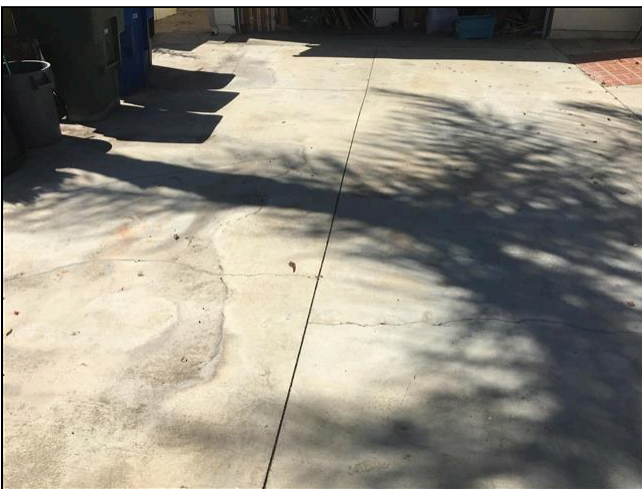
2.4 Item 1(Picture)

(2) The concrete driveway/walkways at the home has settlement cracks. Cosmetic. Seal areas to prevent further cracking or general replacement. I recommend repair as desired.

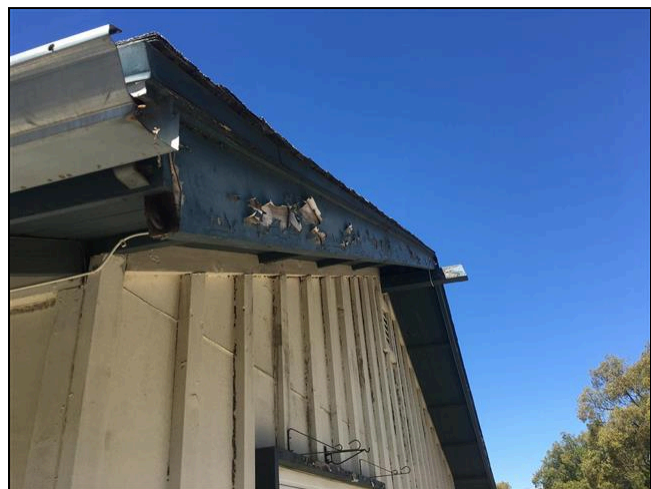
2.5 Item 1(Picture)

2.5 The wood fascia and soffit panels at eave on the exterior in areas deteriorated, peeling paint or not primed and painted. Further deterioration may occur if not repaired. A qualified contractor should inspect and repair as needed.

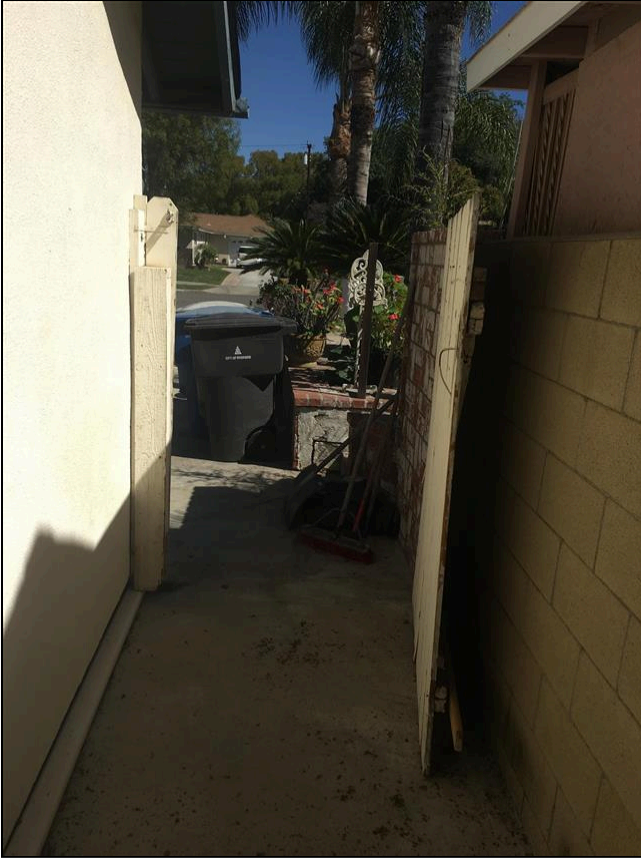
2.6 Item 2(Picture)

(2) **Fence gate rubs ground at the back yard. Recommend a qualified person repair or replace as needed.**

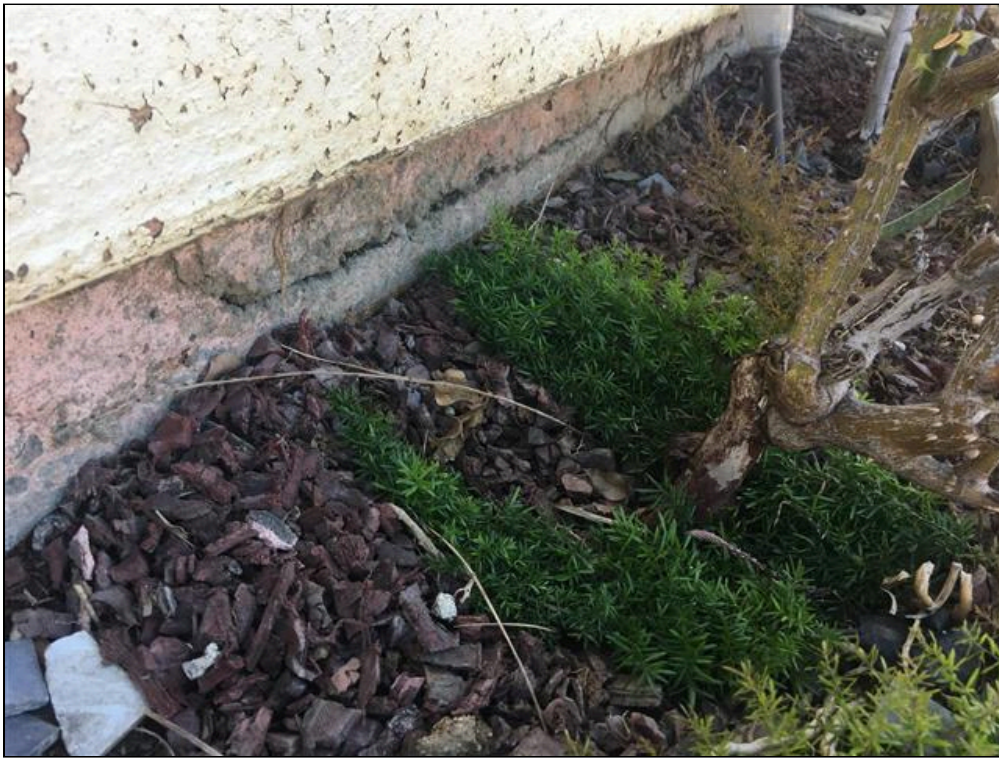
3.0 Item 1(Picture)

(2) **The Foundation wall at the exterior areas deteriorated. I recommend repair or replace as needed.**

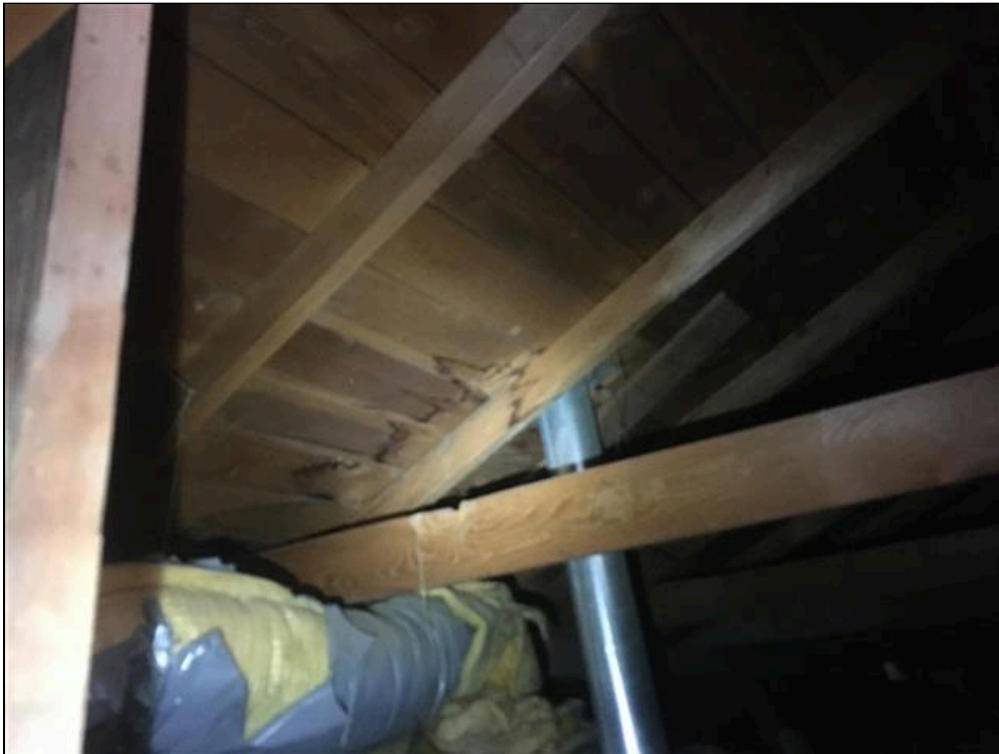
3.4 Item 7(Picture)

(4) **Discovered what appears to be water signs/deterioration resulting from a roof leak found in attic and garage areas. I am unable to determine if leak has been corrected. A qualified roofing contractor should inspect further and correct as needed.**

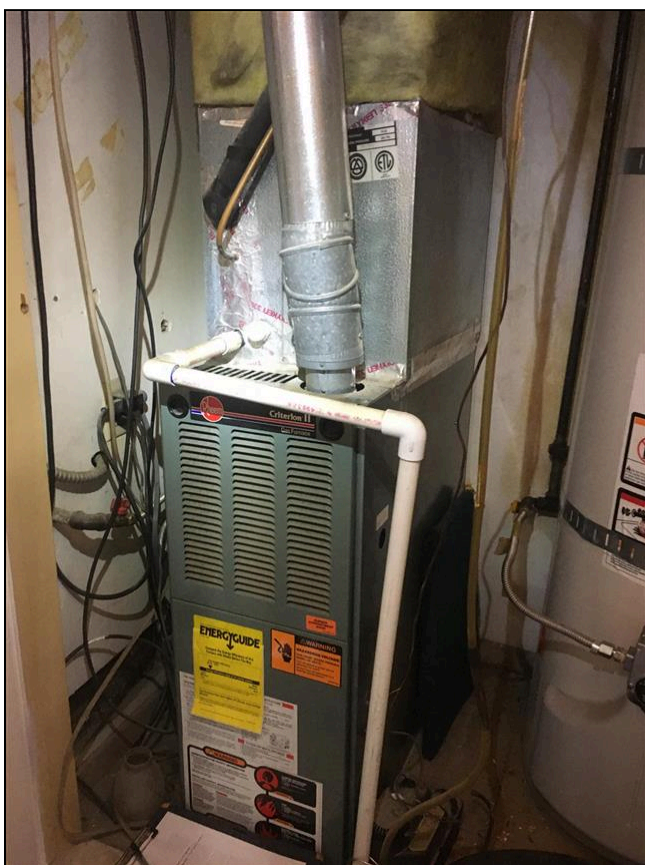
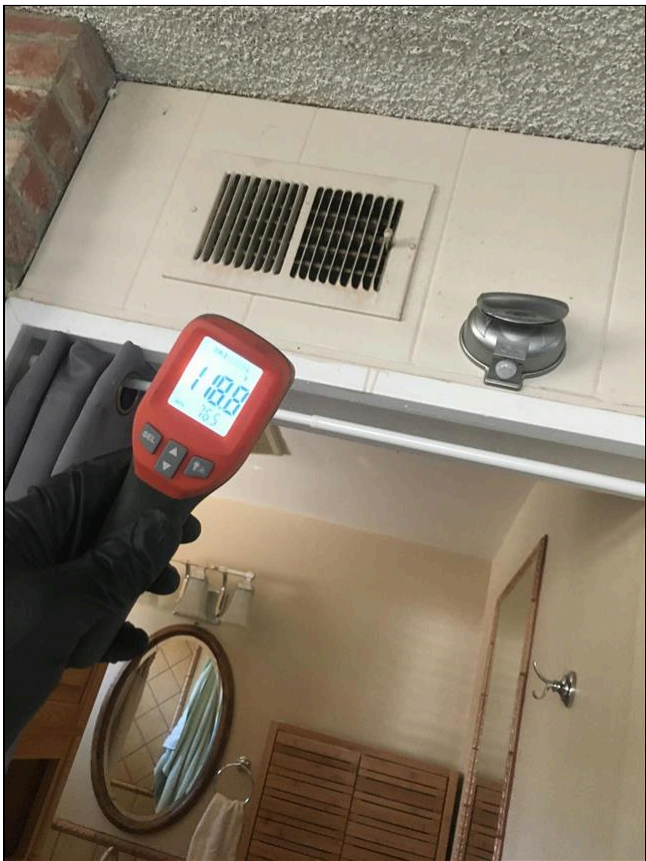
- cabinet interior and exterior;
- fuel supply and shut-off (not tested);
- electrical shut-off - Adequate combustion air;
- proper ignition;
- Burn chamber conditions (when visible);
- exhaust venting;
- air filter and blower;
- plenum and ducts;
- response to the thermostat;
- adequate return air; automatic damper and controls; and condensate drain components.

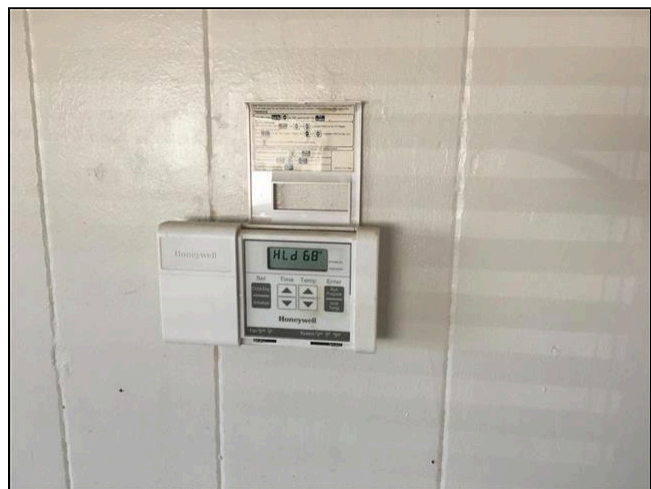
4.1 Item 1(Picture)

4.1 Normal operating controls appeared functioning/ operating at the time of the inspection.

Controls are located in master bedroom.

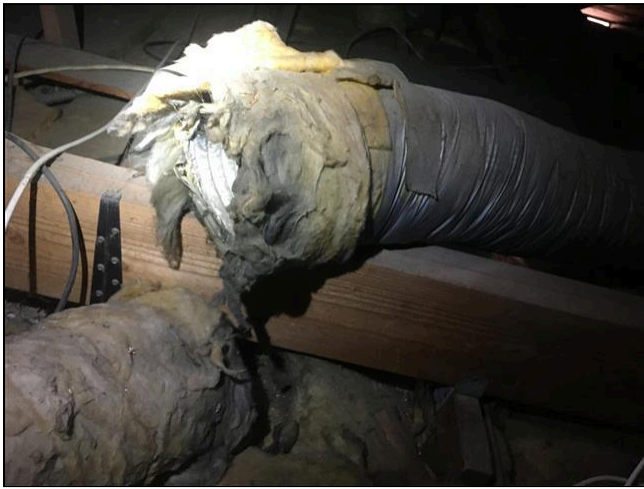
4.3 Item 2(Picture)

(2) **The supply duct pipe is loose and is damaged in the attic. Energy loss is occurring. A few registers are more weak than others in home. I recommend further inspection by a licensed HVAC contractor.**

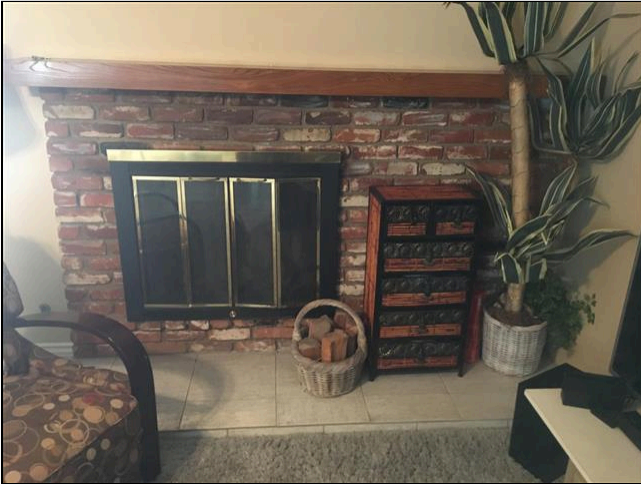
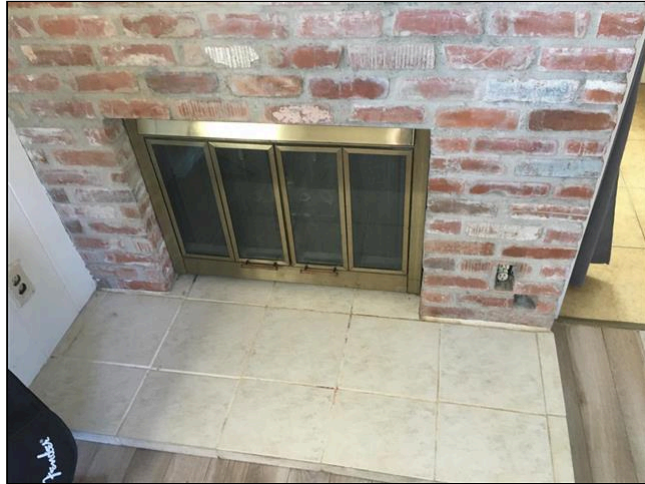
4.6 (1) Solid fuel heating devices (manufactured fireplace/vented gas logs for master bedroom) and the damper appeared functioning/ operating at the time of the inspection. I do not inspect the shape of fireplace or the design to determine if your fireplace has a proper air draw. The fireplace is also equipped with a gas connection to install gas logs or fire starters if desired. There is a set of glass doors installed. Used correctly, these will help minimize heat loss when the fireplace is not in use. They also eliminate burning amber from flying into the room during a fire and reduce the volume of room air sucked up the chimney. The inspection is limited to the visible portions of the fireplace flue. Drop light, mirrors, and smoke testing are not a part of the inspection. Visibility in the flue is limited to as little as 20 percent. If further investigation is necessary, a qualified professional chimney sweep is recommended.

Its highly recommended to have the fireplaces further evaluated by qualified chimney sweep/contractor and service before use.

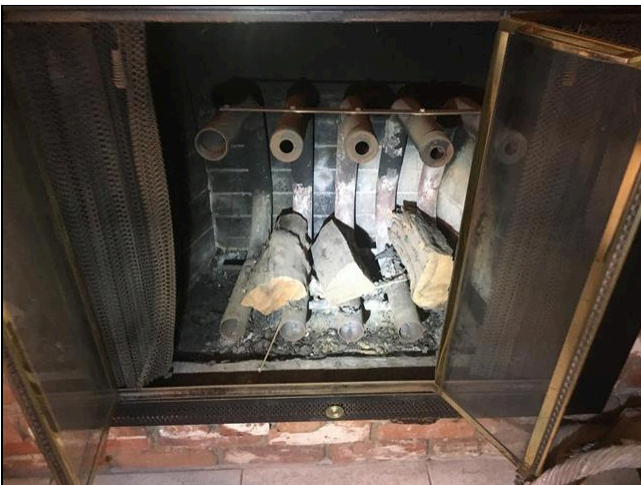
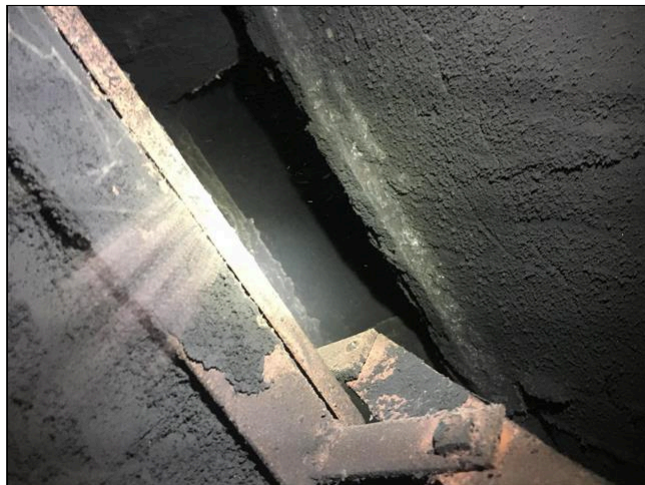
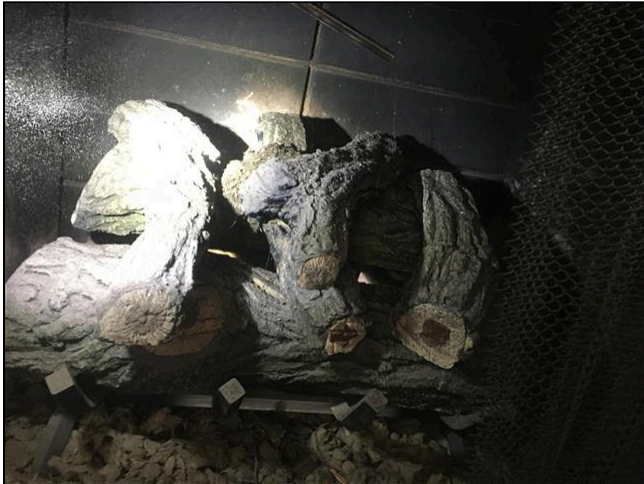
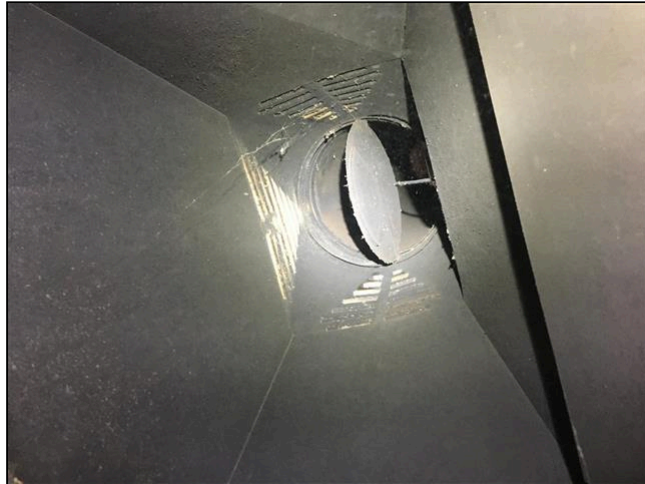
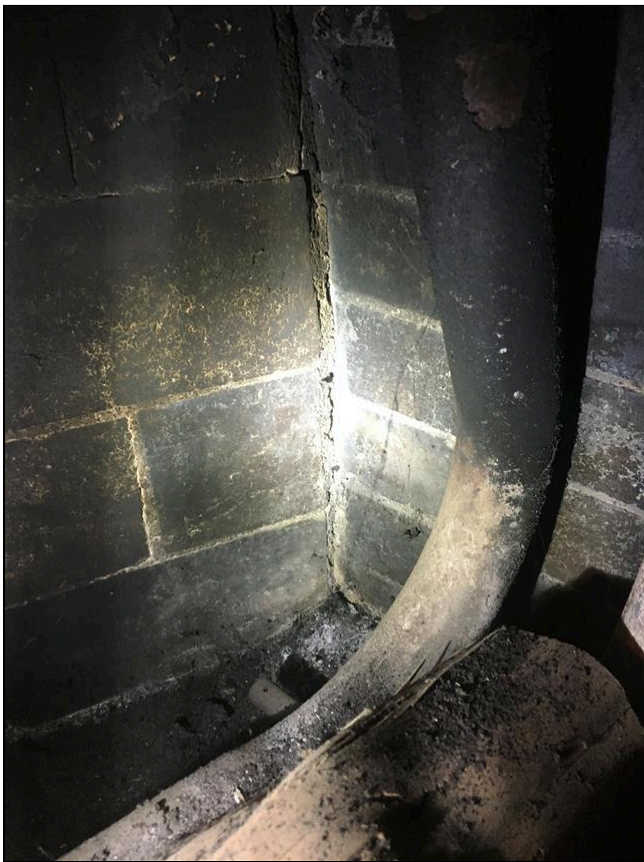
(2) The firebox and flue of the fireplace in the in the living room and master bedroom needed cleaning at the time of the inspection. Deterioration in areas of burn areas for living room. For a full inspection to more accurately determine the condition of the fireplace and to ensure that safe conditions exist, the Inspector recommends that you have the fireplace inspected by an inspector certified by the Chimney Safety Institute of America (CSIA). Find a CSIA-certified inspector near you at <http://www.csia.org/search>

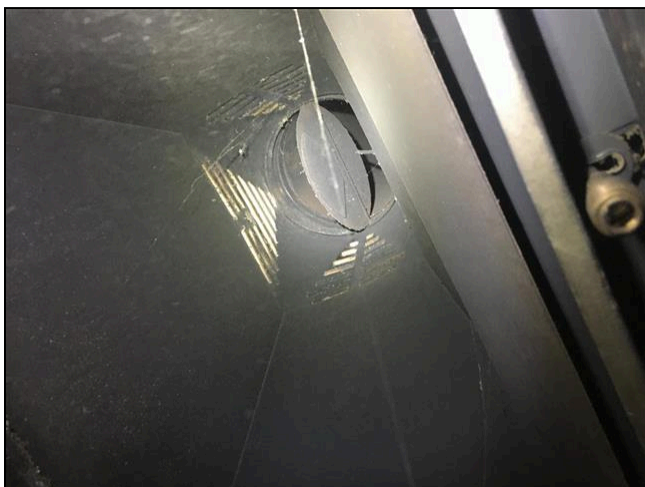
4.6 Item 8(Picture)

(3) **The damper lid for vented fire logs at the Master bedroom is missing a clamp or lock that forces lid to stay open (required for Vented Gas/LP logs). A qualified chimney sweep should inspect and repair as needed.**
