Inspection Report

Property Address:
3480 Hoytt St
Riverside CA 92504

USA Property Inspection LLC

Property Address 3480 Hoytt St Riverside CA 92504	Date of Inspection 3/9/2025	Report ID 1213
Customer(s) Maria Vargas	Time of Inspection 12:00 PM	Real Estate Agent Adrian Villallobos

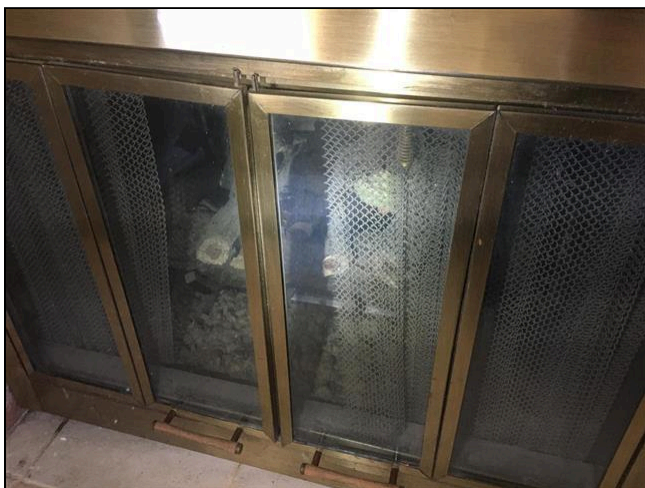
4.6 Item 9(Picture)

(4) **The glass doors on enclosure at fireplace in the Master bedroom do not stay in track and could fall out when used. I recommend repair as needed.**

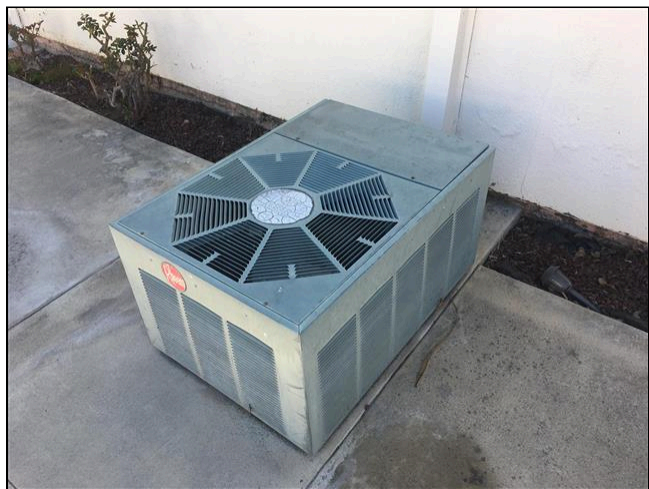
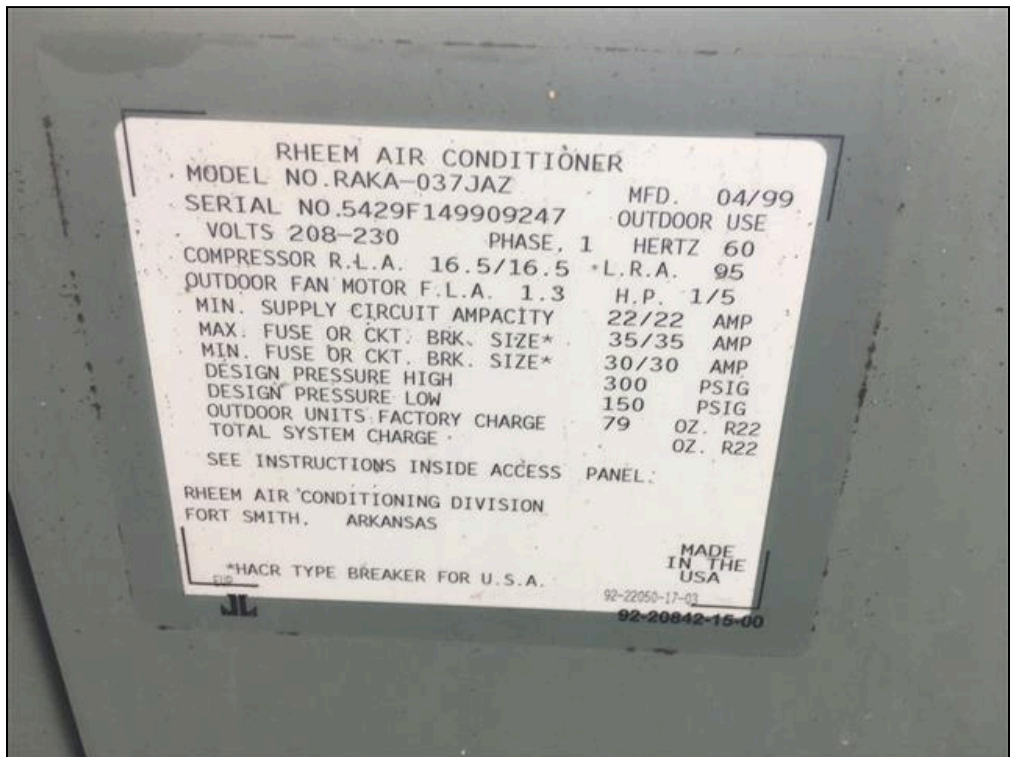
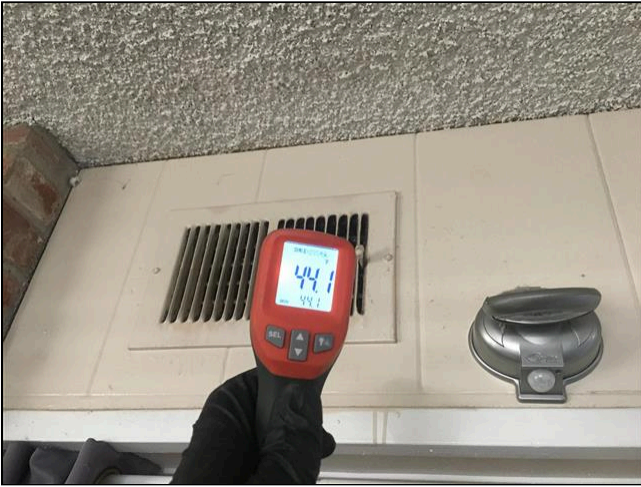
The air conditioning system was a split system in which the cabinet housing the compressor, cooling fan and condensing coils was located physically apart from the evaporator coils. As is typical with split systems, the compressor/condenser cabinet was located at the home's exterior so that the heat collected inside the home could be released to the outside air. Evaporator coils designed to collect heat from the home interior were located inside a duct at the furnace.

The condenser outside (AC unit) is older and may last a few years more, but maybe not. I have

seen units fail shortly after a home inspection during the seasonal change from mild to hot weather. I cannot determine how long your AC will last before a replacement is necessary.

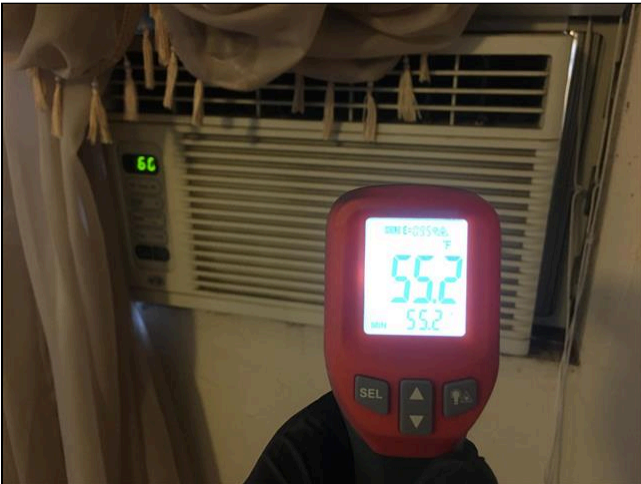
4.7 Item 4(Picture)

(2) The wall-mounted air-conditioning unit appeared to be in serviceable condition at the time of the inspection and produced cool air upon demand. Inspection of wall-mounted air-conditioning units is limited to confirmation of proper operation.

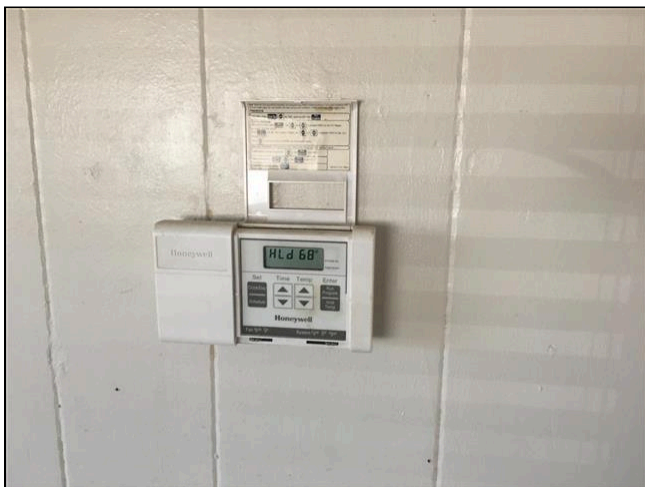
4.8 Item 1(Picture)

4.8 Normal operating controls appeared functioning/ operating at the time of the inspection.

Controls are located in the master bedroom.

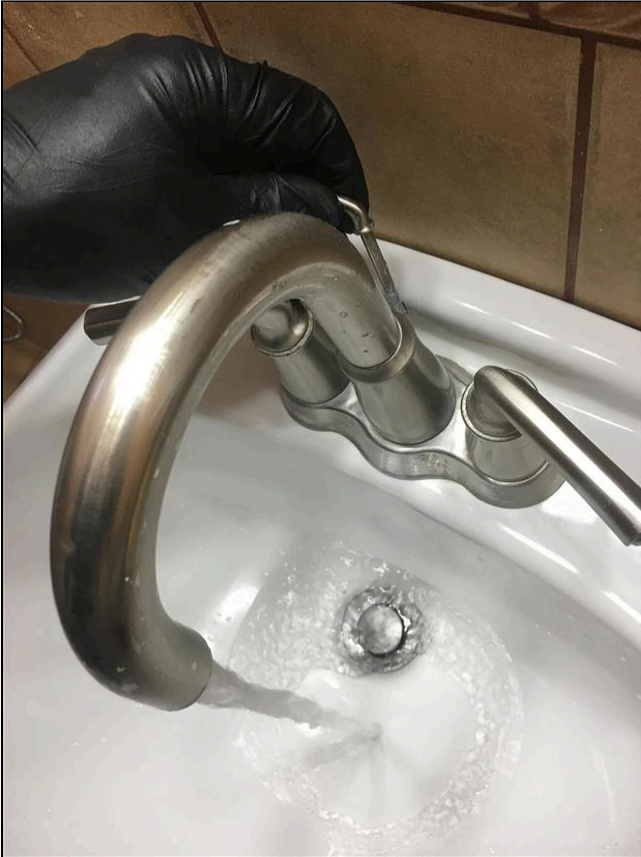
5.0 Item 1(Picture)

(2) The stop-valve is missing or does not work properly at the Hall Bath sink and Master Bath sink. Small repair. A qualified person should repair as necessary.

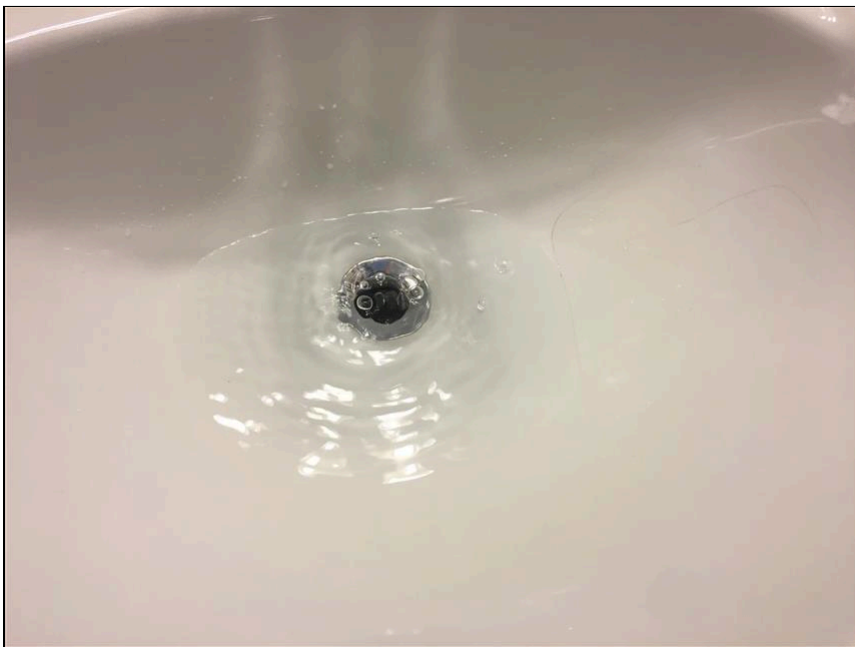
5.0 Item 4(Picture)

(3) **The plumbing waste line drains slowly at the Hall Bath sink. A cause of a slow drain can range from a simple cleaning at stop valve or at the trap under sink. Sometimes the drain can be partially clogged down line. I am unable to determine the cause of the slow drain. A qualified person should repair as necessary.**

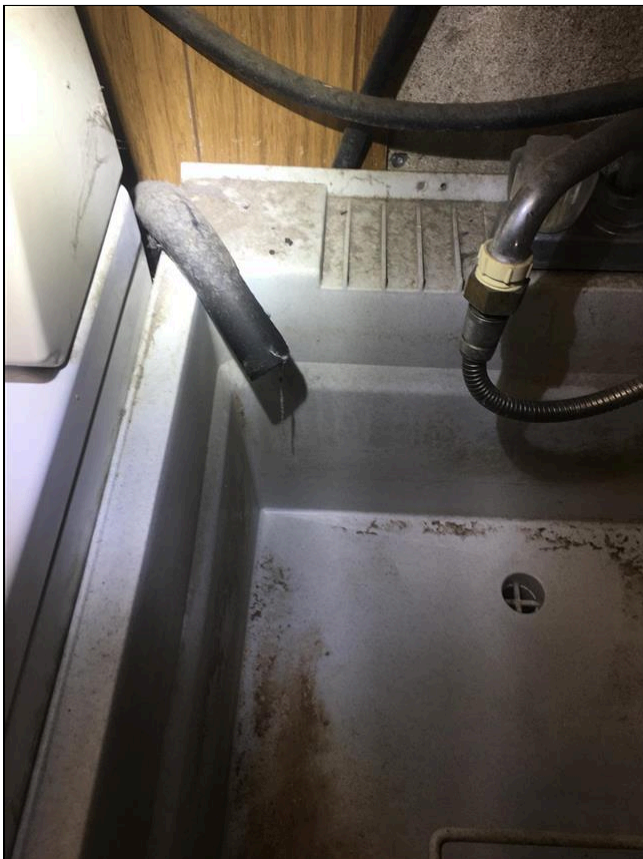
5.1 Item 2(Picture)

(3) **The waste line at clothes washer drains into sink (does not have its own drain line).**

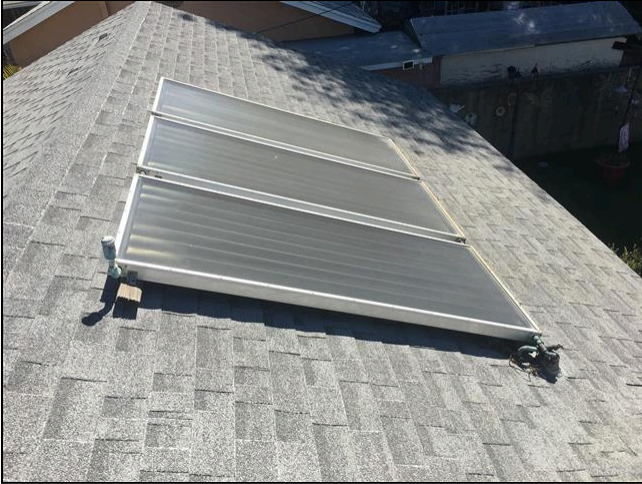
5.1 Item 3(Picture)

(4) **Solar water heater panels on roof top appeared inoperable and not inspected. For your information**

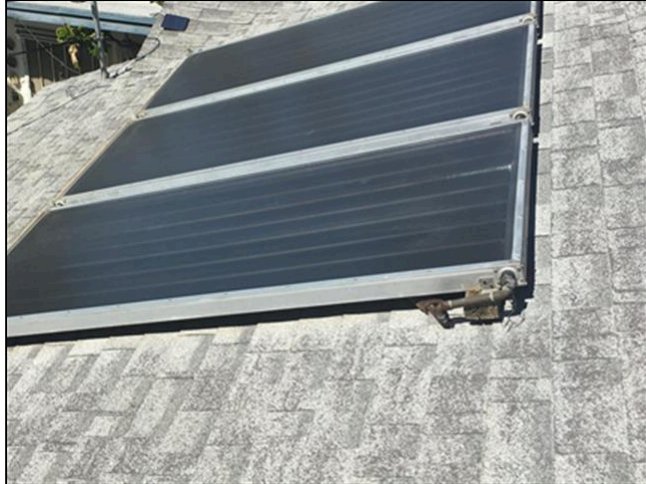
5.1 Item 4(Picture)

(5) **Some piping connections for supply or drain had rust in areas of home. Deferred maintenance. I recommend repair as needed.**

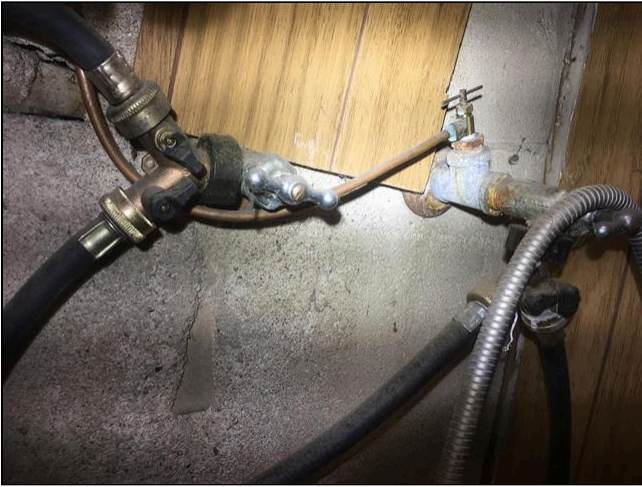
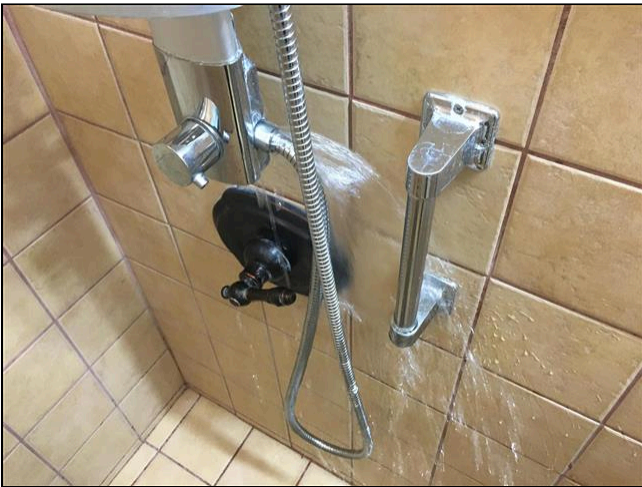
5.1 Item 6(Picture)

(6) The shower fixture leaks at the master bath and knob drip when on in hall bath tub. Small repair. I recommend a licensed plumber inspect further and repair as necessary.

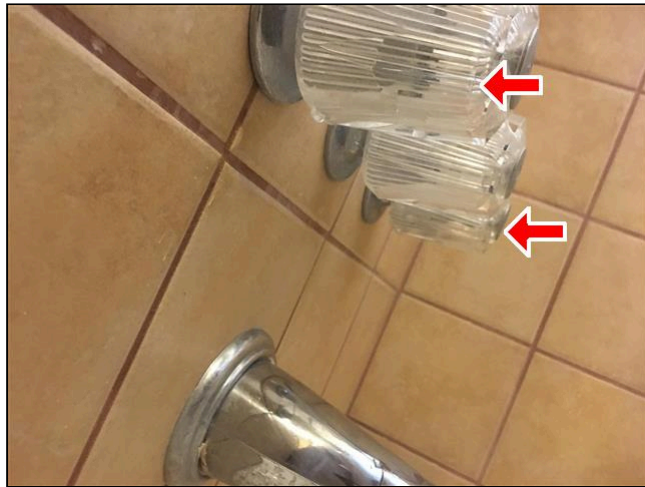
5.1 Item 8(Picture)

(7) **The sink have hairline cracks but no leaks during inspection at the hall bath. A qualified person should repair as necessary.**

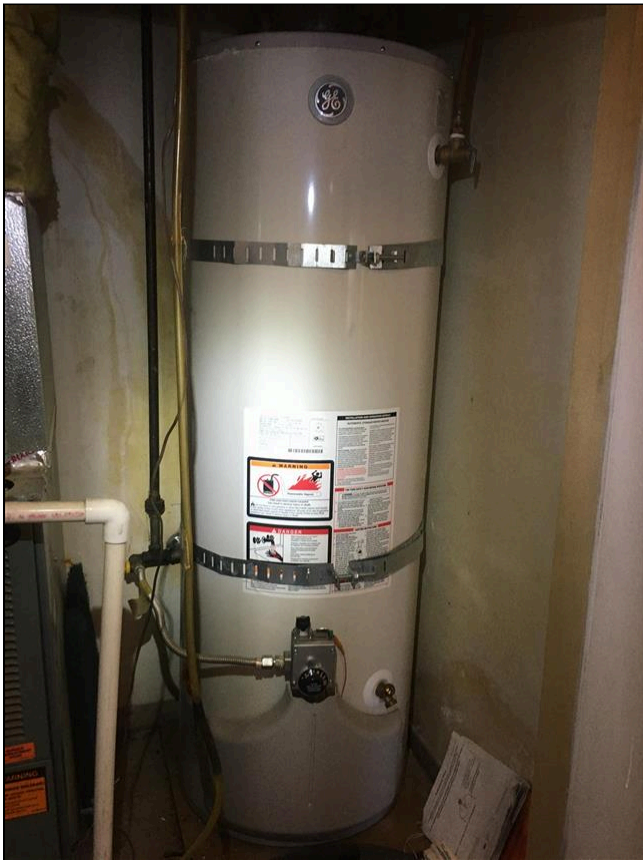
5.2 Item 1(Picture)

The gas supply pipe at this water heater had no drip leg. A drip leg is generally recommended but not always required, depending on the local Authority Having Jurisdiction (AHJ). The purpose of a drip leg is to prevent moisture from condensation from entering and clogging the water heater gas valve, which can cause the water heater to shut down. You may wish to consult with local HVAC contractors concerning the advisability of installing a drip leg in the gas line. Not immediate

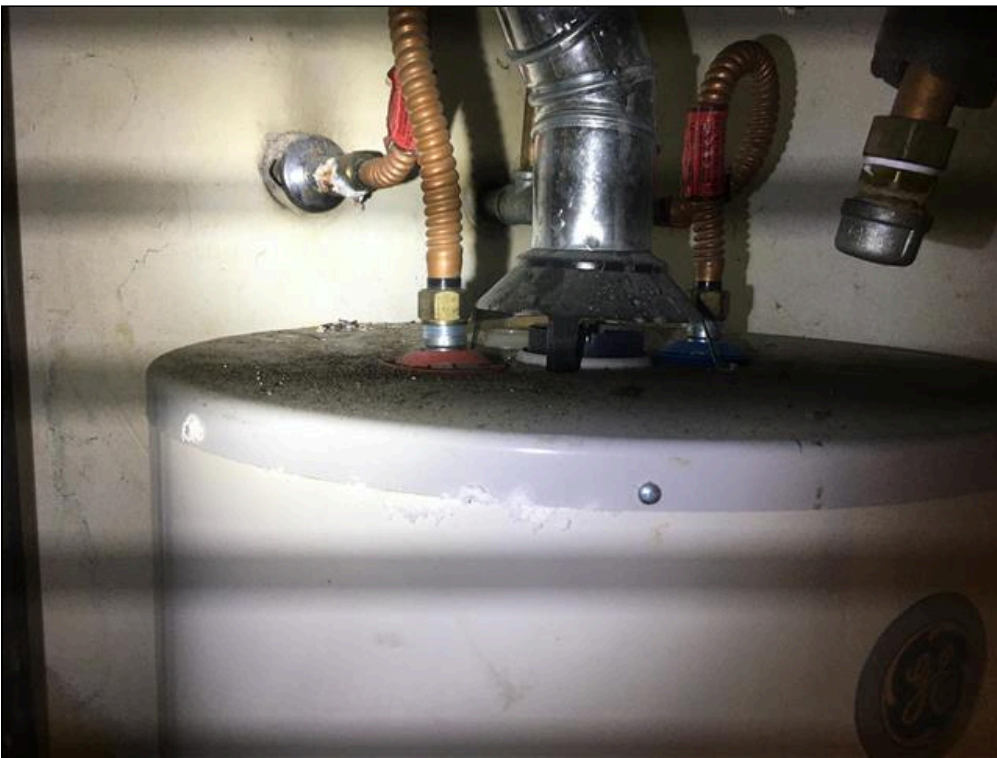
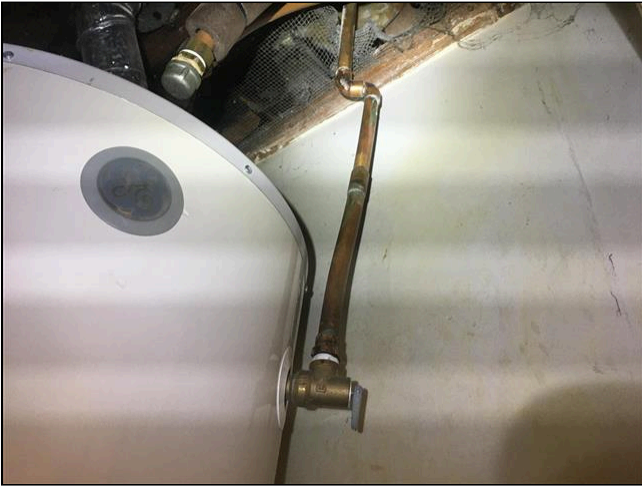
5.2 Item 5(Picture)

(3) **The discharge pipe of this water heater temperature/pressure relief (TPR) valve had a trap or loop. This condition can restrict the discharge and is potentially unsafe. Discharge from the temperature pressure relief valve should flow with gravity. The Inspector recommends correction**

by a qualified HVAC or plumbing contractor.

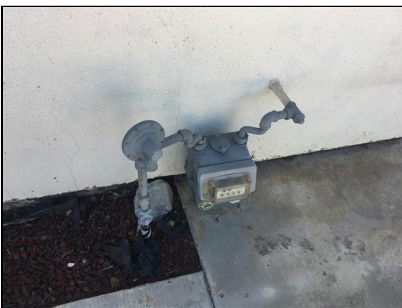
5.5 Item 1(Picture)

5.5 The main fuel shut off is at gas meter outside

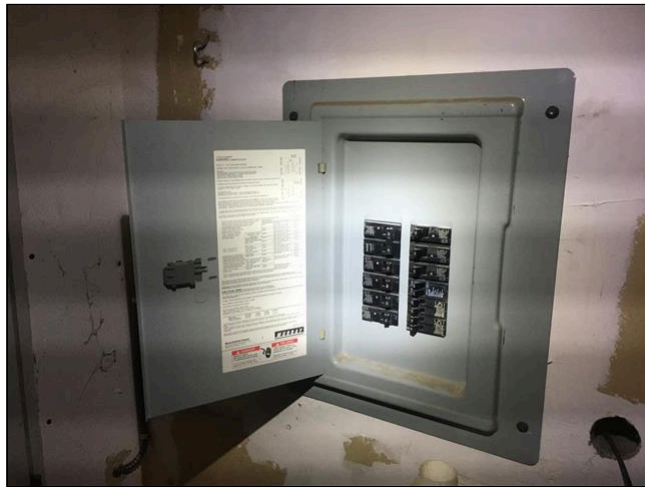
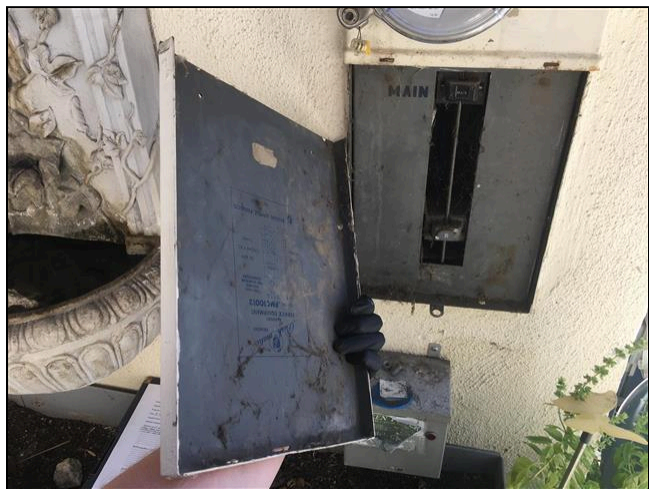
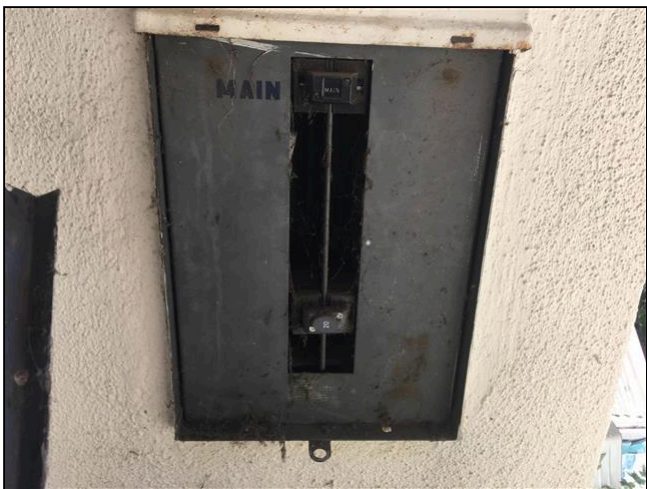
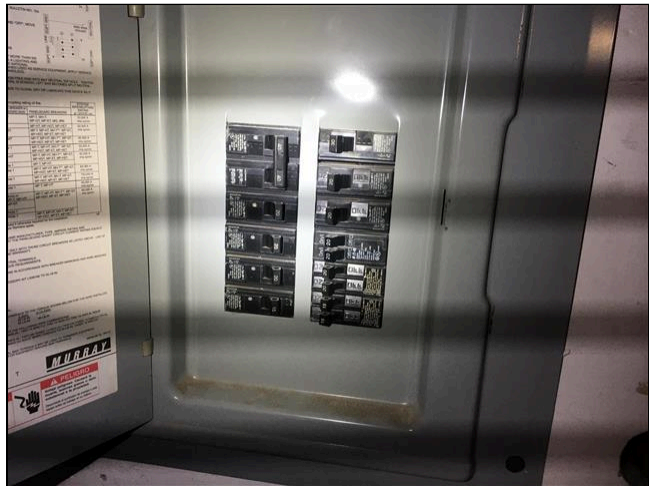
6.1 Item 2(Picture)

(2) The problem(s) discovered in the panel such as circuits not labeled or identified (main/sub), doubled wiring at circuit(s), knock-outs missing on panel dirty interior, loose front cover, dead front stuck(main) and any other problems that an electrical contractor may discover while performing repairs need correcting. I recommend a licensed electrical contractor inspect further and correct as needed.

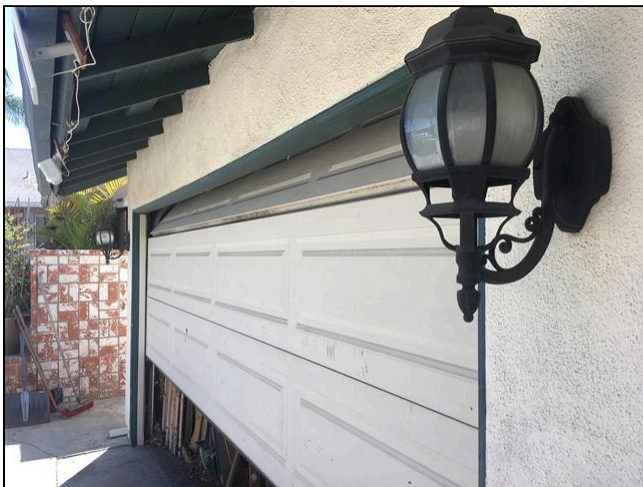
6.3 Item 1(Picture)

[\(2\) The light fixtures do not work \(try bulb first\) at the front garage. I recommend repair as needed.](#)

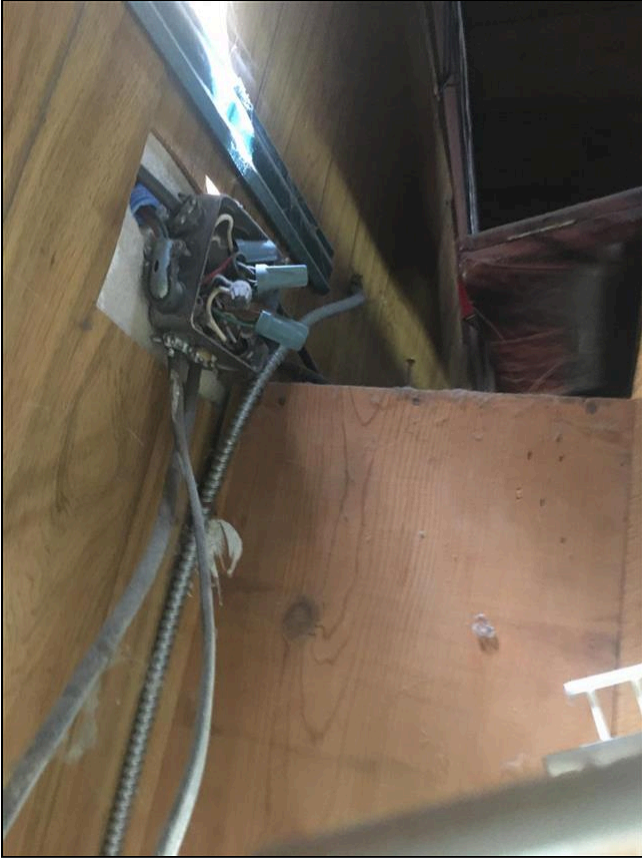
6.3 Item 7(Picture)

(4) **Exposed wiring in the garage. This is a safety issue that needs to be corrected. I recommend repair as needed.**

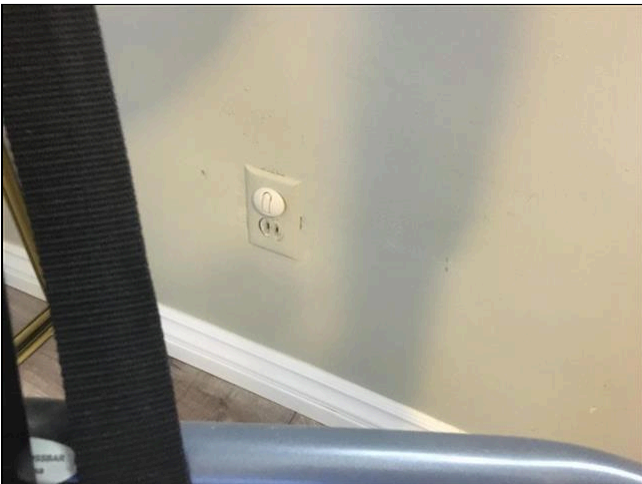
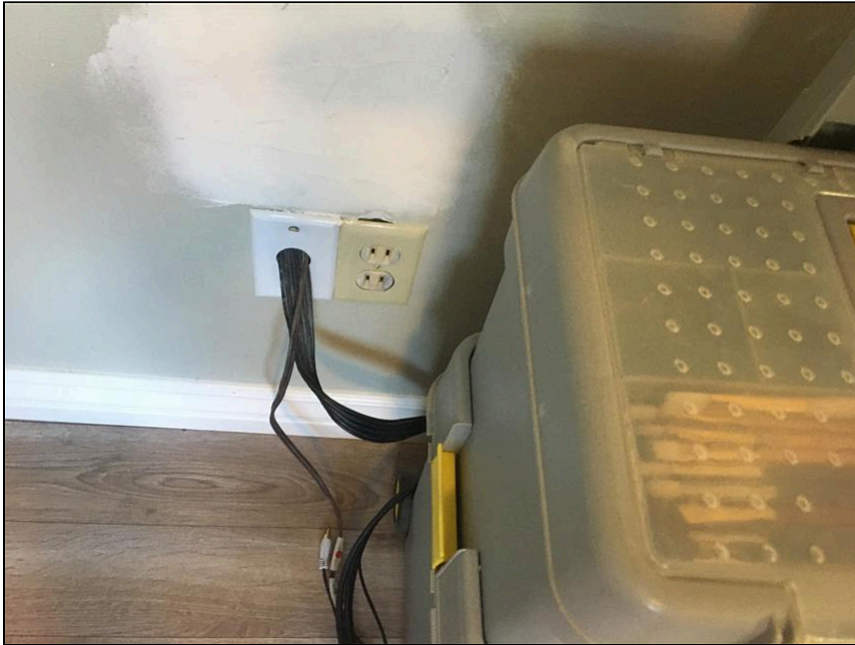
6.3 Item 8(Picture)

(5) **Two-prong outlets are outdated and not a three-prong at least in the 2nd bedroom. A qualified licensed electrical contractor should correct as needed.**

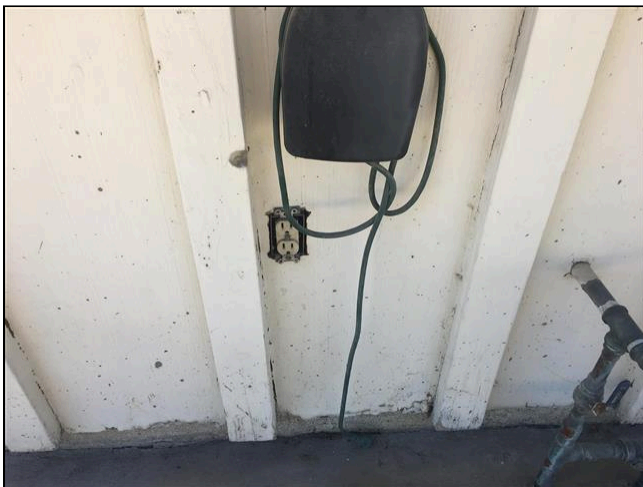
(2) At the time of the inspection, receptacles in the garage(all), front exterior, kitchen(1) and enclosed patio(all) had no ground fault circuit interrupter (GFCI) protection. Consider having GFCI protection installed as a safety precaution.

6.4 Item 1(Picture) weather cover missing

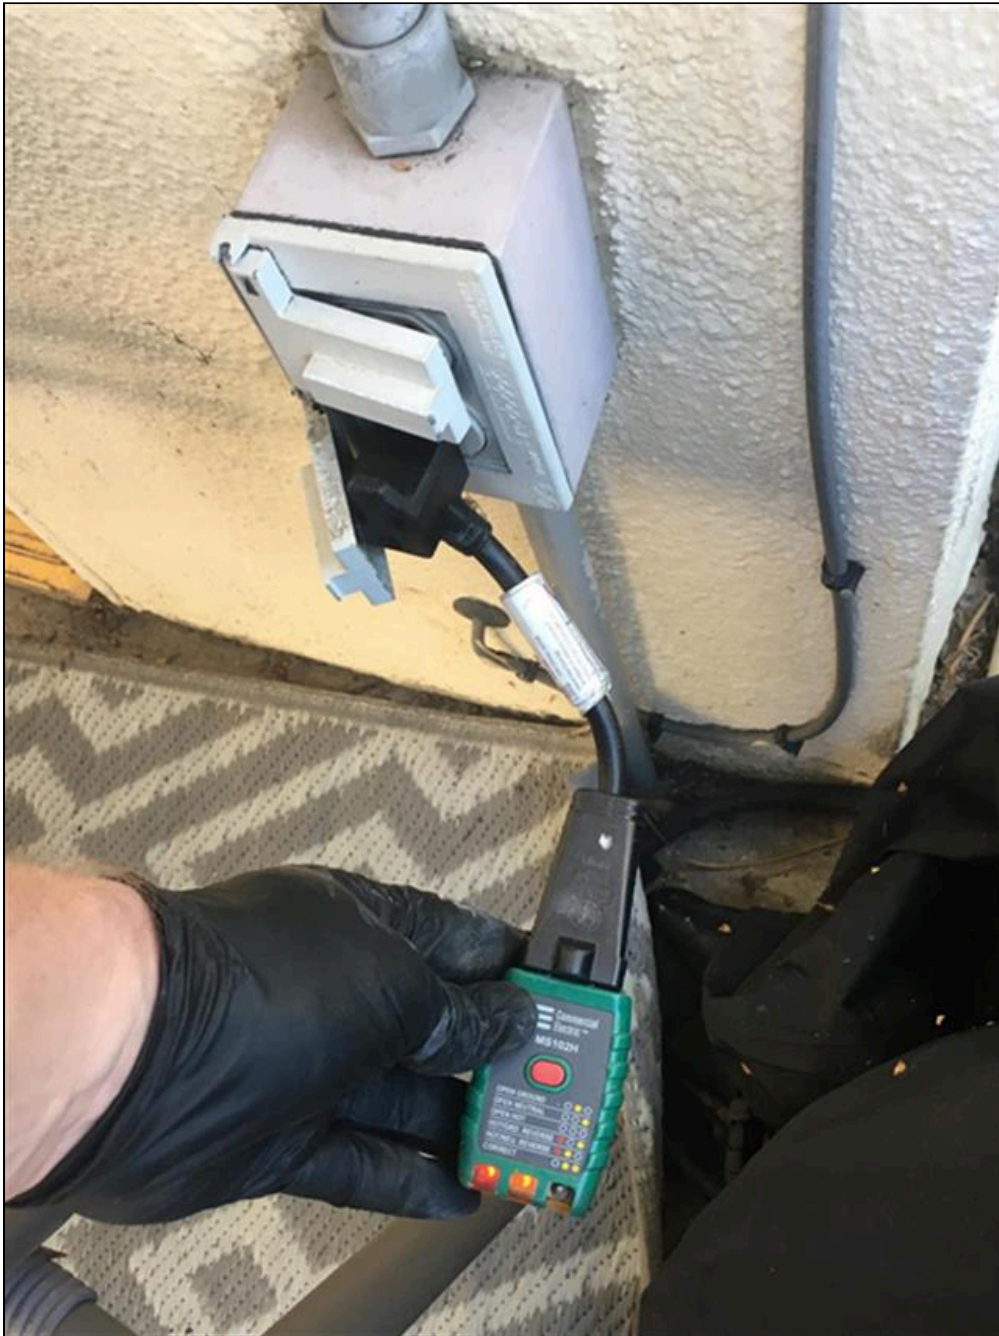
6.4 Item 4(Picture)

(3) A few "three-prong" outlets are not grounded or wired improperly rear side patio, 2nd bedroom, dinning room and kitchen. Further inspection is needed by a qualified licensed electrical contractor. A qualified licensed electrical contractor should perform repairs that involve wiring.

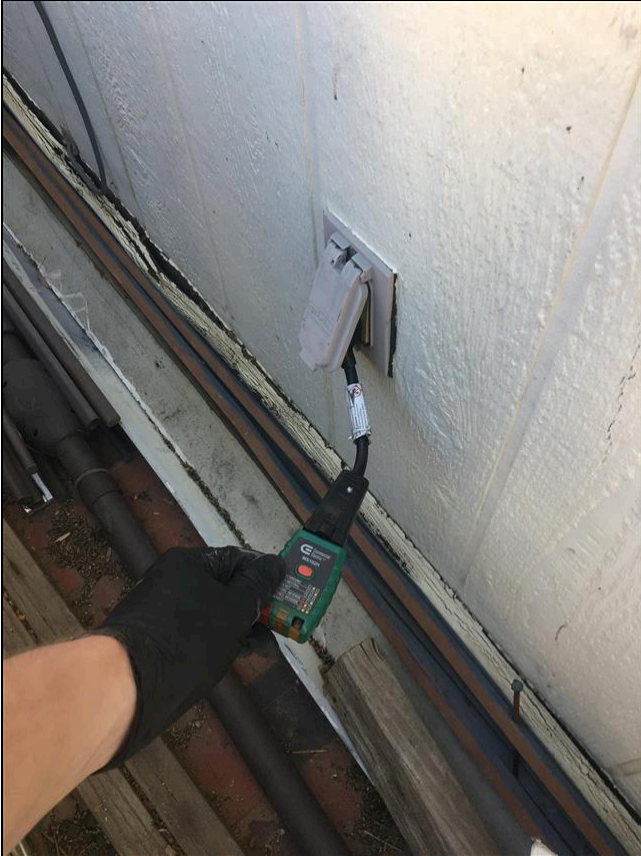
6.5 Item 1(Picture)

(2) **One GFCI (Ground Fault Circuit Interrupter) outlet at the rear left corner did not work or there is no power to outlet. A qualified licensed electrical contractor should correct as needed.**

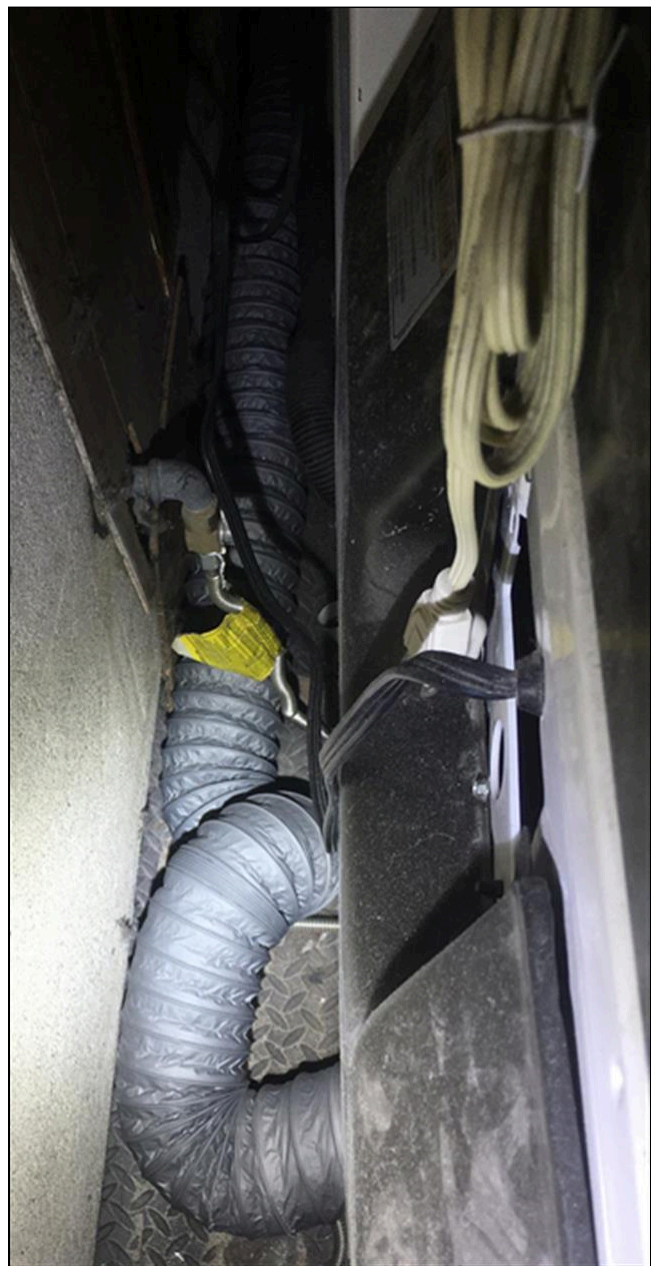
7.4 Item 1(Picture)

A dryer vent connection was installed in the garage. The dryer vent was examined visually only.

A visual examination will not detect the presence of lint accumulated inside the vent, which is a potential fire hazard. The Inspector recommends that you have the dryer vent cleaned at the time of purchase and annually in the future to help ensure that safe conditions exist. Lint accumulation can occur even in approved, properly installed vents. All work should be performed by a qualified contractor.

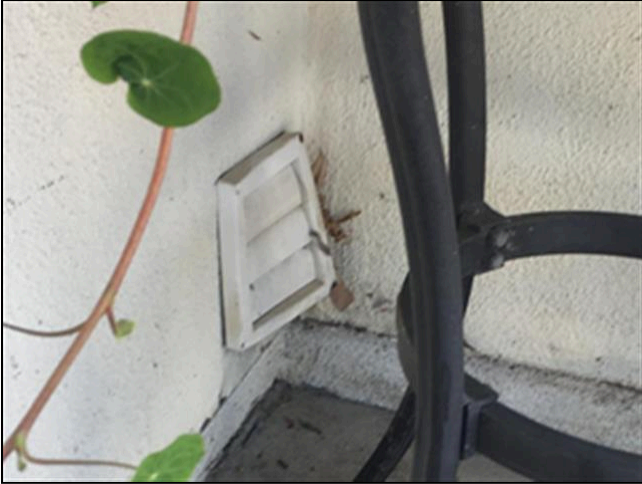
7.4 Item 3(Picture)

(2) The dryer vent piping has a loose vent hood outside and vent piping is plastic vinyl and is not allowed when dryer is powered by gas/propane. I recommend repair as needed.

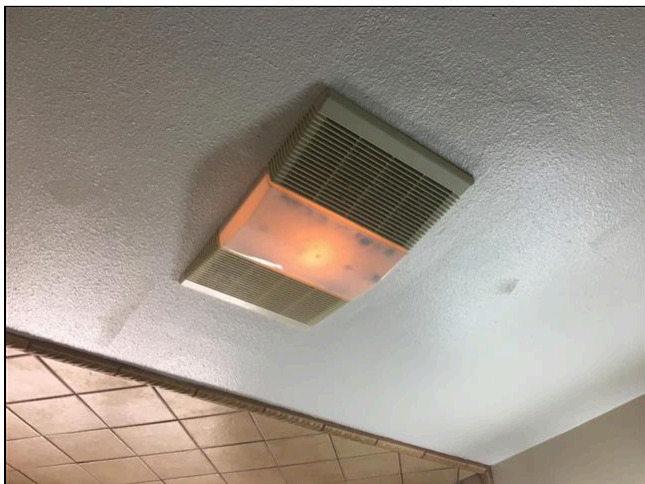
7.4 Item 5(Picture)

(3) **The Exhaust fan is noisy at the master bath. A qualified person should repair or replace as needed.**

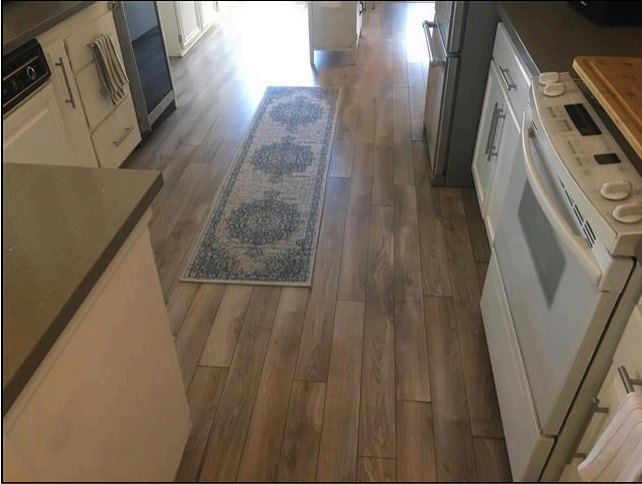
8.2 Item 1(Picture)

(2) The Wood covering had bubbled or some deterioration in kitchen areas. This is a cosmetic issue for your information. I recommend repair as desired.

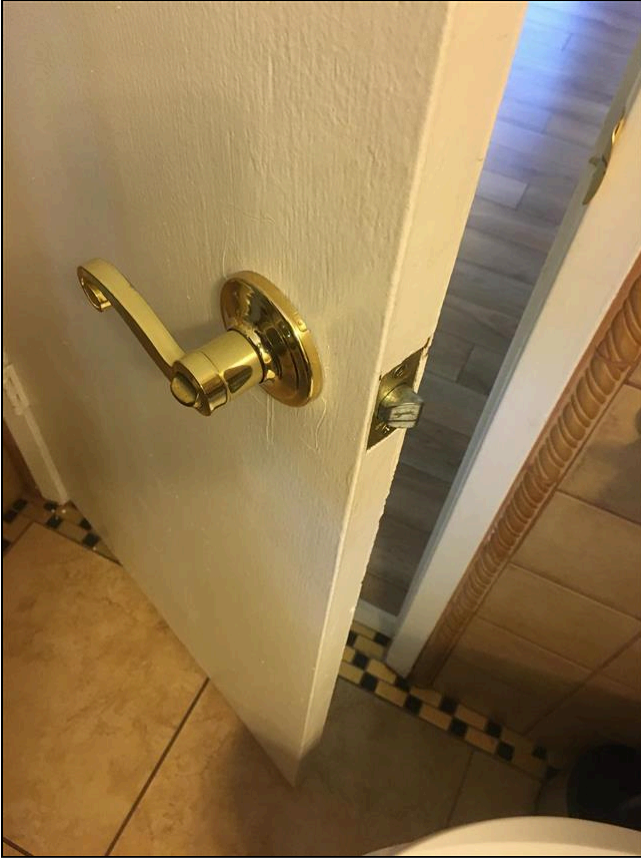
8.5 Item 2(Picture)

(3) The door knob is installed wrong at hall bath and bedroom door. I recommend repair or replace by a qualified person.

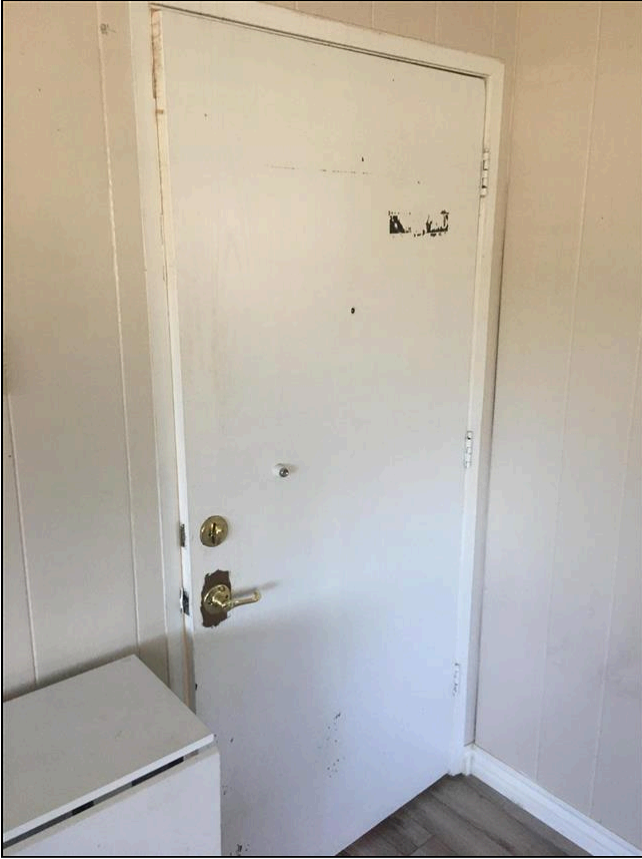
8.5 Item 4(Picture)

(4) The Entry door rubs at jamb when closing at the Master Bedroom. A qualified person should repair or replace as needed.

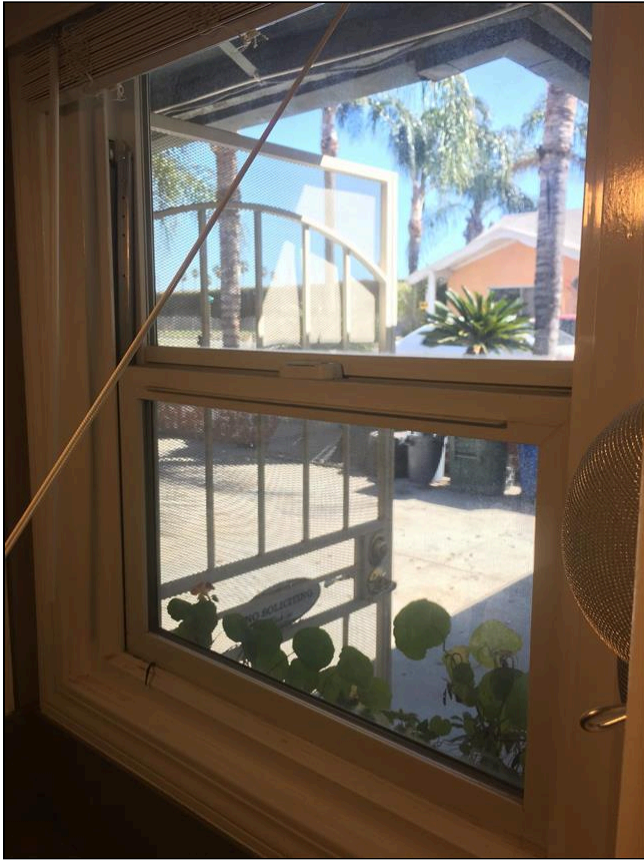
8.6 Item 1(Picture)

(2) One window the jamb spring is weak or no longer works properly at the Kitchen. A qualified person should repair or replace as needed.

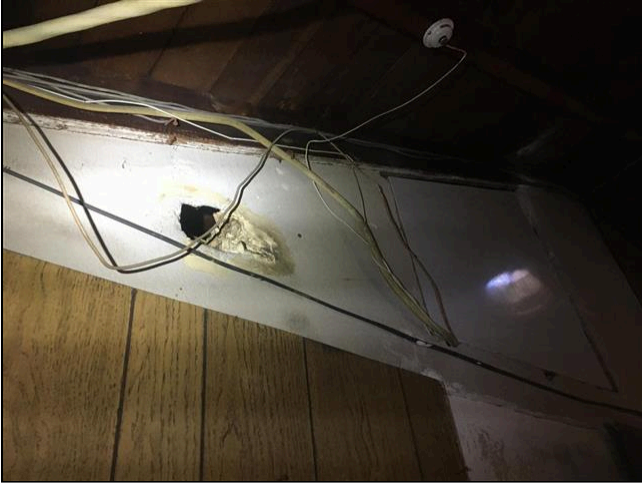
9.1 Item 1(Picture)

(2) The fire protection wall in garage is compromised. A qualified person should correct for safety.

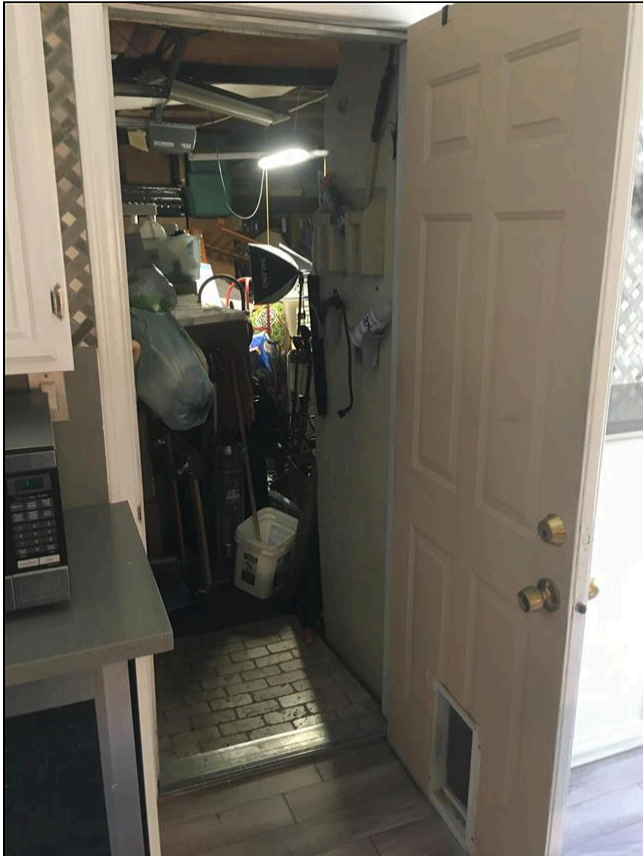
9.4 Item 1(Picture)

9.4 The fire rated entry door from garage to inside home has a pet access feature that removes the fire rating protection. Should a fire occur in garage this door will not maintain an adequate fire protection.

Note the fire rated door does not meet current safety standards. Door must be a self-closing and self latching and a smoke and draft seal not installed.

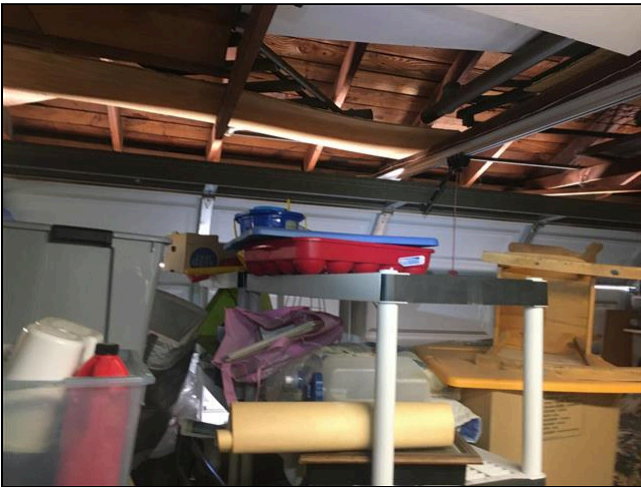
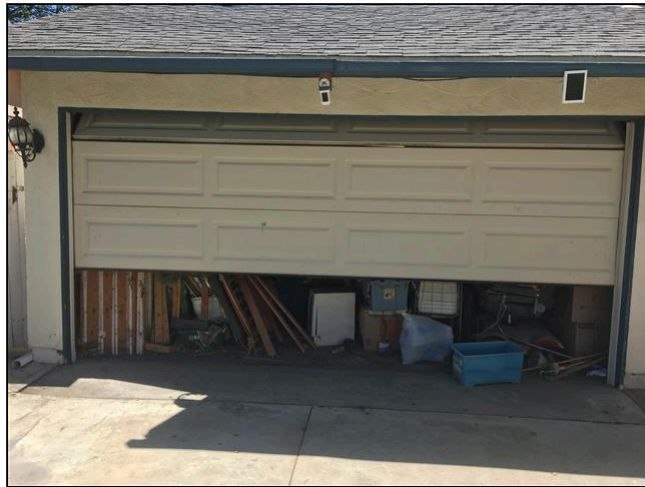
9.5 Item 2(Picture)

(2) The automatic opener for two-door garage at the front of home does not operate properly. A repair or replacement is needed. I recommend a qualified garage door repairman correct as needed.

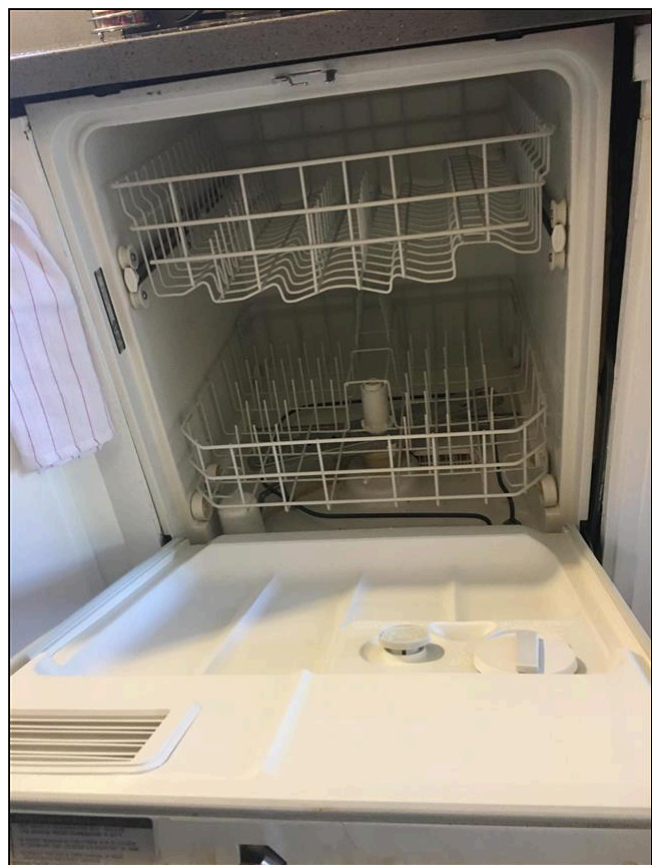
10.0 Item 2(Picture)

(2) The dishwasher is loose and needs securing to underside of countertop (using a proper length screw). I recommend repair as necessary.

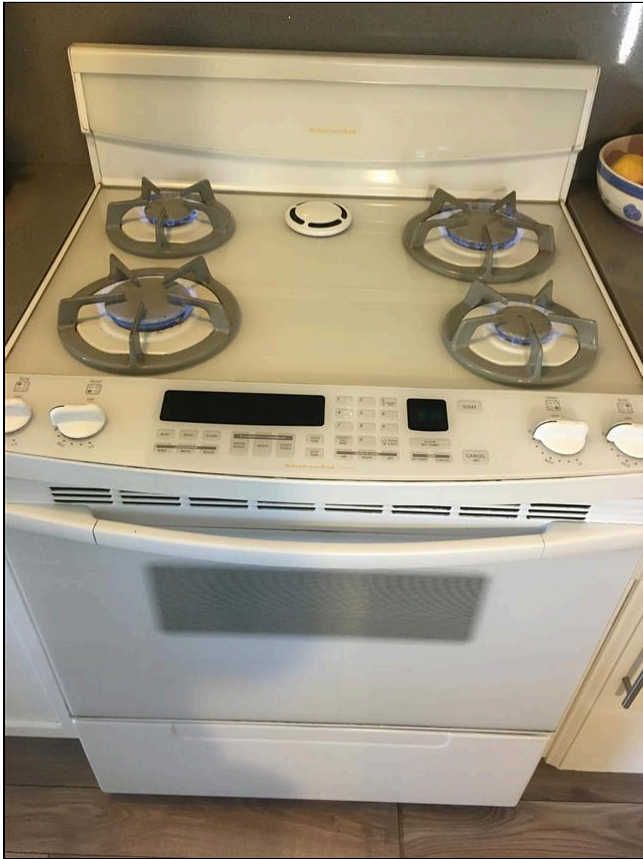
10.1 Item 1(Picture)

(2) The oven had difficult heating to temperature. I recommend repair as needed.

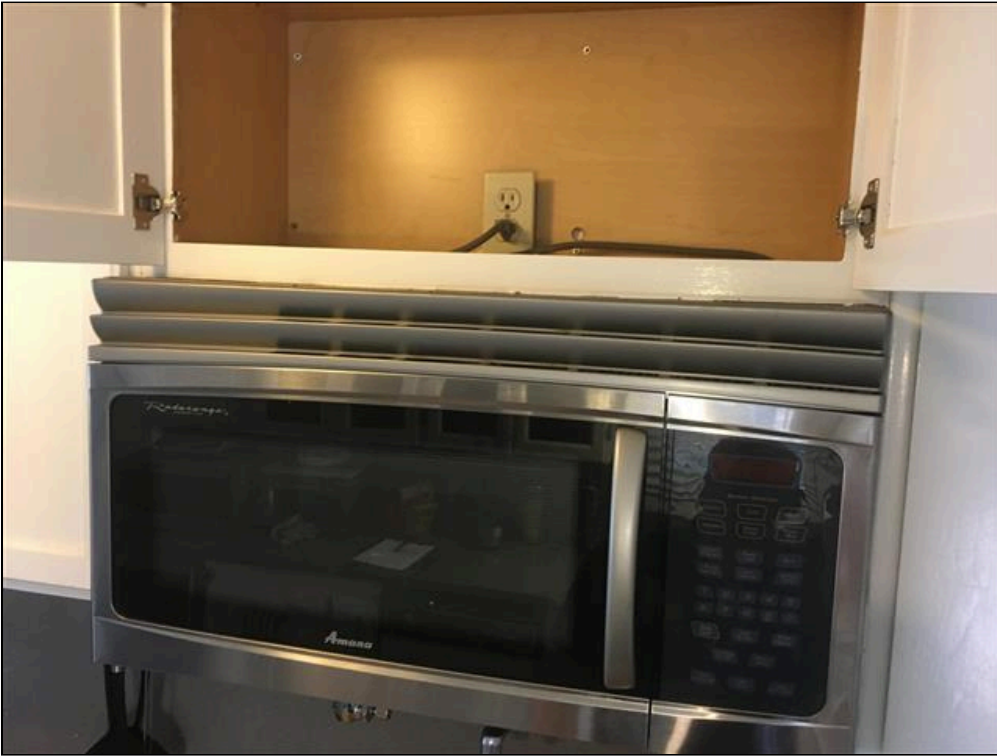
10.2 Item 1(Picture)

10.2 The range hood fan did not work when tested. I recommend repair or replace as needed.

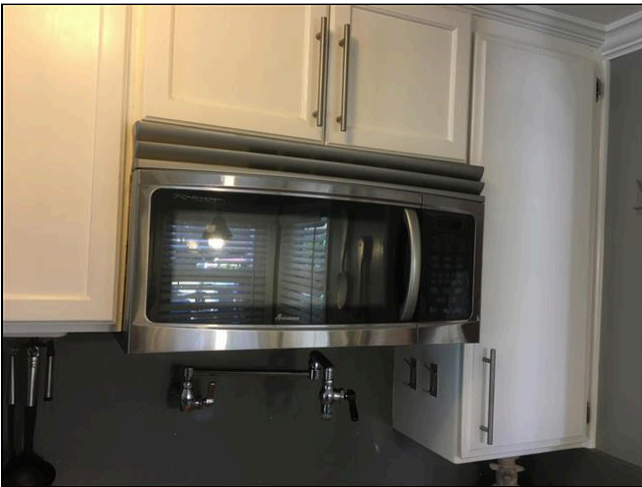
10.5 Item 1(Picture)

10.5 The microwave light did not work. I recommend repair as needed.
