PARADIGM INSPECTION GROUP RESIDENTIAL HOME INSPECTION

1397 Ximeno Ave
Long Beach, CA 90804

MARCH 11, 2025

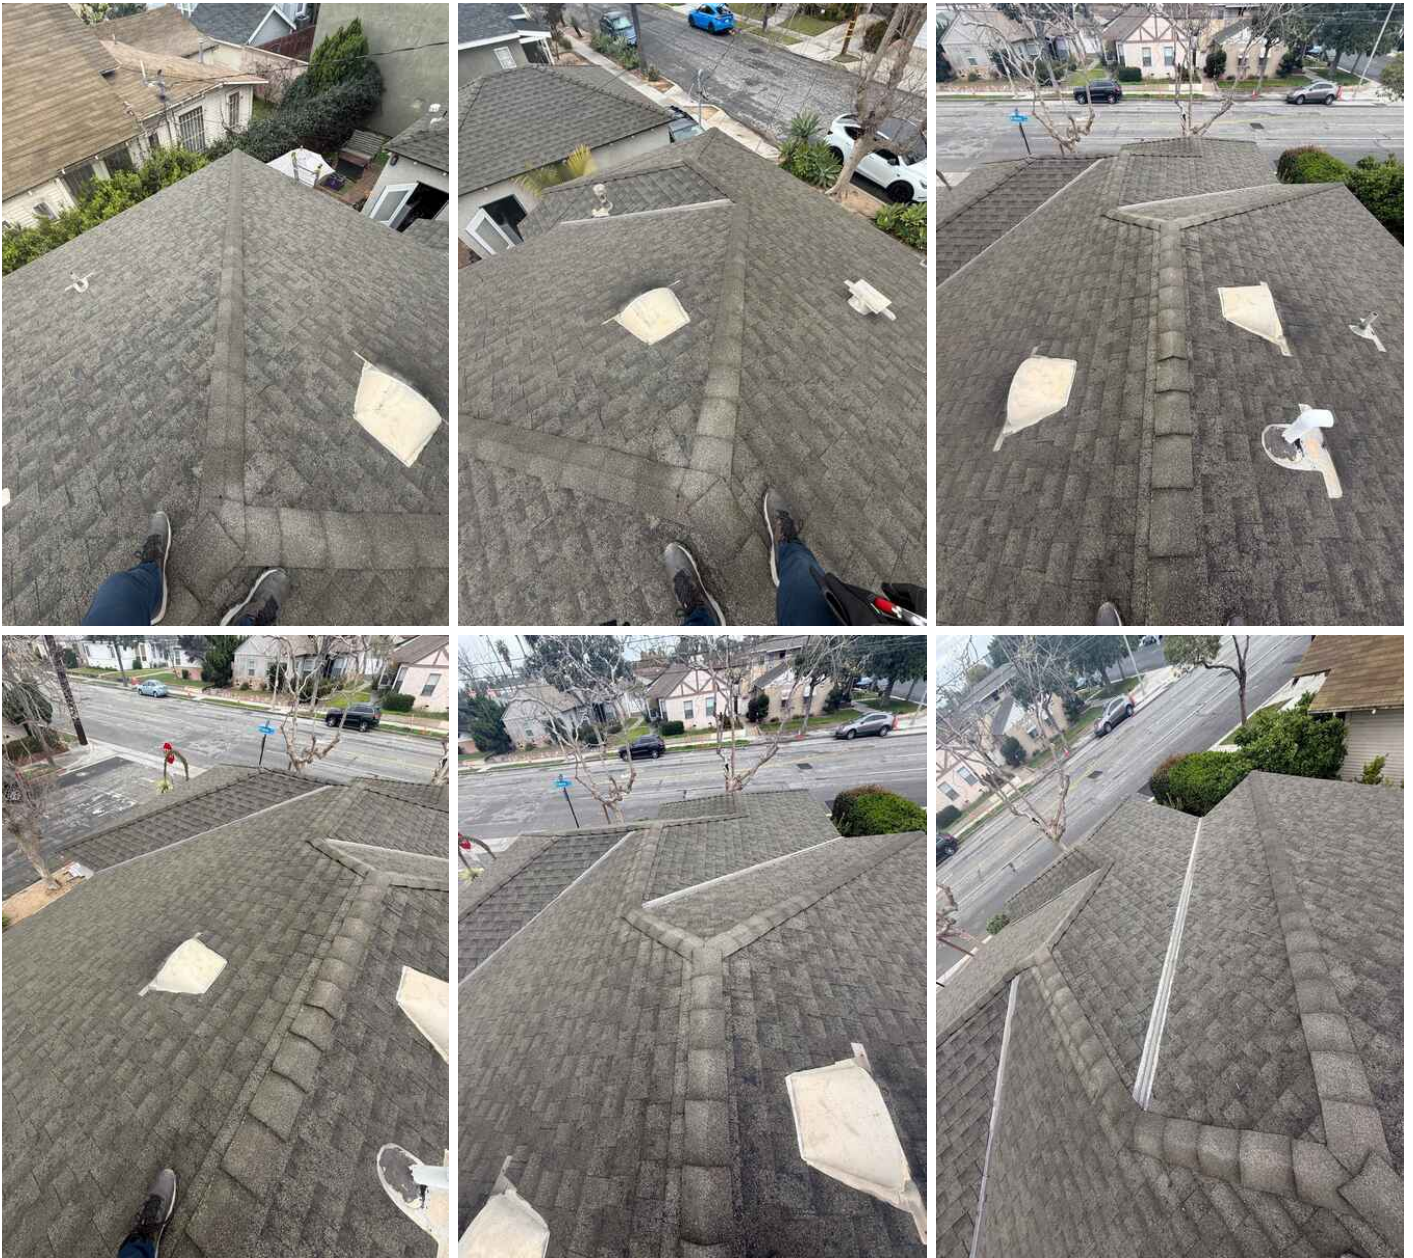
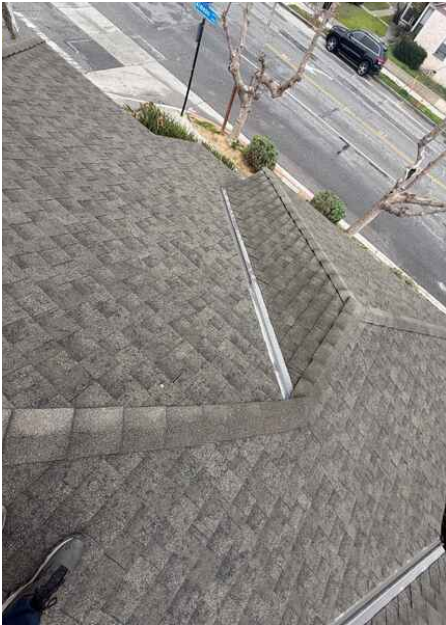
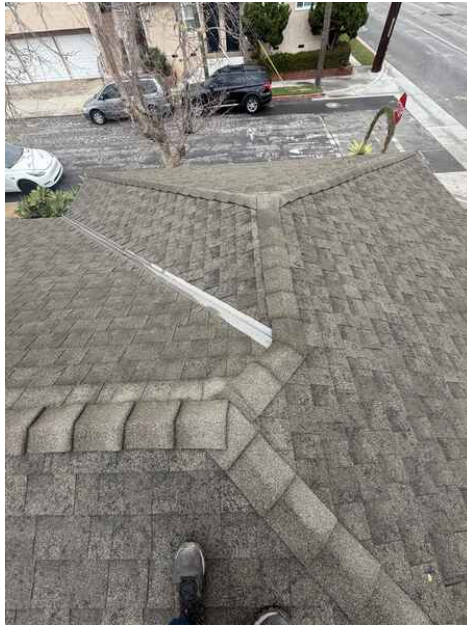
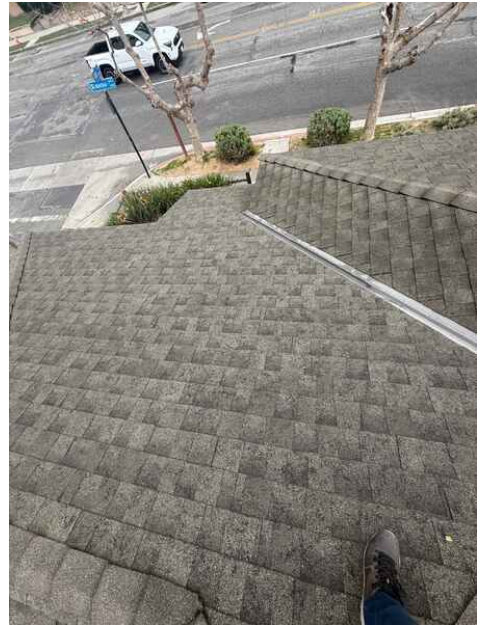
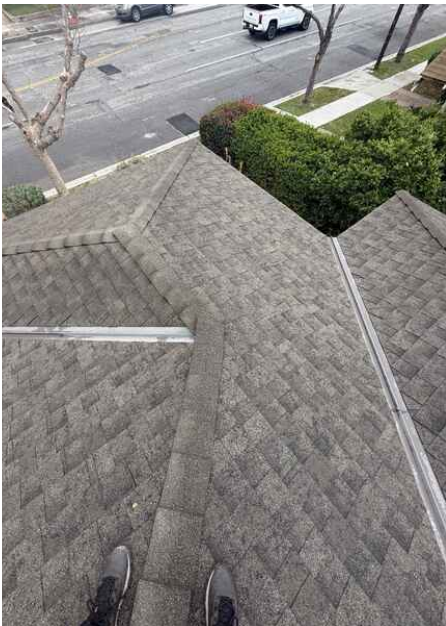
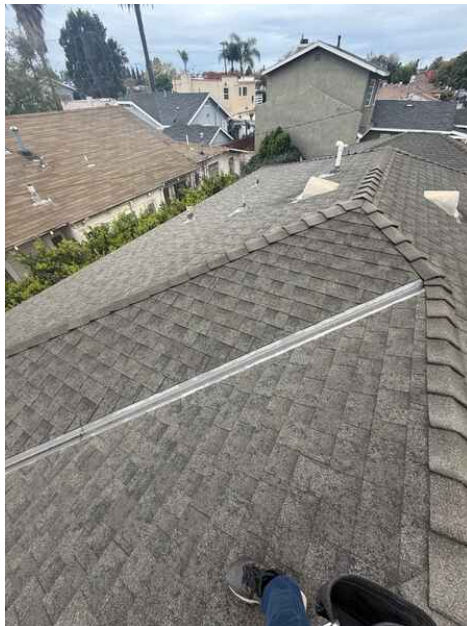
Coverings: Roof Was Inspected

We attempted to inspect the roof from various locations and methods.

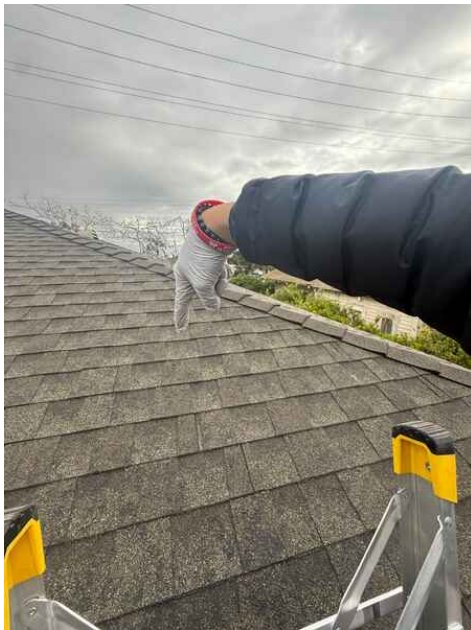
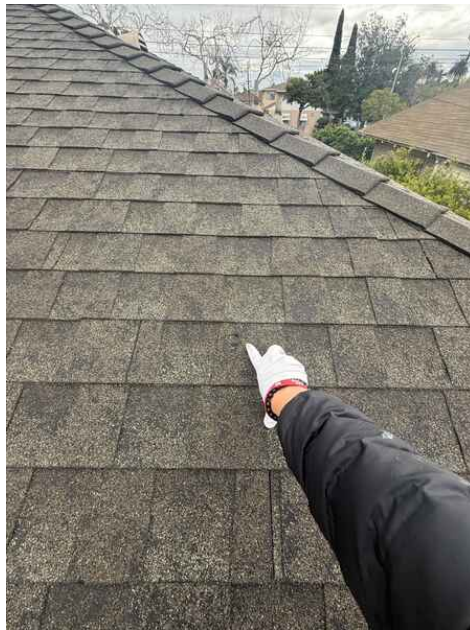
2.4.1 Plumbing Vent Pipes

EXPOSED FASTENERS

I observed one of more exposed fasteners on the vent flashings. Proper installation and sealing fasteners help keep the roof and its system free from corrosion and damages. Recommend sealing fasteners to prevent moisture intrusion.

Recommendation

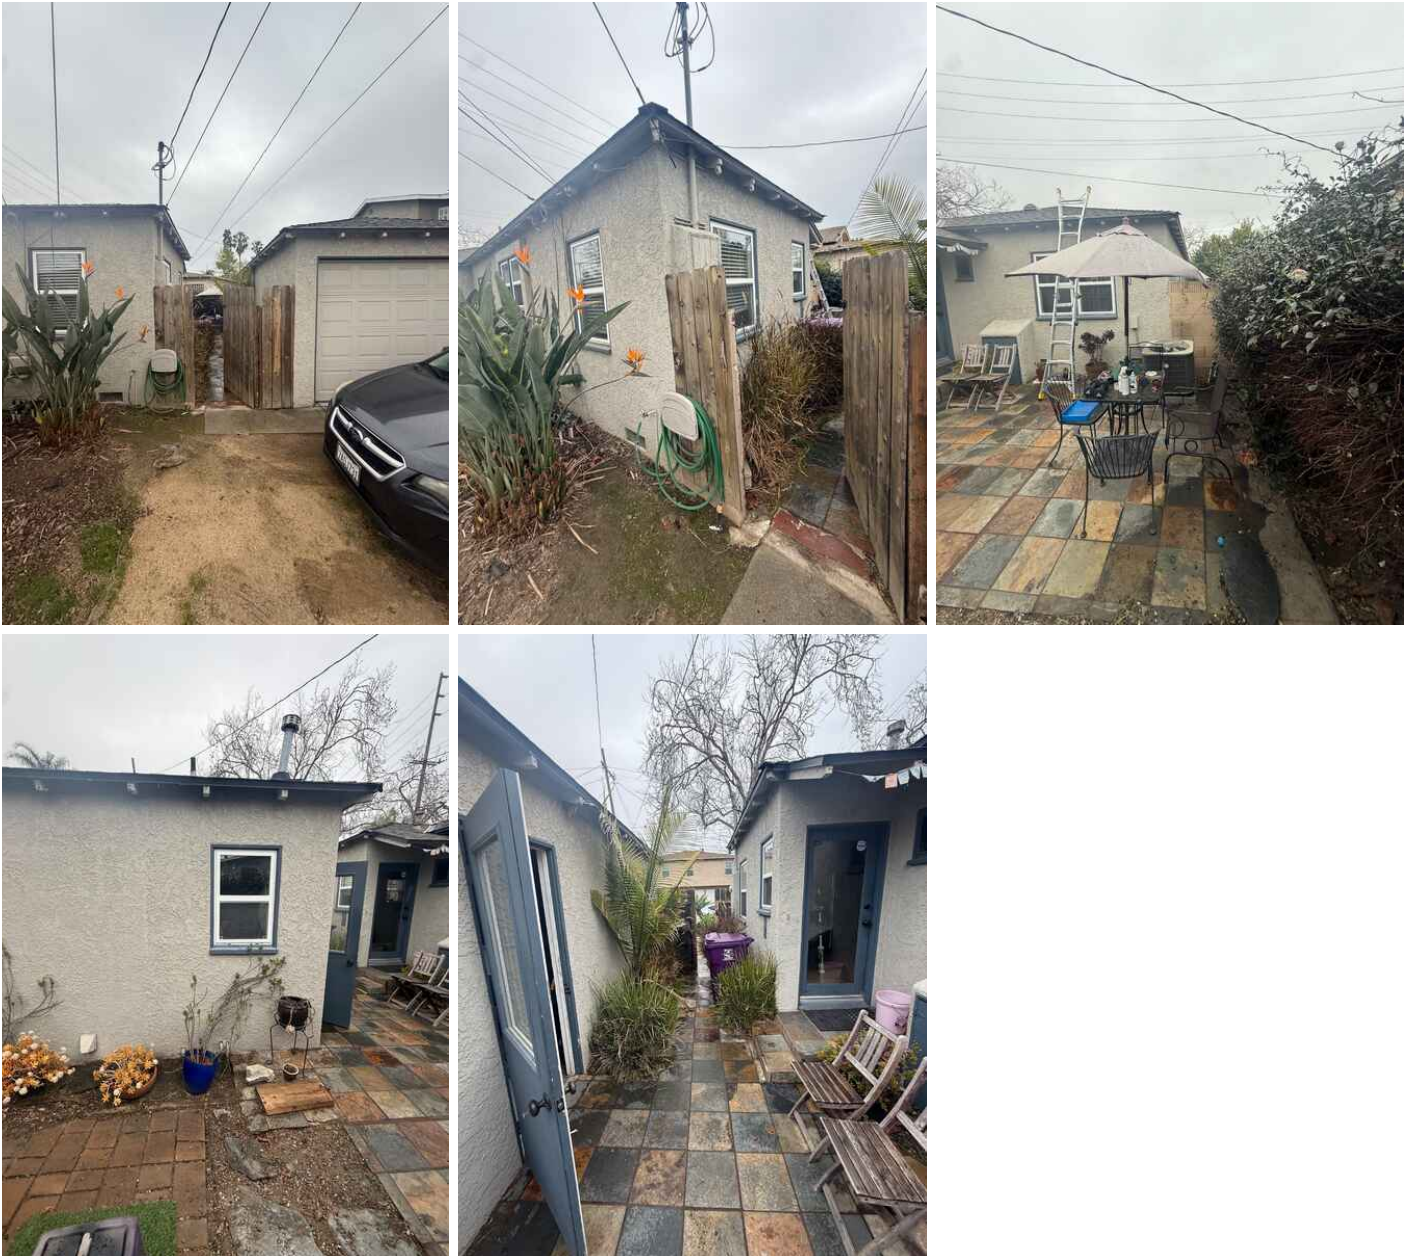
Exterior Was Inspected

I inspected the exterior of the house.

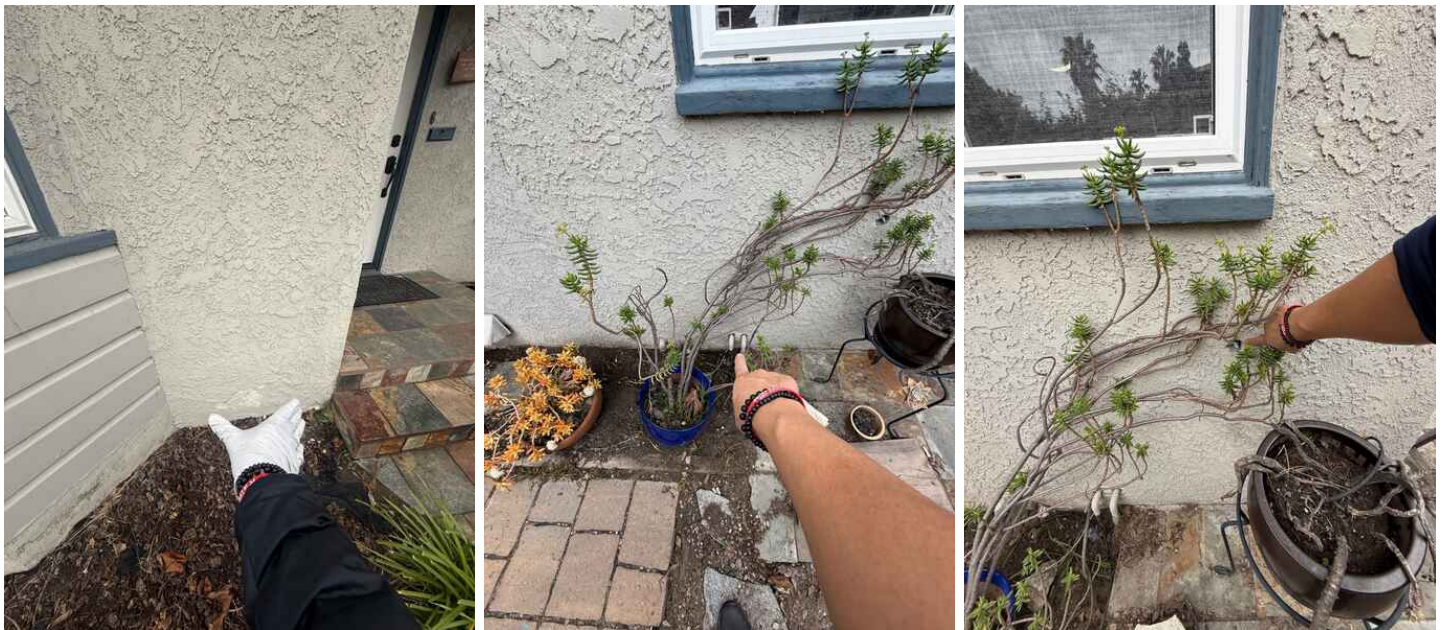
DAMAGED WALL-COVERING MATERIAL

I observed indications of damages and deterioration at the exterior wall-covering material(s).

Correction and further evaluation is recommended to prevent moisture intrusion and further deterioration.

Recommendation

Contact a qualified professional.

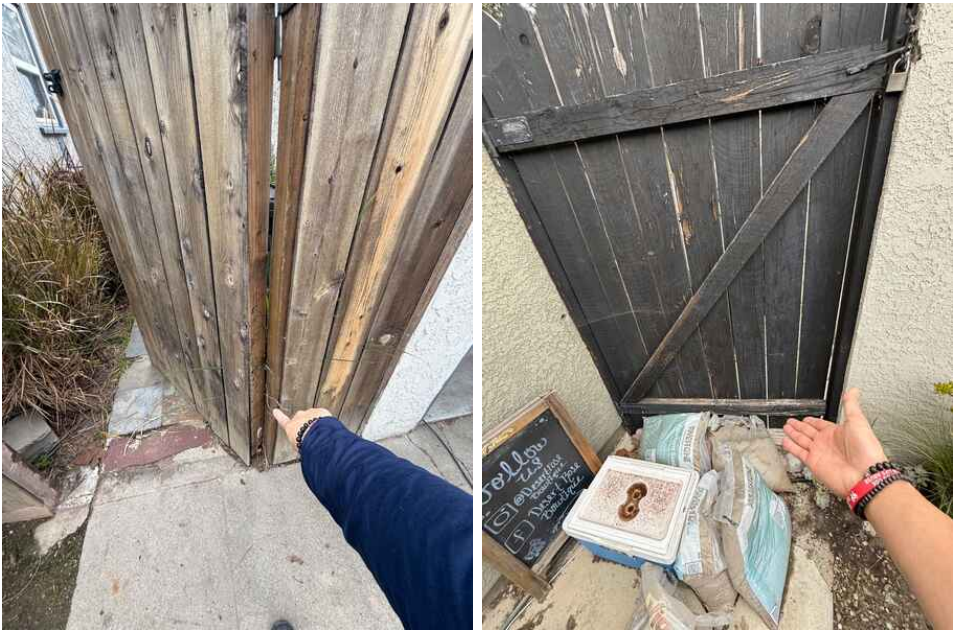
FENCE DEFECT

I observed that the condition of the fence is poor.

Recommendation
Contact a qualified fencing contractor

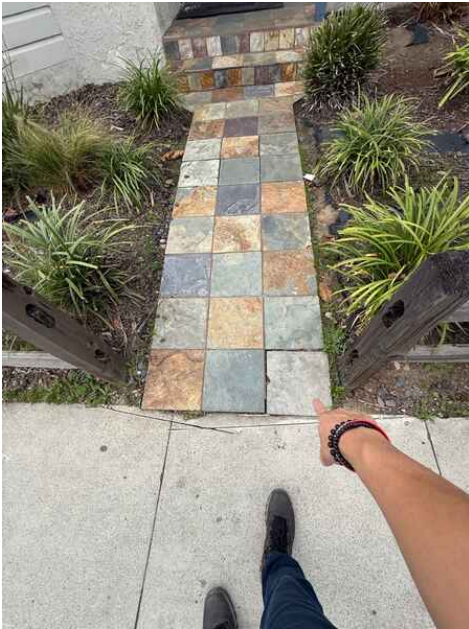
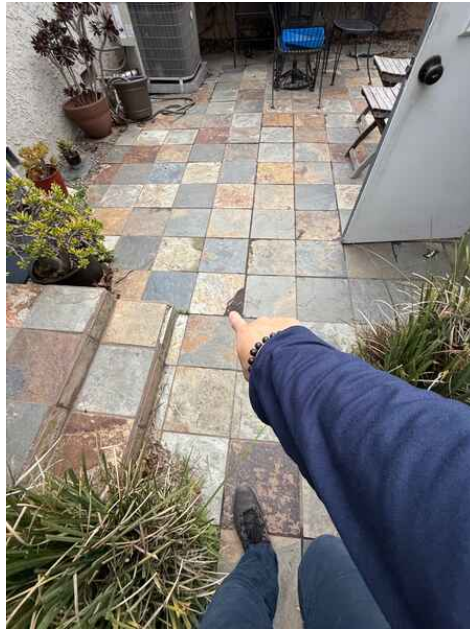
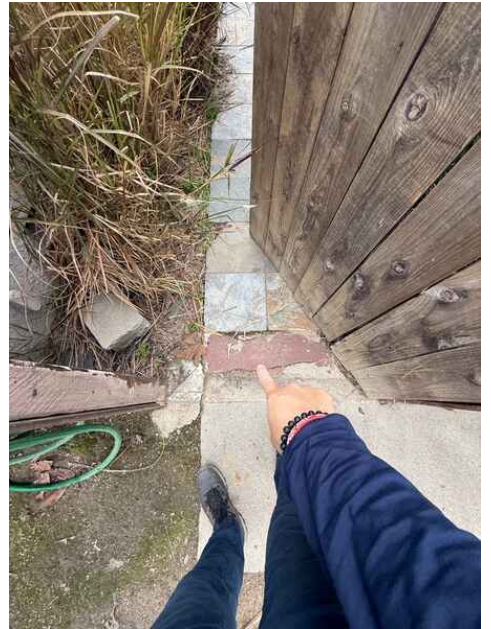
3.5.1 Walkways & Driveways

DAMAGE TILES

I observed damaged tiles on the exterior walking way. Repair is recommended.

Recommendation
Contact a qualified professional.

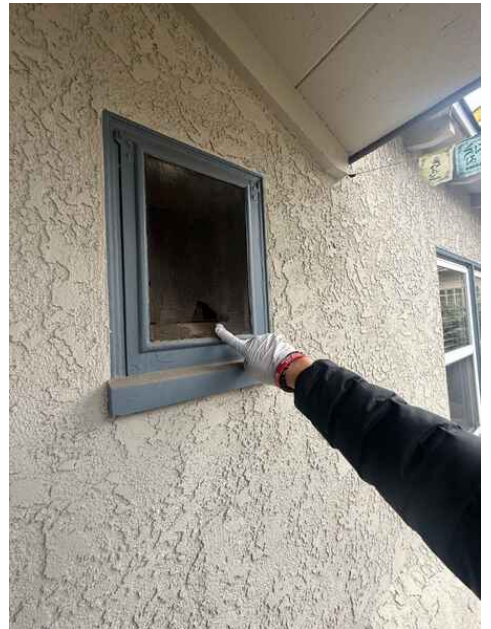
3.9.1 Windows

DAMAGED WINDOW SCREEN

I observed one or more damaged window screen. Replacement is recommended.

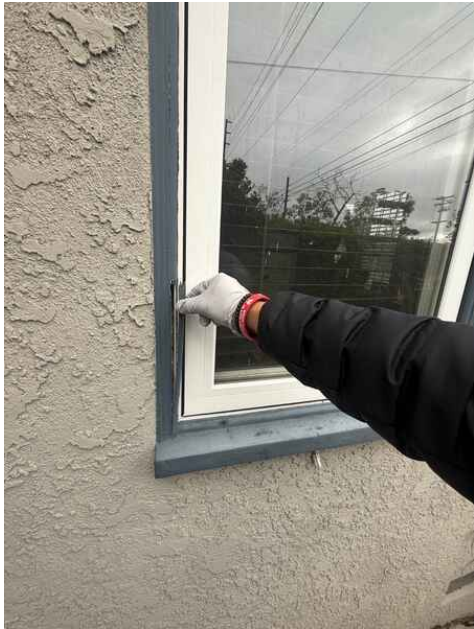
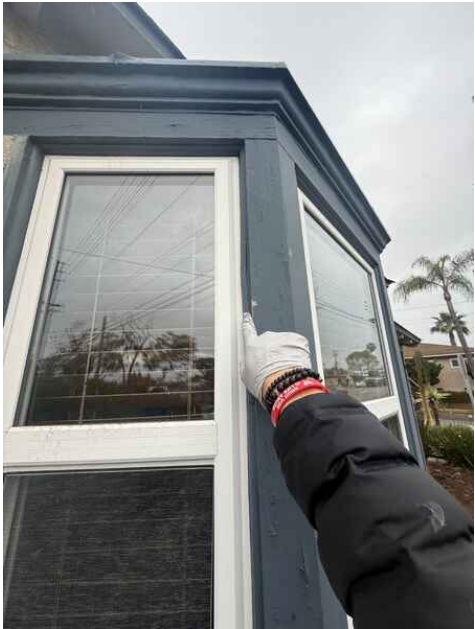
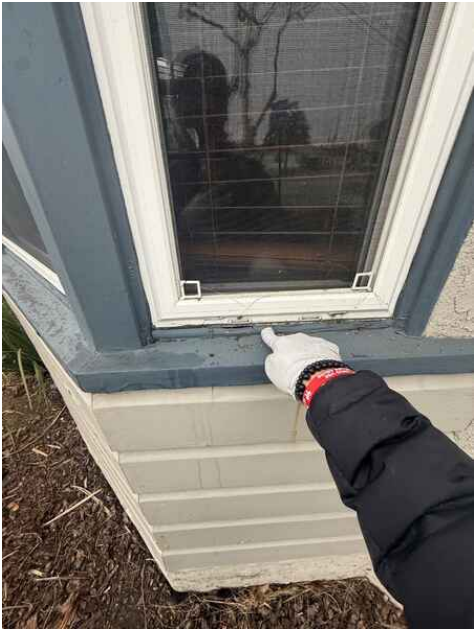
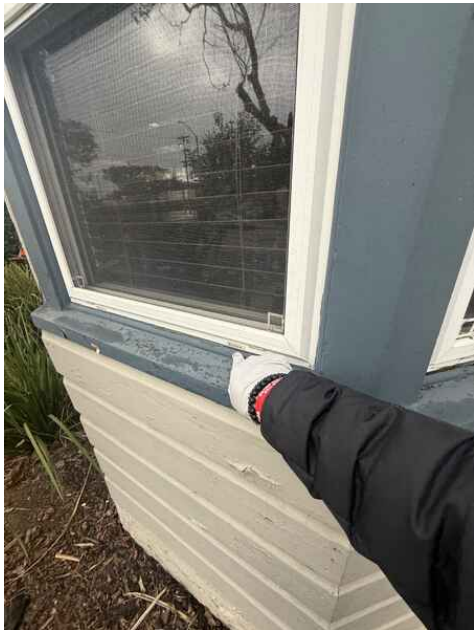
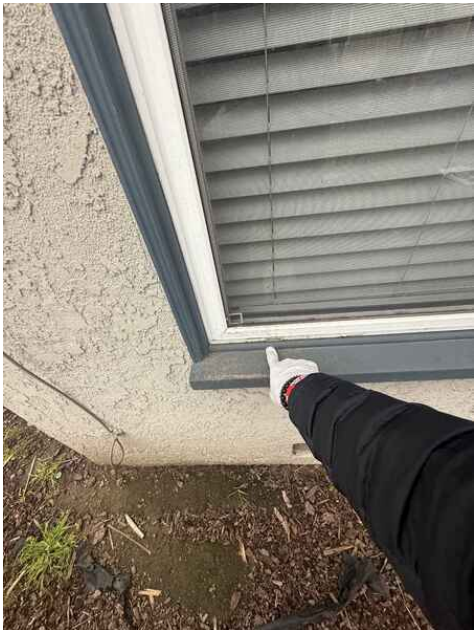
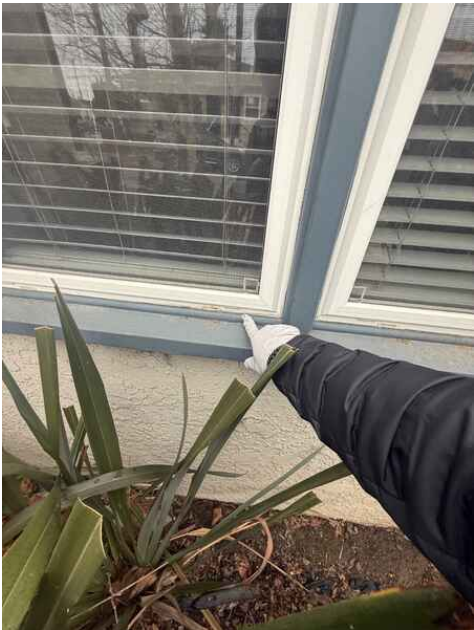
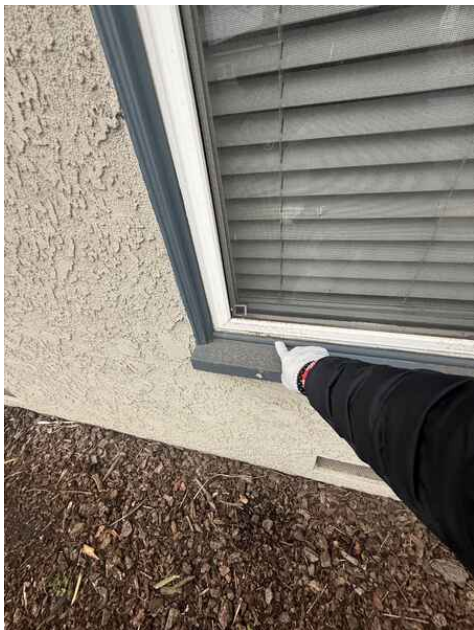
3.9.2 Windows

DAMAGE WINDOW TRIM

I observe damage around the window trim. Recommend repair or replace to prevent further deterioration.

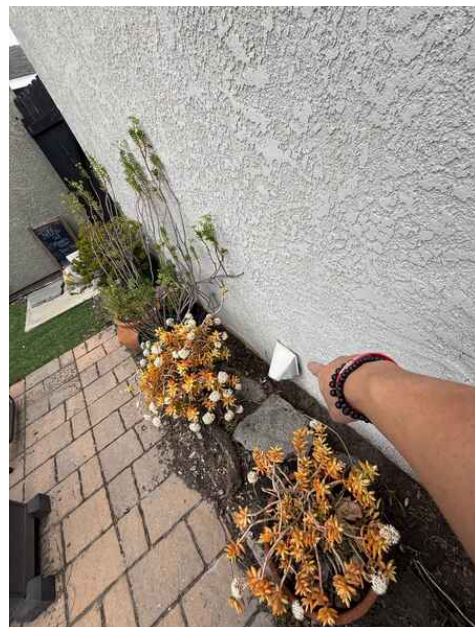
3.10.1 Exhaust Hoods

LOOSE EXHAUST HOOD

I observed an exhaust hood that was loose.

Recommendation

Recommended DIY Project

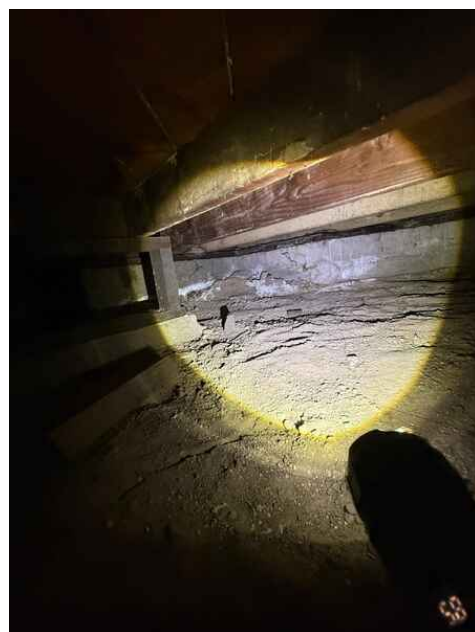
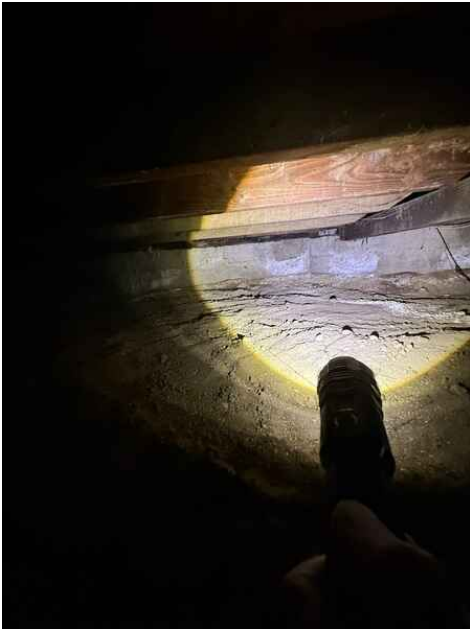
3.11.1 Foundation

EFFLORESCENCE ON FOUNDATION WALLS AND CRAWLSPACE

Possible Efflorescence (white mineral deposits) is present on the foundation walls in the crawl space. This condition is typically caused by moisture intrusion through the concrete, which brings dissolved minerals to the surface as the water evaporates.

Recommendation:

Further evaluation is and correction is recommended to determine the source of moisture and if any drainage or ventilation improvements are needed.

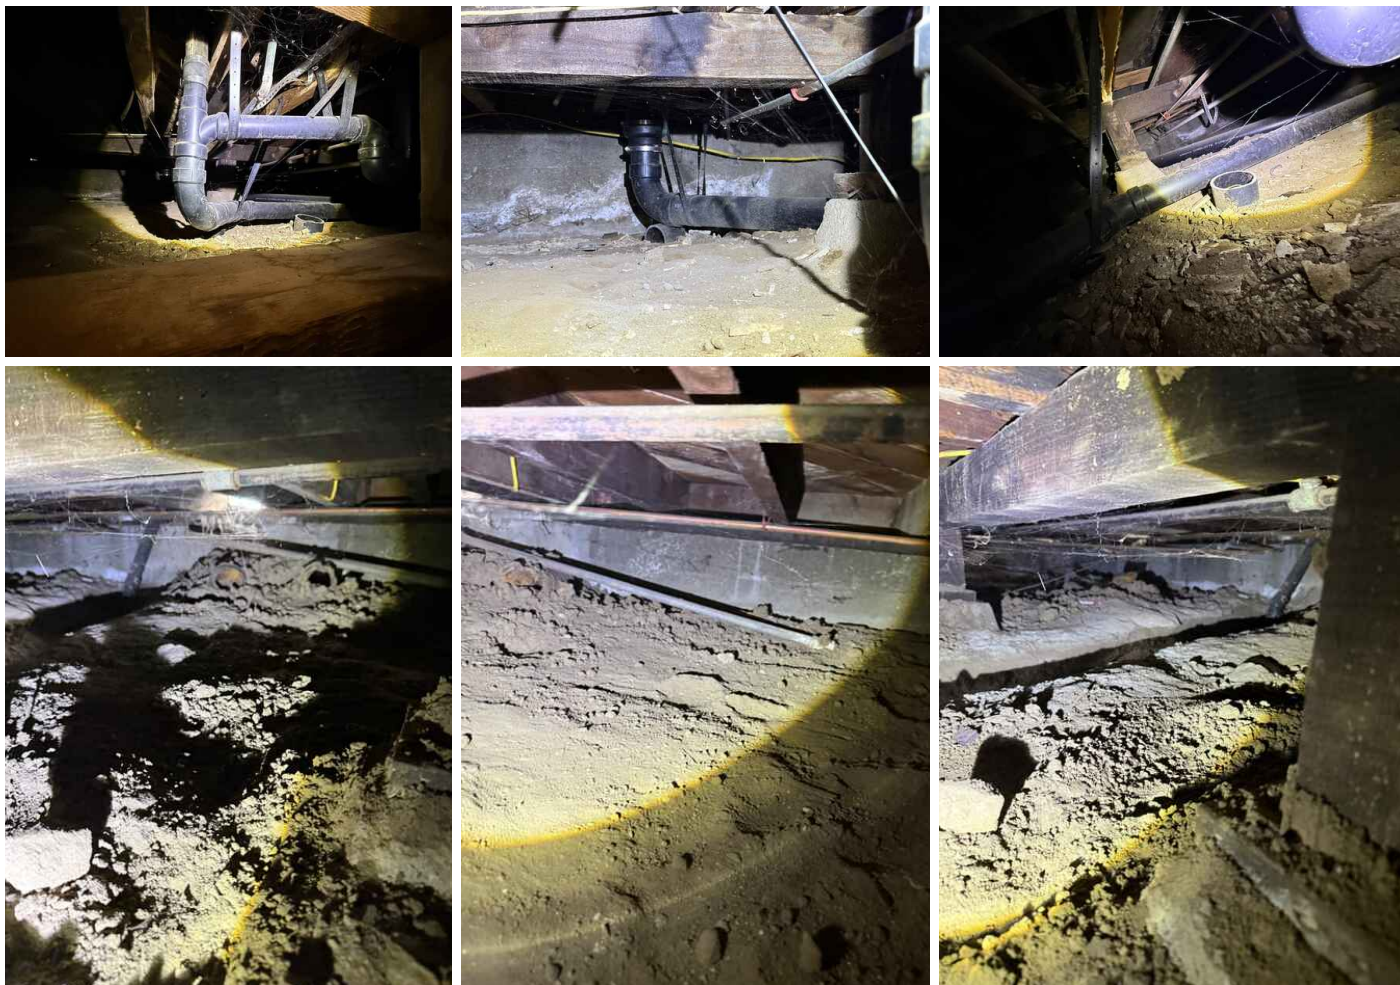
Under-Floor Crawlspace: Structural Components Inspected

Structural components were inspected according to the [Home Inspection Standards of Practice](#), including readily observed floor joists.

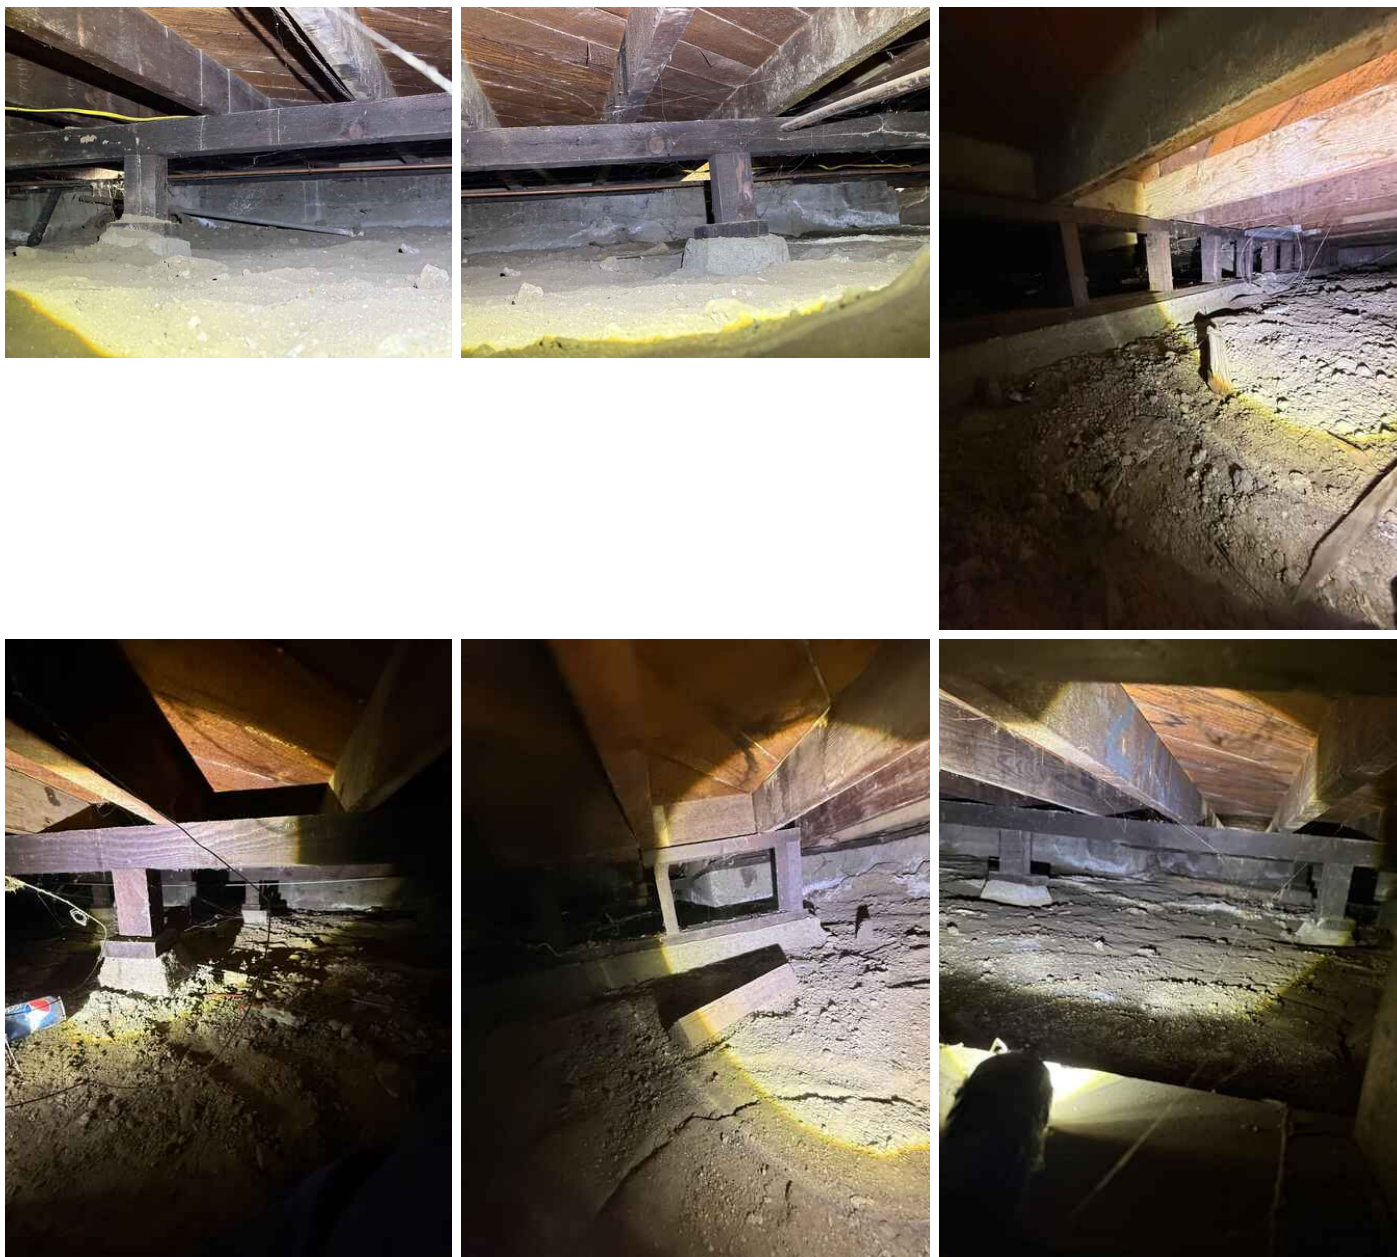
Insulation in Crawlspace: Approximate Average Depth of Insulation

missing insulation

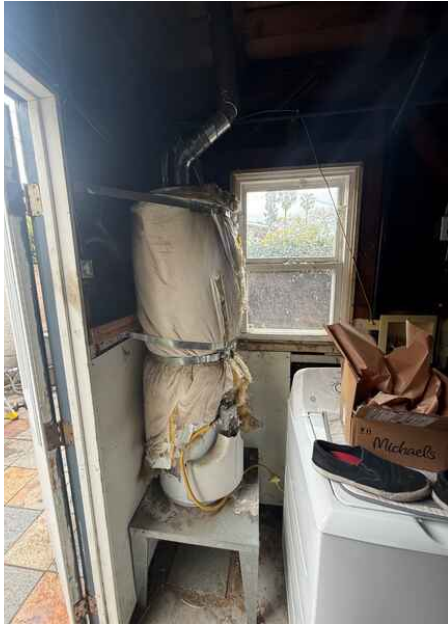
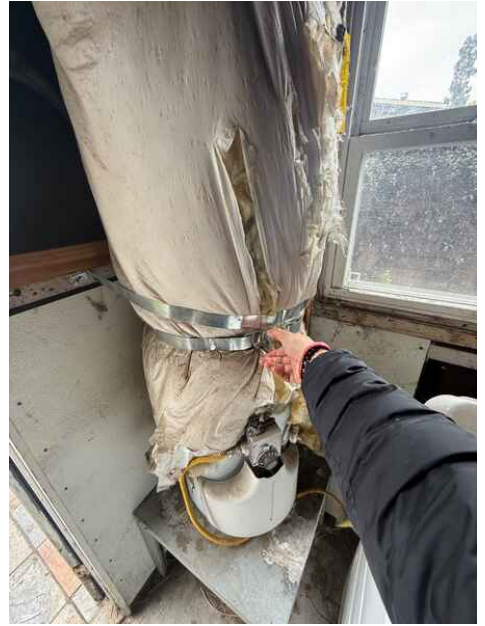
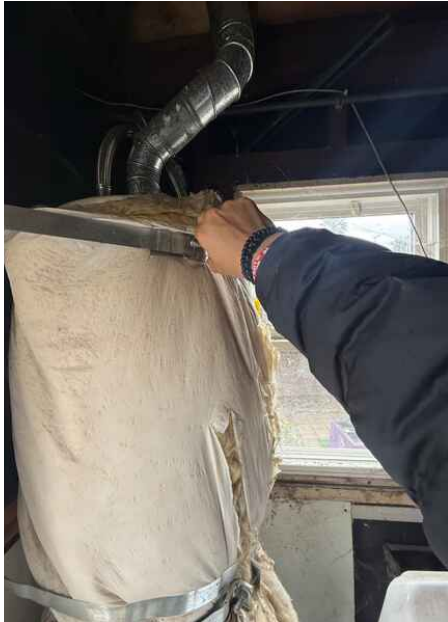
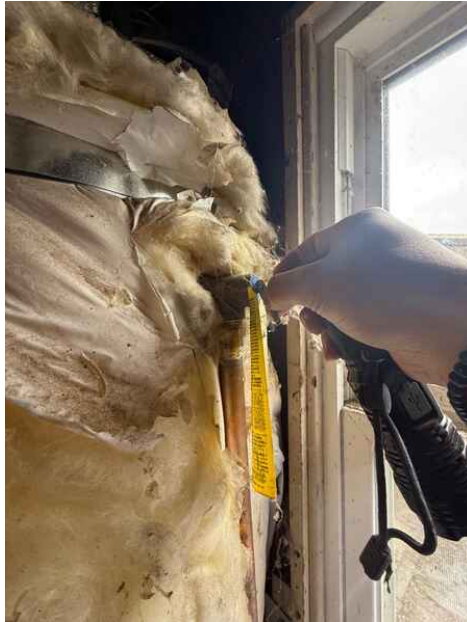
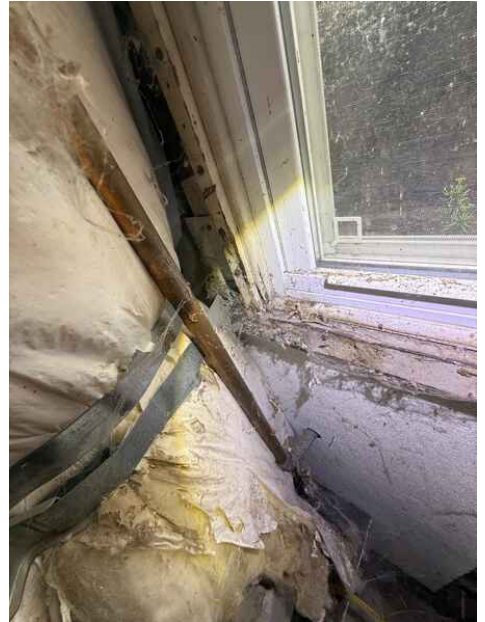
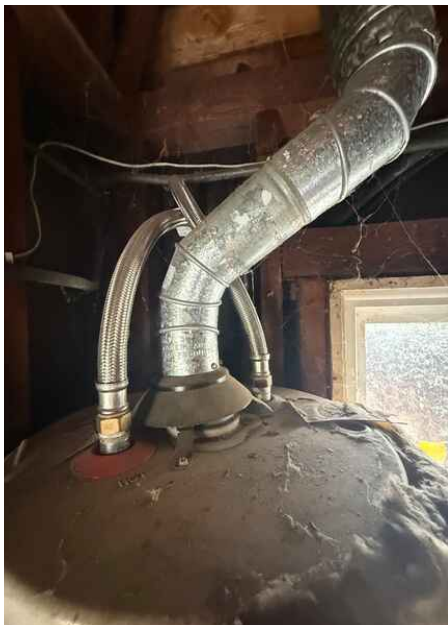
Hot Water Source: Hot Water Source, TPR Valve , Seismic Brace Venting Connections

I inspected the hot water source, TPR valve, venting connections, and seismic brace.

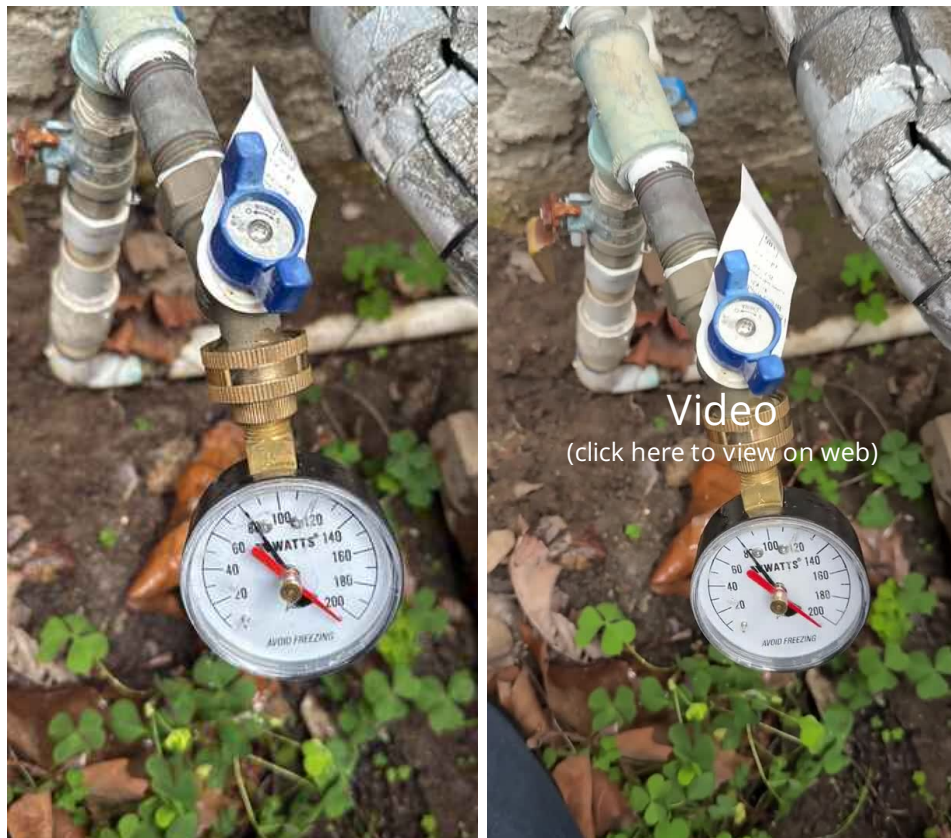
The reading of the water pressure is above normal standards. For residential homes, the ideal water pressure should be between 40 and 60 psi (pounds per square inch). Pressures above 60 psi can cause excessive wear and tear on plumbing fixtures and appliances, while pressures below 40 psi may not provide sufficient water flow. Most homeowners aim for a water pressure reading of around 50 psi for optimal performance.

Recommendation

Contact a qualified professional.

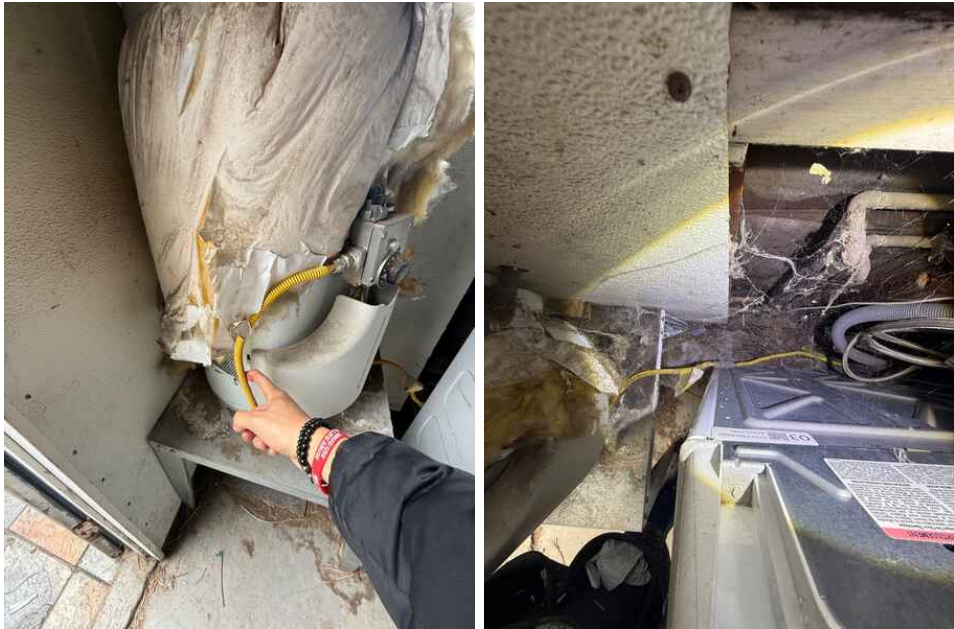
5.3.1 Hot Water Source

WATER HEATER - MISSING SEDIMENT TRAP

The sediment trap, required by current plumbing standards, is absent at the gas line serving the water heater. Sediment traps are designed to collect debris or sediment in the gas supply line to prevent damage to the gas control valve and ensure safe operation.

This could result in debris entering the gas valve, potentially causing operational issues or hazards.

Recommendation

Contact a qualified plumbing contractor.

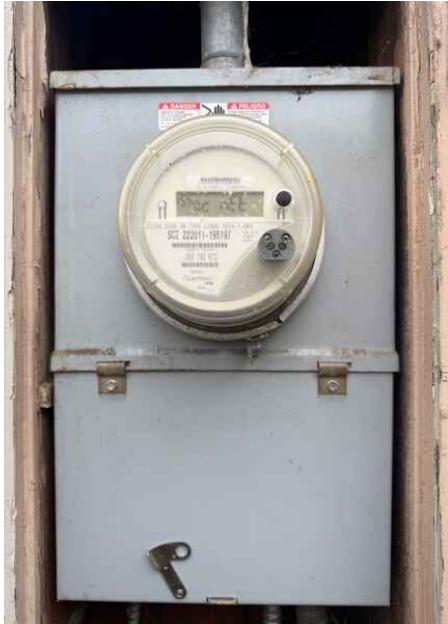
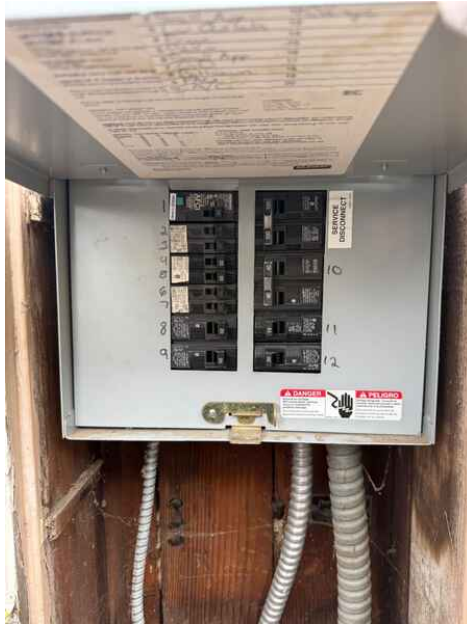
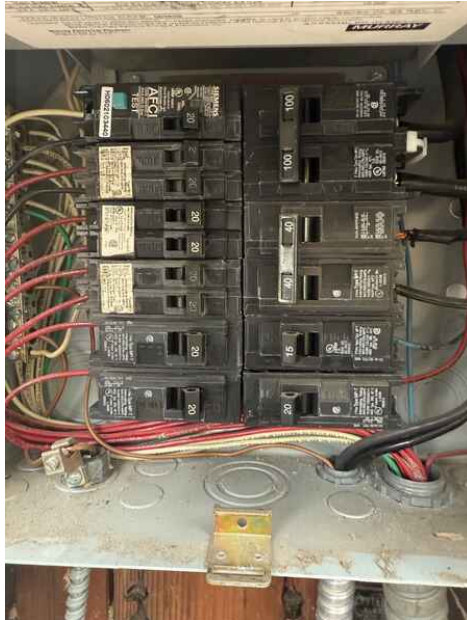
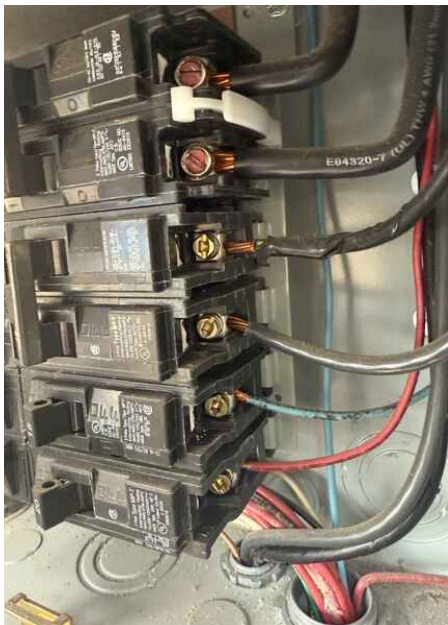
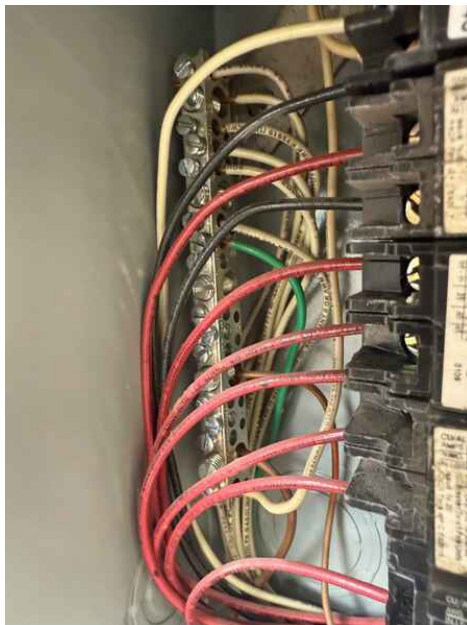
Panelboards & Breakers: Inspected Main Panelboard & Breakers

I inspected the electrical panelboards and over-current protection devices (circuit breakers and fuses).

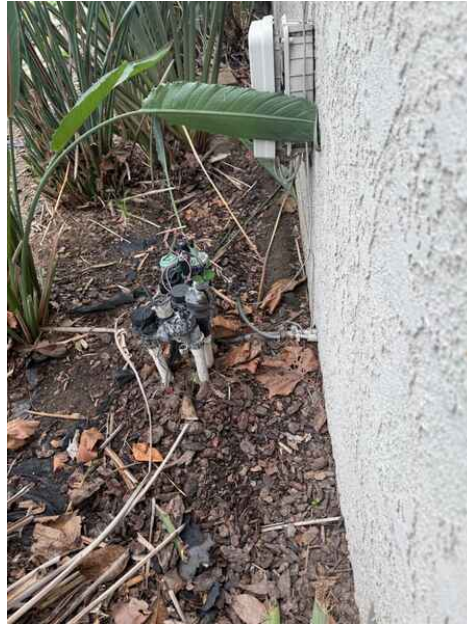
Service Grounding & Bonding: Inspected the Service Grounding & Bonding

I inspected the electrical service grounding and bonding.

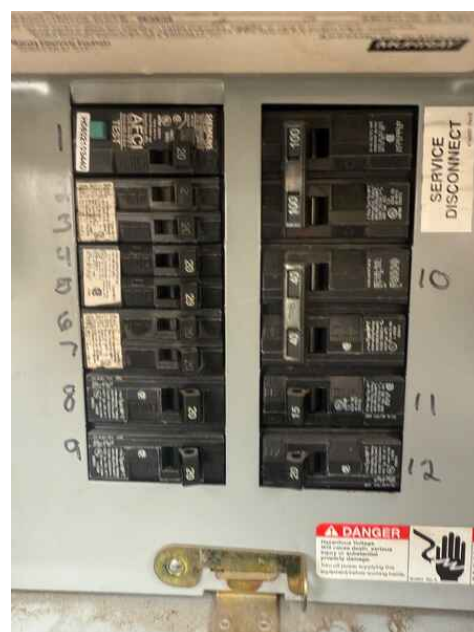
MISSING AFCI & GFCI BREAKERS

The electrical panel is missing Arc-Fault Circuit Interrupter (AFCI) breakers and Ground-Fault Circuit Interrupter (GFCI) breakers where they are typically required by modern electrical safety standards.

Recommendation

Contact a qualified professional.

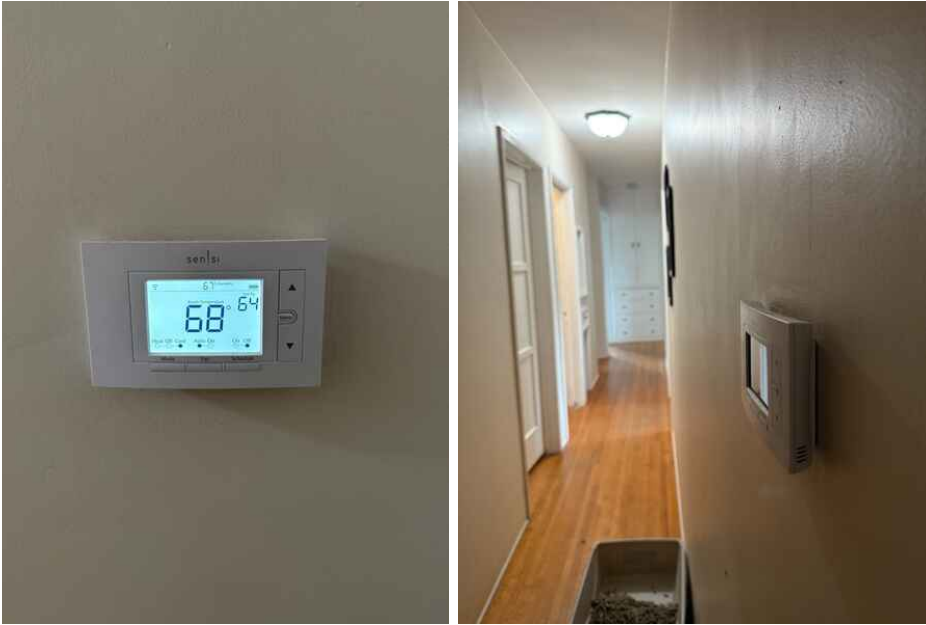
Thermostat and Normal Operating Controls: Thermostat

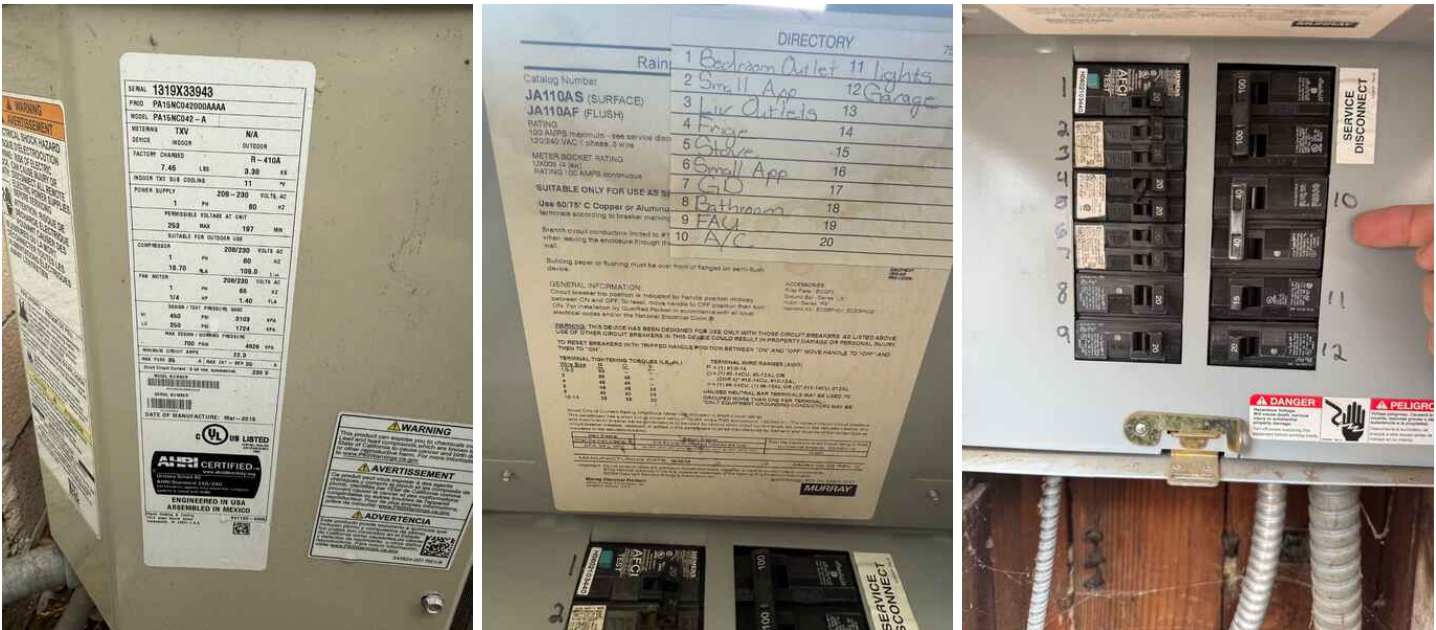
Repair Recommended

Recommendation:
A qualified electrician should evaluate and install the appropriately sized breaker as needed.

Recommendation
Contact a qualified professional.

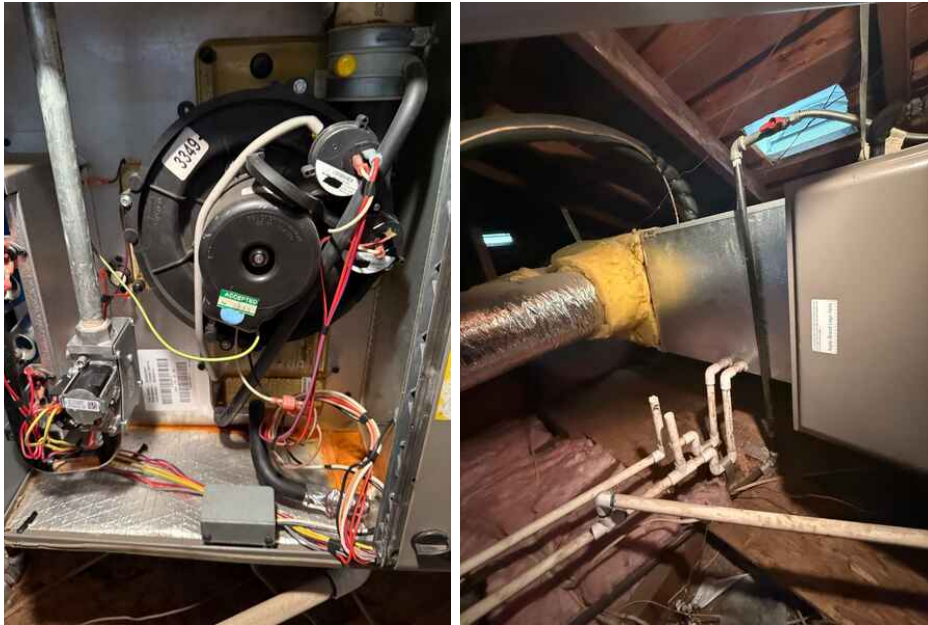
Heating System Information: Heating System Approximate Age

The serial number of the furnace is W0E9836716. Most HVAC manufacturers use the first four digits of the serial number to indicate the manufacturing date.

In W0E9836716, the second character is 0, which likely indicates the year 2020, and 98 is the production batch or unit number.

This furnace was manufactured in 2020, making it approximately 4 to 5 years old as of 2025.
