PARADIGM INSPECTION GROUP RESIDENTIAL HOME INSPECTION

1397 Ximeno Ave
Long Beach, CA 90804

MARCH 11, 2025

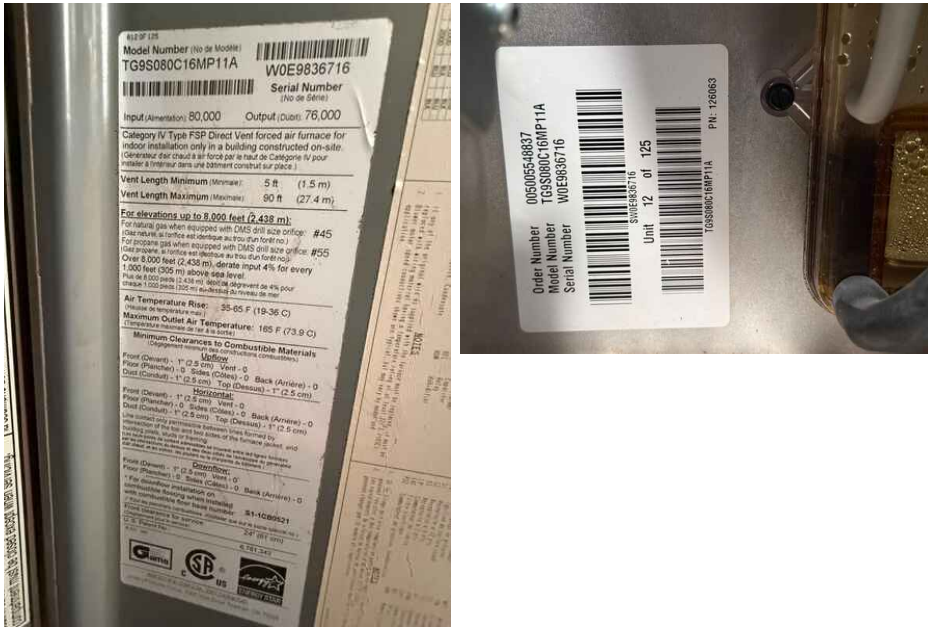
8.1.1 Heating System Information

GAS LINE OBSERVATION: MISSING SEDIMENT TRAP

The gas line serving the furnace does not have a sediment trap installed. A sediment trap is designed to capture debris and moisture from the gas supply, preventing potential damage to the furnace's components.

Implication: Without a sediment trap, contaminants in the gas line could enter the furnace, potentially leading to operational issues or premature wear.

Recommendation: Consult a licensed plumber or HVAC technician to install a sediment trap in accordance with current standards and manufacturer requirements.

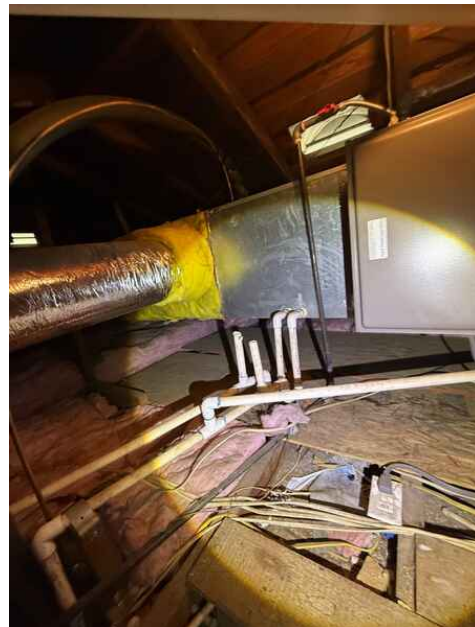
8.1.2 Heating System Information

MISSING CONDENSATION DRAIN PAN

The furnace is installed without a catch pan (condensate drain pan) beneath it. The absence of a catch pan is a defect, particularly given the furnace's location in an attic space where any leaks could cause significant water damage to the structure below.

It is recommended to have a licensed HVAC technician install a catch pan with a proper drain line beneath the furnace to prevent potential water damage. This is especially important in attic installations where leaks can lead to costly repairs.

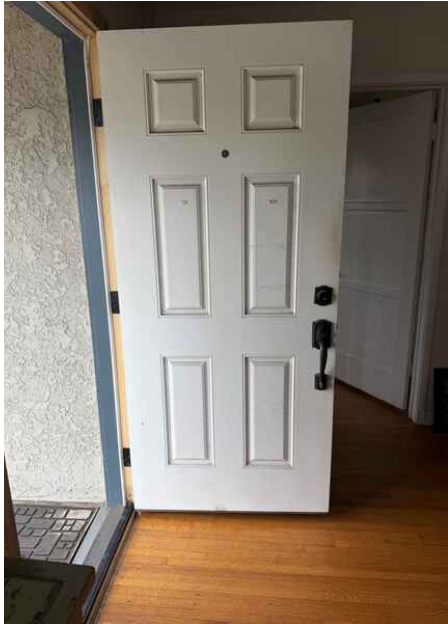
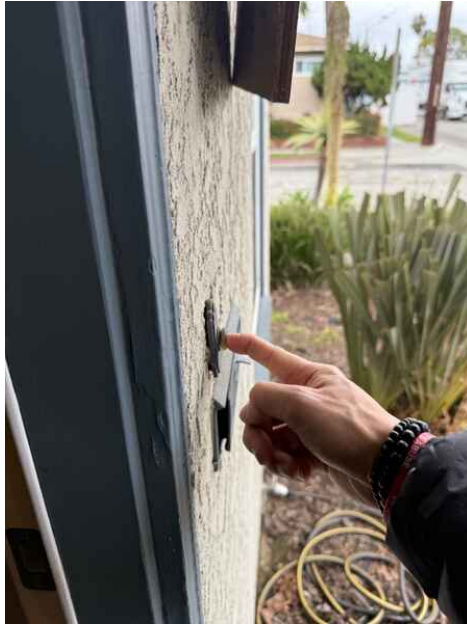
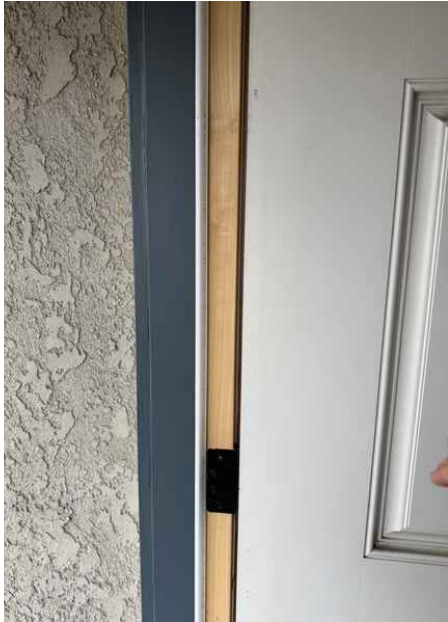
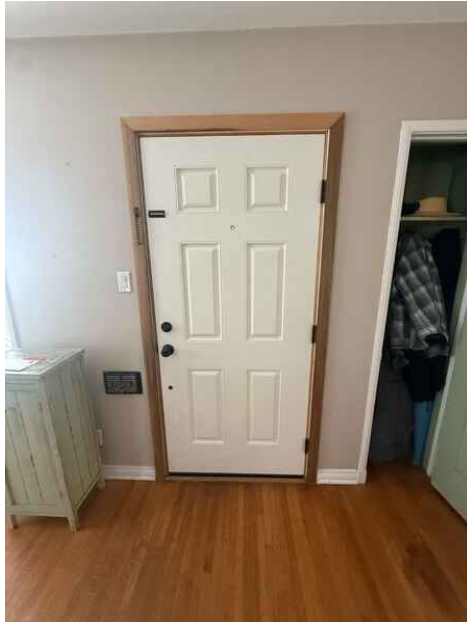
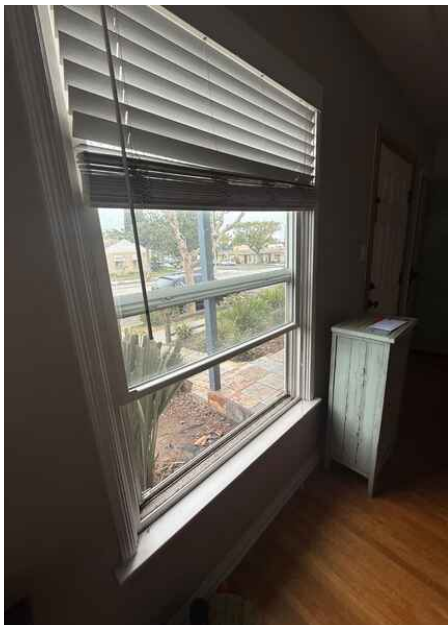
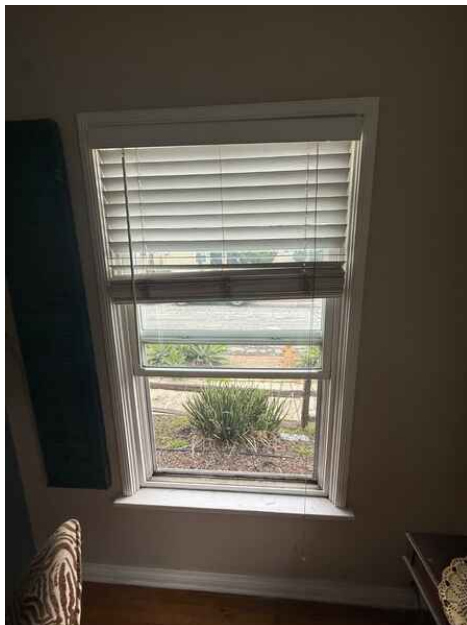
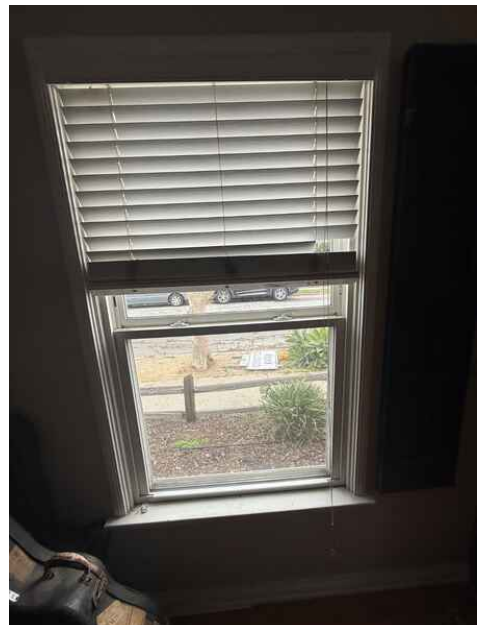
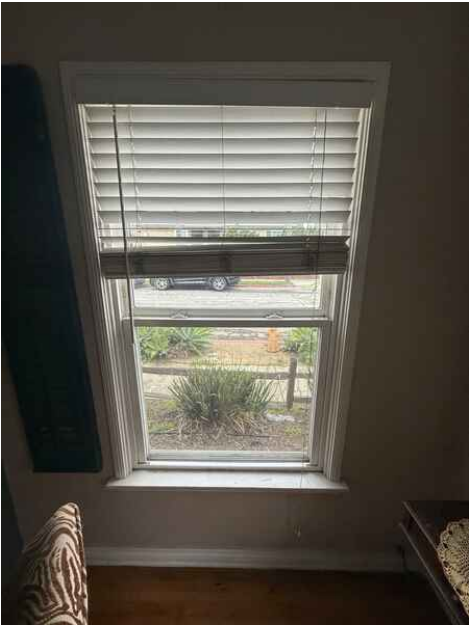
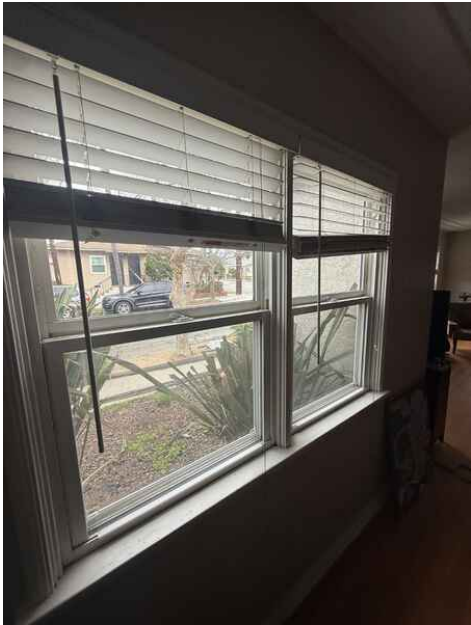
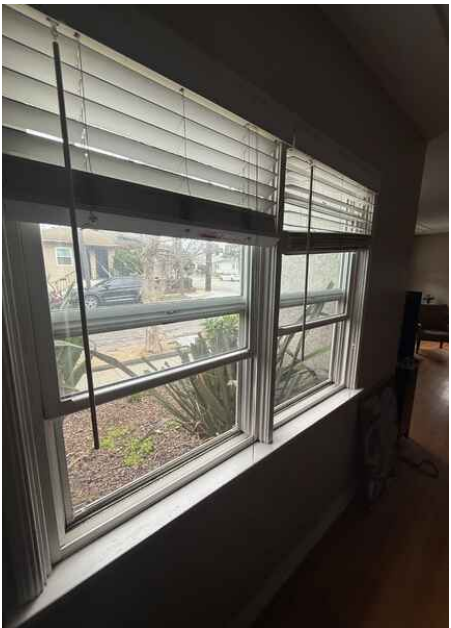
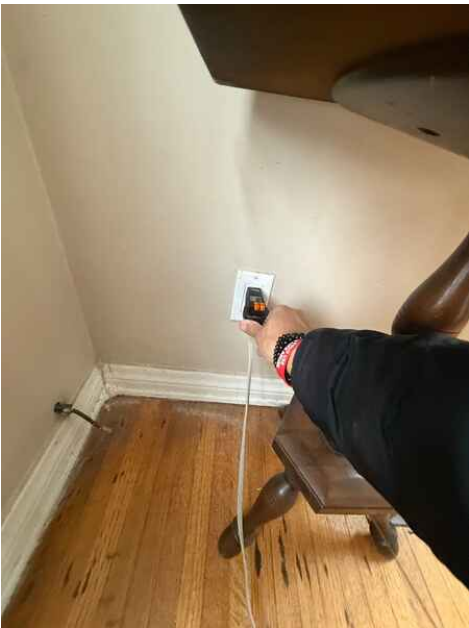
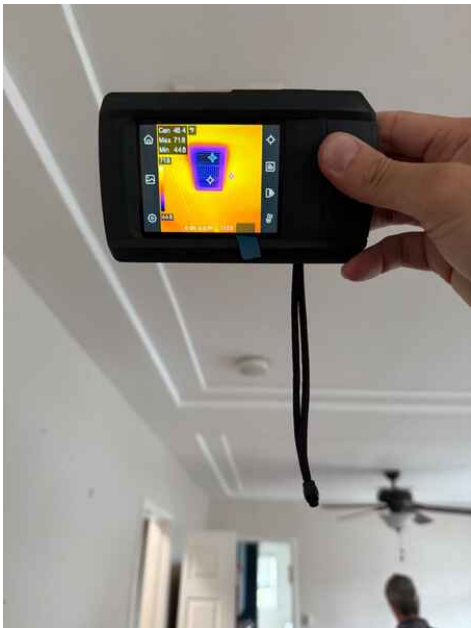
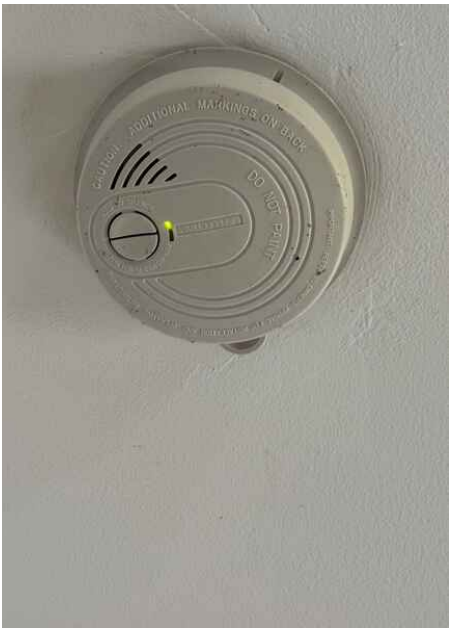
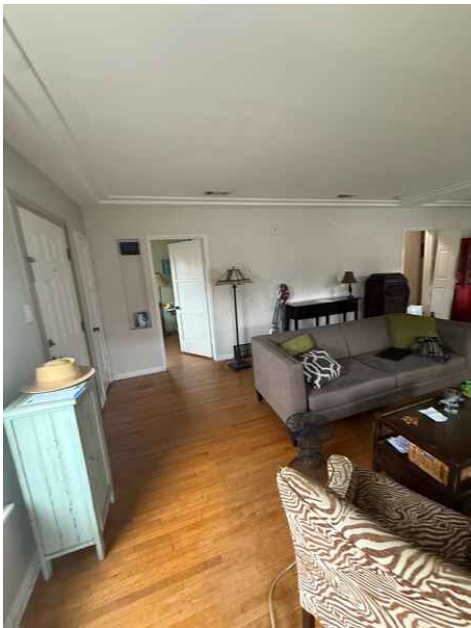
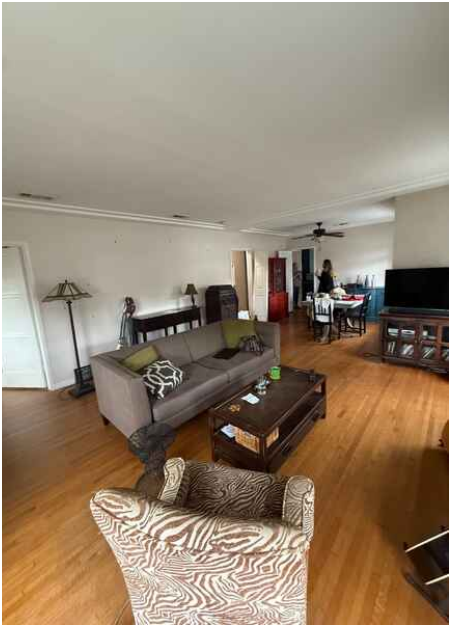
General: Living Room

Living room was inspected.

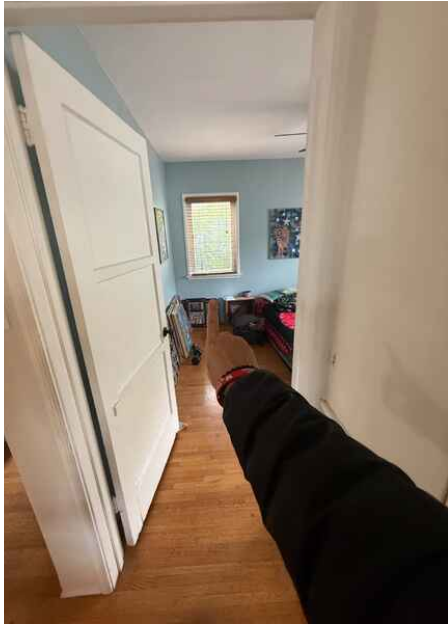
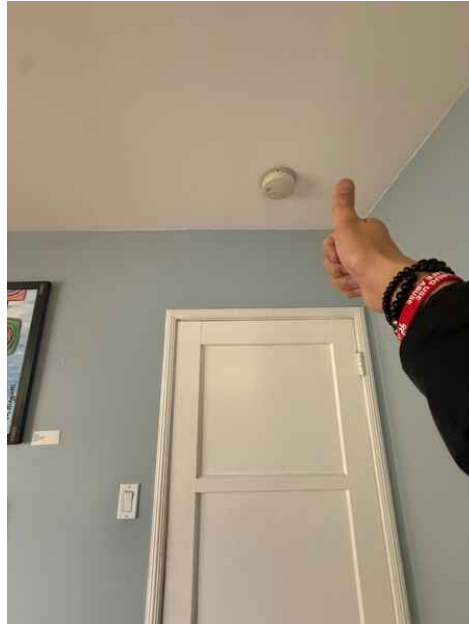
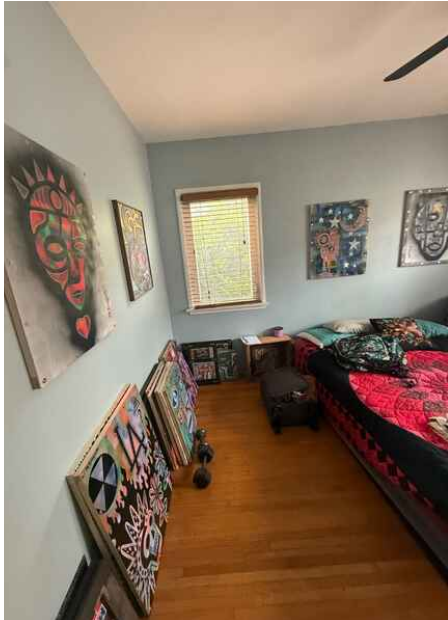
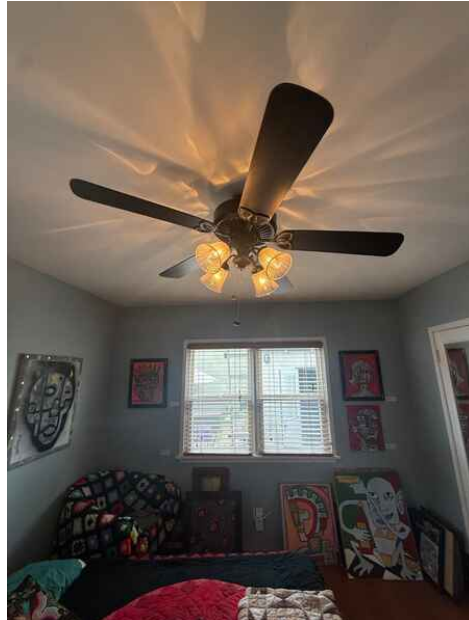
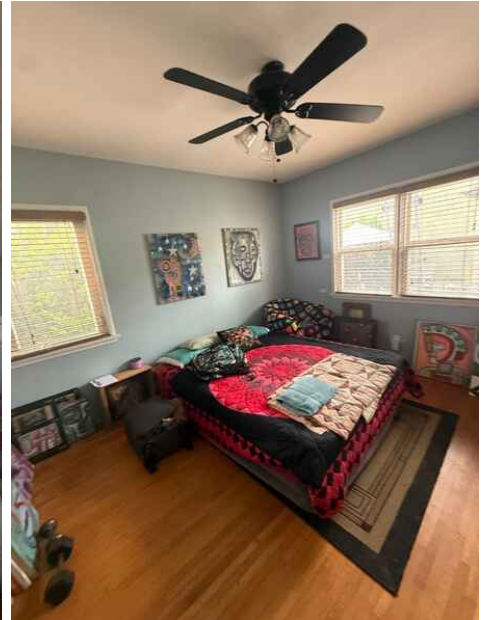
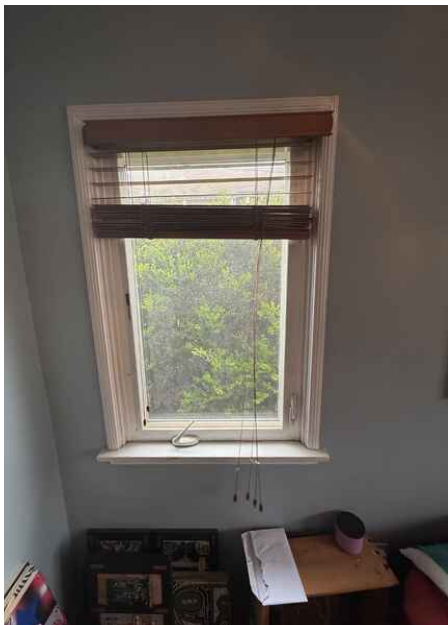
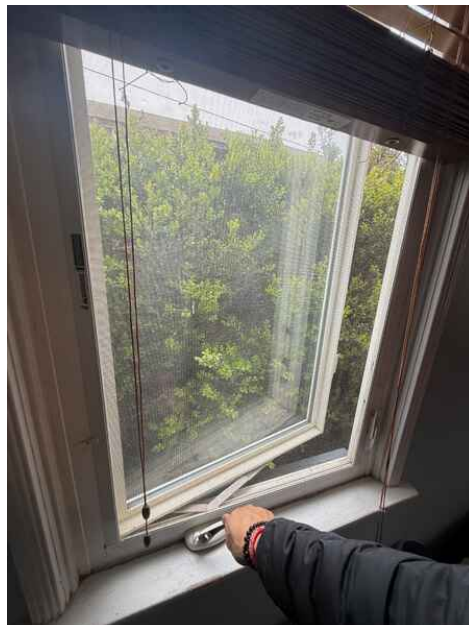
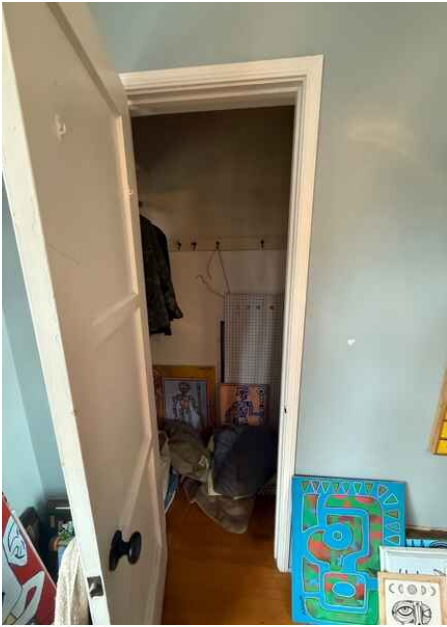
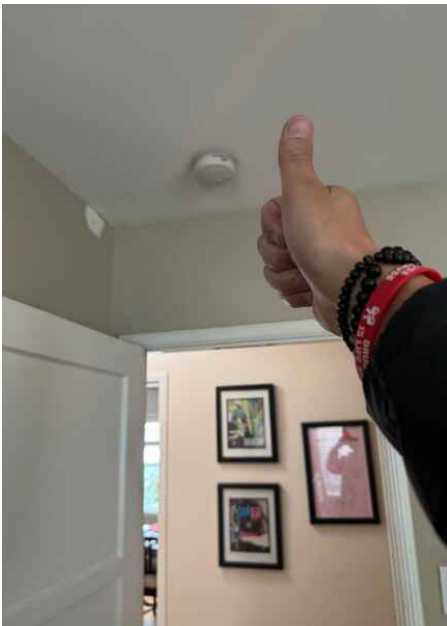
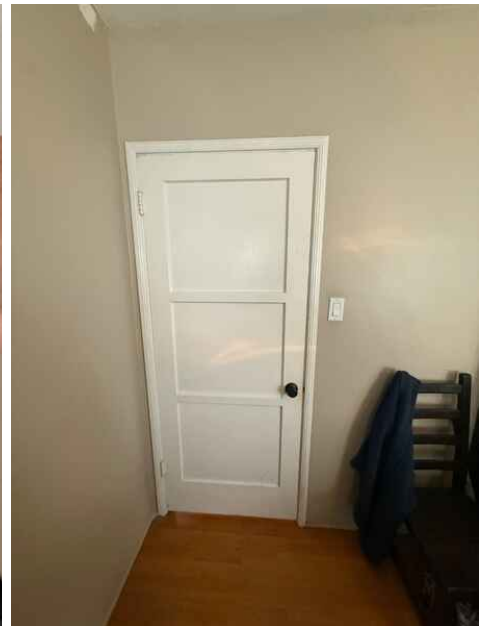
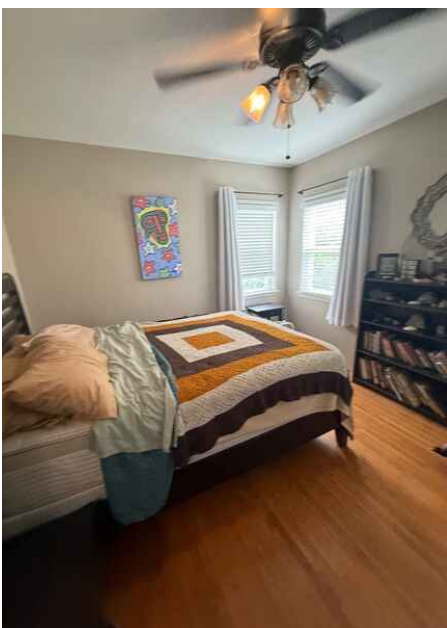
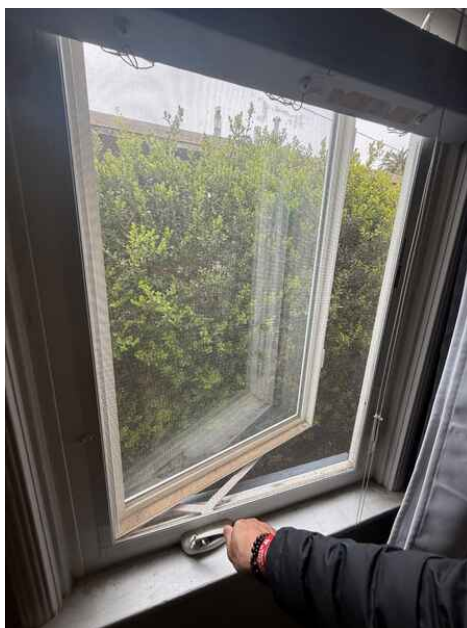
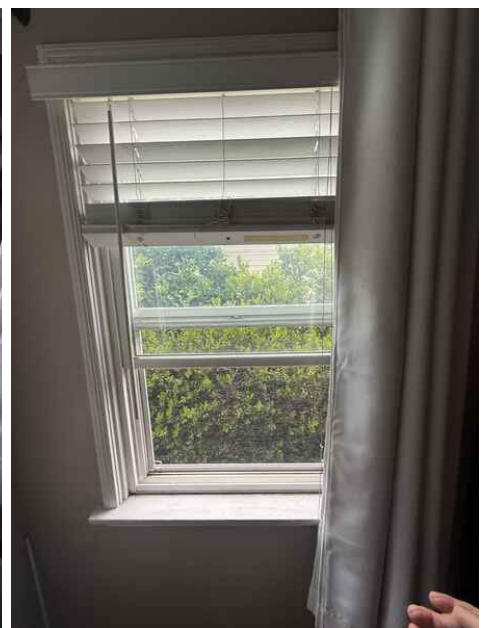
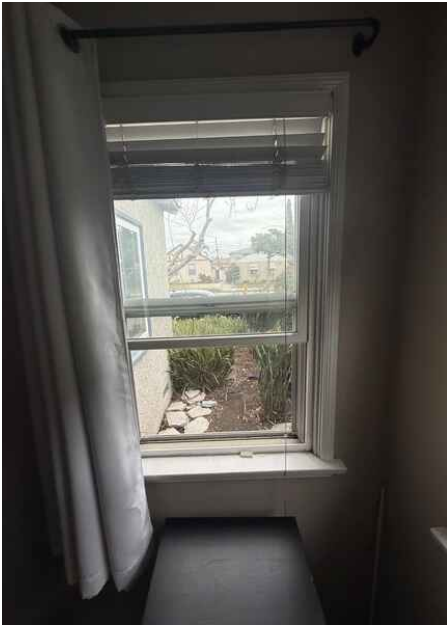
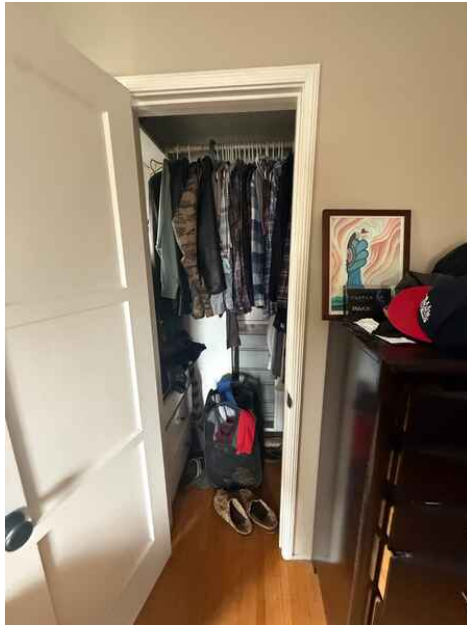
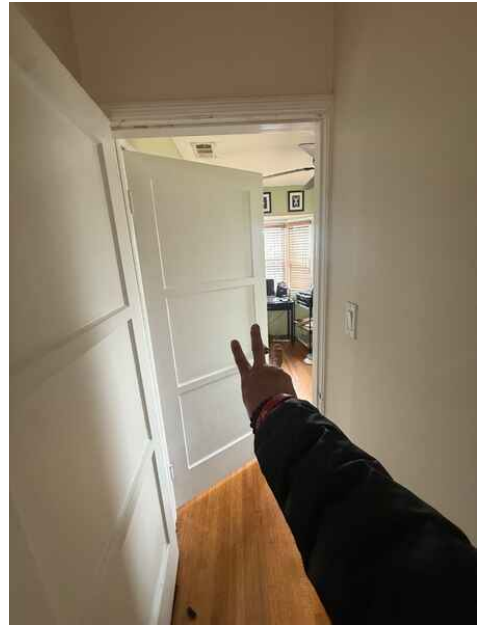
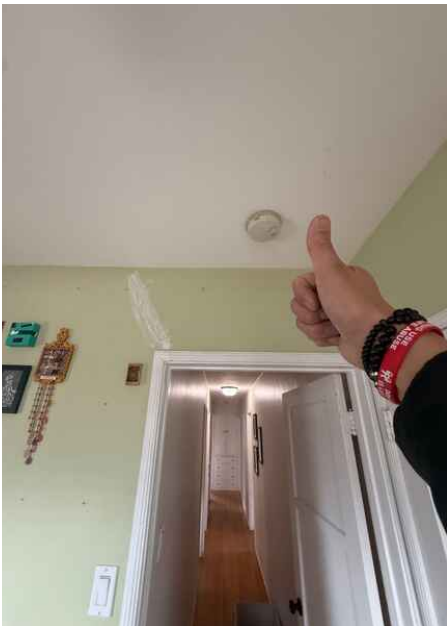
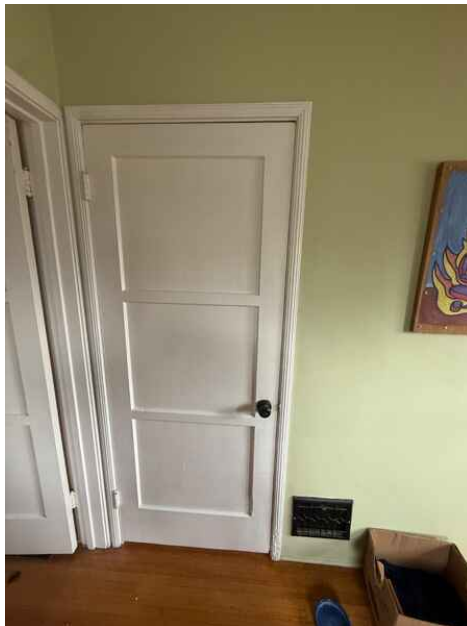
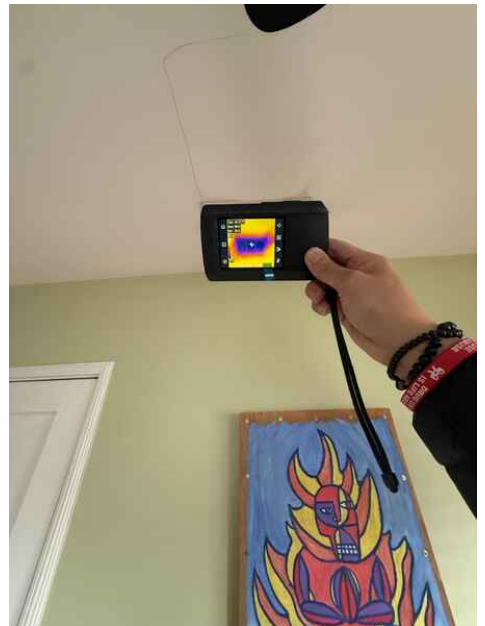
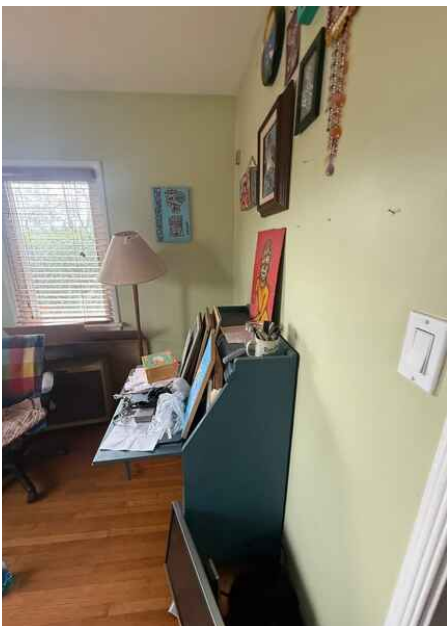
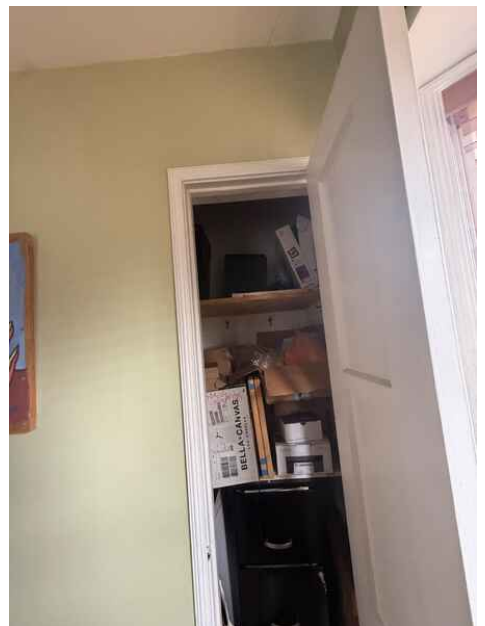
General: Bedroom(s)

Bedrooms was inspected.

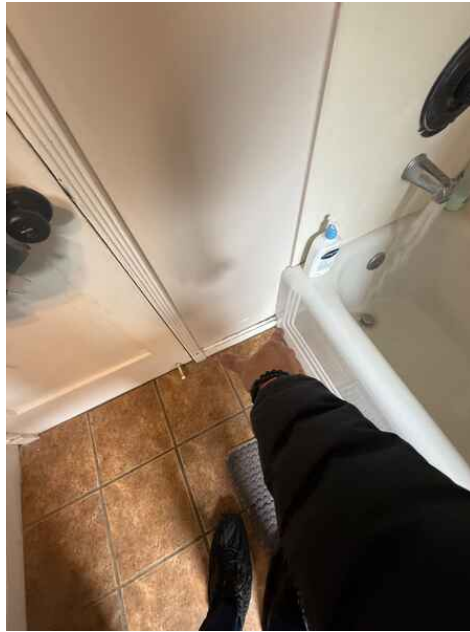
14.7.2 Cabinetry, Ceiling, Walls & Floor

CRACKED FLOORING TILES

Observed cracks on the tile. Repair recommended.

Recommendation

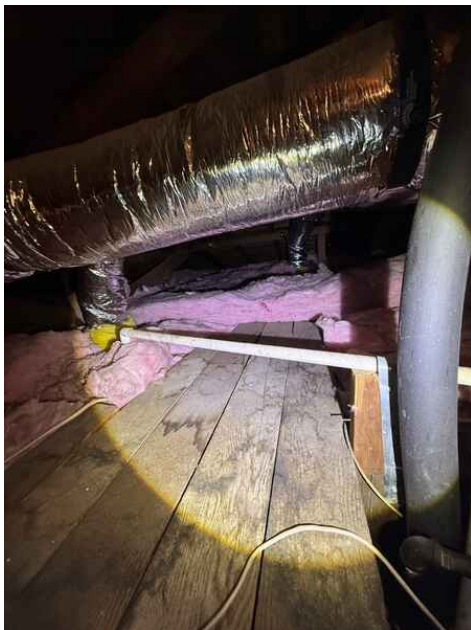
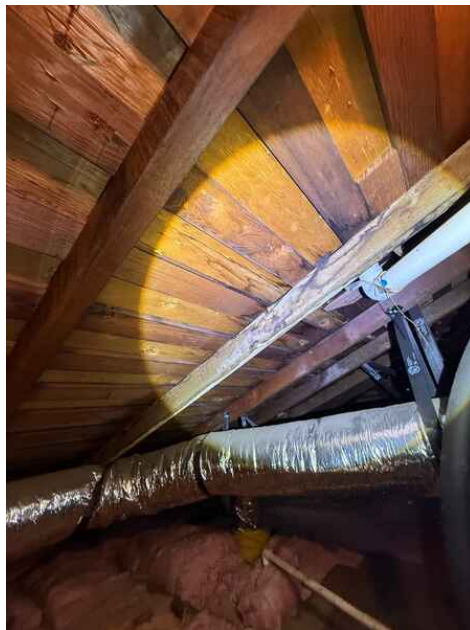
Observed discoloration on the wood. Possibly related to moisture. No current leak observed. Please also ask seller for overall and past performance.

Recommendation

Contact a qualified professional.

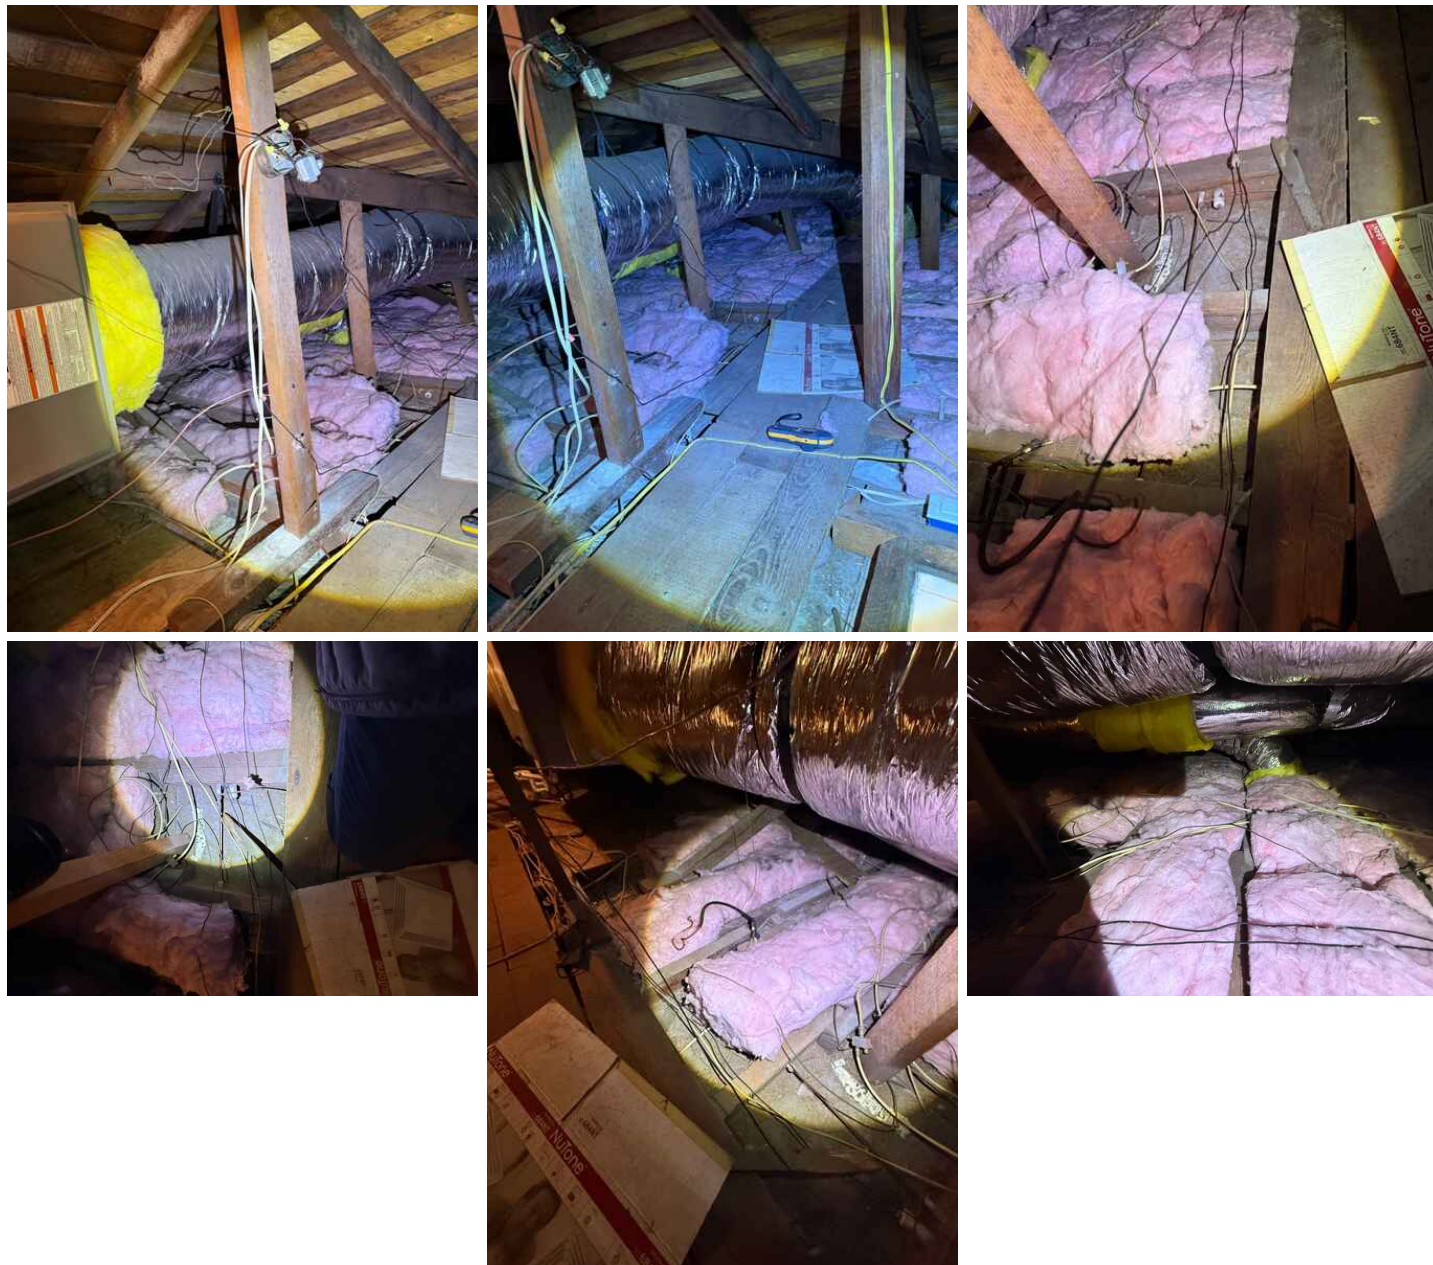
15.1.2 Structural Components & Observations in Attic

EXPOSED AND UNSECURED ELECTRICAL WIRING IN ATTIC

Observation: Electrical wiring is exposed and loosely secured throughout the attic. Some wires appear to be unsupported, improperly terminated, or lacking protective conduit.

Recommendation: A qualified electrician should evaluate and address as needed.

Recommendation

Contact a qualified professional.

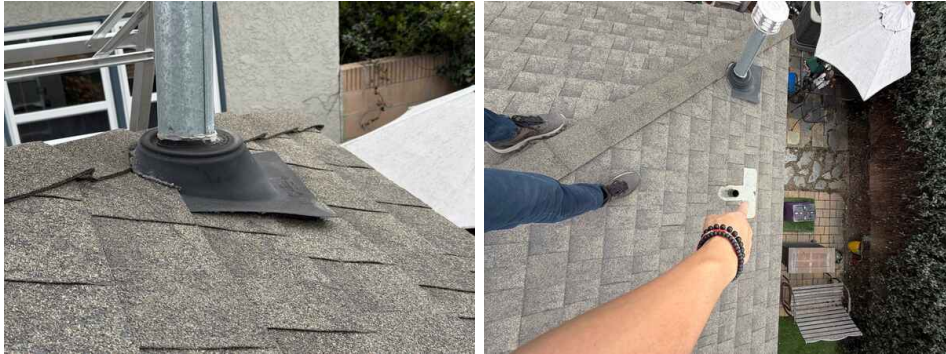
DETERIORATED/LOOSE ROOF PIPE BOOT FLASHING

Recommendation: A qualified roofing professional should evaluate and address as needed.

Recommendation

Contact a qualified professional.
